**FOURTH FIVE-YEAR REVIEW REPORT FOR
BUCKINGHAM COUNTY LANDFILL SUPERFUND SITE
DILLWYN, VIRGINIA**

**U.S. Environmental Protection Agency
Region 3
Philadelphia, Pennsylvania**

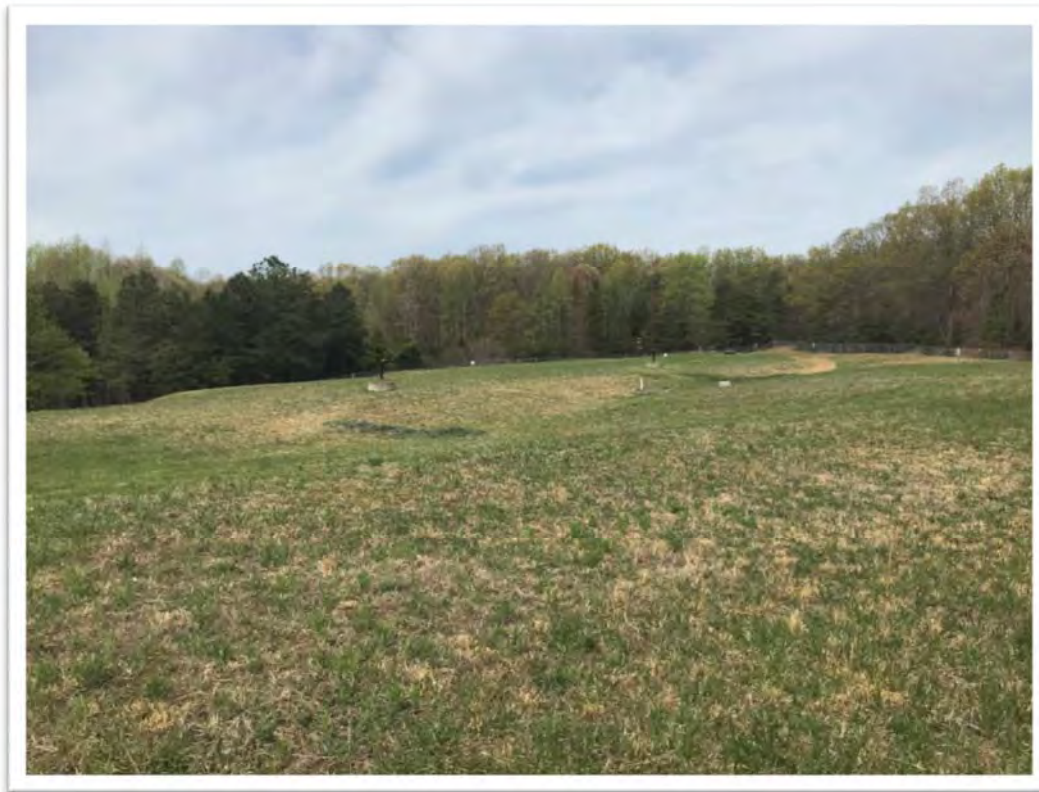
Photo: 001 Date: 04/23/18 Description: Facing northwest at Landfill. Landfill grass cover.
Photographer: [REDACTED]

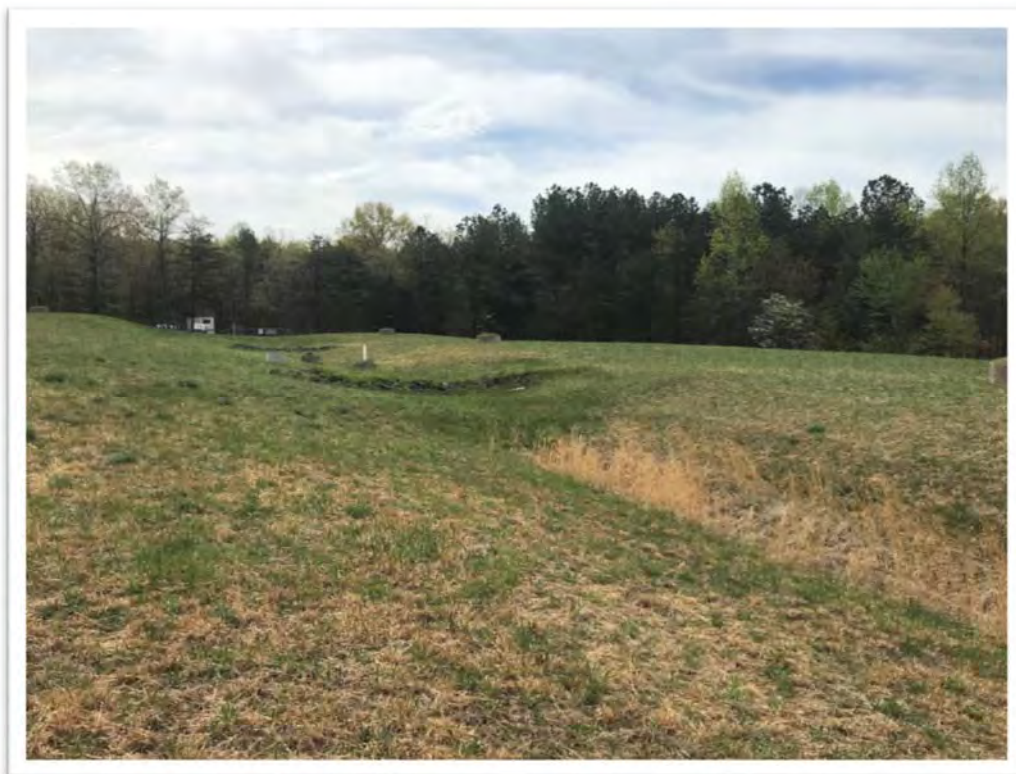
Photo: 002 Date: 04/23/18 Description: Facing southeast at Landfill. Landfill grass cover.
Photographer: [REDACTED]

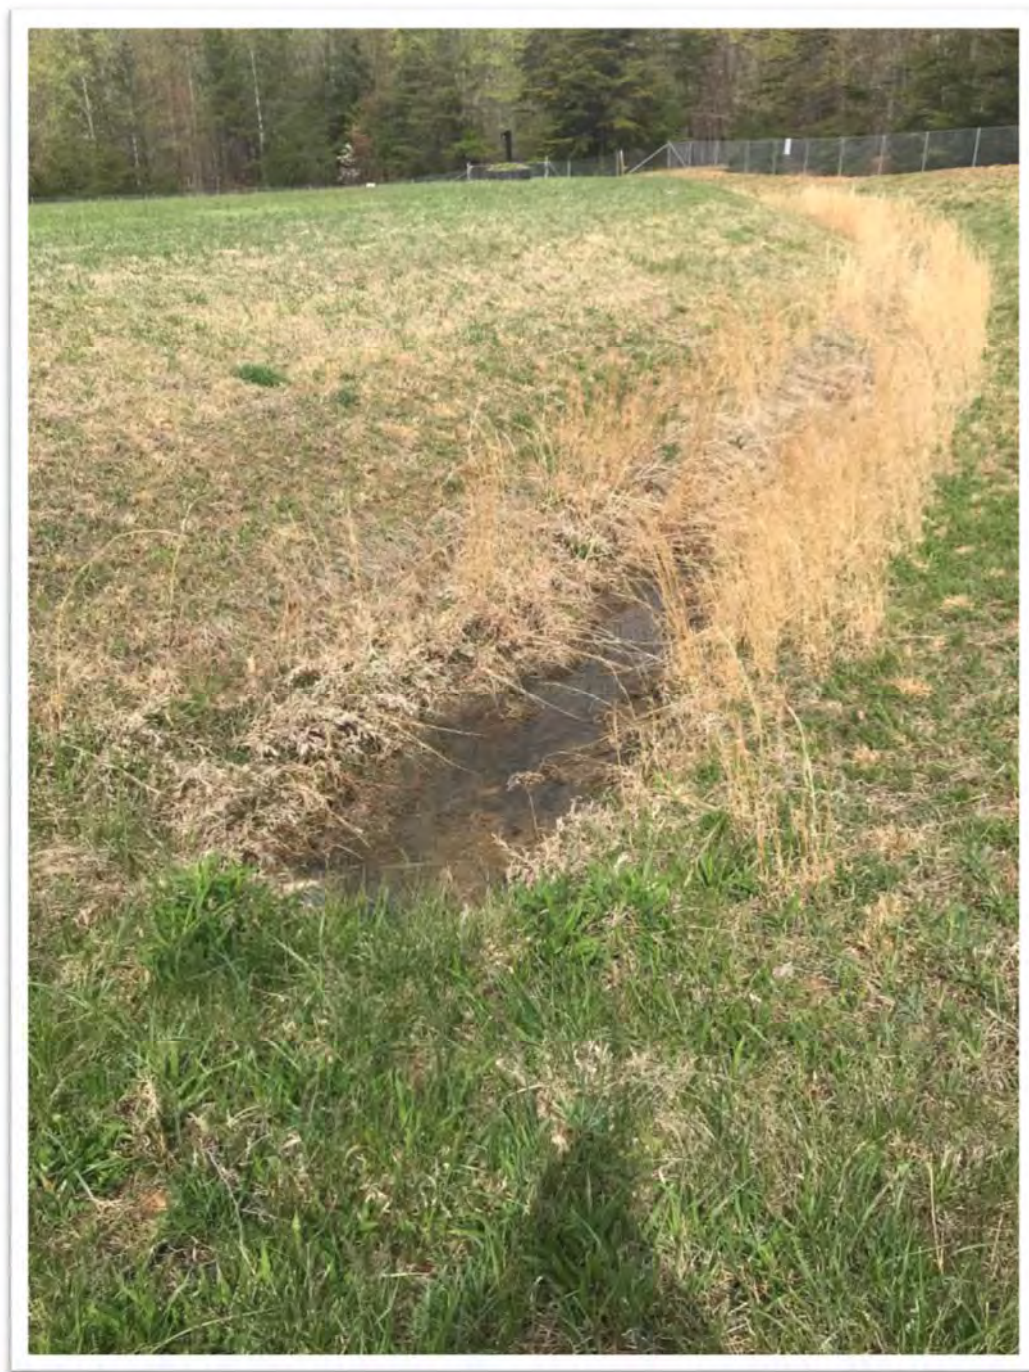
Photo: 003 **Date:** 04/23/18 **Description:** Facing northwest at Landfill. Standing water in drainage swale. **Photographer:** [REDACTED]

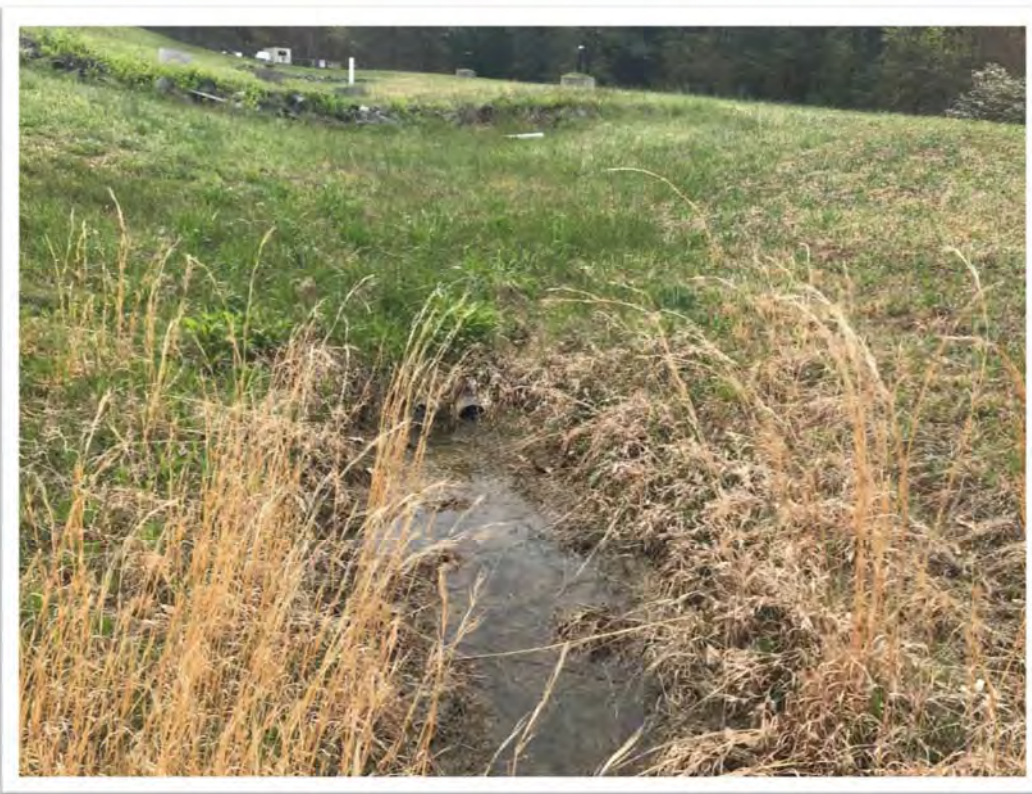
Photo: 004 Date: 04/23/18 Description: Clogged drainage pipe located at the northern portion of Landfill. **Photographer:** [REDACTED]

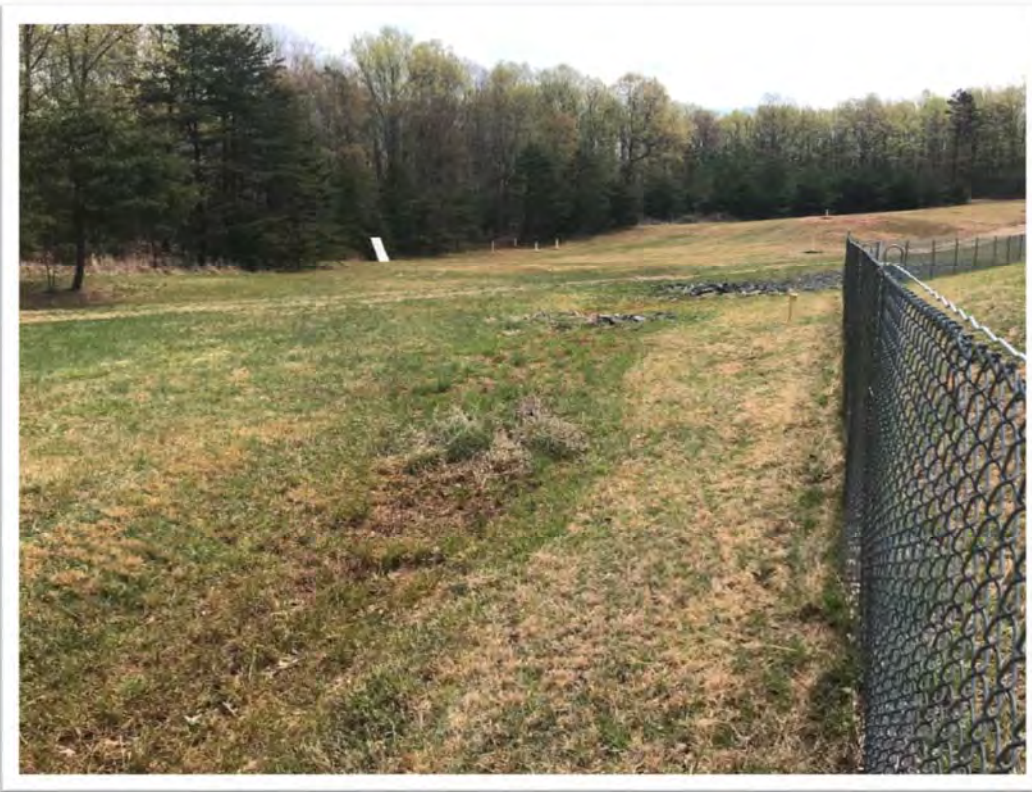
Photo: 005 Date: 04/23/18 Description: Facing west at outside of northern edge of landfill. Overgrown drainage path. **Photographer:** [REDACTED]

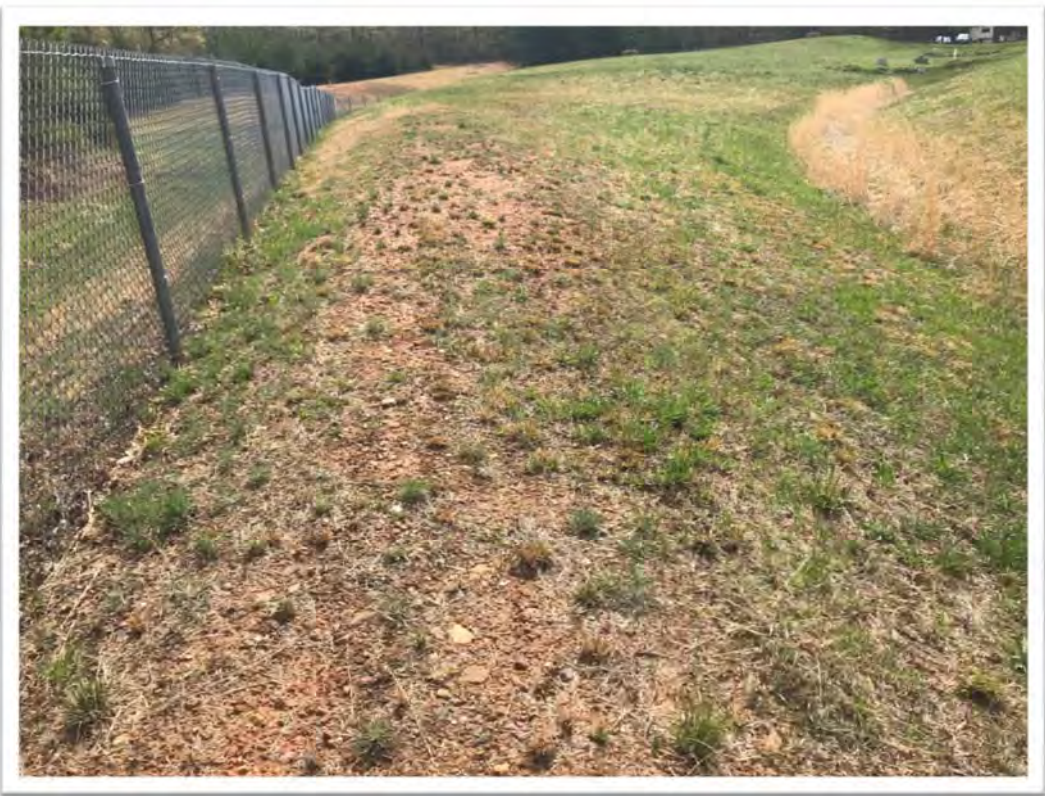
Photo: 006 Date: 04/23/18 Description: Facing west at inside of norther edge of landfill. Bare grass spot. **Photographer:** [REDACTED]

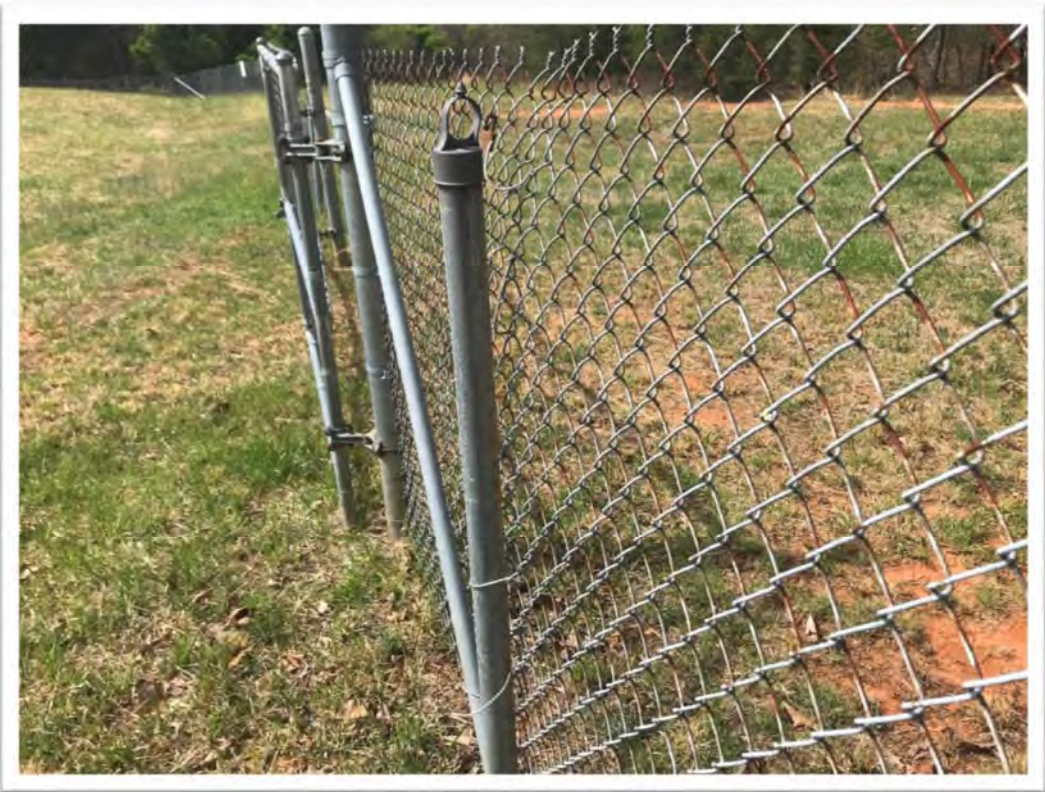
- A loose fence pole at the northwestern edge of the landfill and a damaged portion of fence in the southeast corner of the landfill require repair;
- MW-3B within the landfill fence line is missing a monitoring well cap and lock;
- The protective concrete ring around MW-2SU is damaged;
- MW-7S was not locked;
- The well pad for MW-25SL is cracked.

Photo: 007 Date: 04/23/18 Description: Loose fence pole at northwestern edge of landfill. **Photographer:** [REDACTED]

Buckingham County is responsible for maintenance of the fence. EPA will notify Buckingham County of the portions of the fence requiring repair. During LTGWMP sampling in June 2018, EHS Support replaced the well cap and lock for both MW-3B and MW-7S. EHS Support indicated to EPA that repair of the concrete pads around MW-2SU and MW-25SL was scheduled to occur during upcoming monitoring well installation activities at the Site.

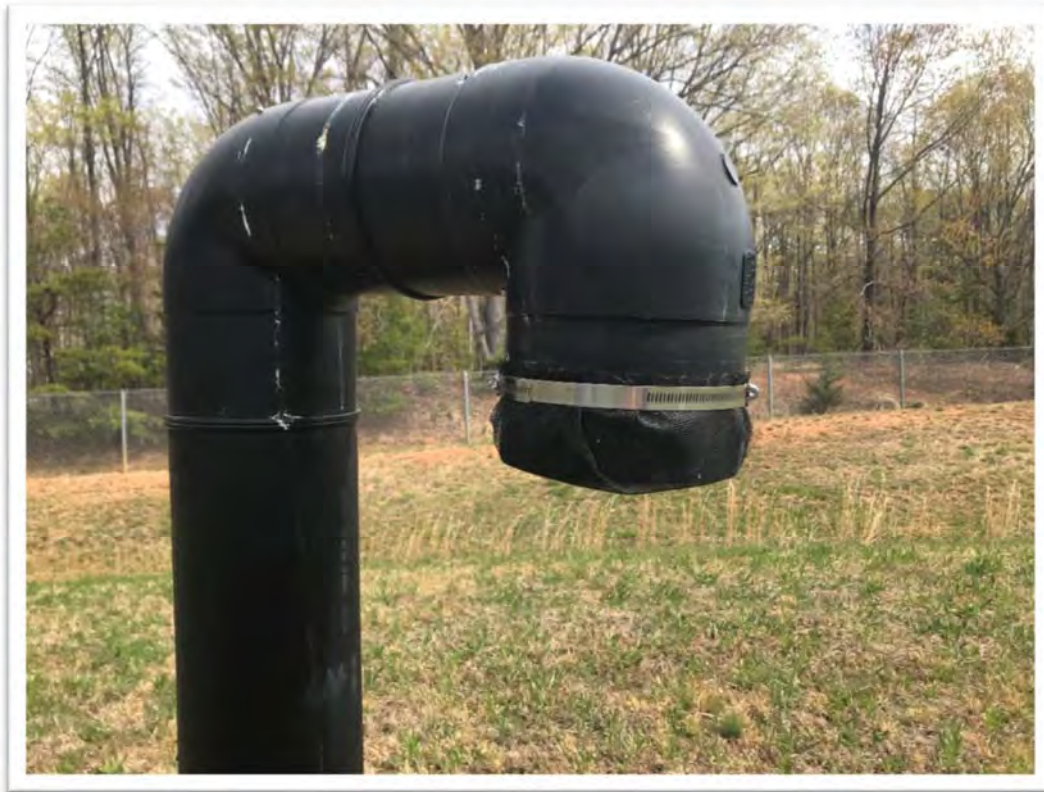
Photo: 009 Date: 04/23/18 Description: On Landfill. Gas vent, GV-4, in good condition.
Photographer: [REDACTED]

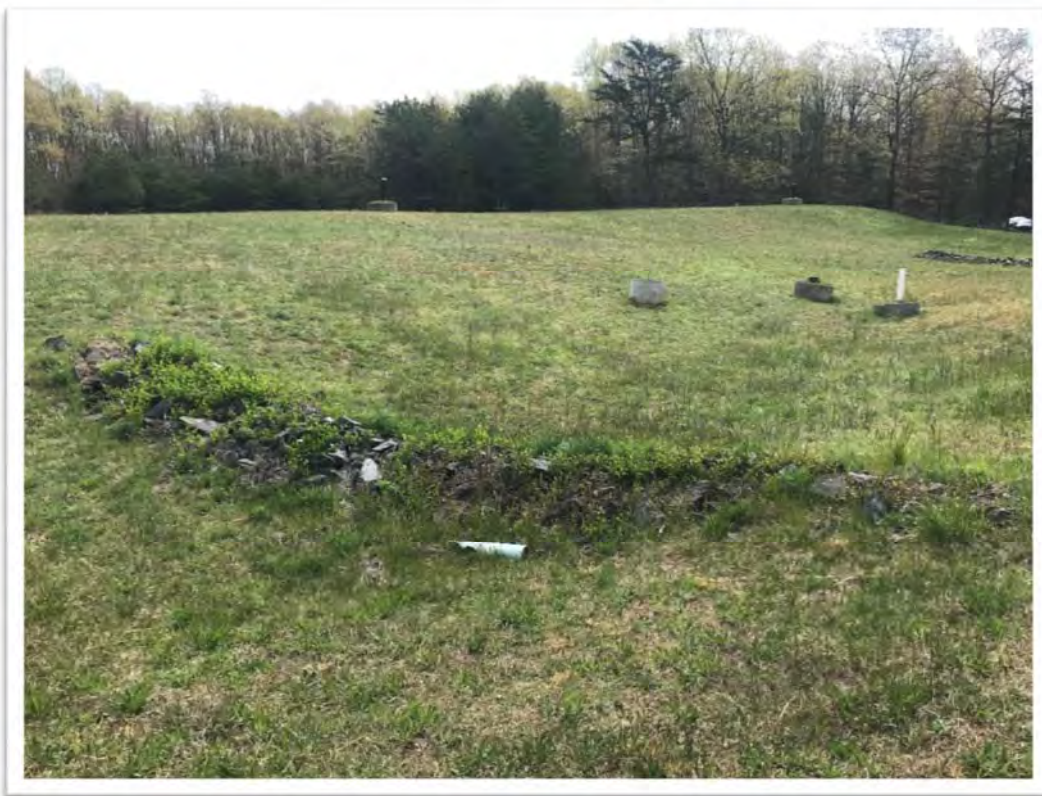
Photo: 010 Date: 04/23/18 Description: Near MW-2SU. Overgrown vegetation within rock dam.
Photographer: [REDACTED]

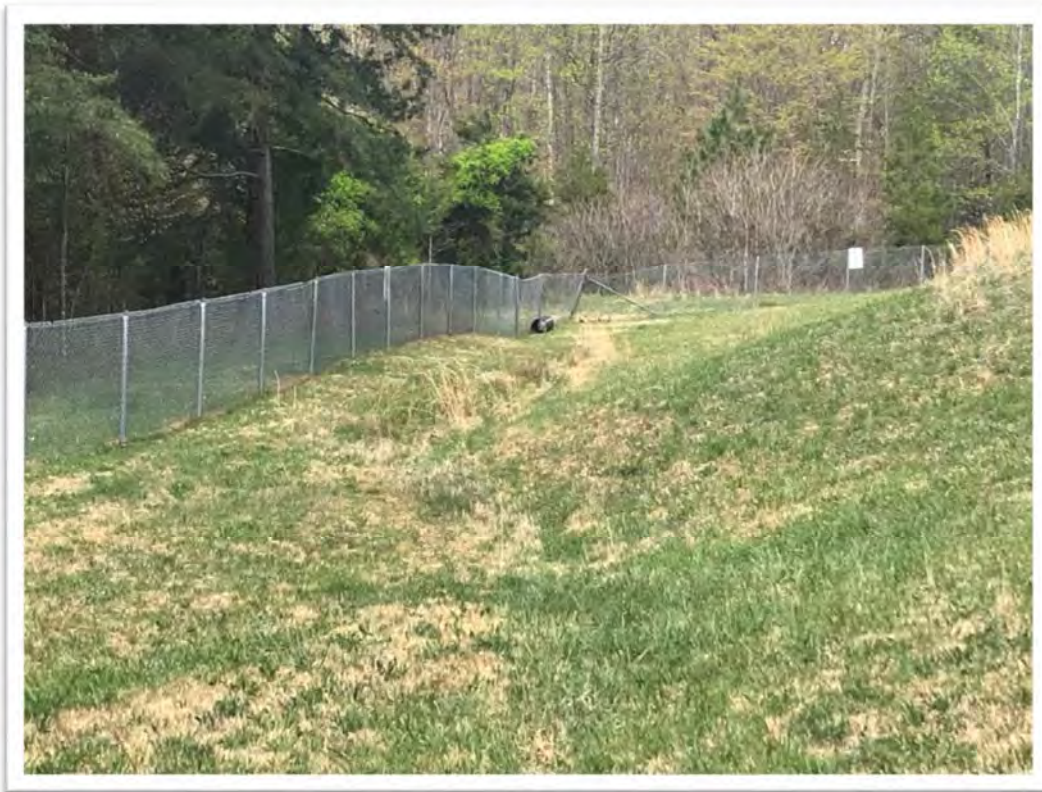
Photo: 011 Date: 04/23/18 Description: Near MW-2SU. Overgrown vegetation in southeast corner of landfill. **Photographer:** [REDACTED]

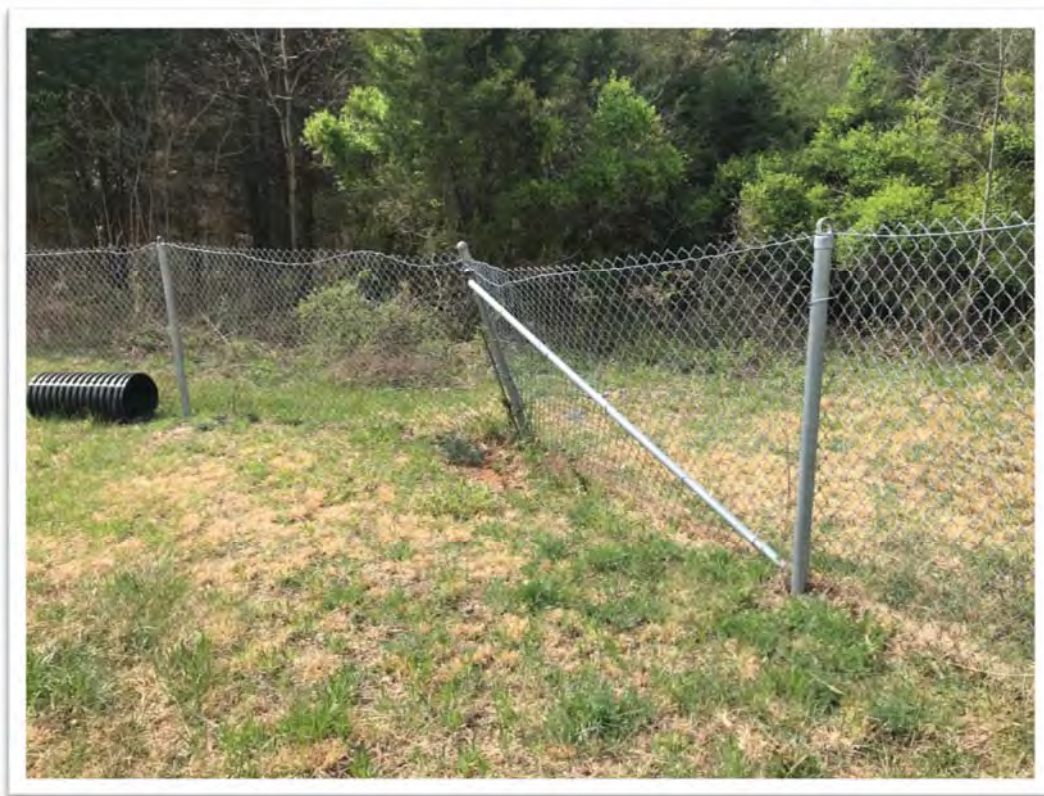
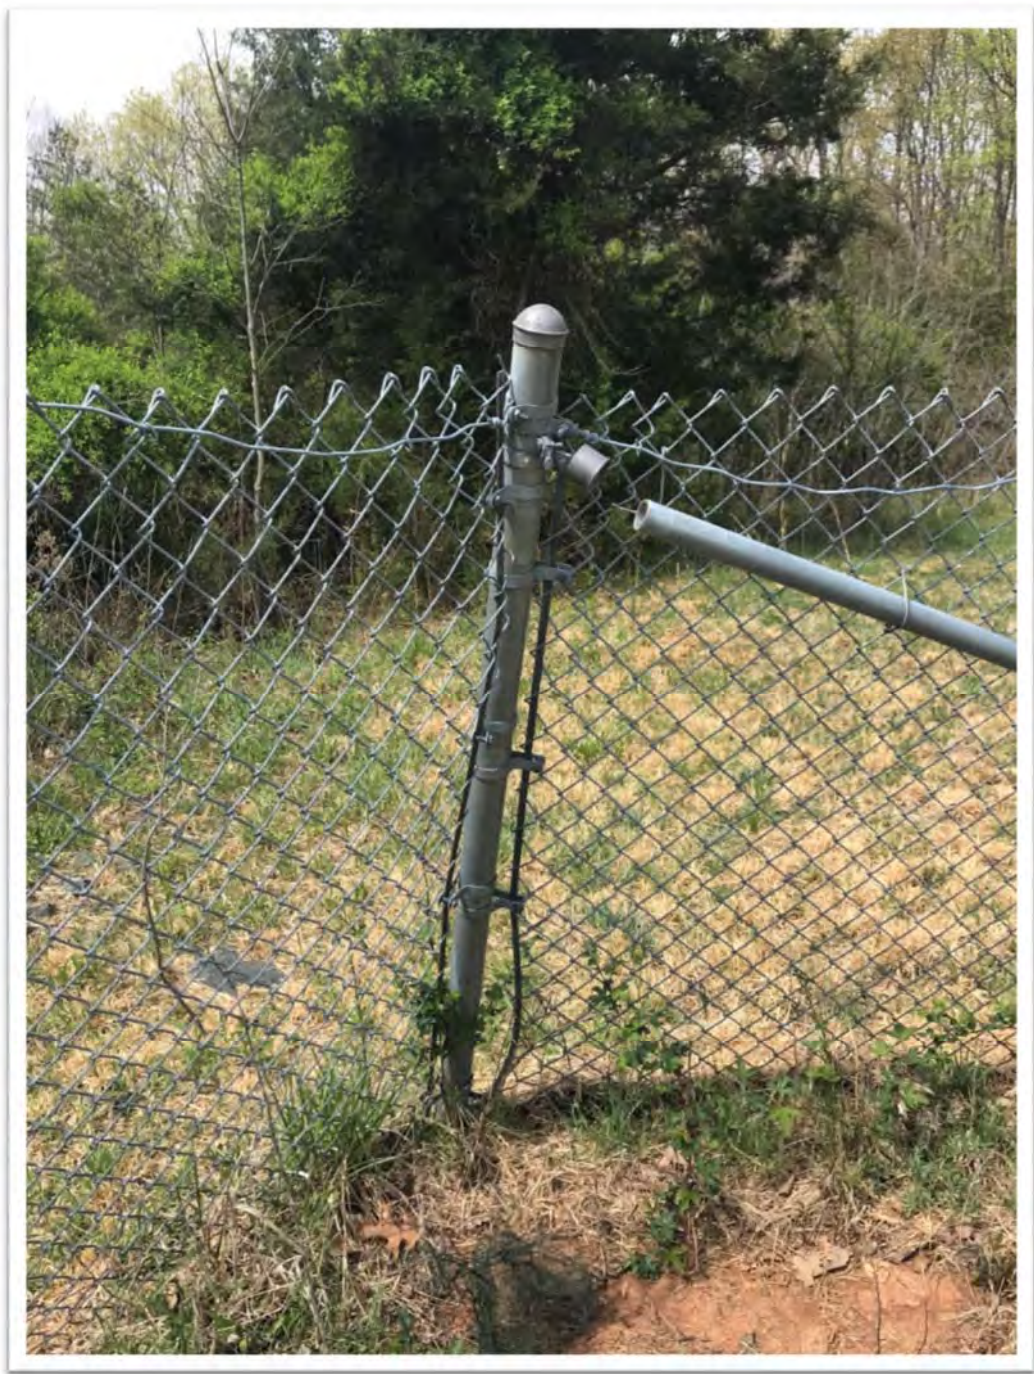
Photo: 012 **Date:** 04/23/18 **Description:** Near MW-2SU. Damaged fence in southeast corner of Landfill. **Photographer:** [REDACTED]

Photo: 013 **Date:** 04/23/18 **Description:** Damaged fence in southeast corner of Landfill (closeup).
Photographer: [REDACTED]

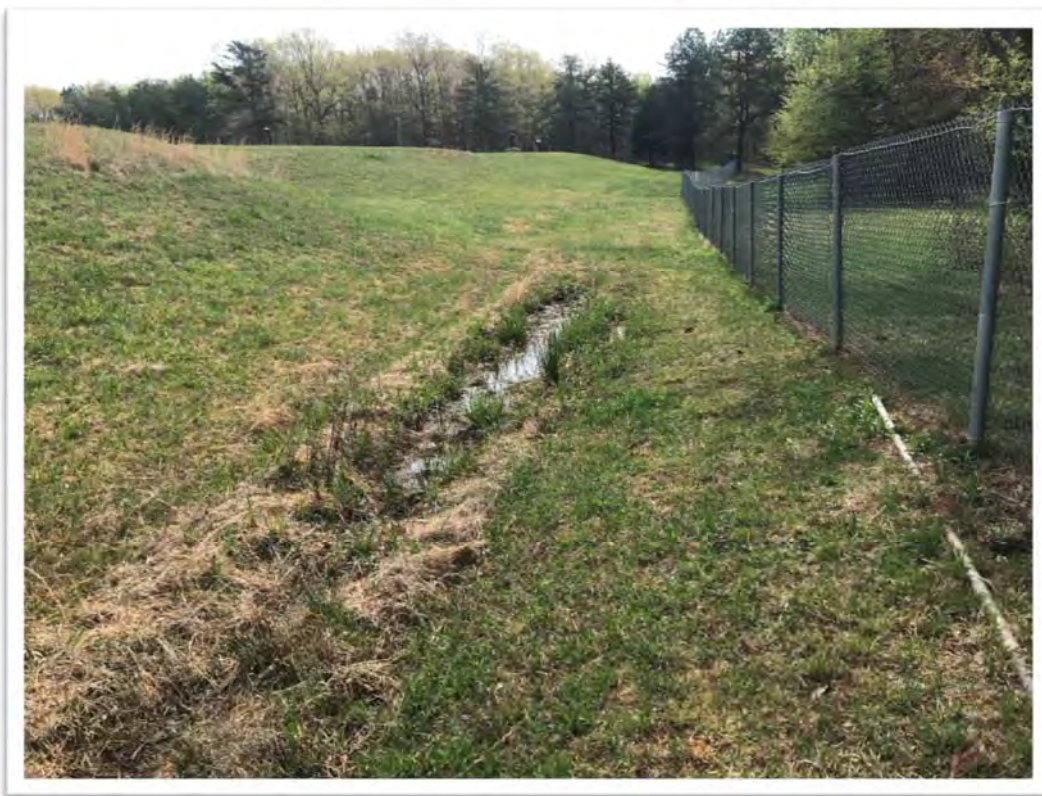
Photo: 014 **Date:** 04/23/18 **Description:** Facing southwest at northeast corner of landfill. Standing water and overgrown vegetation. **Photographer:** [REDACTED]

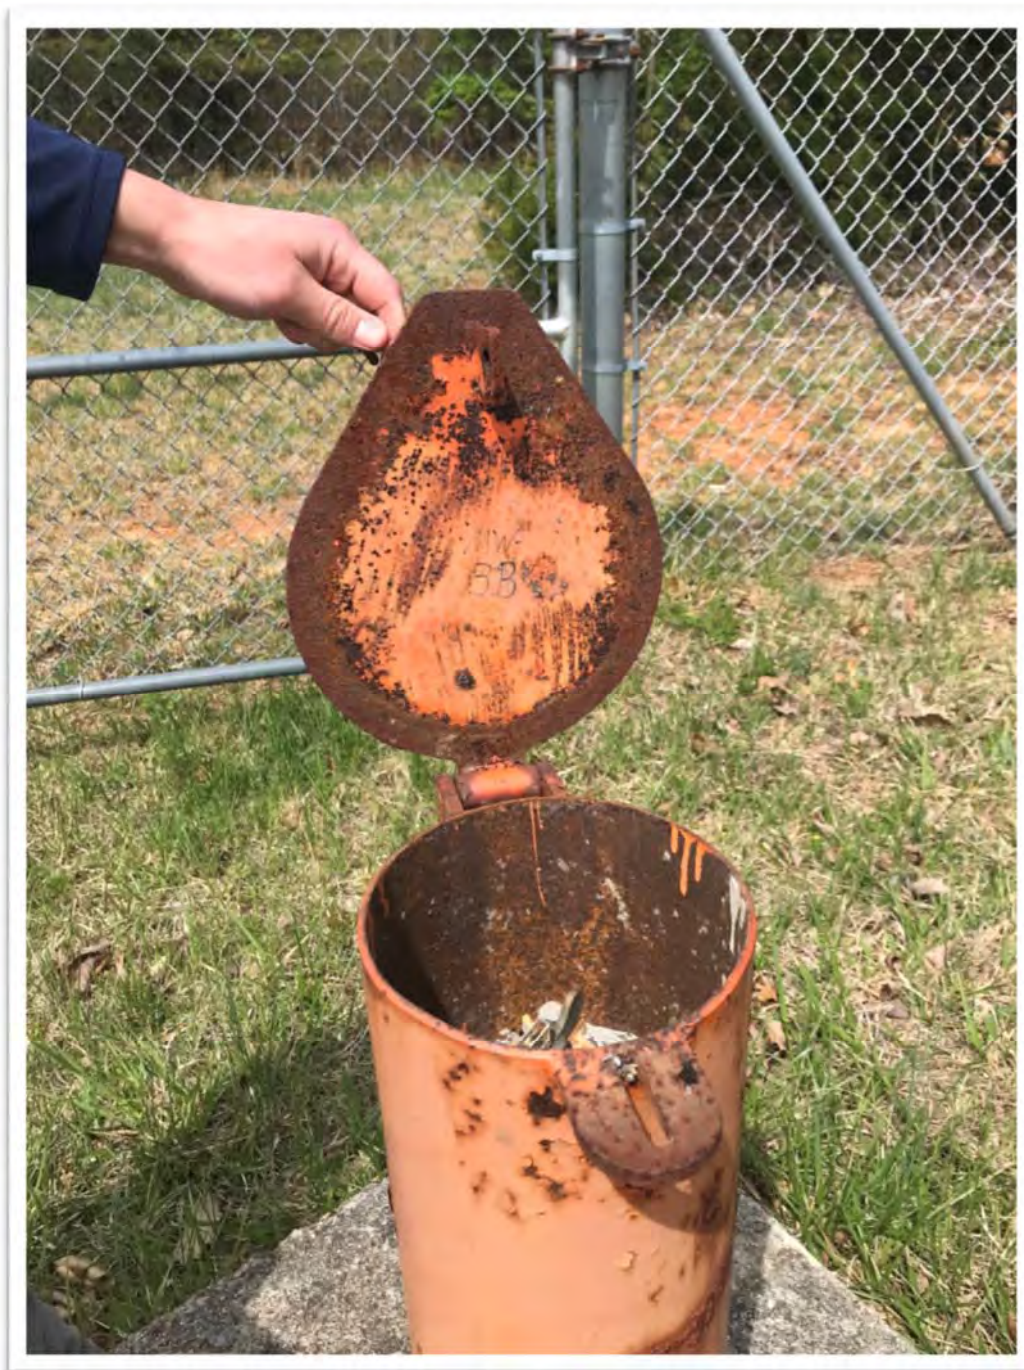
Photo: 015 **Date:** 04/23/18 **Description:** At monitoring well, MW-3B. Well protective casing missing lock. **Photographer:** [REDACTED]

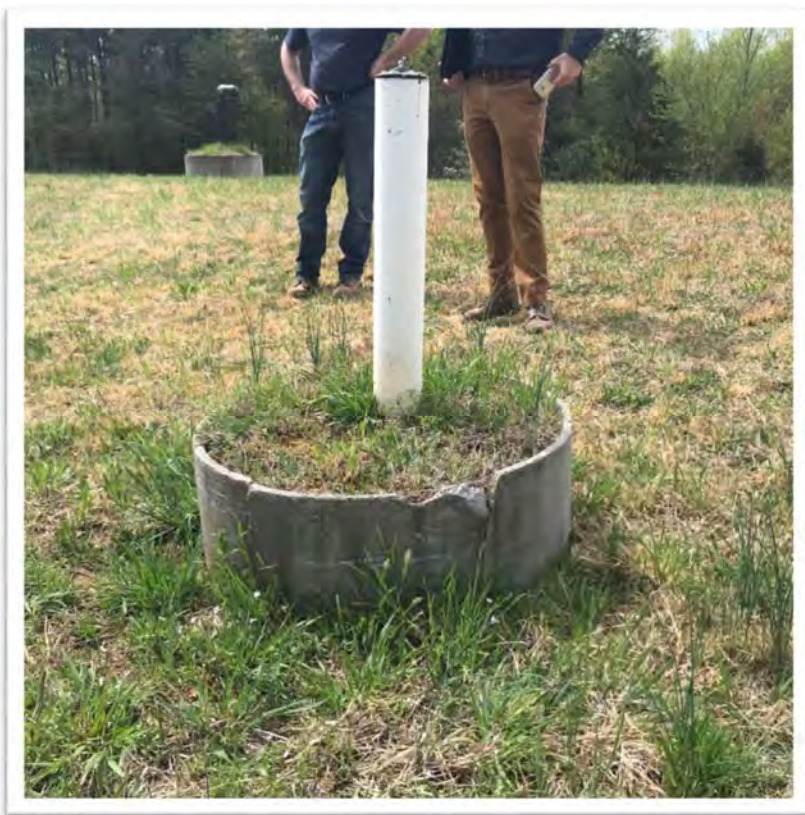
3.	Monitoring Wells (within surface area of landfill) <input type="checkbox"/> Properly secured/locked <input type="checkbox"/> Functioning <input type="checkbox"/> Routinely sampled <input type="checkbox"/> Good condition <input type="checkbox"/> Evidence of leakage at penetration <input checked="" type="checkbox"/> Needs Maintenance <input type="checkbox"/> N/A Remarks_MW-2SU has cracked concrete ring around well. MW-3B and MW-7S are not locked. _____

Photo: 016 Date: 04/23/18 Description: At monitoring well, MW-2SU. Concrete ring cracked.
Photographer: [REDACTED]

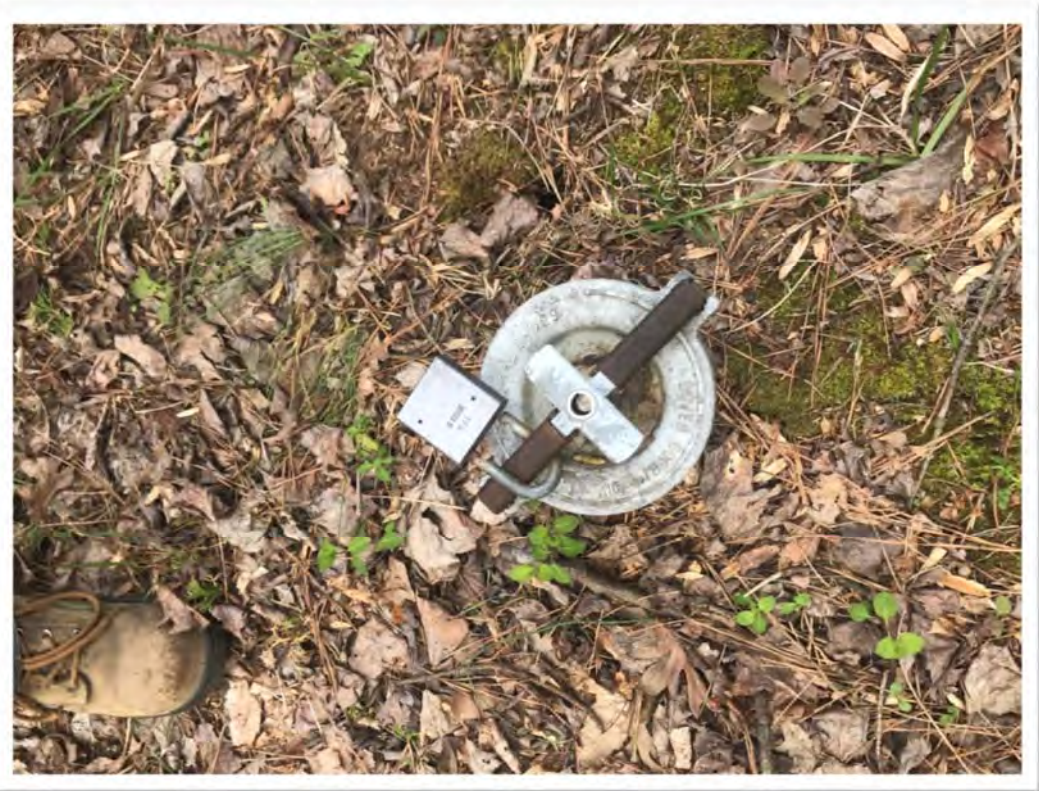
Photo: 017 Date: 04/23/18 Description: At monitoring well, MW-7S. Well cap not locked.
Photographer: [REDACTED]

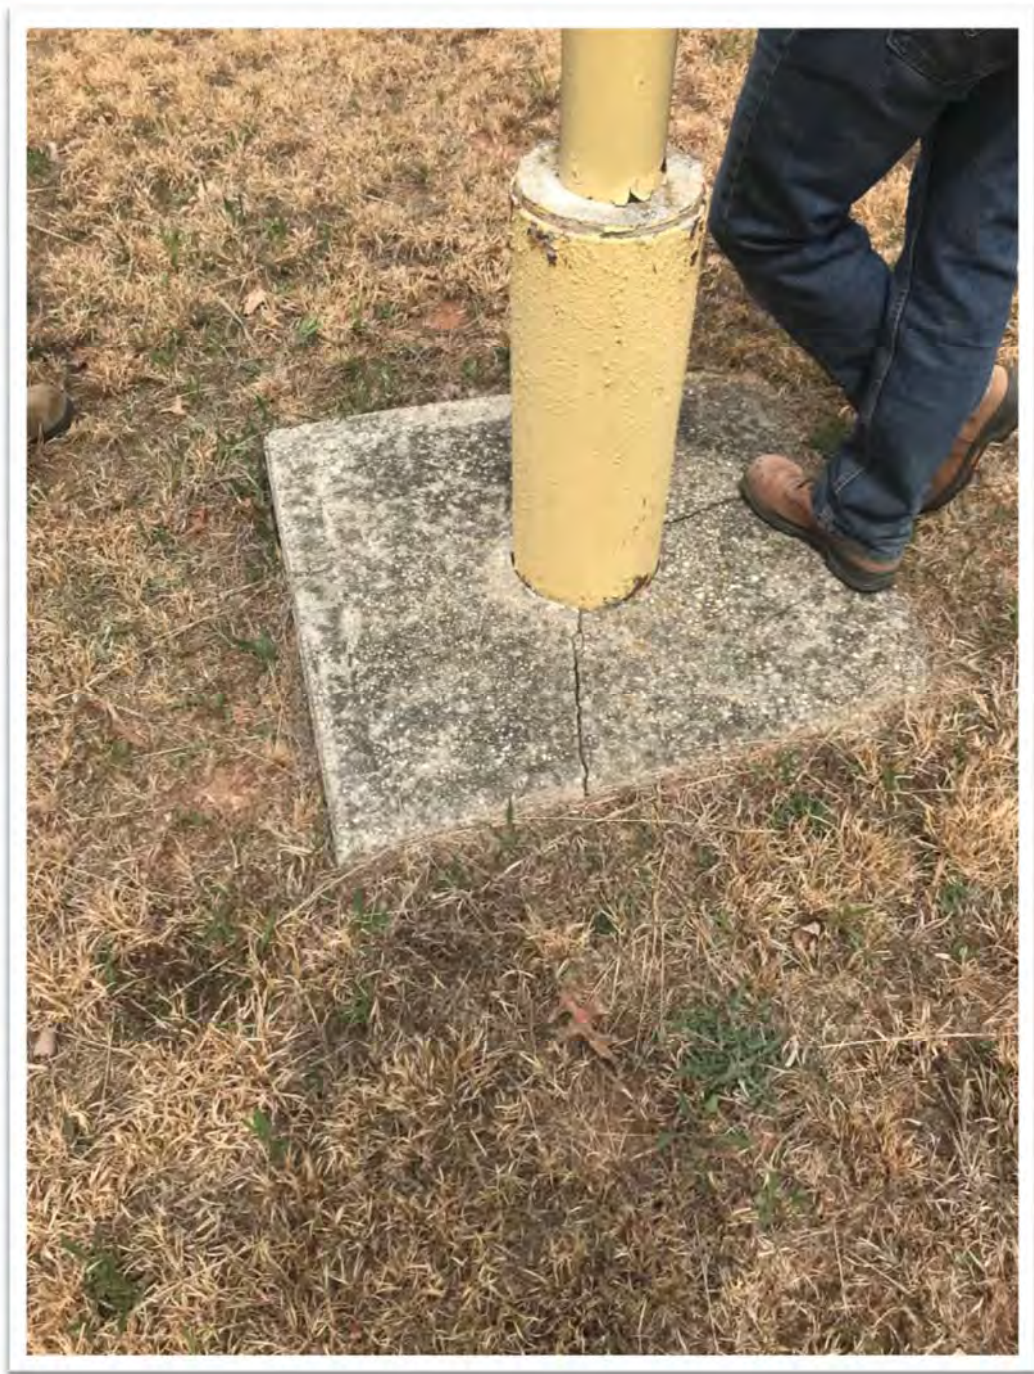
Photo: 018 **Date:** 04/23/18 **Description:** At monitoring well, MW-25SL. Well pad cracked.
Photographer: [REDACTED]
