**FIFTH FIVE-YEAR REVIEW REPORT FOR
MID-ATLANTIC WOOD PRESERVERS, INC. SUPERFUND SITE
ANNE ARUNDEL COUNTY, MARYLAND**

August 2018

**U.S. Environmental Protection Agency
Region III
Philadelphia, Pennsylvania**

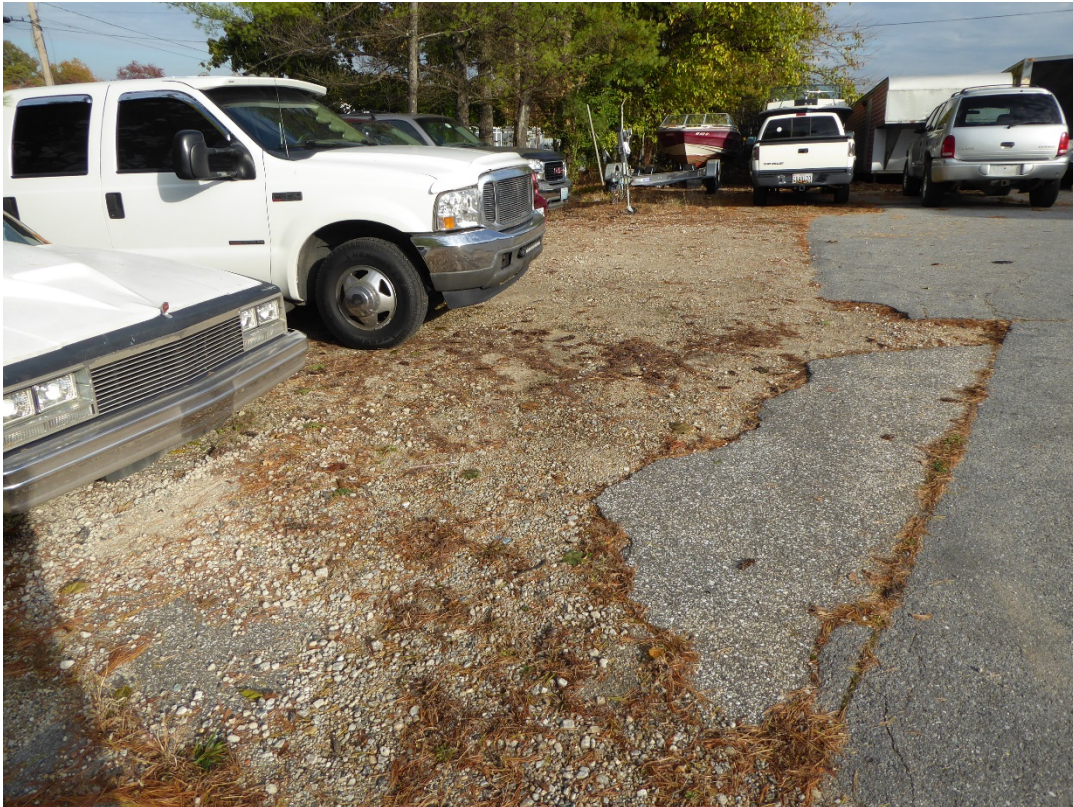
The findings of the Site inspection indicate that the asphalt caps have not been resealed or repaired in the past five years. During the Site inspection, the Treatment Yard cap had many deep cracks and exposed areas; plants and small saplings were growing through the cap. The gutters had fallen off the south side of the treatment building. The Storage Yard cap had some shallow, surficial cracks. Following the Site inspection, the Treatment Yard property owner repaired the deep cracks and exposed areas in the Treatment Yard cap in January 2018. The Storage Yard property owner resealed the Storage Yard cap in Spring 2018.

Deteriorated asphalt at the front of the Treatment Yard area

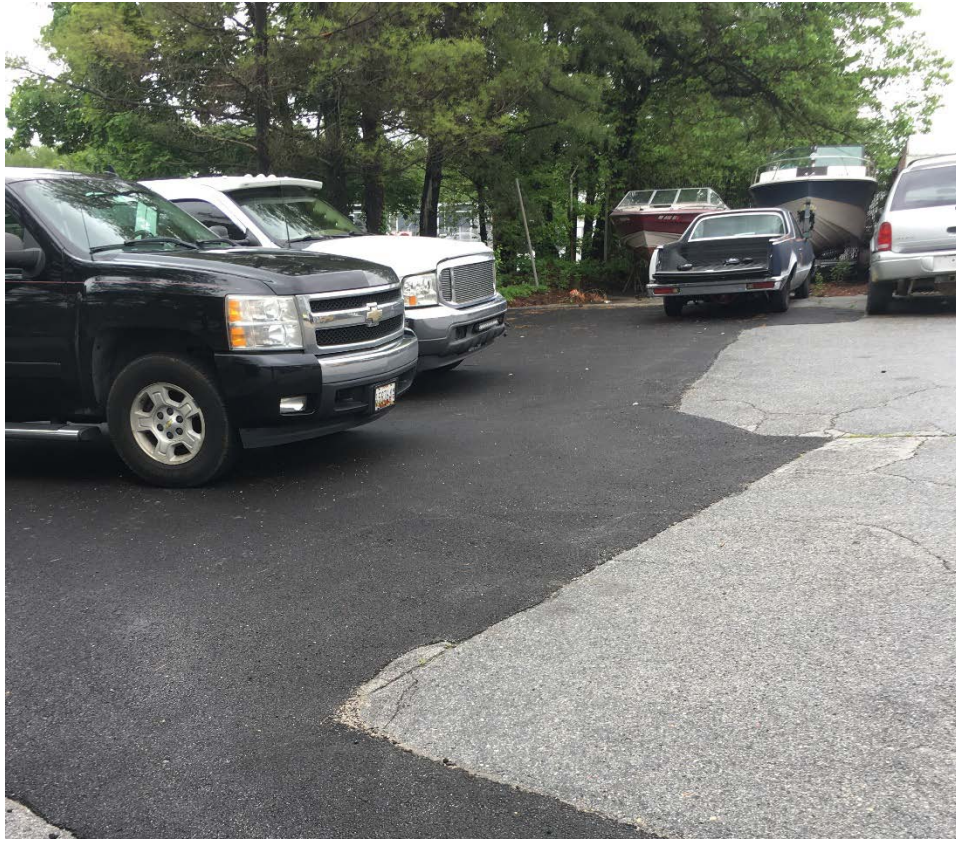
Repaired asphalt at the front of the Treatment Yard area

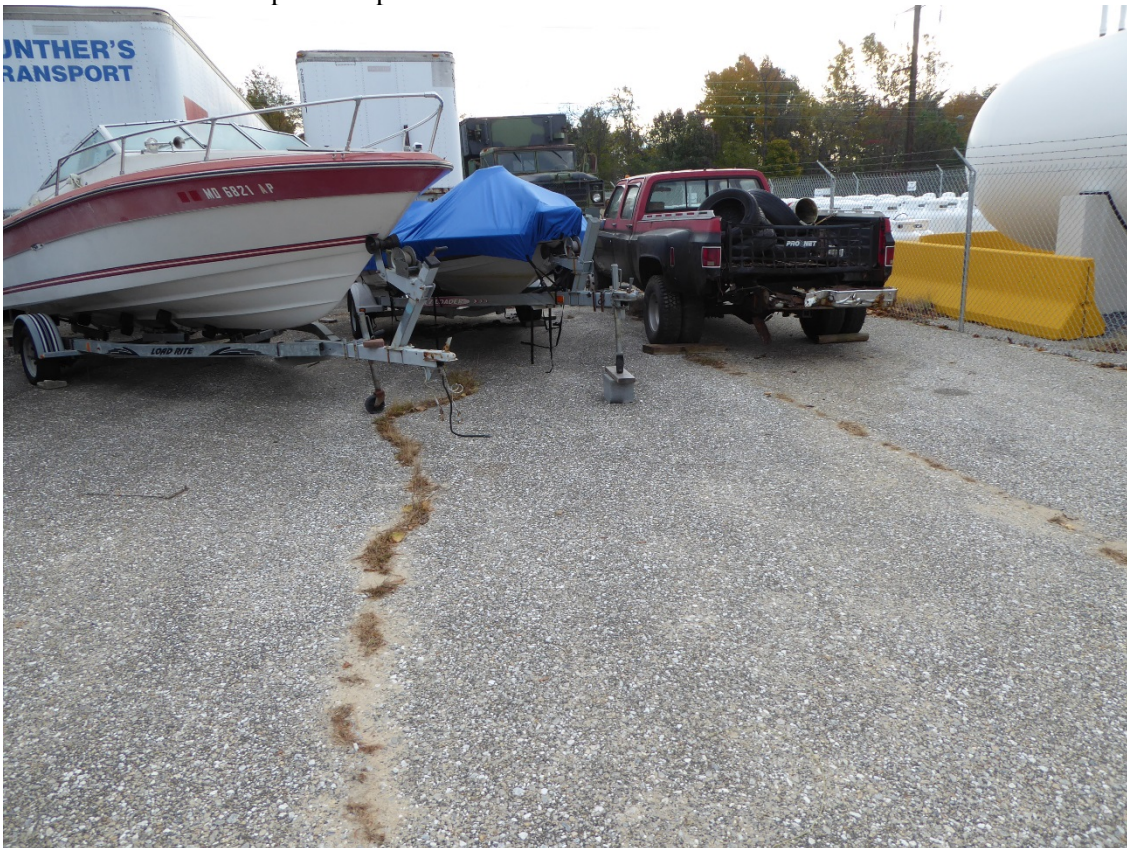
2.	Cracks	<input type="checkbox"/> Location shown on site map	<input type="checkbox"/> Cracking not evident
	Lengths: _____	Widths: _____	Depths: _____
	Remarks: <u>There are many deep cracks in the treatment yard property; the few cracks on the Storage Yard property are shallow.</u>

Cracks in the asphalt cap at the Treatment Yard area

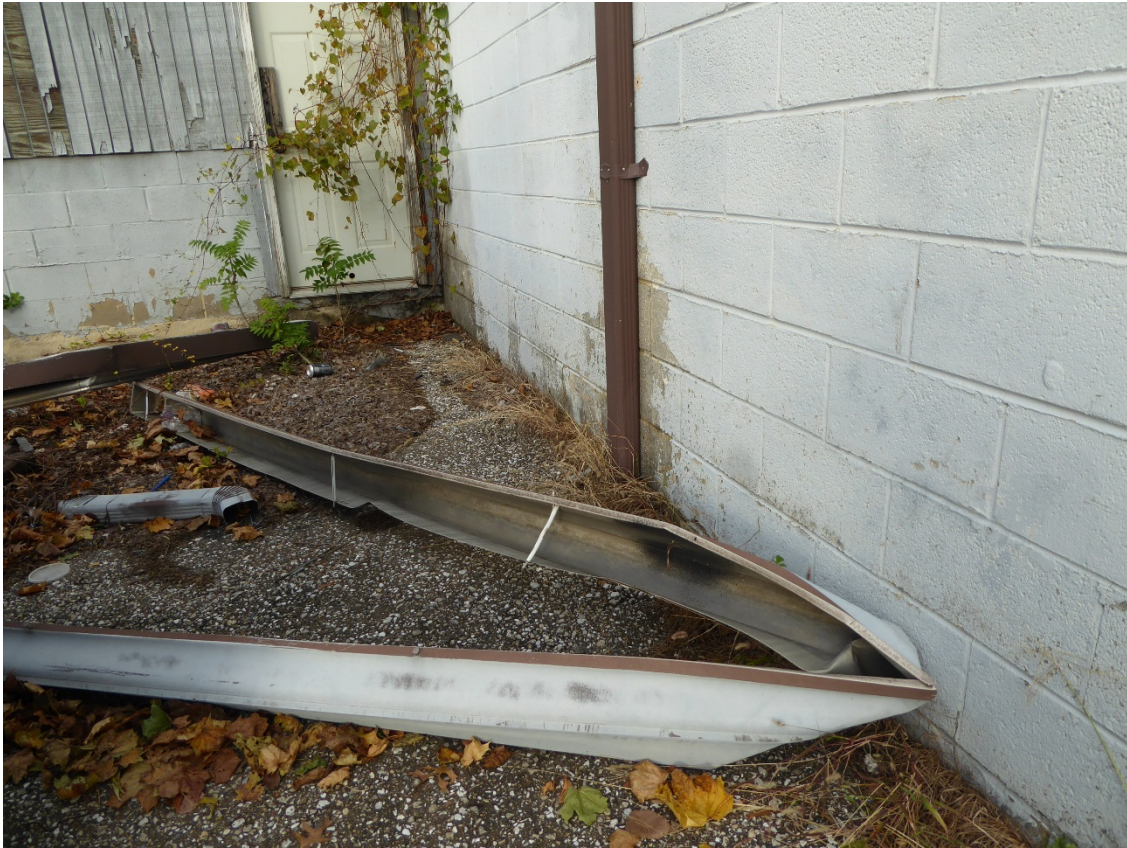
The Site inspection started on the Treatment Yard property at 7457 Shipley Avenue. LMS, a boat repair business, leases this property. LMS uses the former treatment building for its operations. Some of the gutters had fallen off the building, and the downspouts were discharging to the base of the building. During the inspection, there were boats stored on the Treatment Yard property associated with LMS. There were also many other parked trucks and vehicles, mostly on the northeast quarter of the Treatment Yard property. Site inspection participants identified a new use since the previous FYR: Sharp Energy uses the southeast corner of the Treatment Yard property to store a large propane tank (about 30 feet in length) as well as many smaller empty propane tanks and a propane delivery

Damaged rain gutter at the Treatment Yard area

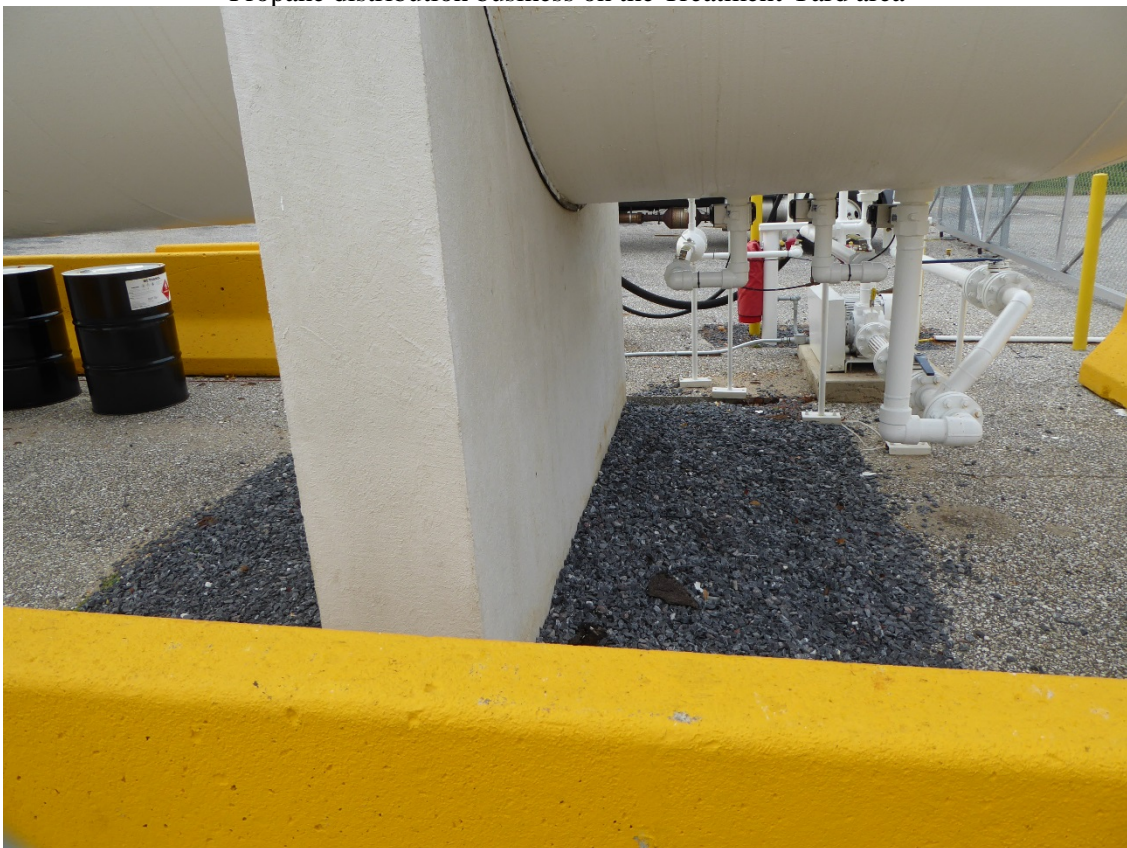
Site inspection participants noted that to install the foundation and possibly other components of the large propane tank, the Site's asphalt cap was cut and removed in several areas, including two areas each approximately 10 feet by 10 feet in size. These cuts show that the asphalt cap is 3 to 4 inches thick. These areas of removed cap were filled with gravel. It appeared that the cap was also cut to install bollards around the large tank. The posts for the fence surrounding the Sharp Energy storage area likely also necessitated cutting the cap. The asphalt cap was cracked throughout the Treatment Yard property and vegetation was growing in the larger cracks, including saplings in some places. There were also larger areas (particularly west of the main building) where gravel was exposed and the integrity of the cap could not be determined.

Area where asphalt cap was cut and removed during propane tank installation at the Treatment Yard area

Issues and Recommendations Identified in the FYR:				
OU(s): 1	Issue Category: Operations and Maintenance			
	Issue: There have been continued instances of unauthorized cutting and removal of the asphalt cap. Additionally Property has changed hands without notification to EPA.			
	Recommendation: Conduct regular inspections of the cap and Site. Also, notify the property owners of cap restrictions and O&M requirements under the PPA. EPA is evaluating the PPA to determine the best follow up action.			
Affect Current Protectiveness	Affect Future Protectiveness	Party Responsible	Oversight Party	Milestone Date
No	Yes	PRP	EPA/State	9/30/2019

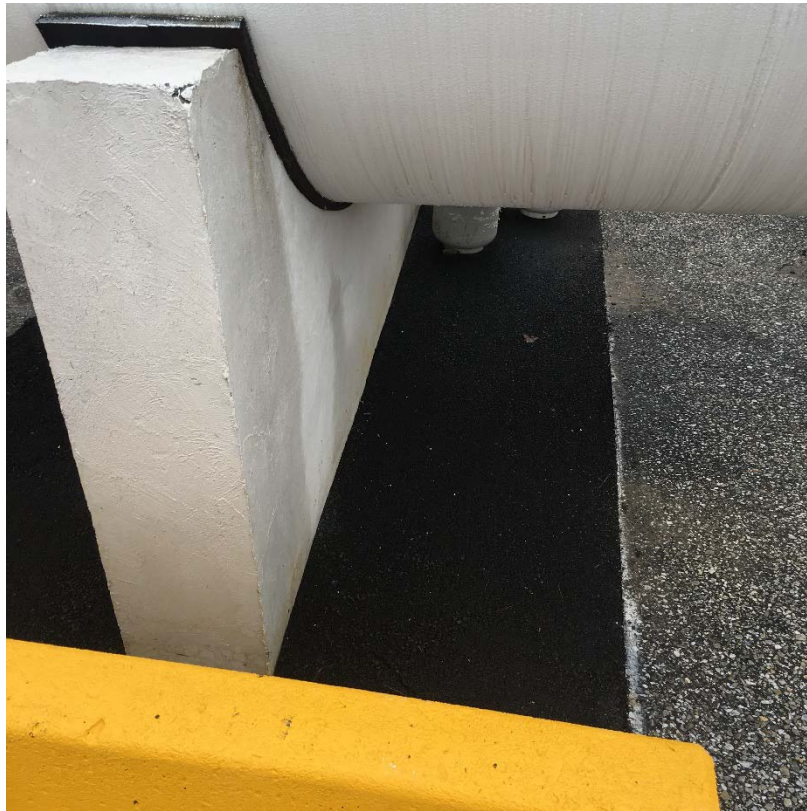
Repaired Propane Tank installation in the Treatment Yard area

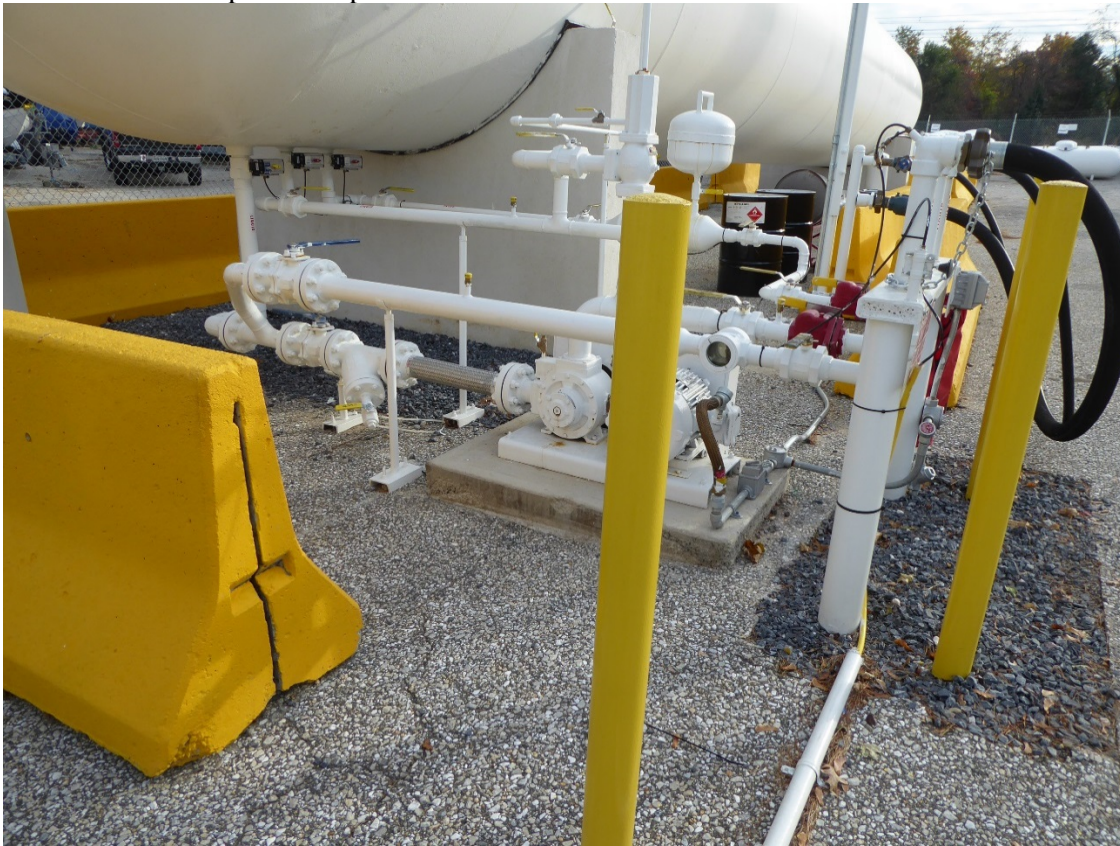
Areas where asphalt cap was cut and removed during propane tank installation at the Treatment Yard area

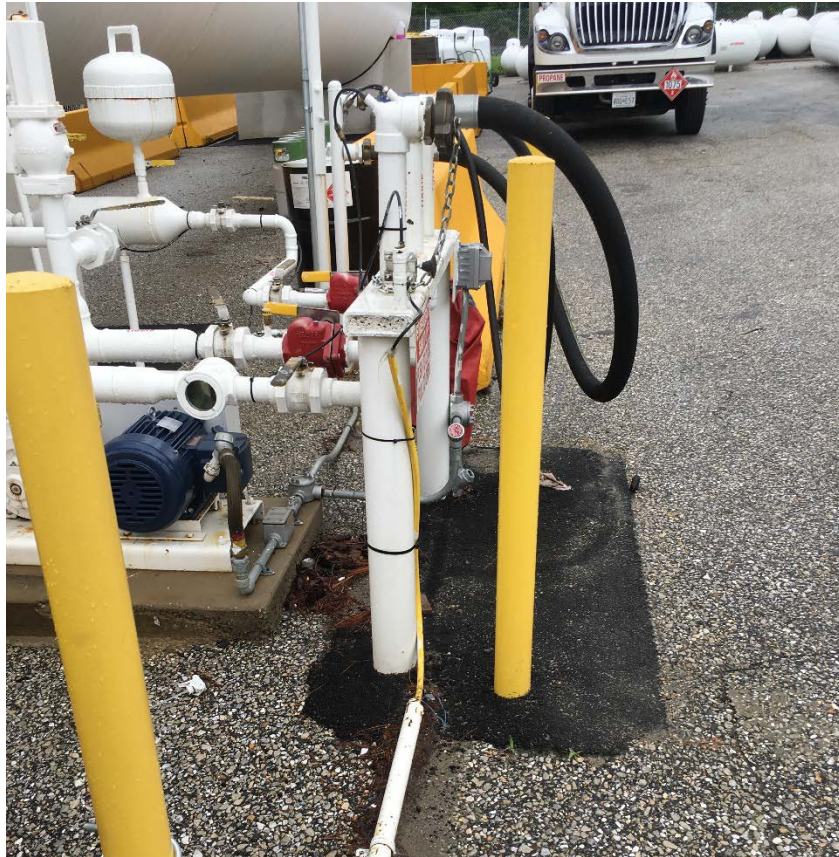
Repaired asphalt from the propane tank installation in the Treatment Yard area

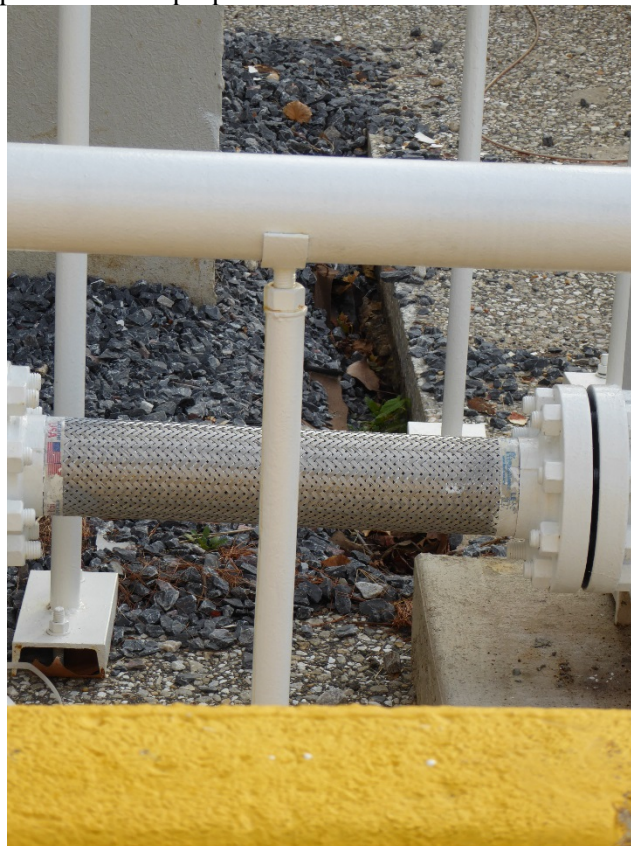
Area where asphalt cap was cut and removed during propane tank installation at the Treatment Yard area

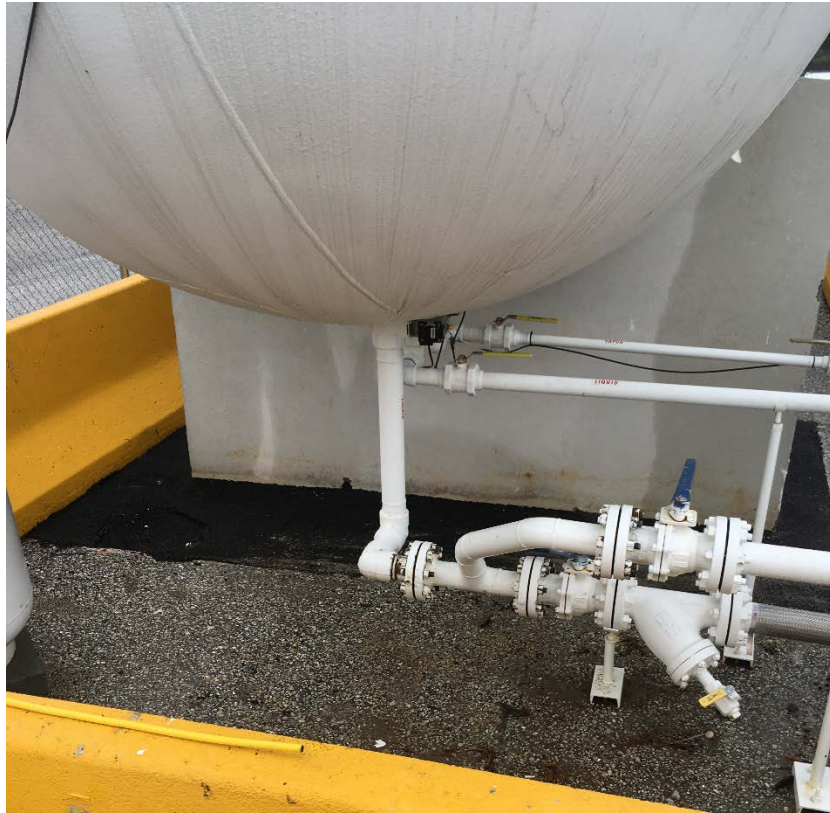
Repaired asphalt from the propane tank installation on the Treatment Year area
