**FOURTH FIVE-YEAR REVIEW REPORT FOR
SAUNDERS SUPPLY CO. SUPERFUND SITE
CITY OF SUFFOLK, VIRGINIA**

DECEMBER 2019

**U.S. Environmental Protection Agency
Region 3
Philadelphia, Pennsylvania**

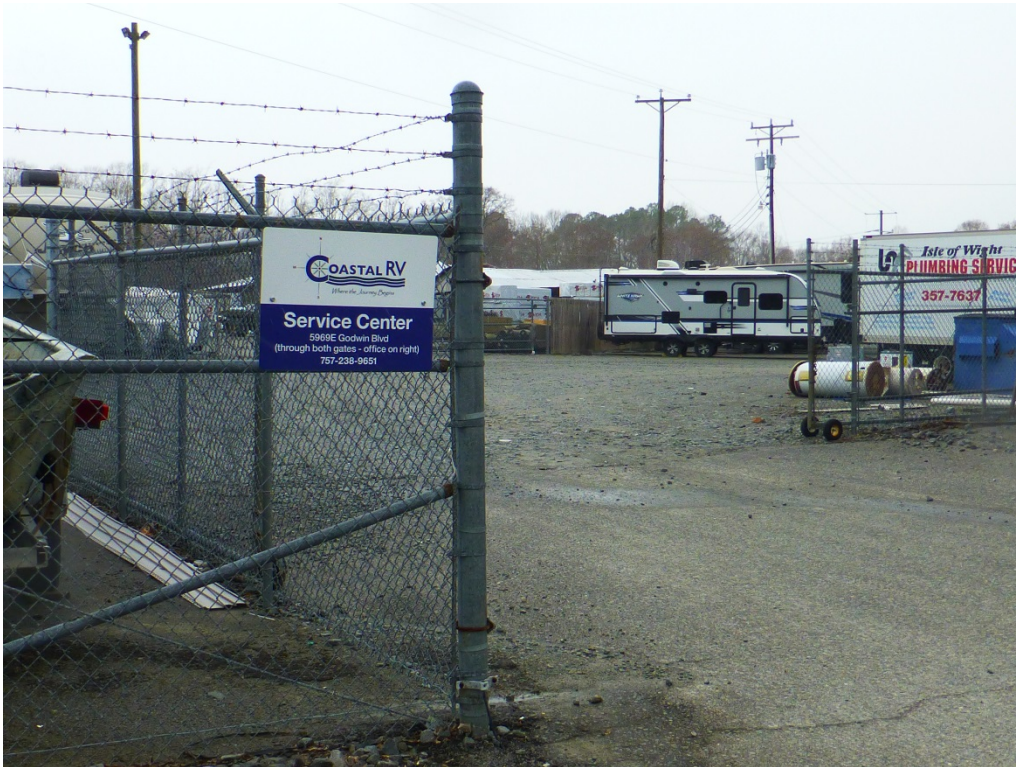
Gate and fence at the main Site entrance

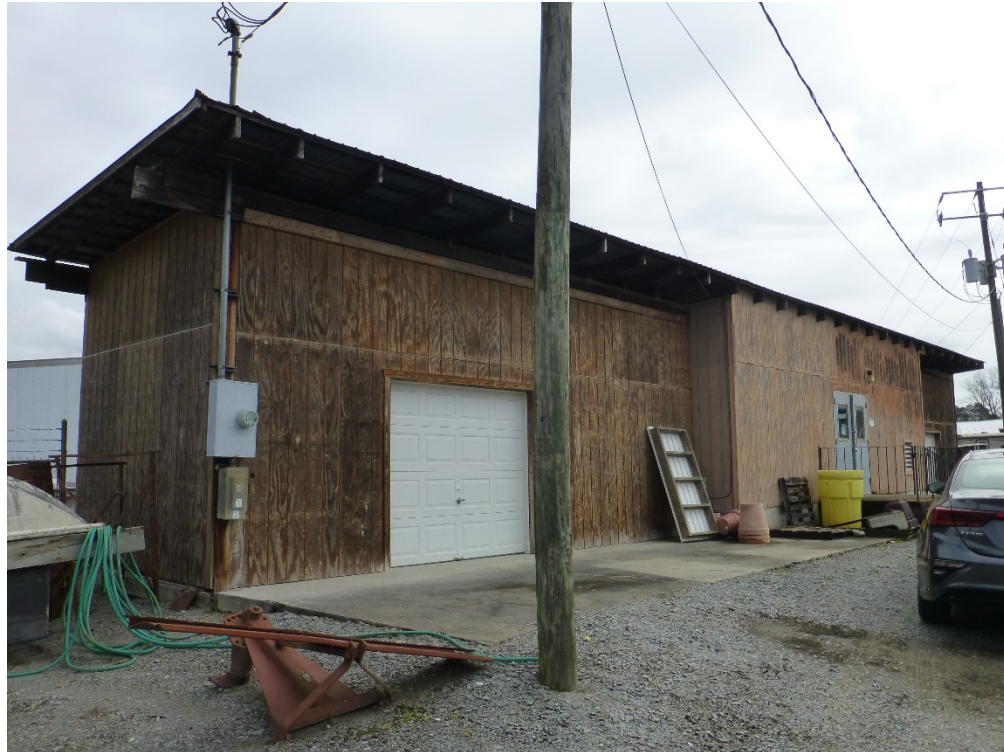
The groundwater treatment building

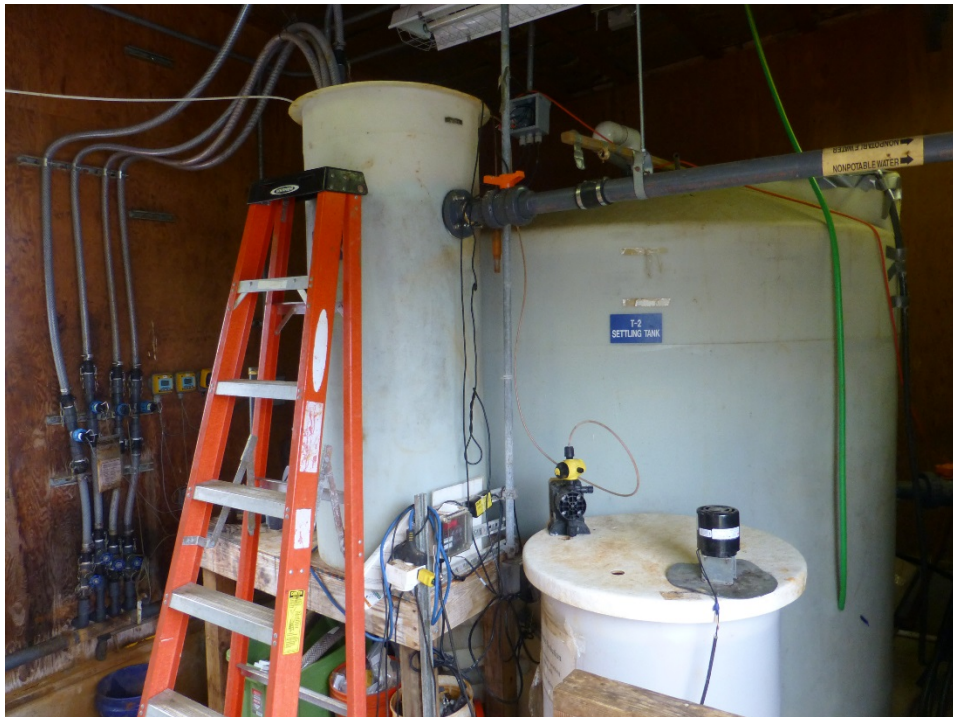
Blending and settling tanks in the treatment system building; extracted groundwater enters the system through the four lines shown on the left side of the above photo

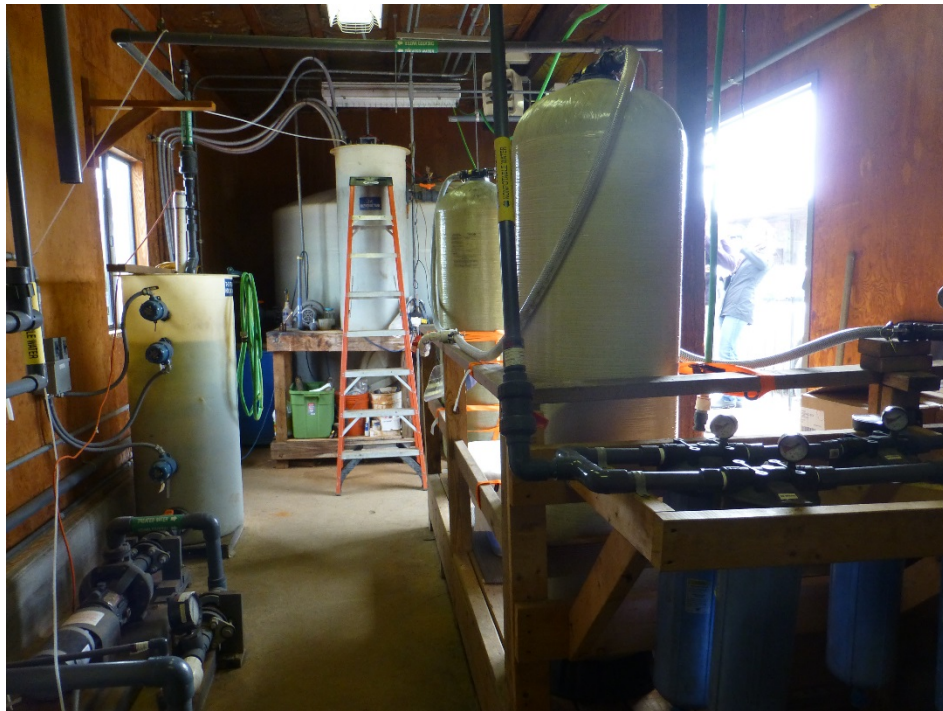
System filtration units (blue bag filters and white carbon filters) on the right side of the above photo

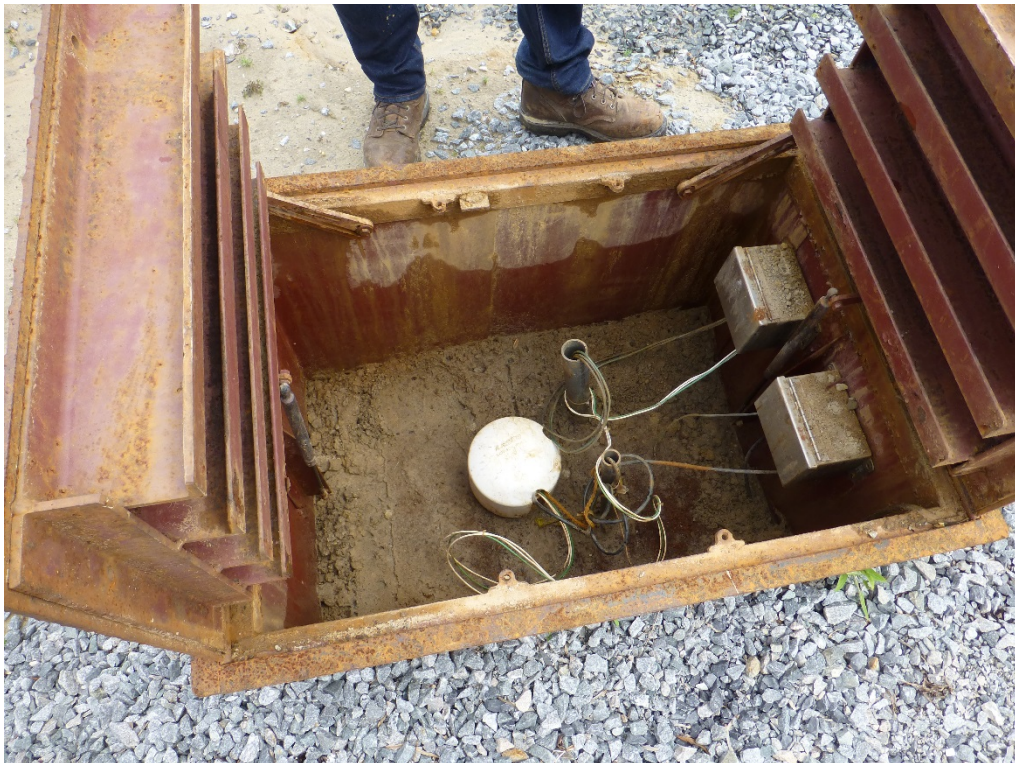
RW-4 is the farthest downgradient recovery well

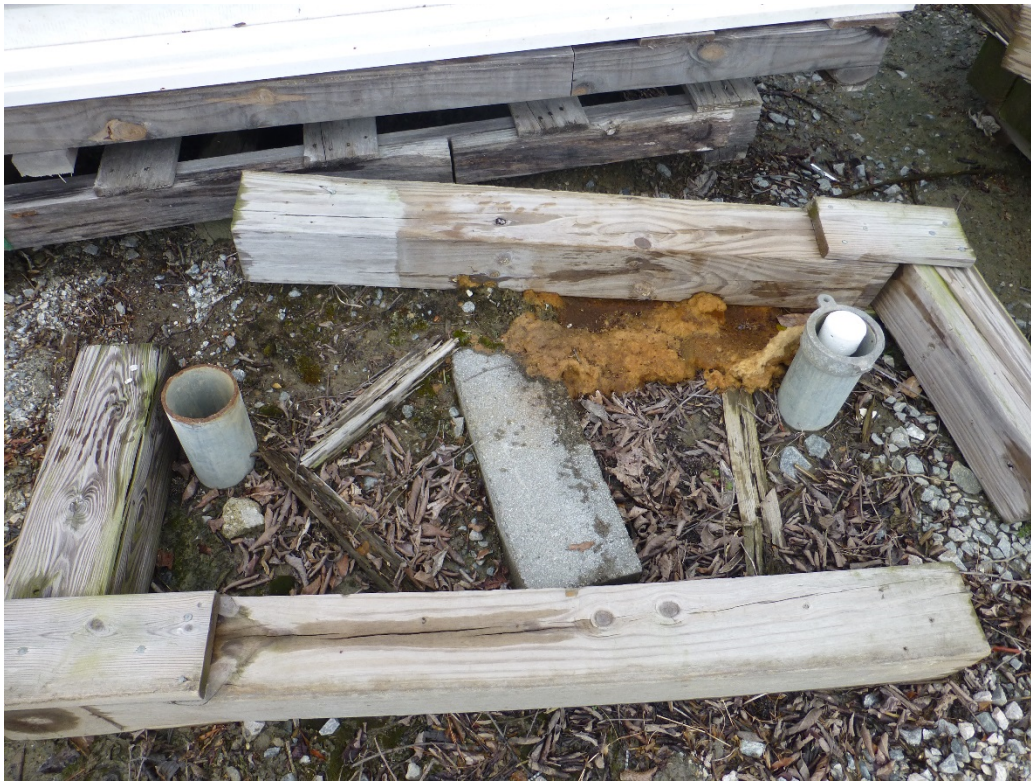
Participants toured the adjacent commercial property and observed recovery and monitoring wells as well as greenhouses used by the plant nursery that operates there. All wells appeared to be in good condition. Some monitoring wells were unlocked; however, they are located on closely monitored properties in active use. The likelihood of someone coming on to the adjacent property and tampering with the unlocked wells is low. Water was observed flowing in the unnamed intermittent stream that runs along the western side of the Site. Site inspection participants observed Godwin's Millpond, which is north and downgradient of the Site. Participants then walked south of the Site to observe the northernmost, upgradient surface water sampling location along the intermittent stream. Two inactive groundwater monitoring wells, MW-1S and MW-2D, were observed inside the fence of the adjacent (off-site) Saunders Supply Company retail and sales business. State and EPA staff discussed the need to evaluate whether the two wells were needed or could be properly abandoned.

Two inactive monitoring wells located north of the Site

- Additional speciation of chromium to confirm if hexavalent chromium is a concern and being treated sufficiently.
- During the FYR Site inspection, participants observed two inactive groundwater monitoring wells, MW-1S and MW-2D, inside the fence of the adjacent (off-site) Saunders Supply Company retail and sales business. Evaluate whether the two wells are needed or could be properly abandoned.

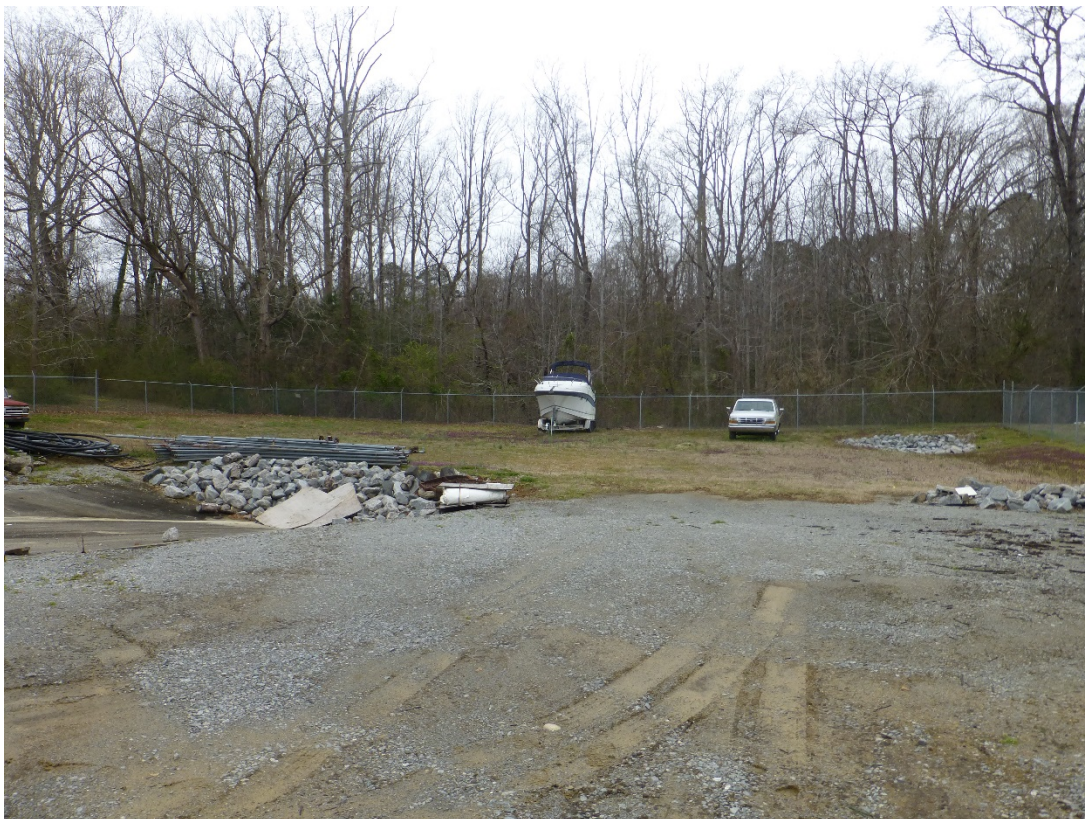
Former location of the Site's wastewater pond

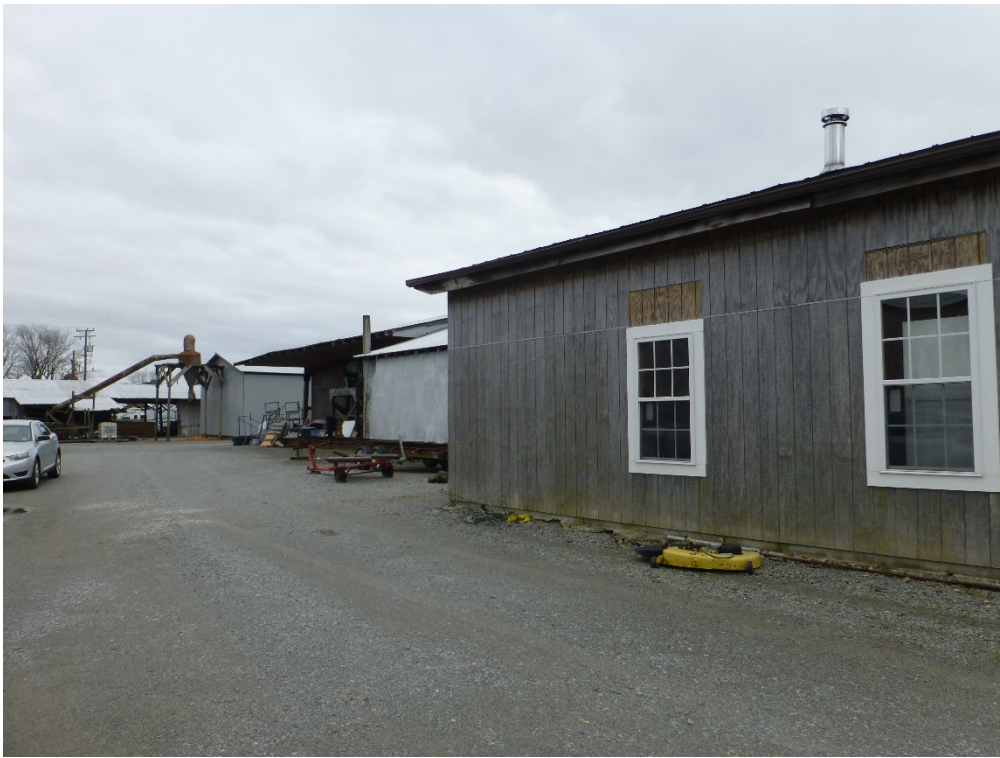
The former wood-treating process area

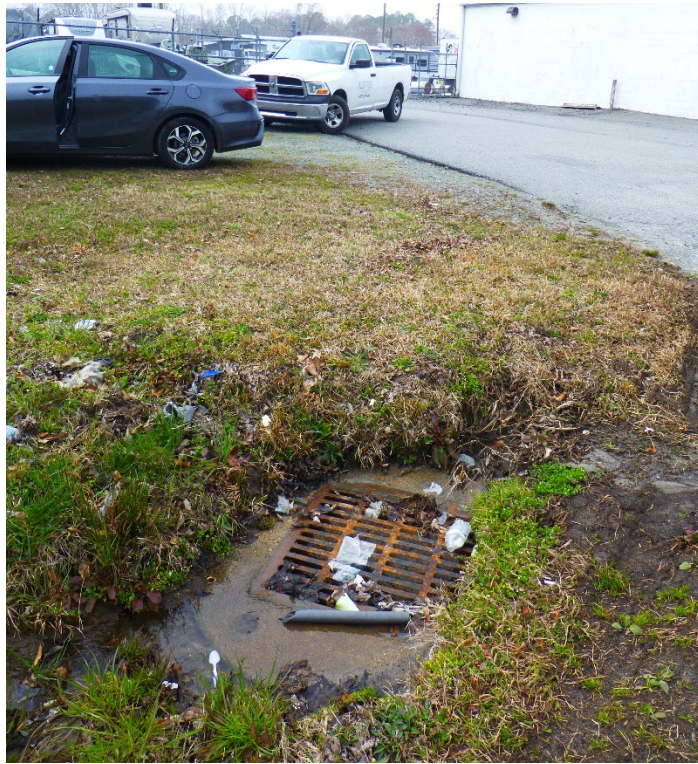
Treated effluent from the Site's groundwater treatment plant discharges to the local sewer system at this approximate location along Godwin Boulevard
