FIVE-YEAR REVIEW REPORT First Review

St. Louis River Superfund Site

U.S. Steel Site - EPA OU 02

St. Louis River/Interlake/Duluth Tar Site, Tar Seep OU – EPA OU 01

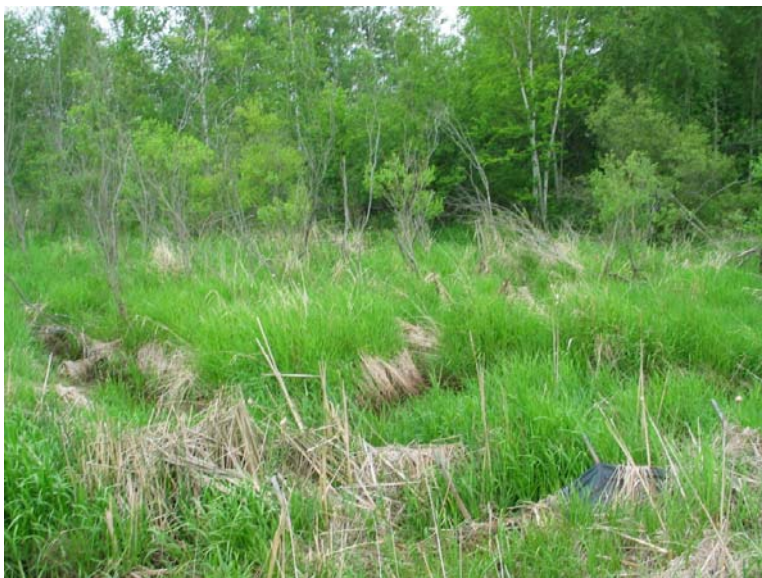
Several beaver dams were observed within this reach. There were no oil sheens or other visual evidence of PAHs in the creek. The former settling basin is covered with sediment and is well vegetated with wetland and terrestrial plants as viewed in the photo to the left. The vantage point of this photo is viewed looking in a northerly direction from OU-J.

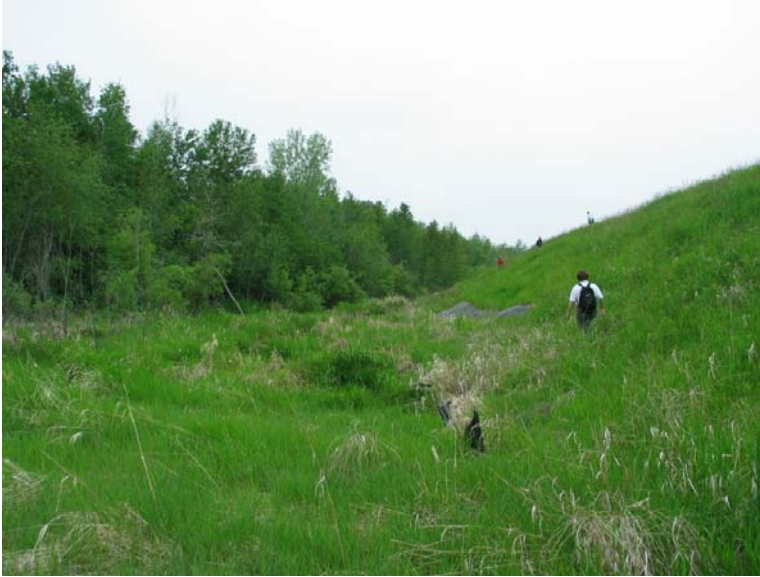
The entire surface of the cover was inspected. The vegetation was found to be in excellent condition. No trees were found on the cover. There were no obvious settlement areas. The cover surface appeared to have adequate slope for to facilitate surface drainage. The vantage point of this photo is viewed looking in a northerly direction along the Unnamed Creek.

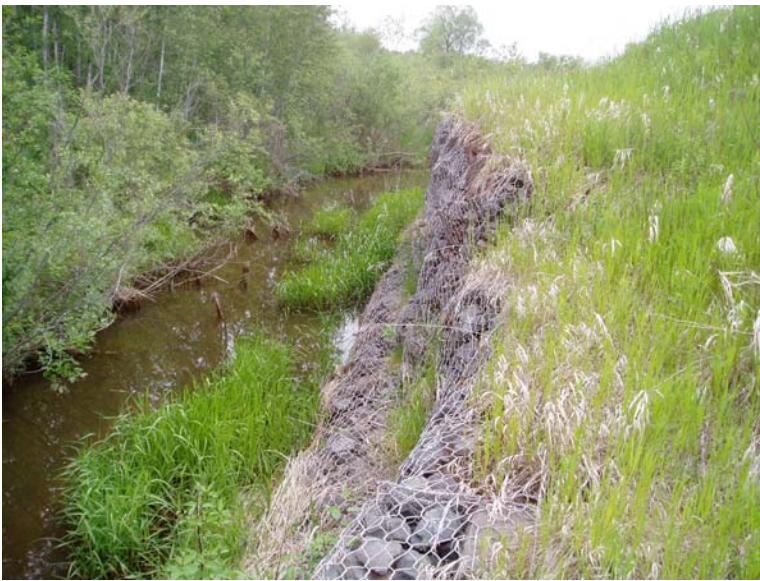
Recent movement of the steep sideslope near the near vertical gabion structure was noted. The toe drain of the cover system discharges onto the steep slope above the vertical gabion structure. Saturating the steep sideslope would contribute to the stability problem at this location. The vantage point of this photo is viewed looking in a northerly direction along

the Unnamed Creek. The flow in the Unnamed Creek was unobstructed. There were no oil sheens or other visual evidence of PAHs in the creek.

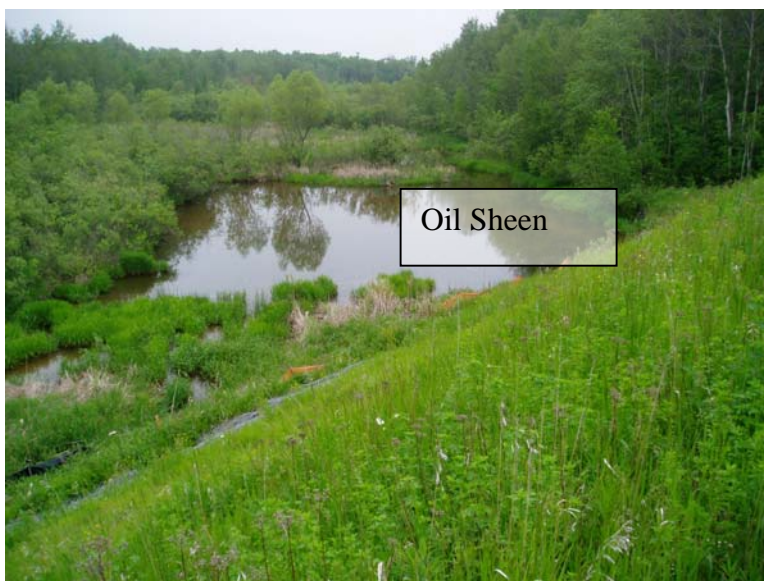
An oil sheen was observed in the pond pictured on the left. The sheen was located adjacent to the toe of the cover. Floating tar balls were also noted during the inspection and continued intermittently eight weeks later. ATV tracks were observed on the northern slope of the cover. The vantage point of this photo is viewed looking in a northerly direction along the Unnamed Creek.

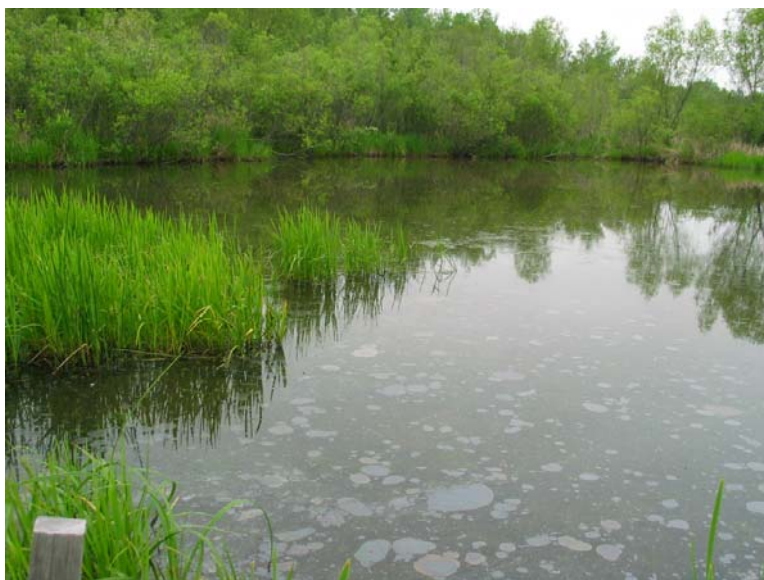
Pictured on the left is a close-up of the oil sheen and tar balls described above. The vantage point of this photo is viewed looking in a northeasterly direction.

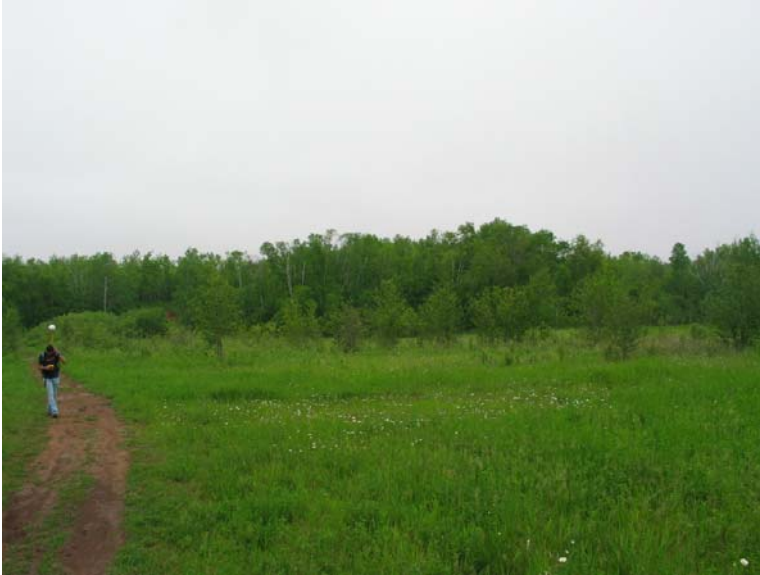
Trespassers had worn an ATV trail across the site that ran in the north - south direction. The photo on the left is viewed looking east. Note the ATV trail at the left of the picture. The tire ruts have penetrated into the cover nearly eight inches. The GPS unit is being used to define the trail. The perimeter of OU-K was defined using a GPS unit. ATV trails were also noted adjacent to the OU being to the north and west of Cell C.

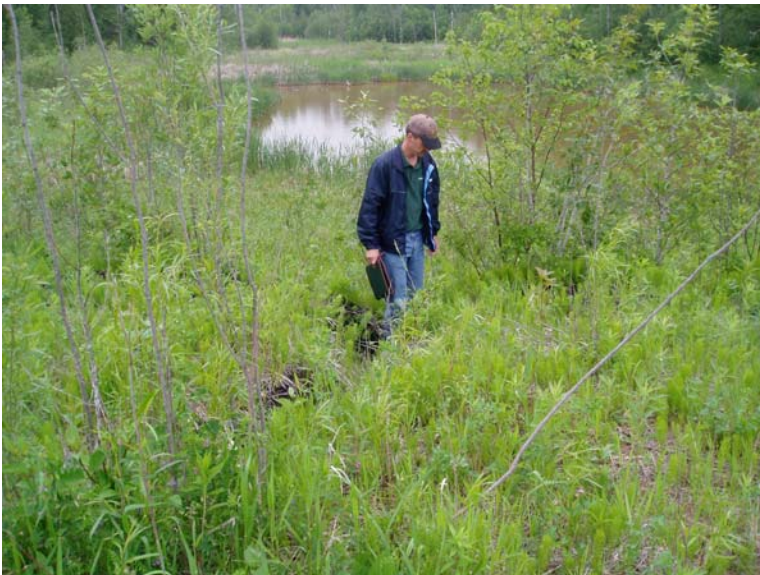
The photo on the left is viewed looking north at the berm separating Cell A and the up-gradient pond. Note the erosion runnel in the center of the photo. These erosion runnels were nearly a foot deep.

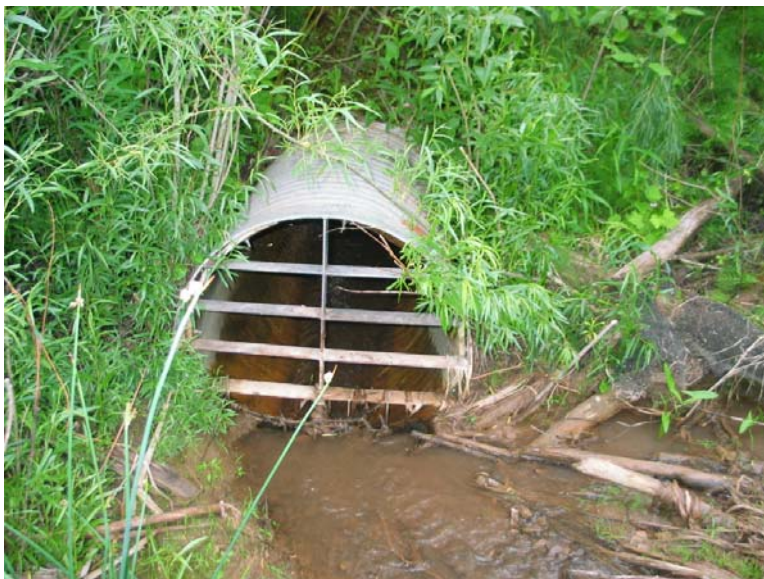
The inlet as shown in the photo on the left was found to be in good condition and free flowing. There were no oil sheens observed in the pond or water entering the culvert.

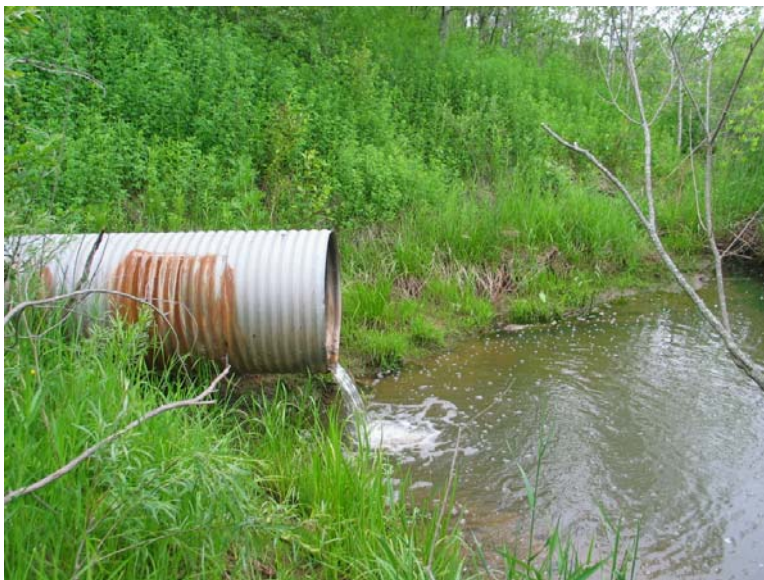
The outlet as shown in the photo on the left was also found to be in good condition and free flowing. There were no oil sheens observed in the discharge water or in the plunge pool.

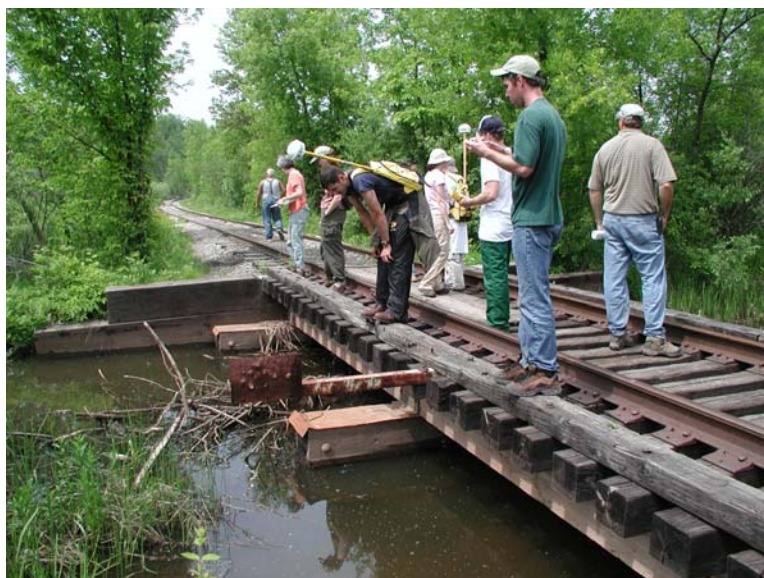
Pictured on the left is the downstream terminus of OU-L. The Water Monitoring Point CP-3 is located at this location. Members of the inspection team observed a small sheen near the bridge abutment. The photo on the left is viewed looking northerly or downstream relative to the parallel St. Louis River.

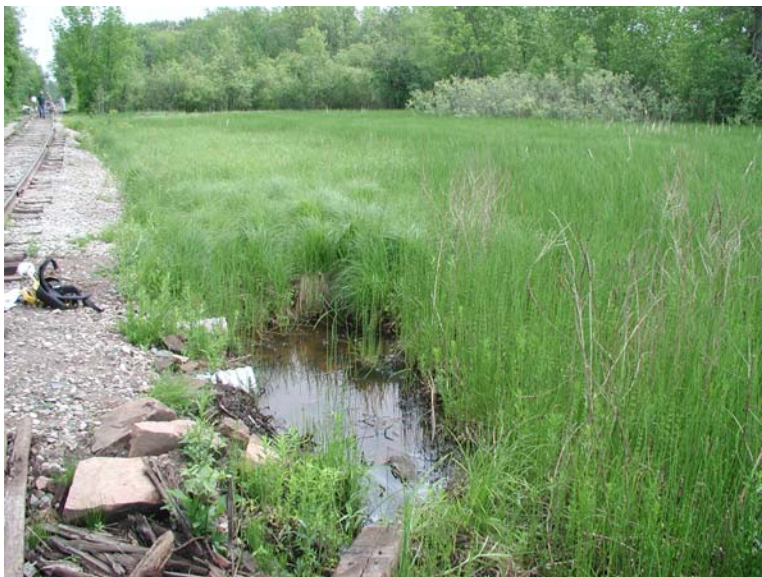
An oil sheen was observed west of the railroad tracks in the delta of the Unnamed Creek. The oil sheen was located adjacent to a culvert that was recently installed under the railroad tracks. New replacement ties were found in the immediate area of the oil sheens. The source of the sheens is unknown. The photo on the left is viewed looking south or upstream relative to the parallel St. Louis River.

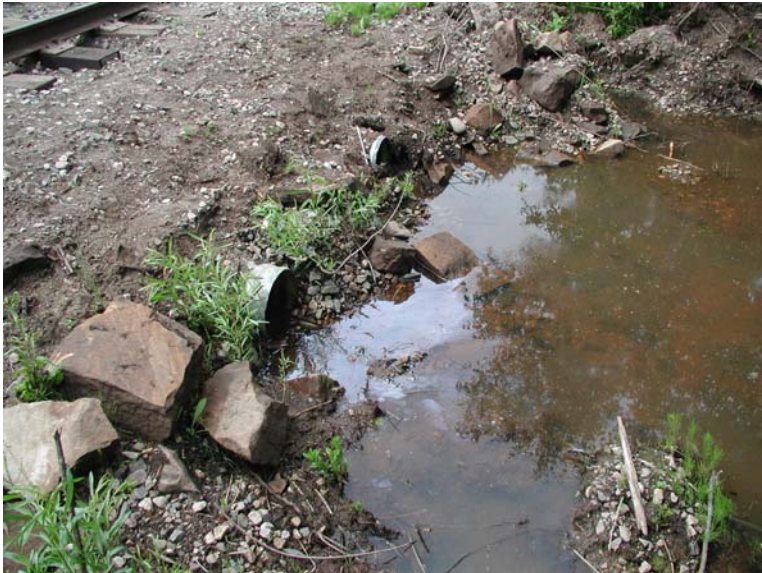
Close up view of the oil sheen that is described above. A second sheen was located in the delta to the north of this location. Both sheens were surveyed with GPS.

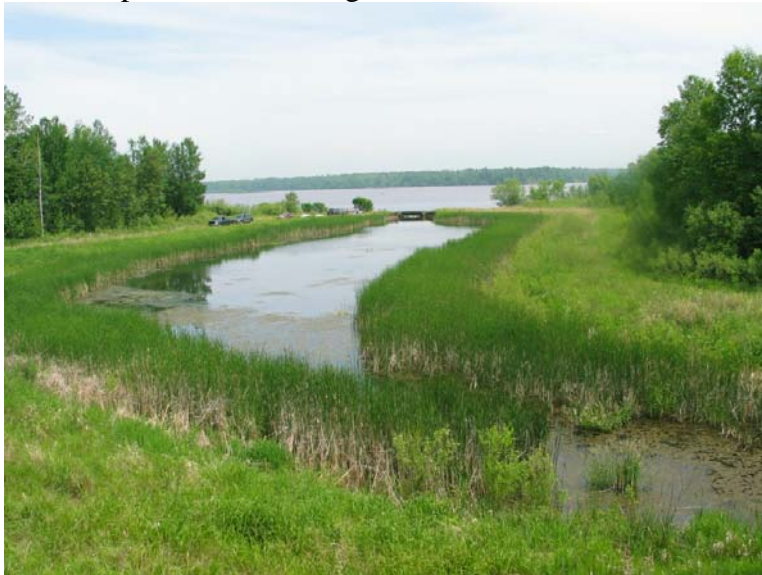
The photo on the left is view of the Wire Mill Pond looking easterly towards the St. Louis River. The wetland vegetation was well established. There was an oil sheen observed on the pond surface near the hydraulic control structure on June 27, 2003. There was no shoreline erosion or sloughing noted. The perimeter of the pond was surveyed with GPS.

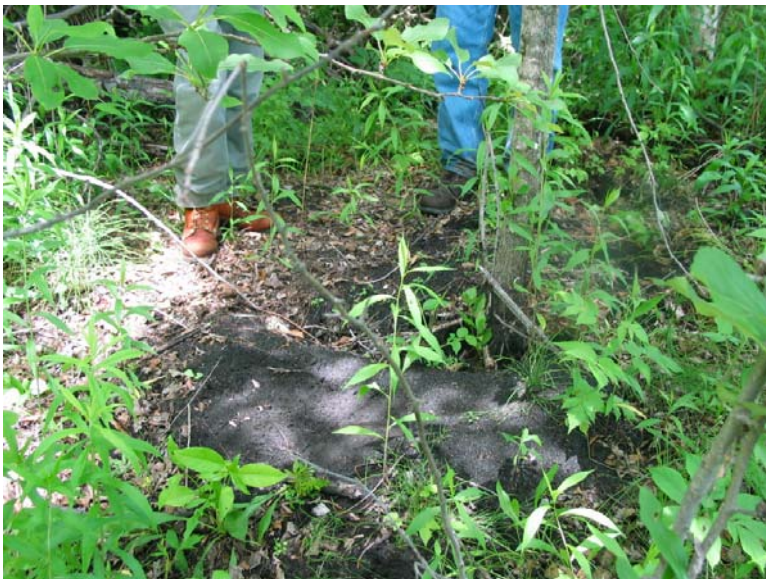
The spoil areas on both the north and south sides of the basin were inspected. Non-native materials were found exposed at the ground surface on the south side as pictured in the photo to the left. There was no exposed non-native materials found on the north pile. The north pile was well vegetated with tree and covered with soil. This south spoil pile was surveyed using GPS.

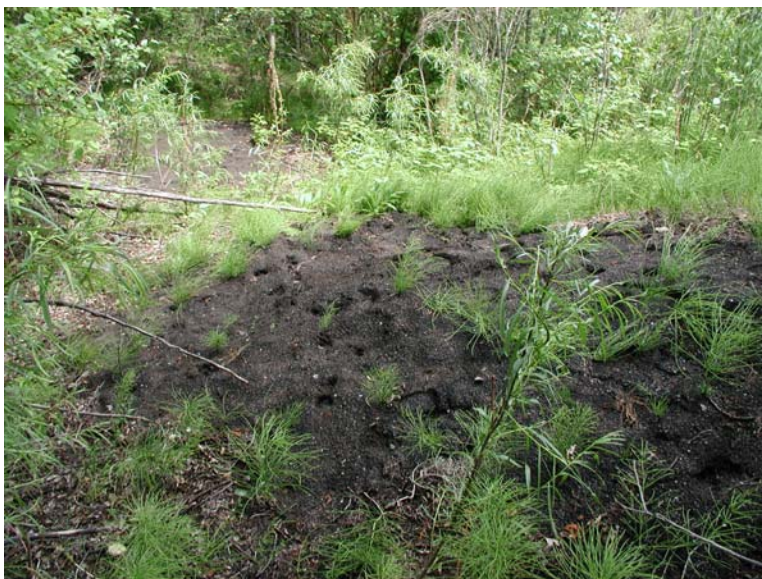
The west bank of the Wire Mill Pond was inspected. There was a large area of non-native material located south of the pond. The non-native material did not support vegetation. This area was surveyed using GPS. A seep was discharging from the south spoil pile into the bank of the Wire Mill Pond about three feet above the water surface.

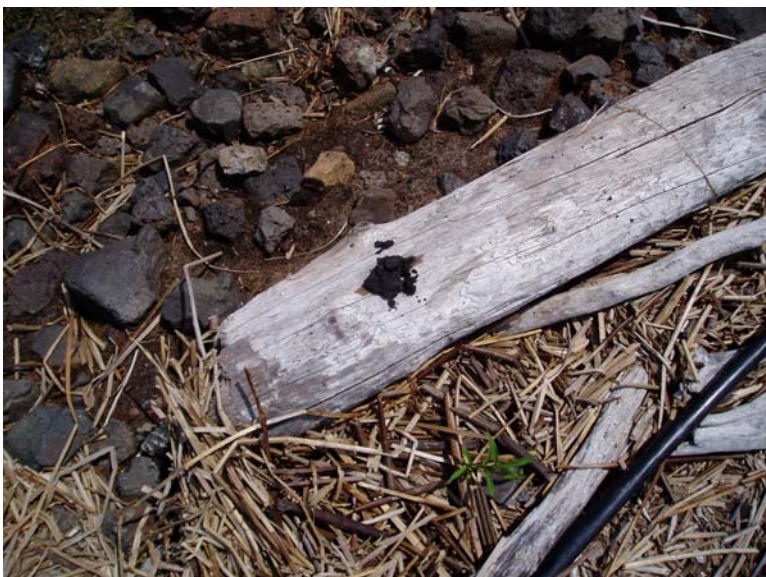
Non-native materials were observed along the shoreline of the St. Louis River near the Wire Mill Pond. The photo on the left is a close-up view of the non-native material.

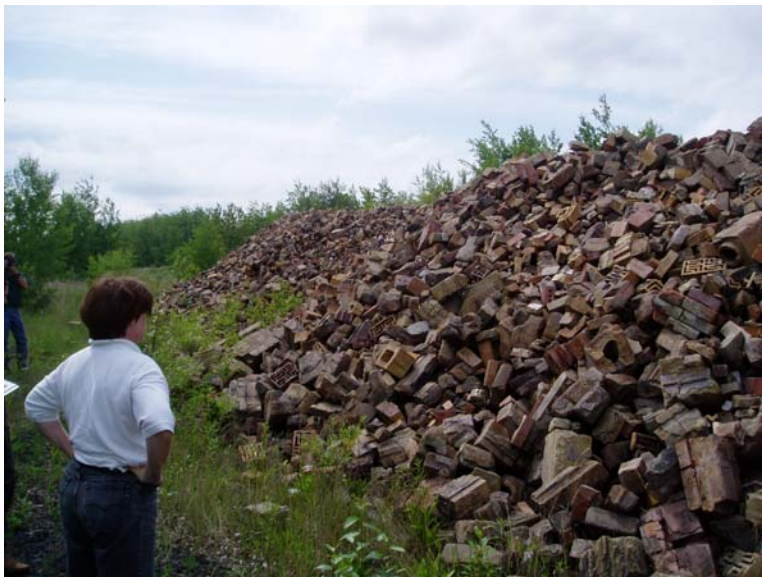
A demolition stockpile of bricks was located near the northeast corner of the former Materials Storage Area. The area was not surveyed. This demolition stockpile is not Demolition Landfill Nos. 1, 2 or 3 that were previously discussed in this report. No information could be found in the literature search that indicates this demolition stockpile was ever permitted.

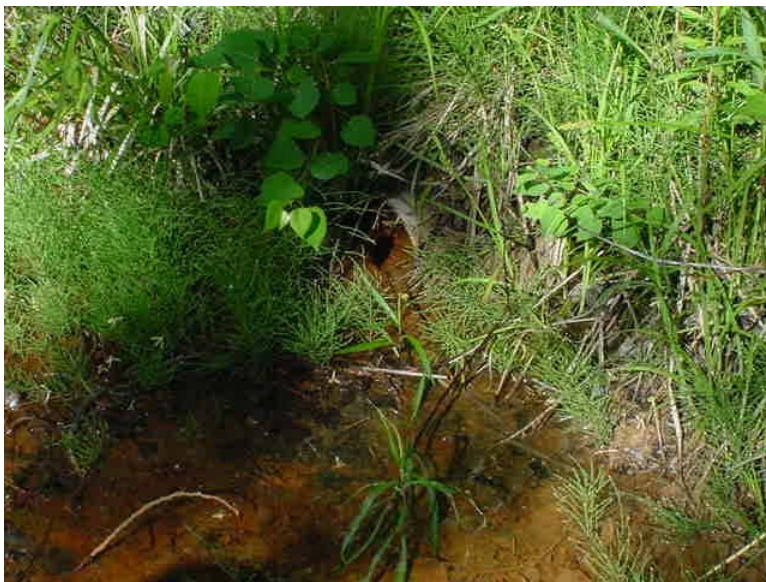
A steel pipe of unknown origin was found in the west railroad ditch between the unused Demolition Landfill No. 3 and the St. Louis River. Post inspection research indicates this pipe may be there repaired monitoring location of Seep #2. Approximately 200 feet of ditch was stained red.

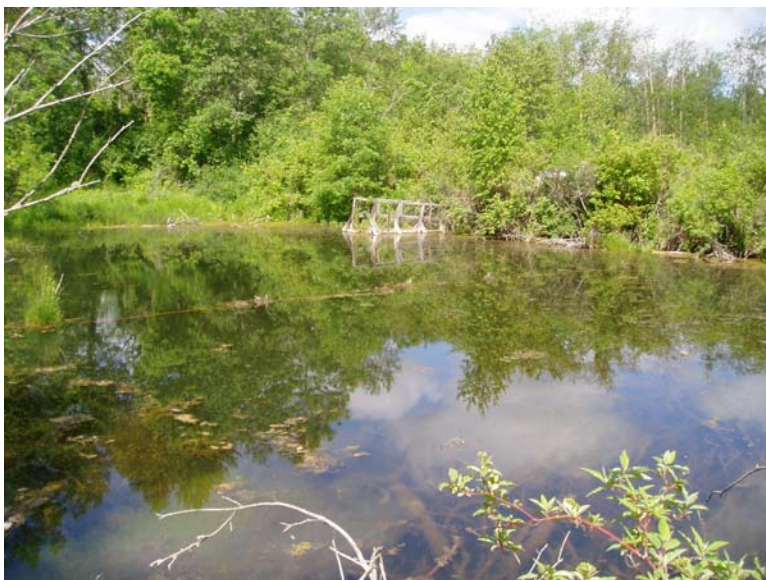
This pond was inspected on June 27, 2003. The pond is located south of Seep 1. A citizen stated his dog fell through the ice at this pond and was coated with an oily material.

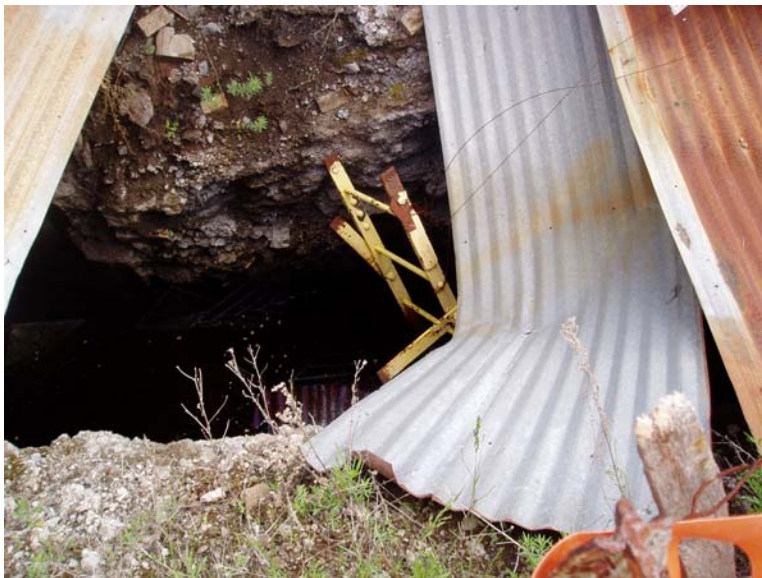
This gatewell was inspected on June 27, 2003. The gatewell is located near Well 7. There was floating product in the gatewell. The orange protective fence around the structure needs repair.

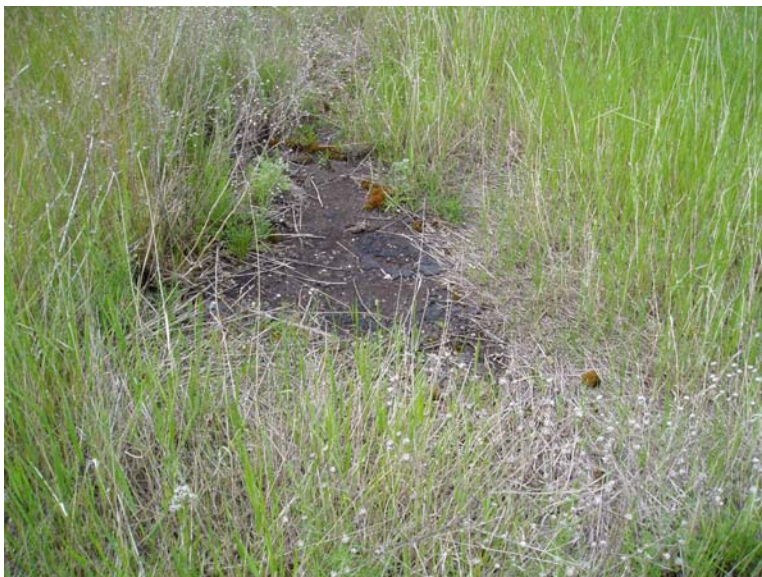
This non-native material was observed on June 27, 2003. The soil is located near Well 7.

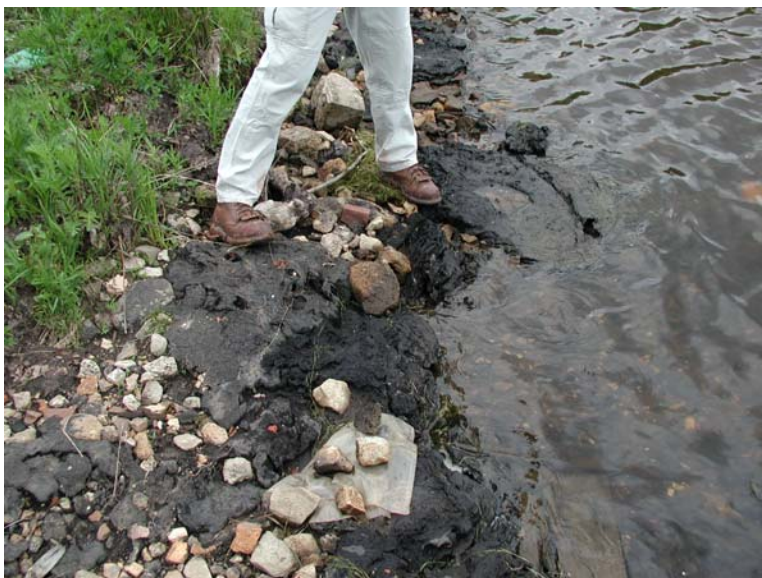
Hardened tar was observed at several locations along the water's edge on the north bank of Slip 6. These seeps appeared to be fairly fresh. The locations were marked by GPS and are shown on Figure 7.

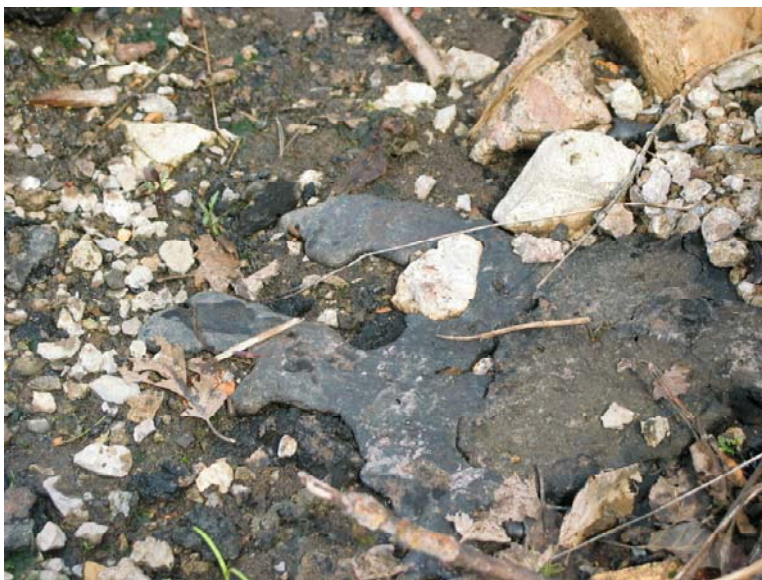
Tar located at the water's edge at the north end of Slip 6. The locations are shown on Figure 7 as Tar at Slip 6.

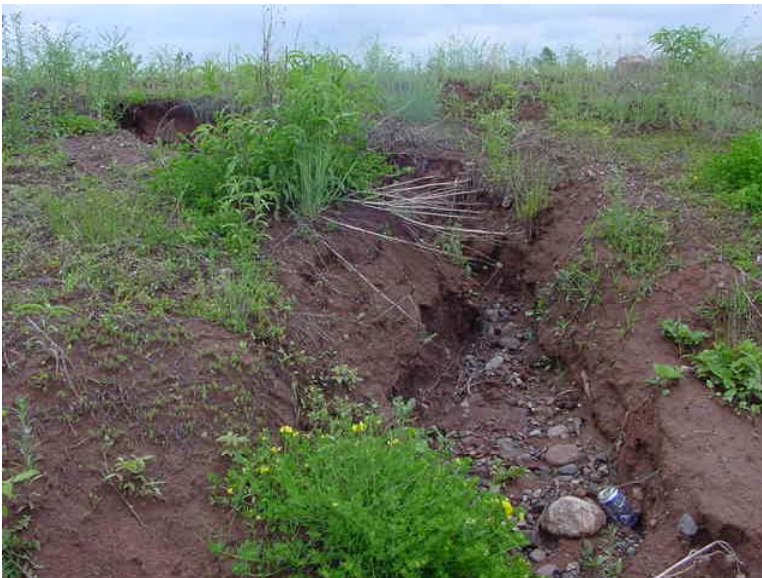
The erosion in this photo is the deepest observed at approximately 3 feet. The location was marked using GPS and is shown on

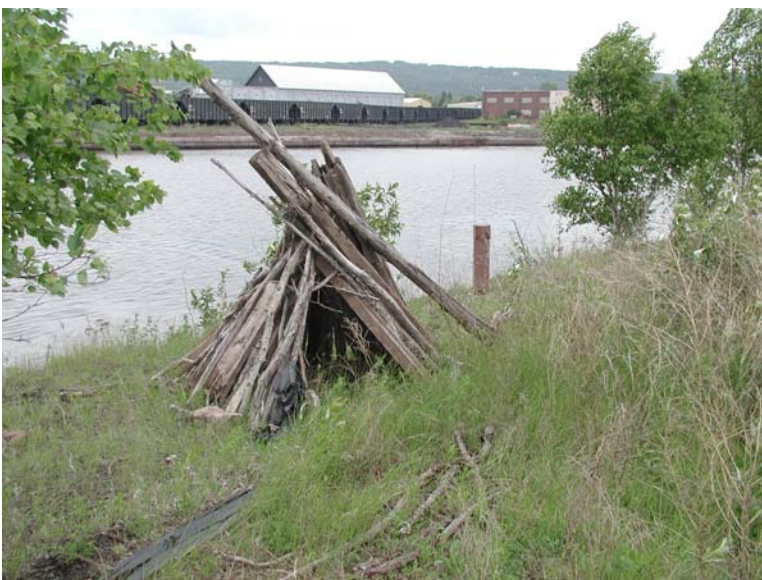
Figure 7.
Evidence of trespassing, like that shown here, was observed along the shoreline of the peninsula. Trash, debris, and small fire rings were common across the site.

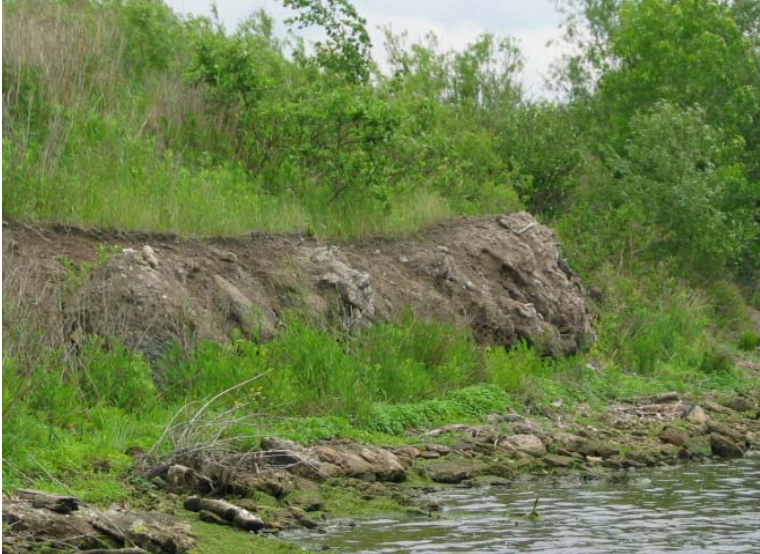
Erosion was observed along the west shore of the 59th Avenue peninsula. The location was marked using GPS and is shown as Area F 1 on Figure 7

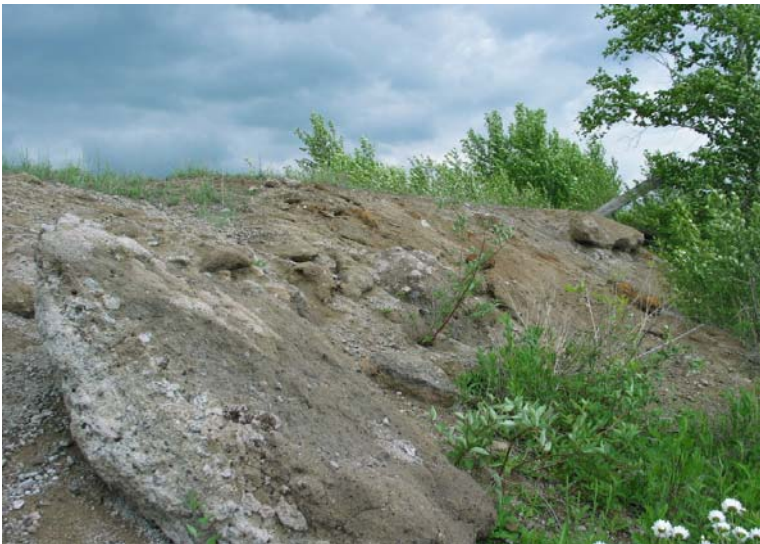
Erosion along the west shore of the 59th Avenue peninsula was observed. The location was marked using GPS and is shown as Area F 2 on Figure 7

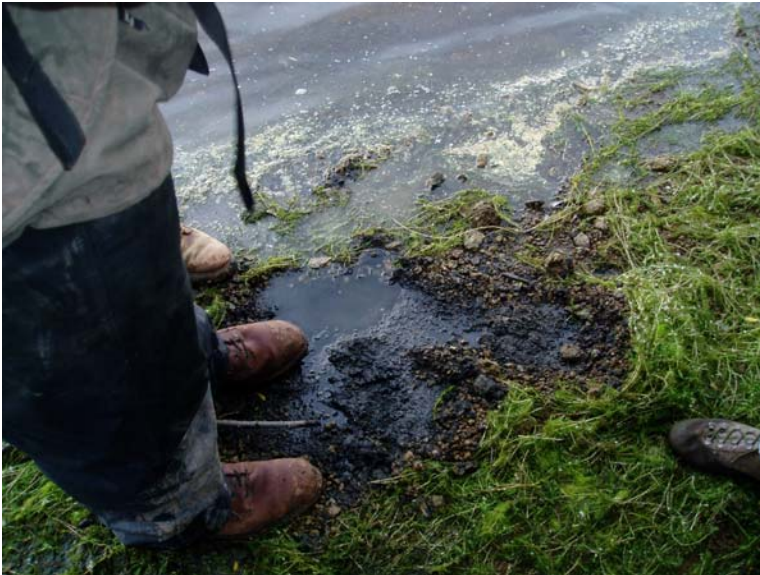
An example of the oily material was observed along 59th Avenue peninsula west shoreline.

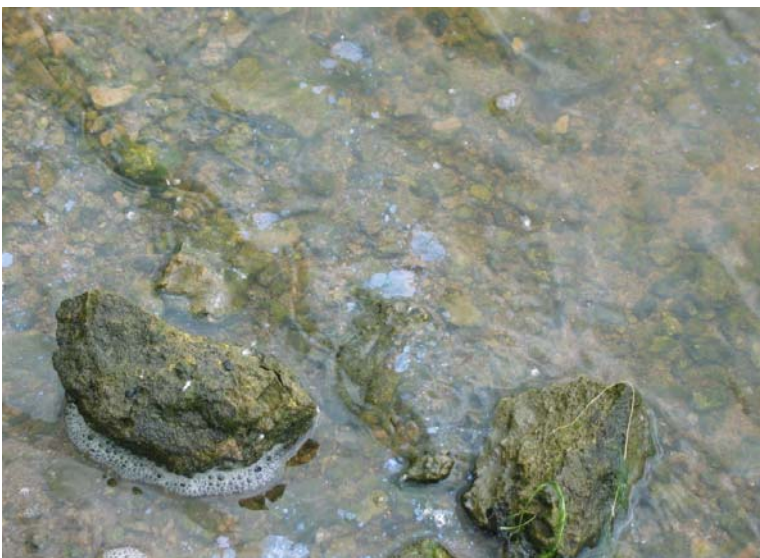
This is an example of the oil sheens observed on Stryker Embayment Surface.

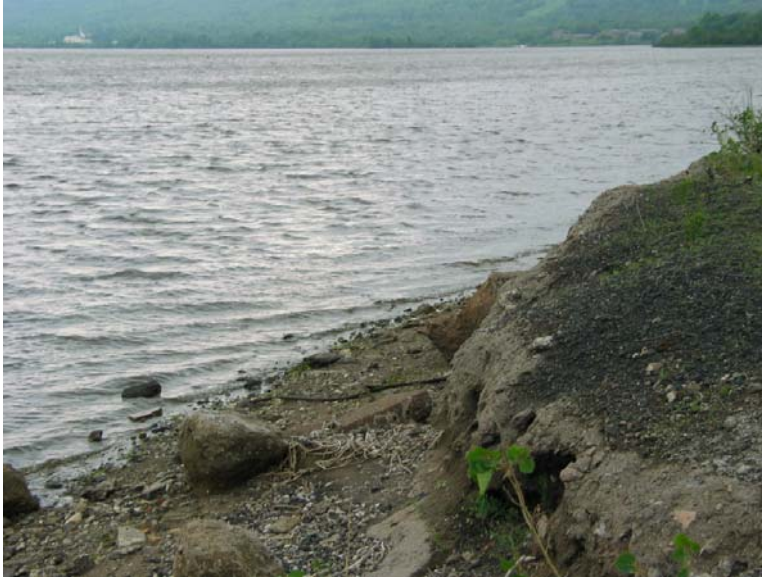
Viewed here is erosion observed at the southern tip of the 59th Avenue peninsula.

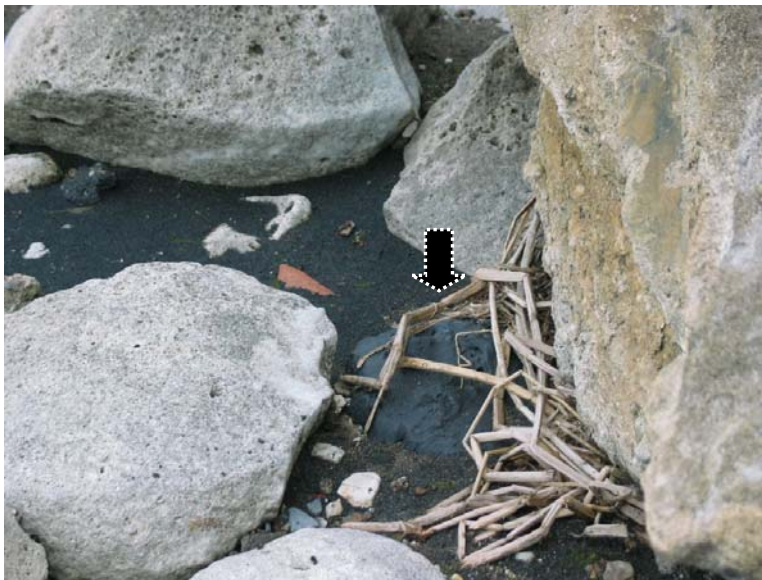
This tar was observed in the same general location that the erosion was noted. The tar and erosion location are approximated on Figure 7 as Area F 3.

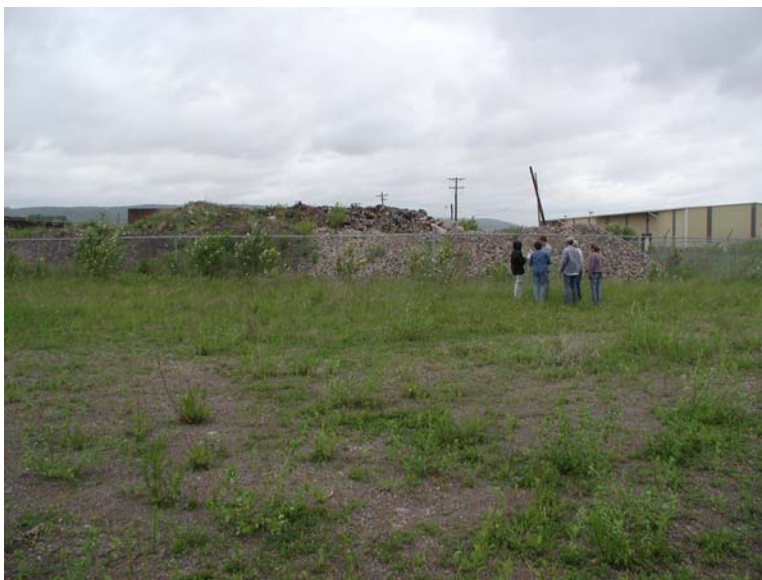
The tar seep was originally located at the fence line, approximately where the ground is standing. This point was marked using GPS and is shown as Area A/E tar seep on Figure 7

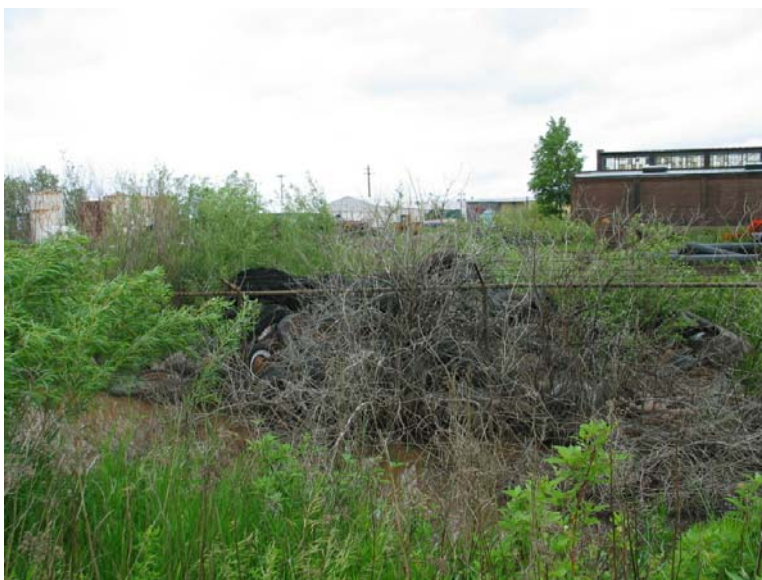
This photo is the west side of Area E, looking east, northeast. A low point with poor drainage is noted in foreground.
