ON-SCENE COORDINATOR'S REPORT

CERCLA REMOVAL PROJECT

INTERNATIONAL DISC CORPORATION

ELLSWORTH, MICHIGAN

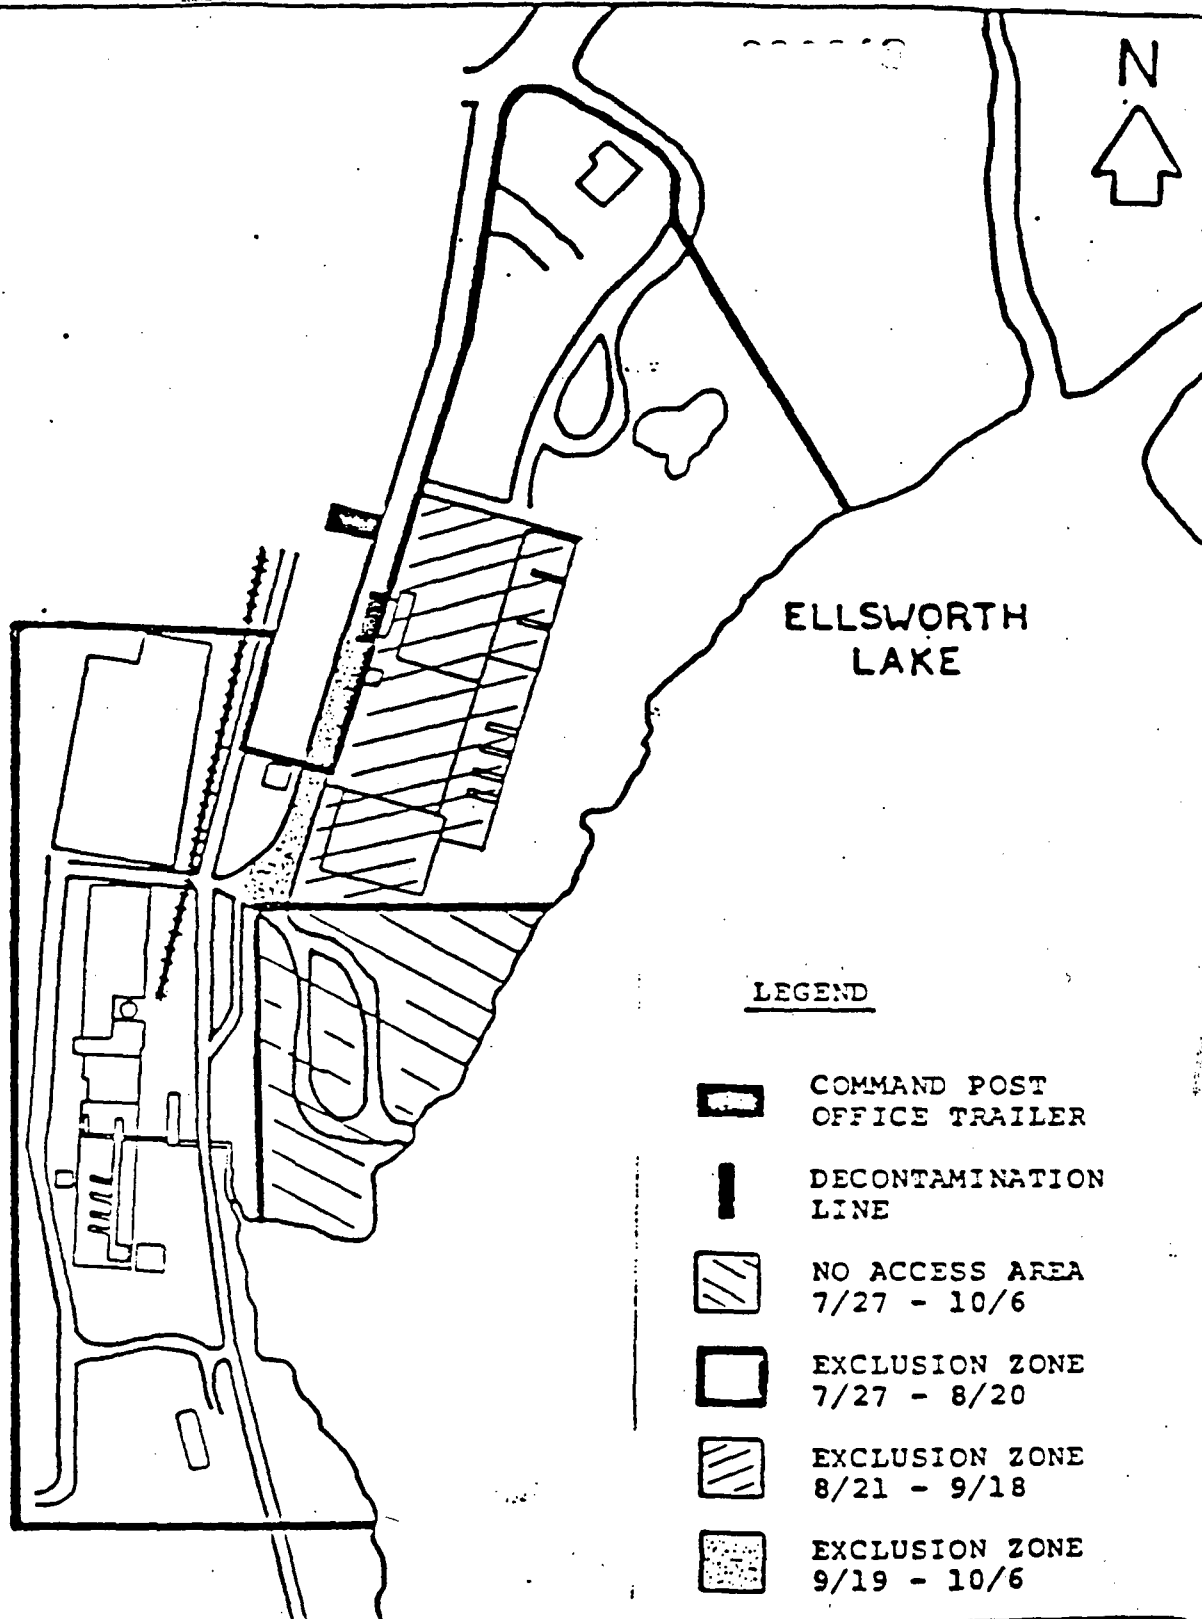
FIGURE 4. INTERNATIONAL DISC CORP. ZONE DELINEATION MAP.

Delineations of the exclusion zone were modified with changes in site activities, and in accordance with the access warrant. The hot zone initially included all of the buildings on the property. As specified in the warrant, the Federal cleanup action could only be conducted on the facility grounds until the evening of September 18, 1987. By September 19, 1987, all hazardous waste materials identified during the removal had been staged off of IDC property (Figure 4).
