MEMORANDUM

SUBJECT: ACTION MEMORANDUM - Request for Approval of a Time-Critical Removal Action at the Electro Plating Services Site, Madison Heights, Oakland County, Michigan (Site ID #C5ZC)

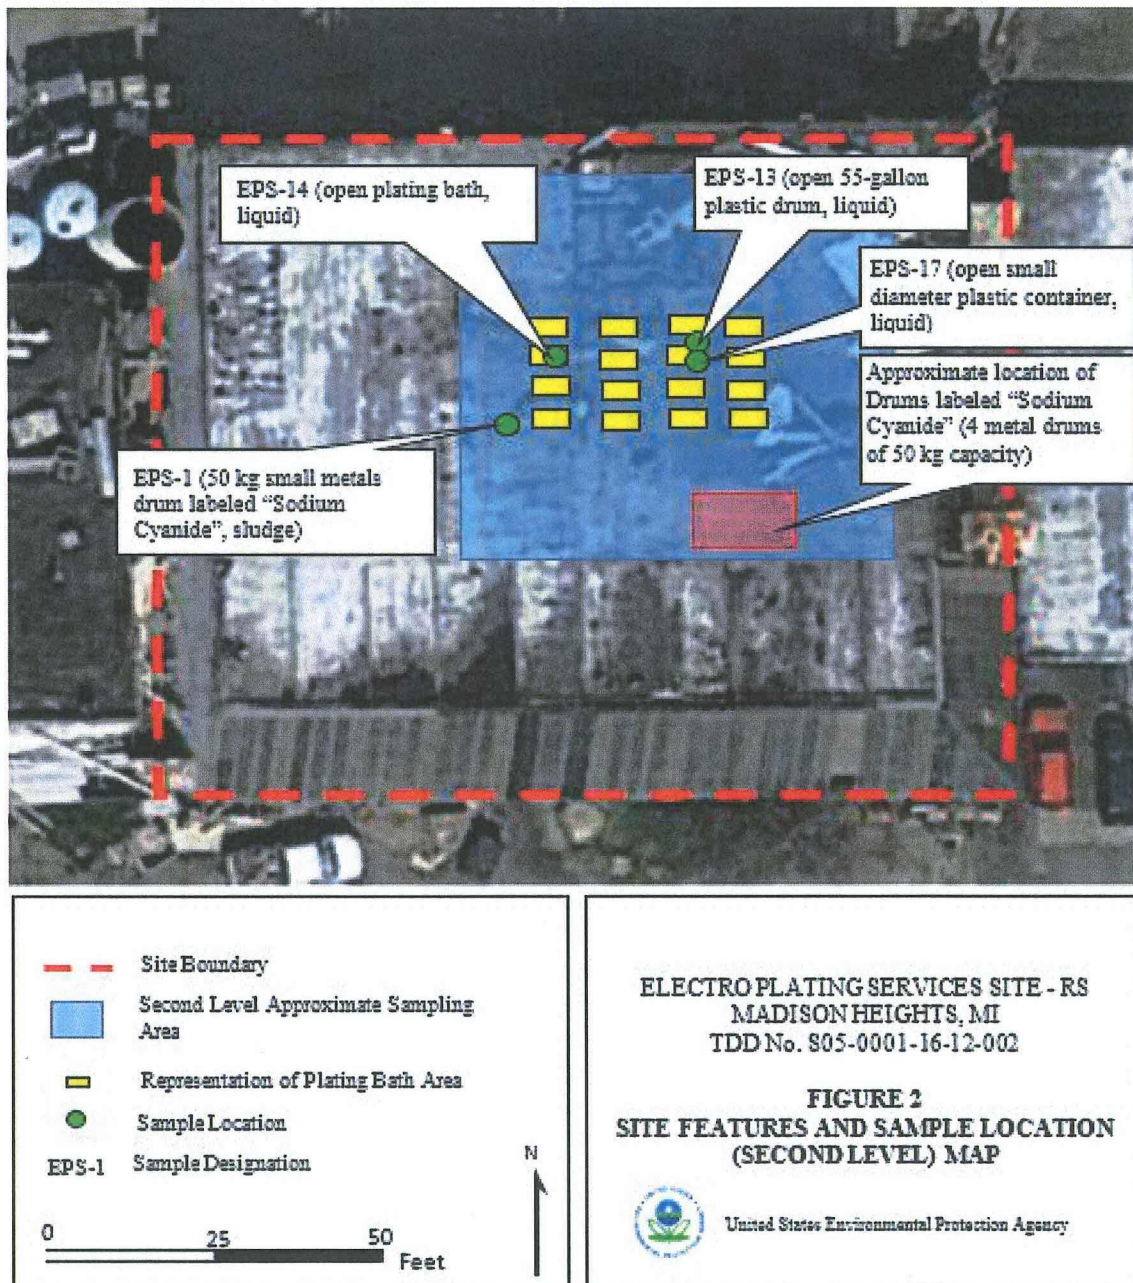
FIGURE A-2

SITE FEATURES MAP
SECOND LEVEL
ELECTRO PLATING SERVICES SITE
MADISON HEIGHTS, OAKLAND COUNTY, MICHIGAN

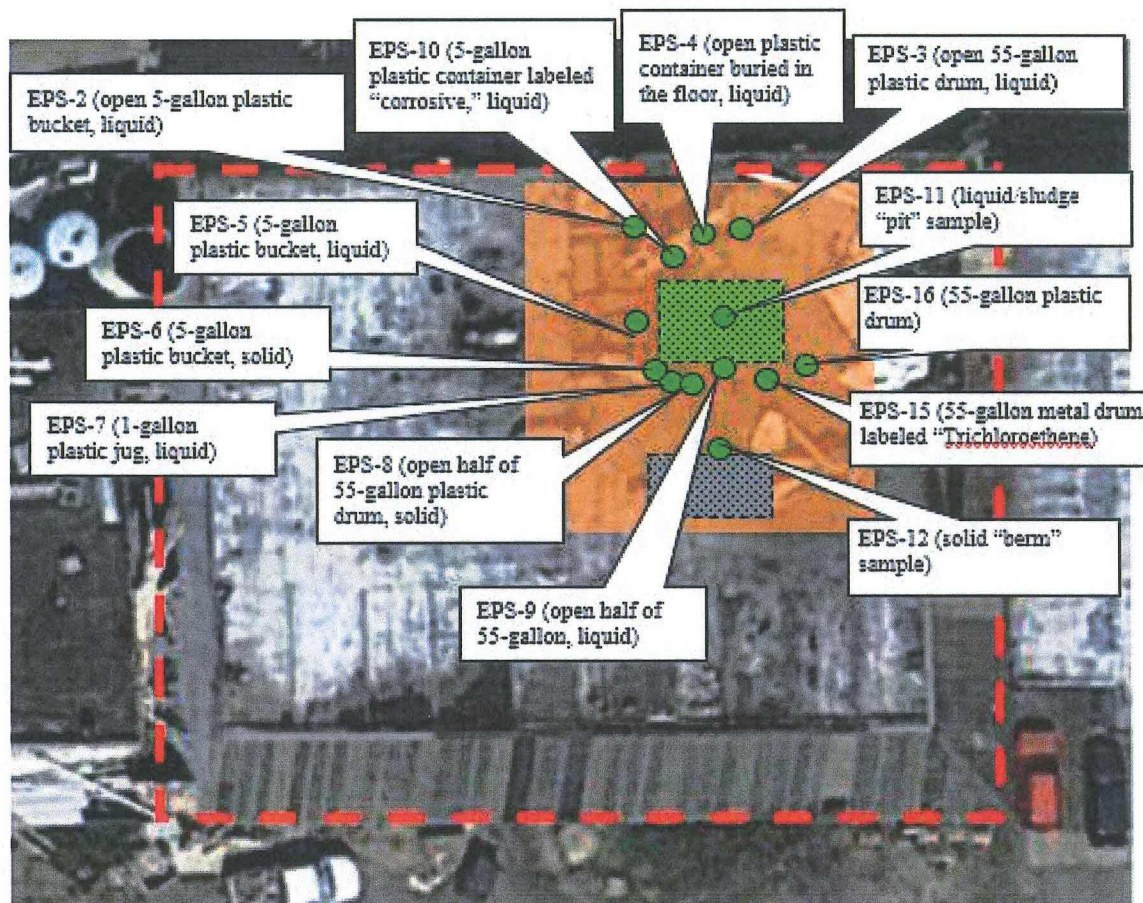
FIGURE A-3

SITE FEATURES MAP
BASEMENT LEVEL
ELECTRO PLATING SERVICES SITE
MADISON HEIGHTS, OAKLAND COUNTY, MICHIGAN
