CAMU Semi-Annual Geosynthetics Inspection Form

Corrective Action Management Unit
U. S. Steel - Gary Works
Gary, Indiana

Date: September 12 - 13, 2017

SEMI-ANNUAL LINER INSPECTION
DOCUMENTATION - SEPTEMBER 2017
CORRECTIVE ACTION MANAGEMENT UNIT
U. S. STEEL - GARY WORKS, GARY, IN
REUSE OF DOCUMENTS
THIS DOCUMENT, AND THE DESIGNS INCORPORATED HEREIN, AS AN INSTRUMENT OF PROFESSIONAL SERVICE, IS THE
PROPERTY OF WEAVER CONSULTANTS GROUP, AND IS NOT TO BE USED IN WHOLE OR IN PART, WITHOUT THE WRITTEN
AUTHORIZATION OF WEAVER CONSULTANTS GROUP.

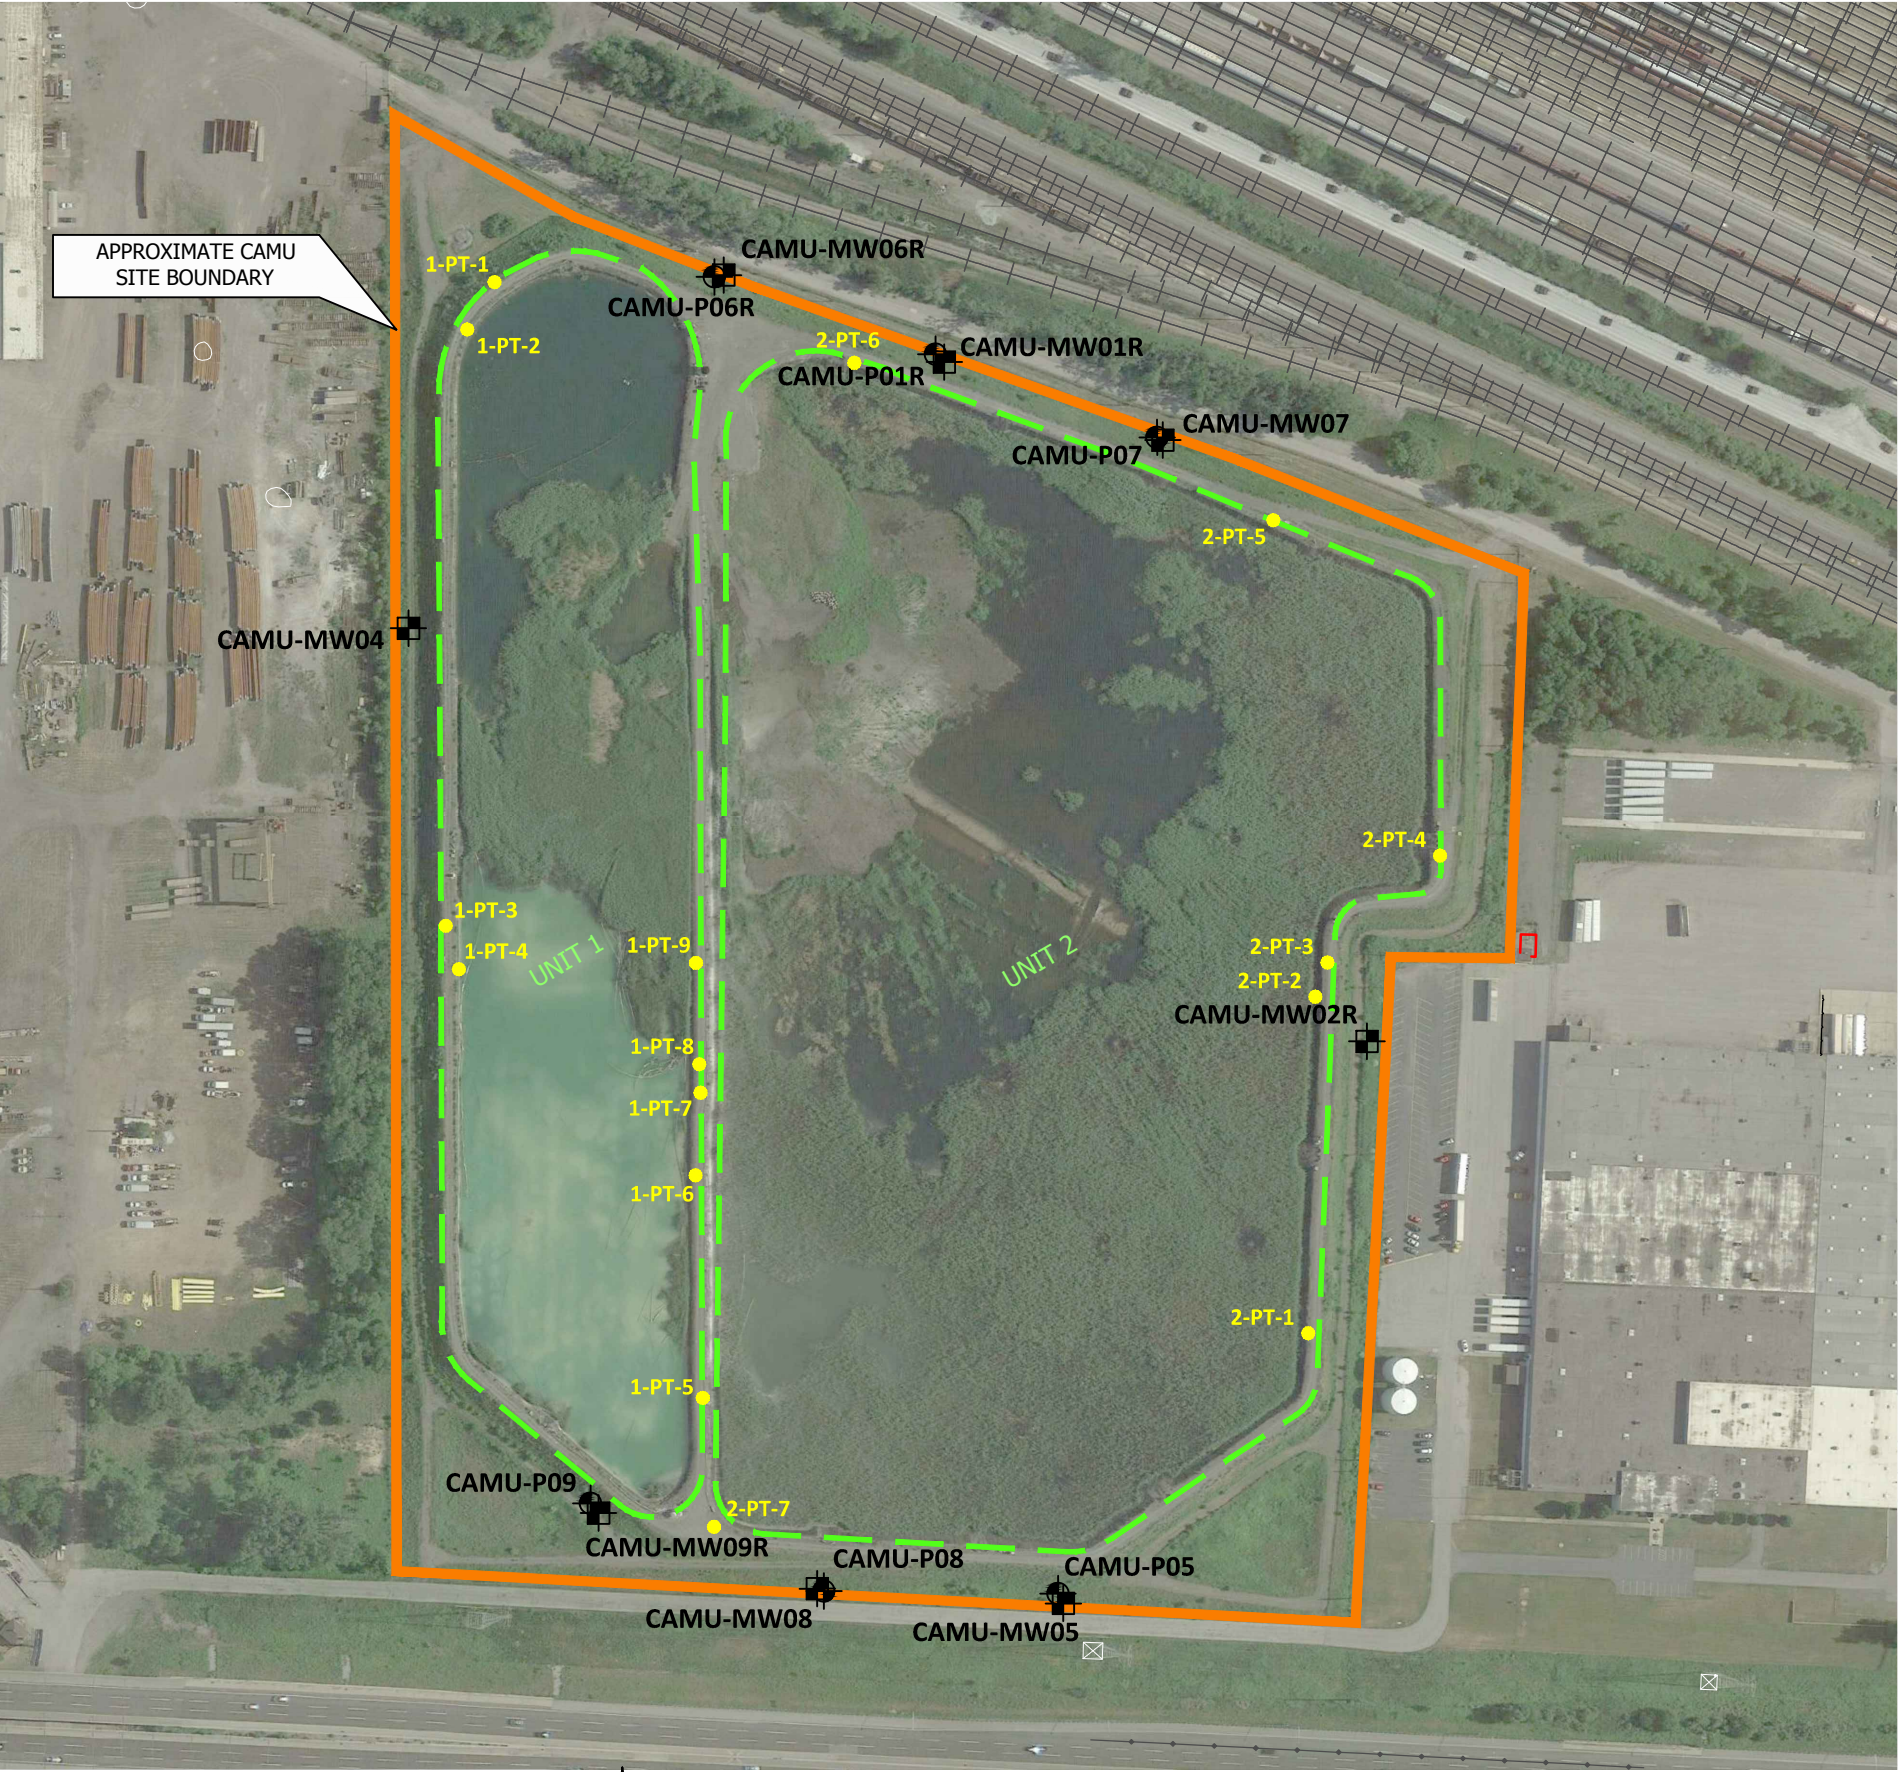
DRAWN BY: RMD
REVIEWED BY: SB
DATE: 9/19/2017
FILE: 4262-300
CAD: site CAMU.dwg
FIGURE 1

Pt No	Northing	Easting
1-PT-1	4607053	469174
1-PT-2	4607037	469163
1-PT-3	4606799	469154
1-PT-4	4606784	469160
1-PT-5	4606617	469255
1-PT-6	4606703	469253
1-PT-7	4606738	469254
1-PT-8	4606748 / 4606762	469254 / 469252
1-PT-9	4606789	469253

Pt No	Northing	Easting
2-PT-1	4606640 / 4606647	469494 / 469497
2-PT-2	4606773 / 4606773	469497 / 469502
2-PT-3	4606786	469502
2-PT-4	4606826	469547
2-PT-5	4606959	469482
2-PT-6	4607022	469317
2-PT-7	4606566	469259
