CAMU Semi-Annual Geosynthetics Inspection Form  
Corrective Action Management Unit  
U. S. Steel - Gary Works  
Gary, Indiana

Date: April 12-13, 2017

Unit 1 Inspection

Unit 2 Inspection

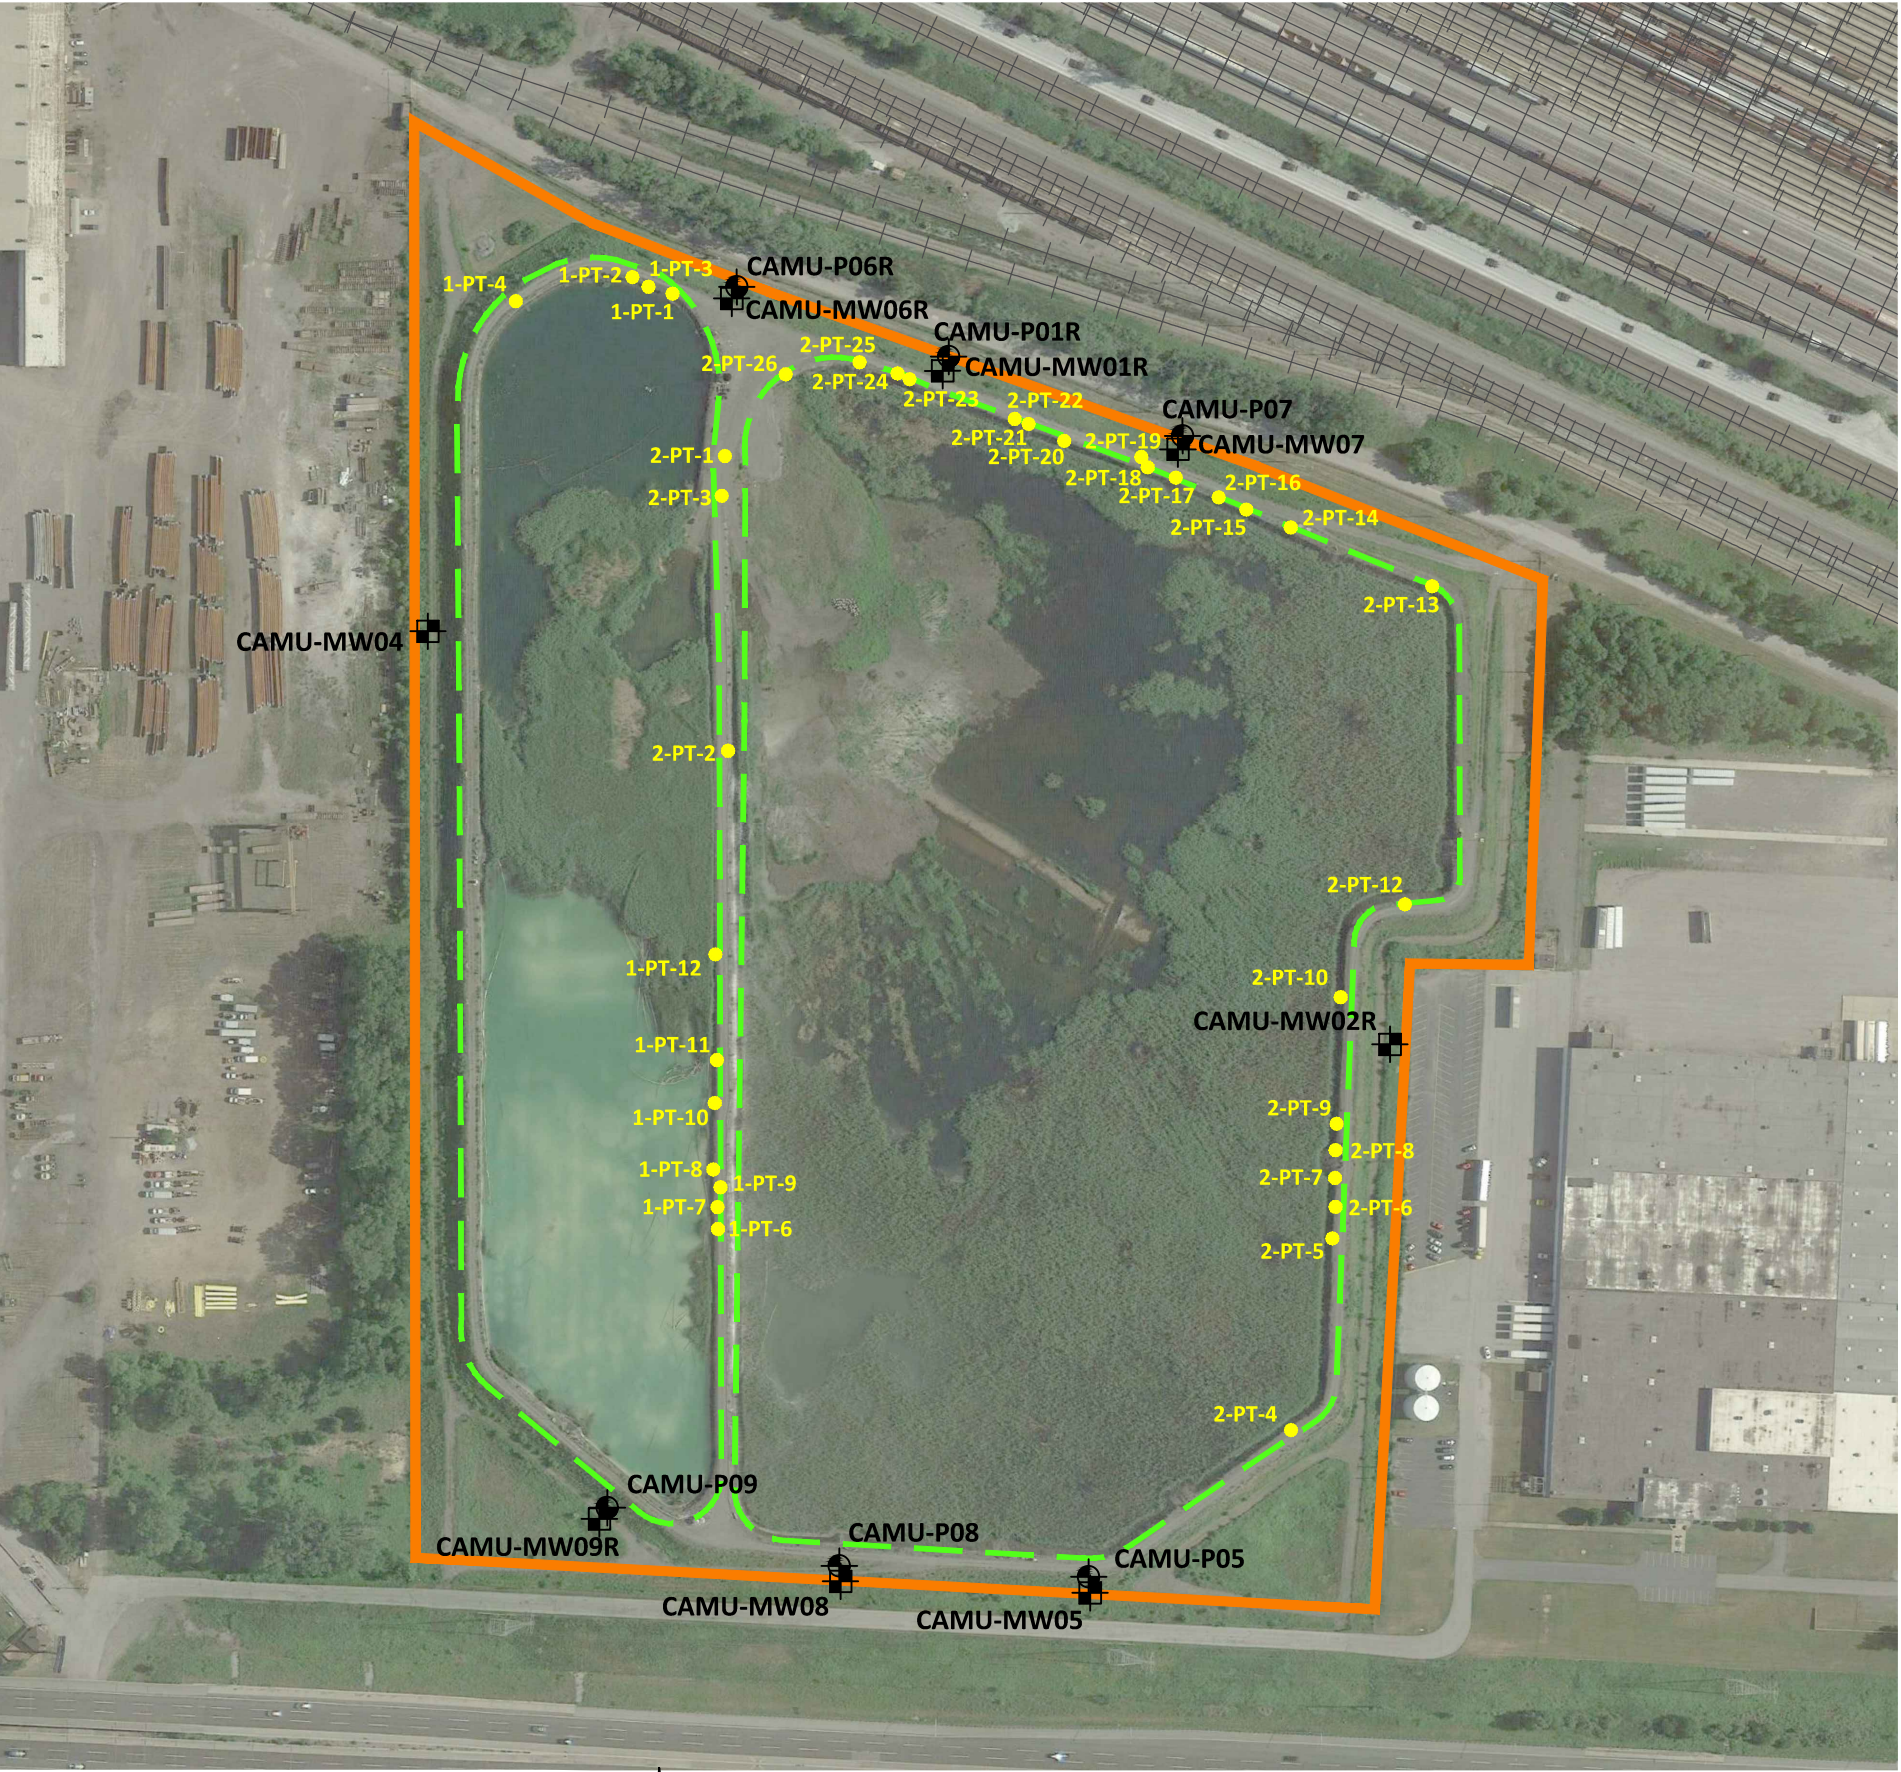
DRAWN BY: RMD  
REVIEWED BY: RS/SB  
DATE: 4/26/2017  
FILE: 4262-300  
CAD: site CAMU.dwg  
**FIGURE 1**

Adverse deterioration (such as exposure of the underlying geomembrane) was observed at the locations noted above.

Locations of repairs are noted on Figure 1.

Repairs to the exposed geomembrane will be performed by placing double sided geocomposite over the exposed geomembrane, and fastening the geocomposite to

the existing net (which overlies the geomembrane) with plastic ties as recommended by the manufacturer.
