Norfolk Southern

Culvert Sediment Removal Report

East Palestine Train Derailment Site

December 21, 2023

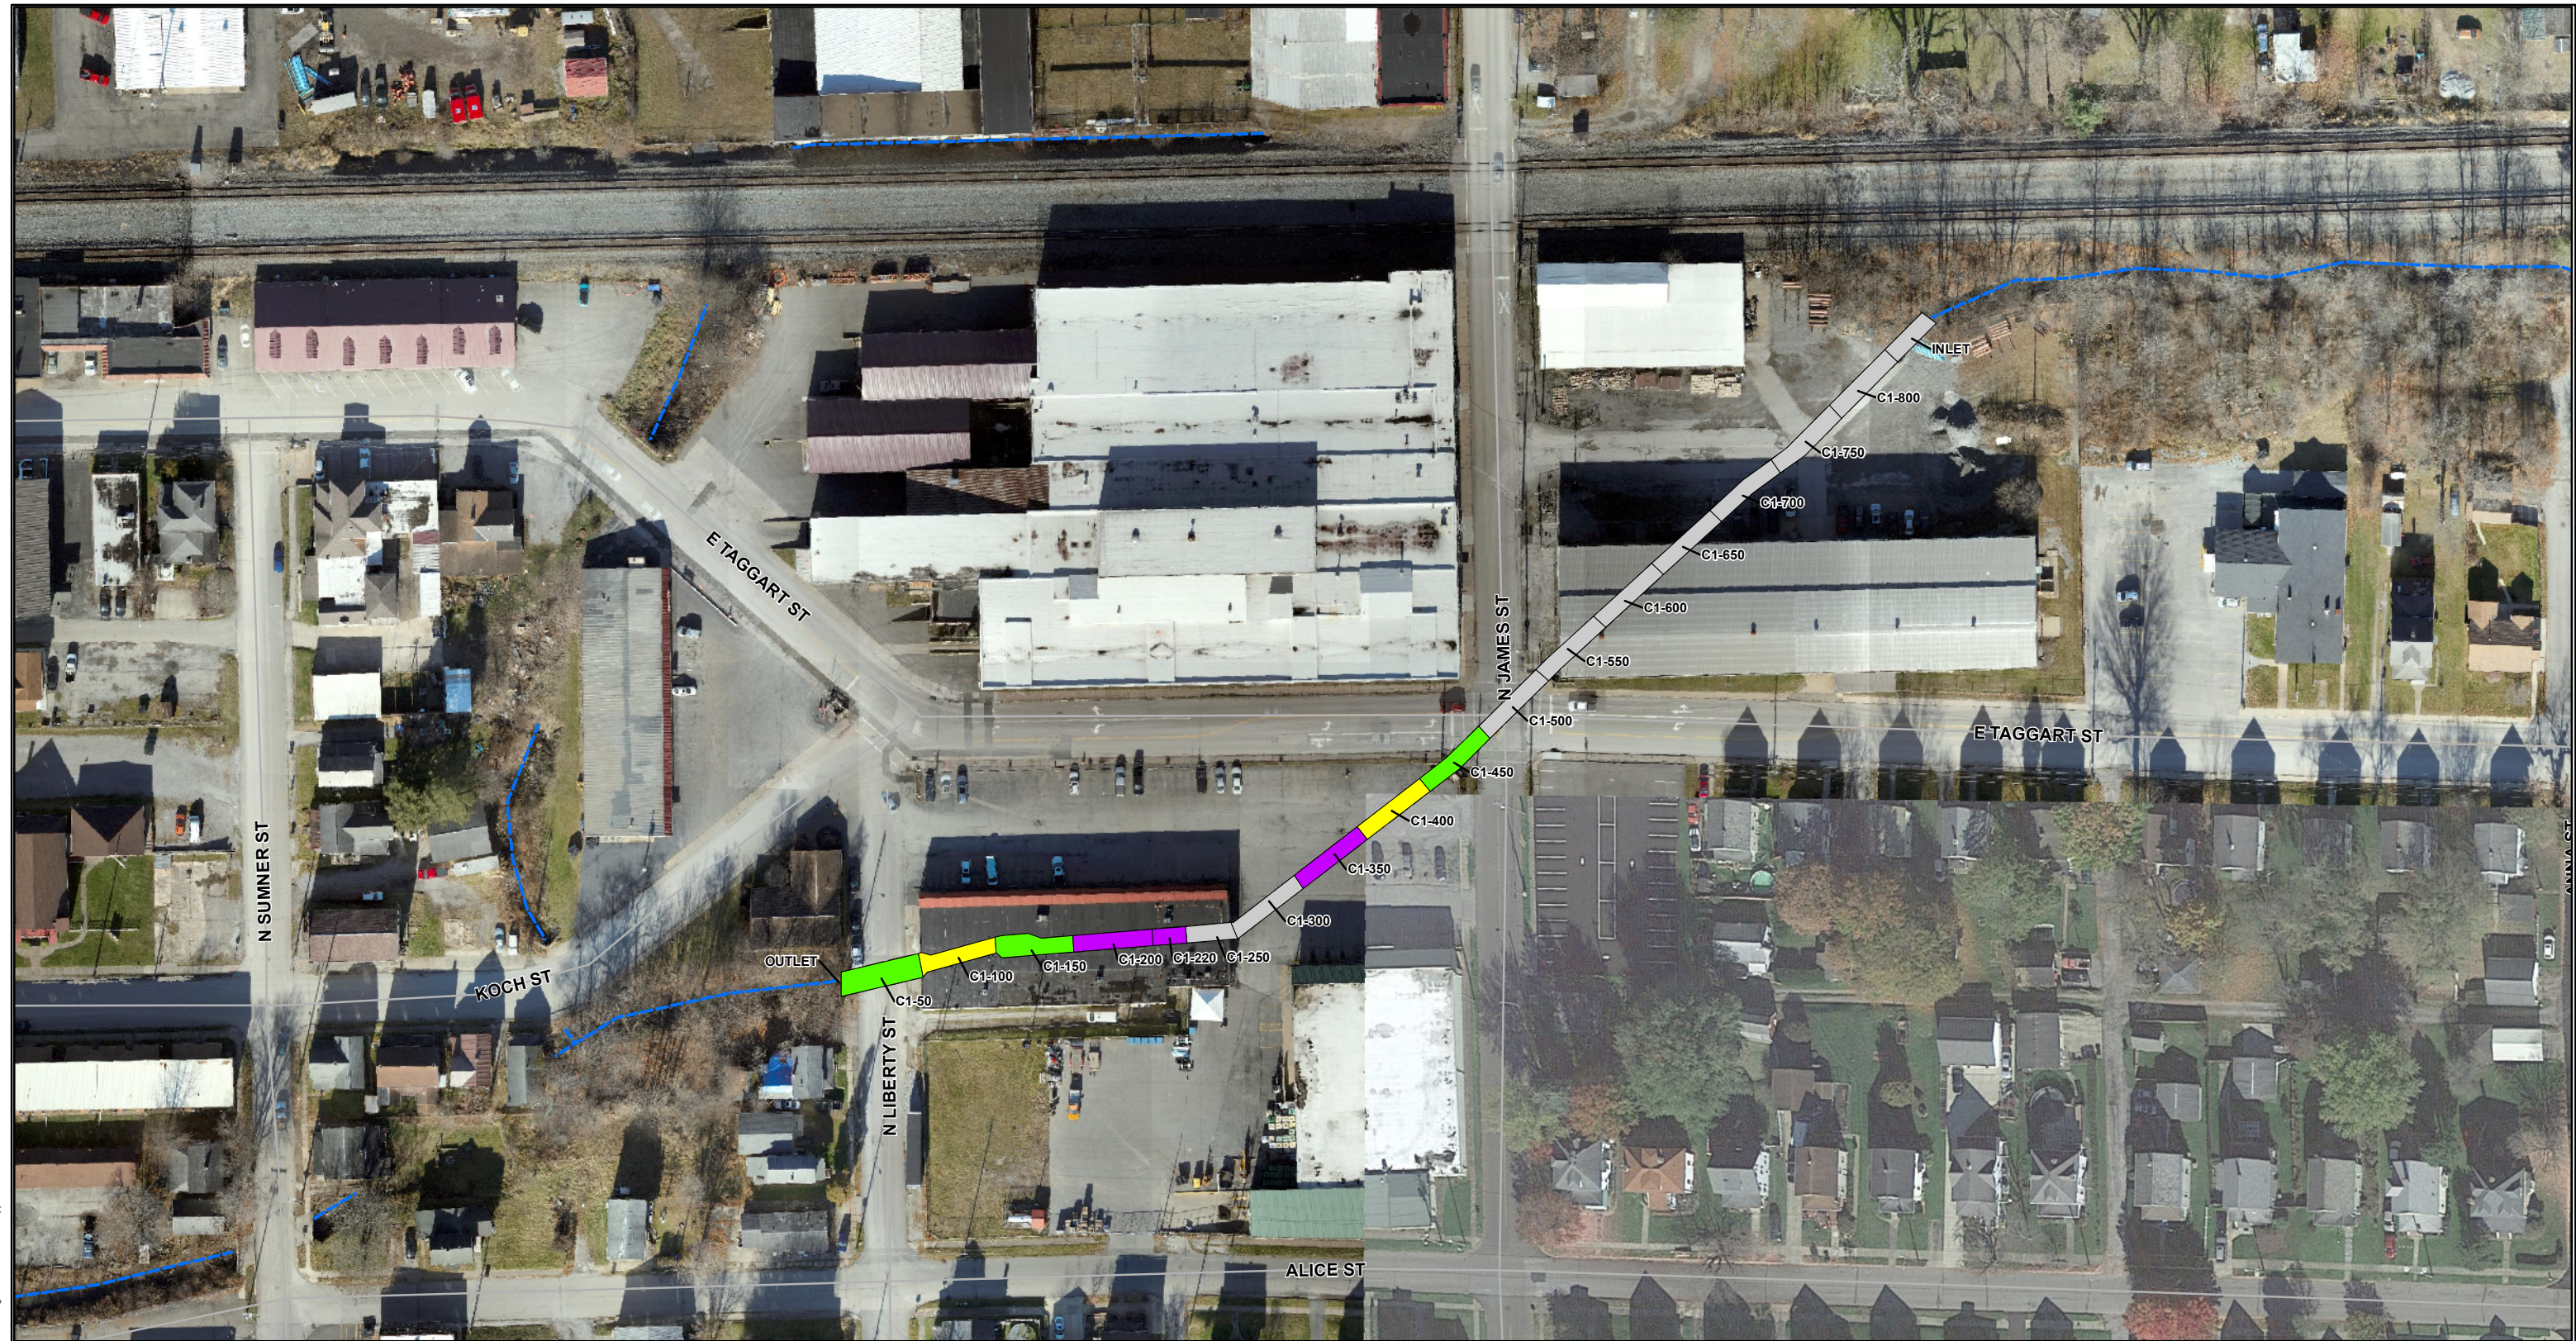
2-1

A qualitative assessment of sheens was conducted throughout the length of Culvert C1 on December 19, 2023. The assessment methods were conducted consistently with the Comprehensive Sheen and Sediment Investigation Work Plan – Sulphur Run and Leslie Run (CWA Investigation Plan, Arcadis 2023c). For the culvert, a transect disturbance was conducted at a minimum spacing of 50 feet where sediment was observed, and a score of 0 to 3 was assigned based on the sheen observed, shown on Figure 2-1. Table 2-1, attached, summarizes the transect distances, assigned sheen scores, measured sediment depth, and an assessment of the culvert bottom. It is estimated that a sediment volume of approximately 22 CY is present in portions of Culvert C1 that contain an engineered bottom. Of this volume, approximately 9 CY are located in areas that have a sheen assessment rated as 0; approximately 6 CY are located in areas that have a sheen assessment rated as 1; approximately 3 CY are located in areas that have a sheen assessment rated as 2; and approximately 3 CY are located in areas that have a sheen assessment rated as 3.

**CULVERT C1
 SUPPLEMENTAL ASSESSMENT**

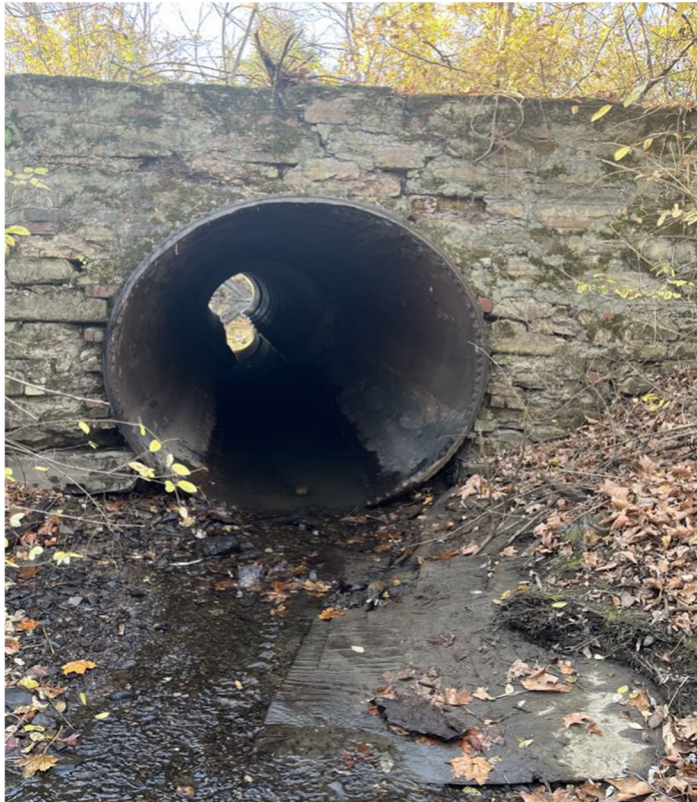
Photograph: 1

- Culvert C0 is constructed of an approximate 40-foot-long, 6-foot diameter steel pipe that transitions to a 20-foot-long, 4.5-foot diameter reinforced concrete pipe.
- Culvert C0 appeared in good condition with no signs of significant deterioration.
- A hard bottom was confirmed in Culvert C0 throughout its length prior to cleaning.
- There were no inlets or lateral pipes entering this culvert.

Description: Culvert C0 before cleaning.

Sediment removal activities were conducted on November 16, 2023. Minimal sediment was found in the culvert, less than 1 cubic yard (CY). Following cleaning activities, prior to removing the sandbag berms and bypass piping, USEPA representatives confirmed cleanup activities were adequately achieved. Appendix A contains initial condition photographs and completion photographs following sediment removal activities in Culvert C0.

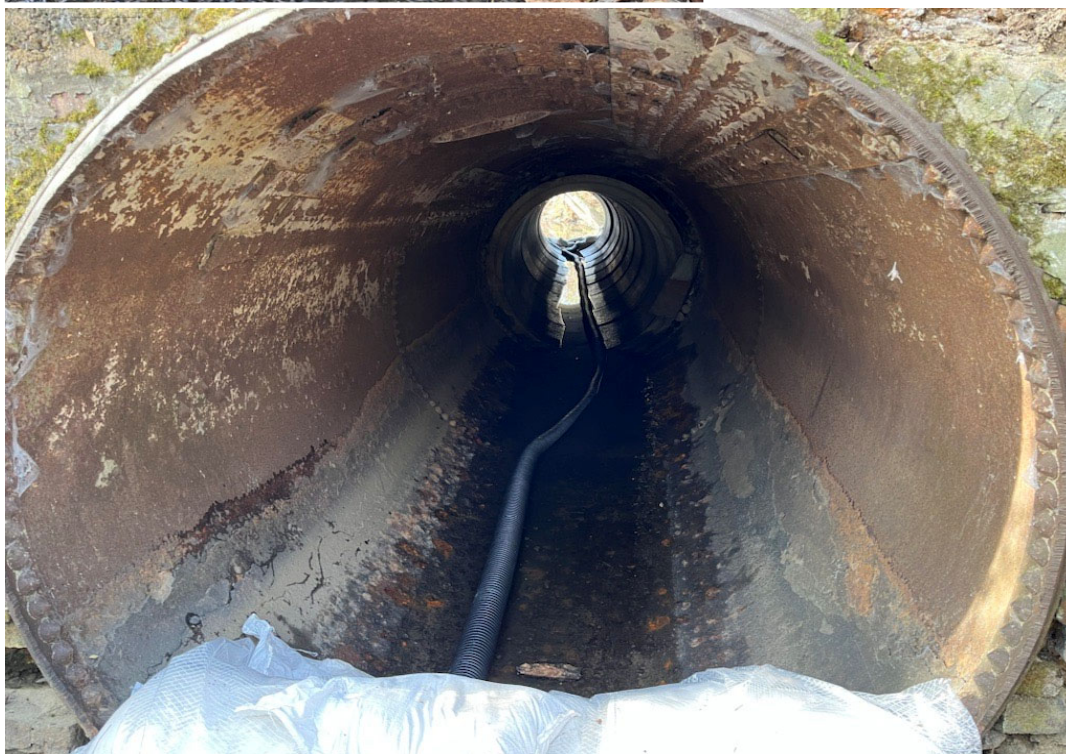
Photograph: 2

Description: Culvert C0 after cleaning.

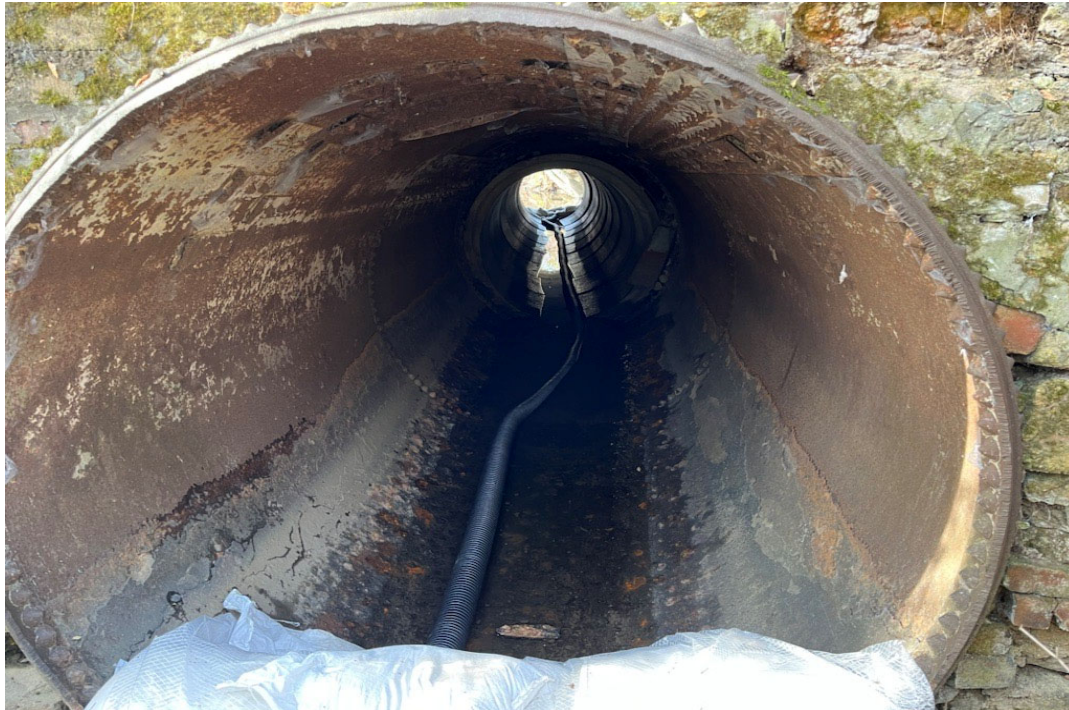
Photograph: 3

Description: Culvert C0
after cleaning.

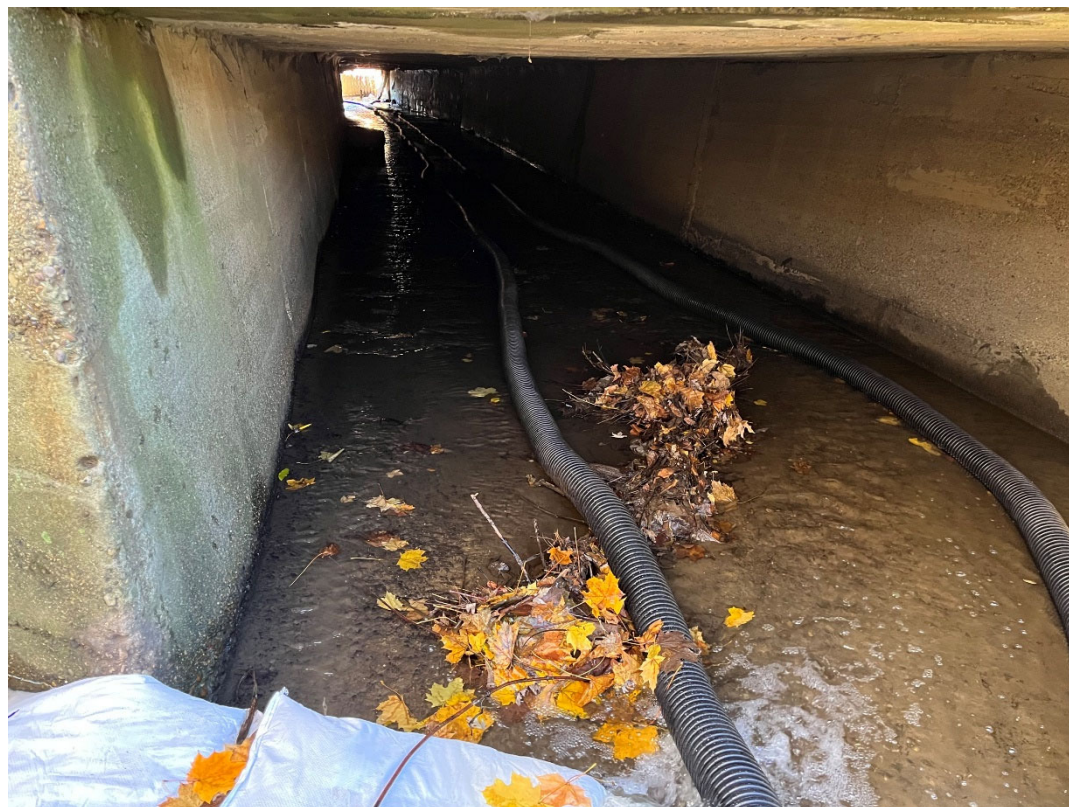
Photograph: 4

- Culvert C2 is constructed of an approximate 150-foot-long, 10-foot-wide by 5-foot-tall concrete box culvert.
- Culvert C2 appeared in poor to fair condition with signs of deterioration of the ceiling and sidewalls of the culvert, especially towards the southern (outlet) end of the culvert.
- A hard bottom was confirmed in Culvert C2 throughout the length of the culvert prior to cleaning.
- There was one inlet to this culvert, a 4-inch diameter iron pipe.

Description: Culvert C2
before cleaning.

Sediment removal activities were conducted on November 18, 2023. Approximately 4 CY of sediment, stones, and debris (e.g., leaves) was removed from Culvert C2. Following cleaning activities, prior to removing the sandbag berms and bypass piping, USEPA representatives confirmed the cleanup activities were adequately achieved. Appendix A contains initial condition photographs and completion photographs following sediment removal activities in Culvert C2.

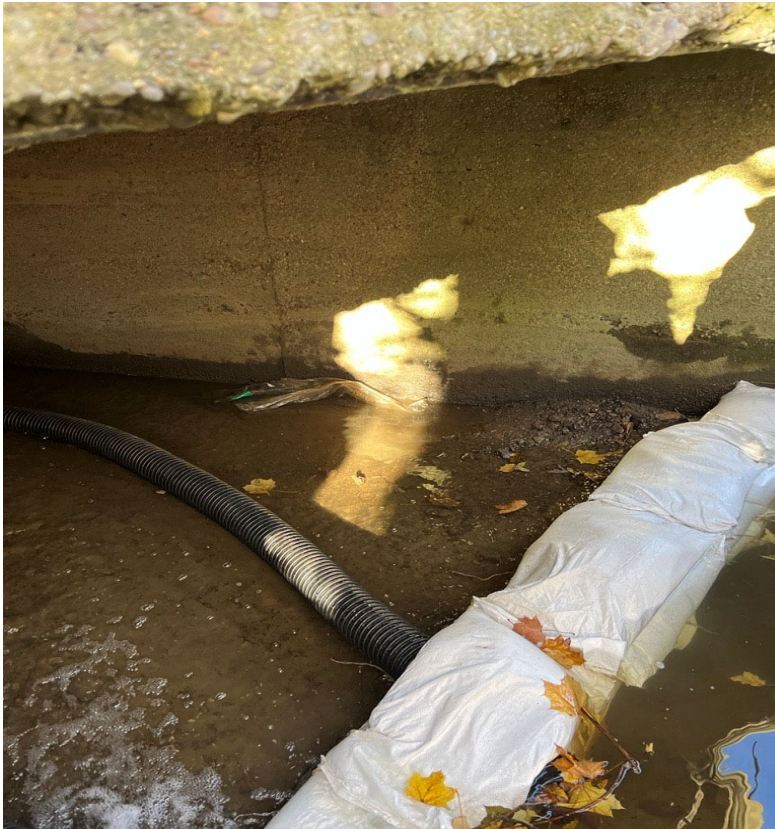
Photograph: 5

Description: Culvert C2 before cleaning.

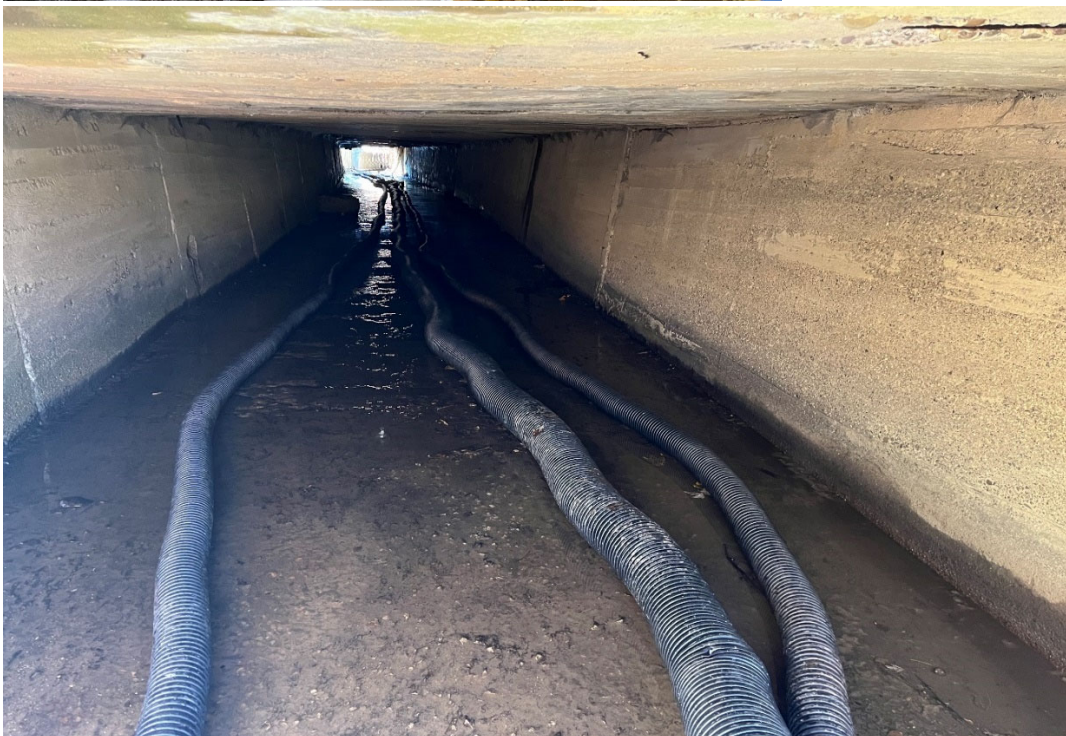
Photograph: 6

Description: Culvert C2 after cleaning.

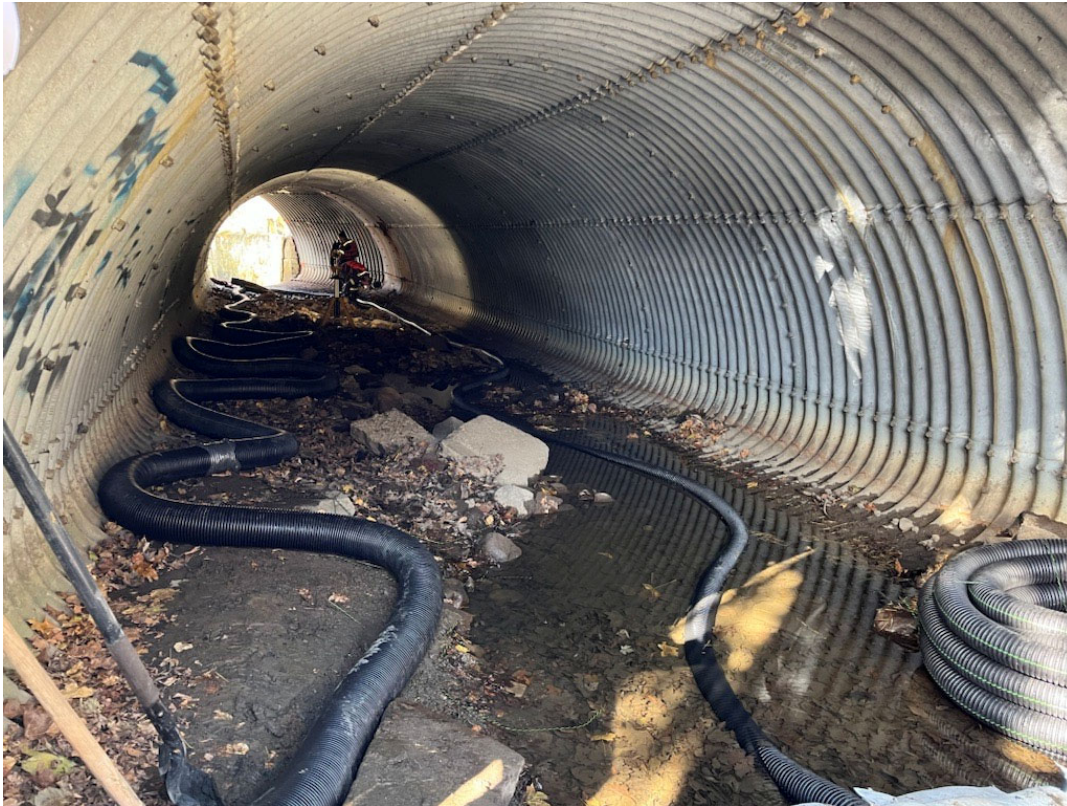
Photograph: 7

- Culvert C4 is constructed of an approximate 83-foot-long, 15-foot-wide by 6-foot-tall corrugated metal arch pipe.
- Culvert C4 appeared in good condition with no signs of significant deterioration.
- A hard bottom was confirmed in Culvert C4 throughout its length prior to cleaning.
- There were no inlets or lateral pipes entering this culvert.

Description: Culvert C4 before cleaning.

Sediment removal activities were initiated on November 13, 2023 and completed on November 16, 2023. Approximately 14 CY of sediment, stones, and debris (e.g., leaves) was removed from Culvert C4. Health and safety concerns associated with removing stones that could not be vacuumed were evaluated following the removal of the sediment. Stone collection and transportation up the steep embankment posed a high potential for injury. It was determined, at the direction of USEPA representatives, that stones that were not vacuumed-up could be vacuumed-off to remove any gross sediment, rinsed, and redistributed within the culvert. Following sediment removal and rinsing activities, prior to removing the sandbag berms and bypass piping, USEPA representatives confirmed the cleanup activities were adequately achieved. Appendix A contains initial condition photographs and completion photographs following sediment removal activities in Culvert C4.

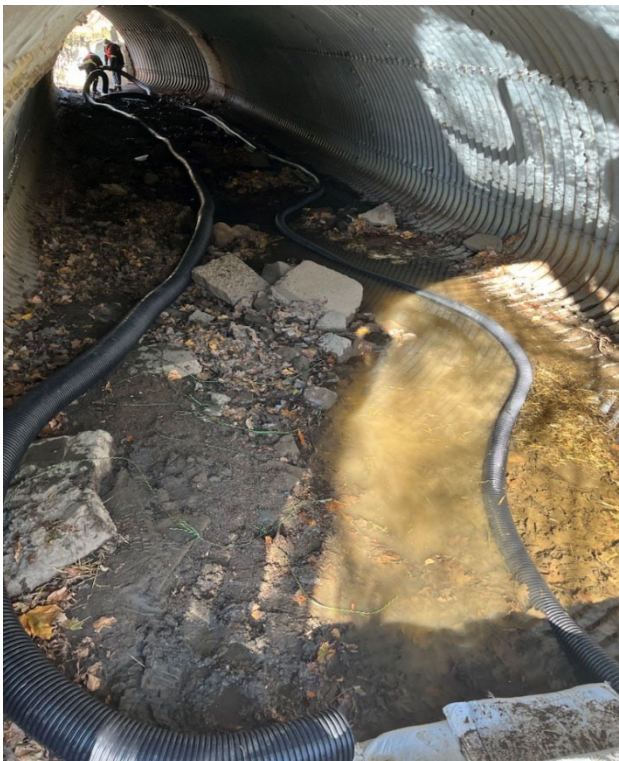
Photograph: 8

Description: Culvert C4 before cleaning.

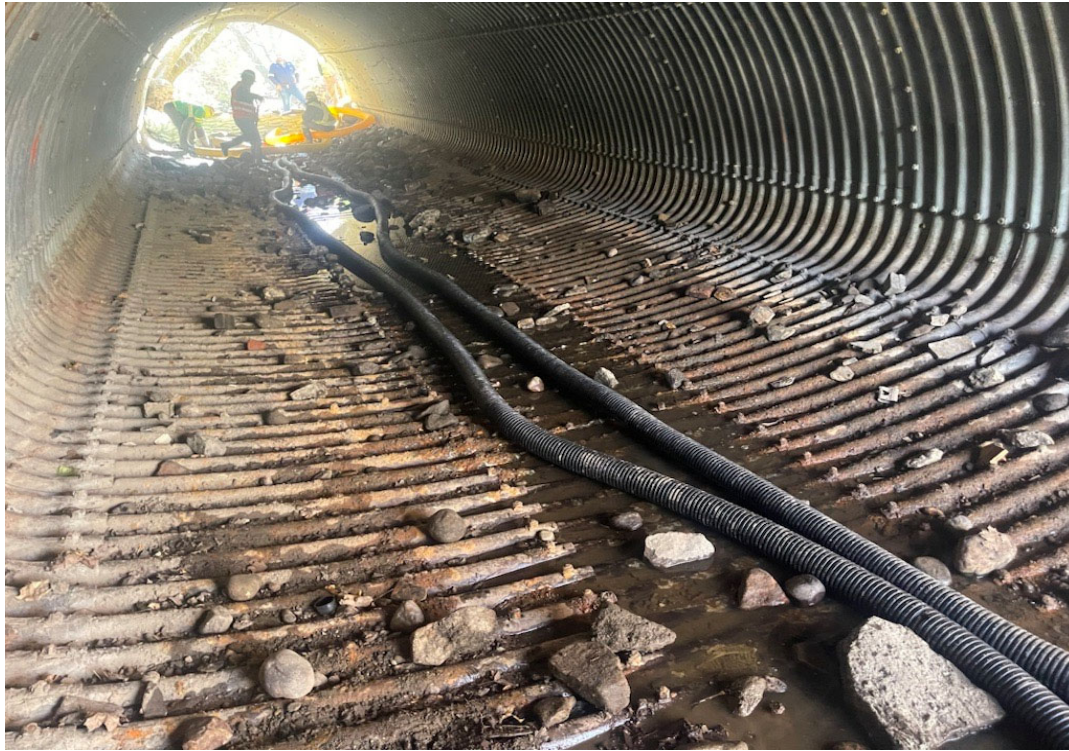
Photograph: 9
Description: Culvert C4 after cleaning.
Date: 11/16/2023
Location: C4

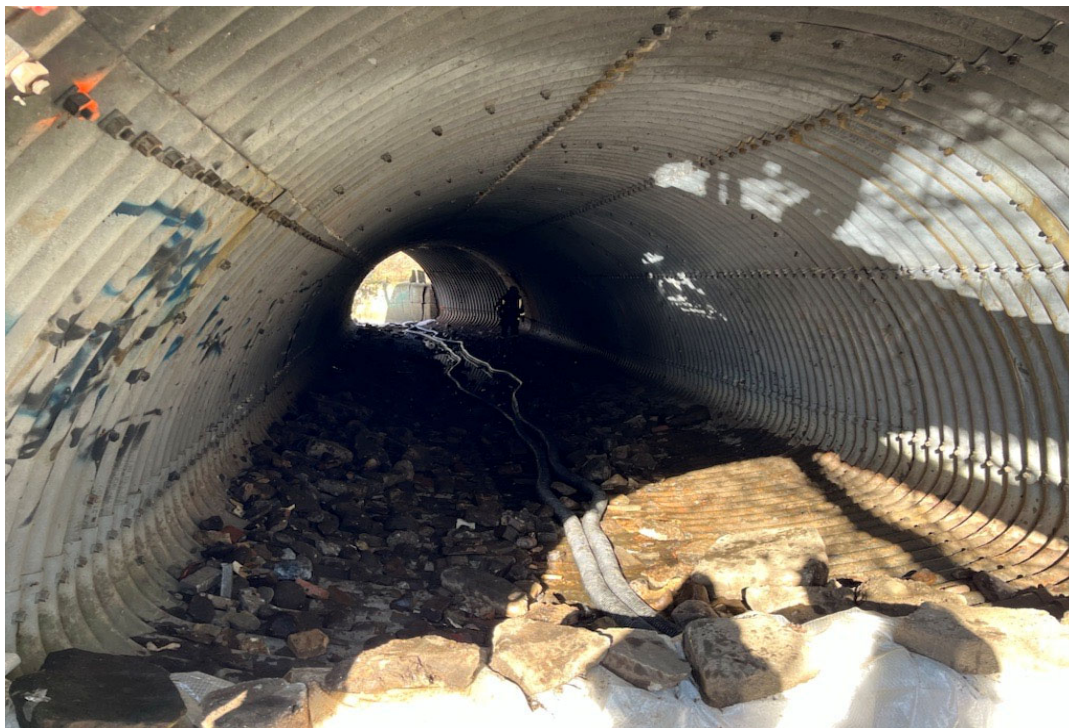
Photograph: 10
Description: Culvert C4 after cleaning.
Date: 11/16/23
Location: C4

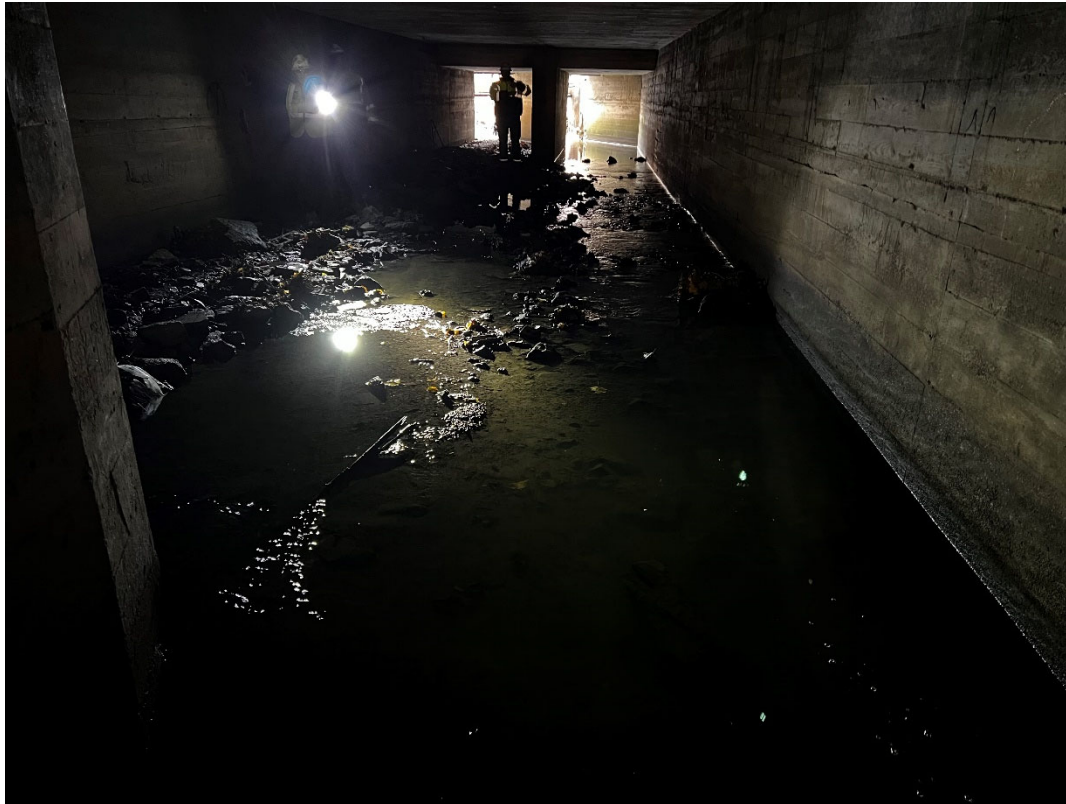
Photograph: 11

- Culvert C3 appeared in fair to good condition. The upstream end appears to be a box culvert section that was inserted into the previous culvert. There are some signs of concrete deterioration near the outlet and select locations on the ceiling.
- A hard asphalt-like bottom was encountered beneath the sediment near the outlet, and transitions to a smooth concrete bottom near the inlet. There are four inlets near the upstream end of the culvert, consisting of 18-inch diameter polyvinyl chloride pipes. The first set of inlet pipes are 32 feet into the culvert from the upstream end, and the second set are an additional 32 feet. The inlets are from storm drains located in Market Street.

Description: Culvert C3 before cleaning.

Sediment removal activities were initiated on November 27, 2023 and completed on December 15, 2023. Approximately 174 CY of sediment, stones, and debris (e.g., leaves) was removed from Culvert C3. Similar to Culvert C4, as described in Section 2.5, stone collection and transportation out of the creek posed a high potential for injury. It was determined, at the direction of USEPA representatives, that stones that were not vacuumed-up could be vacuumed-off to remove any gross sediment, rinsed, and redistributed within the culvert. Following sediment removal and rinsing activities, prior to removing the sandbag berms and bypass piping, USEPA representatives confirmed the cleanup activities were adequately achieved. Appendix A contains initial condition photographs and completion photographs following sediment removal activities in Culvert C3.

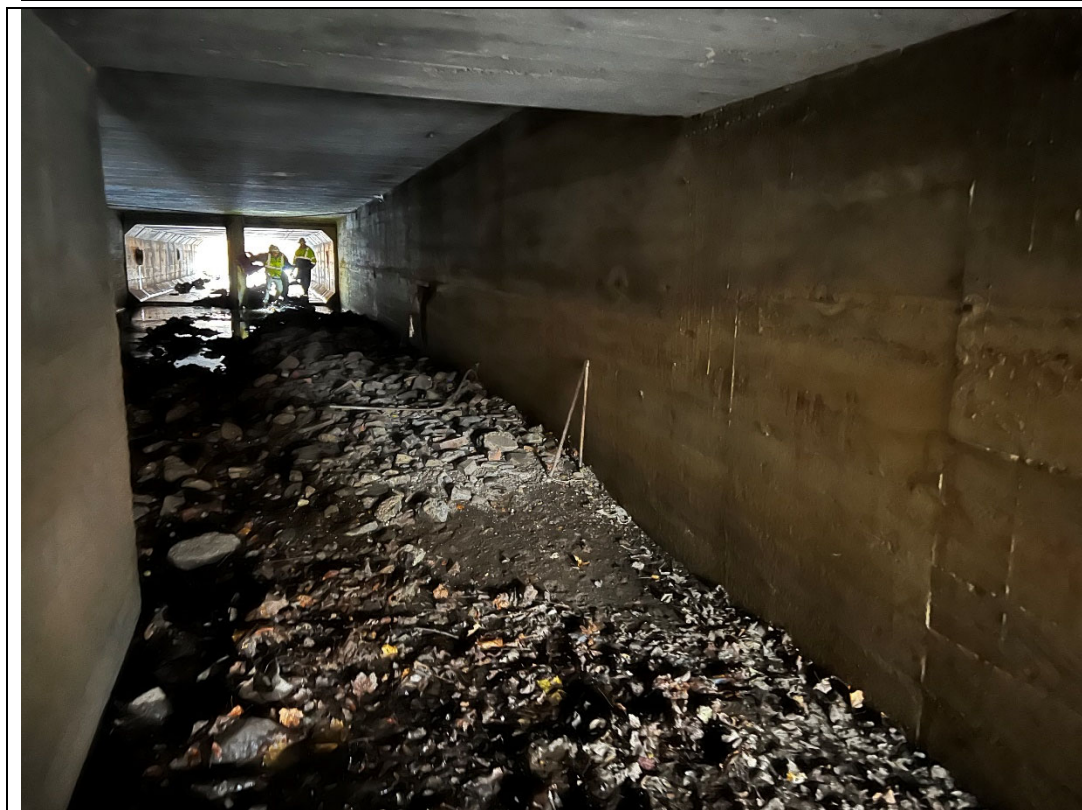
Photograph: 12

Description: Culvert C3 before cleaning.

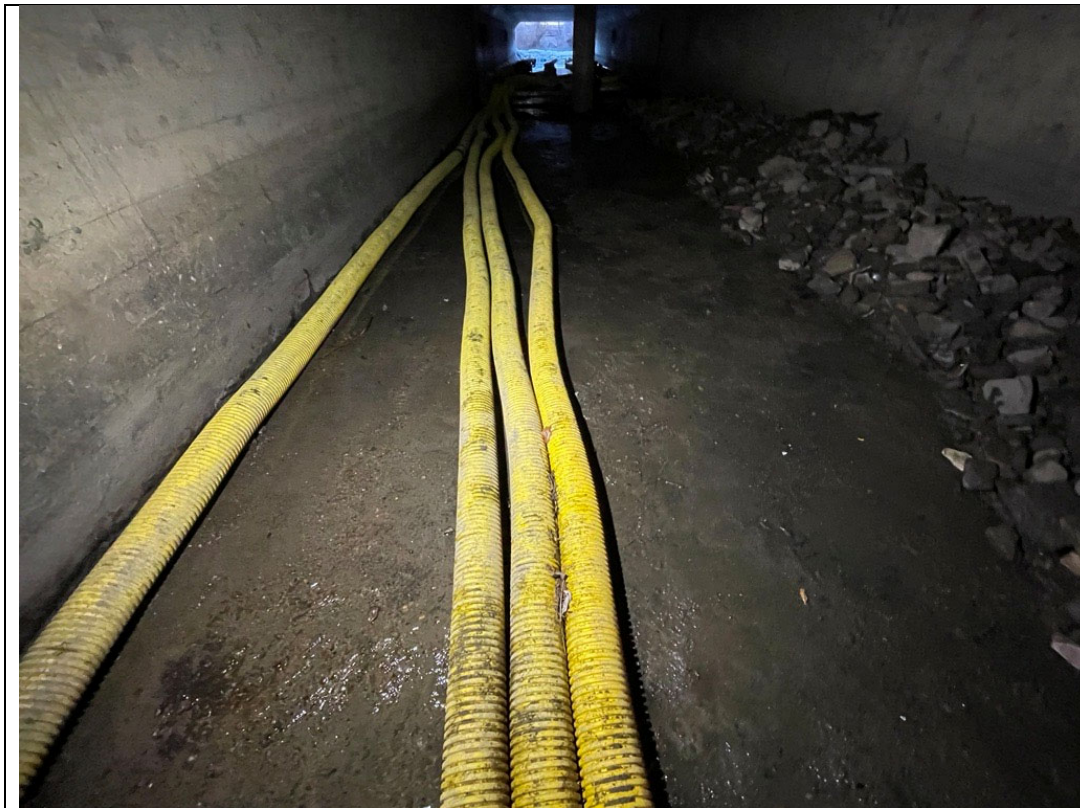
Photograph: 13
Description: Culvert C3 after cleaning with the redistributed vacuumed and rinsed stones.
Date: 12/15/23
Location: C3

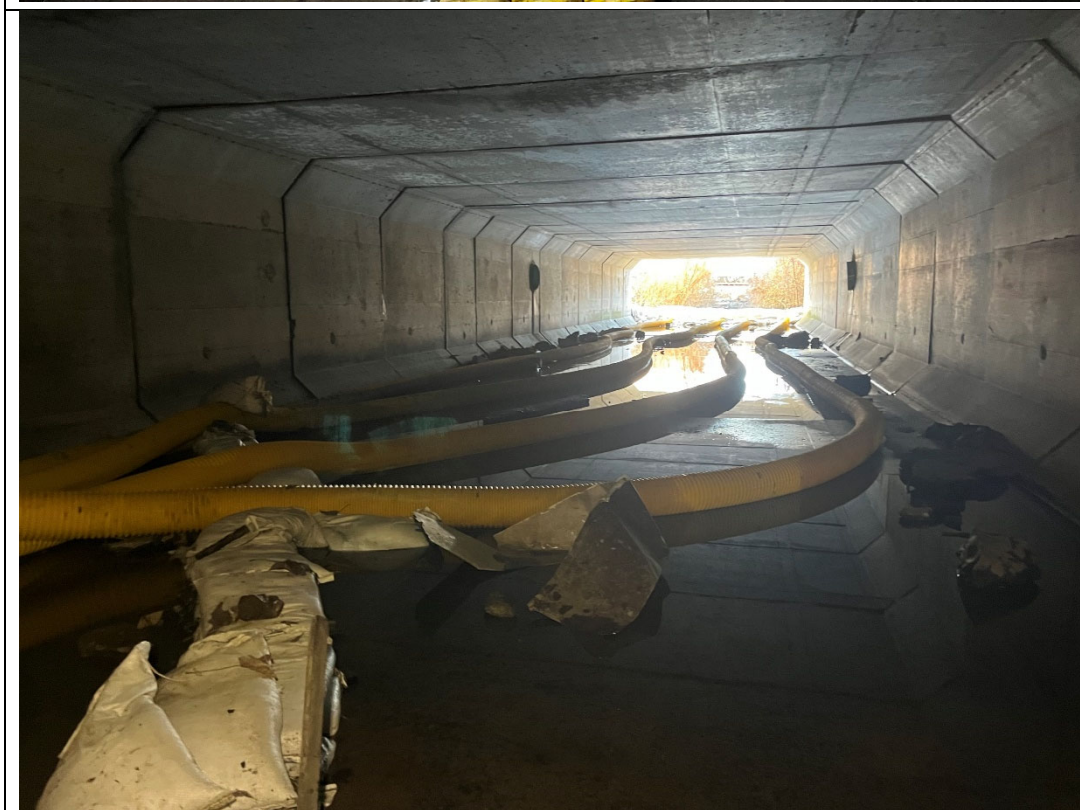
Photograph: 14
Description: Culvert C3 after cleaning.
Date: 12/15/23
Location: C3
