**FIFTH FIVE-YEAR REVIEW REPORT FOR
PMC GROUNDWATER SUPERFUND SITE
EMMET COUNTY, MICHIGAN**

**U.S. Environmental Protection Agency
Region 5
CHICAGO, ILLINOIS**

3/5/2025

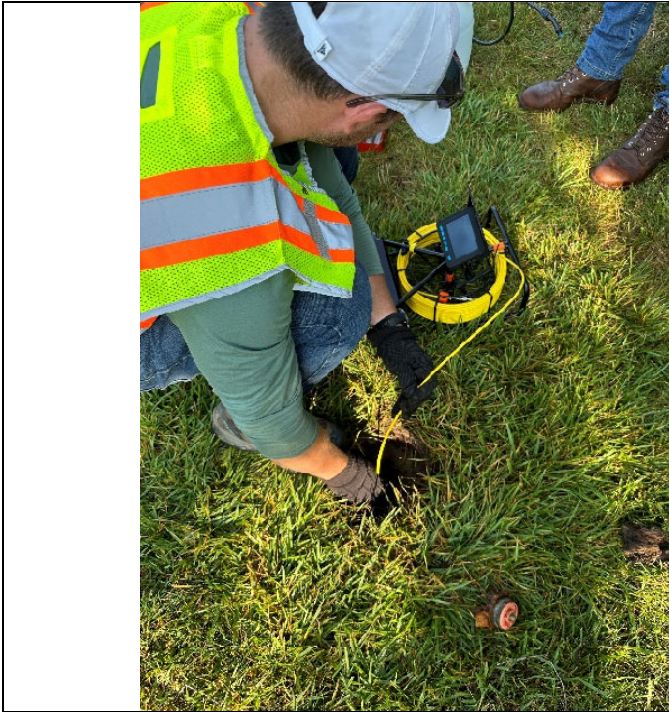
Photograph #: 2
File Name: IMG_2111.jpg
Date: 7/30/2024
Photographer: Cheryl Kondreck
Location: Well COP-1
Subject: FSS team, Sonny Divita conducting down-hole well inspection.

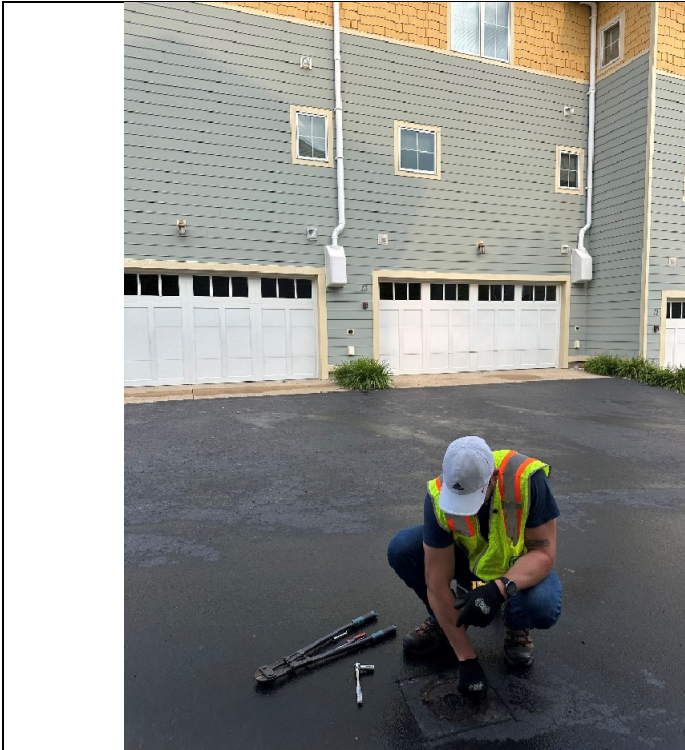
Photograph #: 3
File Name: IMG_2135.jpg
Date: 7/31/2024
Photographer: Cheryl Kondreck
Location: PS-10A
Subject: One of three stick-up wells at the Site

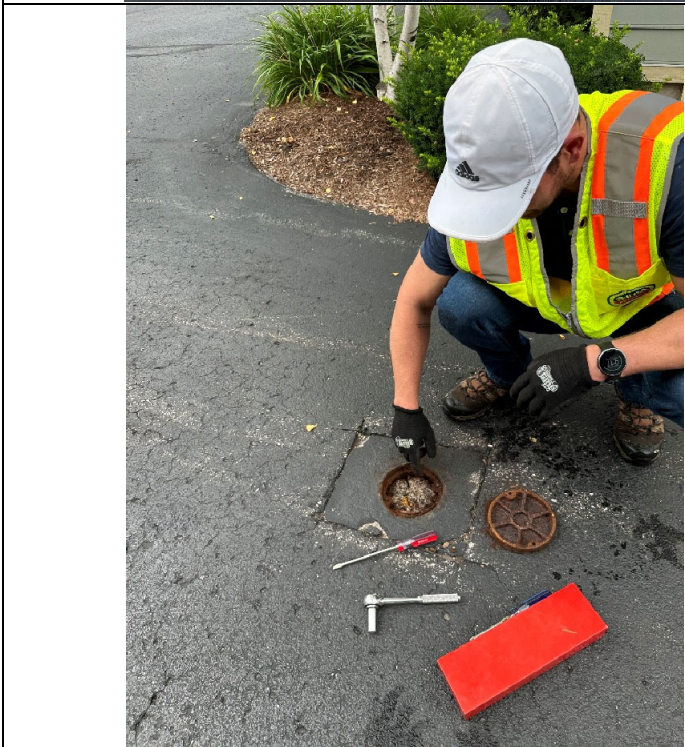
Photograph #: 4
File Name: IMG_2137.jpg
Date: 7/31/2024
Photographer: Cheryl Kondreck
Location: CMW-01
Subject: Well cover was “sealed” due to resurfacing of the parking lot at 200 W Lake St.

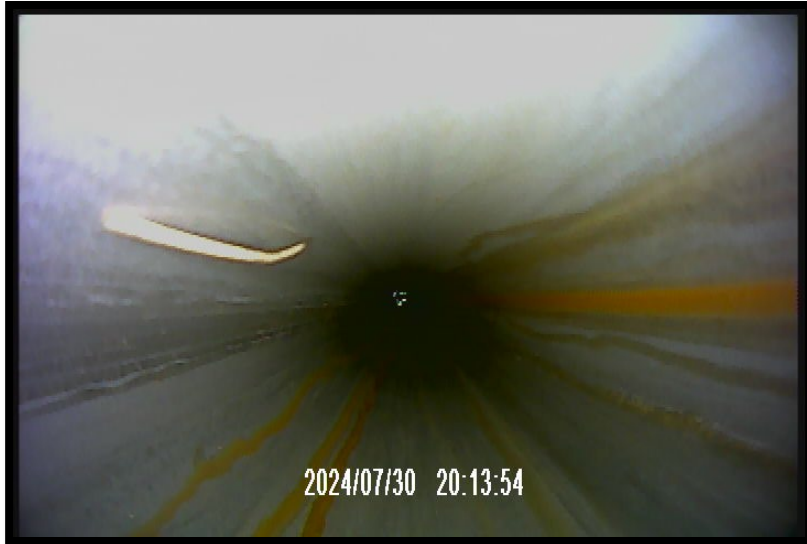
1

MW401D – Casing in good condition

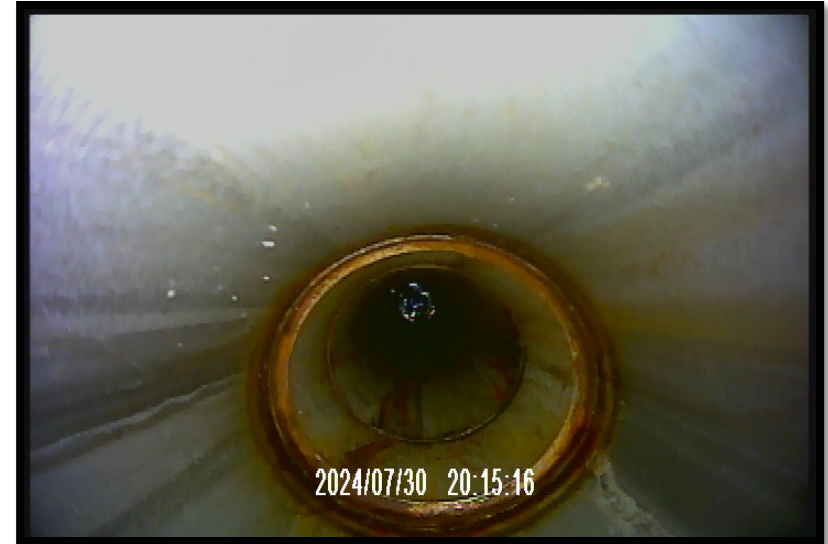
2

MW401D – Rusting around joint

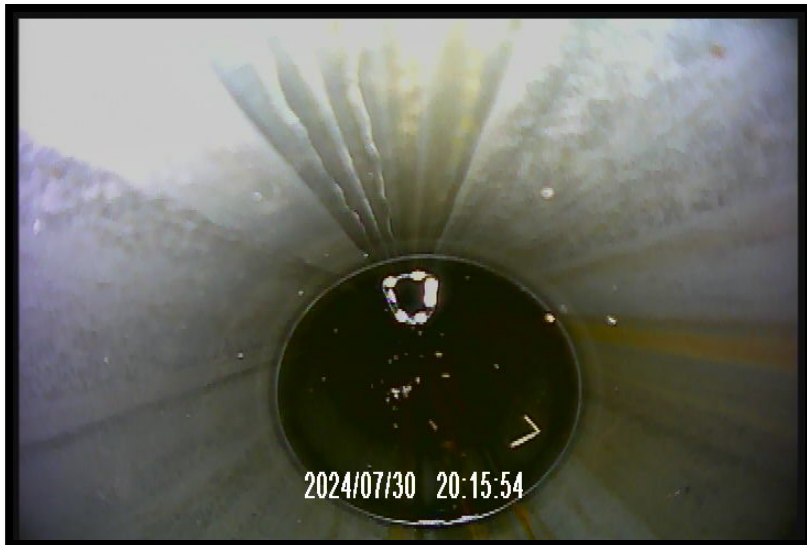
3

MW401D – Water table

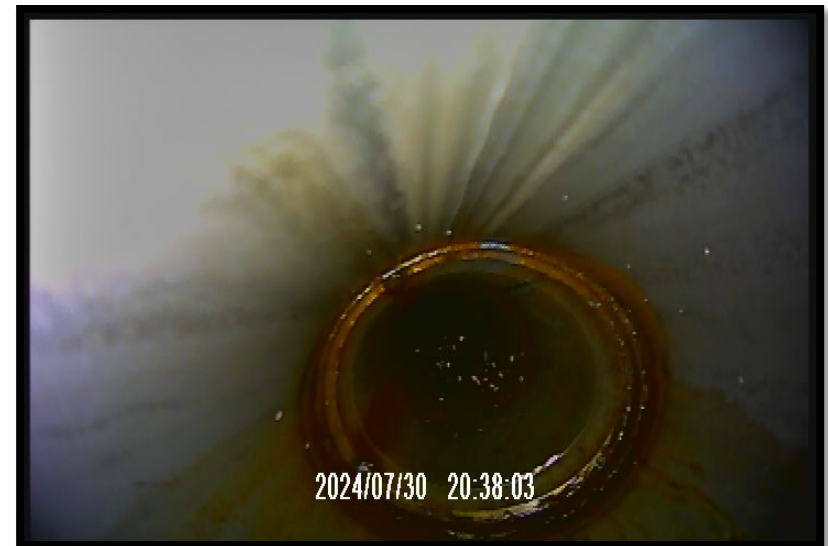
12

MW401S – joint / water table

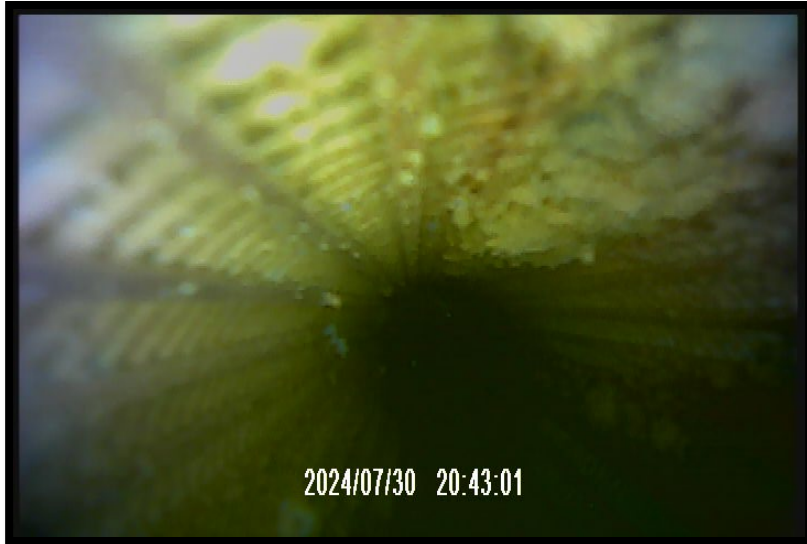
17

MW401S – additional buildup around screen

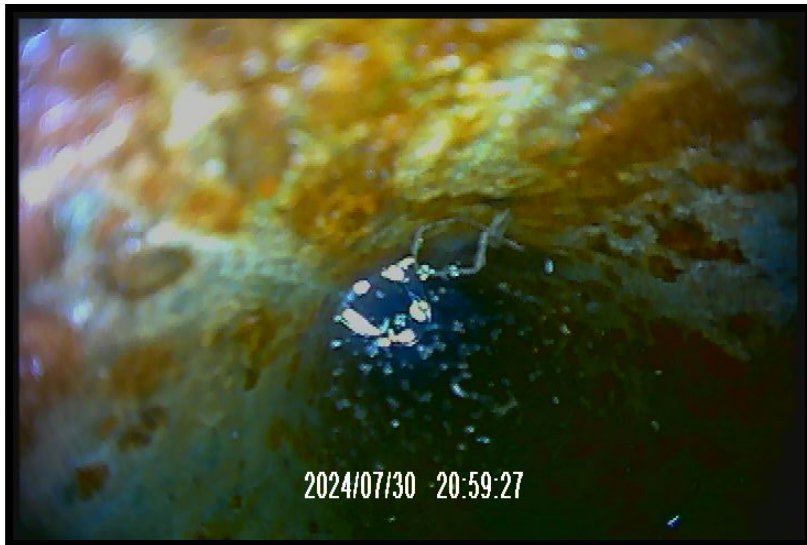
23

COP1 – heavy rust above water table

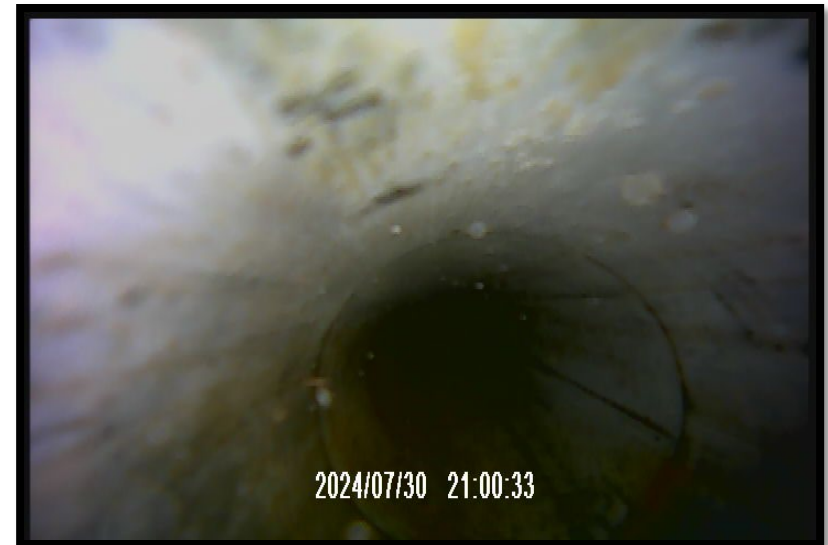
24

COP1 – joint beneath water table

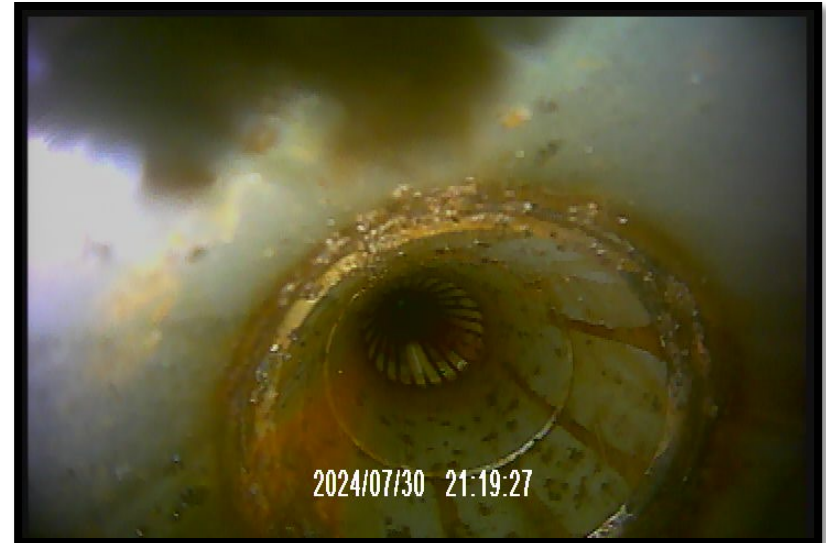
28

COP5R – rusty joint, and top of screen

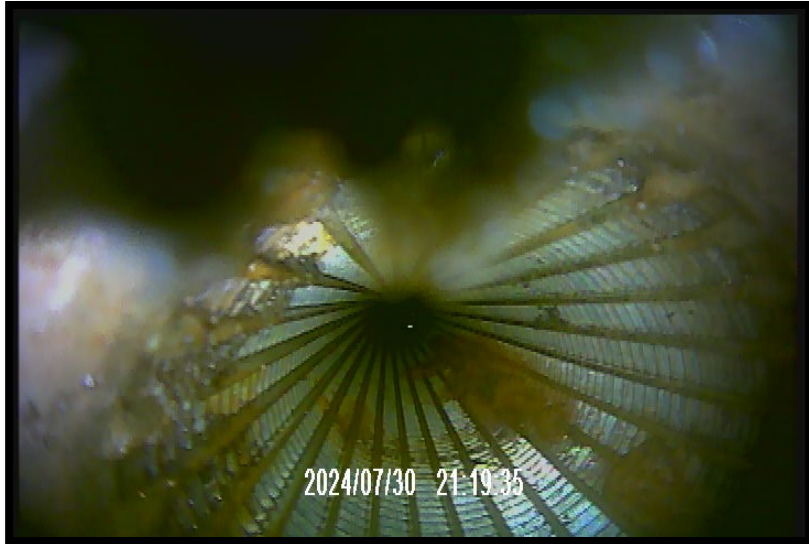
29

COP5R – some buildup near top of screen

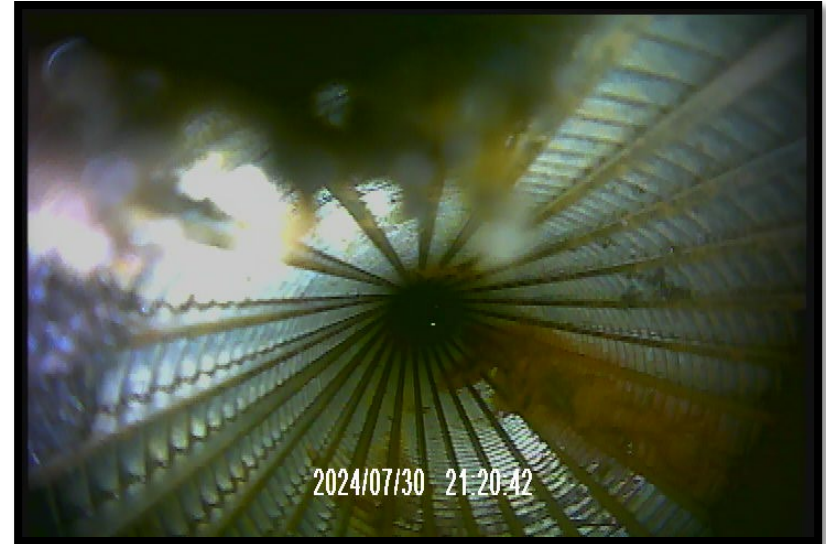
30

COP5R – little rust lower right side

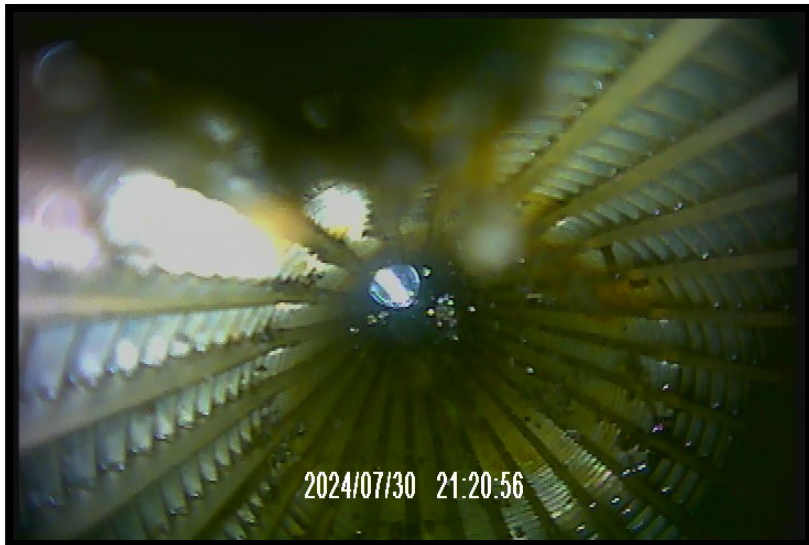
31

COP5R – mostly clean screen

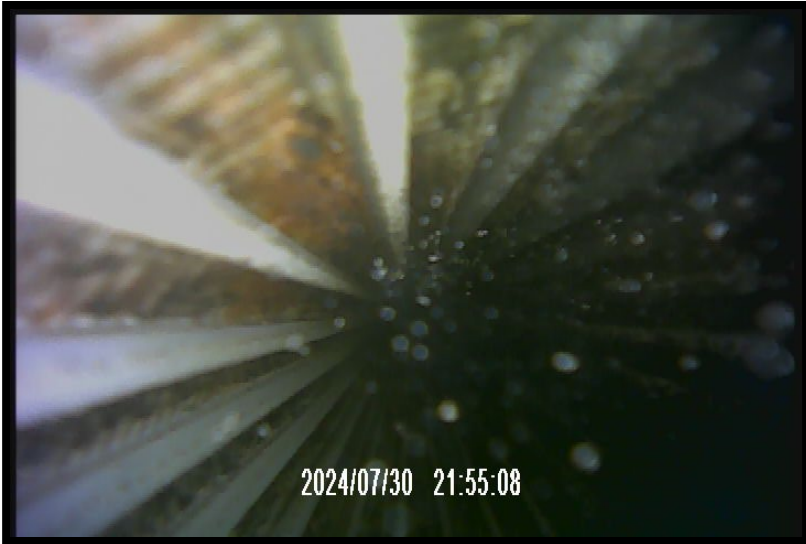
45

PSCD – slight rust further down screen

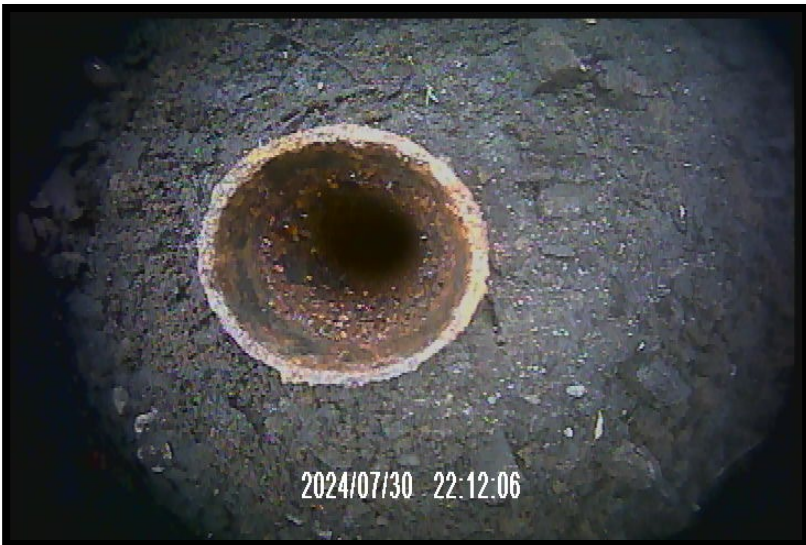
47

PS105S – rusty well within flush mount

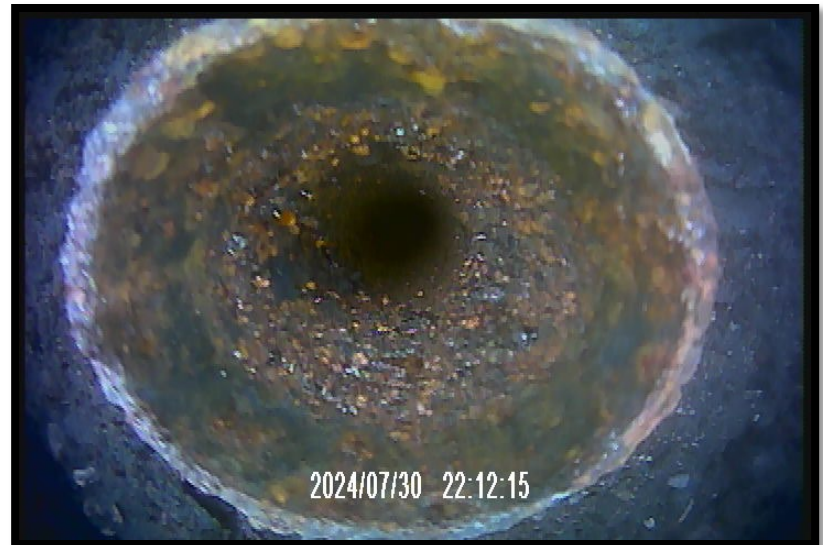
48

PS105S – top of well, rusty

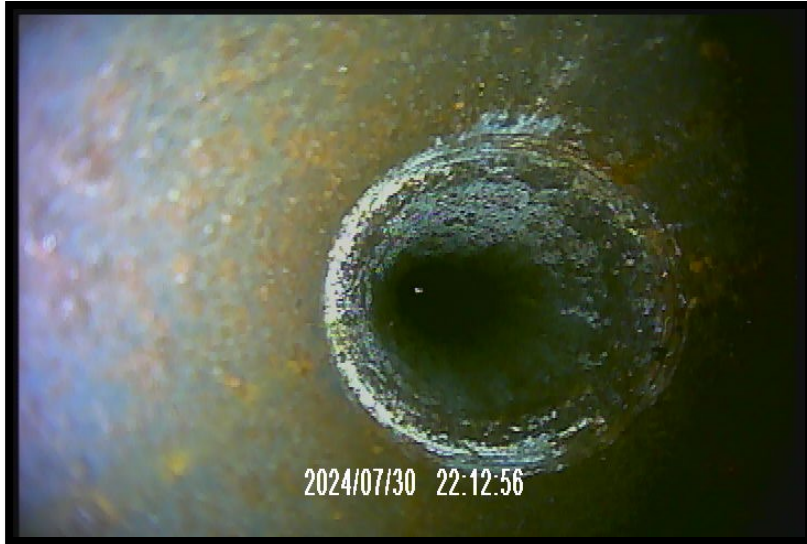
49

PS105S – joint with rust

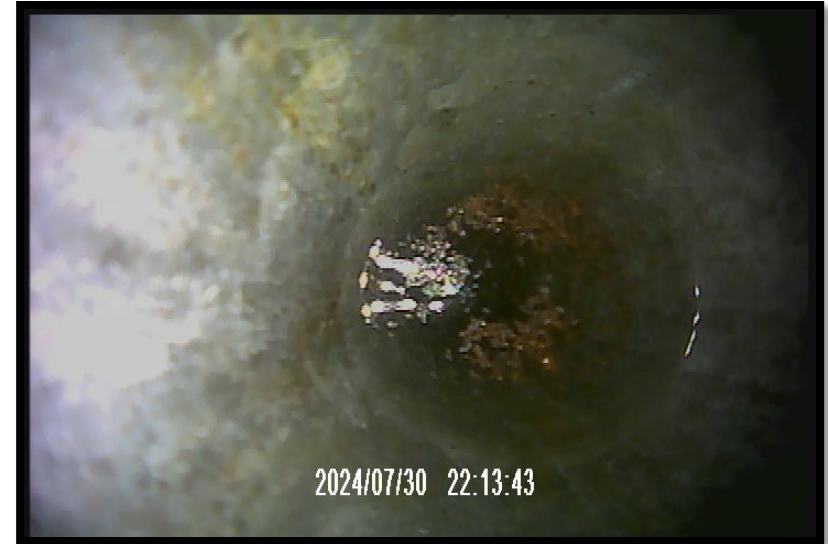
50

PS105S – water table above rusty joint

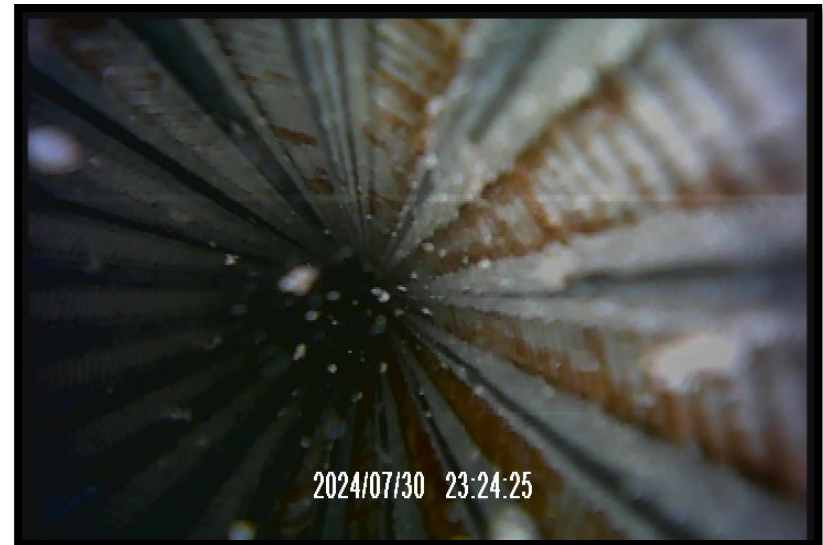
64

PS106 – screen appears rusty with some white calcite buildup

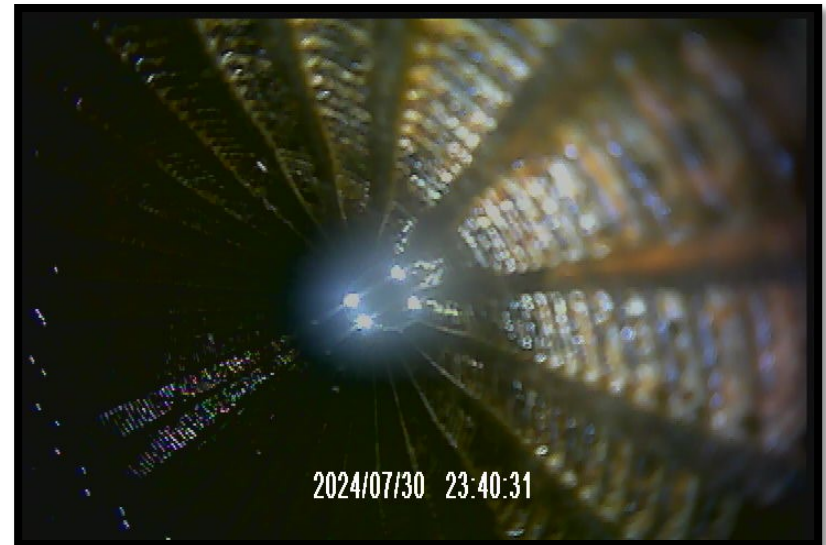
68

COP4 – reflection of water table within screen, some rust

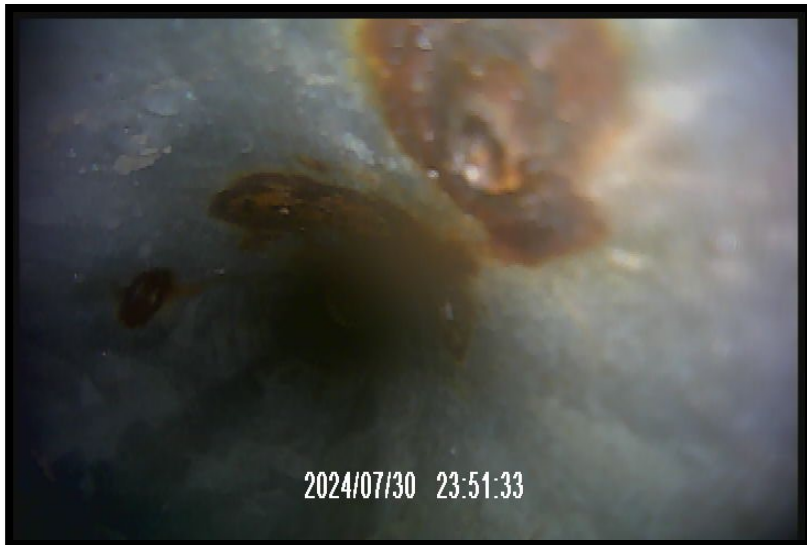
71

COP3 – rust feature that may be a hole

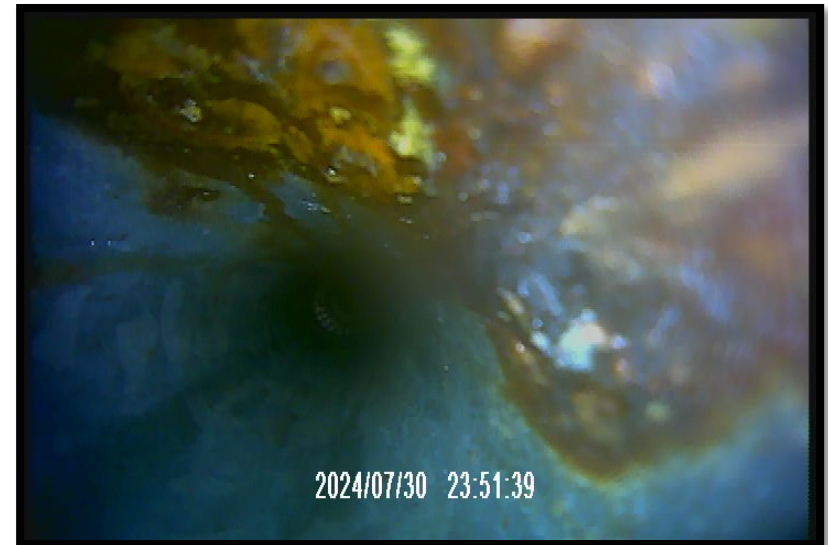
72

COP3 – heavy rusting above water table

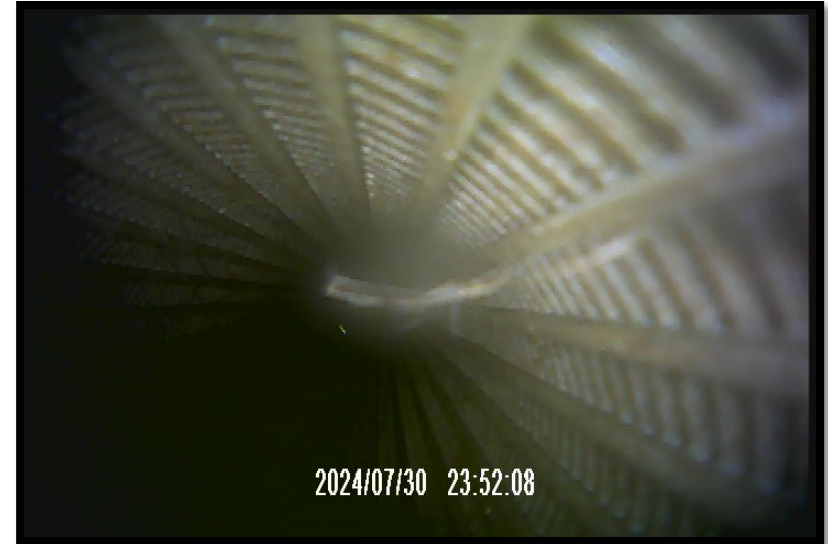
74

COP3 – screen in good condition

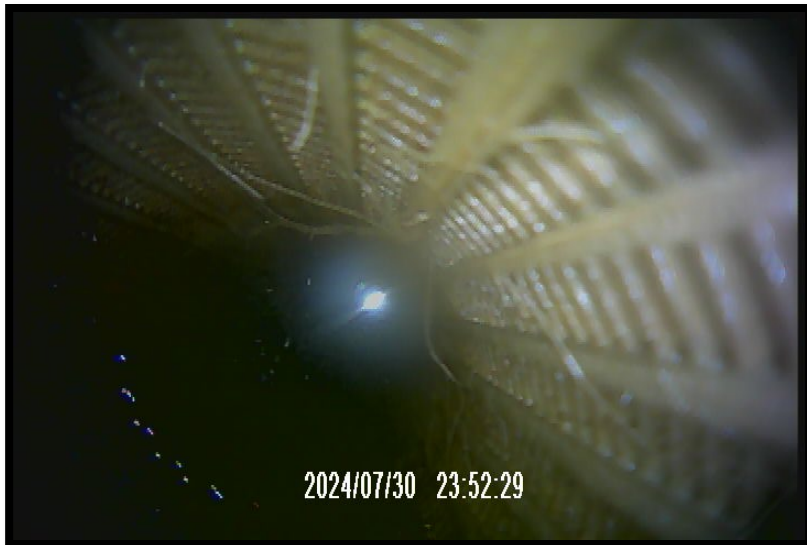
75

COP3 – possible roots getting into screen, water table reflection

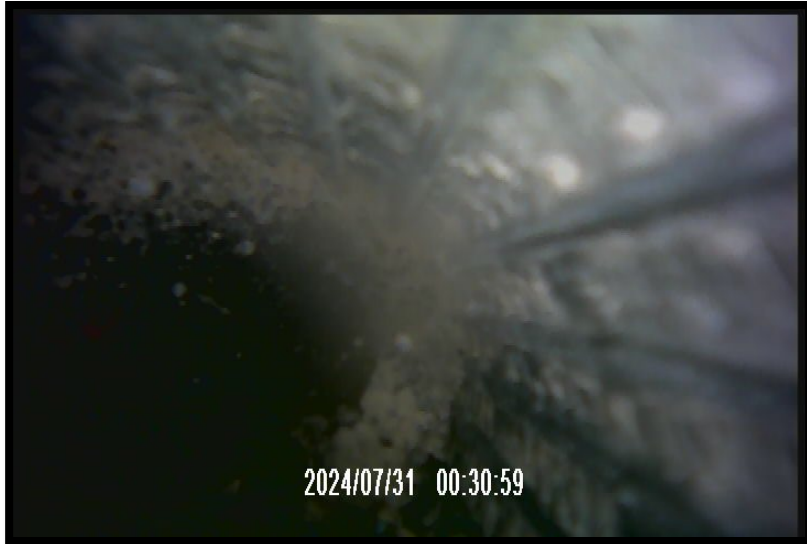
101

MW205DR – Sediment being knocked off screen by camera, screen in good condition otherwise

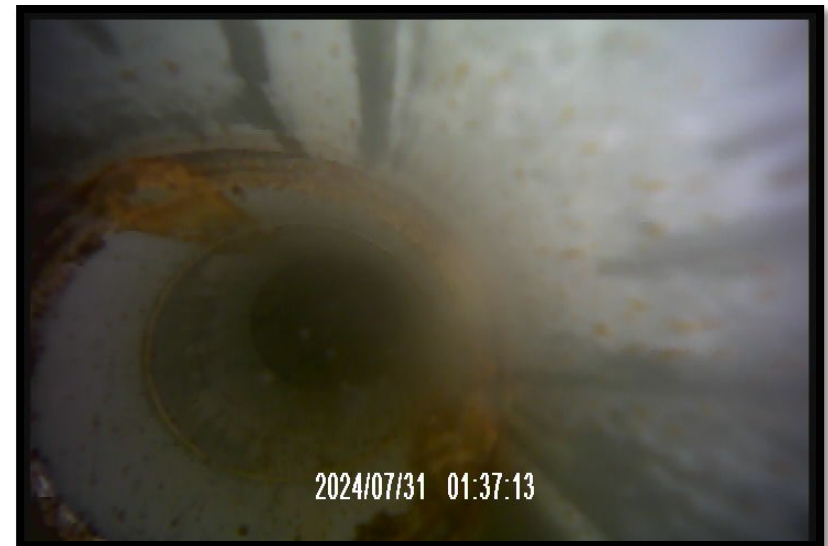
112

MW402S – some rusting on joint below water table

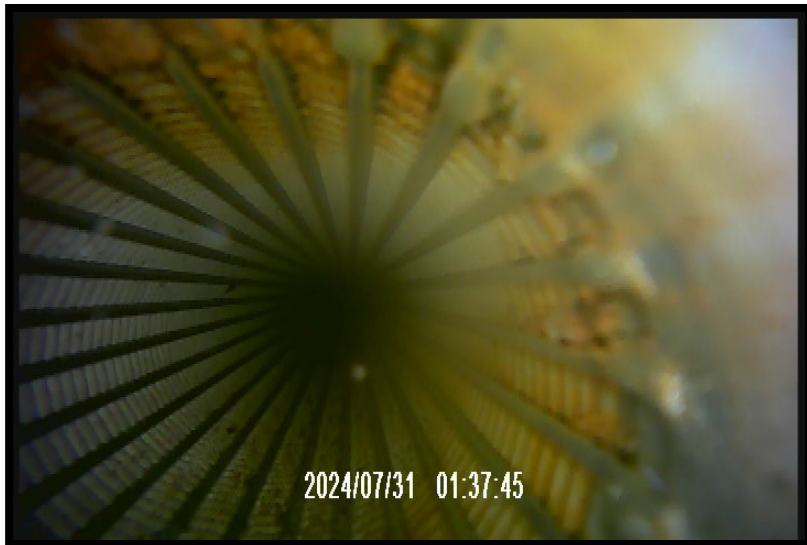
114

MW402S – some rust near top of screen

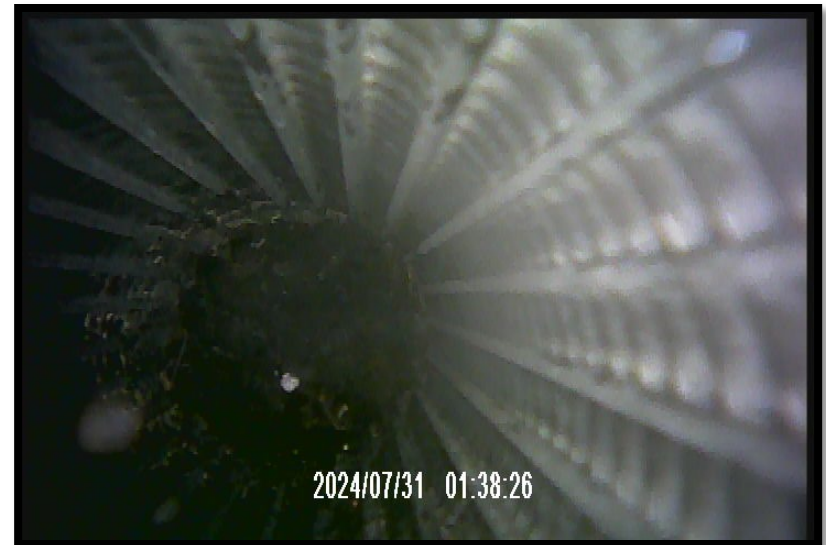
115

MW402S – screen in good condition

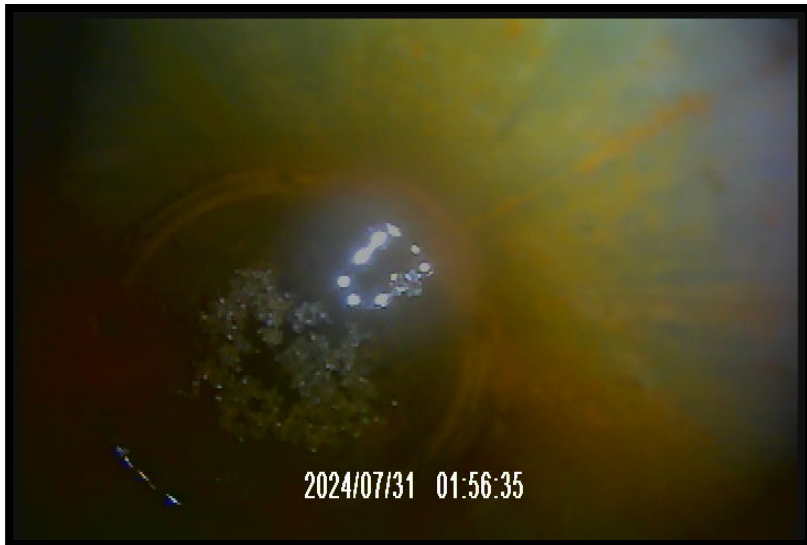
119

MW402D – material on top of water table

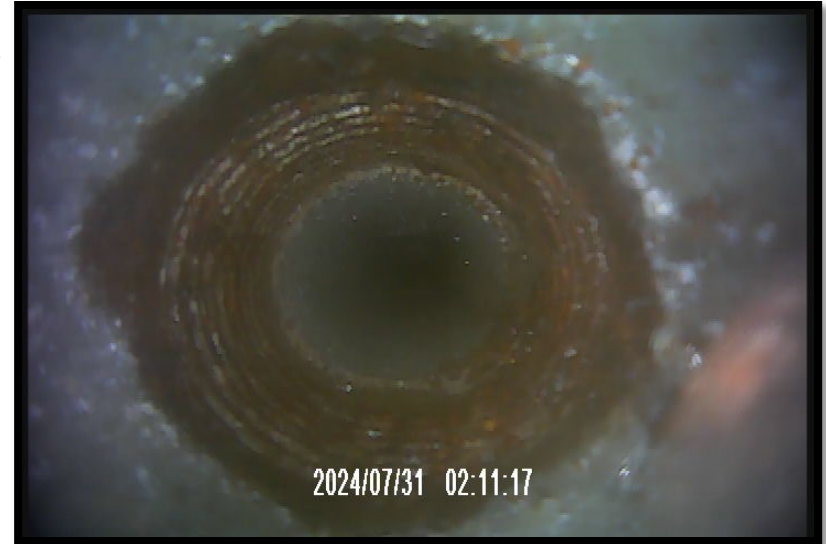
126

PS6 – rusty joint

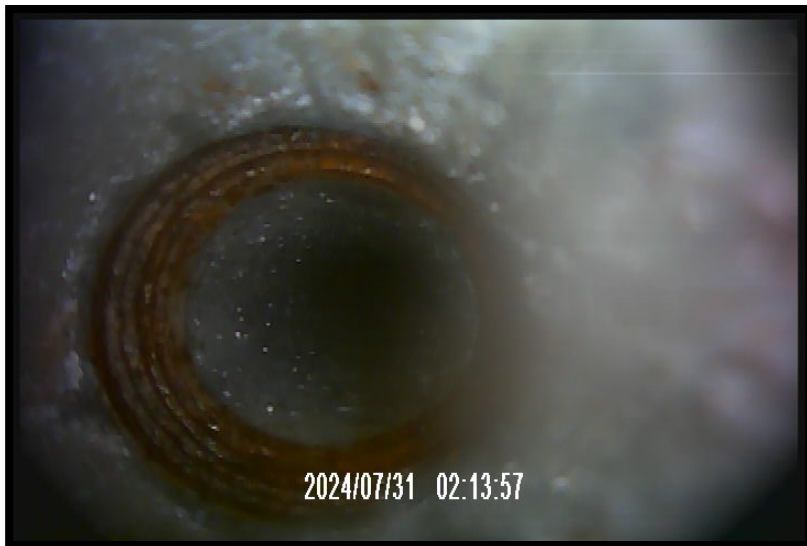
127

PS6 – rusty joint

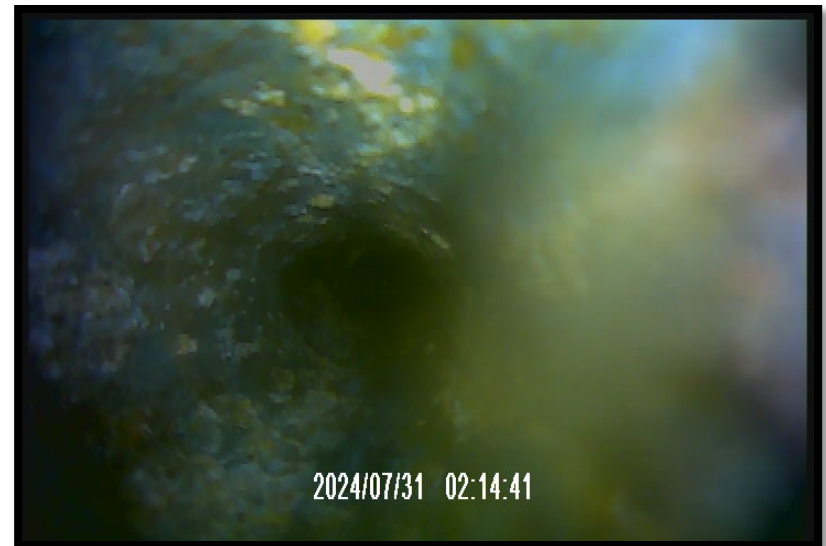
128

PS6 – casing slight degraded

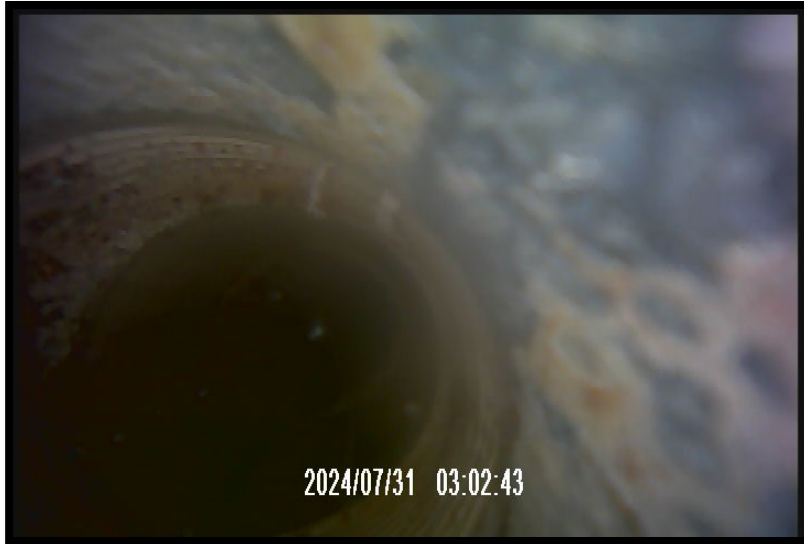
149

PS4 – rusting near joint

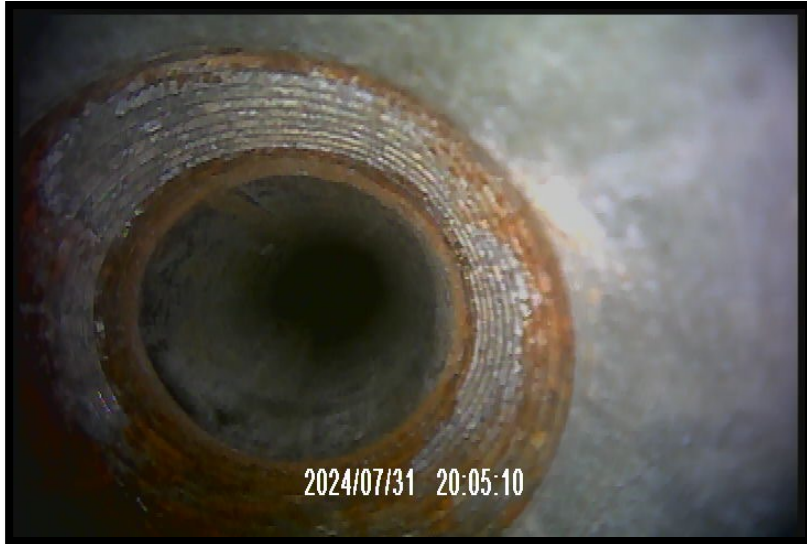
161

PS10A – rusty joint

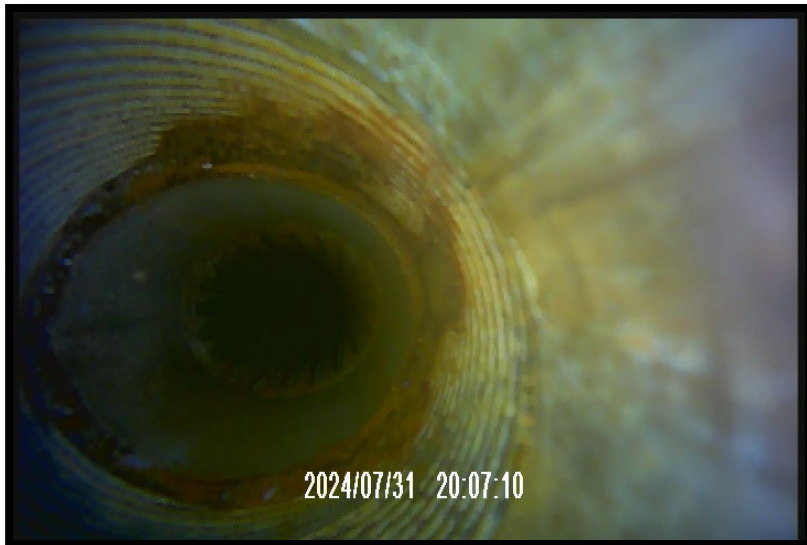
163

PS10A – rusty joint

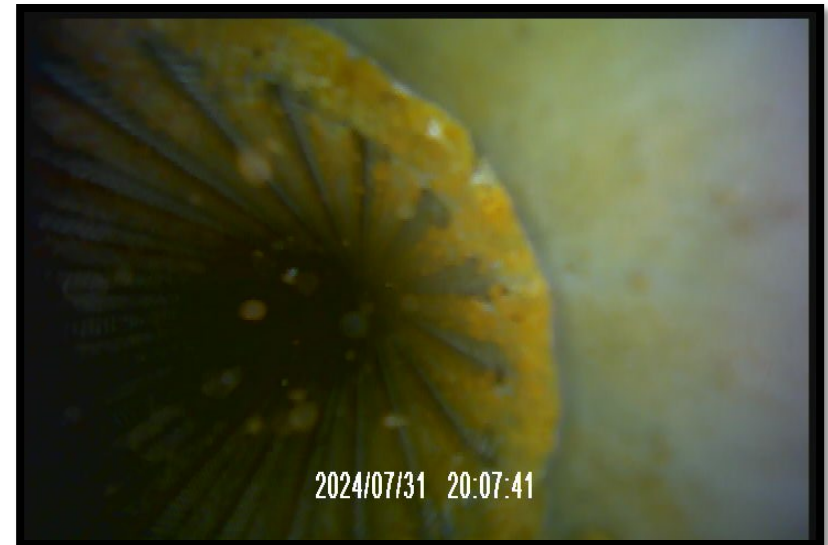
164

PS10A – off center, top of screen, rust

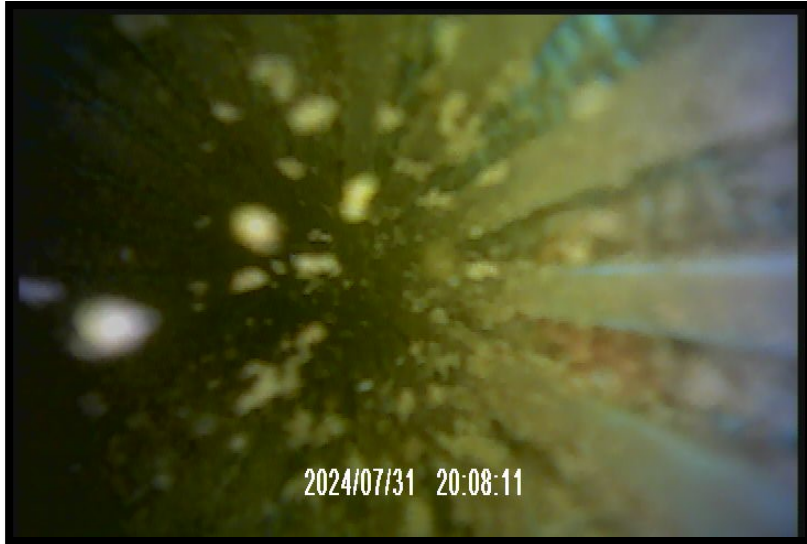
165

PS10A – sediment along screen loosened by camera drag
