Memorandum

August 13, 2019

**Re: Northwest Slope Enhancement Completion Report
San Jacinto River Waste Pits Time Critical Removal Action**

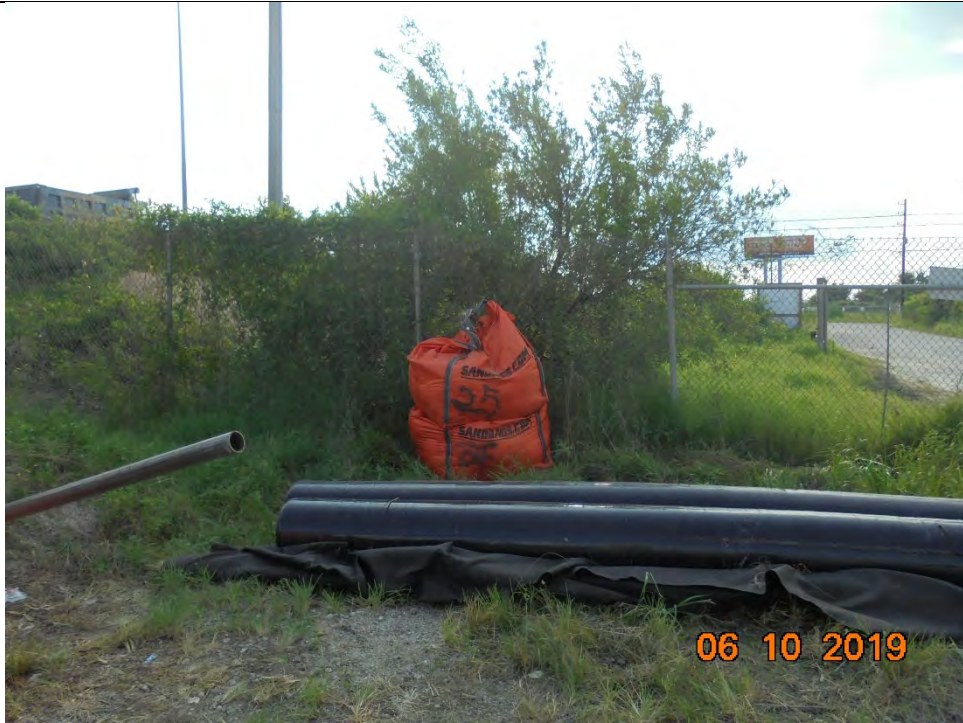
Photo 2 – Hole in security fence, observed during morning setup activities

Photo 3 – Supersacks of sandbags placed in front of hole in security fence

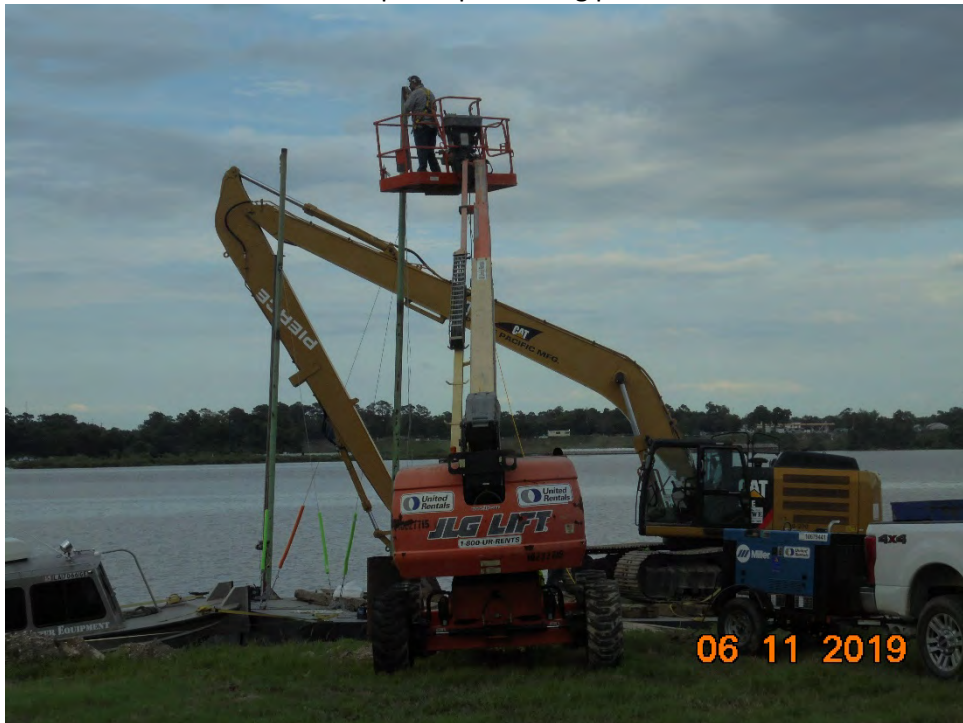
- Deployed ACBM form 304 and anchored it in place on the water bottom.
 - During deployment operations, one of the spuds of SWE's spud barge became damaged to the point of being non-operational. GHD explained to AQ that the lifting of a supersack of sandbags by the barge-mounted excavator caused the barge to roll while the barge's spuds were lowered, bending the spud at its contact point with the barge. With the bent spud non-operational, deployment of additional ACBM forms was suspended until spud repairs could be made.

Photo 5 – Spud repairs being performed

- Dive crew performed underwater cutting/removal of a portion of the damaged spud just below the waterline at the bottom of the barge.
- Sorbent boom detached and brought to shore.
- Spud barge and excavator transported to the adjacent San Jacinto River Fleet facility for repair of damaged spud and spud cable pulley.
- Marsh buggy staged near the shoreline of the western cell near the ACBM installation site.

- Manlift delivered for repair of the spud cable pulley.
- Repair of damaged spud and spud cable pulley at San Jacinto River Fleet facility.

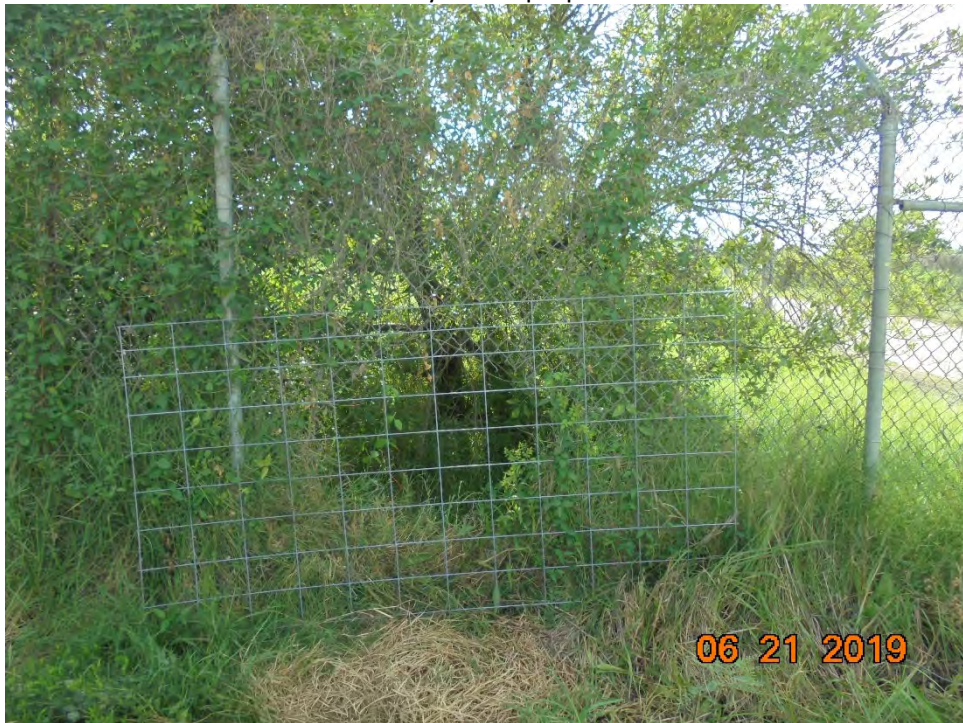
Photo 6 – Temporary wire-mesh patch installed over the hole in the security fence

- AQ to coordinate repair of the fence with National Fence.
