Memorandum

April 9, 2020

Re: Post-TCRA Quarterly Inspection Report – January/February 2020

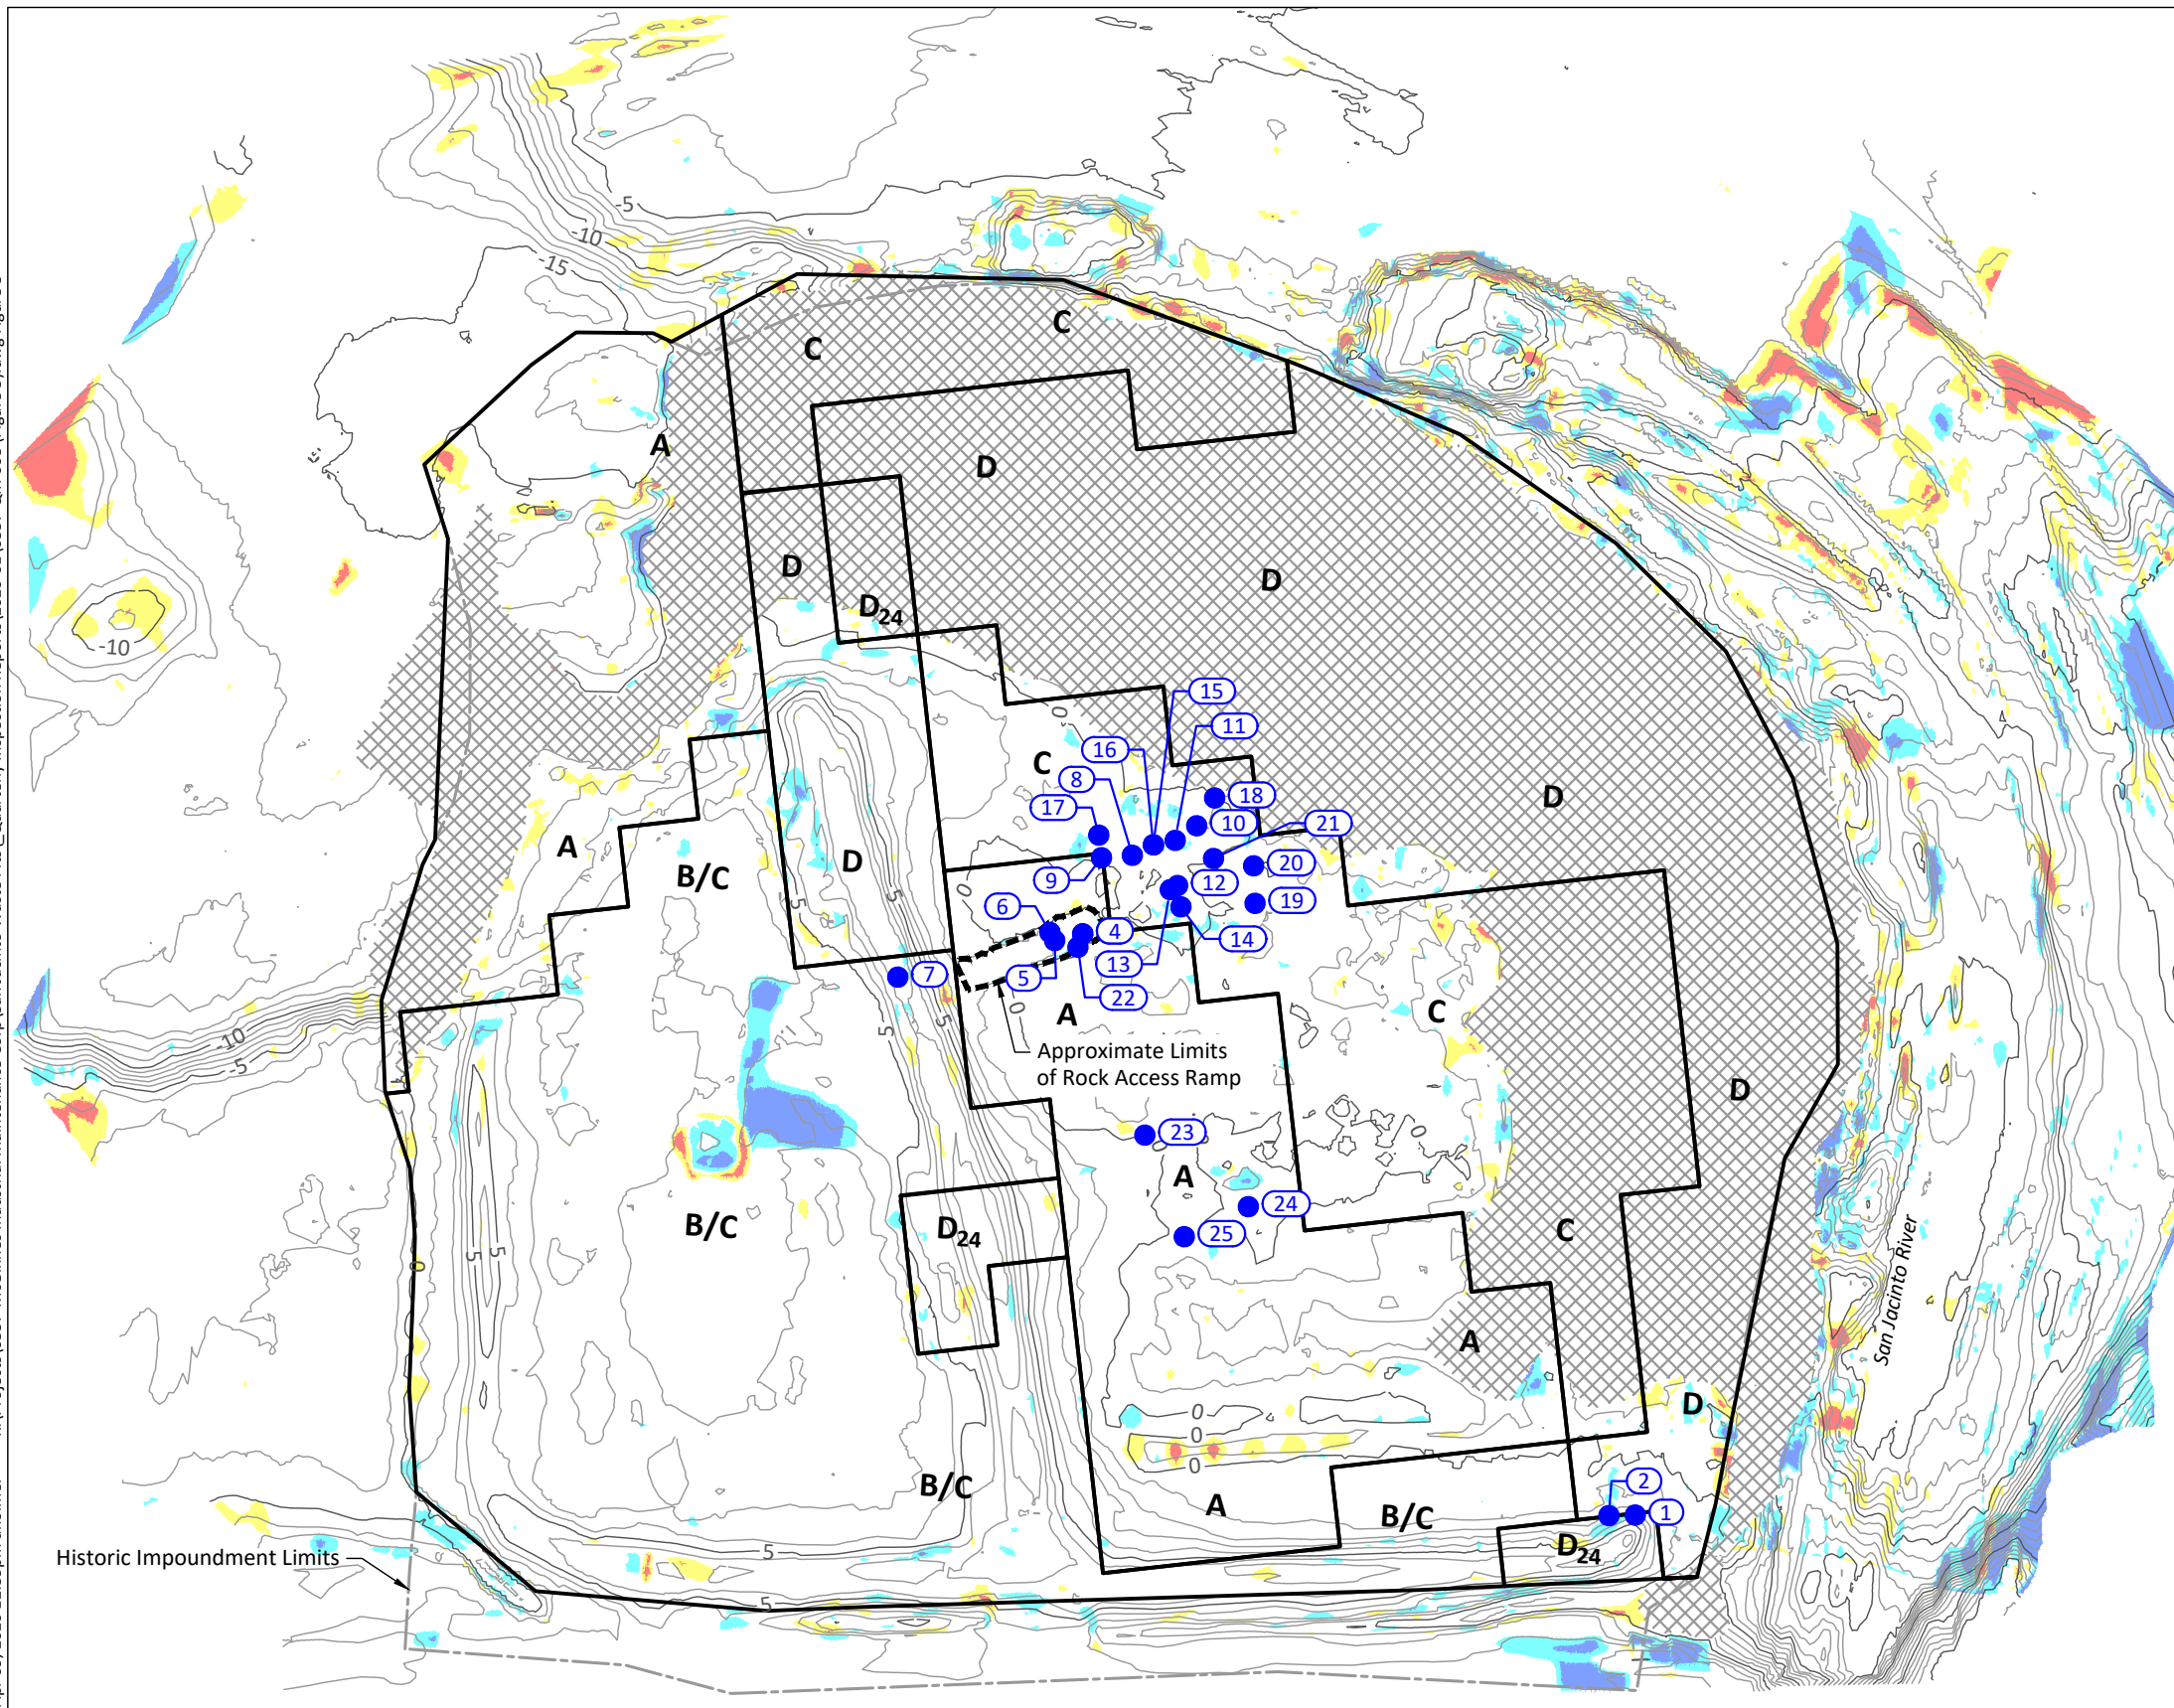
During maintenance activities, Location 7 on the central berm (Figure 3) was determined to be a loose piece of fabric that had previously been laid directly on top of the armored cap (but otherwise not associated with the armored cap) during installation of the security camera footing on top of the central berm. This piece of fabric was removed and the underlying armored cap material visually assessed and probed to confirm that no maintenance was needed at that location.

The survey data from the January 2020 and September/October 2019 inspection surveys were compared to evaluate the differences in the top of the armored cap elevation. These differences are shaded and shown in Figure 3. For the areas in which there are survey data from both January 2020 and September/October 2019, the survey results indicate continued deposition and periodic erosion of alluvial sediment on the surface of the armored cap. An updated comparison will be performed once the remaining areas can be surveyed.

The OMM Plan requires manual probing of armored cap thickness at areas identified by the topographic or bathymetric surveys as more than 6 inches lower in elevation than during the prior survey over contiguous areas of 30 feet by 30 feet. When the January 2020 survey was compared to the September/October 2019 survey, no areas were found that required manual inspection.

NOTE: No maintenance was required at Location 7. See text for more detail.

Because water levels were rising, a field determination was made to immediately address the Additional Maintenance Locations. Maintenance was performed at the Maintenance Locations and Additional Maintenance Locations by placing at least 1 foot of Type D³ armor rock over the visible geotextile at each area in accordance with the approved maintenance work plan (see Photograph 6 in Appendix A for an example). After completion of the maintenance, each Maintenance Location and Additional Maintenance Location was probed to confirm that at least 1 foot of additional rock was placed over the visible geotextile.

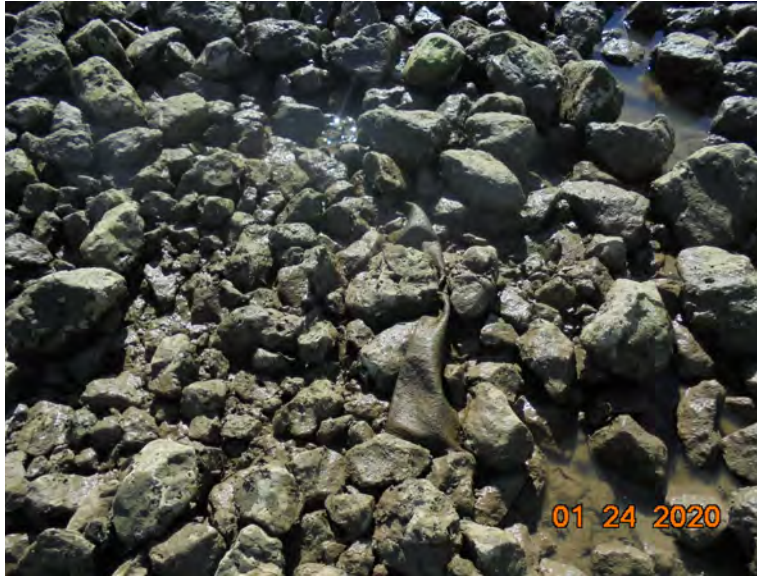
Photographs from the inspection of the armored cap are provided in Appendix A. During the inspection, water levels were very low, providing an opportunity for visual inspection of areas that are typically submerged. Anchor QEA identified 14 areas where visible geotextile was observed in and adjacent to the eastern cell (including one location on the central berm), identified as Locations 1 to 14 in Figure 3 (Maintenance Locations). Notice of these observations was provided to Gary Baumgarten of USEPA on January 29, 2020, and photographs of each of the Maintenance Locations were reviewed with USEPA via conference call on February 4, 2020. Most of the Maintenance Locations were generally less than 10 square feet in area, and most consisted of exposed fabric edge flaps. At all of the Maintenance Locations, there was rock surrounding the fabric as well as rock visible underneath. As such, these Maintenance Locations did not appear to be indicative of any issue with respect to cap performance and there was no evidence of exposed waste at any of the 14 Maintenance Locations. For examples of the condition of the armored cap at the time of the visual inspection, see Photographs 1, 2, 3, 4, and 7 in Appendix A. For an example of the visible geotextile observed, see Photograph 5 in Appendix A.

Photograph 5: Example of visible geotextile edge in the eastern cell, prior to maintenance, on January 24, 2020

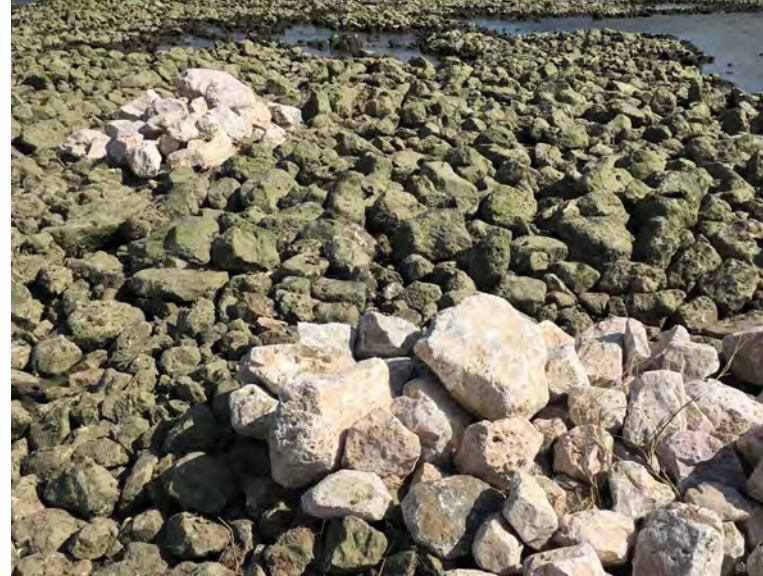
Photograph 6: Example of previously visible geotextile areas in the eastern cell, after the completion of maintenance, on February 26, 2020

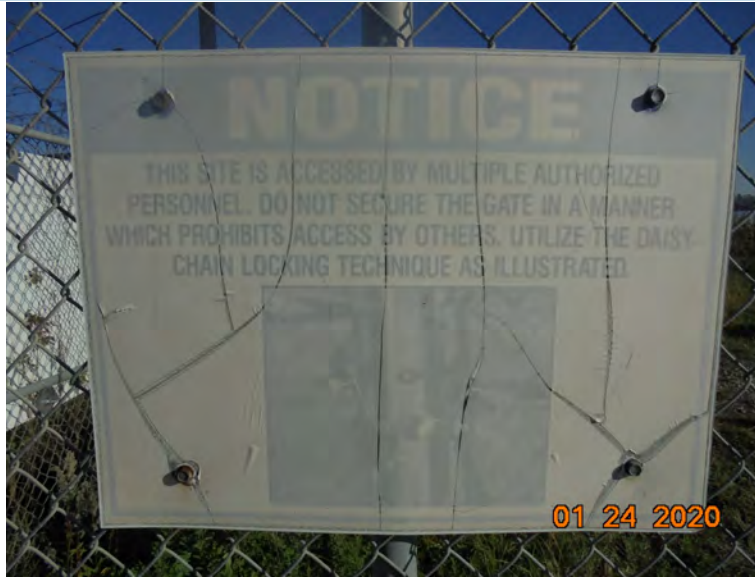
Signage on the two vehicle access gates reminds entrants to "daisy chain" the lock properly prior to leaving the TCRA Site. These signs were observed to be in place, although faded. New signs are being ordered to replace those signs. For examples of these signs, see Photographs 8 and 9 in Appendix A.

Photograph 9: View of daisy chain sign to be replaced. Note this is an informational sign, not an EPA-required sign.

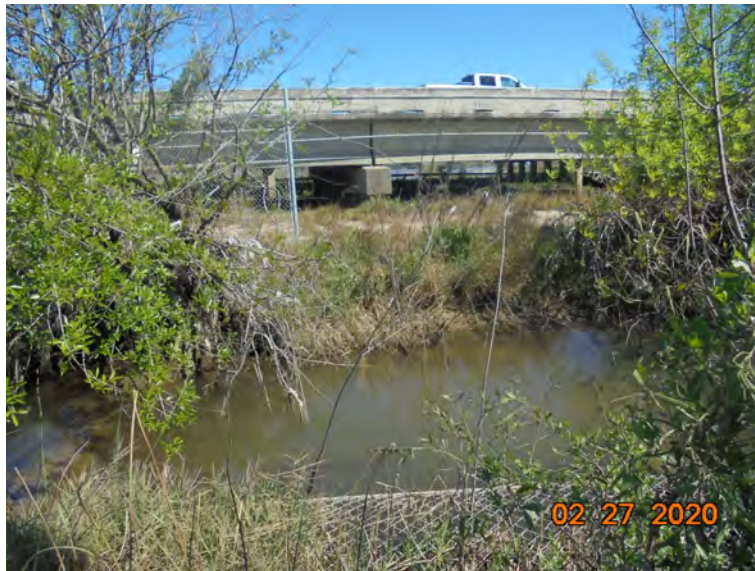
Repairs to the perimeter fencing on the west bank of the San Jacinto River south of Interstate 10 (I-10) were performed in November and December 2019 to address damage from Tropical Storm Imelda. Based on a discussion with Gary Baumgarten of the USEPA on September 23, 2019, the eastern limit of the repaired fence alignment was designed to terminate approximately 100 feet east of the access gate in thick underbrush. During the visual inspection on January 24, 2020, it was observed that extensive vegetation clearing had been performed within the Texas Department of Transportation (TXDOT) right-of-way in the vicinity of the repaired fence termination, leaving a gap

between the underbrush and the fence termination (see Photograph 11 in Appendix A). A ditch filled with standing water was located parallel with and to the south of the gap, impeding access to the area containing the gap. The fencing contractor for the TCRA Site, National Fence, was subsequently authorized to extend the fence south to the existing ditch, as shown in Figure 2 and Photograph 11 in Appendix A, and panels were manufactured during the week of March 16 to March 20. Installation of the fence extension was delayed in light of federal, state, and local requirements imposed in light of COVID-19 and was completed on April 8, 2020 (see Photograph 12 in Appendix A).

Photograph 11: View of eastern fence termination and ditch south of I-10 on west bank, prior to installation of fence extension, on February 27, 2020 (view northeast)

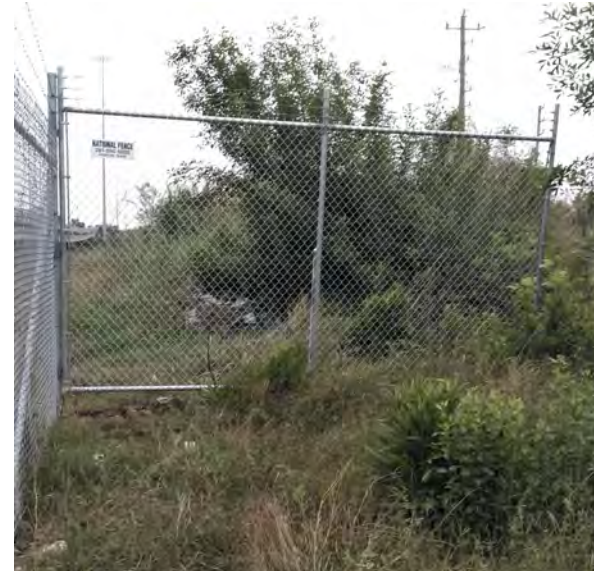
Photograph 12: View of installed fence extension south of I-10 on west bank, on April 8, 2020 (view east)

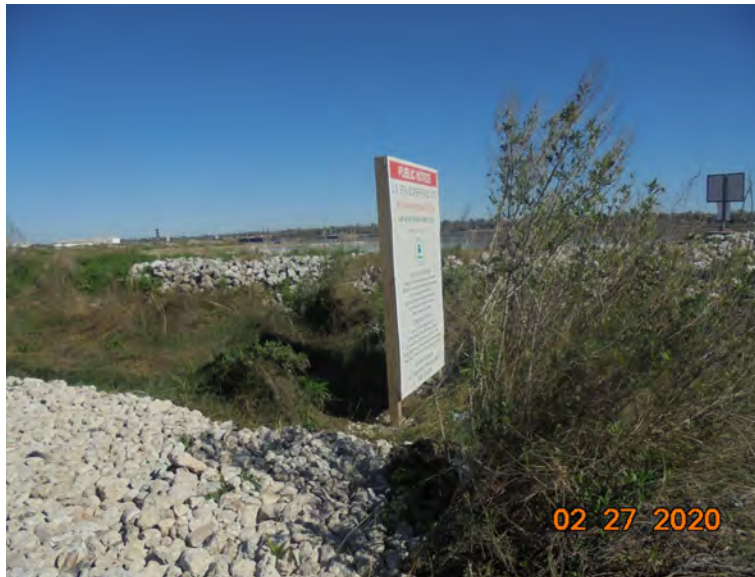
Three USEPA Public Notice signs have been installed around the TCRA Site in the following locations: 1) near the gate entry point for the perimeter fence north of I-10; 2) near a gate entry point south of I-10; and 3) at the end of the TXDOT right-of-way north of I-10 near the San Jacinto River. As part of the TXDOT repairs to the I-10 bridge after Tropical Storm Imelda, the USEPA Public Notice sign at the end of the TXDOT right-of-way had been removed and placed beneath the I-10 bridge, where it was observed during the inspection on January 24, 2020 (see Photograph 14 in Appendix A). This sign was in good condition and was reinstalled on February 27, 2020 (see Photograph 15 in Appendix A). The other two USEPA Public Notice Signs were observed to be in place and undamaged.

Photograph 15: USEPA Public Notice Sign re-installed at the end of the TXDOT right-of-way north of I-10 near the San Jacinto River on February 27, 2020
