Third Five-Year Review Report for the Compass Industries Superfund Site Tulsa County, Oklahoma

April 2006

CH2M HILL Contract Number 68-W6-0036 Work Assignment Number 133-FRFE-06ZZ

THIRD FIVE-YEAR REVIEW Compass Industries Superfund Site EPA ID# OKD980620983 Tulsa County, Oklahoma

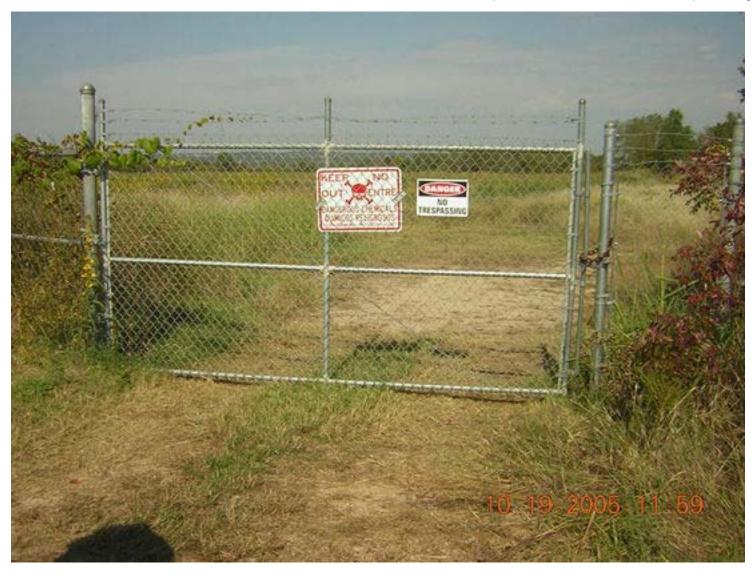
Photo 2: Closed and locked site entrance gate, facing north (refer to Figure 2 for location of this gate).

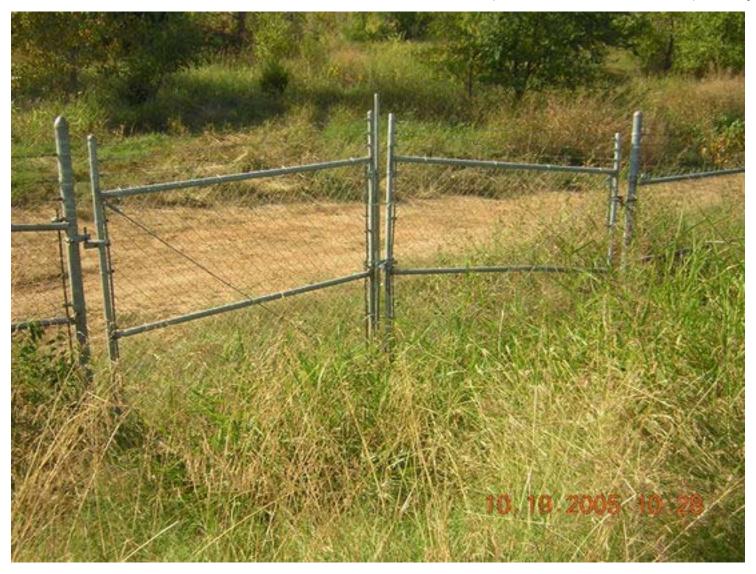
Photograph 11 of 49

Photo 11: Locked gate within southern side of perimeter fence, facing southwest (between Vent #10 and 11; refer to Figure 4 for location of site vents).

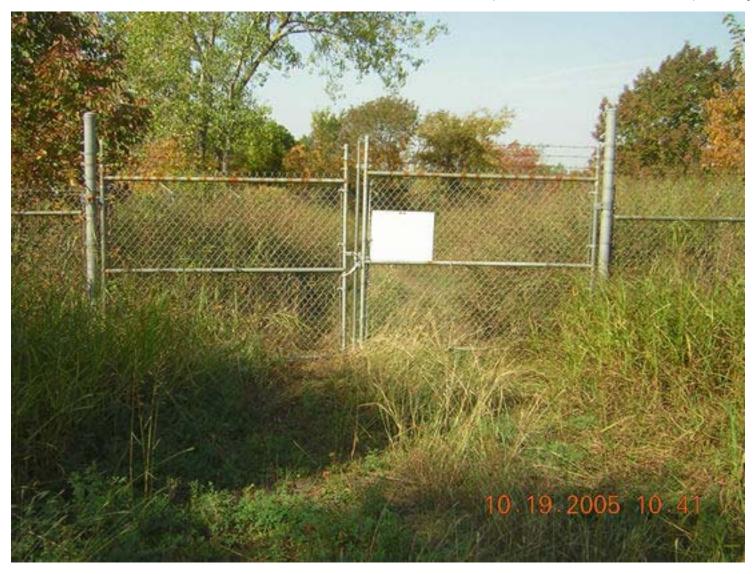
Photo 16: Locked access gate at southwest corner of site, facing west (refer to Figure 4 for location of gate).

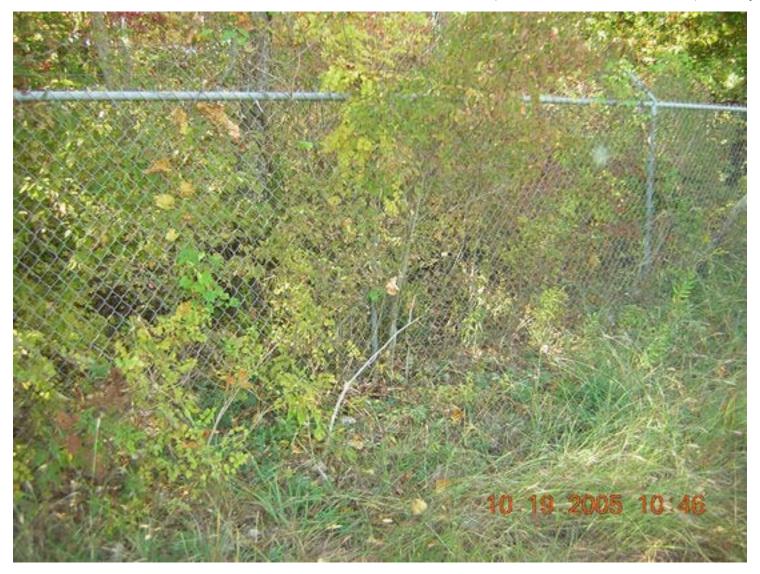
During the site inspection, the perimeter fence, the surface of the landfill cover, surface drainage, and the surface completions of the gas monitoring vents were inspected. The gas monitoring vents were properly labeled and in good condition (for example, Vent #1 illustrated in **Photograph 5**). The perimeter fence was in good condition overall, although there was one location where small trees were observed at locations that will ultimately impact the integrity of the fence (**Photograph 20**). All perimeter gates were locked and in good

Photo 20: Trees growing through perimeter fence on south side.

To address the issues identified during the third five-year review, several recommendations and follow-up actions have been identified for the site. To ensure continued long-term protectiveness, trees located along the perimeter fence and encroaching on the edge of the landfill in the southwestern portion of the site should be removed. In addition, erosion in the western area of the site should be checked and riprap added as necessary to prevent further erosion. The settlement monument surveying scheduled for early 2006 should be performed, and the results should be reviewed in the next annual report for the site. Also, the annual inspections

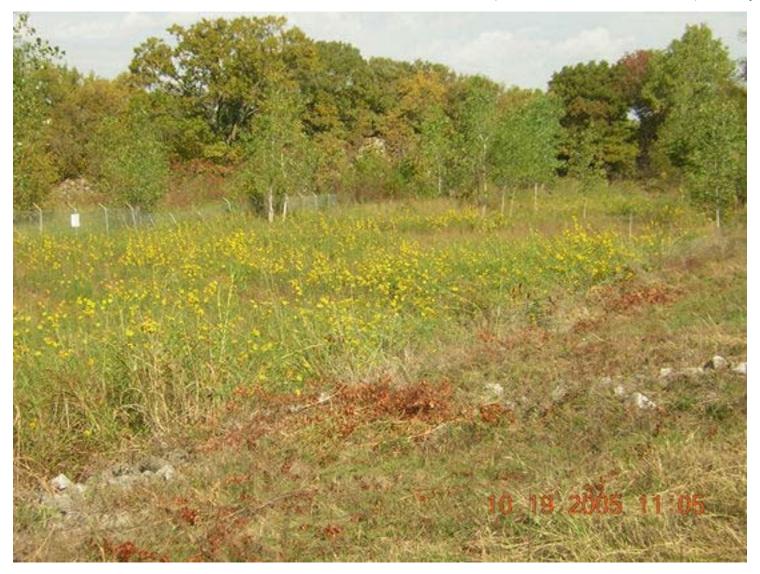
Photograph 28 of 49

Photo 28: Western edge of landfill area. Note riprap to prevent erosion, and western perimeter fence.

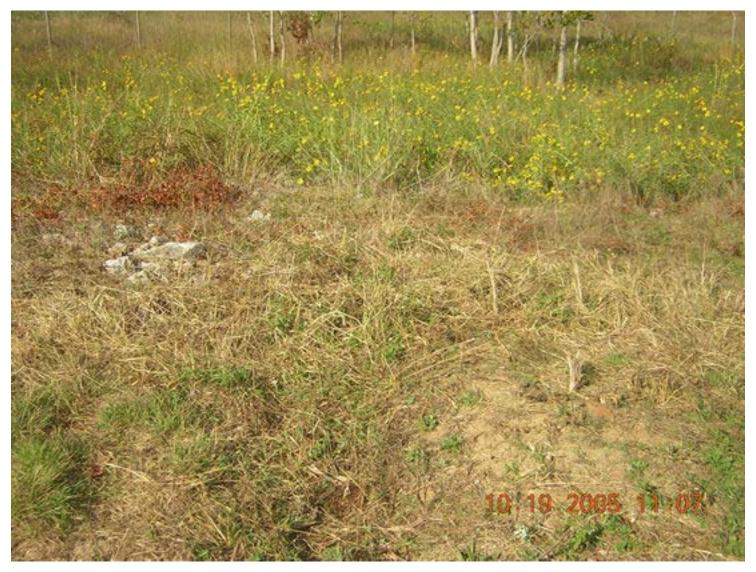
condition (**Photographs 2, 11, 16**). Some evidence of erosion was observed at the western area of the site, where riprap had been placed to prevent previous erosion. Placement of additional riprap would limit the progression of erosion. Some trees at the southern end of the drainage area appear to be encroaching on the landfill cover, and should be removed.

Photo 29: Some minor erosion observed at western edge of landfill area. Note presence of riprap.

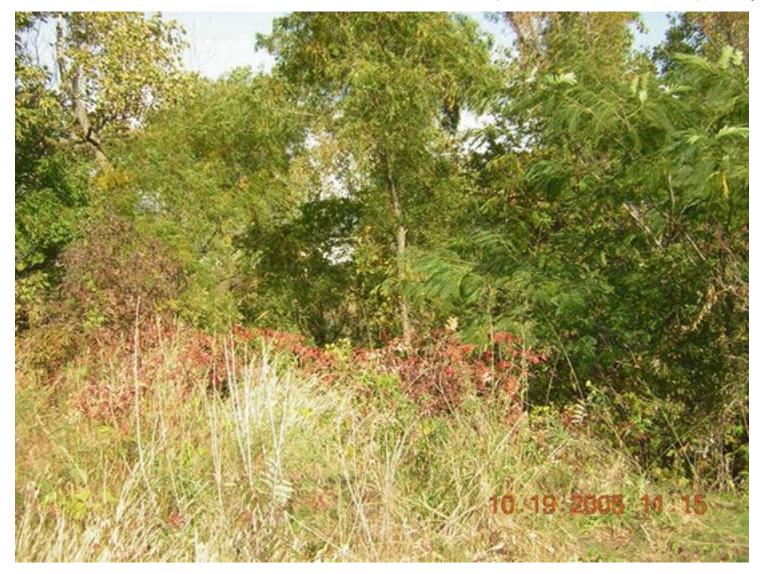
Photo 33: Heavy vegetation northwest of the landfill along top of bluff above the Arkansas River.
