Memorandum

May 26, 2017

Re: Post-TCRA Quarterly Inspection Report – April 2017

This memorandum reports the results of the April 2017 inspections of the armored cap cover, fencing, signage, buoys, and security cameras installed for the Time Critical Removal Action (TCRA) at the San Jacinto River Waste Pits Superfund Site (TCRA Site).

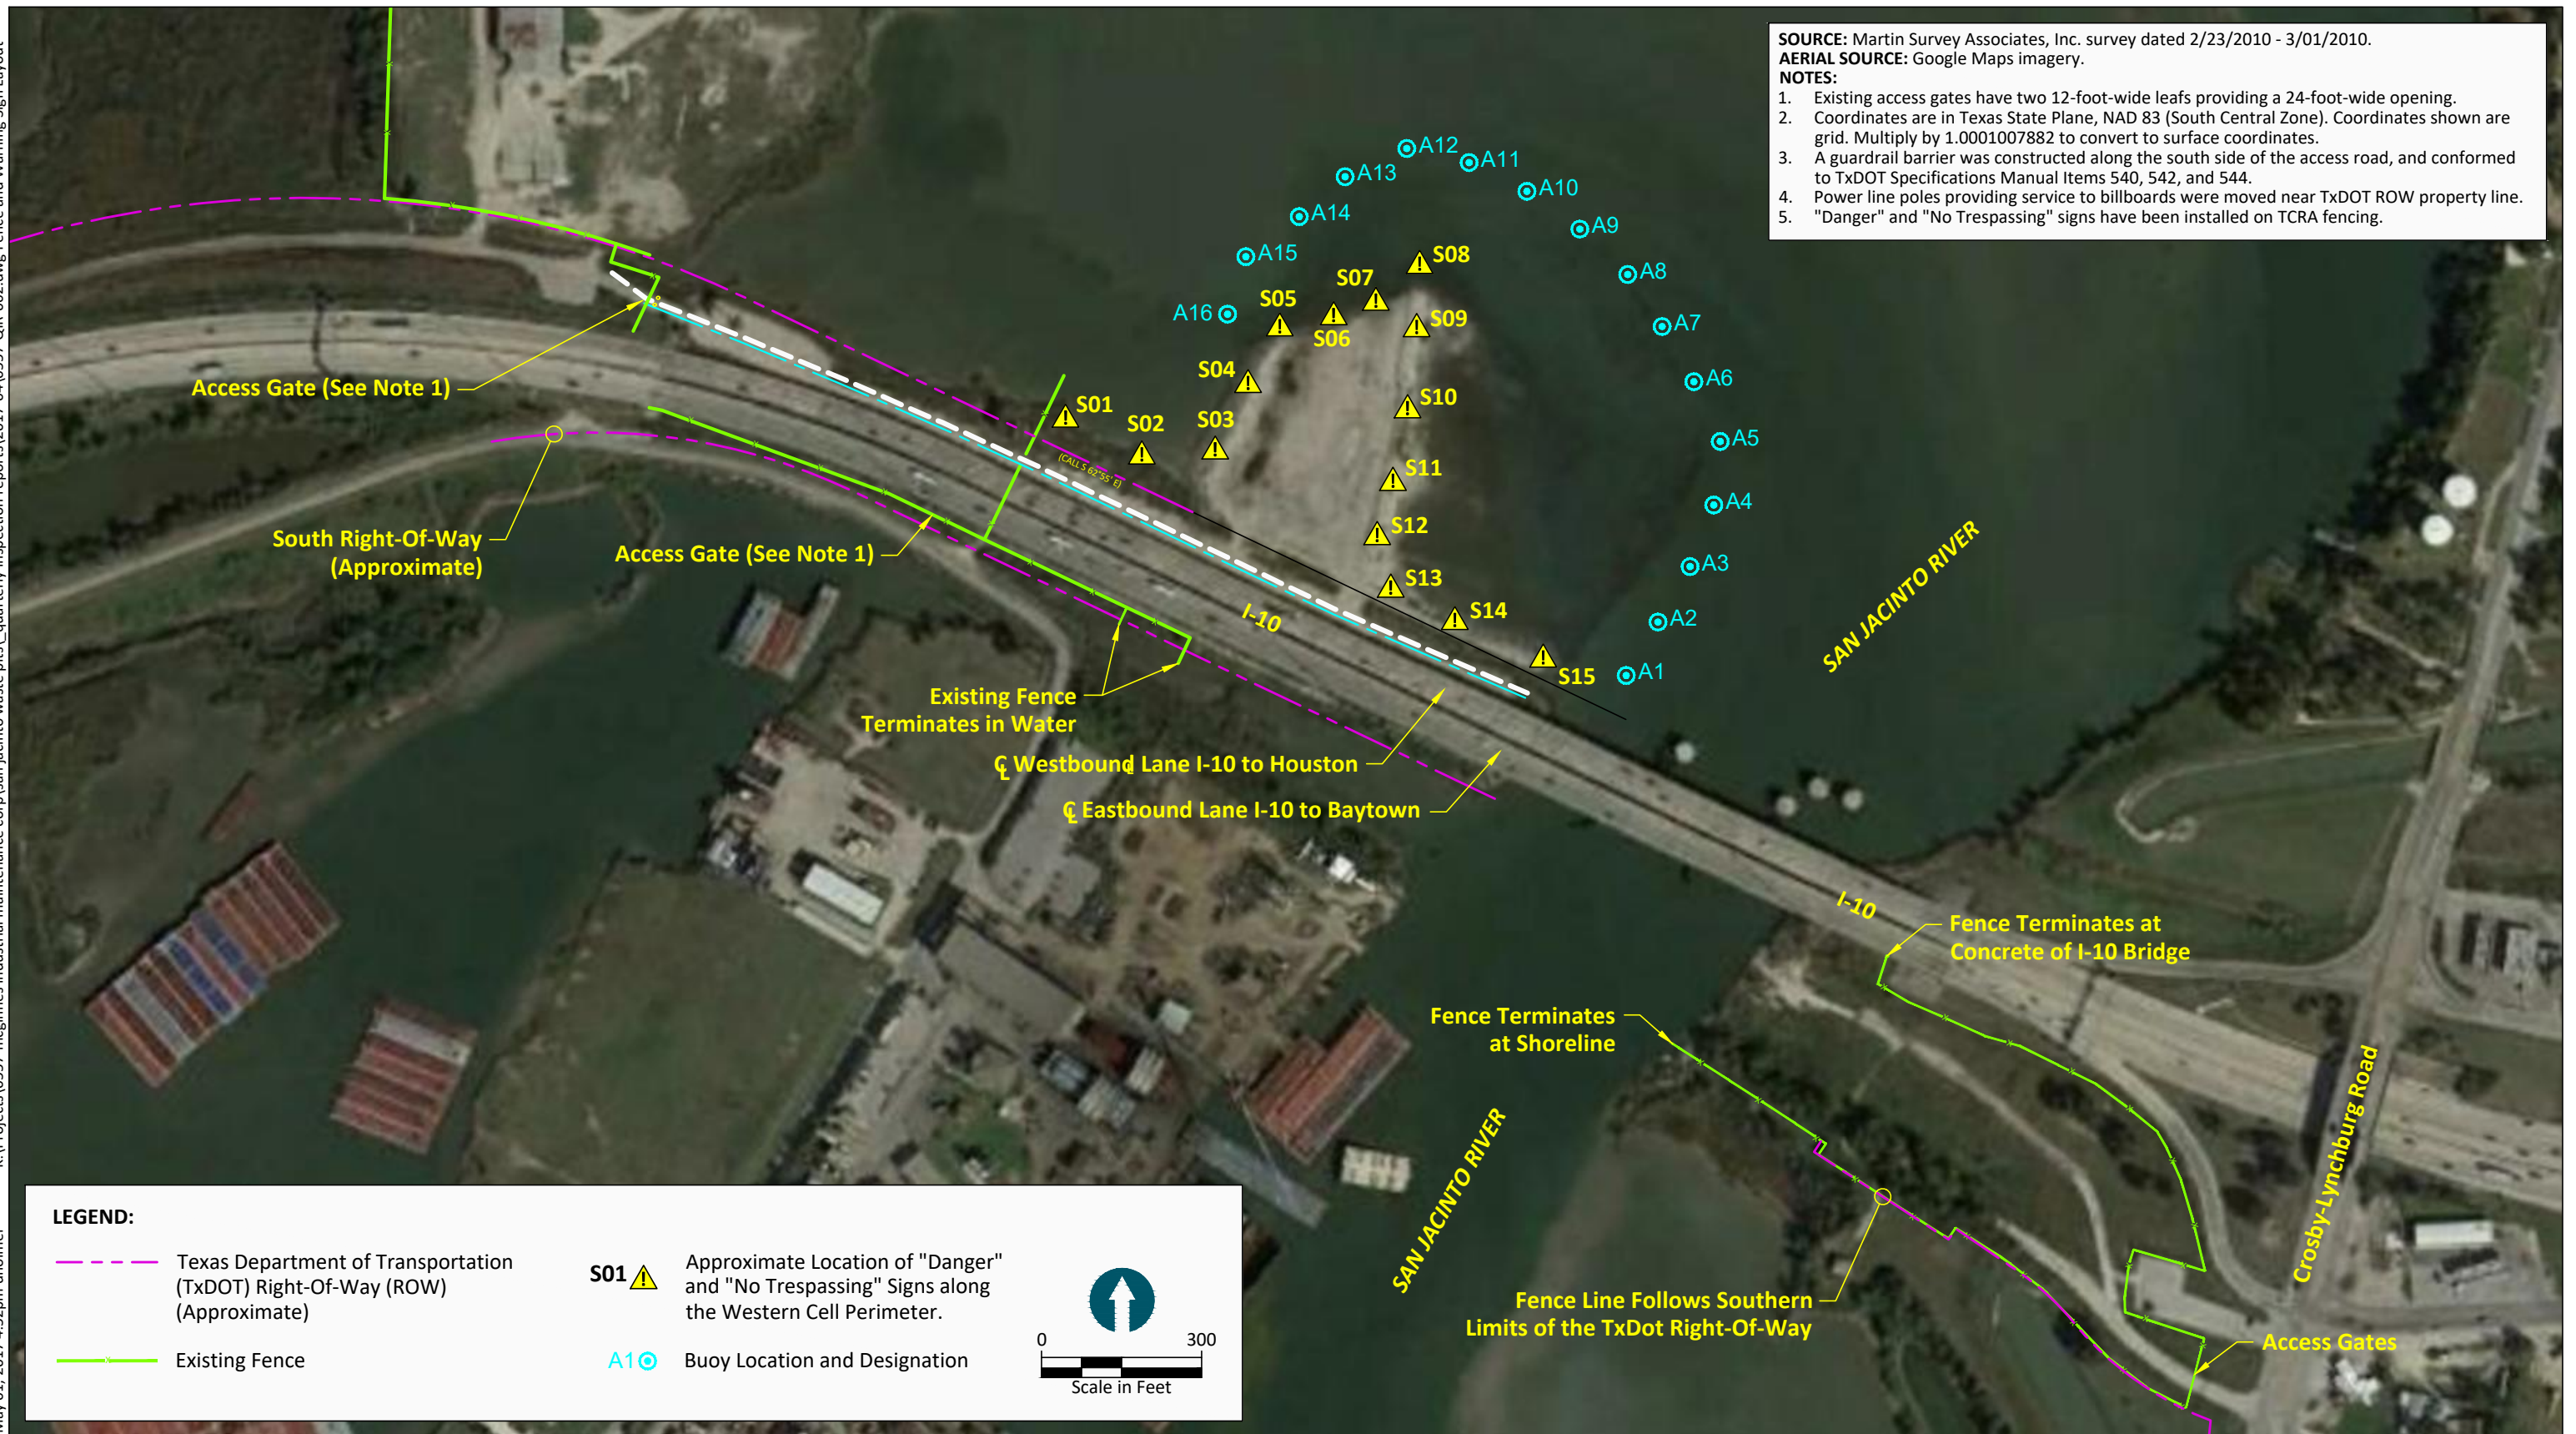
The perimeter fencing (Figure 2) on the west and east banks of the San Jacinto River was visually inspected for breaches or other indications of damage on April 20, 2017. No breaches or indications of fence damage were observed during the inspection of the perimeter fencing around the cap area north of Interstate-10 (I-10). Fencing on the west bank and south of I-10 was in good condition and did not have any breaches. Fencing on the east bank and south of I-10 was in good condition and had no breaches, except for a small area beneath the I-10 bridge (Photograph 11, Appendix A). National Fence was contacted to repair this breach, and the repairs were made on May 16, 2017.

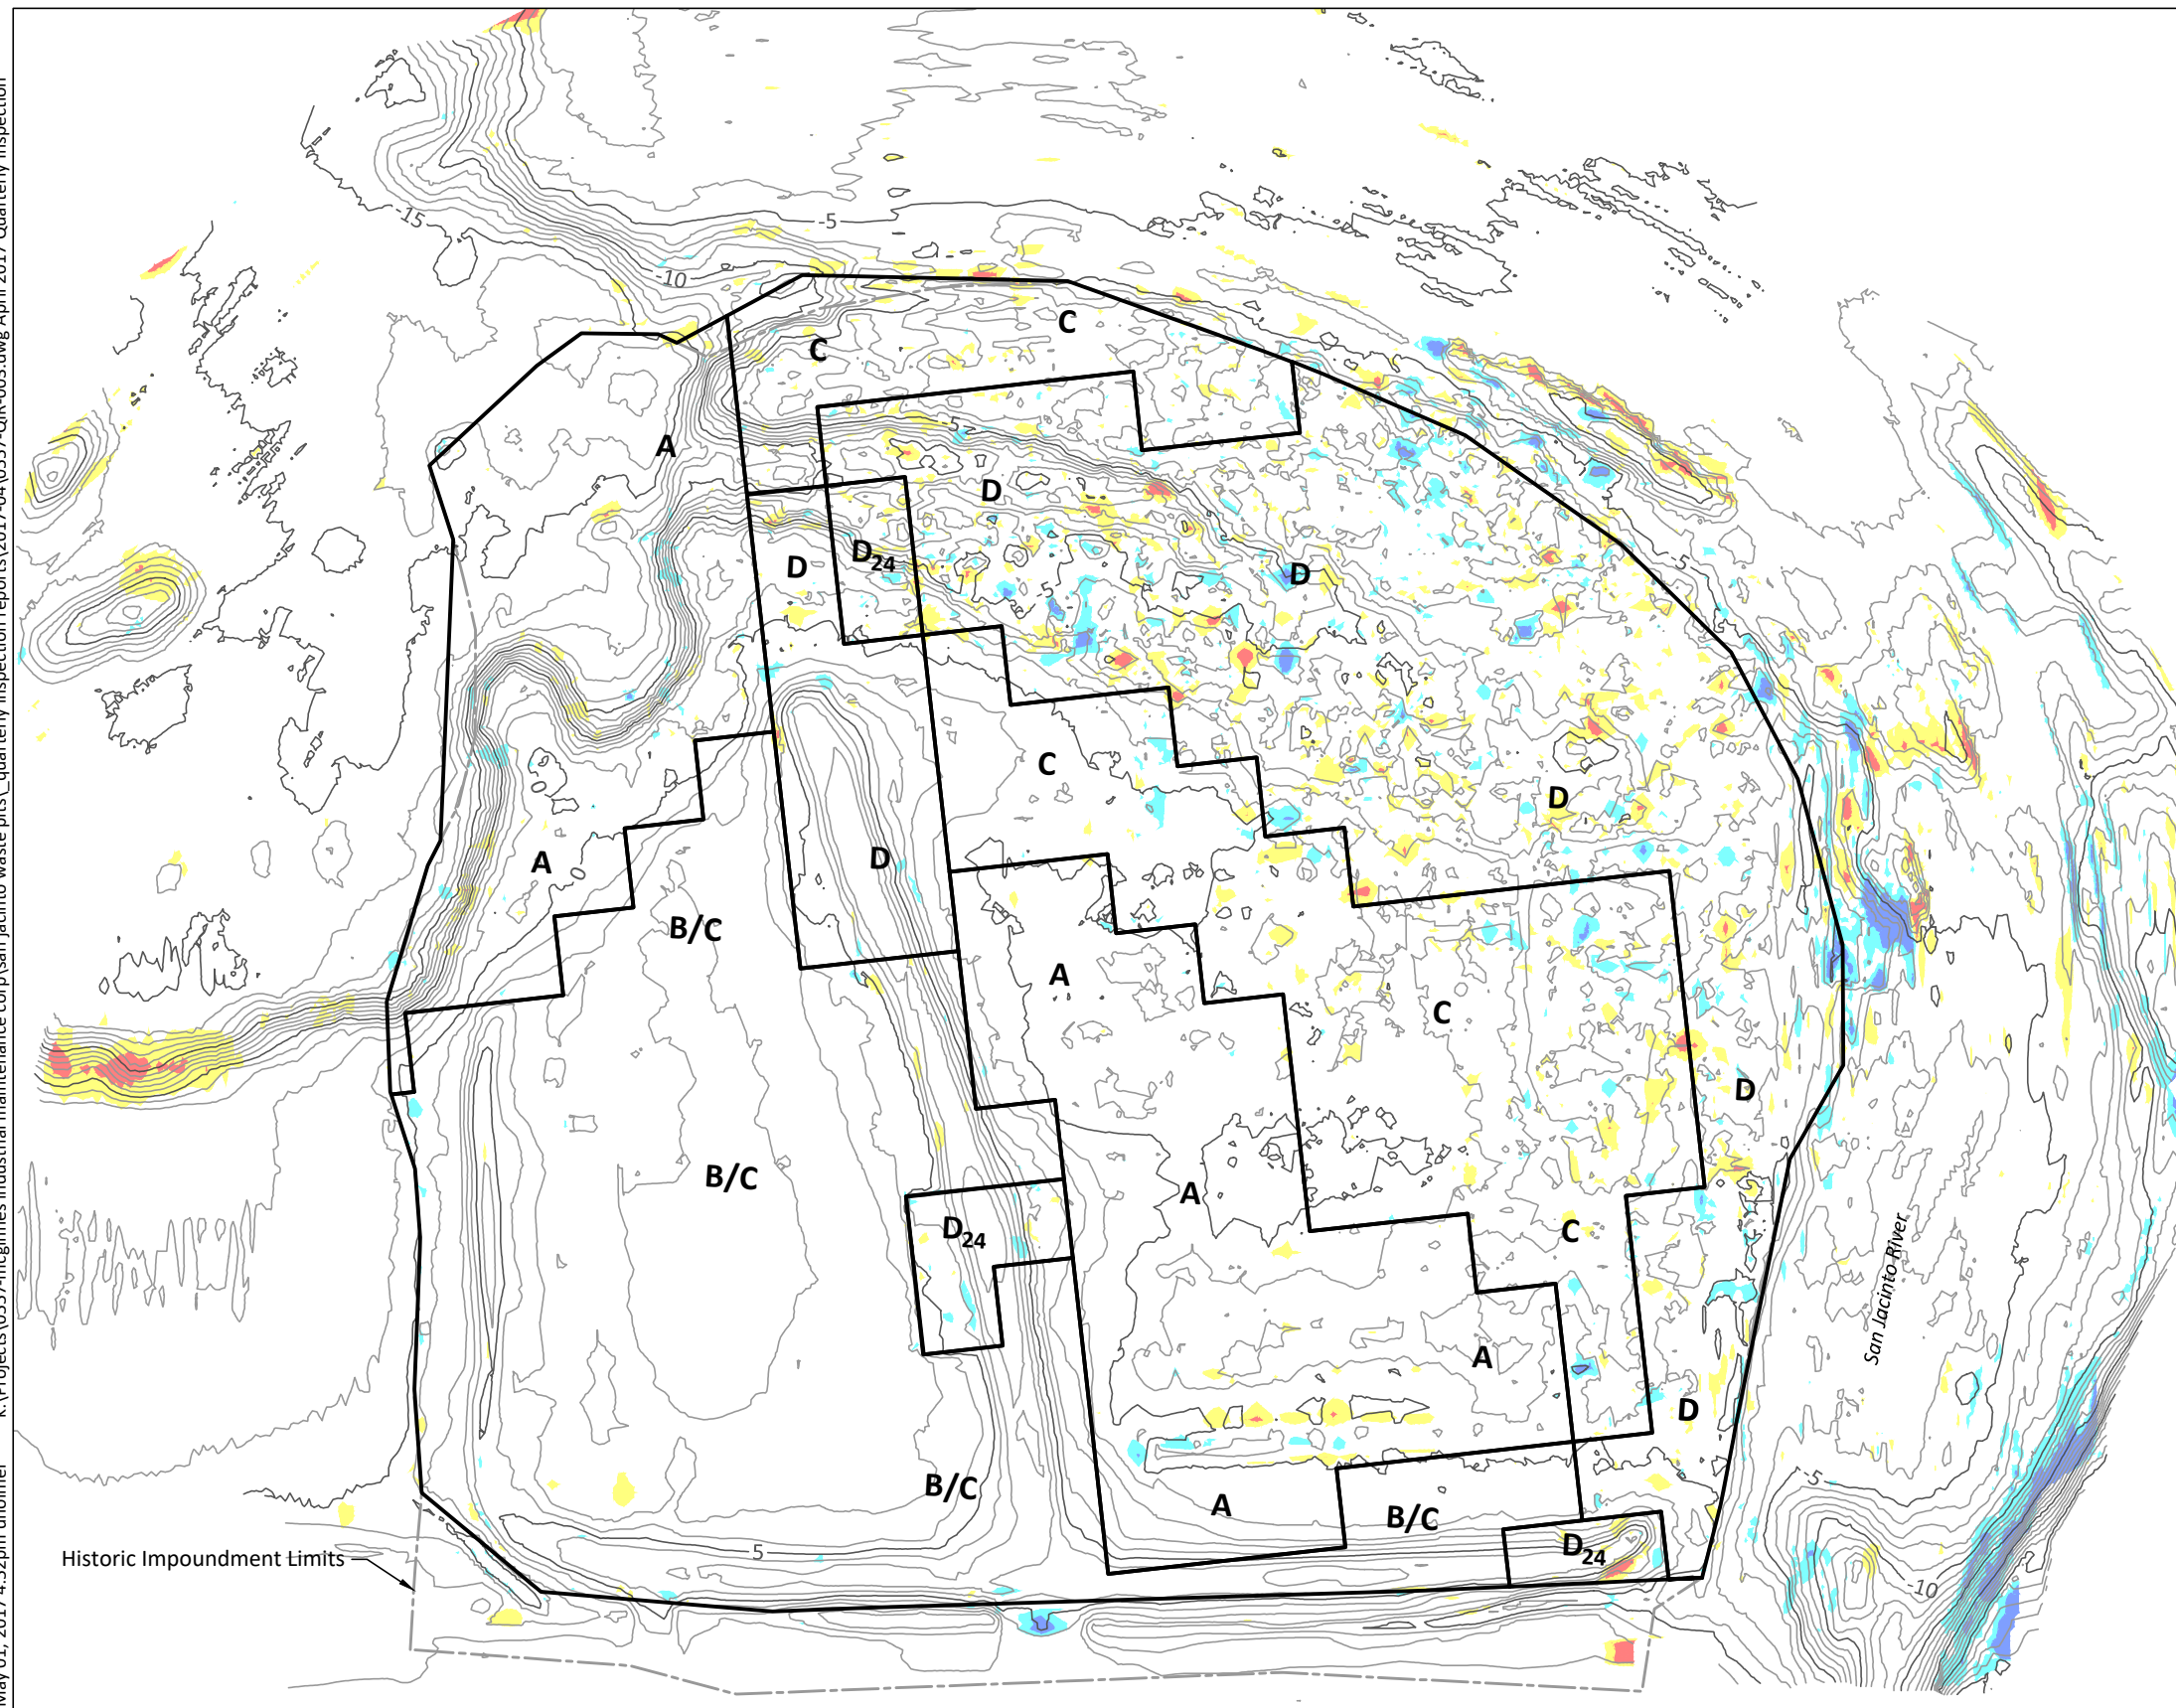
The survey data from the January 2017 inspection survey and the April 2017 inspection survey were compared to evaluate the differences in the top of the armored cap elevation. These differences are shaded and shown on Figure 3. The survey results indicate continued deposition and periodic erosion of alluvial sediment on the surface of the cap.

The OMM Plan (Anchor QEA 2012) calls for manual probing of armored cap thickness in contiguous areas larger than 30 feet by 30 feet identified by the topographic or bathymetric surveys as more than 6 inches higher or lower in elevation as compared to the prior survey. When the January 2017 and April 2017 surveys were compared, the results indicated that there were no areas where manual probing was required.

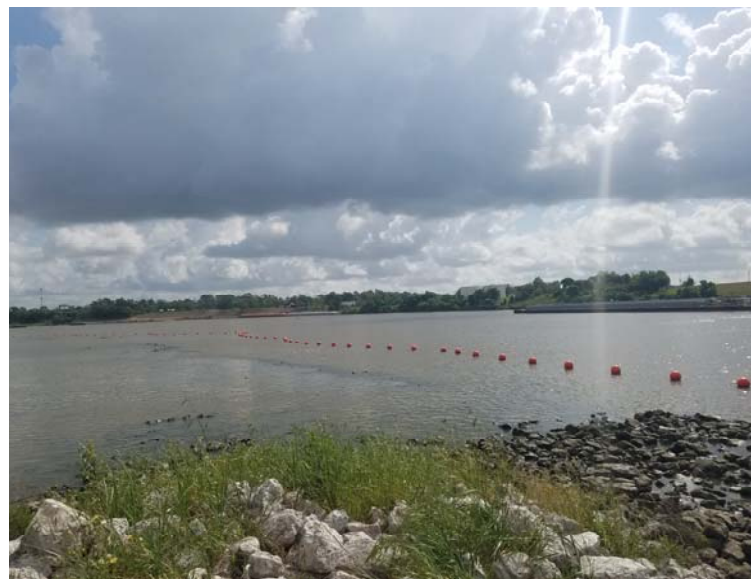
Permanent warning buoys were installed around the perimeter of the armored cap, as outlined in the letter from Respondents' Project Coordinator dated February 16, 2016 (Anchor QEA 2016a). The perimeter buoy system was visually inspected and found to be intact on April 20, 2017, and May 4, 2017. See Photographs 4, 8, and 12 in Appendix A for examples.

Photograph 04: Perimeter buoy system (view northeast)

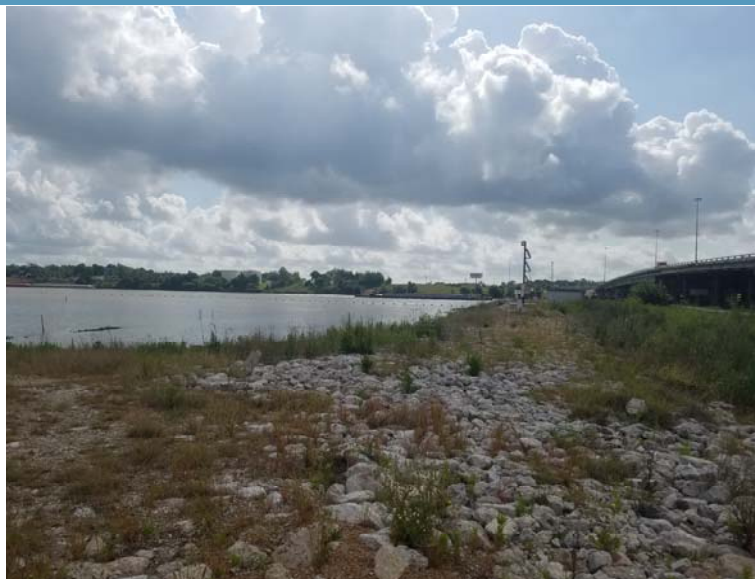
During the inspection, some driftwood, litter, and other debris were observed on the surface of the cap. Additionally, woody vegetation was observed on portions of the cap surface and berm areas. Benchmark Ecological Services, the Respondents' on-call contractor, was engaged to remove litter and debris and perform vegetation control on the cap surface, following USEPA approval for this work on May 3, 2017. This work was performed on May 4 and 5, 2017. A second round of vegetation control is also scheduled for June 2017.

Photograph 05: Vegetation along intertidal area of Eastern Cell (view southeast)

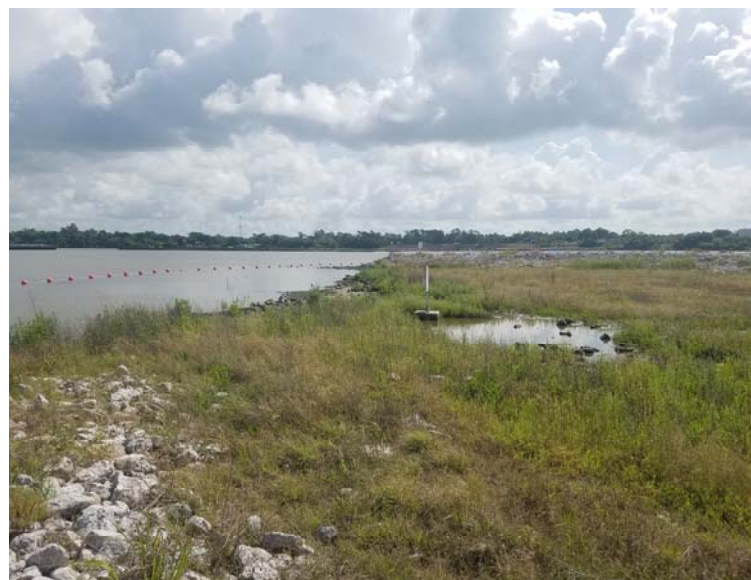
Photograph 08: Interior of Western Cell (view northeast)

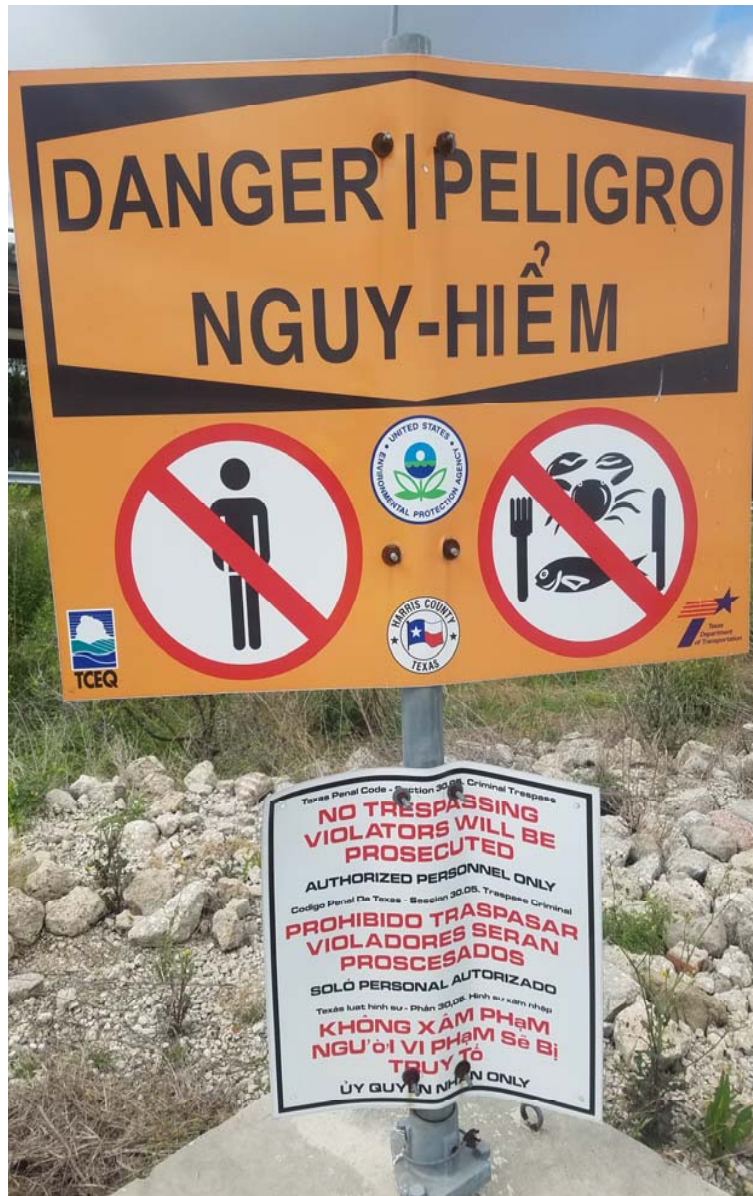
A total of 15 signs were installed around the perimeter of the land portion of the TCRA Site; the signs are mounted on steel posts and set in concrete pads. These signs are intended to face the San Jacinto River to deter water-based entry to the TCRA Site. For an example of these signs, see Photograph 9 in Appendix A. All signs were observed to be in place; however, during the inspection, several of the "Danger" and "No Trespassing" signs on the cap and perimeter fencing were observed to have begun to fade due to weathering. In addition, there are three USEPA Public Notice signs present around the TCRA Site located near the gate entry point for the perimeter fence north of I-10; near a gate entry point south of I-10; and at the end of the Texas Department of Transportation right-of-way north of I-10 near the San Jacinto River. For examples, see Photographs 1 and 13 in Appendix A. A detailed inspection and inventory of the signs that require replacement due to weathering was performed on May 4, 2017. That inspection revealed the signs needing replacement include 36 orange "Danger" signs (36 inches by 48 inches), 31 white "No Trespassing" signs (24 inches by 24 inches), and 2 USEPA Public Notice signs (60 inches by 90 inches). The Respondents have ordered new signs and plan to replace them when the sign fabrication is completed.

Photograph 9: Danger sign located on central berm (view west)

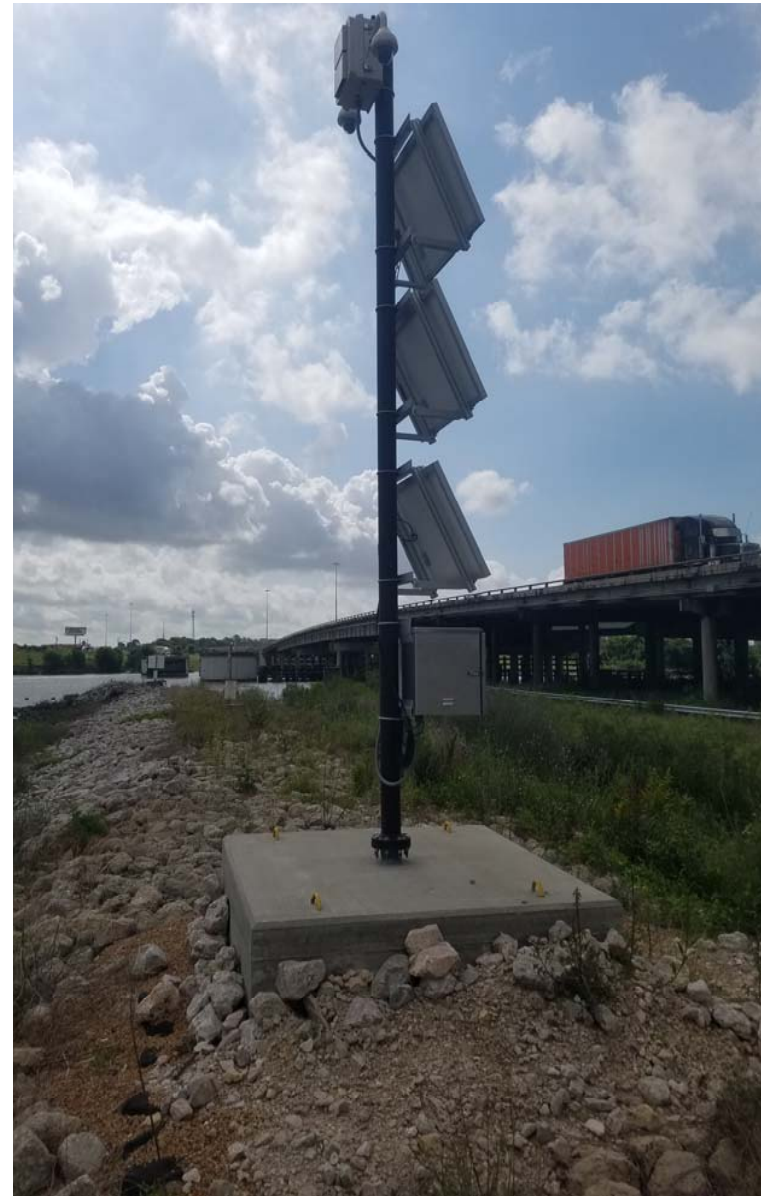
Security cameras, installed as outlined in an addendum to the OMM Plan (Anchor QEA 2016b), were also inspected on April 20, 2017. The security camera system was operating normally during the inspection. For an example of the security camera apparatus at the Site, see Photograph 10 in Appendix A.

Photograph 10: Security camera on southern berm (view east)

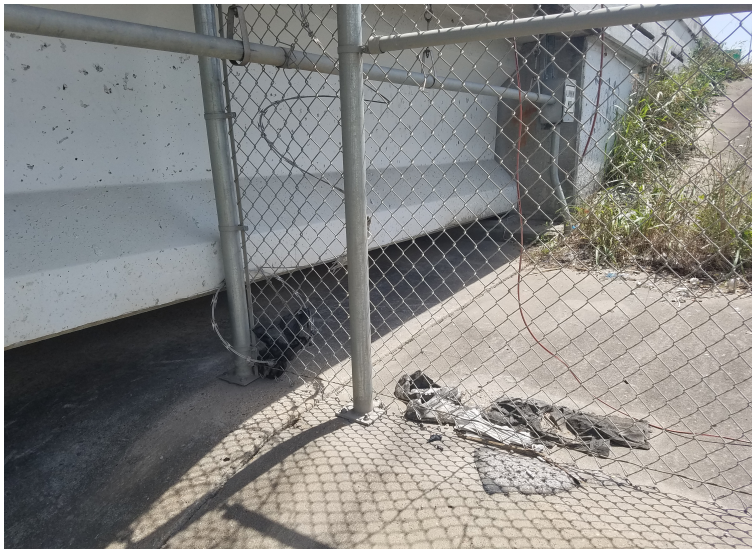
Photograph 11: Fence repair location beneath I-10 Bridge on east bank

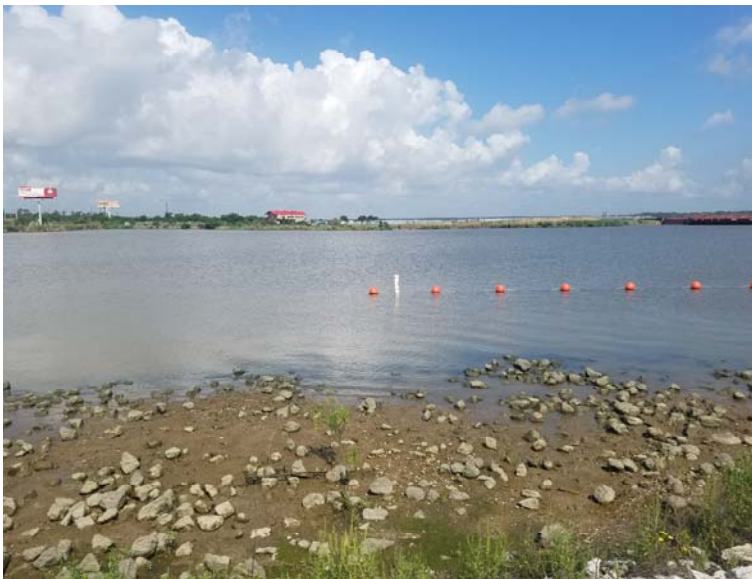
Photograph 12: Perimeter buoy system with warning buoy (view west)

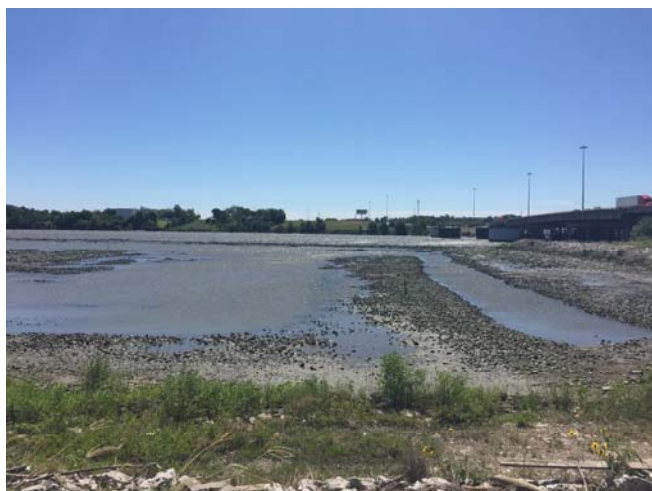
Photographs of the armored cap from the inspection events are provided in Appendix A. The majority of the Eastern Cell armored cap was underwater at the time of the inspection on April 20, 2017; however, there was a north wind and associated low tide during the inspection on May 4, 2017, and large portions of the Eastern Cell were exposed (Photographs 13 through 16 in Appendix A). All the visible portions of the armored cap were observed to be intact, and no movement of cap materials was observed at any location during either of the visual inspections.

Photograph 14: Eastern berm and cell facing east, May 4, 2017, low tide conditions

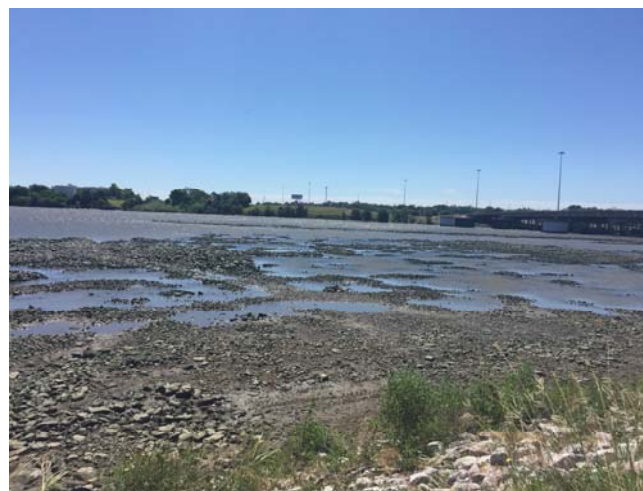
Photograph 16: Middle eastern cell facing southeast May 4, 2017, low tide conditions

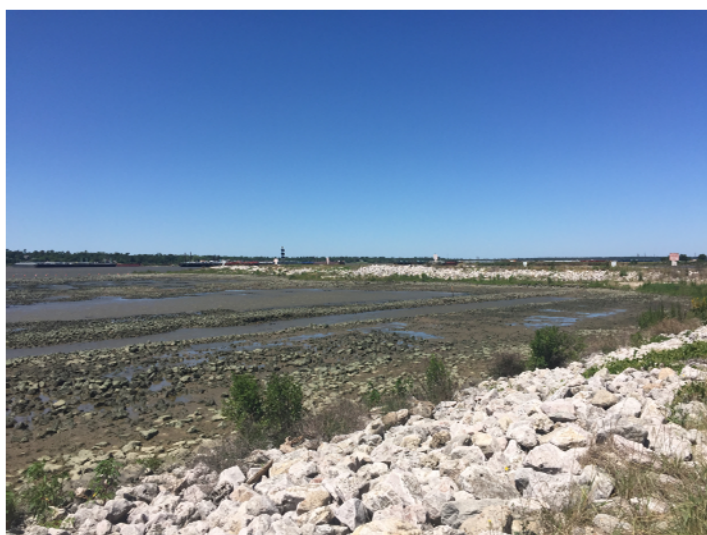
Photograph 15: Eastern berm and cell facing north May 4, 2017, low tide conditions
