**FINAL  
FIRST FIVE-YEAR REVIEW  
FOR THE  
ROCKWOOL INDUSTRIES, INC. SUPERFUND SITE  
BELTON, BELL COUNTY, TEXAS**

September 2012

### FIVE-YEAR REVIEW Rockwool Industries, Inc. Superfund Site EPA ID# TXD06637964

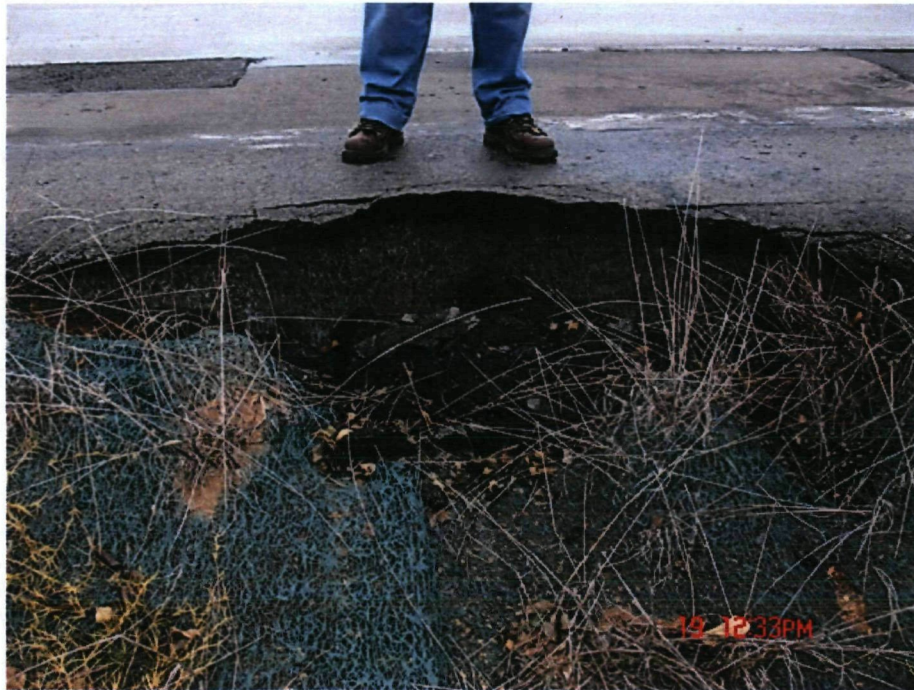
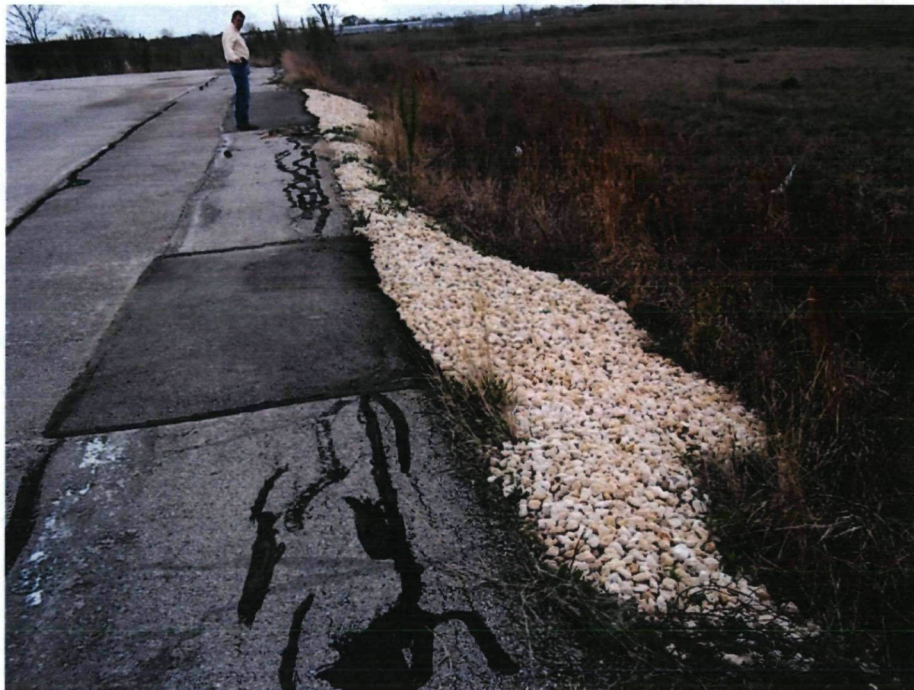
**Figure 10. Erosion Damage and Repairs to Matcon Cap**

EPA was to conduct the O&M for the first year after completion of the remedial action, and TCEQ was to assume O&M activities after the first year. However, the State (TCEQ) has not yet assumed the O&M phase as TCEQ considered damage on the periphery of the Matcon cap as not acceptable. TCEQ is scheduled to begin conducting O&M at the site later this year, except that EPA will continue O&M of the Matcon cap until the damages to the Matcon cap are addressed and TCEQ assumes O&M for the whole site. The City of Belton mows the property 2-3 times per year. EPA conducted baseline groundwater sampling and groundwater elevation measurements on December 18-20, 2006 and January 9-11, 2007 (**EA, 2007**). The groundwater analytical data is included in **Table 3**, the groundwater elevation data is given in **Table 6**, and a review of the data is given in **Section 6.3**. EPA has been making periodic repairs of cracks to the Matcon cap, and in September of 2010 EPA completed repairs of the erosion damage of the southern edge of the Matcon cap. **Figure 10** shows an example of the damage and repairs to the Matcon cap.

**Undated photograph of erosion damage to the Matcon cap.**

**Repaired erosion damage to the Matcon cap, March 17, 2011 photograph.**

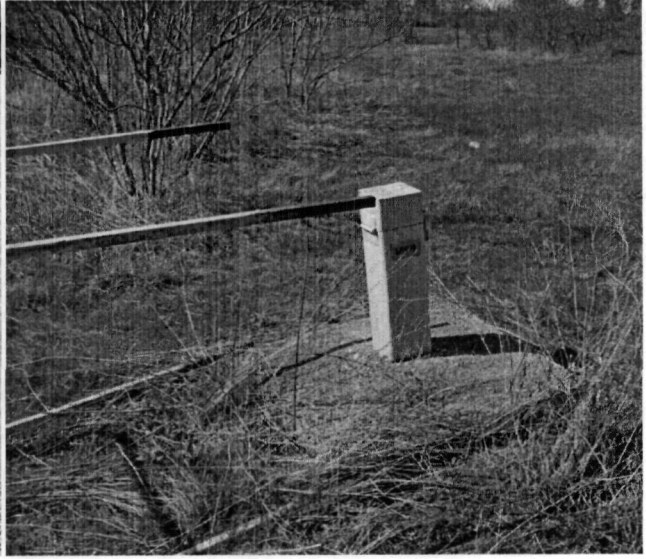
Photo 1. MW-07, no identification marker, enclosed in a corrugated metal housing.

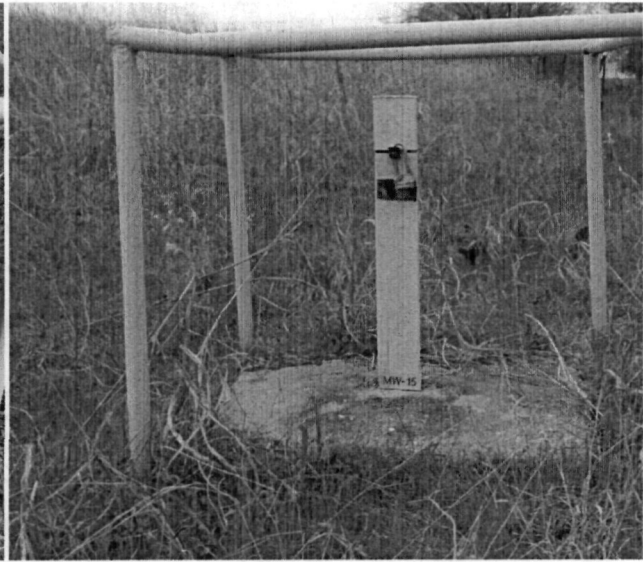
Photo 6. MW-15, identification marker has fallen off

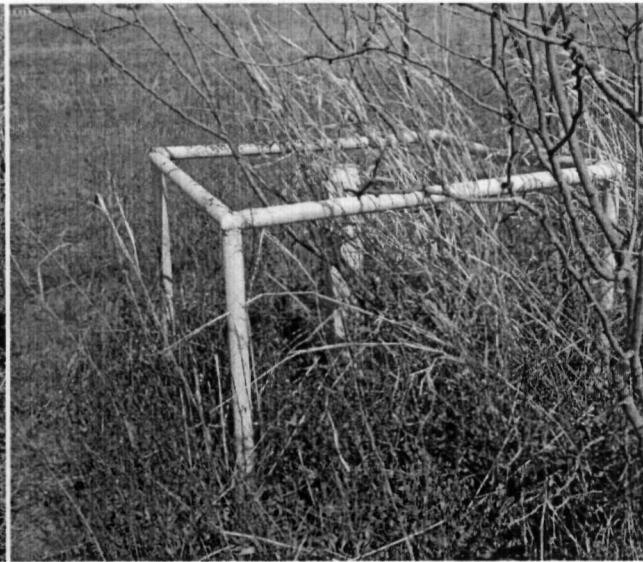
Photo 8. MW-17, has no identification marker,  
overgrown

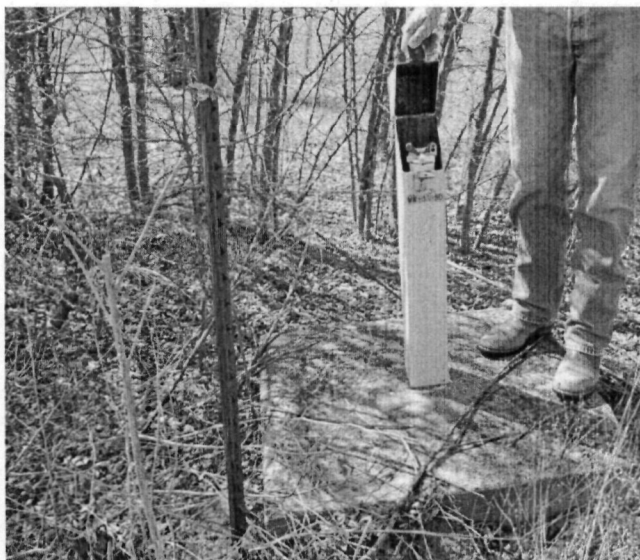
Photo 21. MW-33-90, well is missing the lock

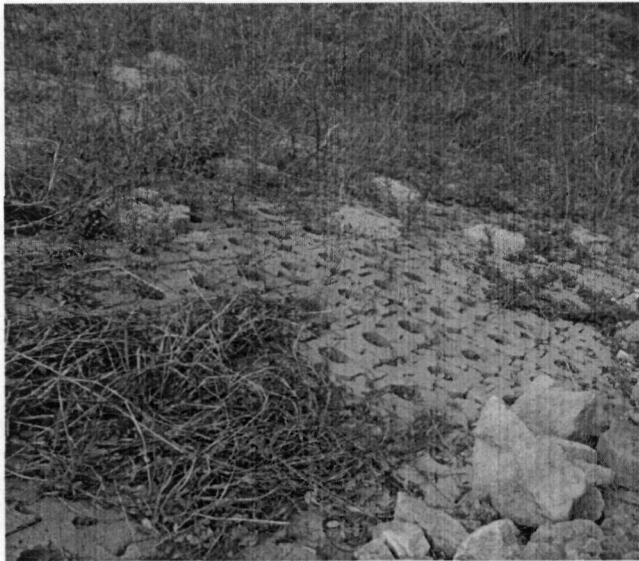
Photo 28. Looking west at ACB from the eastern edge.  
Note the raised concrete blocks.

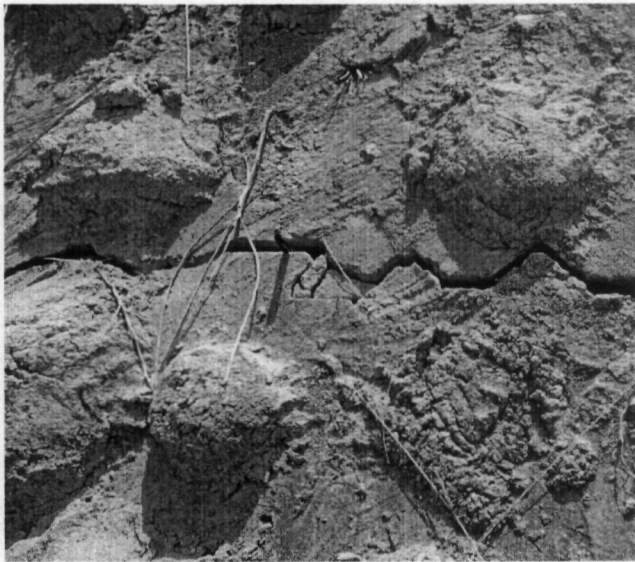
Photo 33. Crack in concrete CMP outfall, the writing pen placed in the crack indicates the depth of the crack.

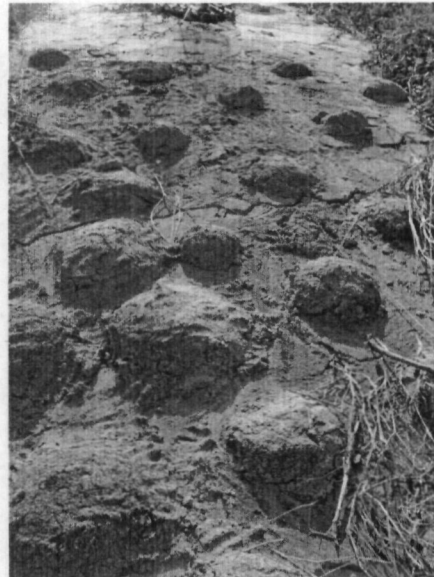
Photo 34. Crack in concrete CMP outfall.

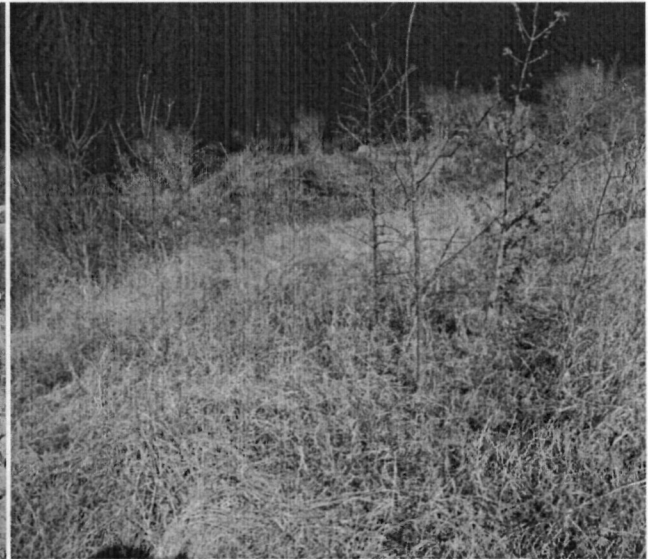
Photo 36. Small trees growing out of the ACB.

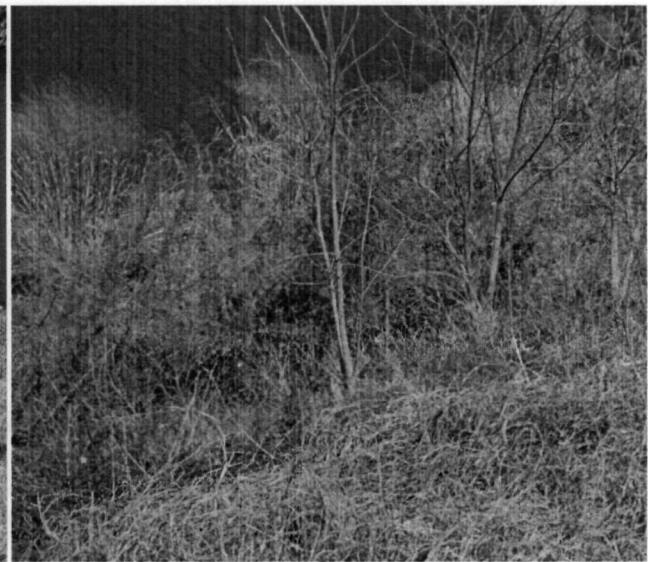
Photo 38. Small trees growing out of the ACB.

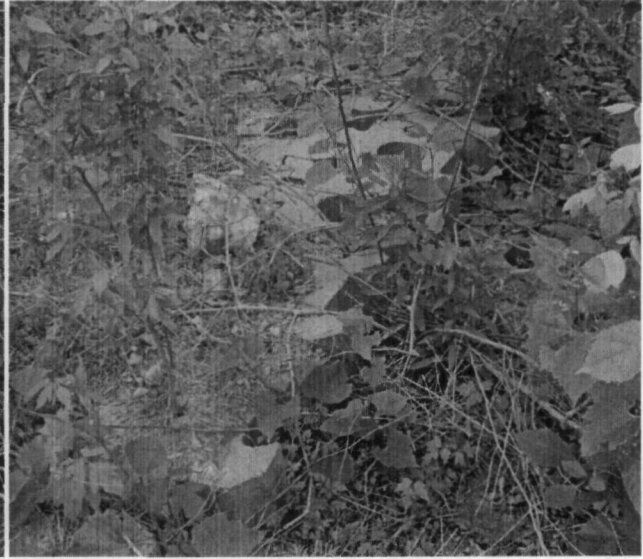
Photo 40. Instability and loss of continuity in the ACB at the toe of the LRB.

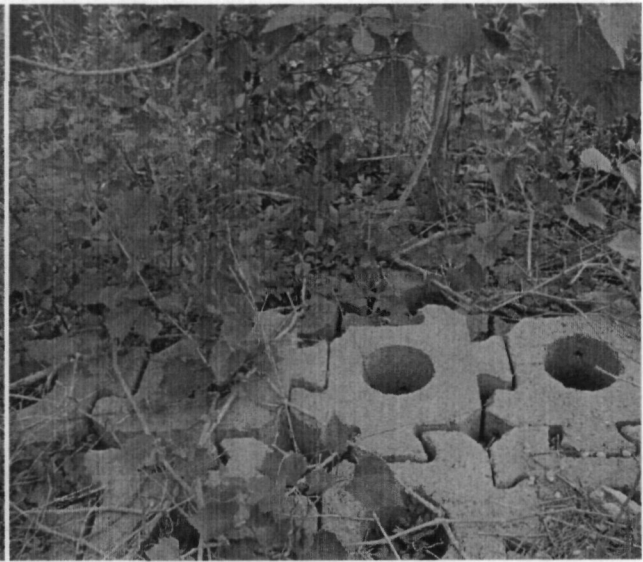
Photo 42. Instability and loss of continuity in the ACB at the toe of the LRB.

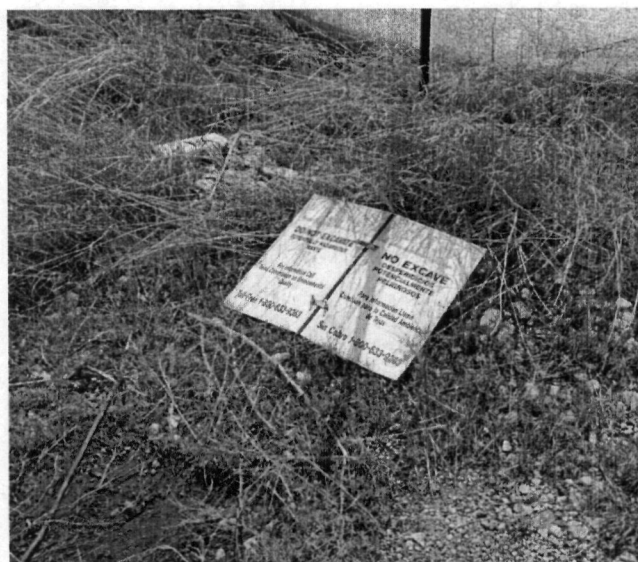
Warning signs have been installed around the perimeter of the site. Locations noted with missing signs were along the northern edge of the paved asphalt parking area on the North Property, along the eastern edge of the North Property, and only one sign was observed along the site boundary along the Leon River. The signs at the boundary of the cemetery and the CSP, which partially overlaps the cemetery (**Photo 56**), are still intact. However, they are sufficiently far apart that they could be missed. Because there could be additional burials in this cemetery, additional signs are recommended to clearly delineate the area in which digging is prohibited. There is a concrete plant at the western edge of the CSP, and operations have encroached on the CSP in the past (**Photo 57**). Additional signs have been added in this area and this is not currently a problem, however, this area needs to be monitored to ensure protection of the CSP cover. Consideration should be given to installing a fence between the CSP and the concrete plant if the plant operations encroach on the CSP in the future.

Photo 45. Fallen warning sign adjacent to the paved parking area.

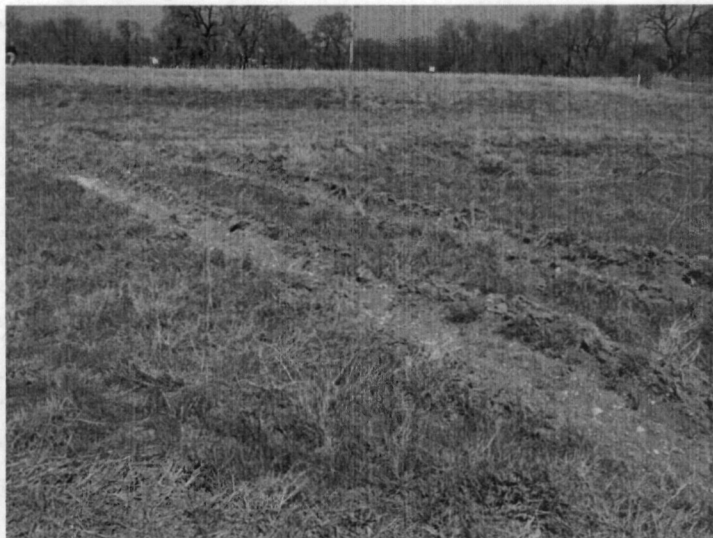
Photo 47. Wheel ruts and grass cover damage in the area between the paved parking area and the EVL in the background.

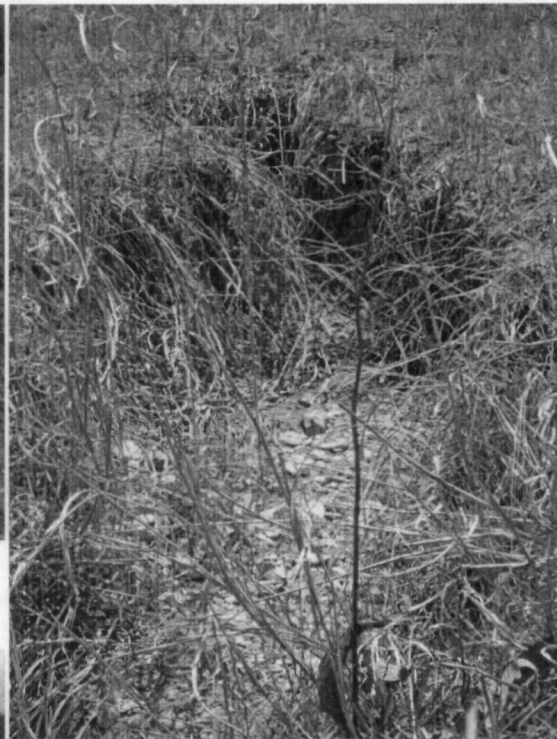
Photo 48. Erosion in EVL area about 25 feet west of well MW-35-90.

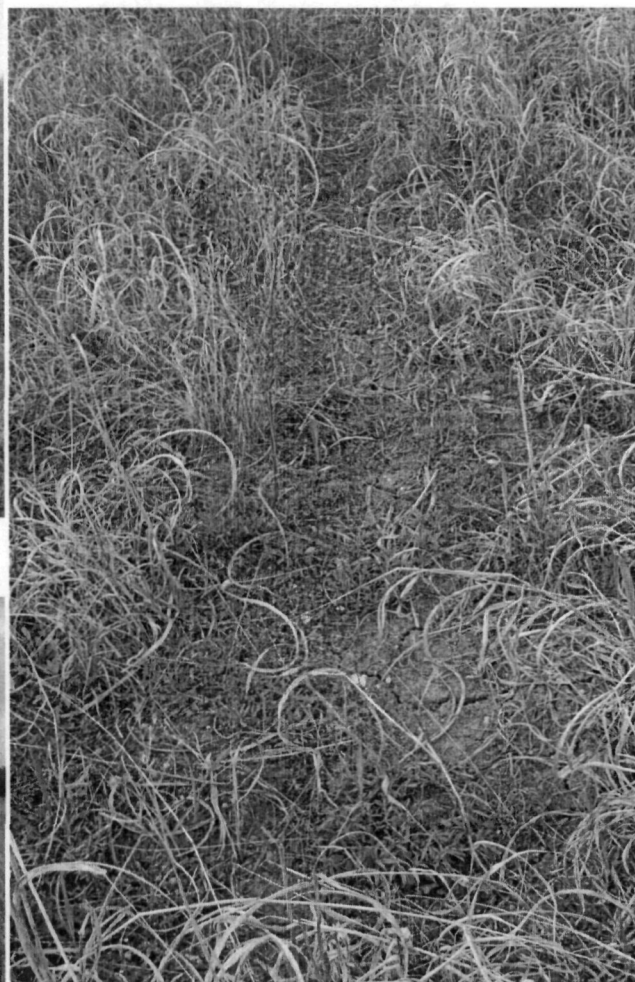
The cap over the CSP and NSP had good grass cover, except that there are some small cracks in the top of the NSP (**Photo 51**). The vegetation needs to be re-established in the western edge of the CSP where the concrete plant operations encroached on the cover. There was a good grass cover over the capped EVL. One area of active erosion was identified along the western edge of the EVL (**Photo 48**), and the erosion continued all the way north to the top bank edge of the ACB. This erosion needs to be addressed to avoid possible exposure of the waste placed in the EVL, and to avoid possible destabilization of the ACB stabilized LRB. Portions of the capped in place wastes and contaminated soils in the SSP area of the Central Property had areas of sparse vegetation (**Photos 72 and 73**). The vegetation needs to be re-established in these areas. Inspection of the ACB stabilized Leon River bank showed several of the ACBs had shifted at the toe of the bank between the EVL and the NSP (**Photos 39-42**). The ACB needs to be monitored to avoid loss of the blocks and erosion of the bank. There are small trees growing out of the ACB which need to be removed. There is a CMP pipe that discharges in the stabilized LRB between the NPS and the EVL that is partially clogged (**Photos 31 and 32**), and needs to be cleaned out. The concrete outfall for this pipe is cracked (**Photos 33 and 34**). These cracks are large enough to possibly allow water to flow under the outfall and should be repaired to avoid possible erosion and undermining of the outfall. There are two CMPs under the CSP. The inlet to one of these pipes is partially clogged (**Photo 55**) and should be cleaned out. On the North Property, wheel ruts were observed in the area between the EVL and the parking lot (**Photo 47**), but this is not an area with covered waste. These ruts were probably caused by city workers performing maintenance at the site.

Photo 51. Small cracks in the cover on the top of NSP.

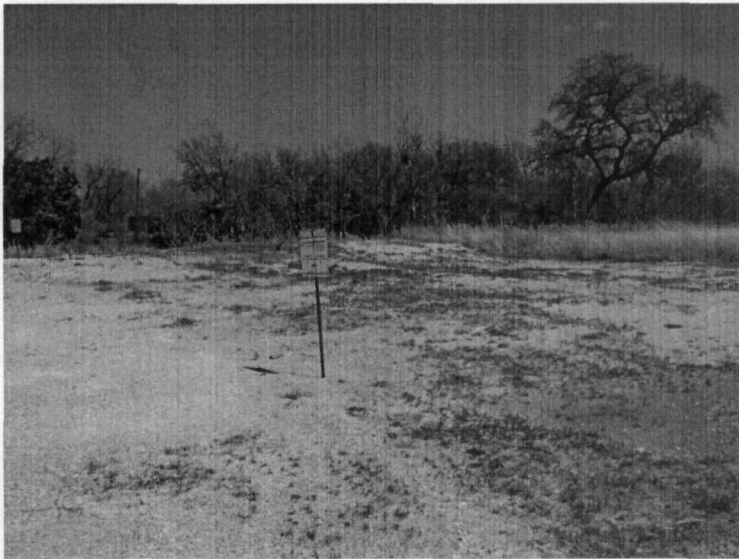
Photo 57. Area of past encroachment on the western edge of the CSP at the concrete plant.

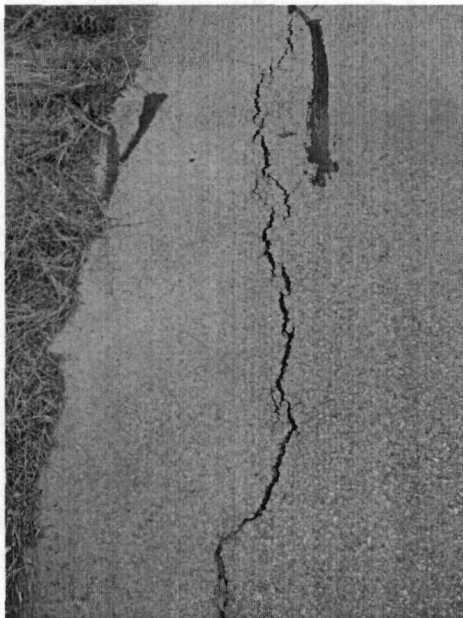
Photo 58. Unpatched cracks.

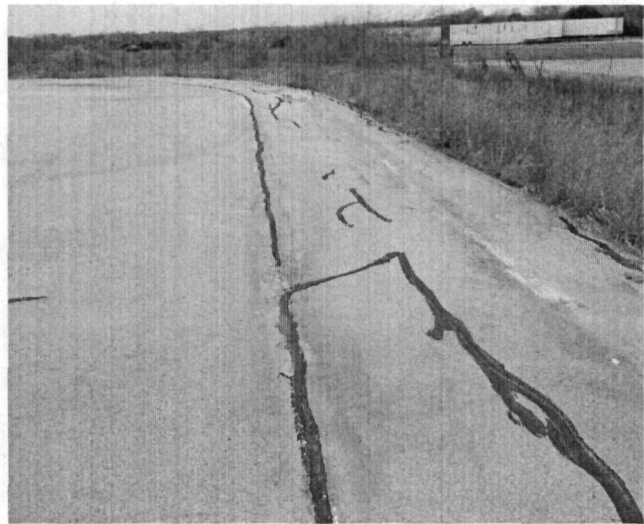
Photo 59. Patched cracks and asphalt repair area.

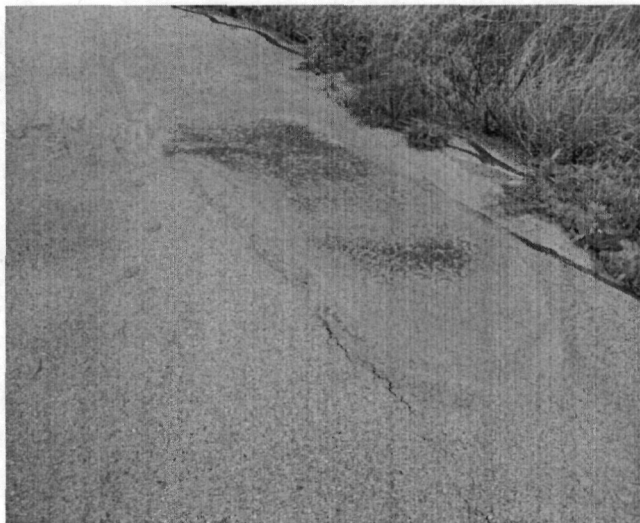
Photo 60. Area where water stands near the edge.

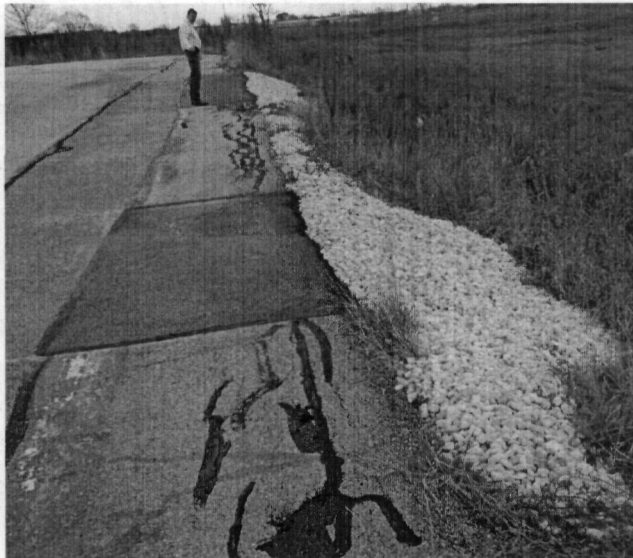
Photo 63. Rip rap along the southern edge of the CC. The hole in the rip rap indicates that erosion may still be occurring.

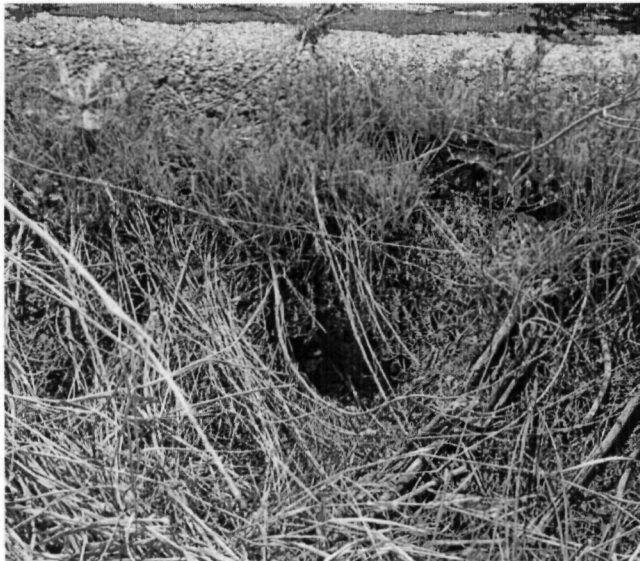
Photo 66. Possible minor erosion at the northern edge of the CC cap.

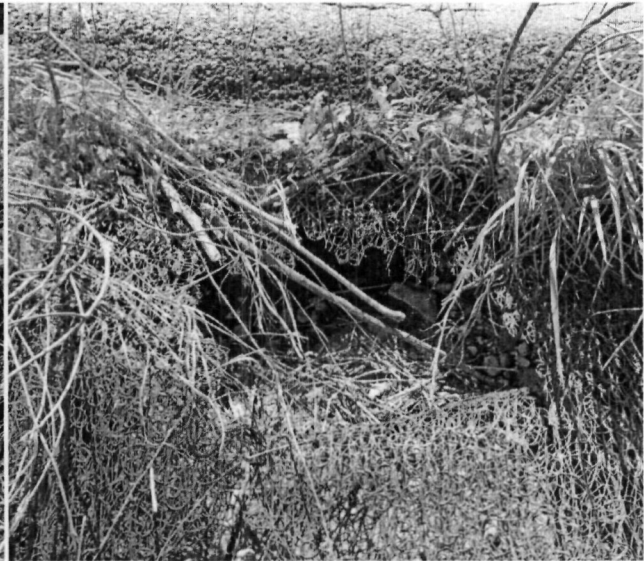
Photo 67. Possible minor erosion at the northern edge of the CC cap.

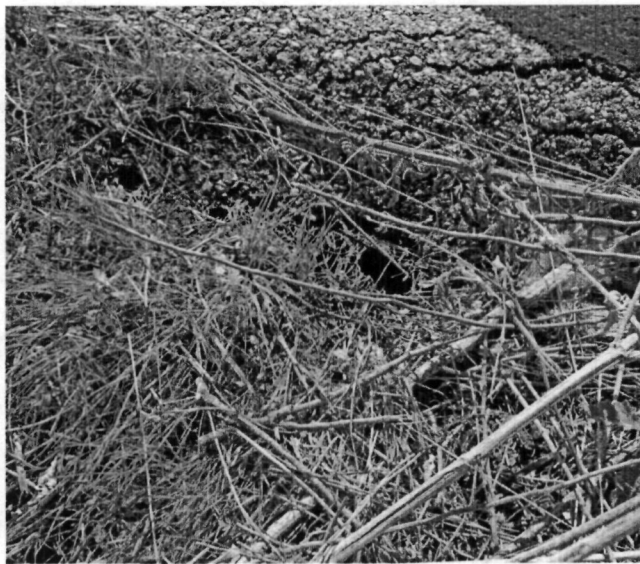
Photo 68. Possible minor erosion at the southern edge of the CC cap.

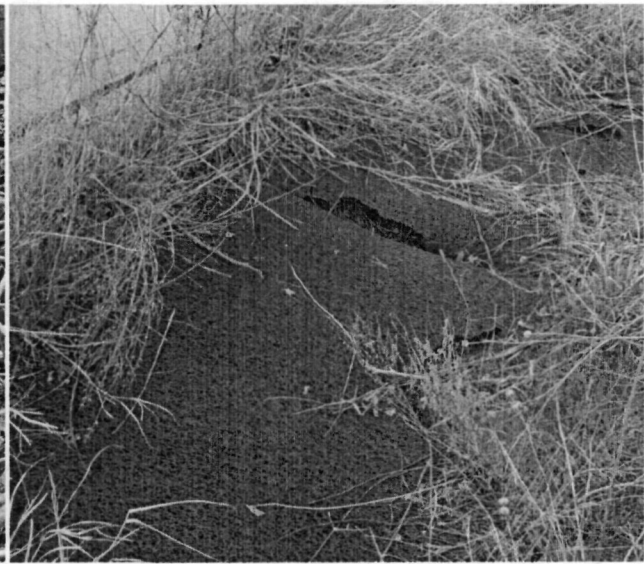
Photo 69. Erosion protection mat has separated from the ground and is several inches above the bottom of the drainage ditch.

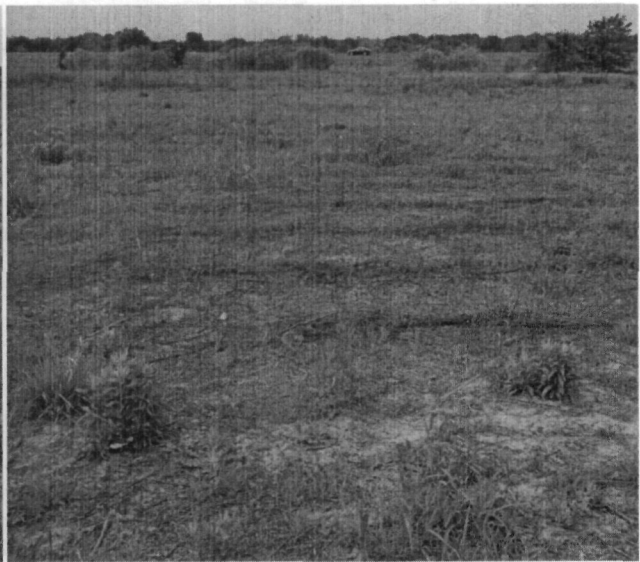
Photo 73. Sparse vegetation cover over SSP waste capped in place.

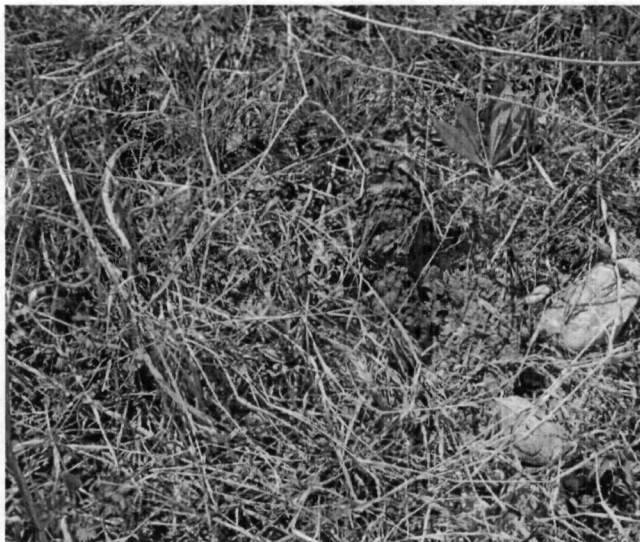
Photo 74. Possible slag/spent shot found northeast of the EVL.

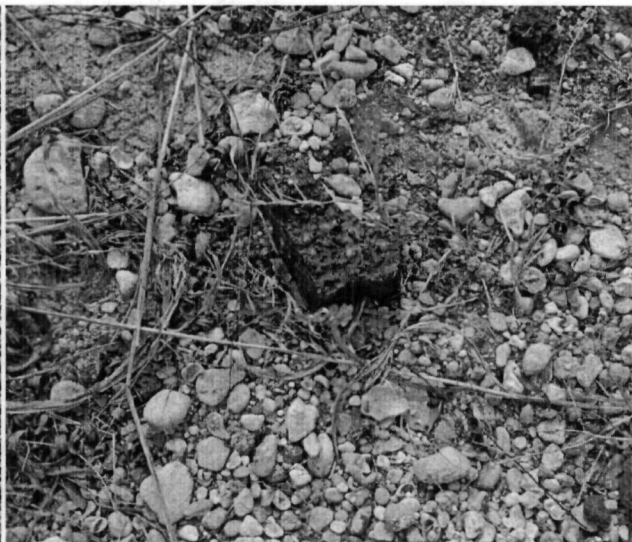
Photo 75. Possible slag/spent shot found northeast of the EVL.

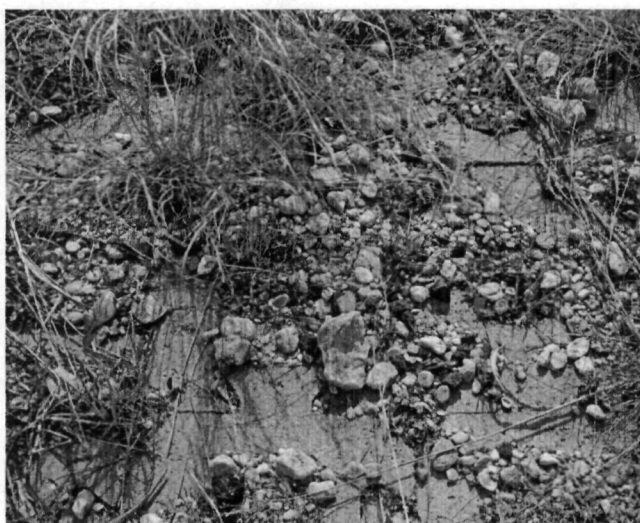
Photo 76. Possible slag/spent shot found on the ACB.

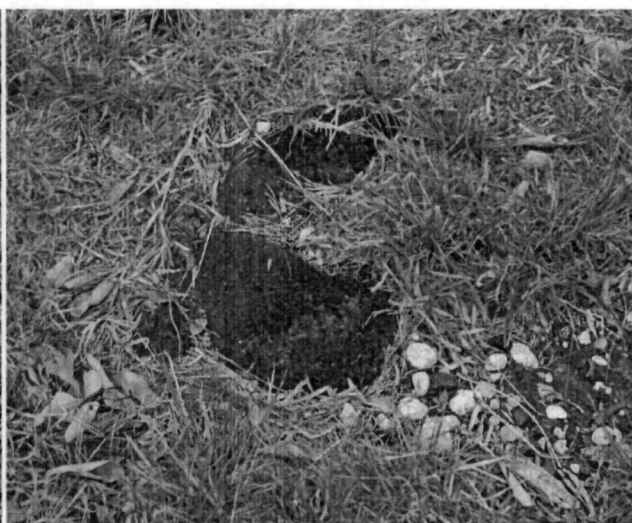
Photo 77. Possible slag/spent shot found in the cemetery.
