## **Five-Year Review Report**

**Third Five-Year Review Report**

Dixie Oil Processors Superfund Site Harris County, Texas

September 2008

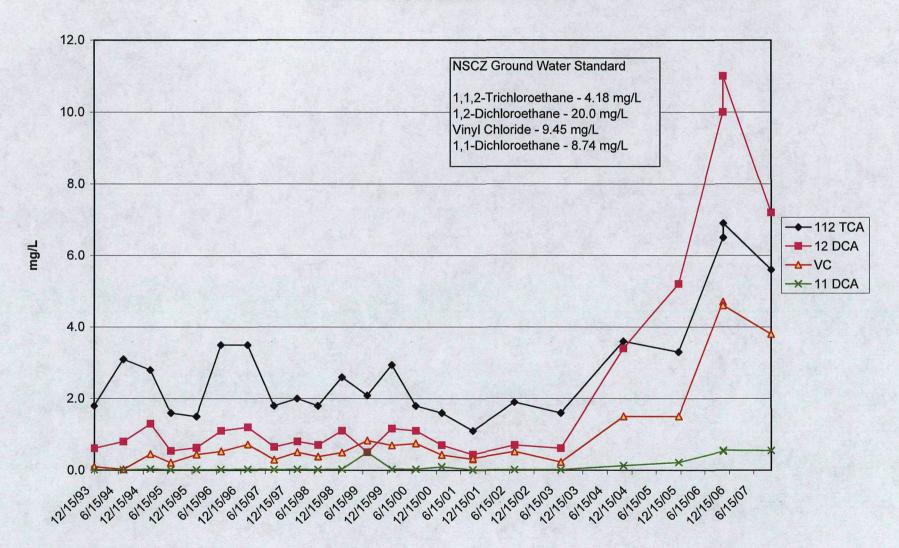
Figure 3
DOP NSCZ Groundwater Well MW 35A

Annual monitoring has shown increasing concentrations of chlorinated organics in one site monitoring well during the five-year review period. The origin of the contaminated ground water is the adjacent Brio Refining site and does not impact the protectiveness of the site remedy.

Recommendations	Party	Oversight	Milestone	Affects Protectiveness? (Y/N)	
Issue	Follow-up Actions	Responsible	Agency	Date	Current	Future
Increasing level of contaminants in NSCZ at DMW-35A.	Continue annual groundwater sampling. Ensure that the Brio site Mud Gully sampling program captures any impacts to the stream from discharge of NSCZ ground water.	DOP Task Force/Brio Site Task Force	ЕРА	Annual Effectiveness Report	N	N

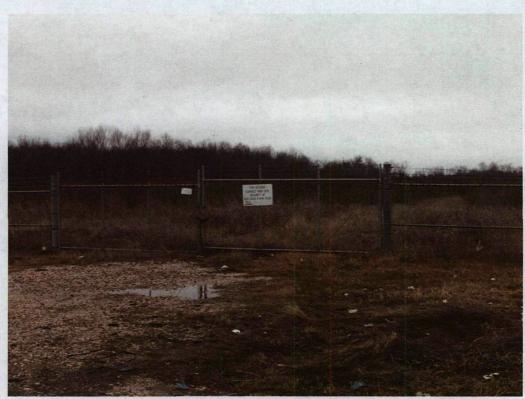
Picture 1: Locked gate at entrance to DOP North

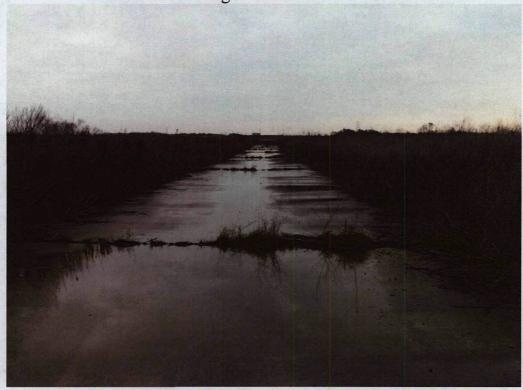
Picture 2: Center drainage swale on DOP North

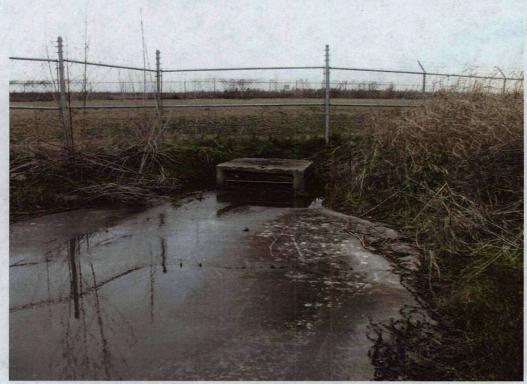
Picture 3: South collection drain on DOP North

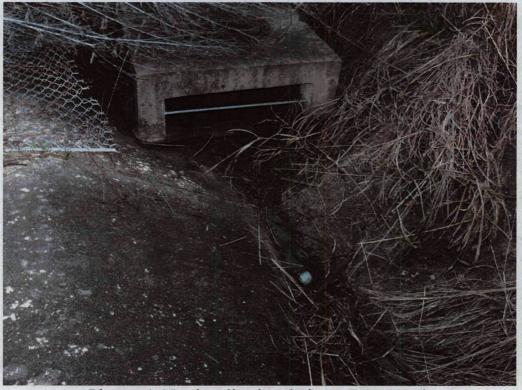
Picture 4: North collection drain on DOP North

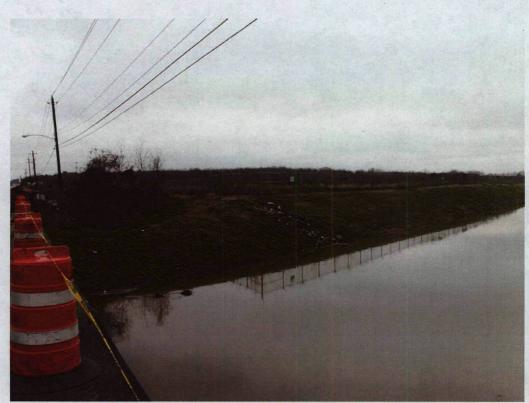
Picture 5: DOP North from Dixie Farm Road

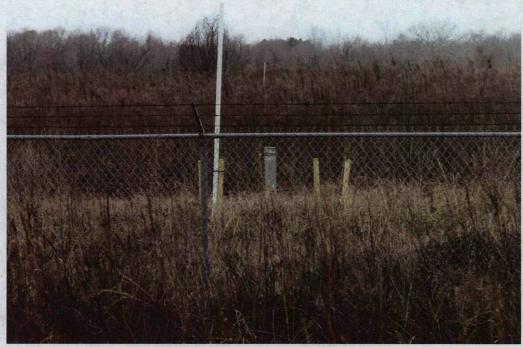
3.	Monitoring Wells (within surface area of landfill)  √ Properly secured/locked Functioning √ Routinely sampled √ Good condition  ■ Evidence of leakage at penetration ■ Needs Maintenance ■ N/A  Remarks

Picture 6: Monitor well on DOP North

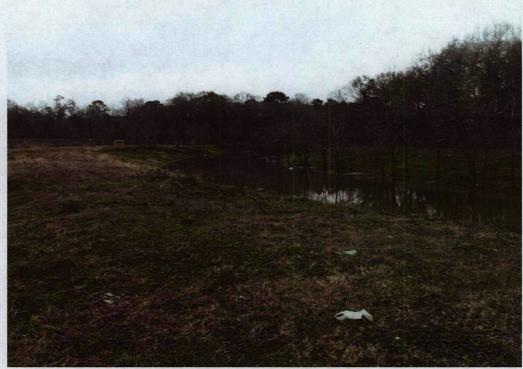
Picture 7: Mud Gully along DOP South
