September 24, 2009

Subject: Completed Actions and Proposed Vents  
Leon Valley Veterinary Clinic  
6701 Bandera Road  
Leon Valley, Texas

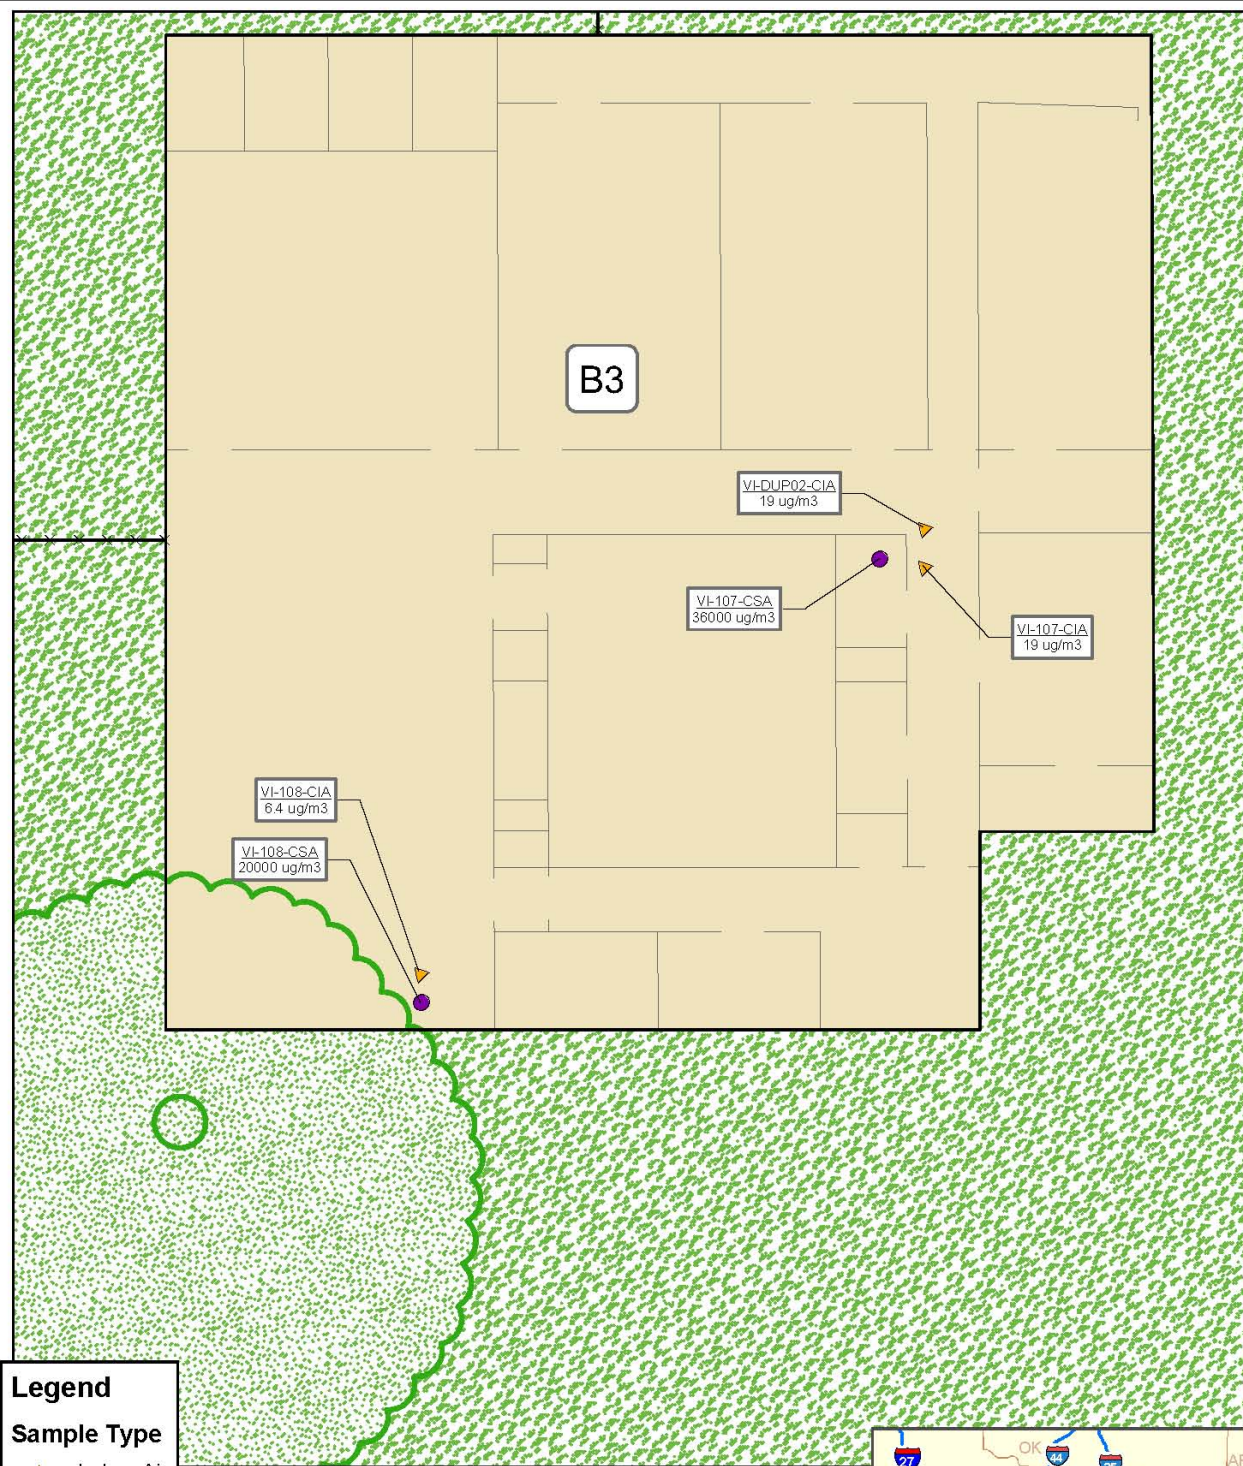
FIG. 3

The United States Environmental Protection Agency (EPA) has conducted testing of the indoor air space at the Veterinary Clinic. The EPA has also tested soil vapor beneath the slab of the building. This testing revealed that concentrations of perchloroethene (PCE) in two indoor air samples at the Veterinary Clinic were 6.4 and 19 ug/m<sup>3</sup>. The concentrations of PCE in two soil vapor samples from beneath the slab were 20,000 and 36,000 ug/m<sup>3</sup>. This testing was conducted by EPA in January 2009. A figure showing the testing locations is presented on Figure 3. A summary of the testing is presented on Table I.

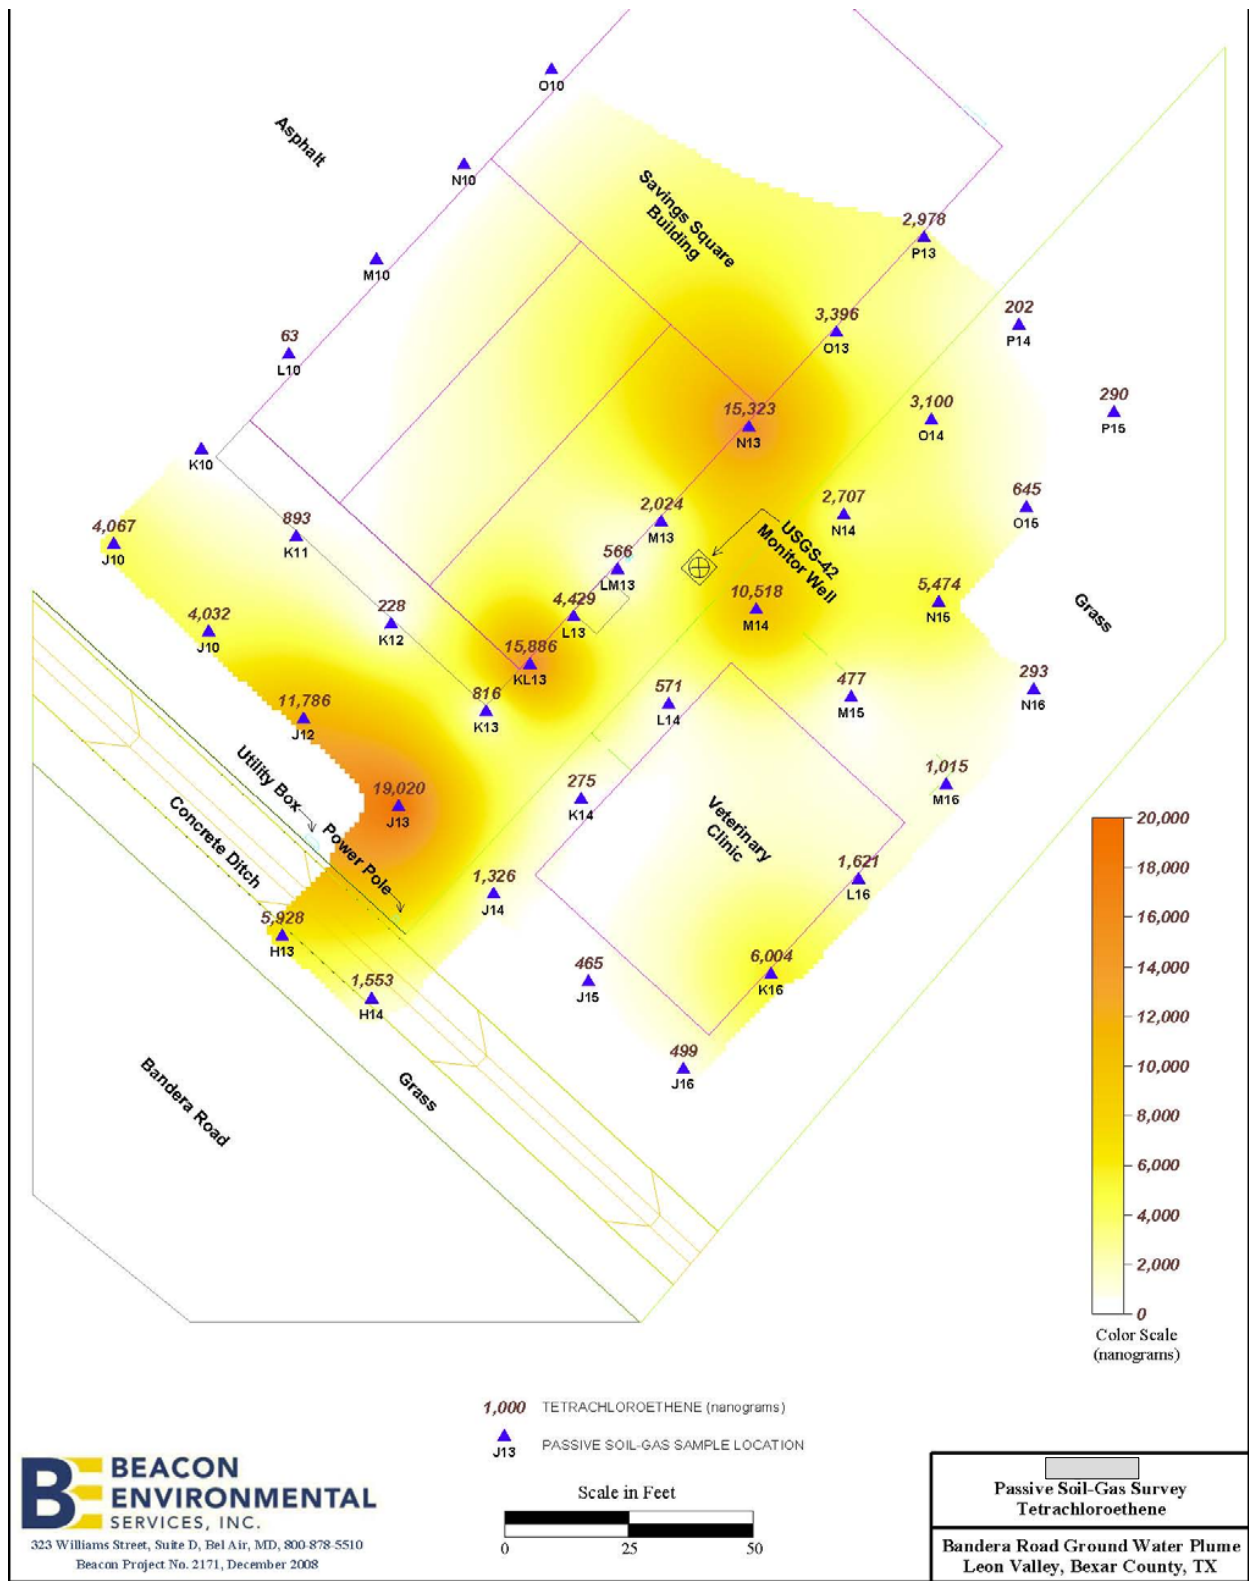
FIG. 4

The EPA also conducted a passive soil vapor survey on the Vet Clinic Property and adjoining property in November 2009. A summary of this testing is shown on Figure 4.

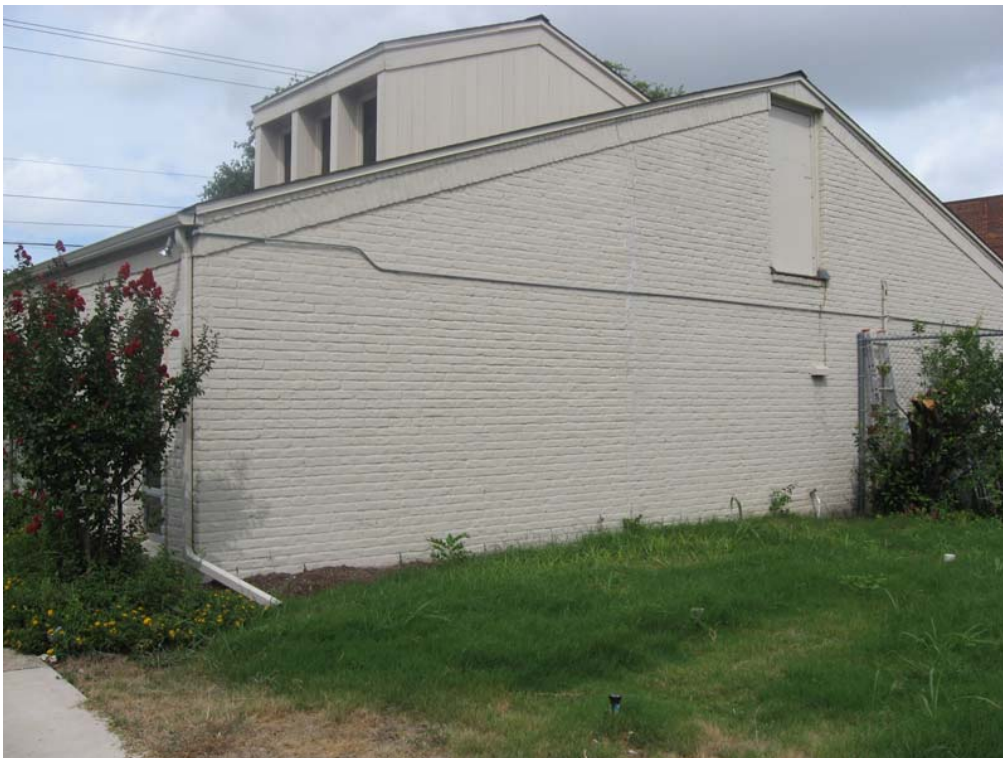
**PHOTO 4: Northern side of the Veterinary Office. It is proposed that SSD Vent 4 will be attached to this wall near the crack in the brick veneer.**

It is proposed that vapors will be withdrawn from the subsurface at two vent locations. One vent will be located near the crack in the north brick wall and the other vent will be located where the sewer line exits the slab. These locations, designated SSD Vent 3 and SSD Vent 4, are shown on Figure 2.

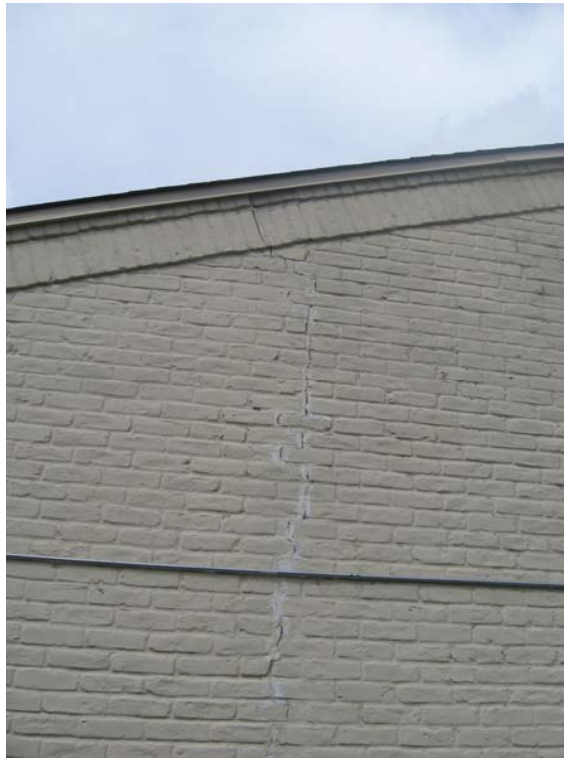
Organic vapor concentrations at weep hole locations in June 2009 were highest on the north side of the building where a crack in the brick veneer wall was evident (See Photographs 5 and 14 in Appendix A).

**PHOTO 5:** This photo shows the crack in the brick veneer on the northern side of the Veterinary Clinic.

1. Near the crack in the brick veneer on the north wall of the lease space.
2. On the northwest corner of the building where it is suspected the main sewer line exits the building and flows to the public system.

The area near the crack in the north brick veneer wall is targeted because this area may be a focal point for sub-slab vapors to escape and enter the indoor air. The sewer line exit point is targeted because permeable backfill around the sewer line could also serve as a collection point for vapor. If organic vapors do indeed accumulate in sewer back fill, withdrawal of vapors in this area could potentially reduce organic vapor concentrations throughout the sub-slab where backfill is located. Withdrawal of vapors in sewer backfill also appeared to be successful at reducing indoor air concentrations at the adjoining property where vapor mitigation<sup>3</sup> has already taken place.

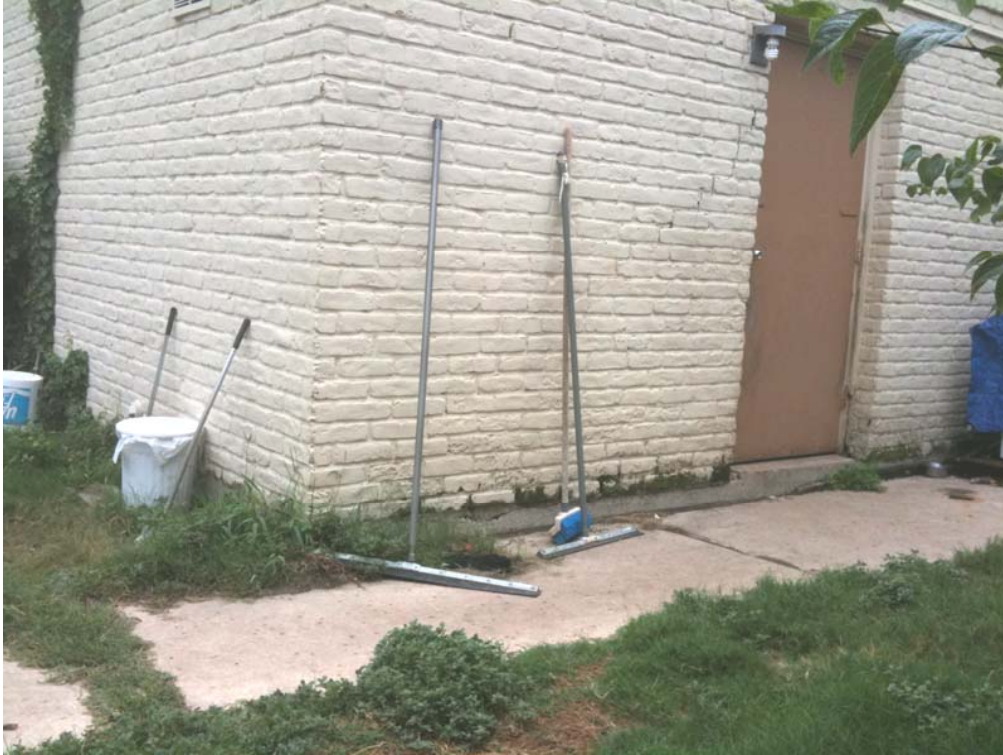
**PHOTO 13:** This photo shows rear (west) door of the Vet Clinic and the proposed area where SSD Vent 3 will be installed.

Provided the sewer line locations shown on Figure 7 are confirmed by the camera inspection, a smaller liner will also be placed around SSD Vent 3. This liner will be placed in areas within a 5 foot radius of the vent where grass is present. This smaller liner area is shown on Figure 7.

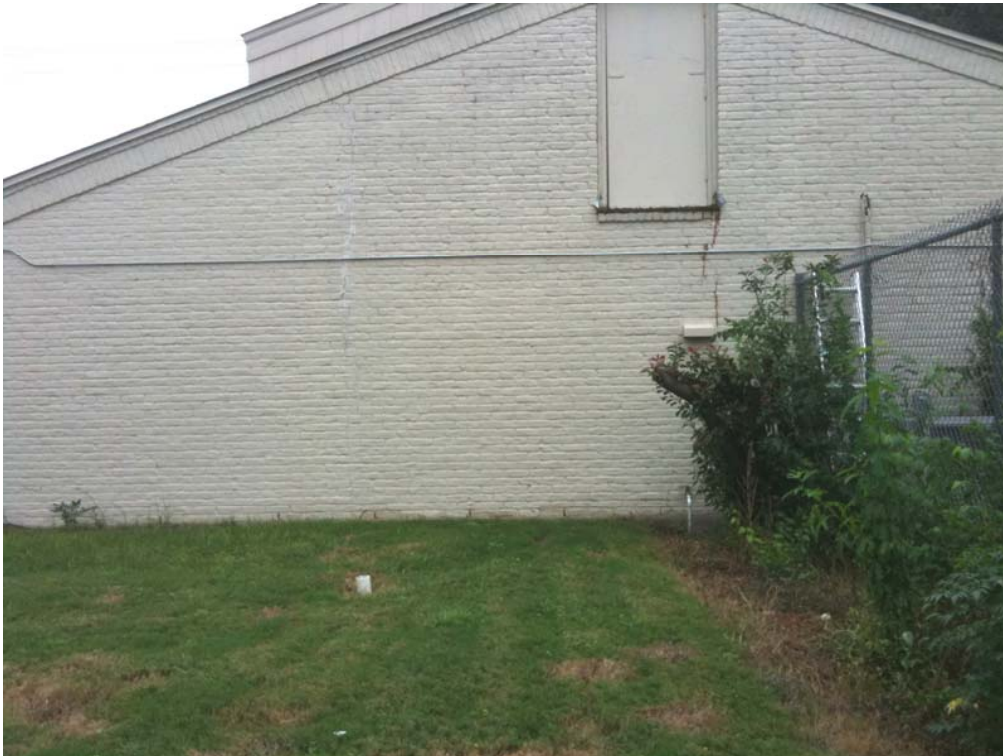
**PHOTO 14:** This photo shows north wall of the Vet Clinic and the proposed area where SSD Vent 4 will be installed.

To potentially enhance vapor withdrawal from under the slab, a plastic liner will be placed in a 5 foot radius around SSD Vent 4. The liner is designed to minimize the infiltration of ambient air and focus withdrawal of vapors from beneath the slab and sewer backfill areas. Depth of the liner will be at least 1 foot below surface to allow vegetative growth. Thickness of the liner will be 40 mil.
