## **Five-Year Review Report**

### **Second Five-Year Review Report for the Vertac Incorporated Superfund Site Jacksonville, Pulaski County, Arkansas**

**November 2003**

**CH2M HILL  
Contract Number 68-W6-0036  
Work Assignment Number 119-FRFE-0604**

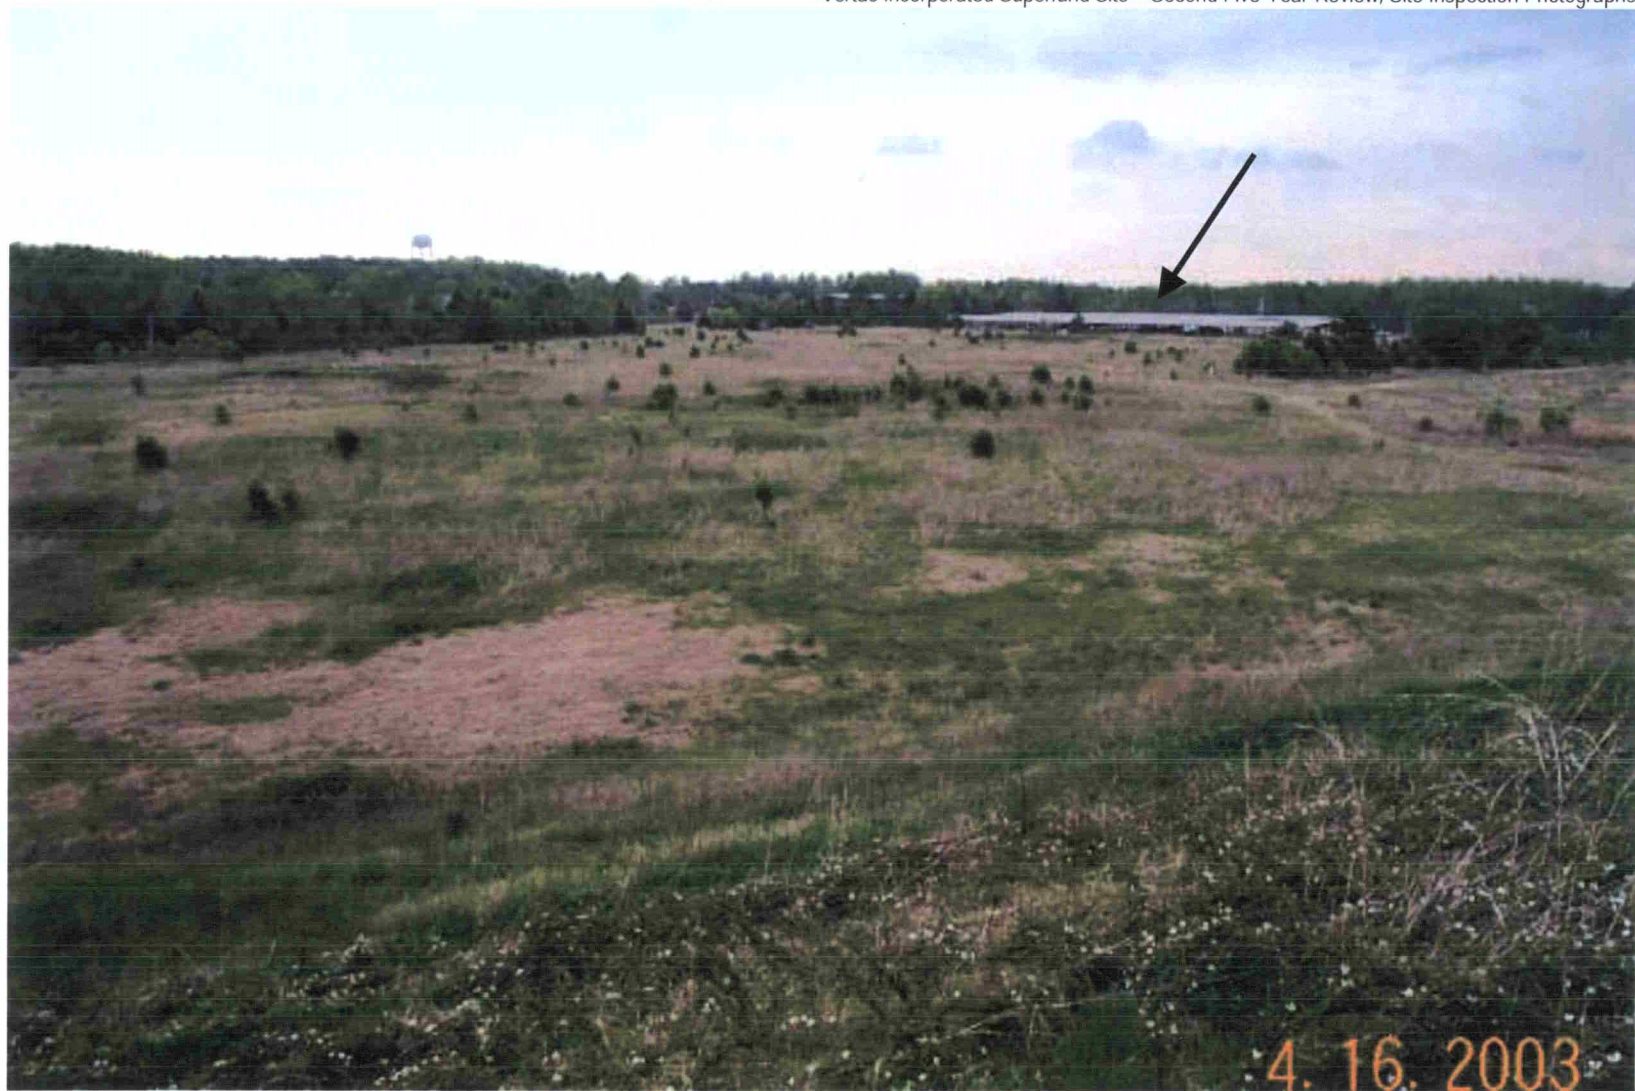
[filename: VI\_DCP 4109.jpg]

Photo 6: View across the North Burial Area from Sedimentation Vault (Mt. Vertac), facing north. Note trees growing on top of cap. Shed in background (at arrow) is a former storage shed used to store drums as part of the incineration (now used by City as part of recycling center).

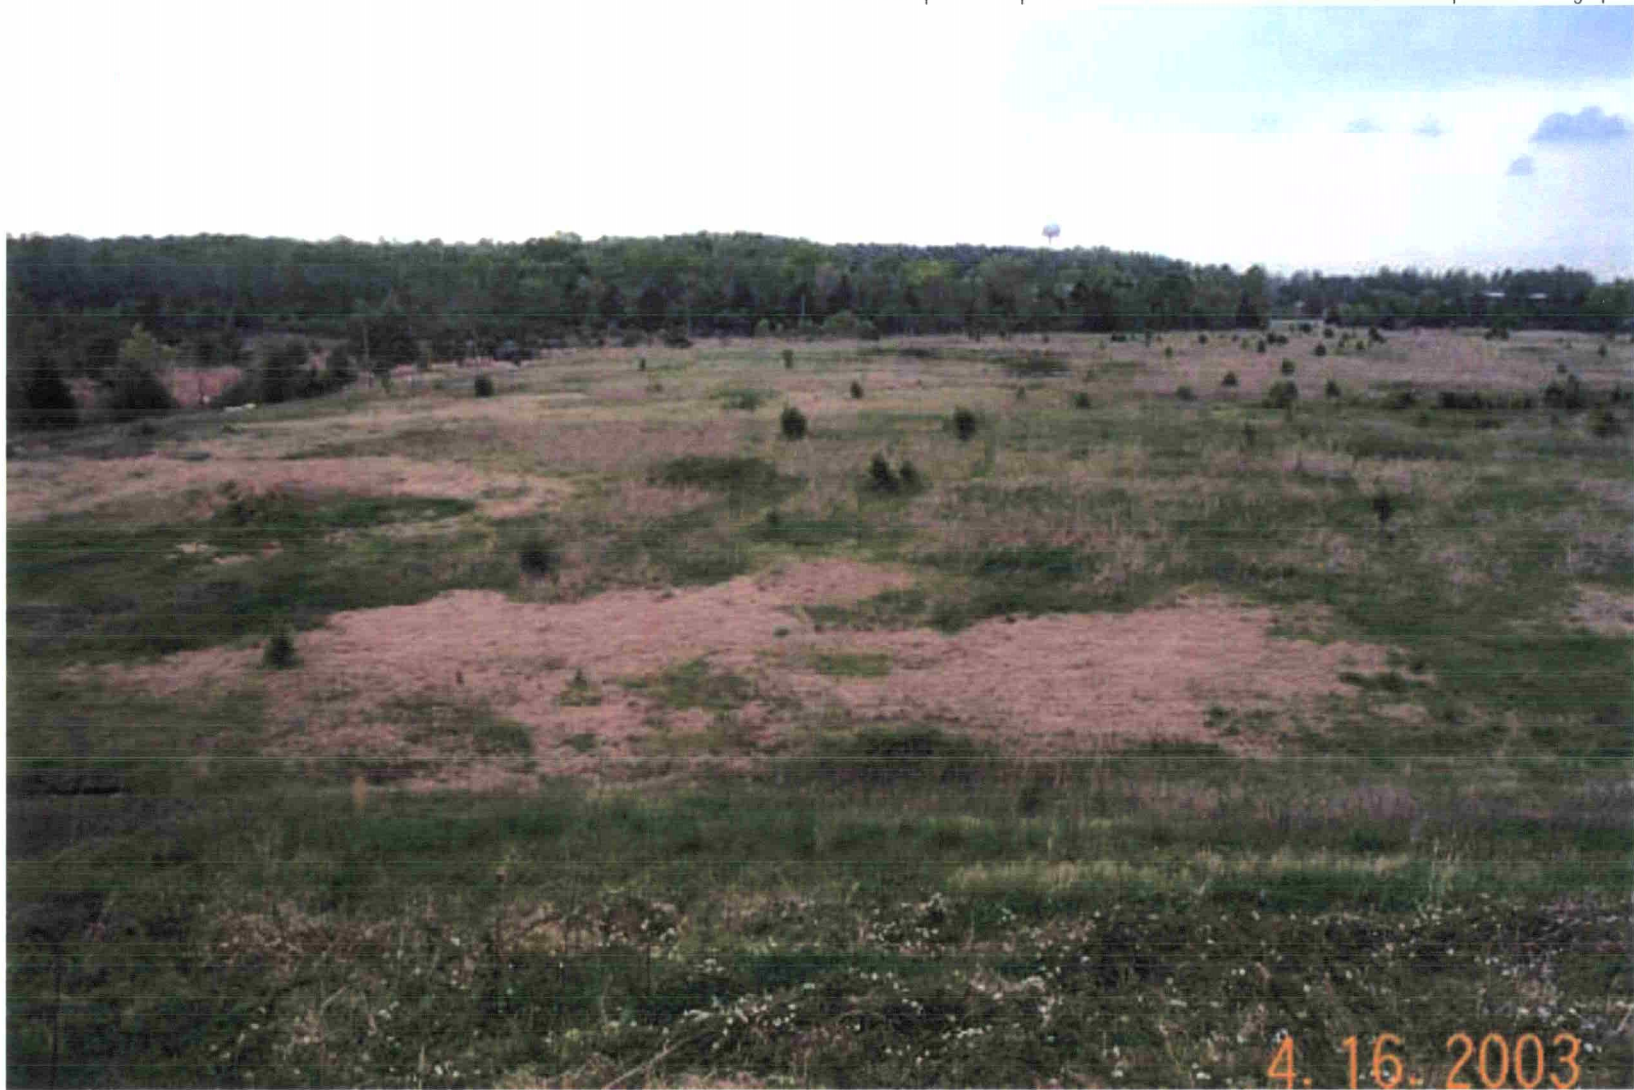
[filename: VI\_DCP 4110.jpg]

Photo 7: View across the North Burial Area from Sedimentation Vault (Mt. Vertac), facing north. Note trees growing on top of cap.

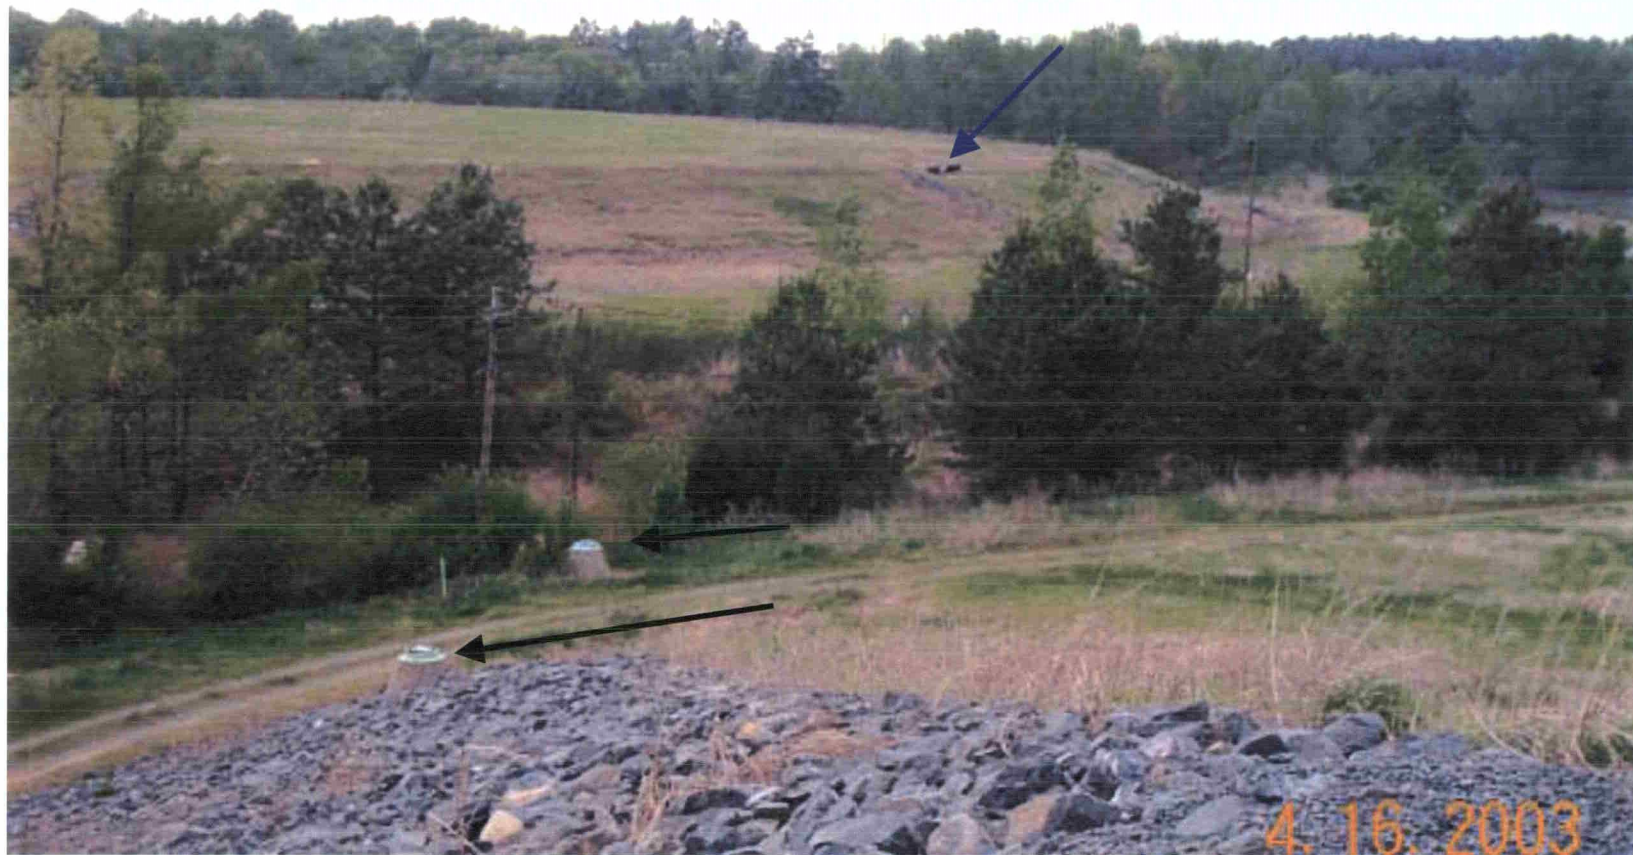
[filename: VI\_DCP 4112.jpg]

**3. Disparity in leachate volume between the north and south cells of the OU1 landfill.** At the time of the five-year review site inspection, the GEC operators indicated that a disparity in the volume of leachate was being observed between the north cell and the south cell of the OU1 landfill (with the north cell generating about 300 gallons a month, depending on rainfall amounts, which is significantly more leachate than is generated in the south cell). This caused the operators to suspect a leak in the top liner, although the landfill leachate collection system was able to adequately handle the increased volume.

Photo 9: View of the OU1 landfill from Mt. Vertac. View is to the northwest. Two sumps for the french drain are visible in the foreground (black arrows). The leachate collection and detection system sumps are visible on the landfill (blue arrow).

- 3. Document status of disparity in leachate volume between the north and south cells of the OU1 landfill.** Actions taken and recommendations for responding to the disparity in leachate volume between the north and south cells of the OU1 landfill should be documented in the next annual progress report for the site and reviewed by EPA and ADEQ.

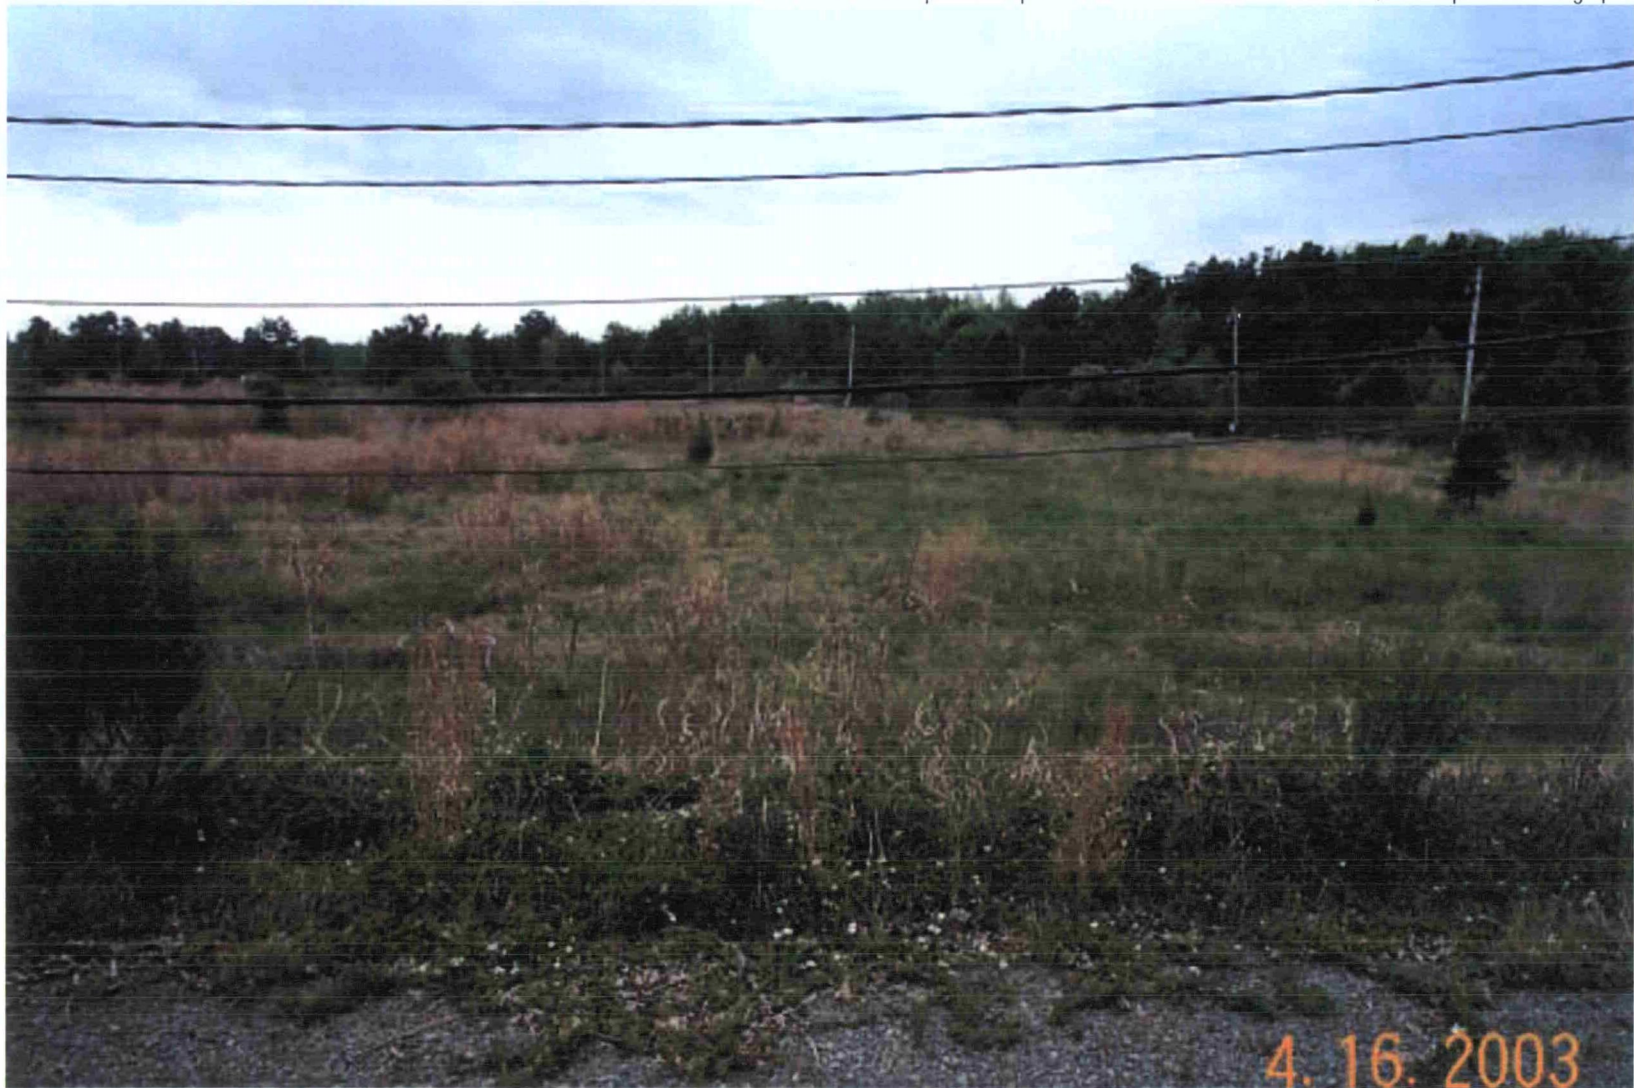
[filename: VI\_DCP 4120.jpg]

Photo 17: View of the Reasor Hill Burial Area. View is facing south. Note trees growing on the capped area.

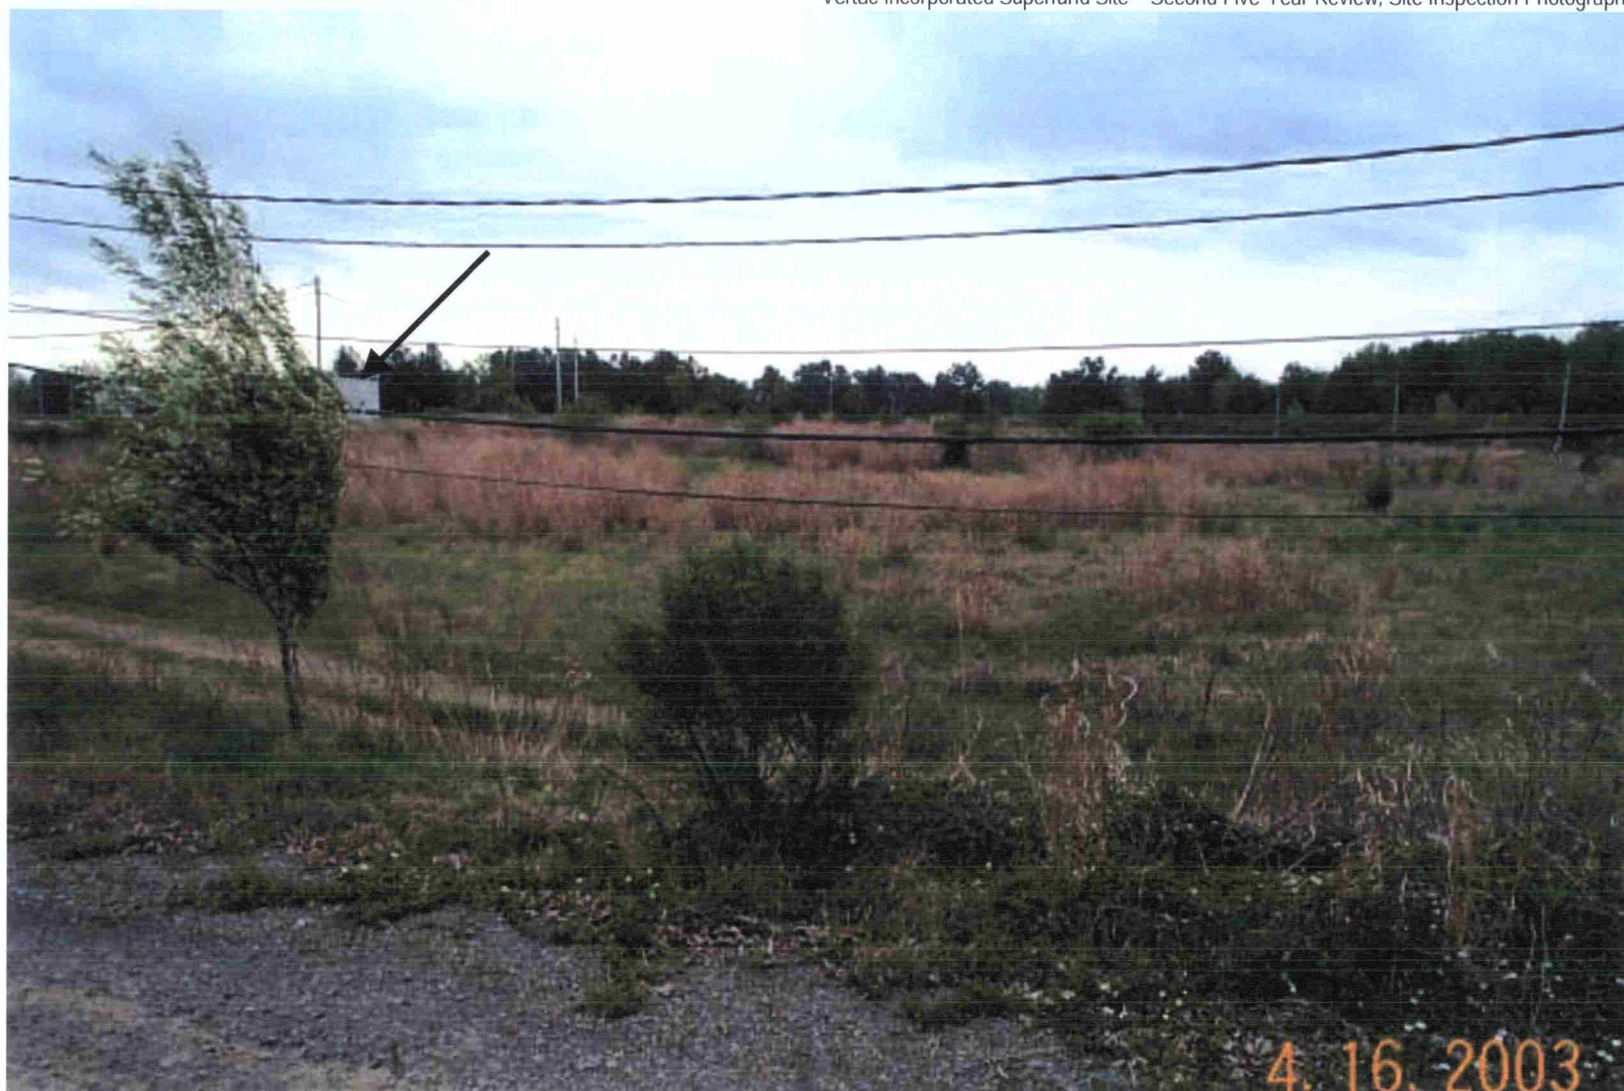
[filename: VI\_DCP 4121.jpg]

Photo 18: View of the Reasor Hill Burial Area. View is facing south. Note trees growing on the capped area. Building in background at left is the Wastewater Treatment Plant (at arrow).

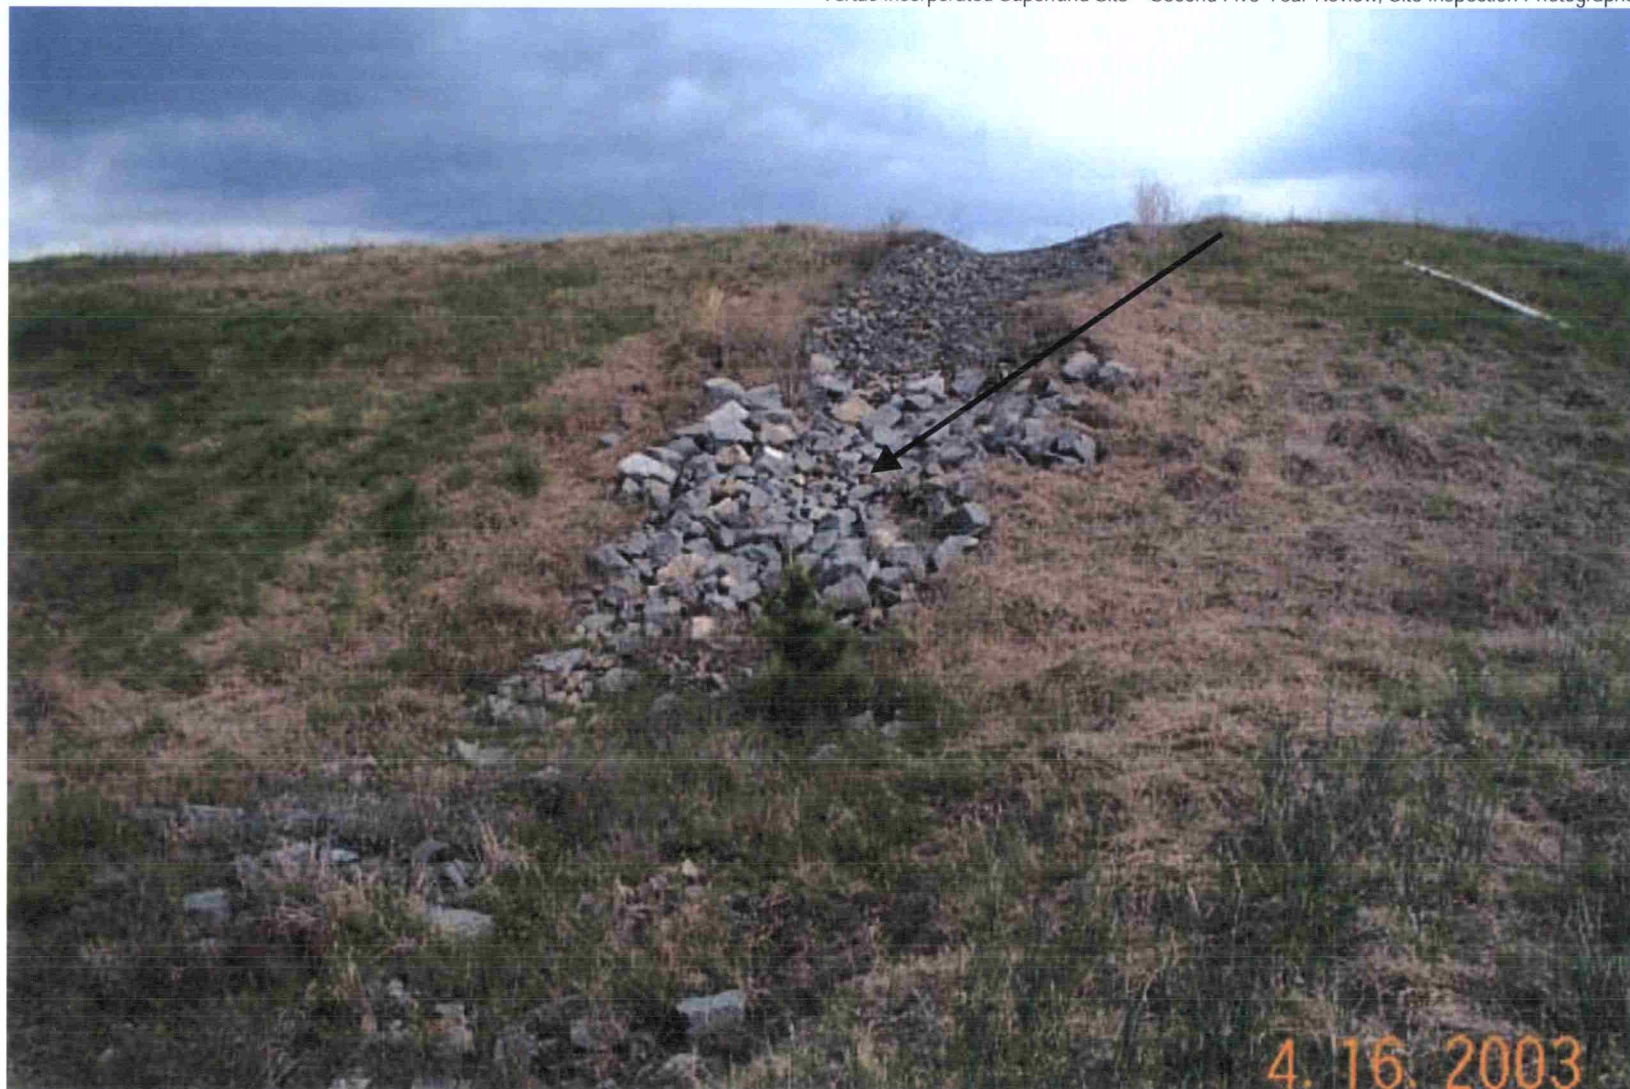
[filename: VI\_DCP 4124.jpg]

Photo 21: View of rock lined letdown channel (at arrow) at the OU1 landfill. These channels drain water from the top of the landfill cap.  
Note small tree growing along letdown channel in the center foreground.

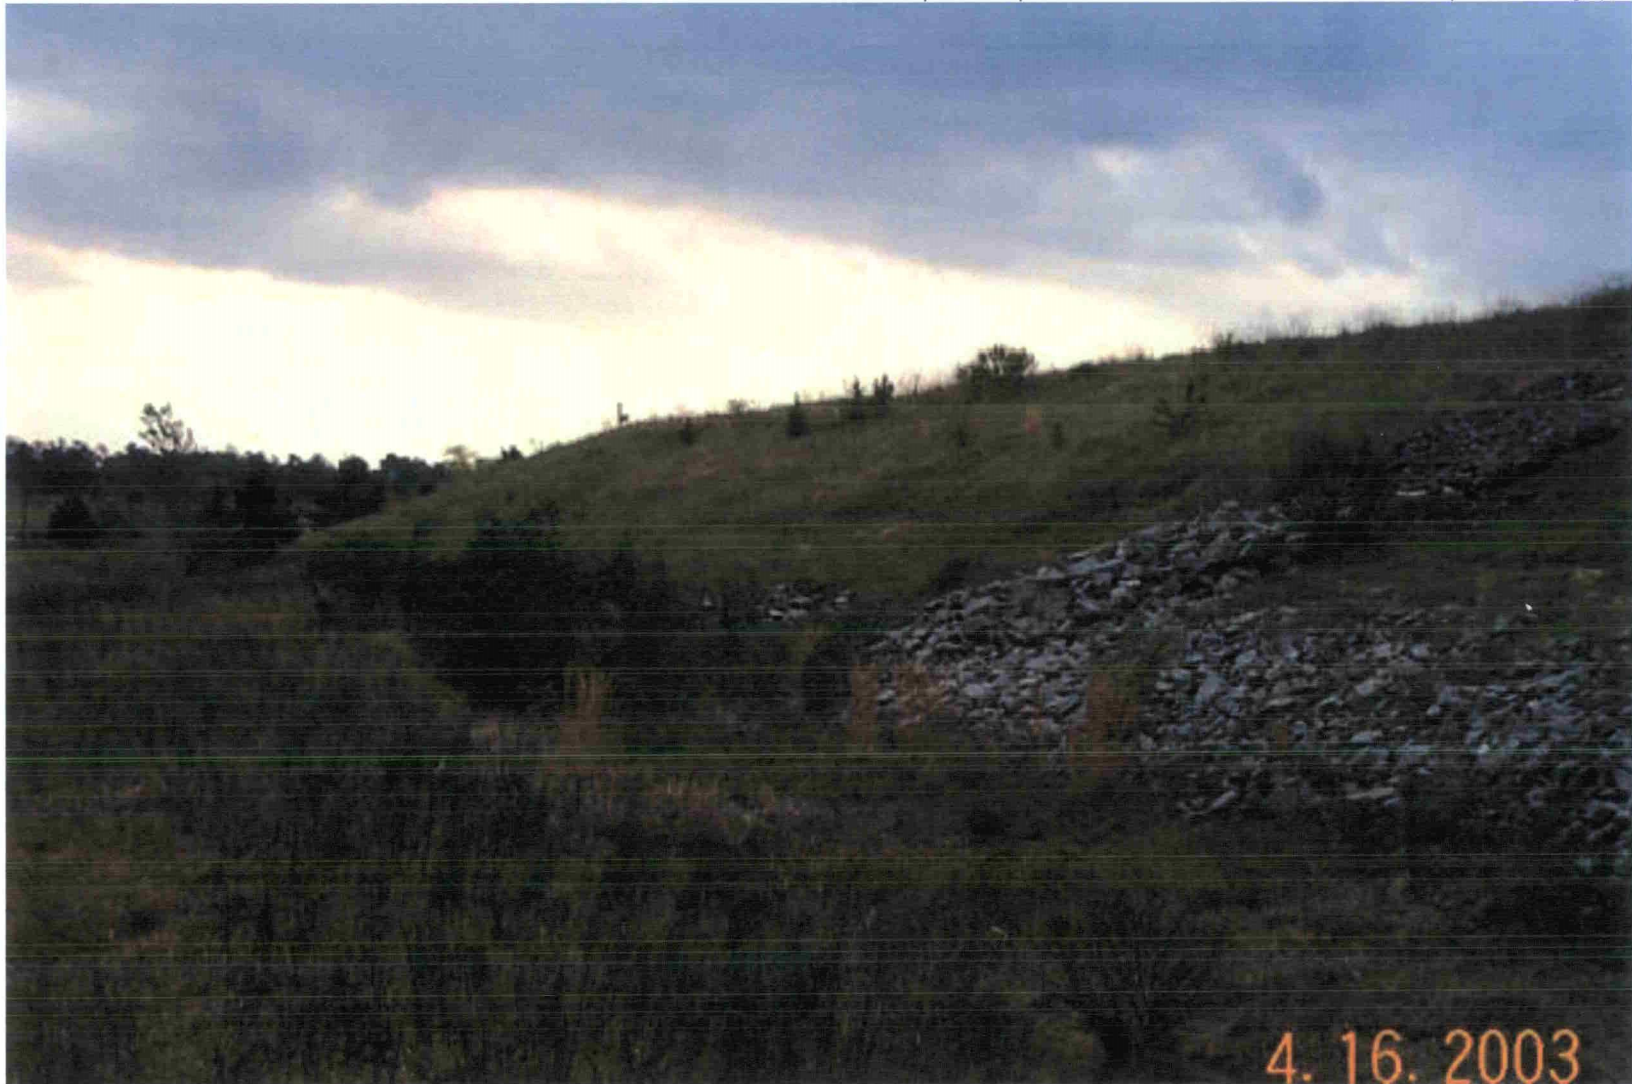
[filename: VI\_DCP 4128.jpg]

Photo 25: View of the east side of the OU1 landfill. View is facing south. Note small trees growing on the cap.

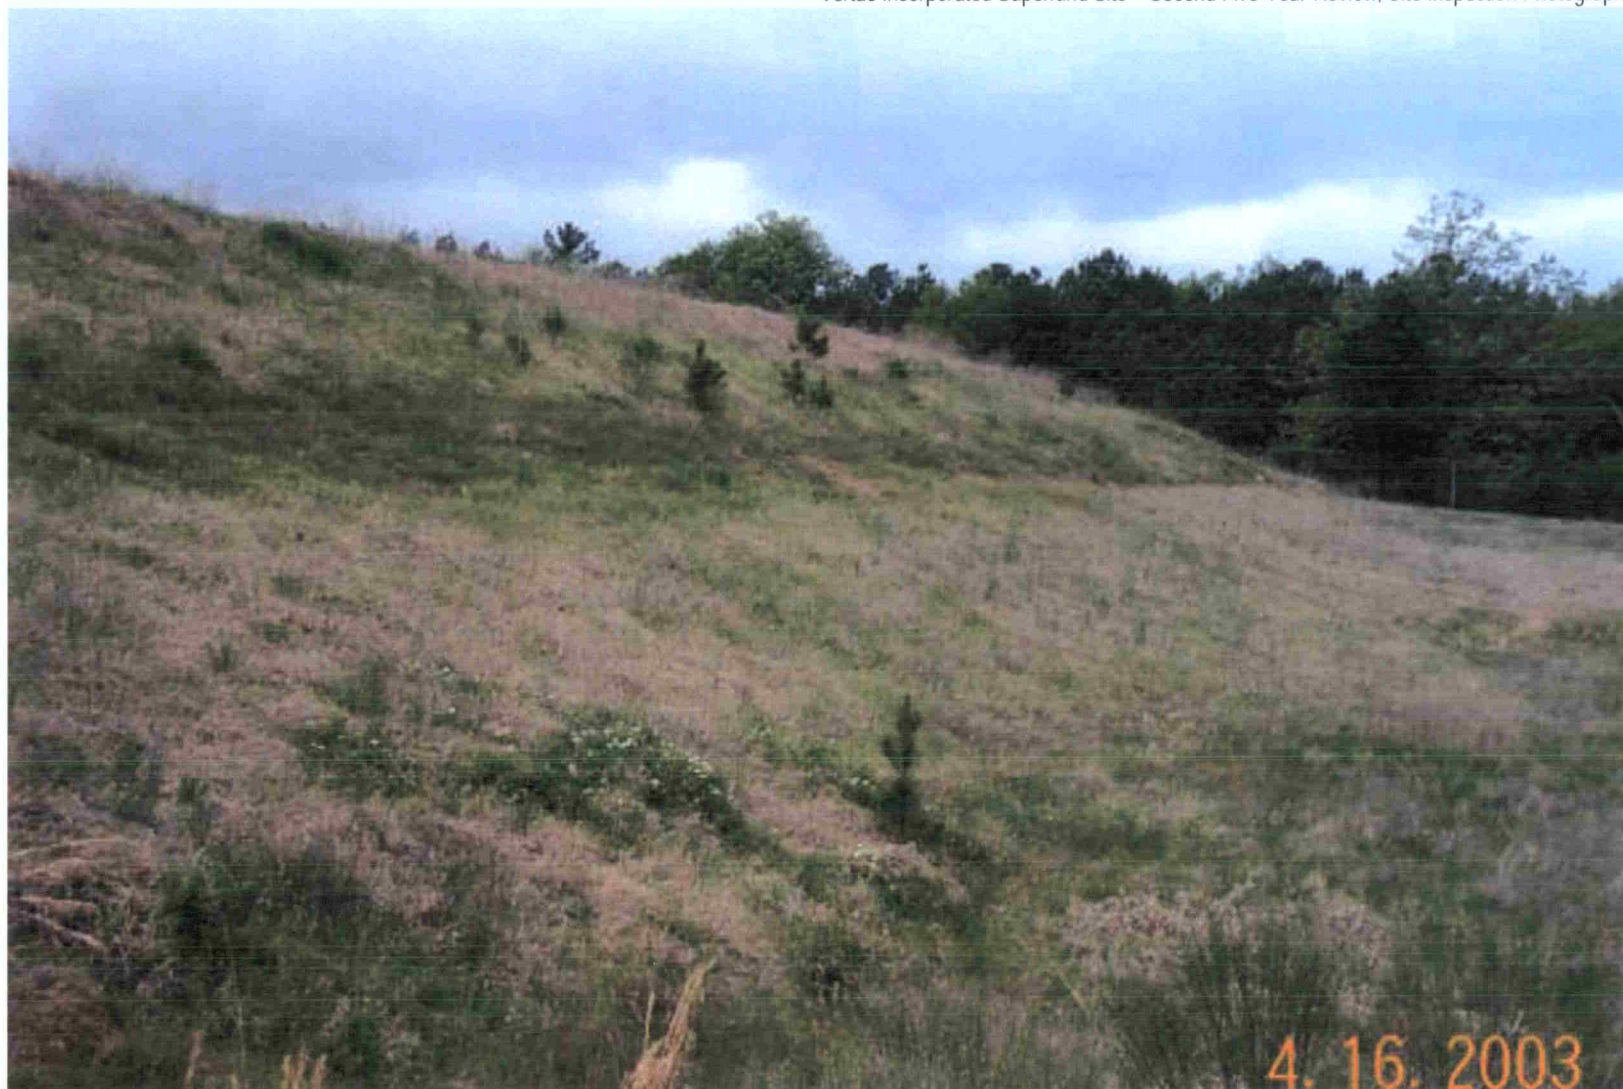
[filename: VI\_DCP 4129.jpg]

Photo 26: View of the north side of the OU1 landfill. View is facing west. Note small trees growing on the cap.

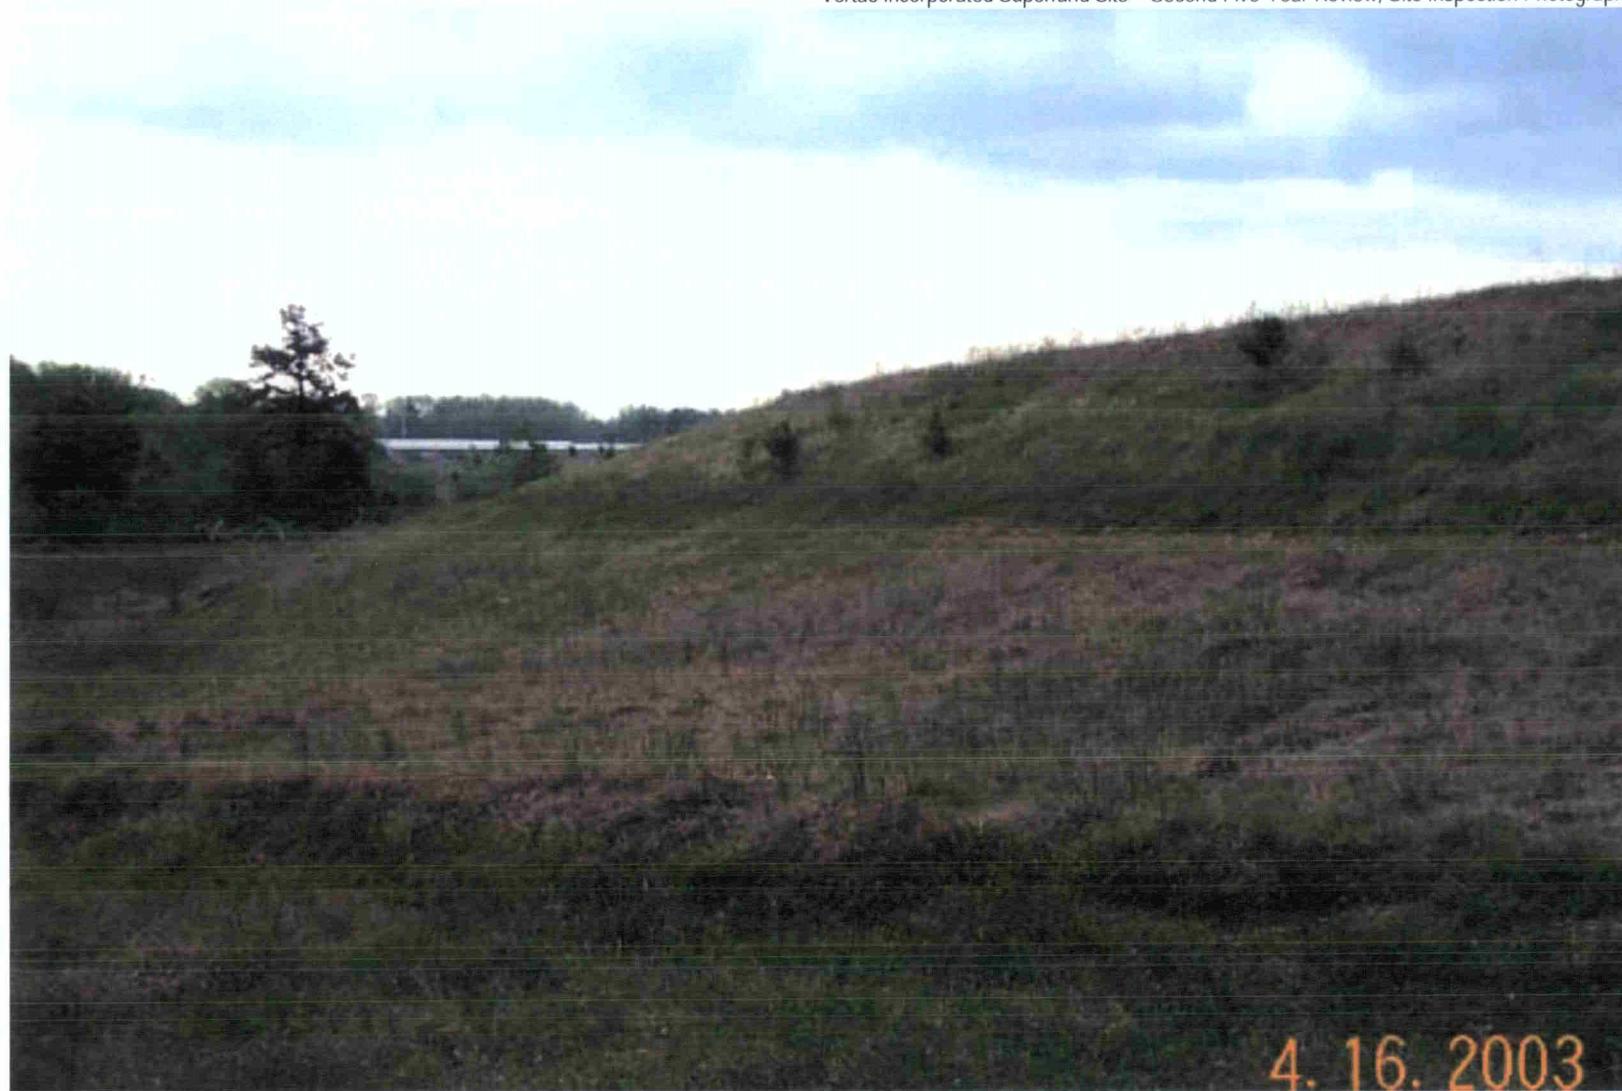
[filename: VI\_DCP 4130.jpg]

Photo 27: View of the north side of the OU1 landfill. View is facing east. Note small trees growing on the cap.

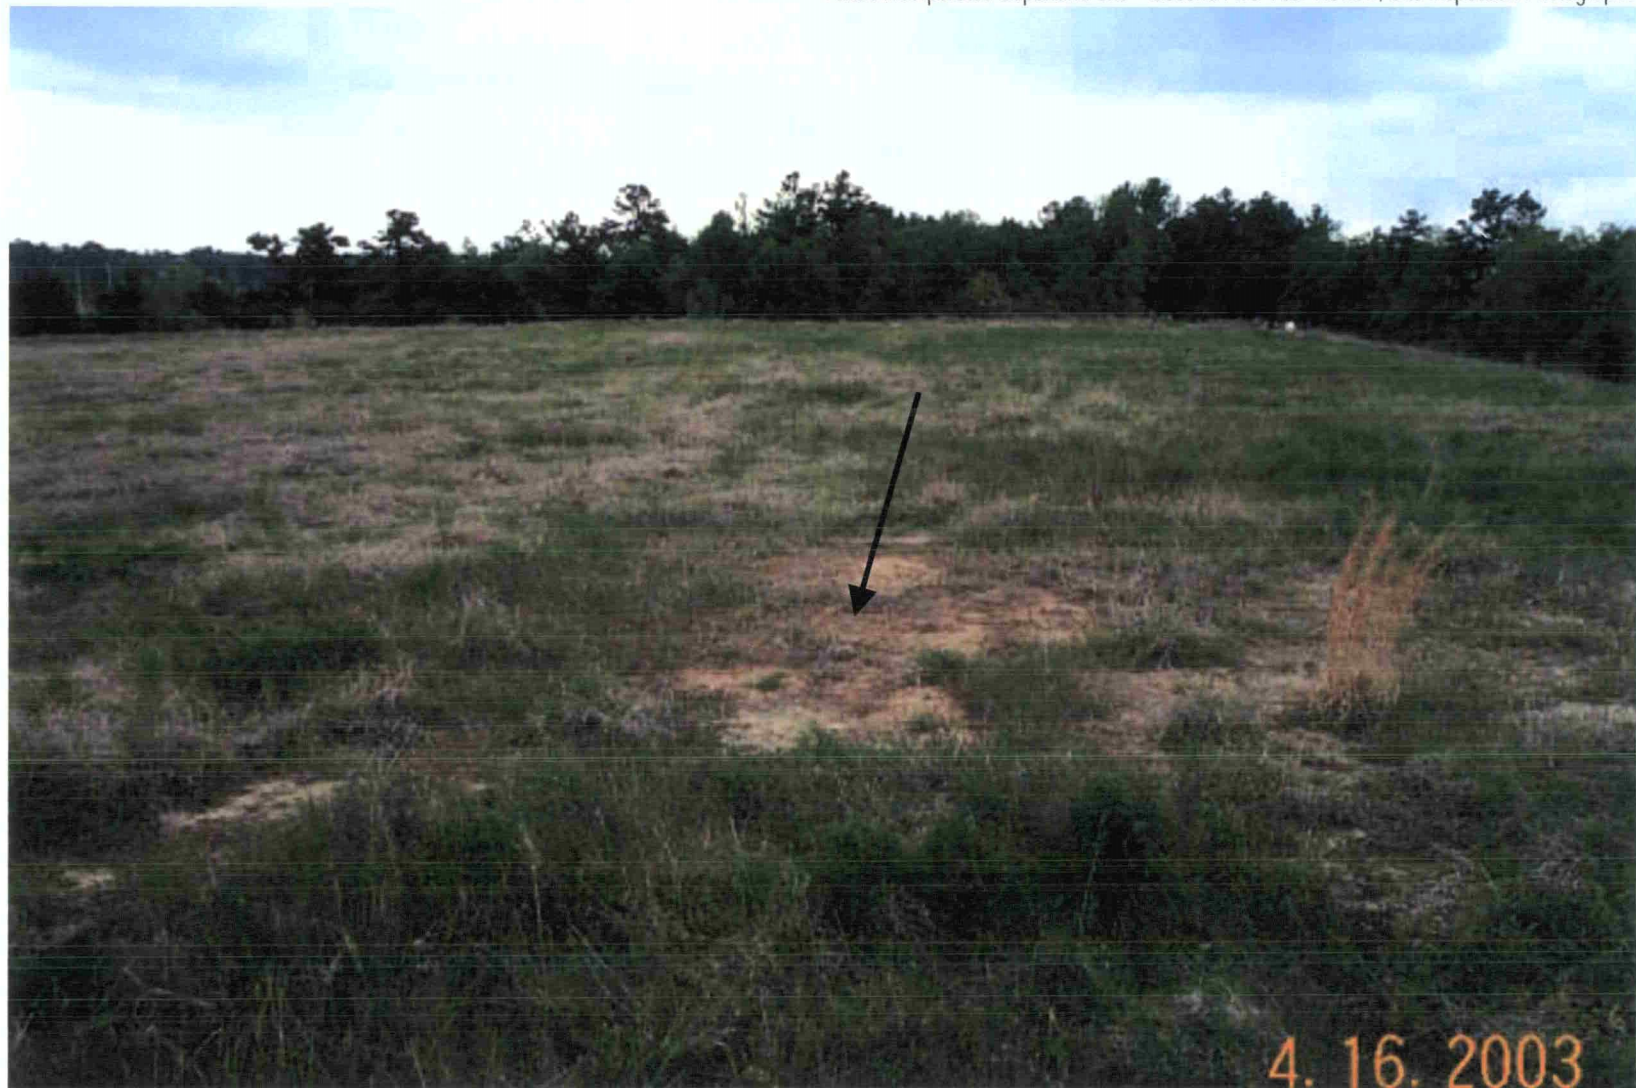
[filename: VI\_DCP 4131.jpg]

Photo 28: View of the top of the cap at the OU1 landfill. Note area of sparse vegetation (black arrow).

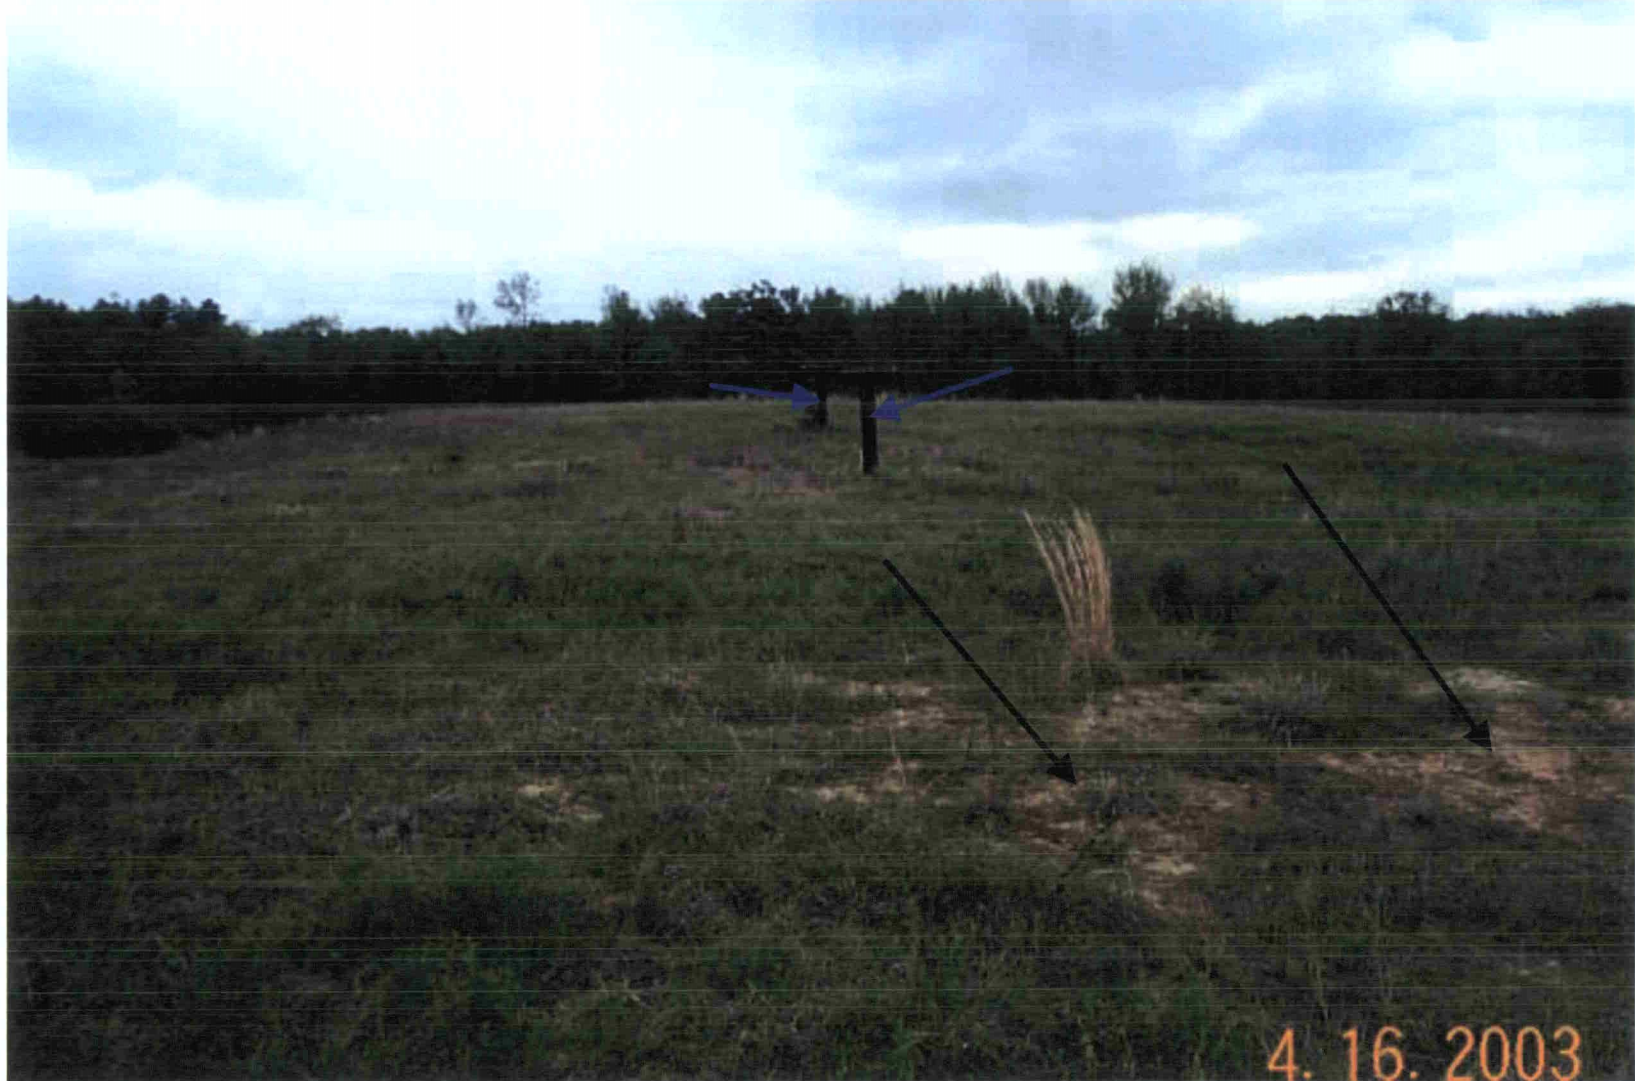
[filename: VI\_DCP 4132.jpg]

Photo 29: View of the top of the cap at the OU1 landfill. Note area of sparse vegetation (black arrow). Blue arrows are pointing to passive gas vents.

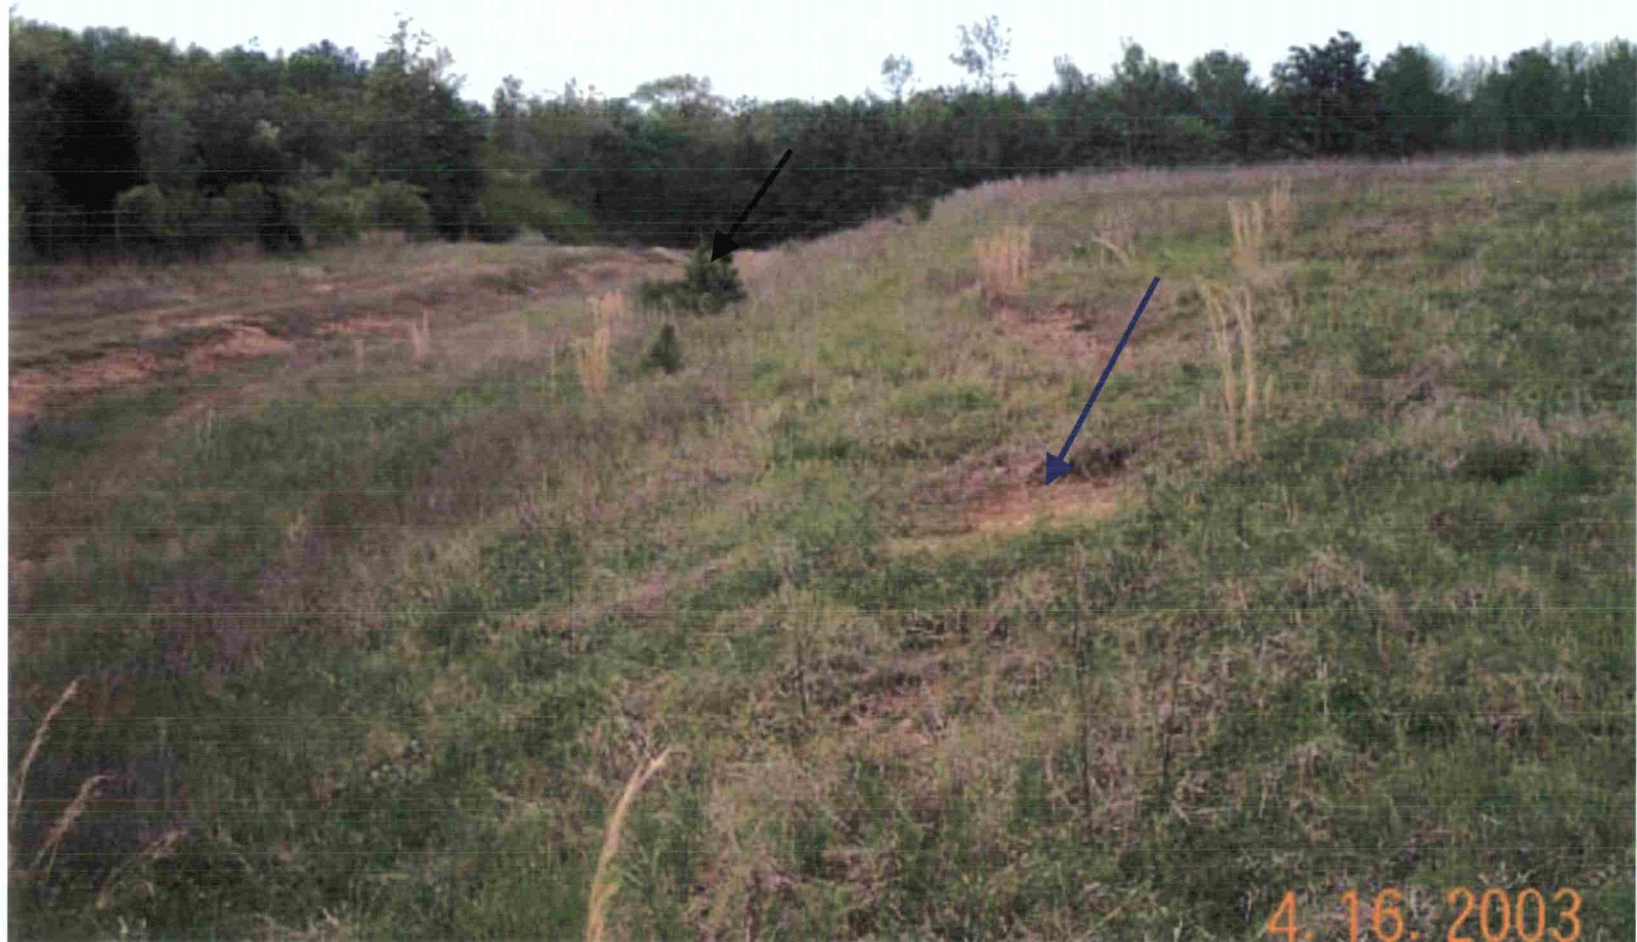
[filename: VI\_DCP 4133.jpg]

Photo 30: View of the west side of the OU1 landfill. View is facing north. Note small trees growing on the cap (black arrow) and area of sparse vegetation (blue arrow).
