## **Five-Year Review Report**

### **Second Five-Year Review Report for the Vertac Incorporated Superfund Site Jacksonville, Pulaski County, Arkansas**

**November 2003**

**CH2M HILL  
Contract Number 68-W6-0036  
Work Assignment Number 119-FRFE-0604**

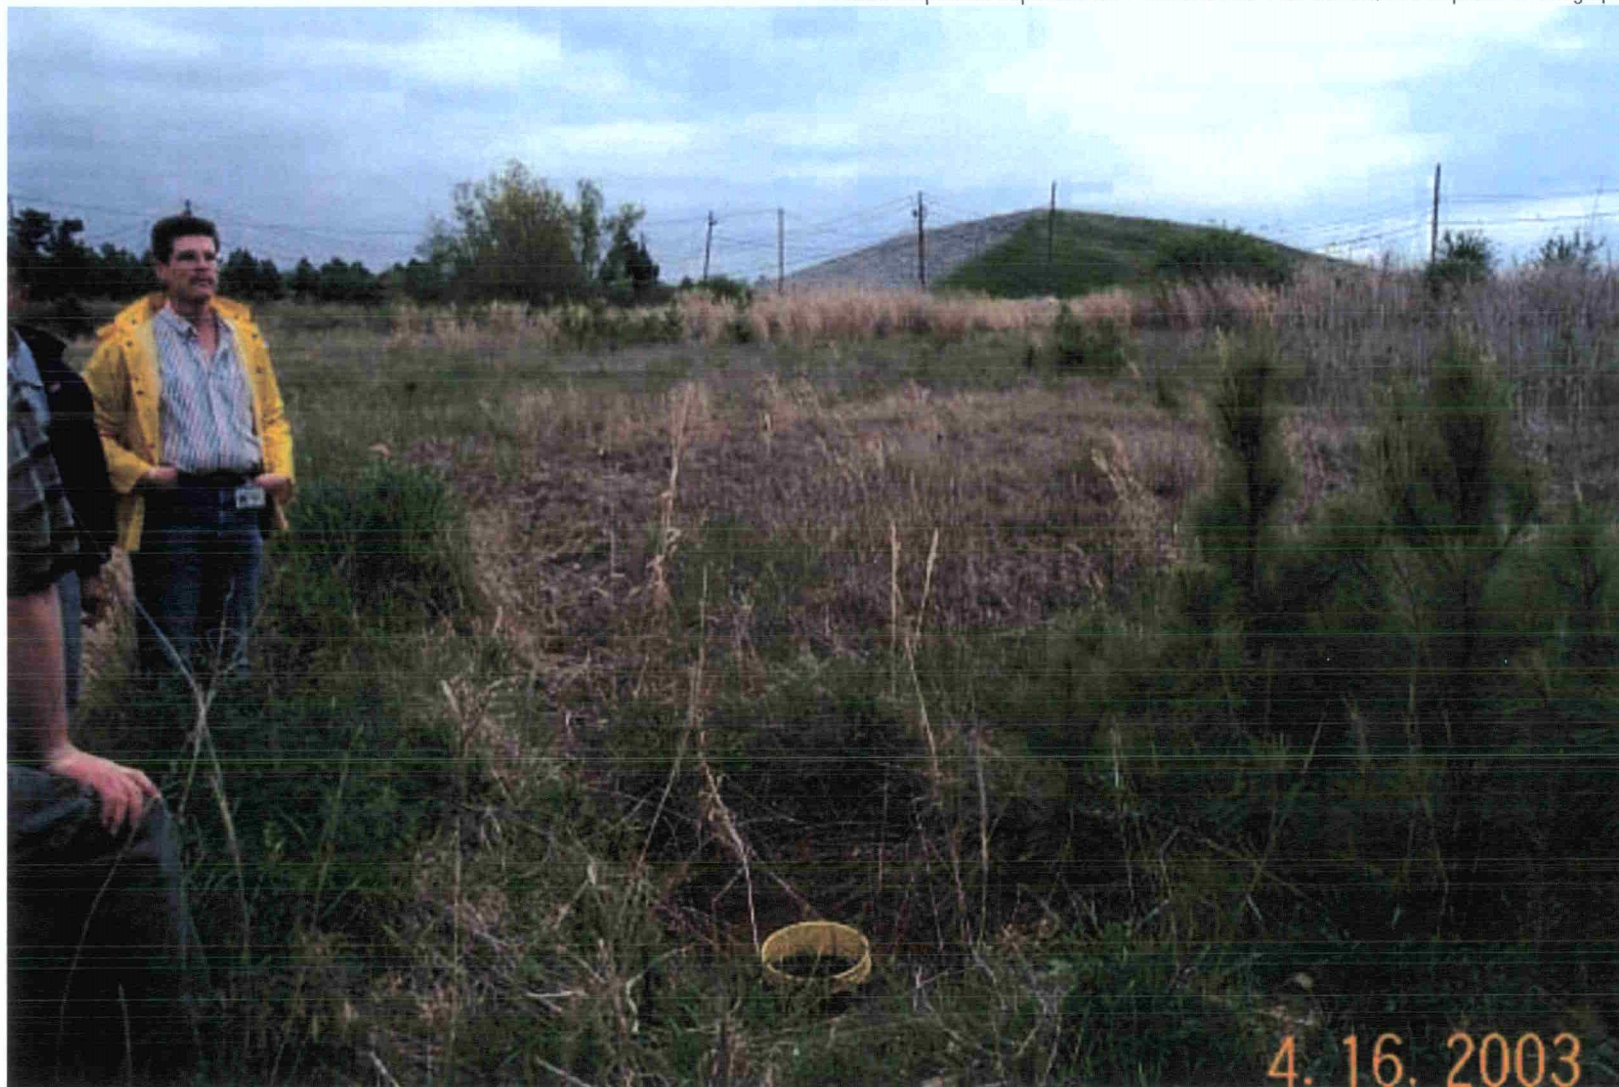
[filename: VI\_DCP 4134.jpg]

Photo 31: View facing north toward Mt. Vertac, across Reasor Hill Burial Area in center of photo. Yellow bucket is sump installed to collected observed surface seep.

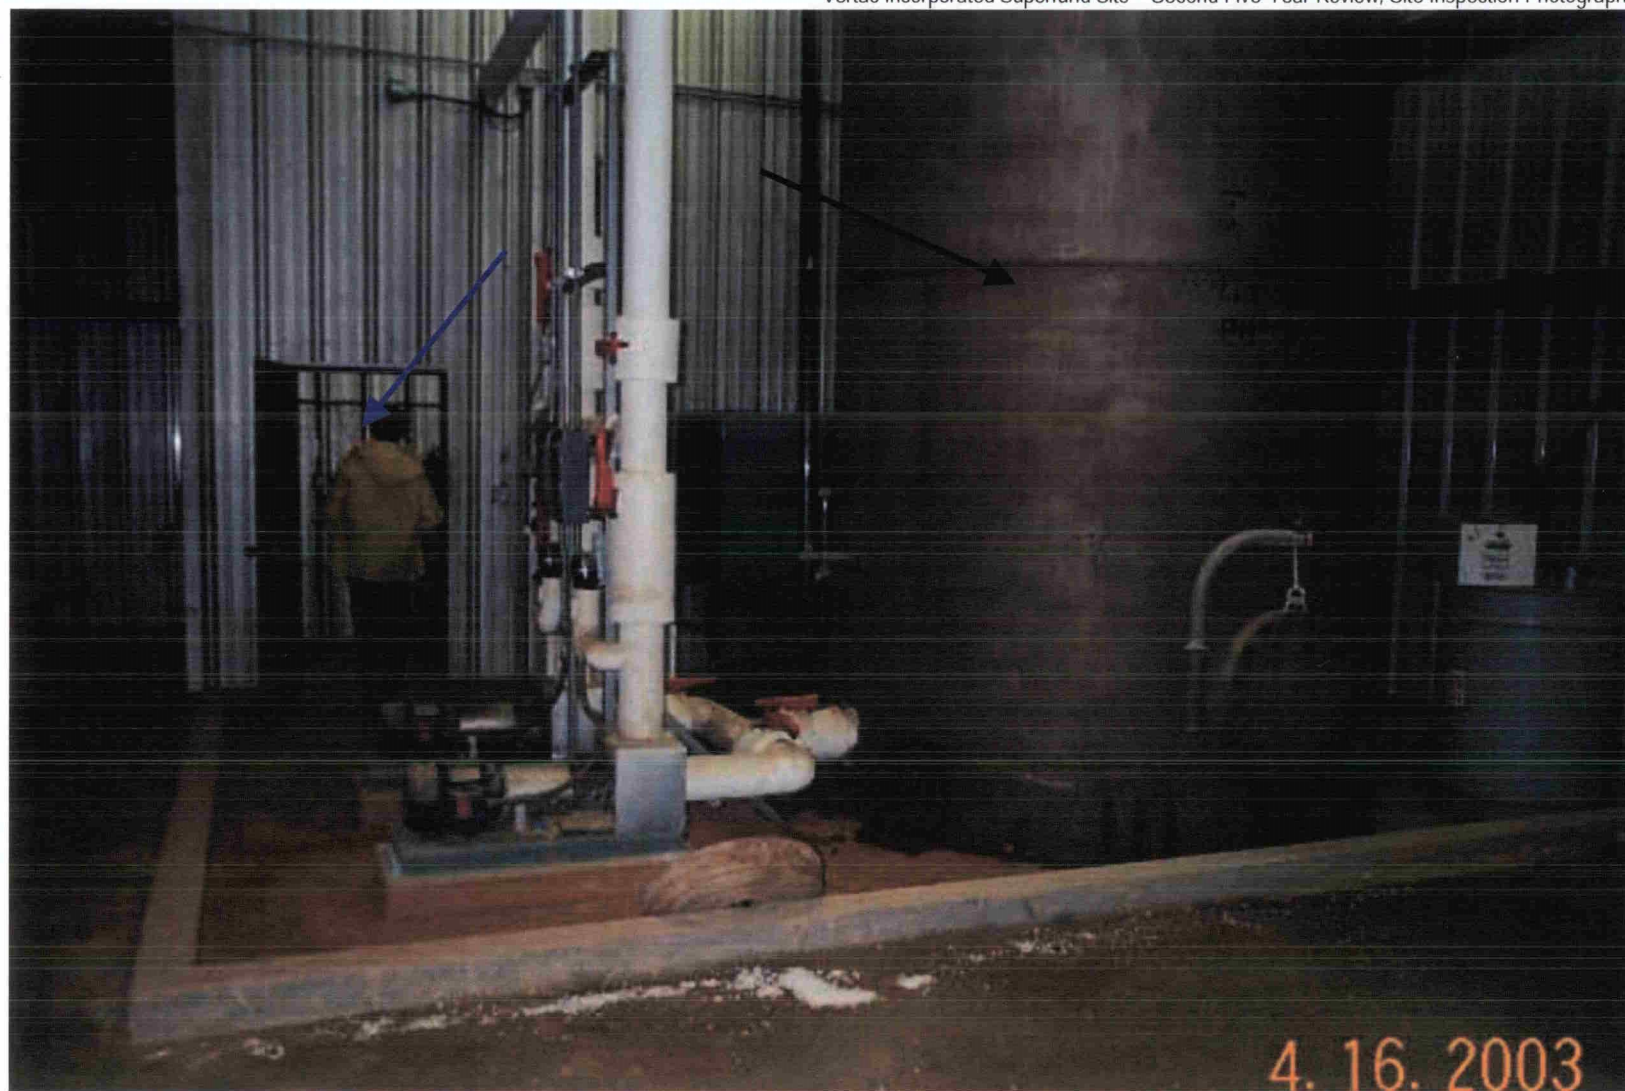
[filename: VI\_DCP 4146.jpg]

Photo 43: View inside the Groundwater Recovery Building. Tank to the right (black arrow) is used to store extracted ground water prior to transfer to the Wastewater Treatment Plant. The room at the back (blue arrow) contains valves for sampling monitor wells and extraction wells. Note dirt on the floor from leaking wall.

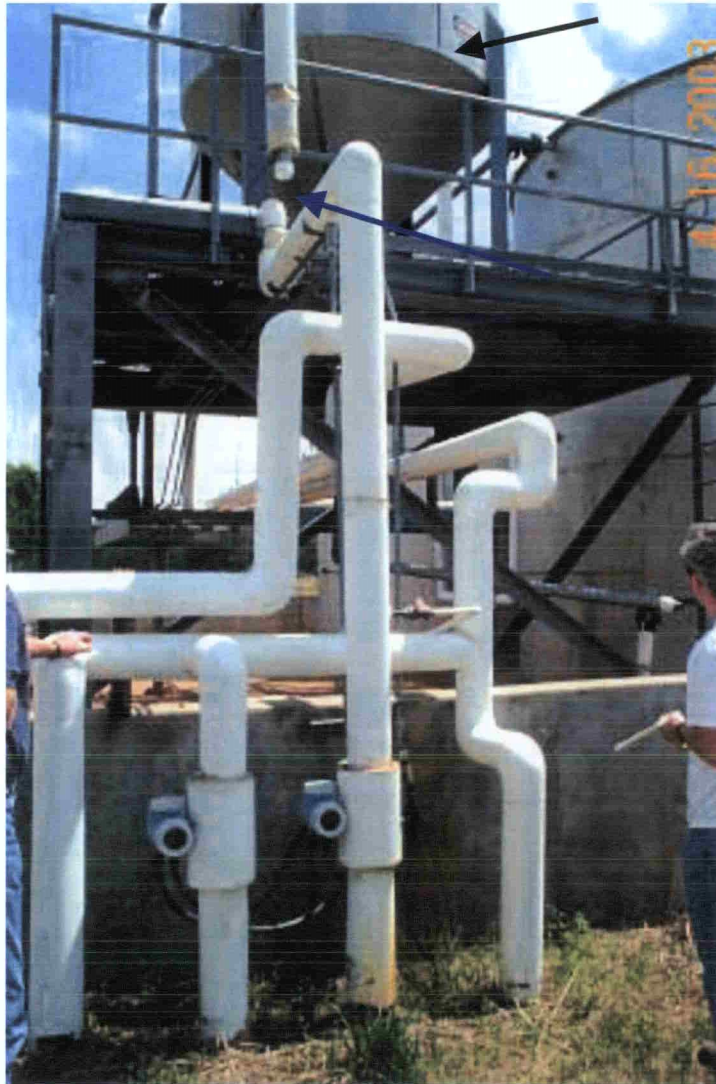
[filename: VI\_DCP 4148.jpg]

Photo 45: View of inlet pipes from french drain and ground water extraction systems at the waste Wastewater Treatment Plant. Tank at top of photo is the oil/water separator (black arrows). Note that the inlet pipes are no longer connected to the oil/water separator (blue arrow).
