RE: Warm Springs Ponds Operable Units of the Silver Bow Creek Area NPL Site, Document No. CERCLA-VIII-91-25 – 2016 Five-Year Dam Safety Inspection Report

**SILVER BOW CREEK/BUTTE AREA NPL SITE
WARM SPRINGS PONDS OPERABLE UNITS**

*Warm Springs Ponds
2016 5-Year Periodic Inspection Report*

December 8, 2016

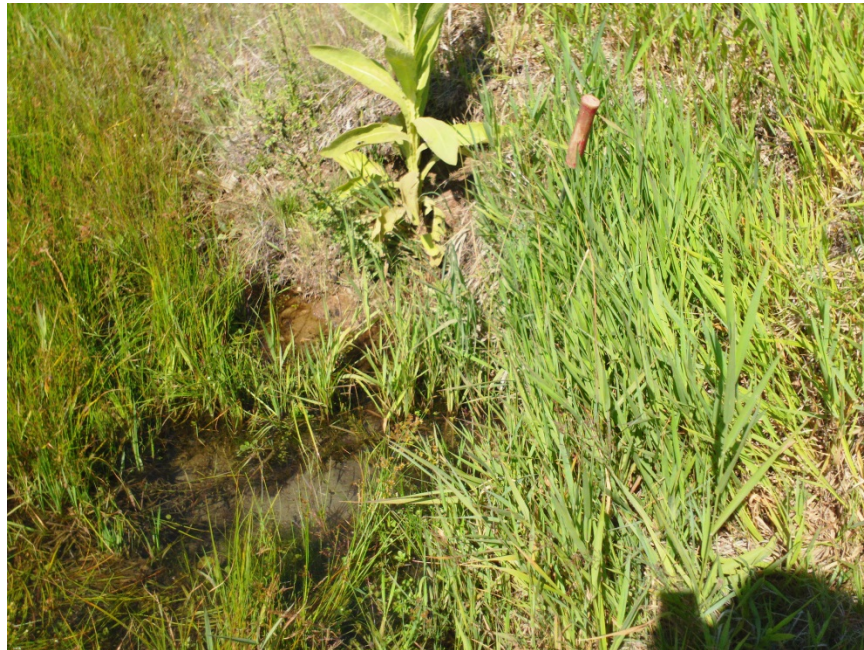
A spongy area has existed between the lower wet closure and the groundwater interception trench for several years and receives regular monitoring. Seepage is occurring on the south bank of the groundwater interception trench, across from the Pond 1 Traveling Screen Building. Five distinct areas of moist soil and wet, spongy soil were observed just above the water surface of the groundwater interceptor trench. The groundwater interception trench was installed downgradient of the lower wet closure to establish groundwater flow paths towards the ditch where it is collected and pumped back to Pond 2, preventing offsite migration of groundwater. The seepage is away from and below the embankment toe and foundation. This seepage is not considered a

hazard to the stability of the lower wet closure embankment; the groundwater interception trench is functioning as intended. No action beyond regular embankment monitoring is recommended. Picture # 7 displays the lower wet closure dam/dike north embankment and Picture # 8 displays a typical seepage/spongy area.

Description: Spongy area observed at Lower Wet Closure Dam/Dike: North Embankment – near Groundwater Interception Trench.

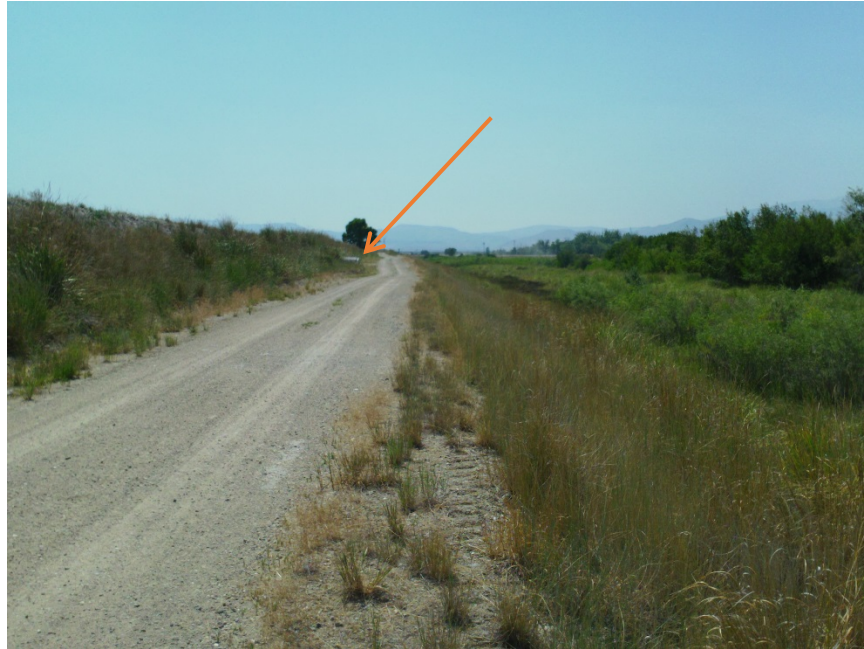
There were no reportable items of concern noted during the time of the inspection. Thick grass vegetation was growing along the downstream toe and approximately on the bottom one-third of the downstream slope, which limited ground surface visibility during the inspection. Minor erosion was noted on the downstream slope approximately 50 feet north of the dual 66-inch outlets. The erosion is not a dam safety concern in its current state. Picture # 9 shows the flood extension dike.

Description: Pond 1 Flood Extension Dike and Soil-Cement Erosion Protection, look south. Arrow denotes location of dual 66-inch outlet pipes.

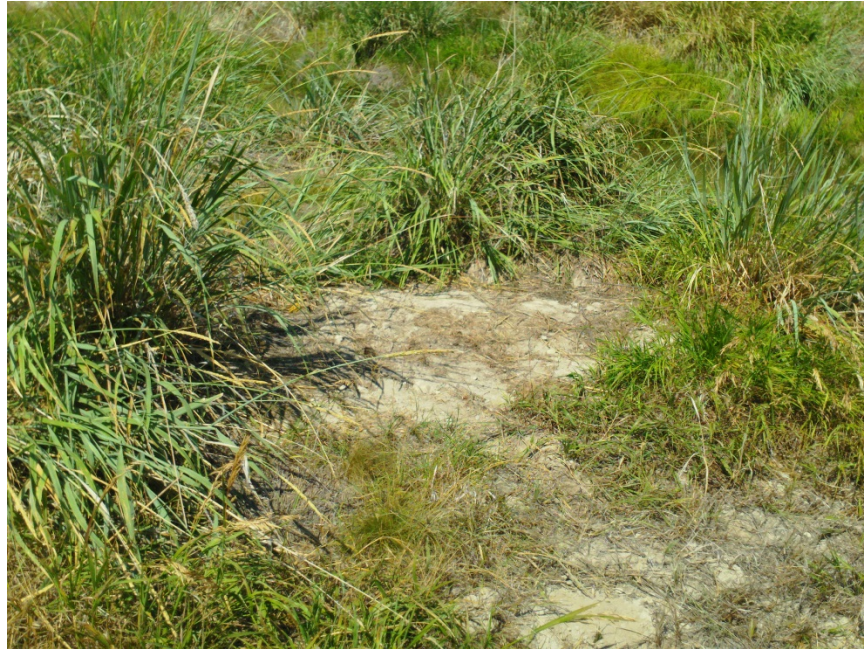
Picture # 21

Description: Pond 2 Dam North Embankment, downstream toe area approximately 250 feet southeast of SS-5. A 10-inch diameter rodent hole observed at this location during 2015 inspection. Rodent hole was repaired in July 2016.

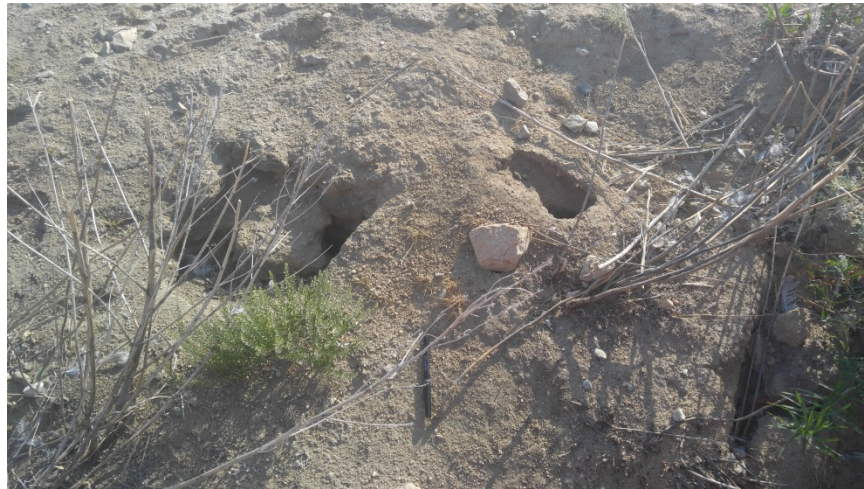
Picture # 22

Description: Rodent hole observed on the west wet closure channel.

Item 13-1: Fill in small animal burrow as part of IMP-1. Small animal burrows are difficult to prevent because of the size of the animals. Fill in small burrows as they are observed and inspect the embankment for distress around the burrow. Document the location and frequency of burrow repairs. If problems continually occur in a particular area, consult the engineer to evaluate mitigating methods such as trapping, fumigants, or toxicants.

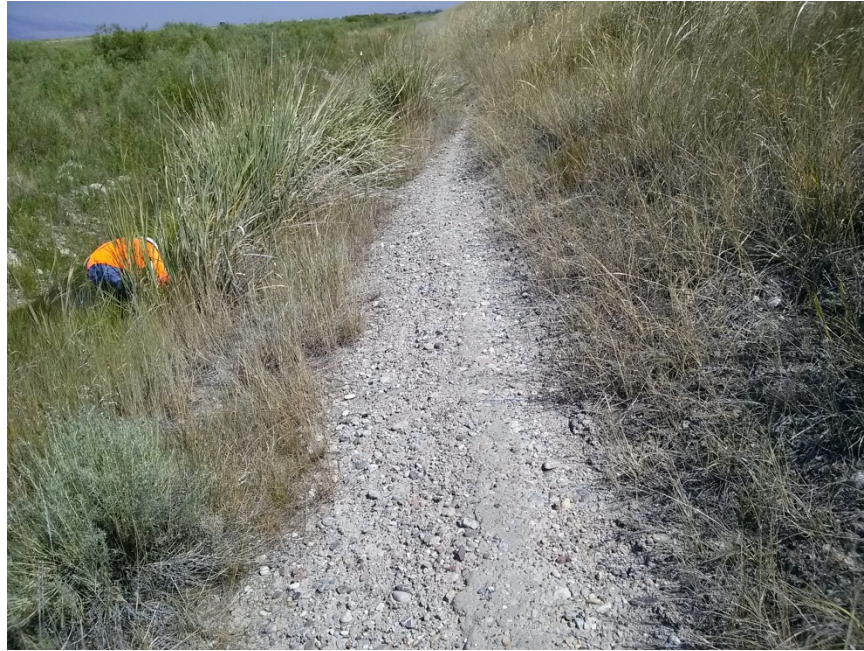
Picture # 29

Description: Pond 3 Dike West Embankment. Note exposed soil cement frequently observed along downstream toe.

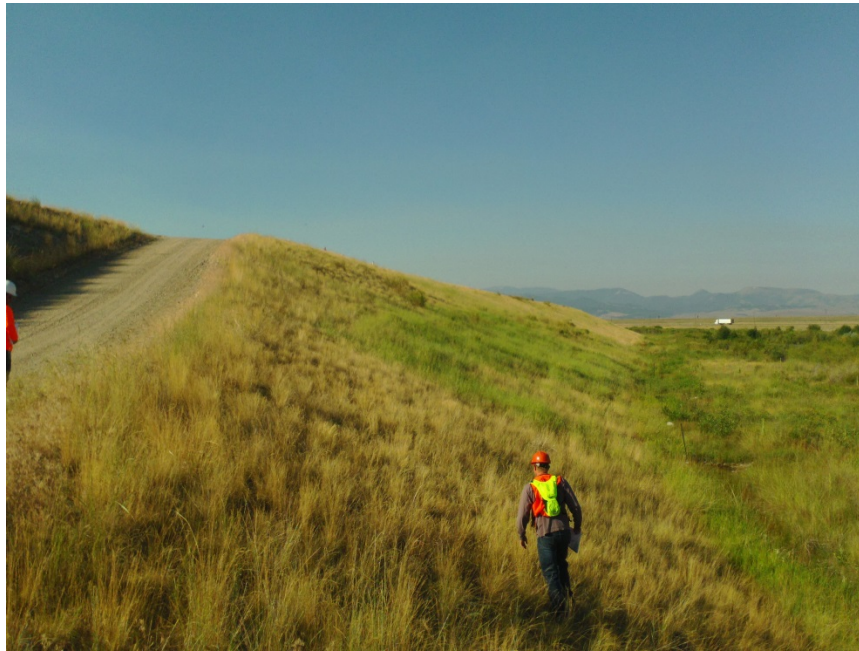
Picture # 30

Description: Pond 3 Dike West Embankment downstream slope. Looking south at southern extents of area of green vegetation near Station 135+00.

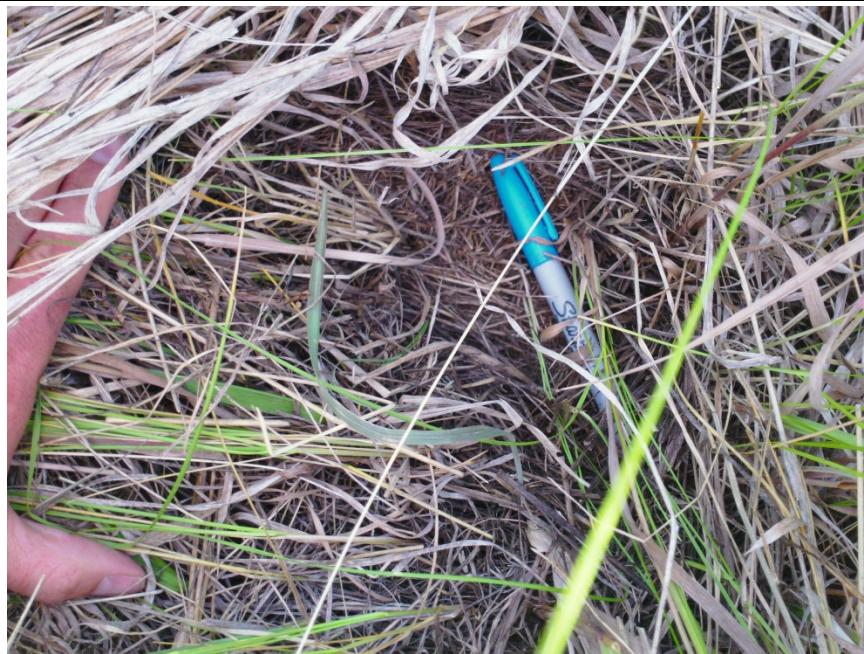
Picture # 32

Description: Pond 3 Dike West Embankment downstream slope. Typical ground/soil conditions at location of green vegetation near Station 135+00.

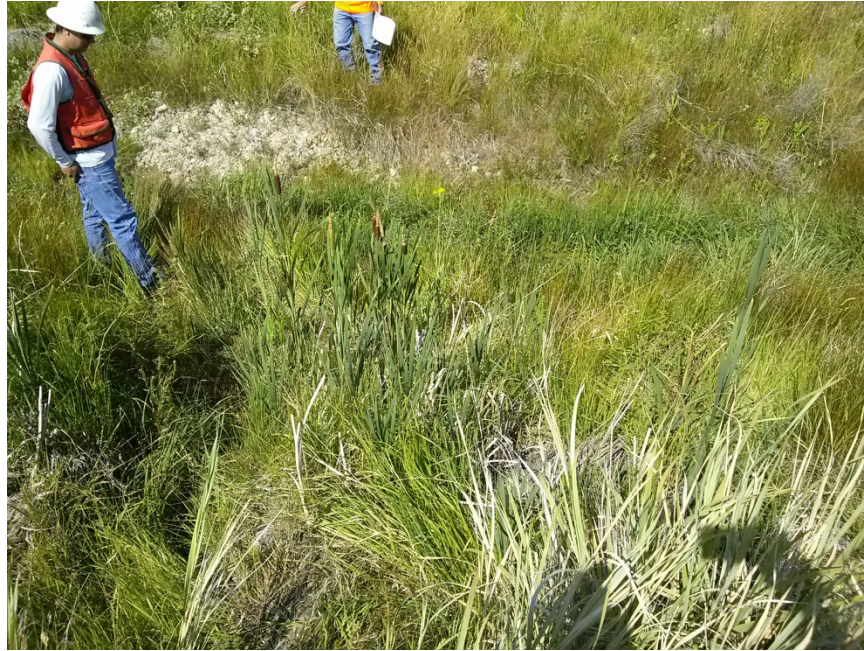
Picture # 33

Description: Pond 3 Dike West Embankment. Downstream slope near toe at Station 89+50. Note green vegetation and cattails.

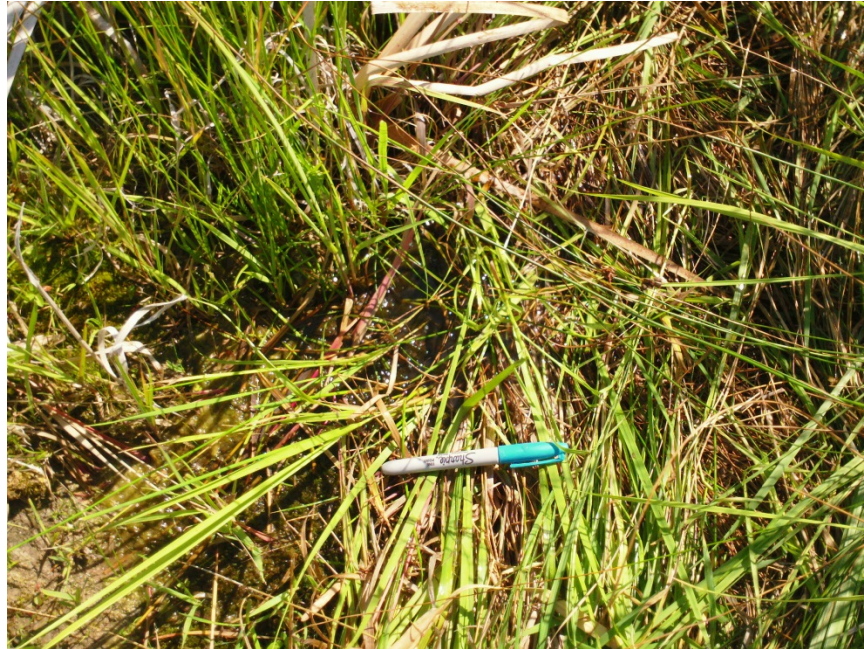
Picture # 35

Description: Pond 3 Dike West Embankment. Downstream slope near toe at Station 89+50. Ground conditions within green vegetation and cattails. Note free standing water on ground surface.

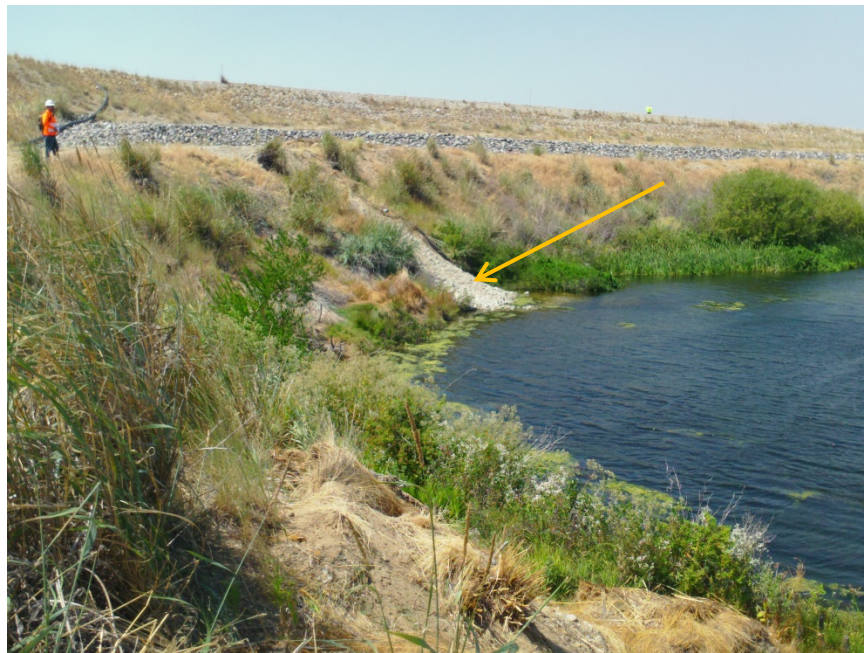
Picture # 40

Description: Pond 3 Dam North Embankment. Arrow shows location of embankment repair in southern corner of hog hole.

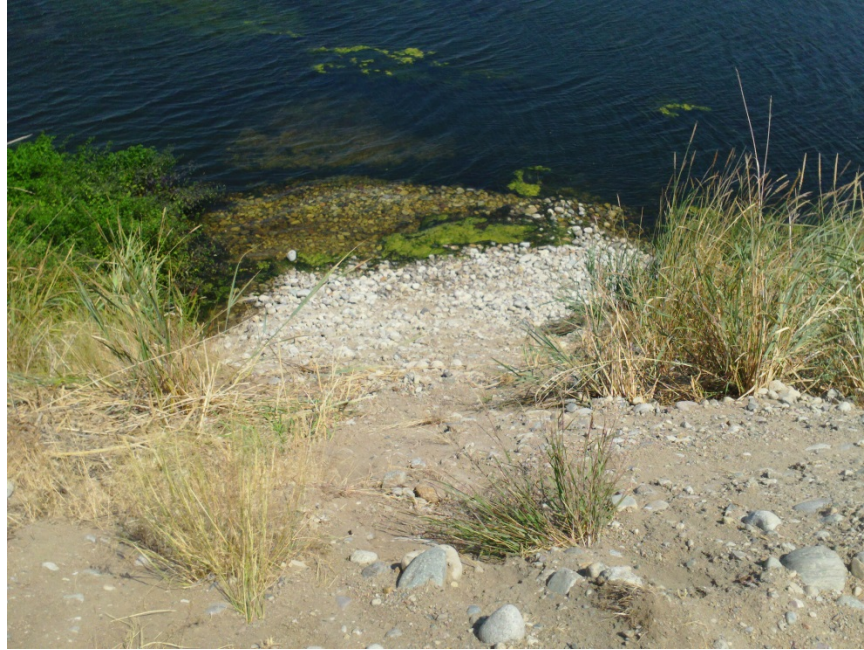
Picture # 41

Description: Pond 3 Dam North Embankment. Looking north at location of embankment repair in southern corner of hog hole.

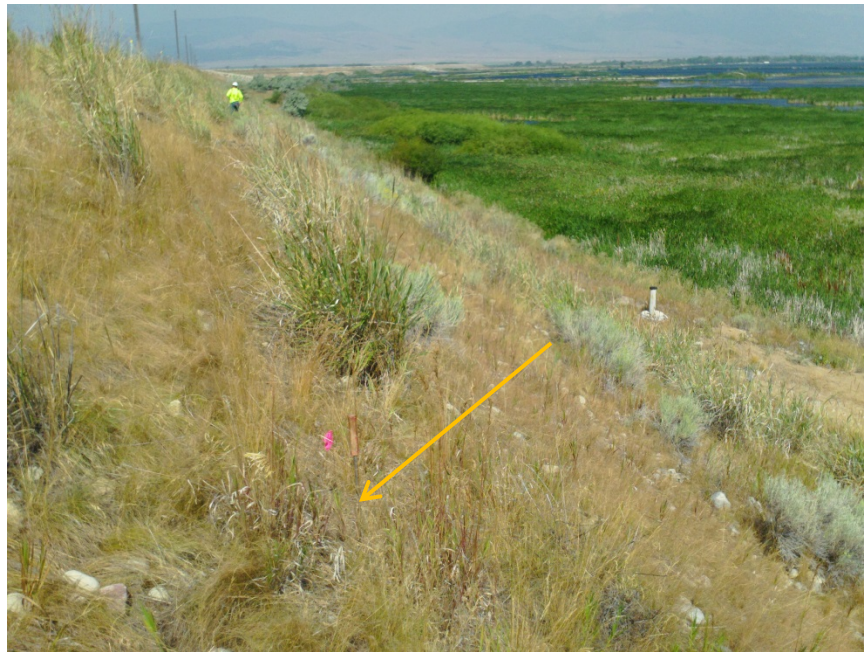
Picture # 46

Description: Pond 3 Dam North Embankment downstream slope. Arrow is pointing to a soft embankment soil location near the right abutment noted in 2015 and 2016.

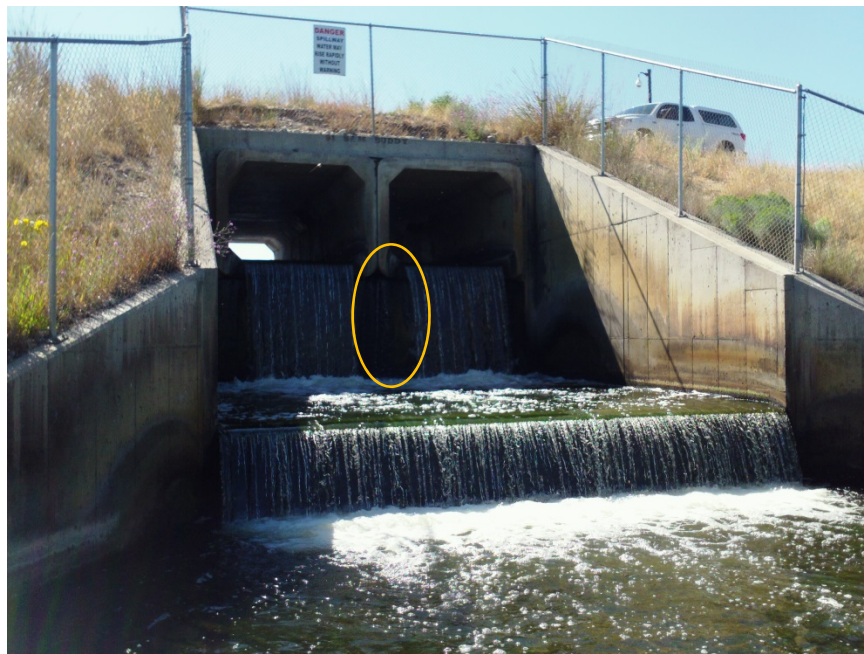
Picture # 60

Description: Pond Outlet Box Culvert Box Structure, looking southeast at downstream portion of structure. Circled area denotes water leaking between the two box culverts.

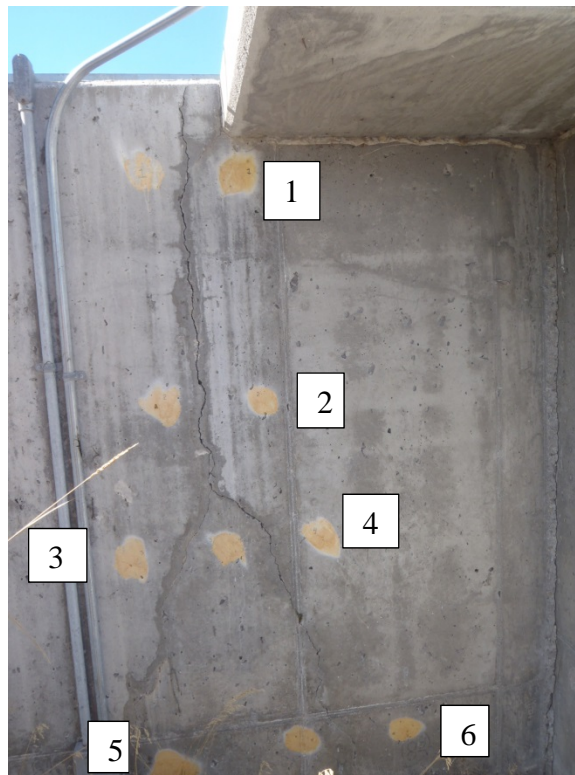
Picture # 62

Description: Pond 3 Inlet Structure crack monitoring. Numbers denote crack monitoring locations.

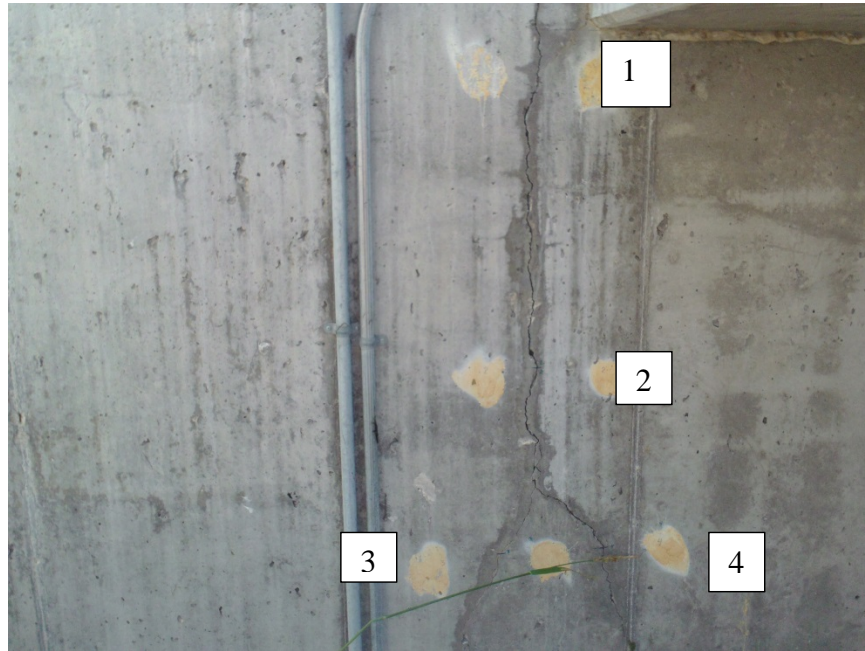
Picture # 65

Description: Pond 3 Inlet Structure crack monitoring locations.
Note: crack monitoring locations 5 and 6 are not shown in picture.
