**FIRST FIVE-YEAR REVIEW REPORT FOR  
BONITA PEAK MINING DISTRICT SUPERFUND SITE  
SAN JUAN COUNTY, COLORADO**

**U.S. Environmental Protection Agency  
Region 8  
Denver, Colorado**

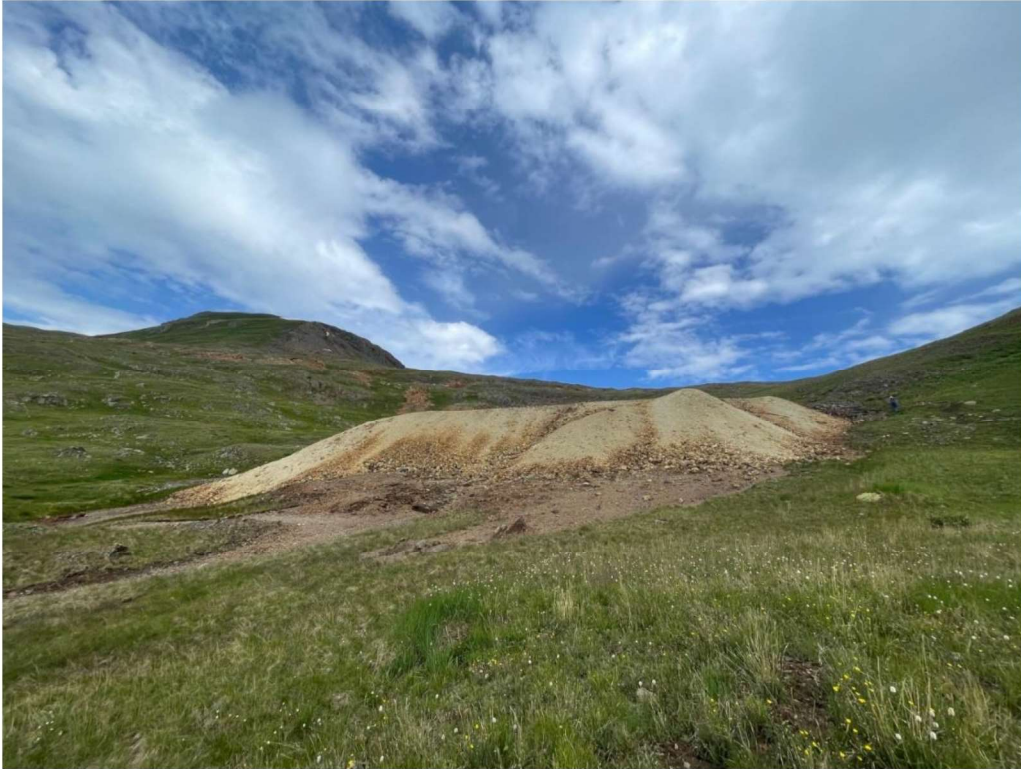
Vermillion Mine – July 16, 2024

The Vermillion Mine waste-rock pile

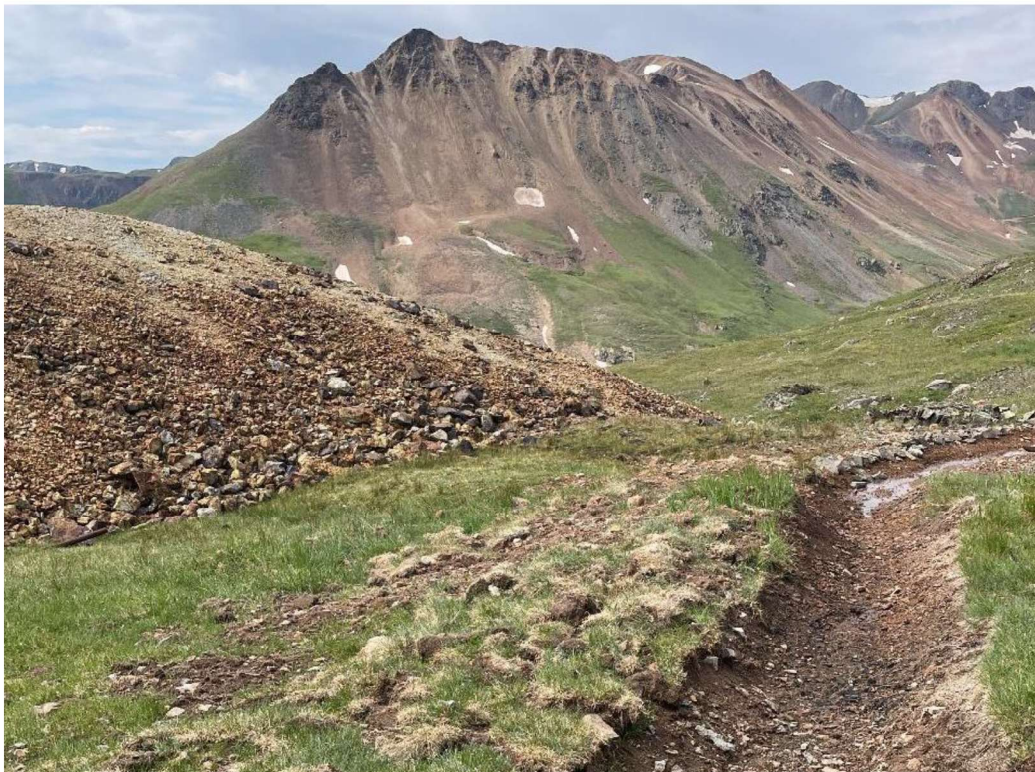
Stormwater drainage swale constructed at the Vermillion Mine to direct flow around the western side of the waste-rock pile

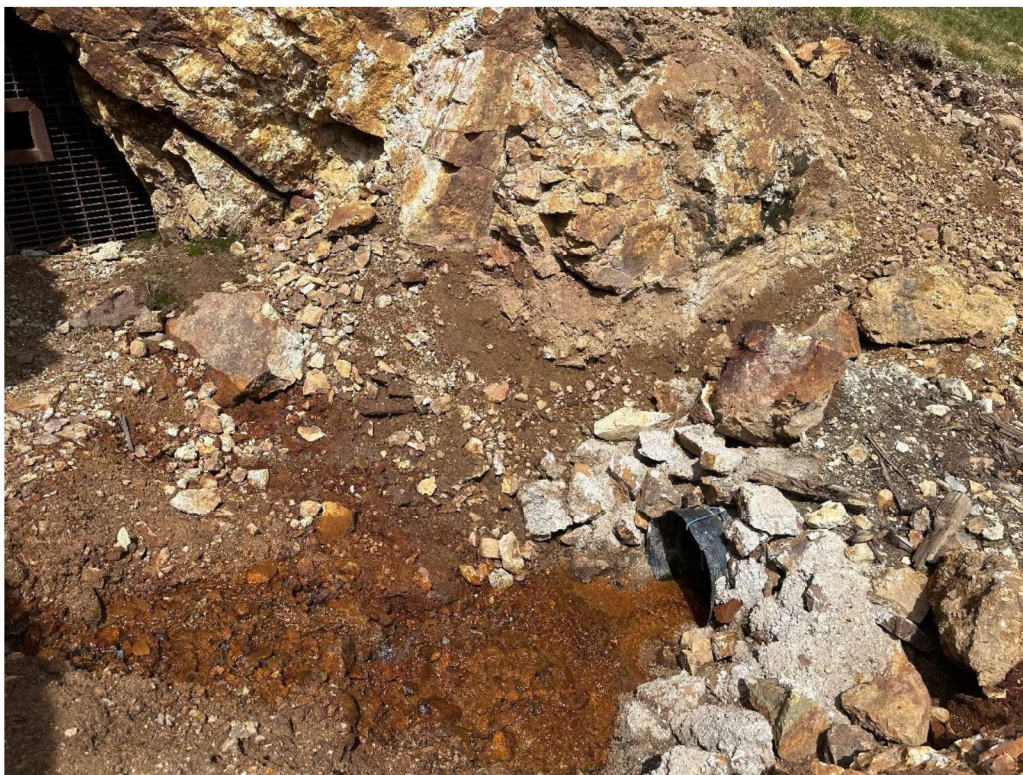
The 12-inch HDPE pipe installed to direct drainage from the adit

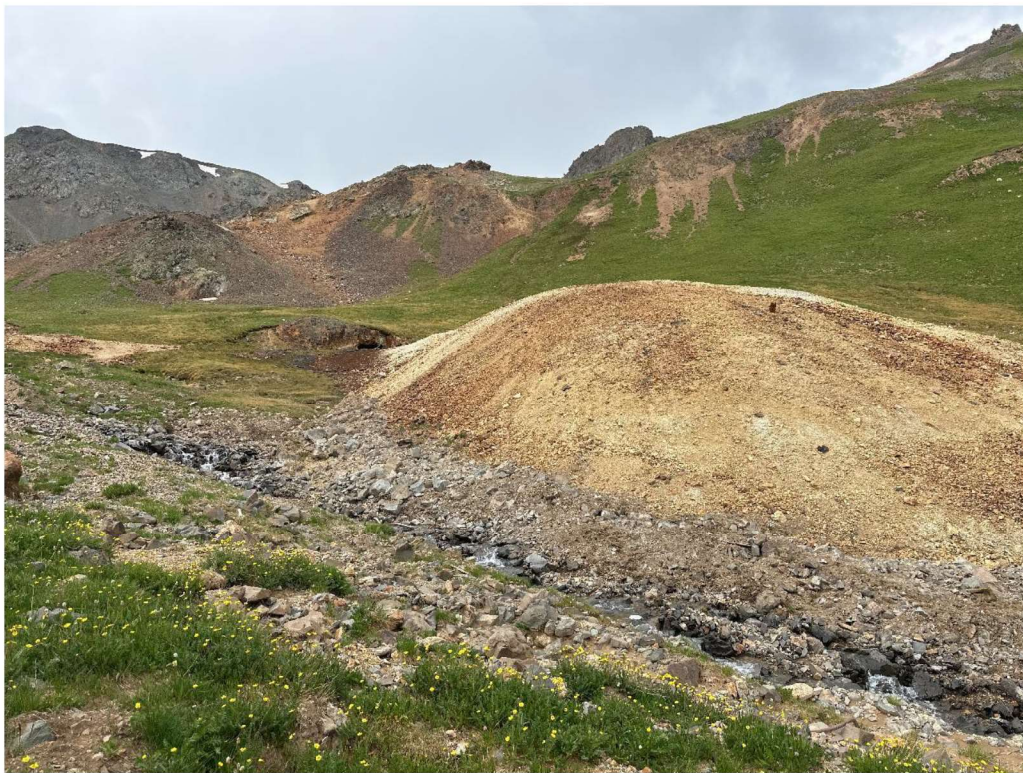
The eastern edge of the Mountain Queen Mine waste-rock pile armored with gray rock

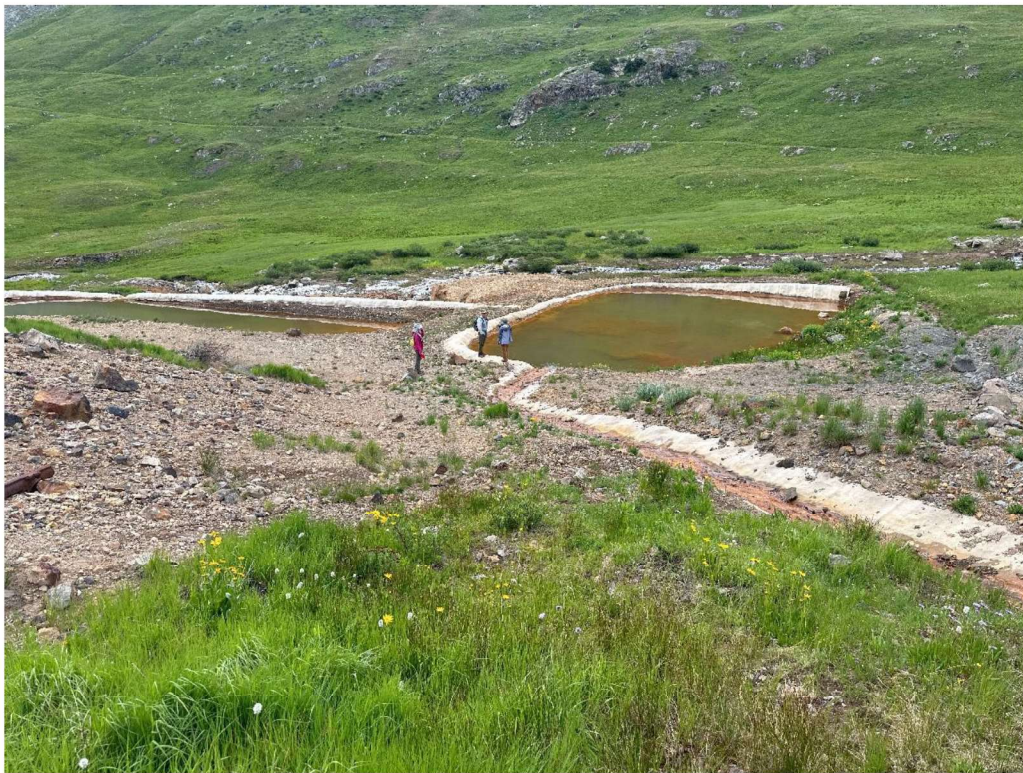
GCCM-lined channel (Reach 1) directing MIW into Pond 1 and then Pond 2 at the Sunbank Group Mine

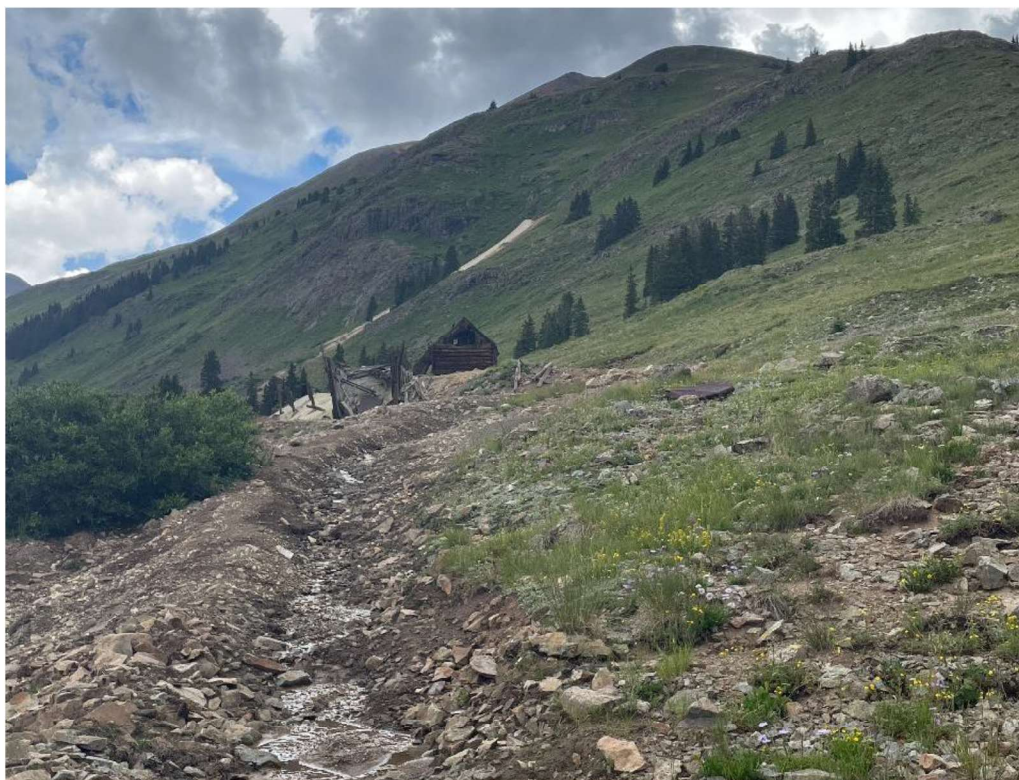
Combined MIW and stormwater drainage at the Columbus Mine

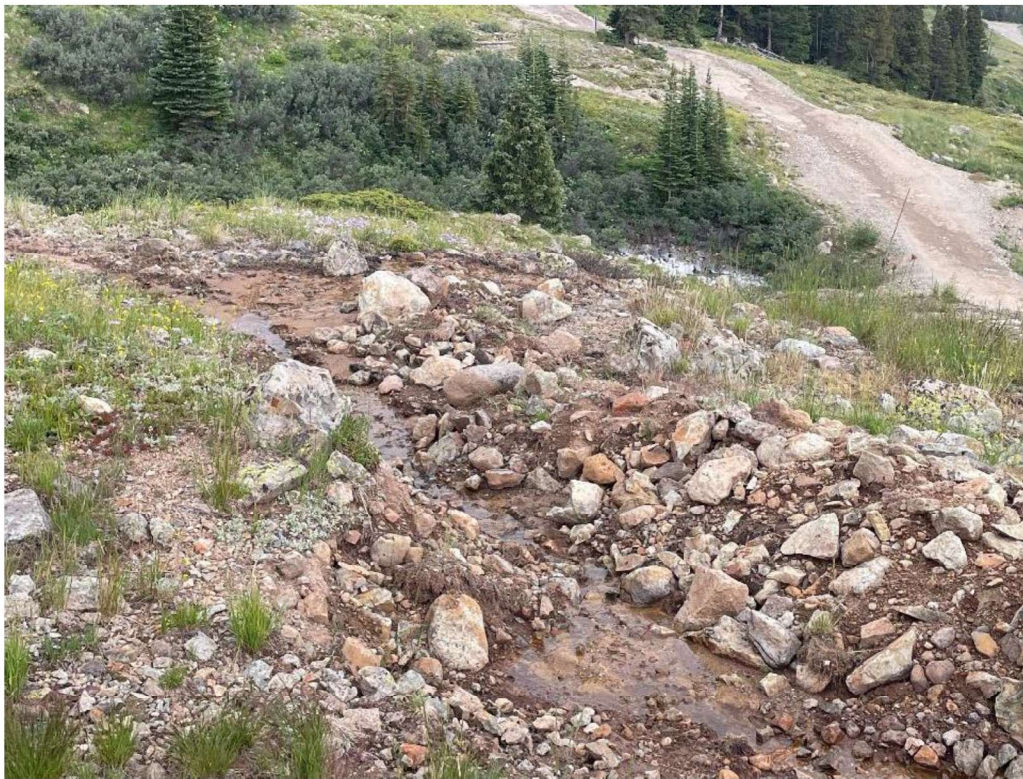
The EPA and the CDPHE inspected the Columbus Mine on July 16, 2024, and observed that water that disperses from the MIW channel downhill of the adit appeared to have a negative effect on vegetation in the new overland flow path. The agencies are working to determine the need for additional actions at the Columbus Mine to correct the drainage issue.

Drainage from the Columbus Mine potentially affecting vegetation

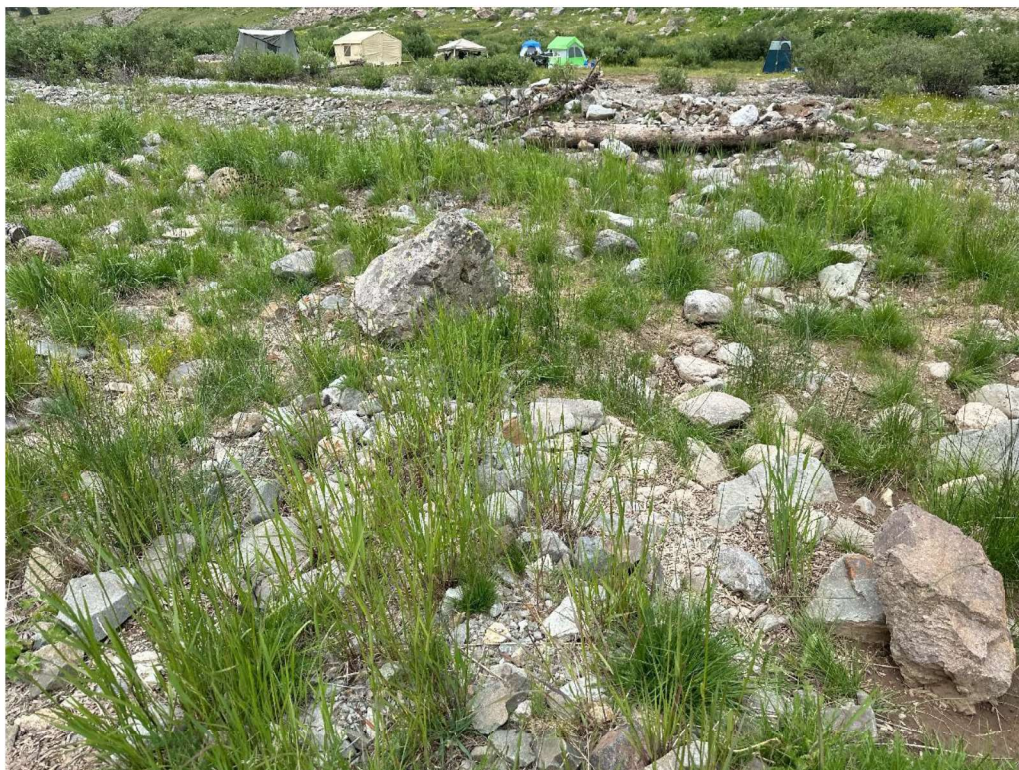
Revegetated IRA area where deeper clean soil was brought to the surface and placed on top of high concentration lead-contaminated soil; tents observed in the background

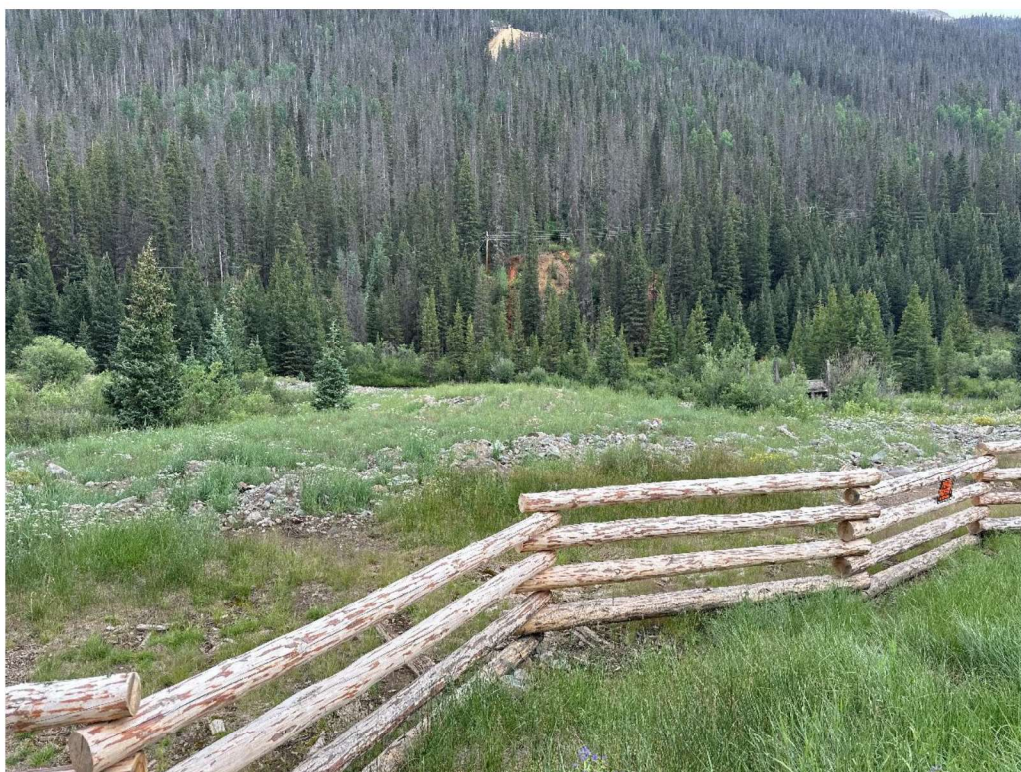
IRA area with a clean soil cover, now revegetated

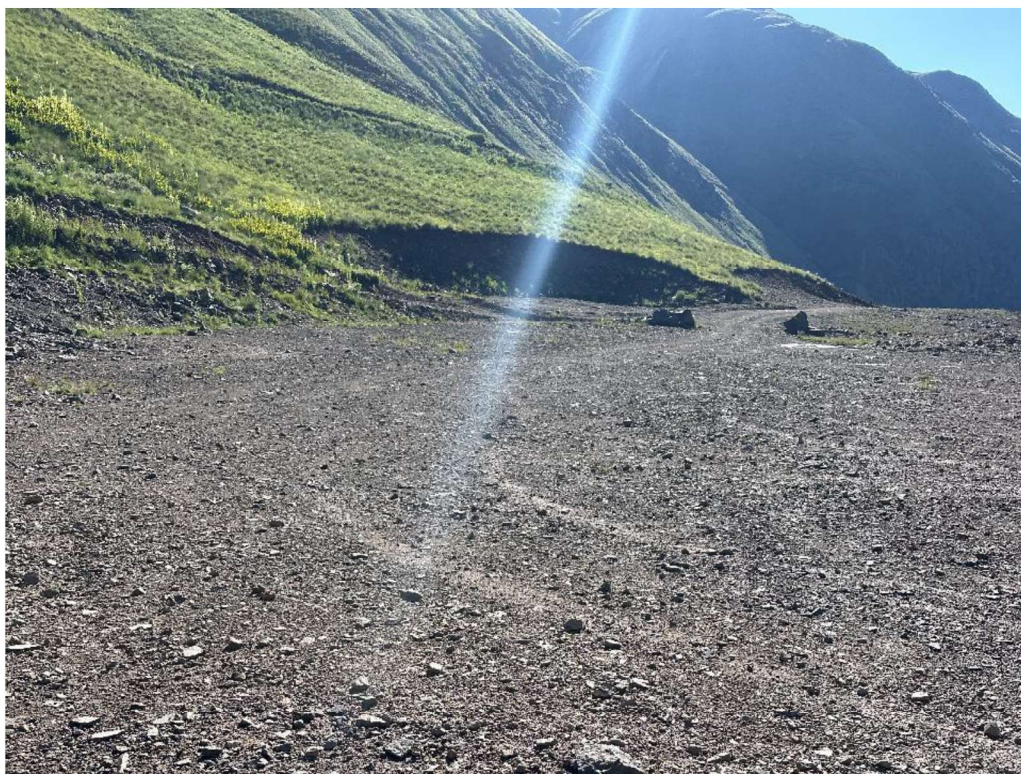
Lack of vegetation on the reclaimed area at the Terry Tunnel site (capping occurred prior to the IRA)

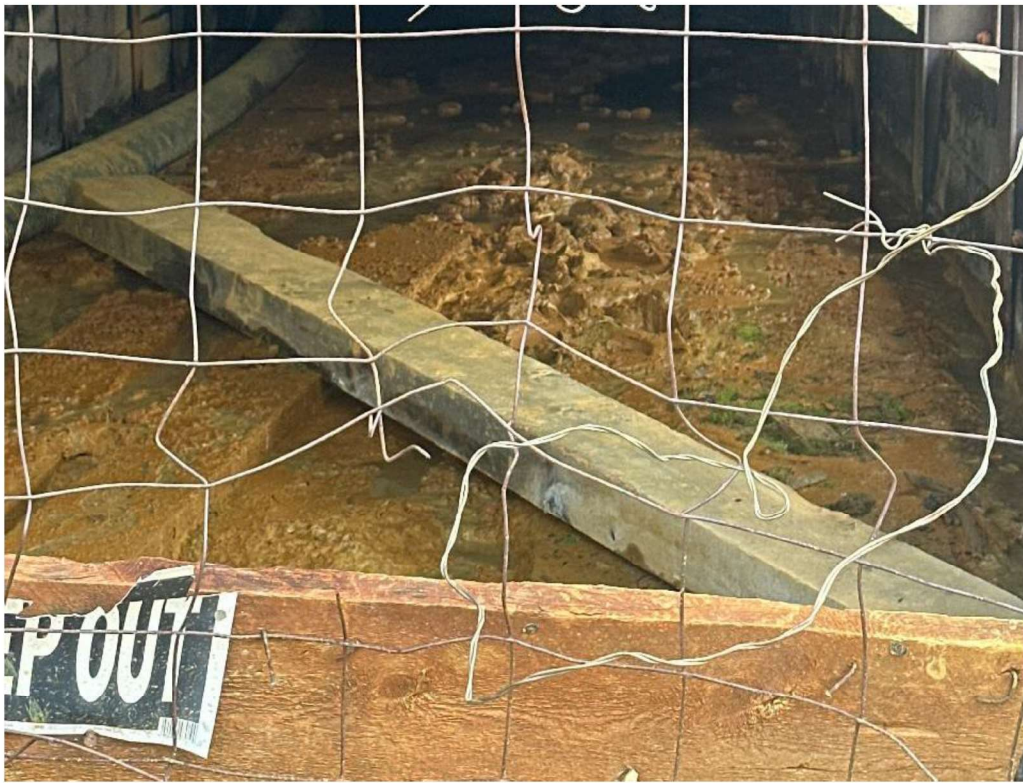
Sludge buildup and broken fencing at the Silver Wing Mine adit

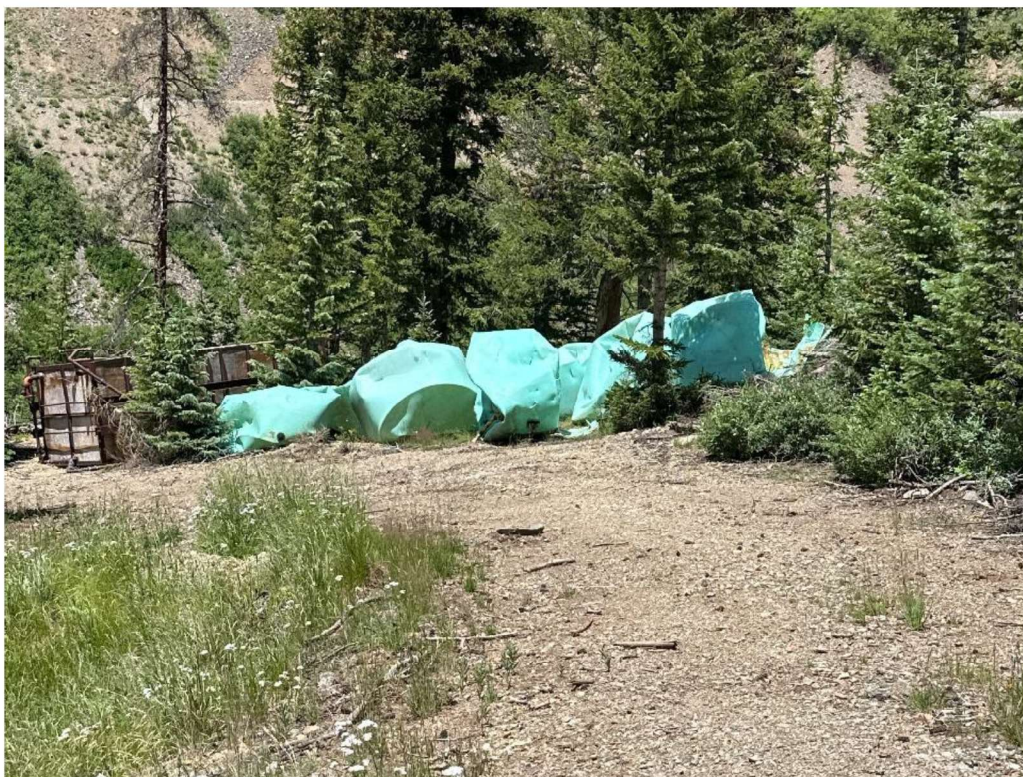
Tanks (now empty) discovered during excavation for the repository; the contents (biochar and mine sediment) of the tanks were stabilized and placed in the repository

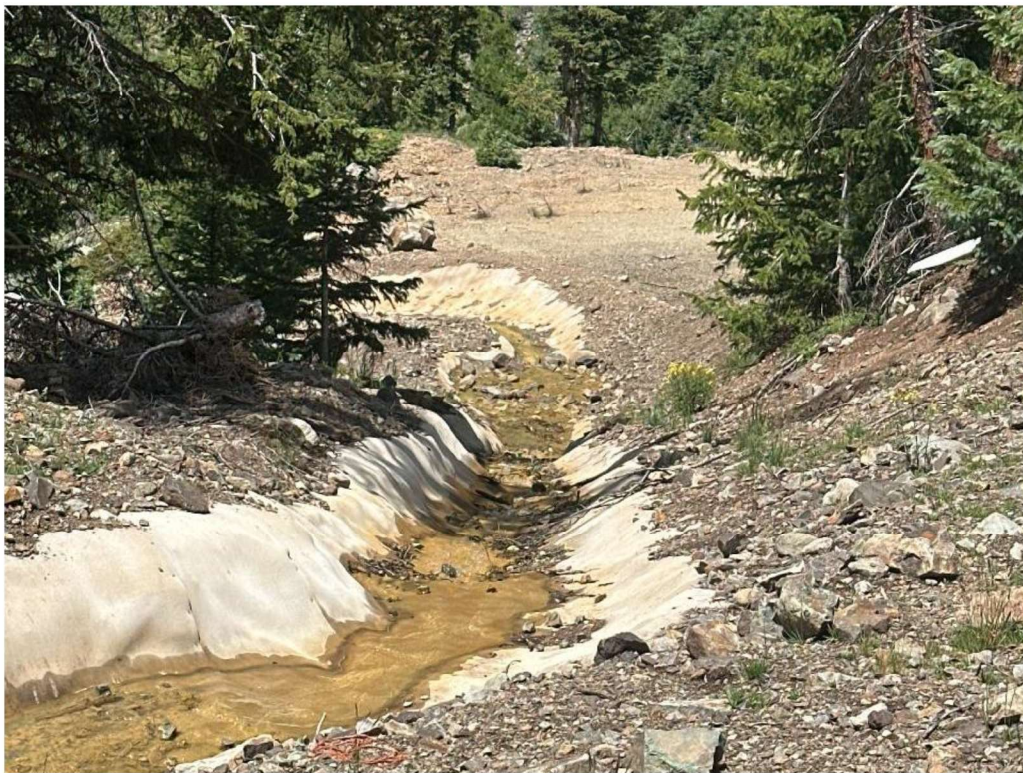
Some debris in the drainage from the pond

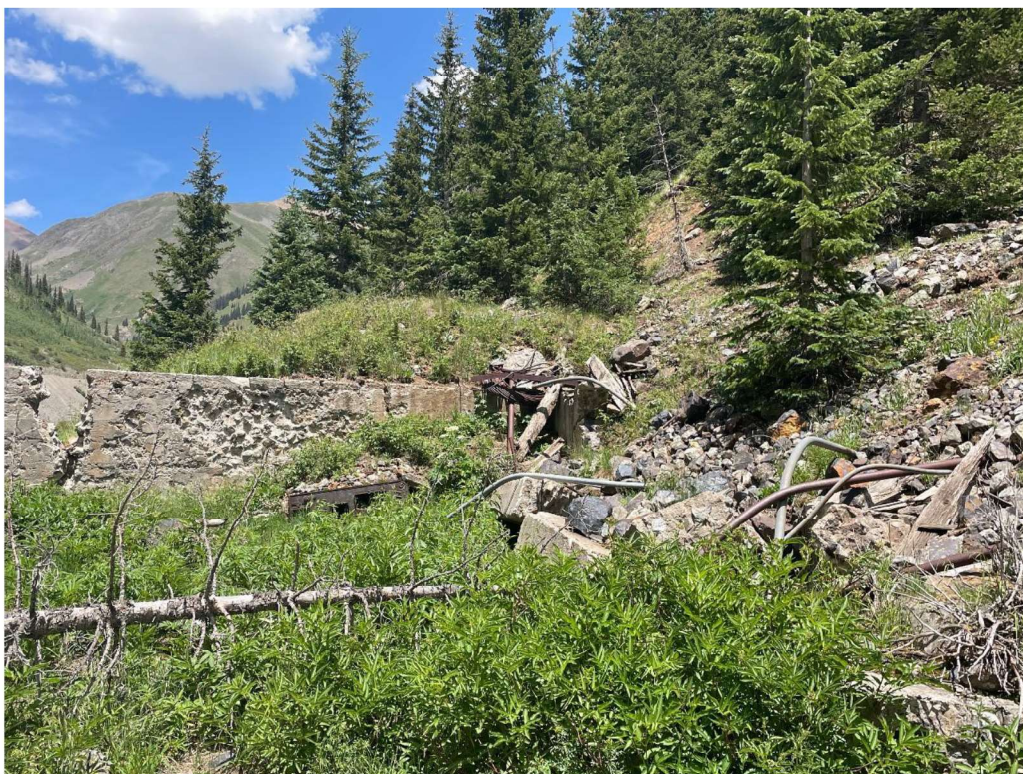
Waste and debris at the Tom Moore Mine site

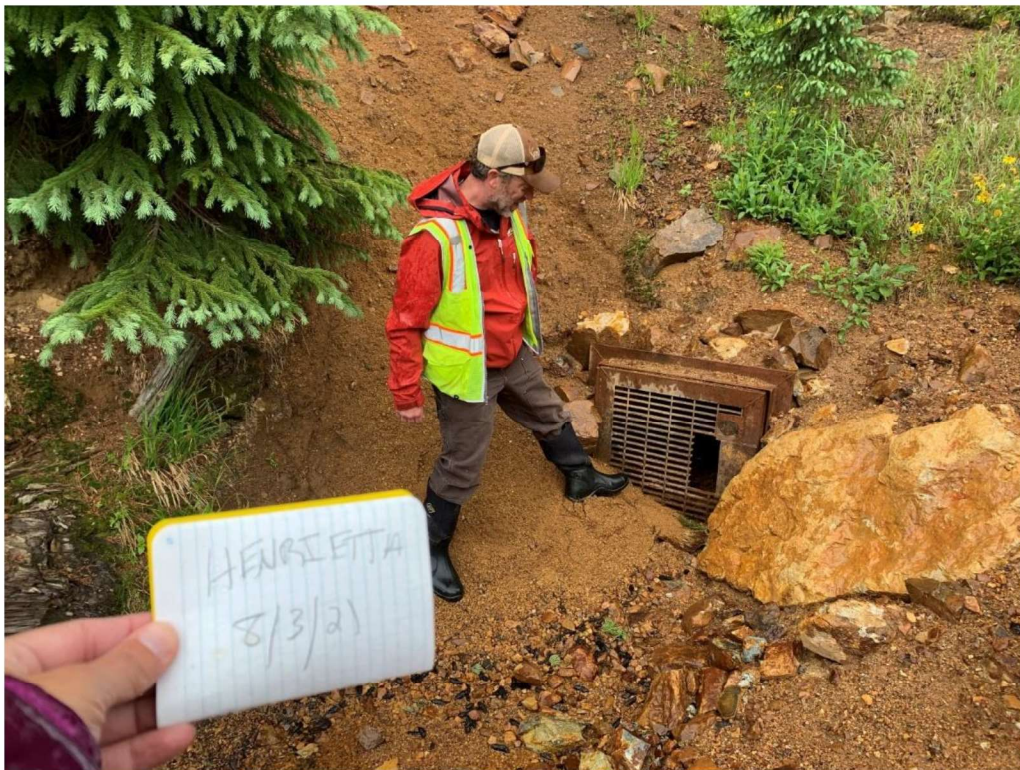
The Henrietta Mine is on the south side of Prospect Gulch (Figure C-2). There are at least six levels in the mine. The 700 level adit flows only during high-flow conditions and is diverted into a drainage channel that flows on the southeast side of waste rock. Before the IRA, the grate on the 700 level portal was observed to be partially buried by material eroding from the surrounding slope. The mine was included in the 2019 IROD to address the partial blockage of the 700 level portal grate so that MIW discharge can flow freely.

Henrietta adit and closure during a site inspection in August 2021

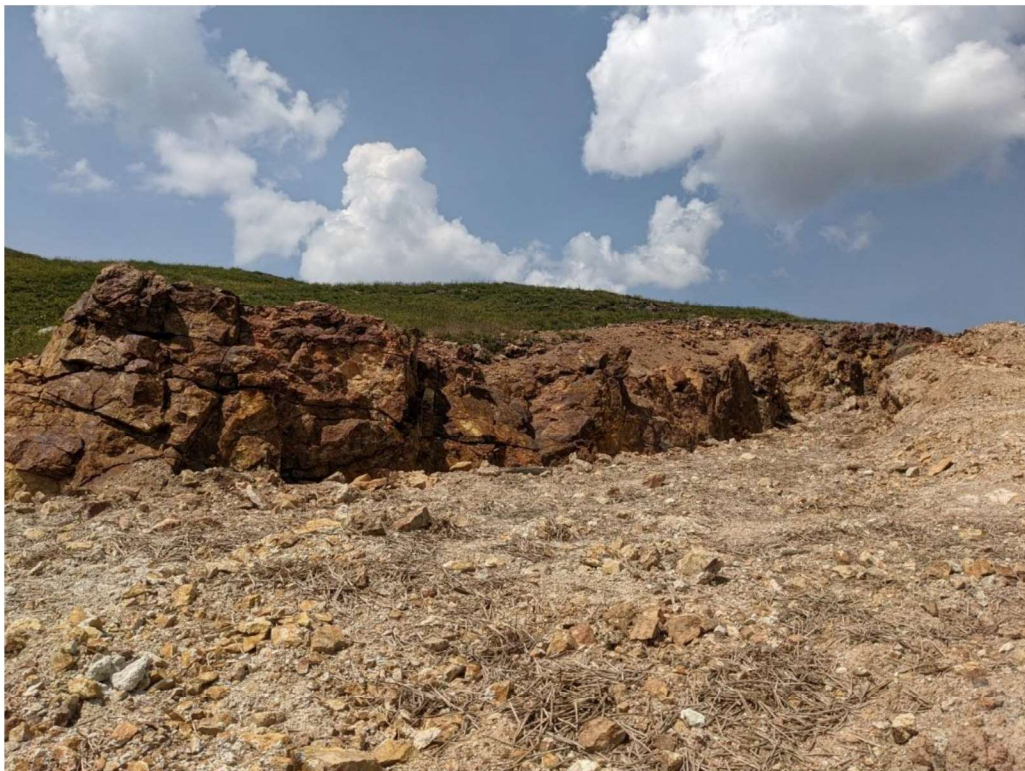
Ben Butler stope with amended waste rock backfill on August 5, 2021

The IRA at the Ben Butler Mine took place in 2020. It included backfilling the mine openings with the on-site waste rock amended with limestone crusher fines. The failing grated shaft was removed. During construction, it was discovered that the volume of waste rock remaining on site was insufficient to completely backfill the shaft and other mine openings. Therefore, a new grated shaft closure was reinstalled over the partially backfilled open shaft but at a location higher in the collar of the shaft with a beam for load spanning. Waste rock was excavated to bedrock or visually to the original underlying soil. The waste-rock-removal area and kill zone below the mine were revegetated with a mixture of compost, limestone and biochar.

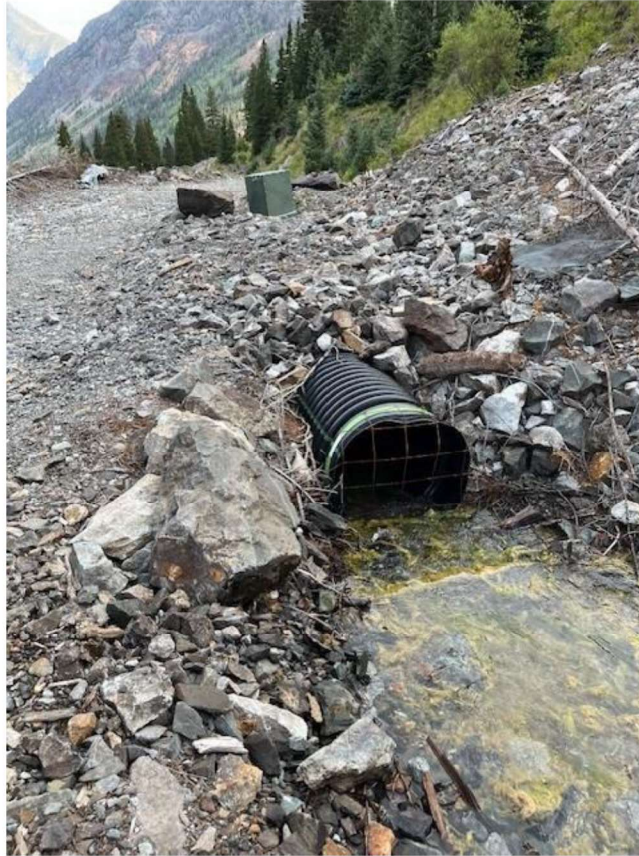
The EPA and the CDPHE/DRMS conducted an inspection of the Pride of the West Mine on August 28, 2024, and found that the remedy was operational and functional. Flow through the newly installed culvert was unobstructed and capturing all MIW as intended.

Pride of the West culvert installed by the CDPHE as part of the MIW diversion IRA, inspected on August 28, 2024

The IRA finished in August 2022. It included the replacement of the 6-inch-diameter pipe with a new double-wall HDPE 24-inch-diameter pipe to restore the functionality of the existing diversion channel.

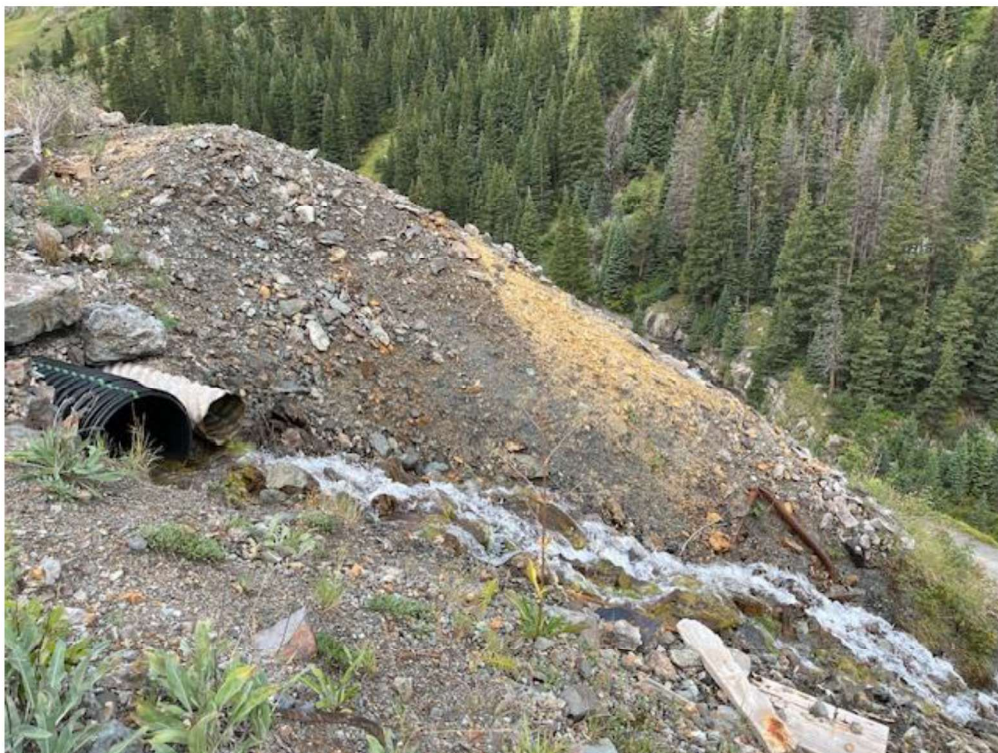
Discharge from the opposite end of the same culvert, old undersized culvert shown
