## Third Five-Year Review Report for Silver Bow Creek/Butte Area Superfund Site

### *Volume 5: Rocker Timber Framing and Treating Plant Operable Unit*

June 2011

Photographs Taken During Site Inspection: October 7, 2009

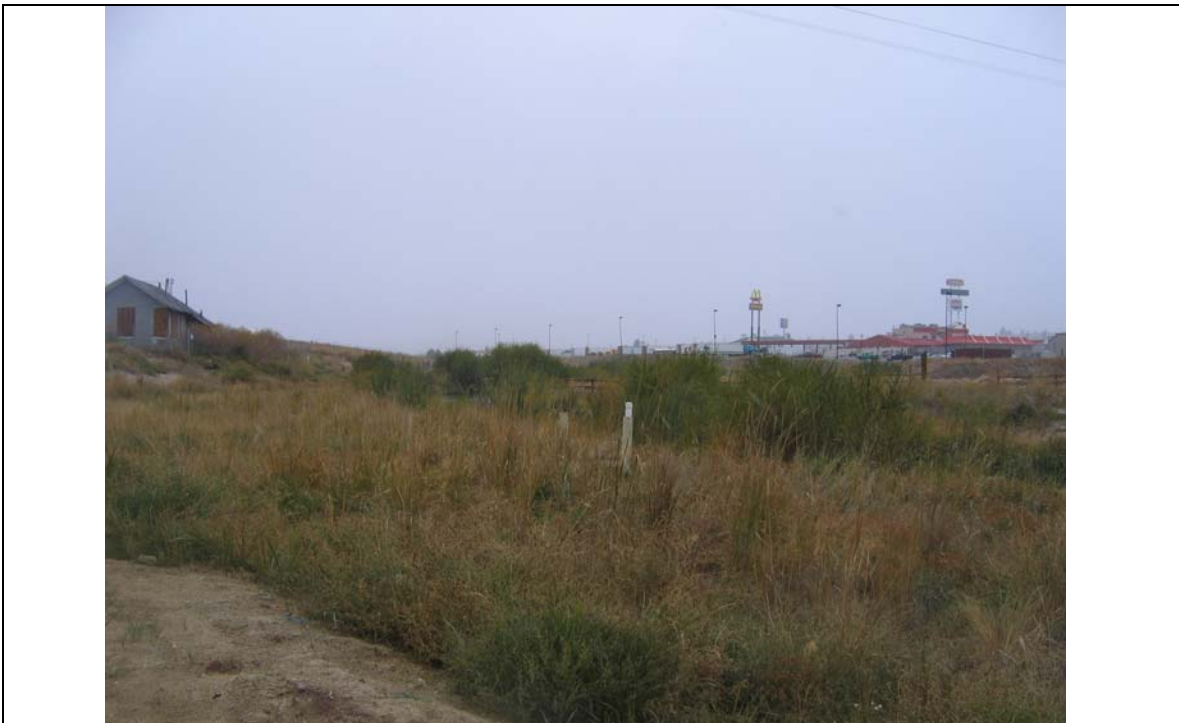
The site inspection determined that nine wells were in need of repair. Wells RH-17, RH-37, RH-26, RH-8, RH-16, RH-15, RH-60, RH-52R, and RH-19 showed evidence of frost heaving (the interior PVC pipe had pushed above the outer casing) and the wells could no longer be capped and locked. Atlantic Richfield has since made necessary repairs to these wells. Other minor issues during the site inspection included:

**Photo 4.** Monitoring wells with evidence of frost heaving. Town pump visible in background.

Atlantic Richfield has since made the necessary repairs at the site.

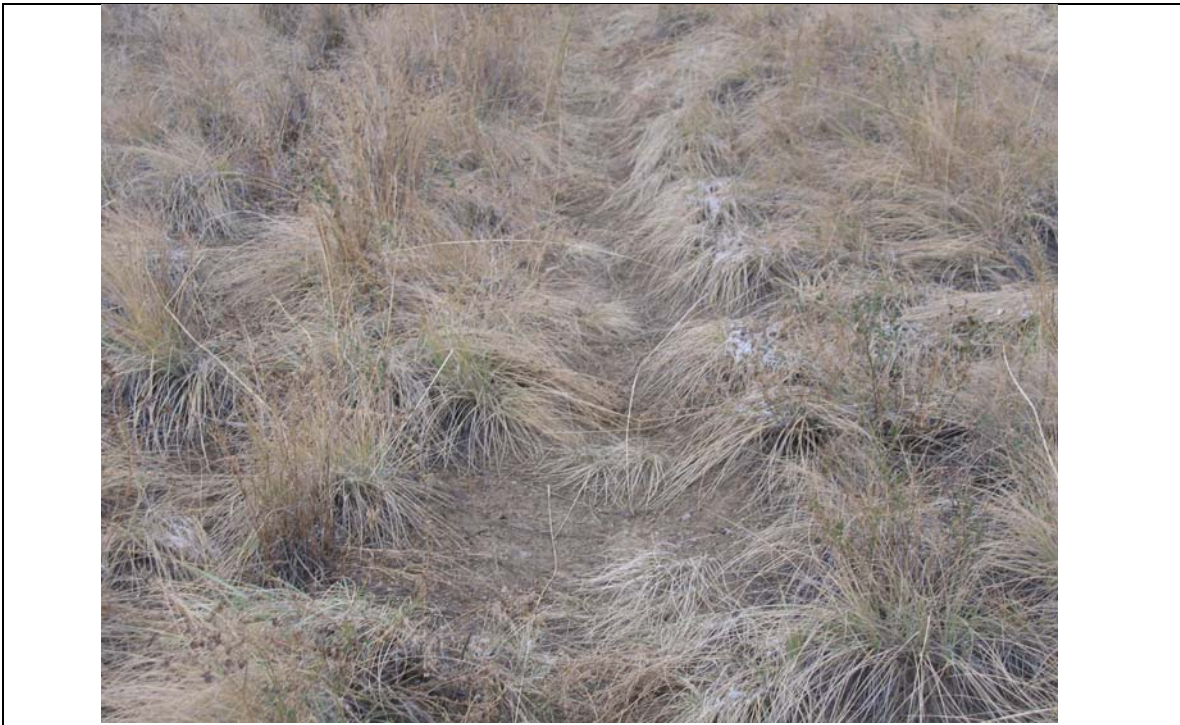
- Fencing, along the north and west sides of the repository area, was in marginal condition and falling down in places.
- The gate on the west side of the site was not secured.
- Vehicle tracks on the repository cap were greater than six inches deep in places; these tracks could eventually develop into erosional rills and compromise cap integrity.

**Photo 9.** Tire ruts from repeated driving on repository cap.

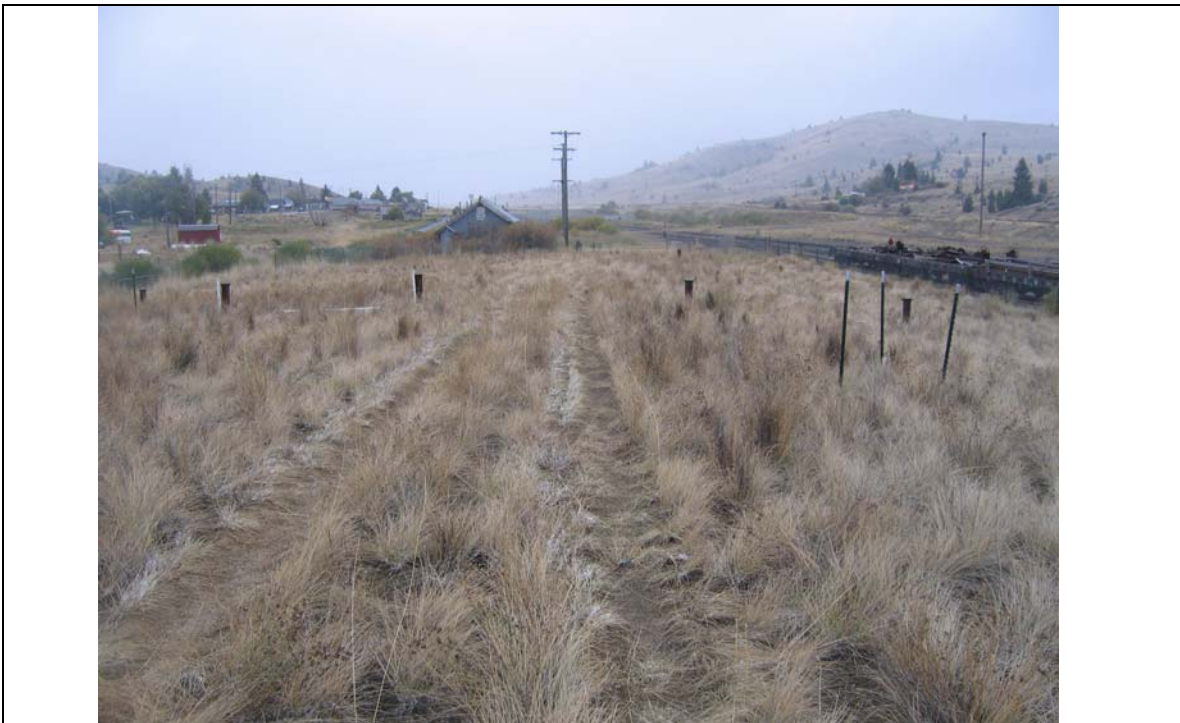
**Photo 10.** Tire ruts on repository cap.
