## ANALYTICAL RESULTS REPORT SITE INSPECTION

**CEDAR RESOURCES**  
Platoro, Colorado

CERCLIS ID # COD983778416

Prepared for:  
U.S. ENVIRONMENTAL PROTECTION AGENCY  
REGION VIII

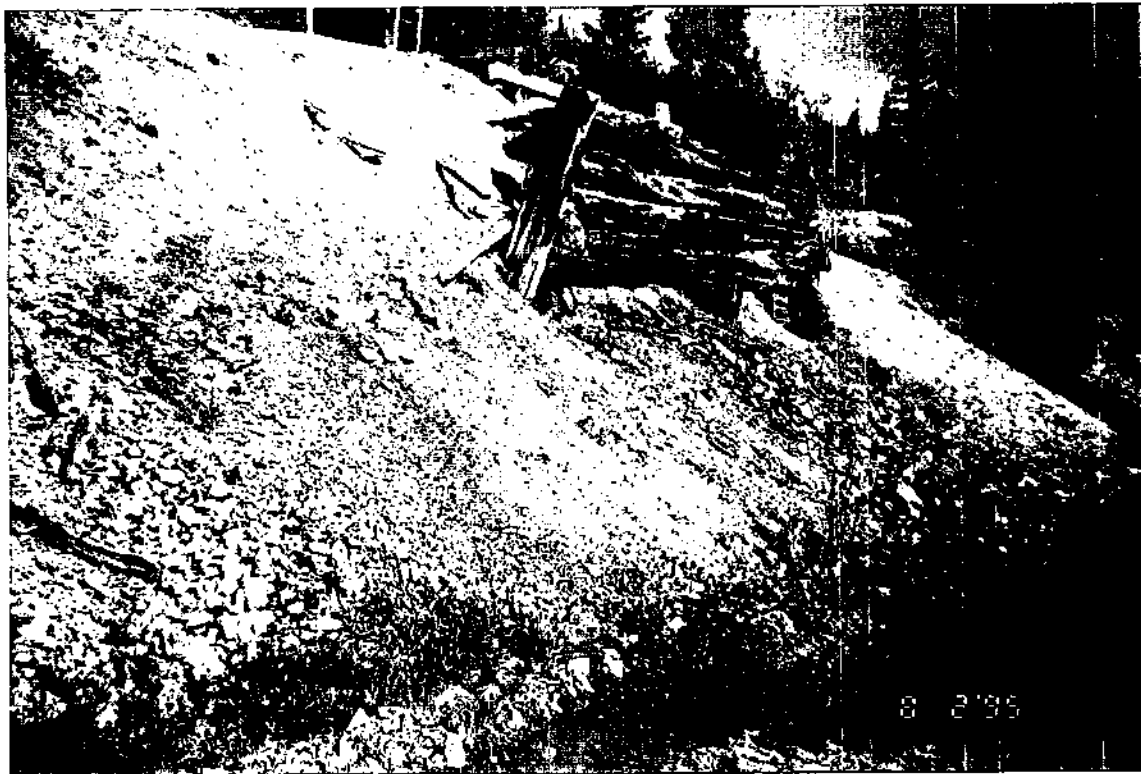
6

Description 1800's Portal.
