**SIXTH FIVE-YEAR REVIEW REPORT FOR  
KOPPERS COMPANY, INC. (OROVILLE PLANT) SUPERFUND SITE  
BUTTE COUNTY, CALIFORNIA**

PREPARED BY

U.S. Army Corps of Engineers

**U.S. Environmental Protection Agency**

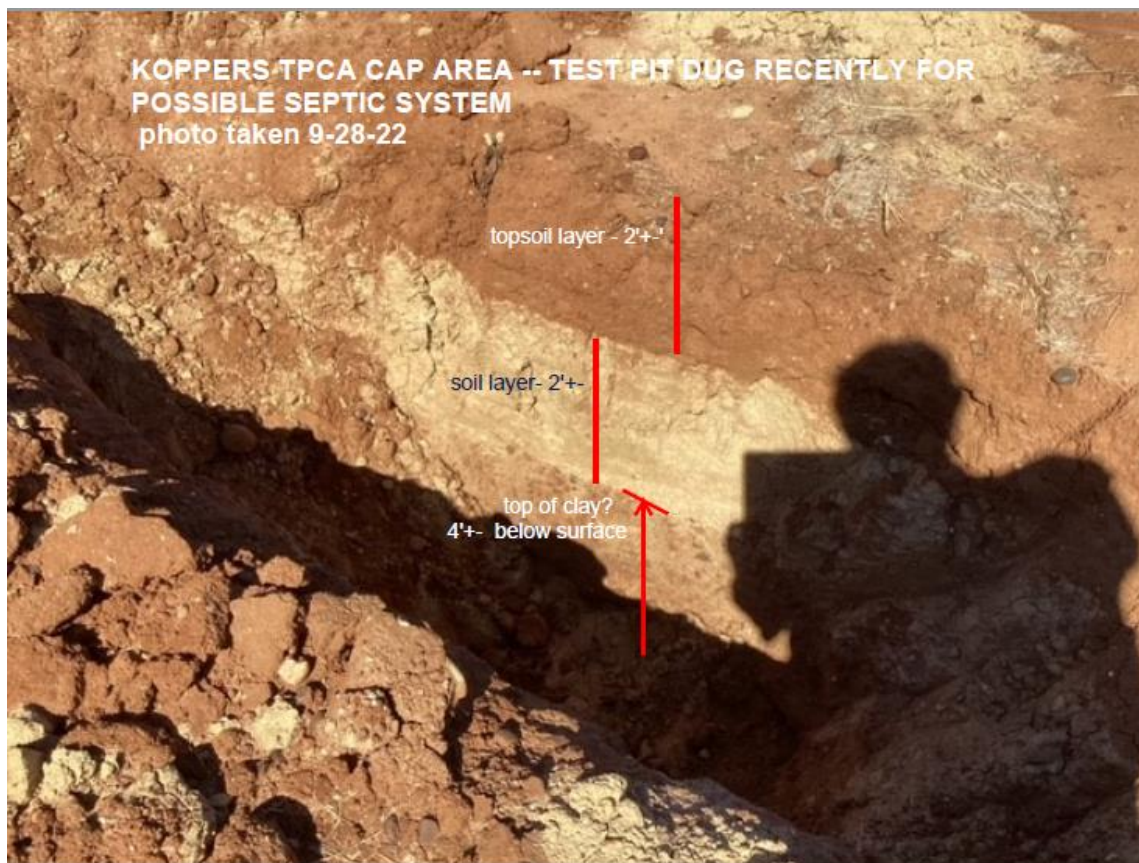
**Figure 5. Test Pit at Parcel 035-470-005**

A violation of the land use covenant occurred at parcel 035-470-005 when a storage shed was constructed on the property and a test pit for a future septic system was excavated. The Toxic Pits Cleanup Act clay cap<sup>1</sup> (“TPCA Unit”) is located on the same parcel as the former biological treatment facility. Photos from the test pit (**Error! Reference source not found.**) show a clay layer at approximately 4 feet below ground surface that may be associated with the cap. The footings for the storage shed were excavated approximately 4 feet based on discussion with the property owner (Appendix I). There are no photos or descriptions about what was encountered in the footing excavation. Site grading was also completed for the storage shed and driveway, altering the drainage of the property which also violates the land use covenant.

EPA notified The City of Oroville Planning and Development Department on September 1, 2022, of the violation and the Department of Toxic Substances Control notified the property owner on September 28, 2022. The City of Oroville responded to the EPA with details about the development at the site including pictures of the structure, engineering drawings and a photo of the test pit (**Error! Reference source not found.**).

| Issues and Recommendations Identified in the Five-Year Review: | | | | |
|---|---|---|---|---|
| | <b>Recommendation:</b> Develop and implement a Land Use Covenant Monitoring Plan and require annual inspections of each parcel under the land use covenant to ensure compliance with the covenant and report the inspection results to the Department of Toxic Substances Control. | | | |

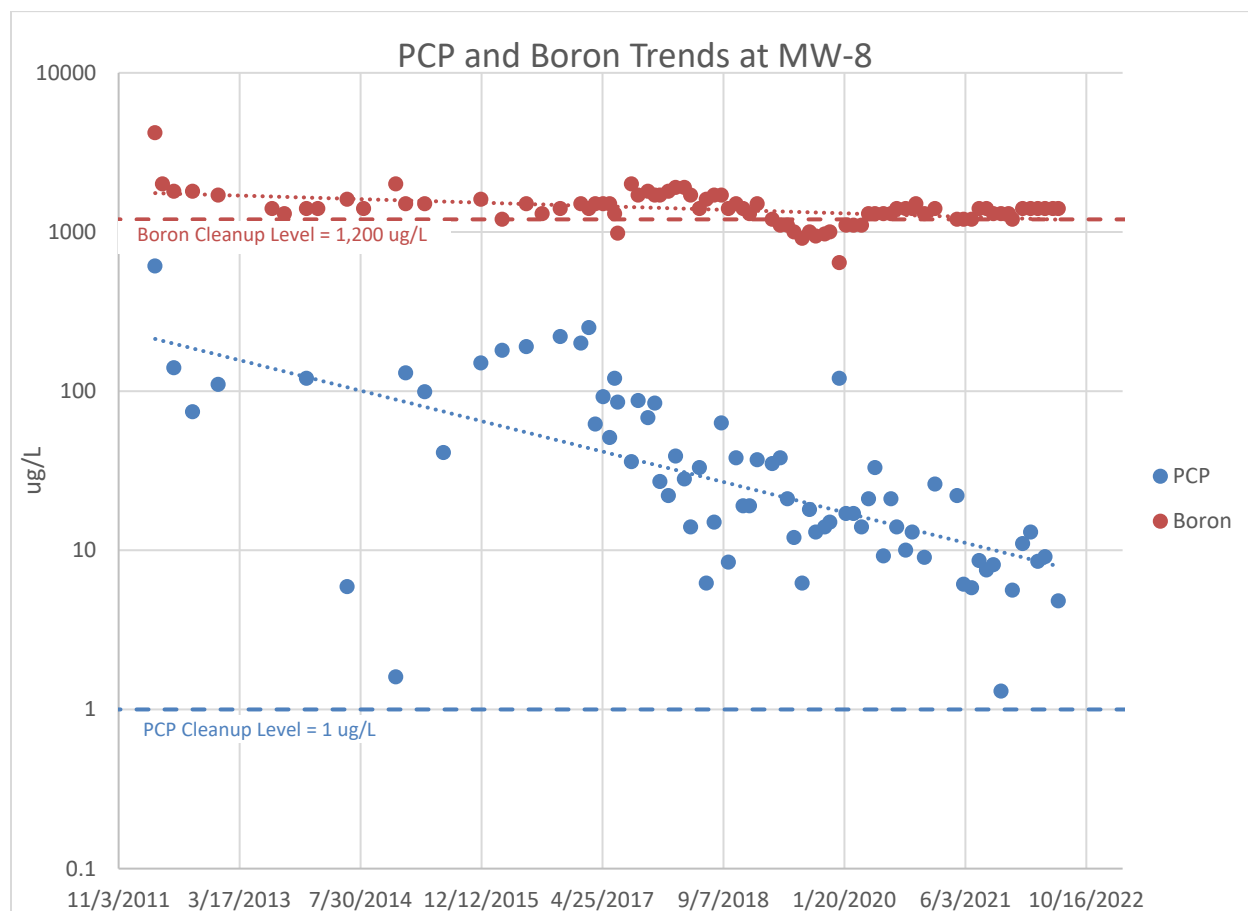
Figure 7. PCP and Boron Trends at MW-8

The remediation of the On-Property Plume has almost achieved its remedial action objective to restore groundwater to beneficial use. Currently, PCP concentrations are below the cleanup goal of 1 µg/L, with the exception of MW-8 (**Error! Reference source not found.**). MW-8 is located near the center of the PCP plume and was converted from a monitoring well to an extraction well in August 2002, primarily to increase the removal of boron, which has remained above the cleanup standard of 1,200 µg/L. During this review period, the PCP concentrations in MW-8 remained above the drinking water standard of 1 µg/L, ranging from 250 µg/L in February 2017 to 1.3 µg/L in October 2021. MW-8 was also the only well with boron concentrations exceeding the cleanup level of 1,200 µg/L with concentrations ranging from 640 µg/L in December 2019 to 2,000 µg/L in August 2017. Mann-Kendall trend analyses using the PCP and boron data from MW-8 indicates that PCP is decreasing while boron is increasing (Appendix C).

The PCP concentrations at MW-8 will likely be below the cleanup level of 1 µg/L in the next five to ten years based on the trends from the previous ten years (Figure 7). The boron concentrations are likely asymptotic and will stay near the cleanup level of 1,200 µg/L.

| Issues and Recommendations Identified in the Five-Year Review: | | | | |
|---|---|---|---|---|
| | <b>Recommendation:</b> Evaluate whether the remedy can achieve the remedy cleanup levels for boron. | | | |

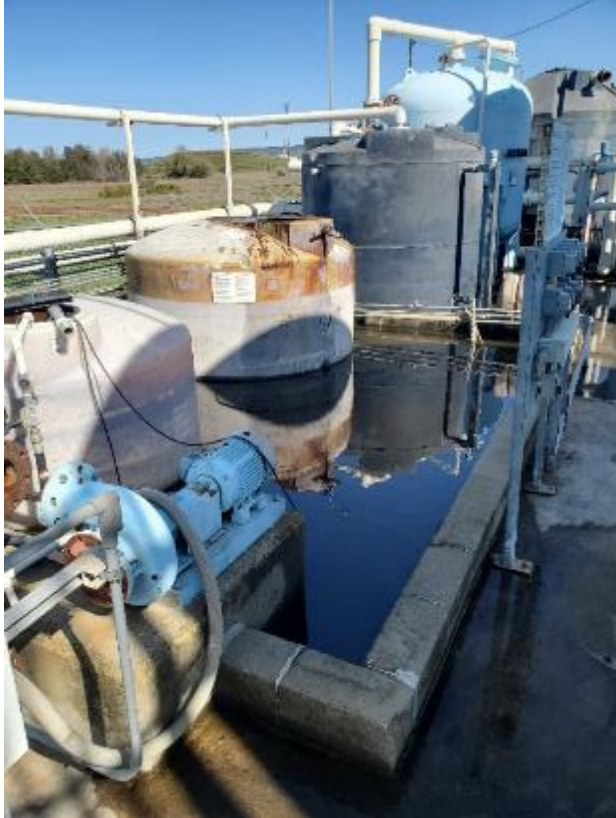
| Photo No. | Photograph and Description |
|---|---|
| 8. | <p>DNAPL storage tank. Secondary storage area contains approximately four inches of water and six to eight inches of freeboard, but presumably would spill to larger additional secondary containment area on right and foreground of photo. Facing northwest.</p> |

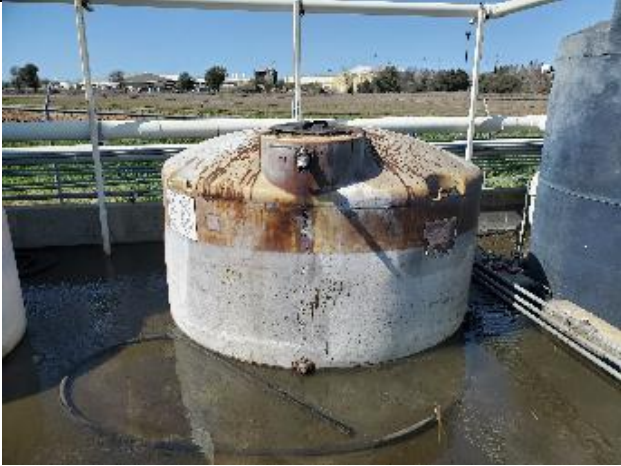
| Photo No. | Photograph and Description |
|---|---|
| 9. | <p data-bbox="344 720 1463 779">650-gallon DNAPL storage tank. Approximately 4 inches of water in secondary containment associated with recent rainfall. Facing west.</p> |

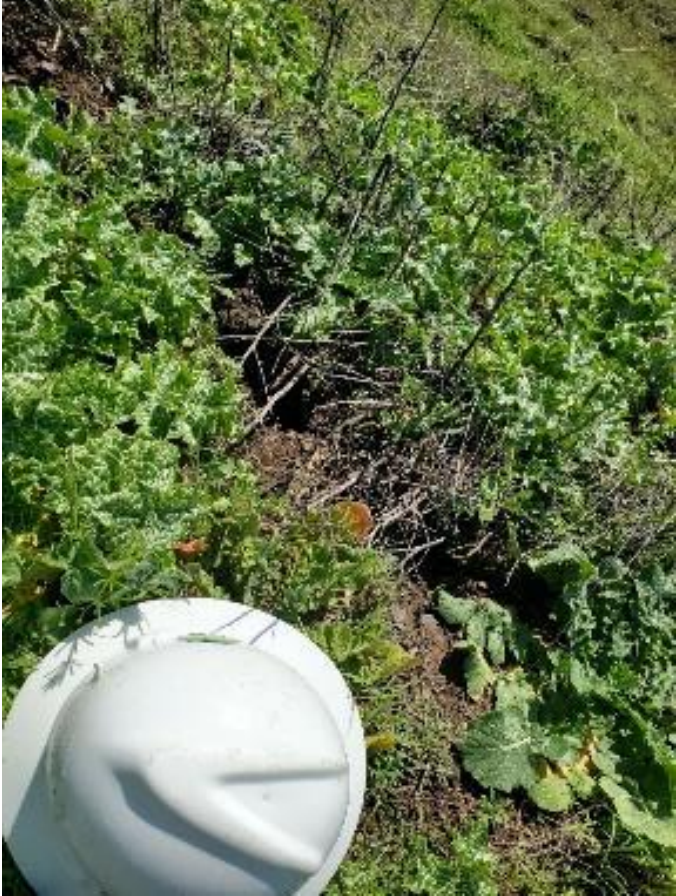
The two soil disposal cells were observed to be in good condition. A few woody plants on a soil cell were cut down and several burrowing animal holes were observed, which are reportedly filled with bentonite to discourage use. No significant runnels or erosion were observed. There was one minor but well vegetated gully on the north side of the disposal cells. Beazer indicated that the cover soil was recently resurveyed to determine whether significant settlement or erosion was occurring.

| Photo No. | Photograph and Description |
|---|---|
| 20. | <p data-bbox="344 1688 862 1715">Burrowing animal holes along access road/shelf.</p> |

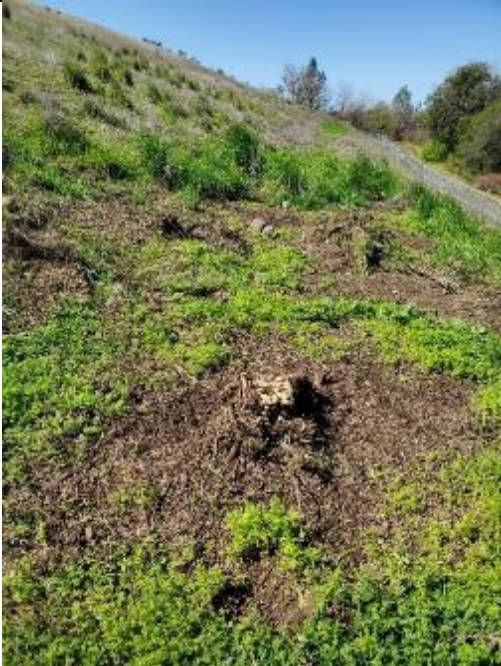
| Photo No. | Photograph and Description |
|---|---|
| 23. | <p data-bbox="344 919 1386 951">Woody plant remains, cut down to ground level. Approximately three-inch diameter. Facing west.</p> |

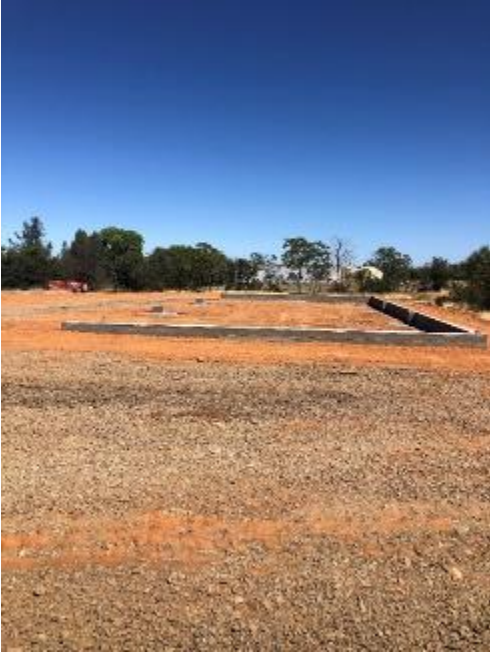
The new building constructed on top of the Toxic Pits Cleanup Act cap was also observed and photographed. Further discussion of observations of the new building is included in Appendix E.

| Photo No. | Photograph and Description |
|---|---|
| 26. | <p data-bbox="345 1617 1435 1646">During construction (July 2022) photo of equipment storage shed footing on TPCA Unit. Facing north.</p> |

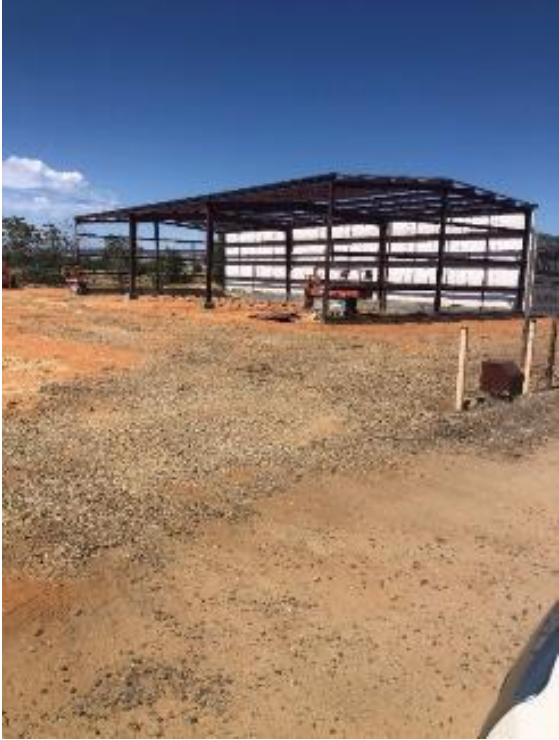
| Photo No. | Photograph and Description |
|---|---|
| 27. | <p data-bbox="344 995 1398 1024">During construction (July 2022) photo of equipment storage shed on TPCA Unit. Facing northeast.</p> |

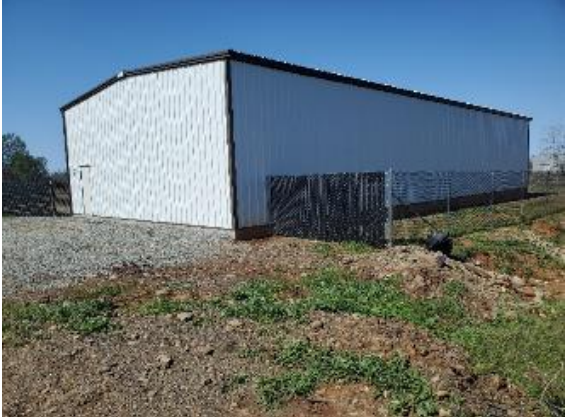
| Photo No. | Photograph and Description |
|---|---|
| 28. | <p data-bbox="344 1444 1146 1474">Current photo of equipment storage shed on TPCA Unit. Facing northwest.</p> |

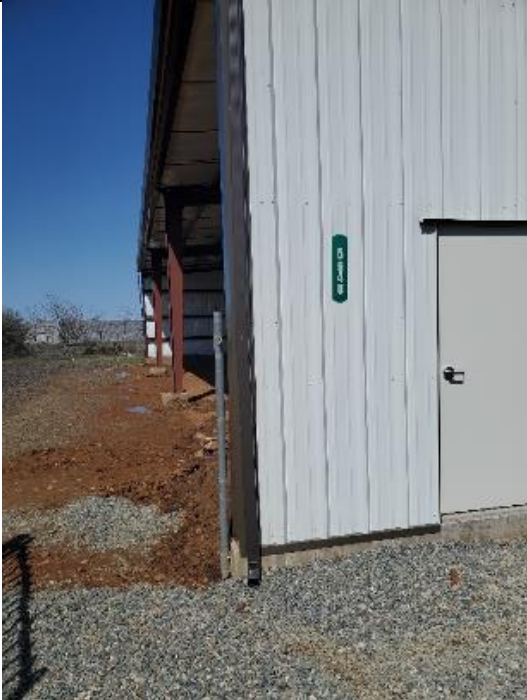
| Photo No. | Photograph and Description |
|---|---|
| 29. | <p data-bbox="344 953 1291 982">Current photo of equipment storage shed on TPCA Unit of open west wall. Facing north.</p> |

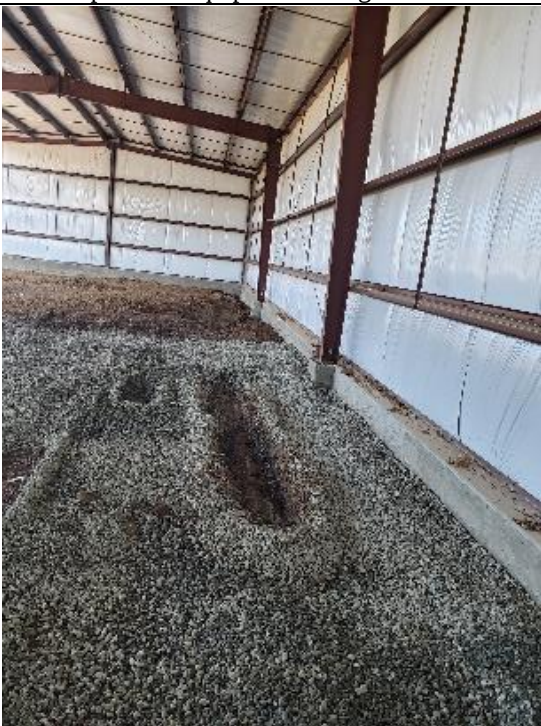
| Photo No. | Photograph and Description |
|---|---|
| 30. | <p data-bbox="344 1703 1209 1734">Current photo of interior of equipment storage shed on TPCA Unit. Facing north.</p> |

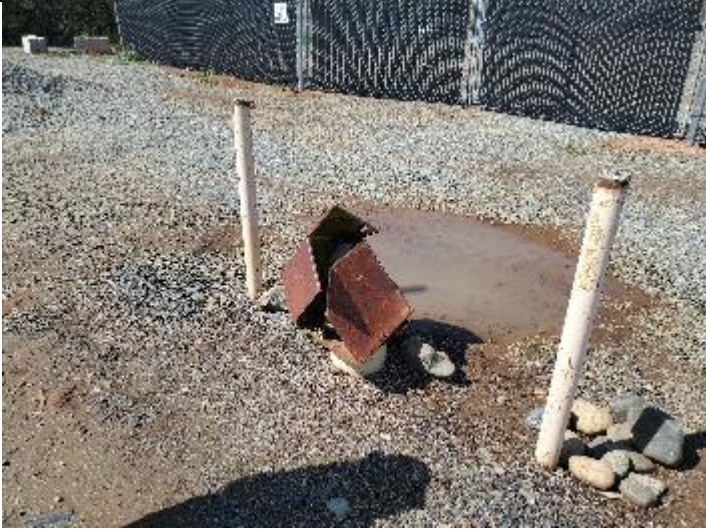
MW-18 was damaged by a vehicle. See Photo 35.

| Photo No. | Photograph and Description |
|---|---|
| 35. | <p data-bbox="344 783 1182 806">Damaged monitoring well MW-18. Storage shed fenced area is in background.</p> |

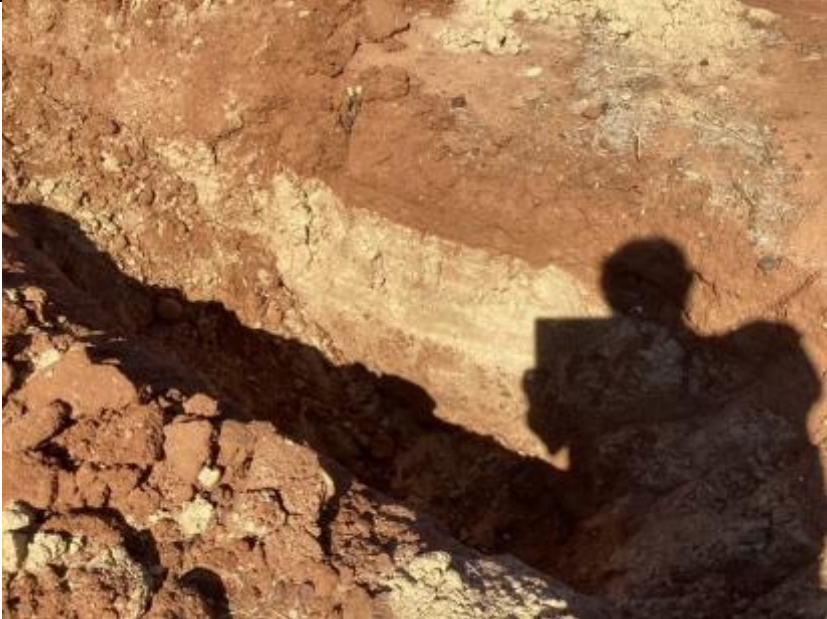
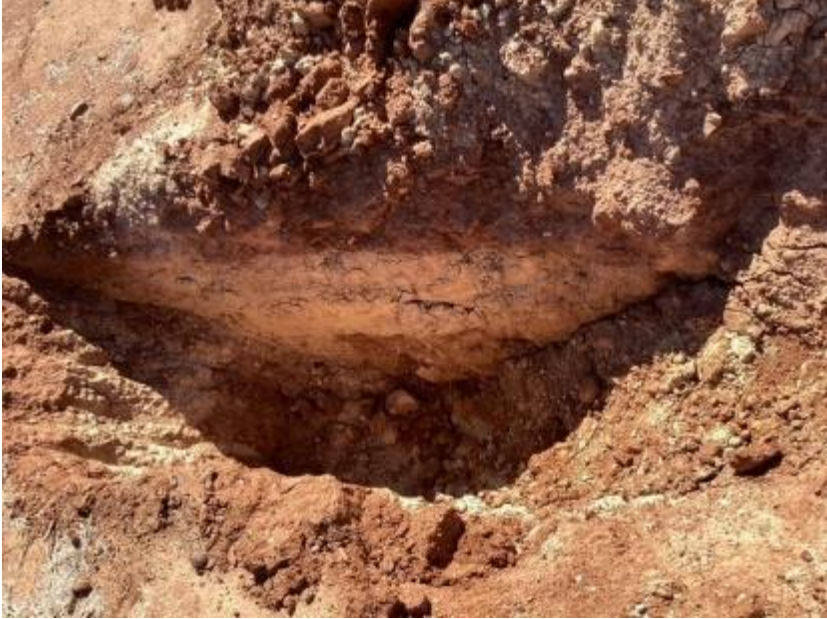
| Photo No. | Photograph and Description |
|---|---|
| 37. | <p data-bbox="344 877 1015 905">Septic tank test pit. Date, depth and specific location unknown.</p> |
| 38. | <p data-bbox="344 1528 1015 1556">Septic tank test pit. Date, depth and specific location unknown.</p> |
