Removal Site Evaluation and Interim Removal Action

Black Jack and Mac Mines

McKinley County, New Mexico

Phase 1 Summary Report

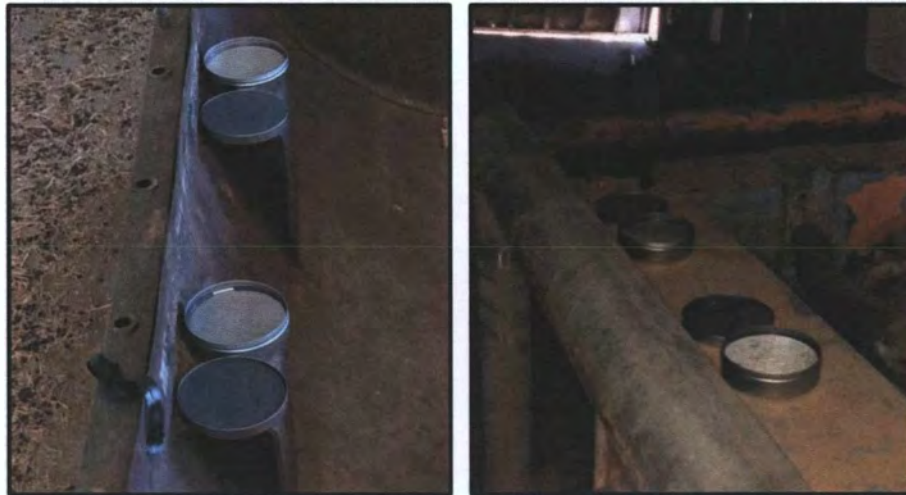
Figure 6: Short-term radon test kits as deployed in the west building (left) and east building (right) at the Mac No. 1 Mine Site.

The two buildings at the Mac No. 1 Mine were found to have considerable ventilation within these deteriorating structures due to broken windows, visible holes or openings in walls, windows or doors. Nevertheless, radon monitoring was conducted per the Phase 1 Work Plan as described in Section 3.3. Radon levels inside of these structures were consistent with typical outdoor background levels. Specifically, average results for the west and east buildings at Mac No. 1 Mine were 1.1 pCi/L and 0.8 pCi/L respectively. Data reports are provided in Appendix A (Attachment A2).

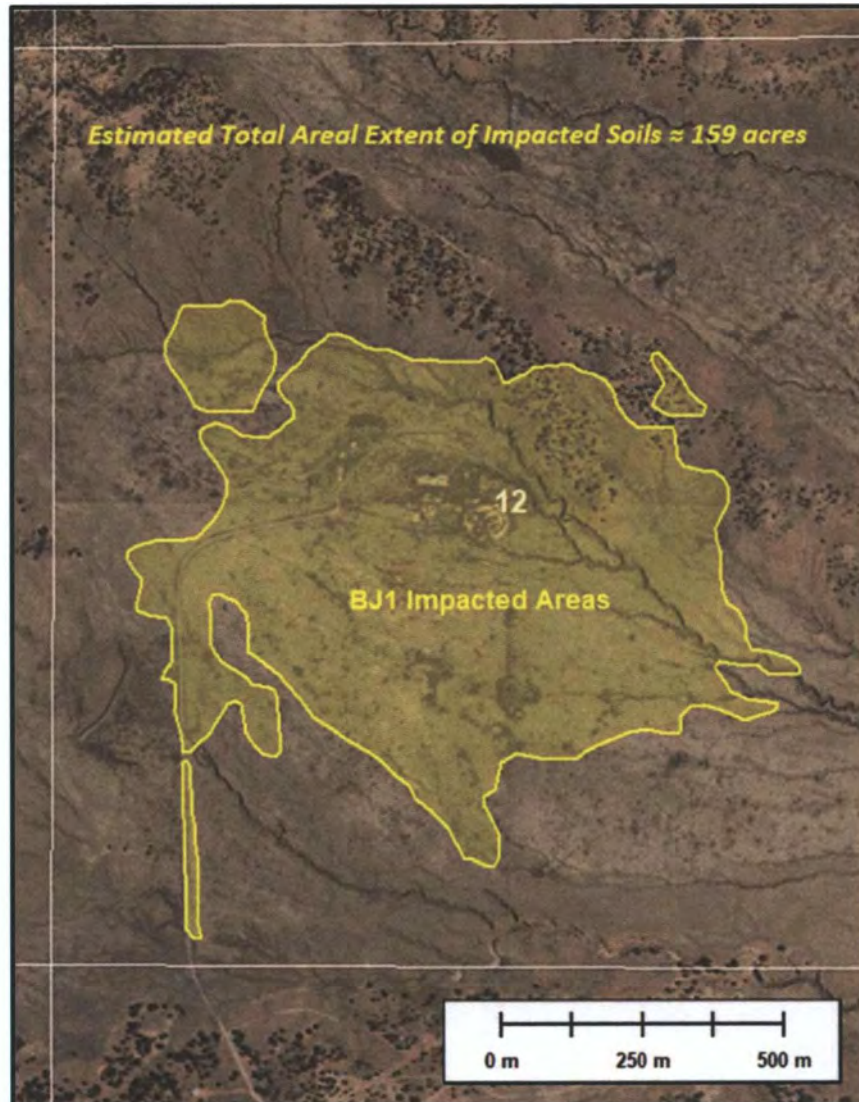
Based on the gamma survey data shown in Figure 10, along with the upper 95% tolerance interval on background gamma radiation readings in BA1 (15 μ R/hr), the estimated total areal extent of surface soils in the vicinity of the Black Jack No. 1 Mine that consistently exceeds background gamma radiation levels is 159 acres (Figure 11). Surface soils within this area are assumed to have been impacted by historic mining activities at the Black Jack No. 1 Mine Site. Near the boundaries of this delineated area, this assumption sometimes has greater uncertainty because readings that exceed background tend to be intermittent.

Figure 11: Estimated areal extent of mine-related impacts to surface soils in the vicinity of the Black Jack No. 1 Mine Site.

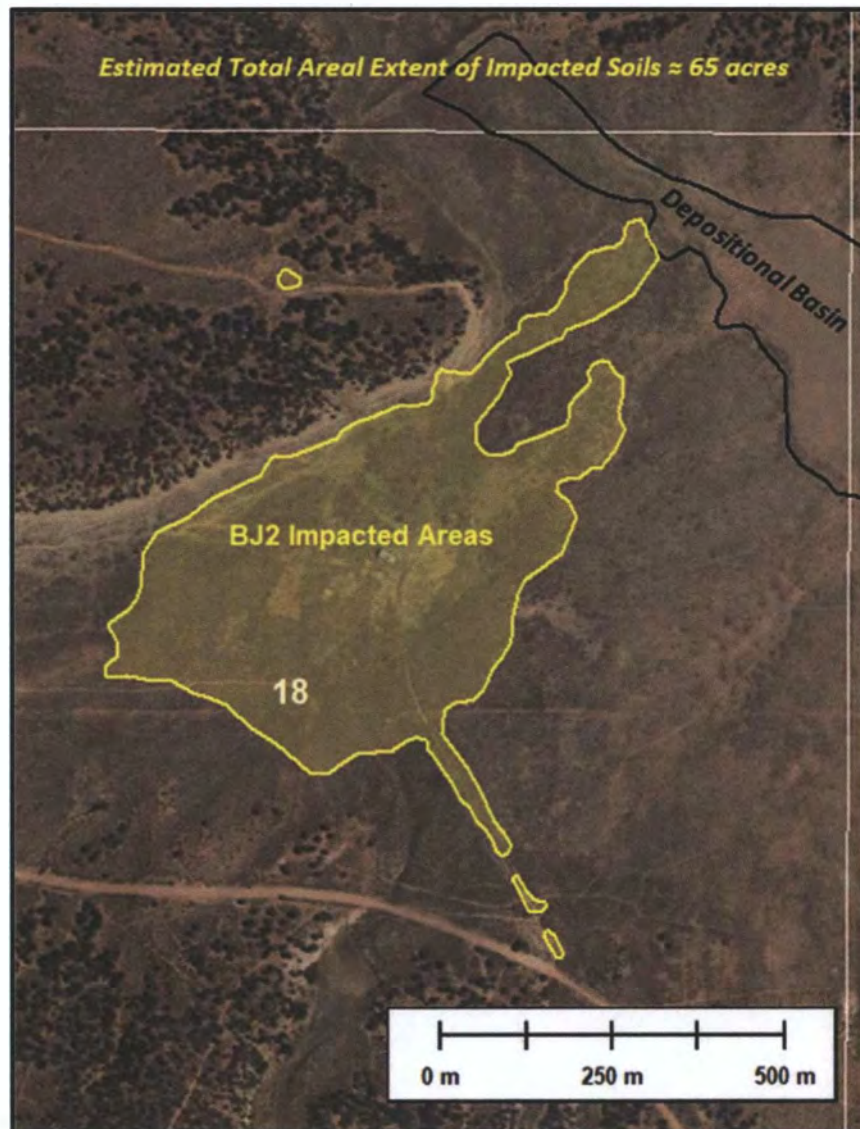
Based on the gamma survey data shown in Figure 12, along with the upper 95% tolerance interval on background gamma radiation readings in BA2 (13.7 $\mu\text{R/hr}$), the estimated total areal extent of surface soils in the vicinity of the Black Jack No. 2 Mine that consistently exceeds local background gamma radiation levels is 65 acres (Figure 13). Surface soils within this area are assumed to have been impacted by historic mining activities at the Black Jack No. 2 Mine Site. Near the boundaries of this delineated area, this assumption sometimes has greater uncertainty because readings that exceed background tend to be intermittent. In addition, there are two related areas of significance that are delineated in Figure 12 as Notes 1 and 2. These special survey notes are discussed further below.

Figure 13: Estimated areal extent of mine-related impacts to surface soils in the vicinity of the Black Jack No. 2 Mine Site.

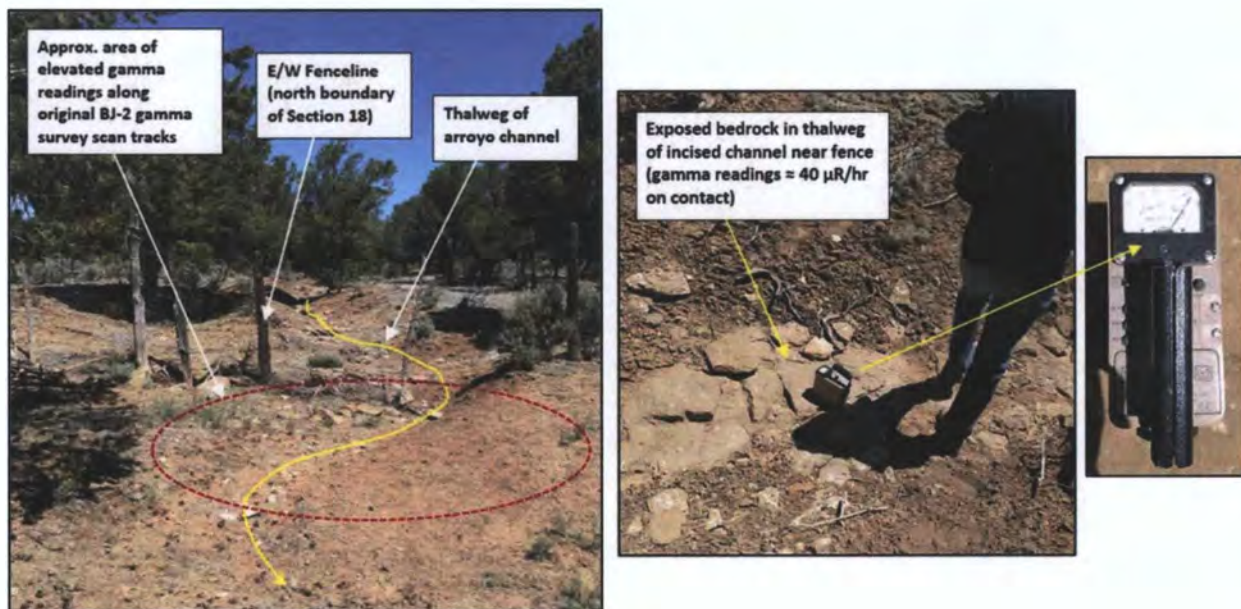
Note 1 (from Figure 8): During the gamma survey at Black Jack No. 2, field personnel attempted to bound elevated gamma readings along a drainage to the northeast of the Site that terminates in a naturally occurring depositional basin on the floor of the valley in this area (Figure 12). This basin is identified by the U.S. Geological Survey (USGS) as upper Holocene alluvial deposits, representing more than a century of local arroyo cutting (USGS, 1990). This depositional basin appears anthropogenically influenced in the vicinity of a nearby dam and ephemeral reservoir, presumably constructed for livestock watering purposes (Figure 12). When surveyors reached this basin, gamma readings became relatively uniform at levels slightly in excess of the upper 95% tolerance interval on background gamma radiation readings in BA2 (13.7 $\mu\text{R/hr}$). These gamma emissions appear to be naturally characteristic of sediments accumulated within the basin.

Note 2 (from Figure 8): Unaware of the geologic features described in Note 1, or of their potential significance with respect to survey objectives, field personnel followed gamma readings slightly in excess of local “background” (BA2) to the northeast of the Black Jack No. 1 Mine and continued the survey onto the lower slopes of the opposite side of the valley. This scanning covered limited upgradient areas, terminating along a fenceline representing the northeast corner of Section 18 (Figure 12). Gamma readings in the northeast corner of Section 18 increased over several small, localized areas. These preliminary gamma survey data were reviewed by EPA, and on May 3, 2017, representatives of HMC, EPA and Navajo Nation EPA (NNEPA) conducted a joint field visit to investigate elevated readings in this area. It was discovered that the elevated readings are naturally occurring, the result of arroyo cutting down to local bedrock comprised of sandstone with gamma radiation emissions in excess of 40 $\mu\text{R/hr}$ on contact (Figure 14).

Figure 14: Photo diagrams of geologic features responsible for elevated gamma radiation readings found on the opposite side of the valley from the Black Jack No. 2 Mine, an area situated on an upgradient hillside in the northeast corner of Section 18.

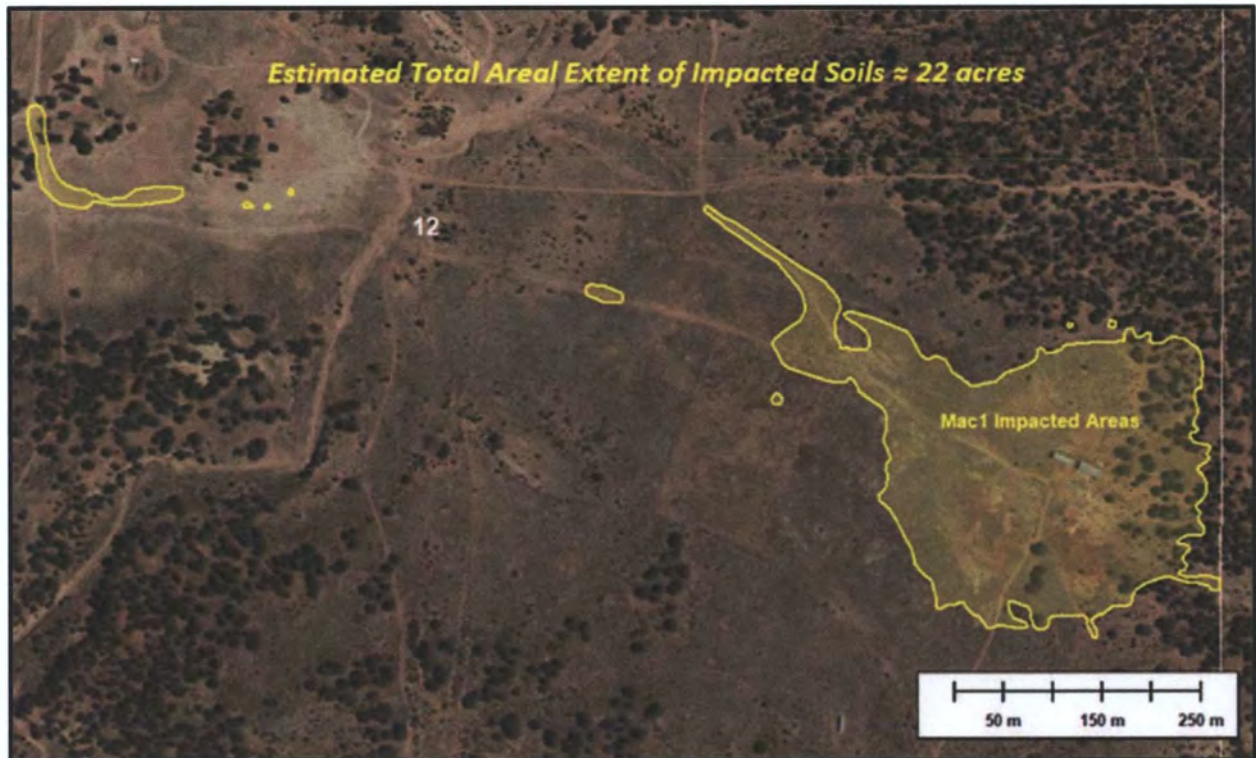
Based on the gamma survey data shown in Figure 15, along with the upper 95% tolerance interval on background gamma radiation readings in BA2 (13.7 $\mu\text{R/hr}$), the estimated total areal extent of surface soils in the vicinity of the Mac No. 1 Mine that consistently exceeds local background gamma radiation levels is 22 acres (Figure 16). Surface soils within this area are assumed to have been impacted by historic mining activities at the Mac No. 1 Mine Site. Near the boundaries of this delineated area, this assumption sometimes has greater uncertainty because readings that exceed background tend to be intermittent.

Figure 16: Estimated areal extent of mine-related impacts to surface soils in the vicinity of the Mac No. 1 Mine Site.

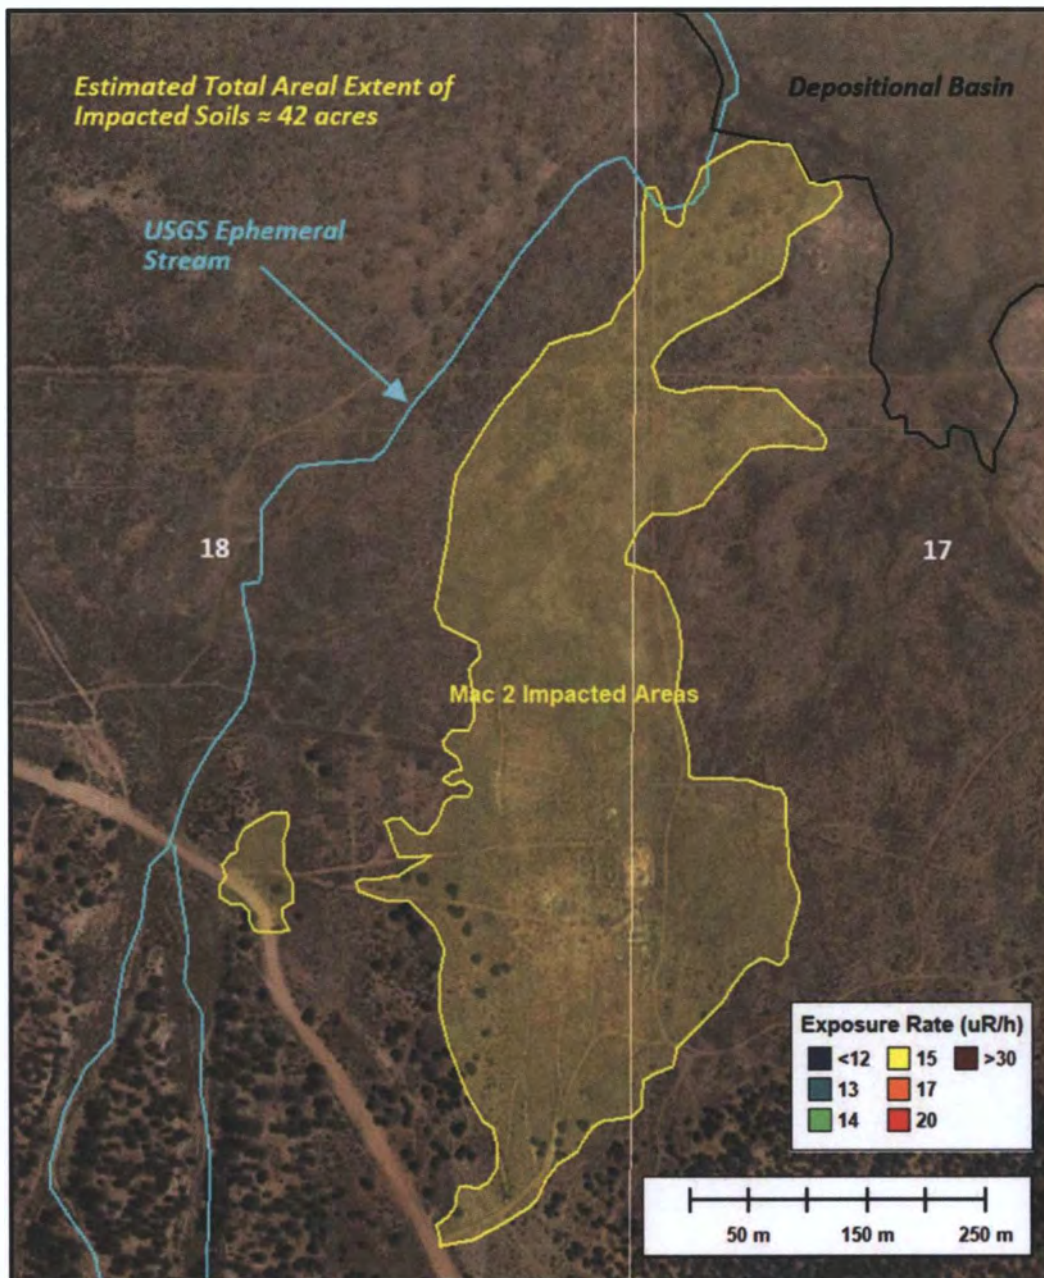
Based on the gamma survey data shown in Figure 17, along with the upper 95% tolerance interval on background gamma radiation readings in BA2 (13.7 $\mu\text{R/hr}$), the estimated total areal extent of surface soils in the vicinity of the Mac No. 2 Mine that consistently exceeds local background gamma radiation levels is 42 acres (Figure 18). Surface soils within this area are assumed to have been impacted by historic mining activities at the Mac No. 2 Mine Site. Although intermittent readings slightly greater than assumed background (i.e. > 13.7 $\mu\text{R/hr}$) are relatively pervasive to north and west of clearly impacted areas (Figure 17), this area appears hydrologically separated from those impacted areas, and lies near a historic ephemeral stream channel and zone of deposition potentially comprised of material with radiological properties similar to that found in the depositional basin as shown in Figures 12 and 13, and as discussed in Section 4.3 of this Report.

Figure 18: Estimated areal extent of mine-related impacts to surface soils in the vicinity of the Mac No. 2 Mine Site.

The consistent step-change in gamma readings at the boundary of the depositional basin in the northwest portion of Figure 17, including areas hydrologically upgradient of the confluence between mine-impacted material and the valley floor, is indicative of sediments with slightly higher natural gamma radiation emissions relative to surface soil in background reference area BA2. For this reasons, intermittent gamma readings slightly in excess of $13.7 \mu\text{R/hr}$ in this area are unlikely to be associated with mine impacts and were thus not included in the respective delineation provided in Figure 18.

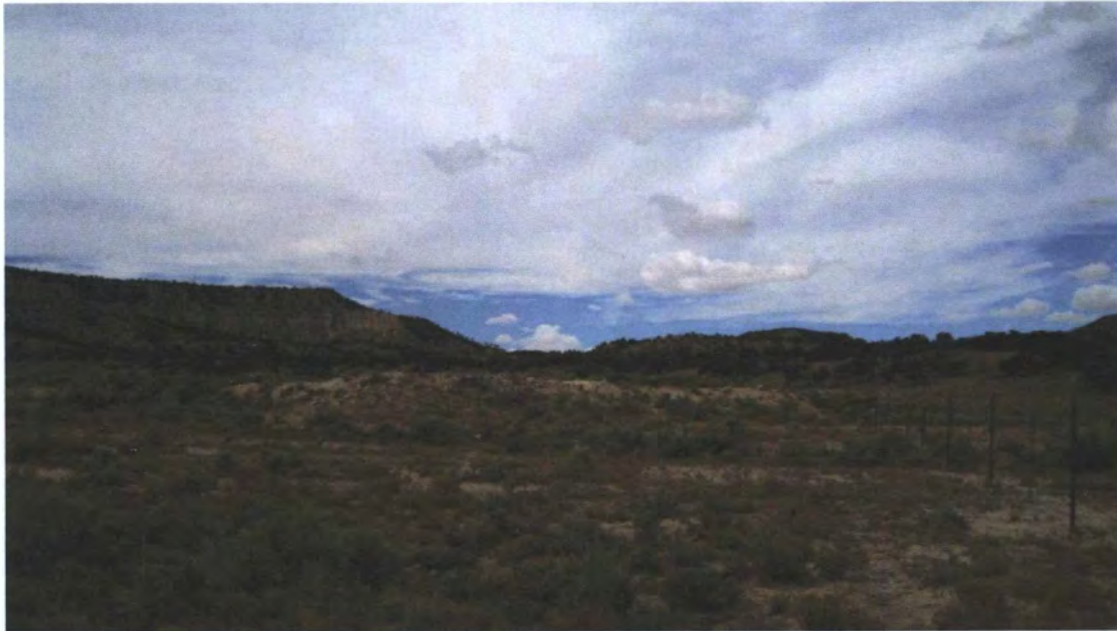
BJ1-1 Waste rock pile, looking north

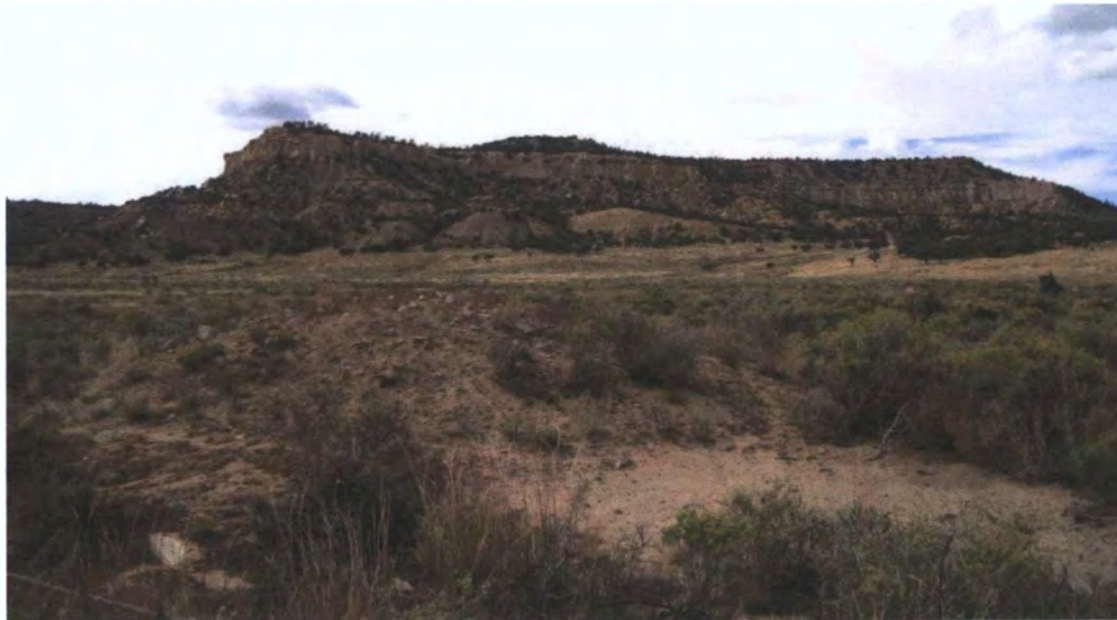
BJ1-2 Main shaft backfill (mound in foreground) looking WNW

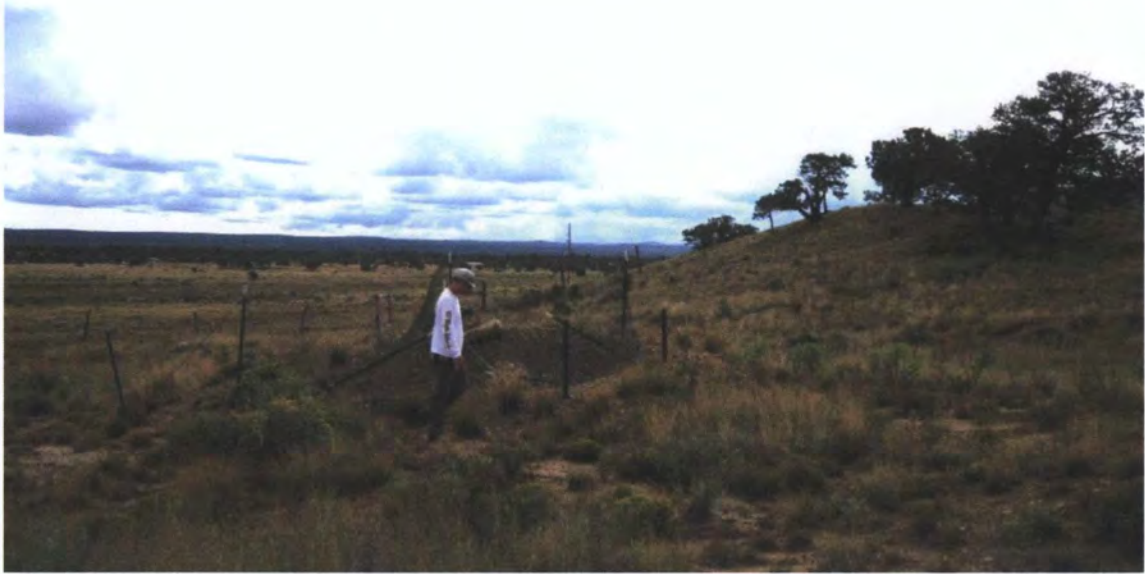
BJ1-3 North vent shaft

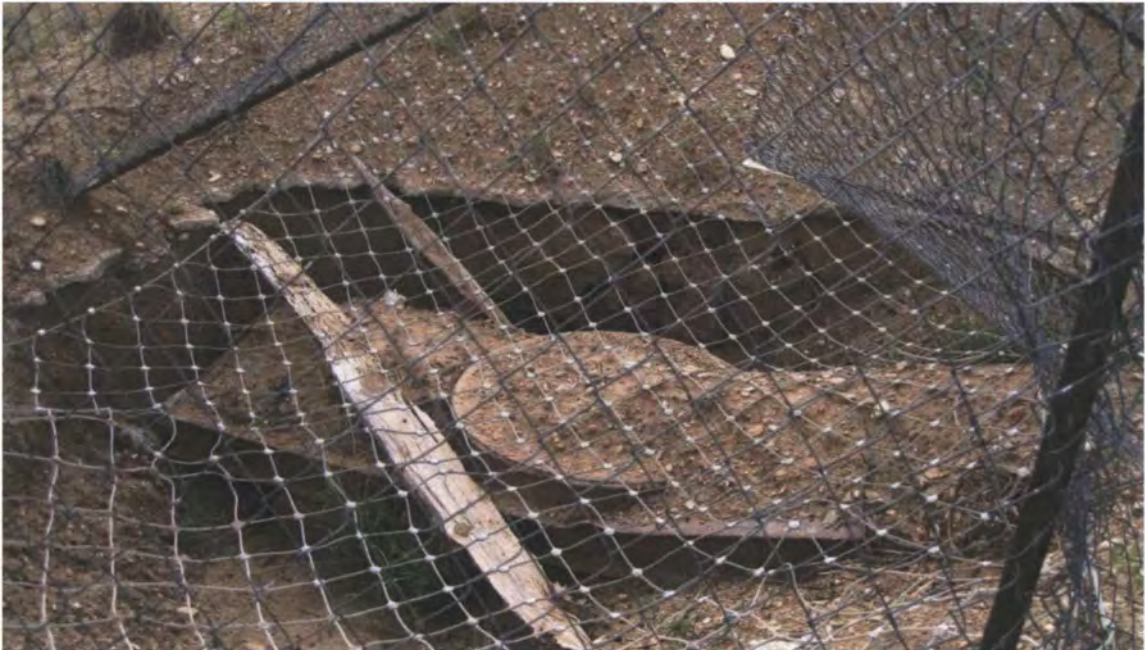
BJ1-4 Close-up view of north vent shaft

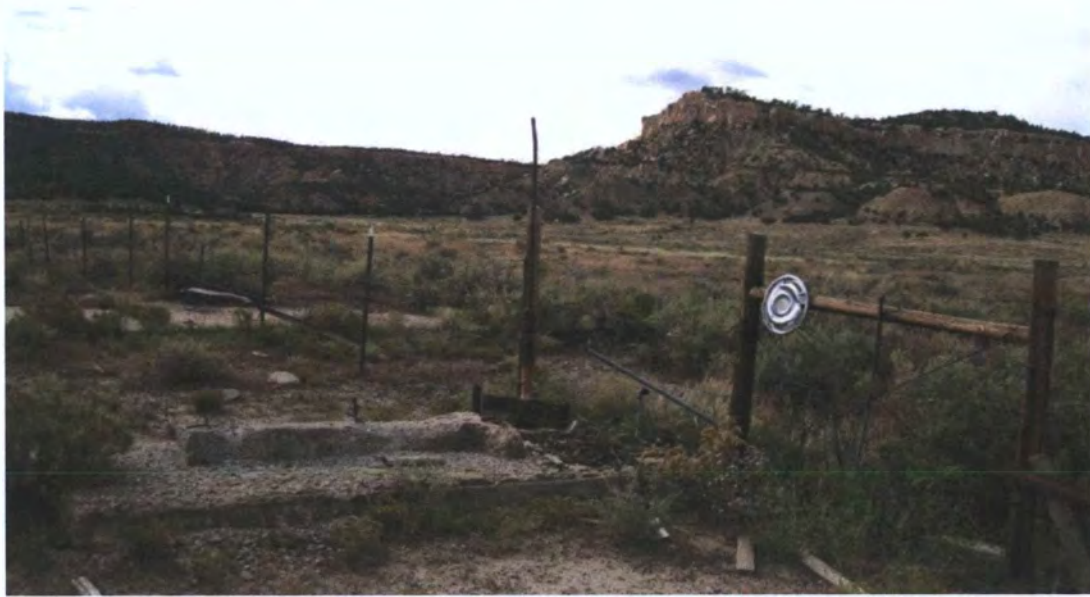
BJ1-5 Concrete foundations near main shaft

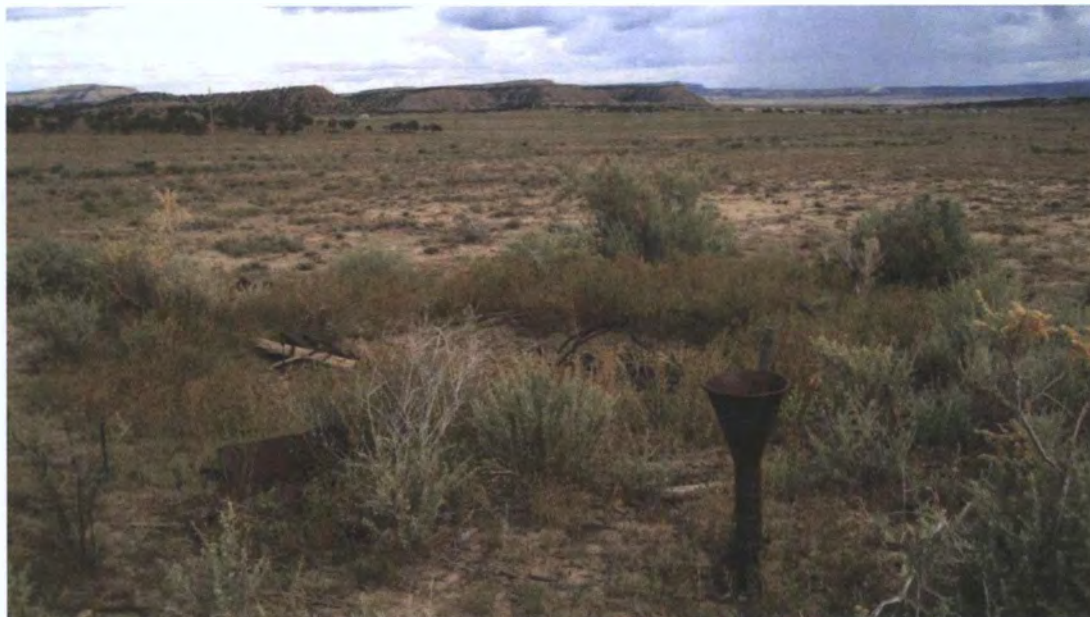
BJ1-6 Utility raise near south vent shaft

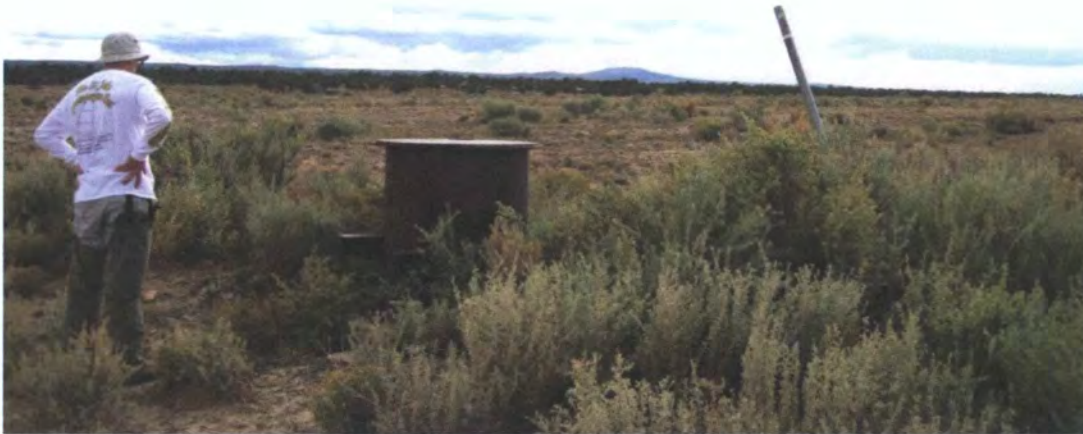
BJ1-7 South vent shaft

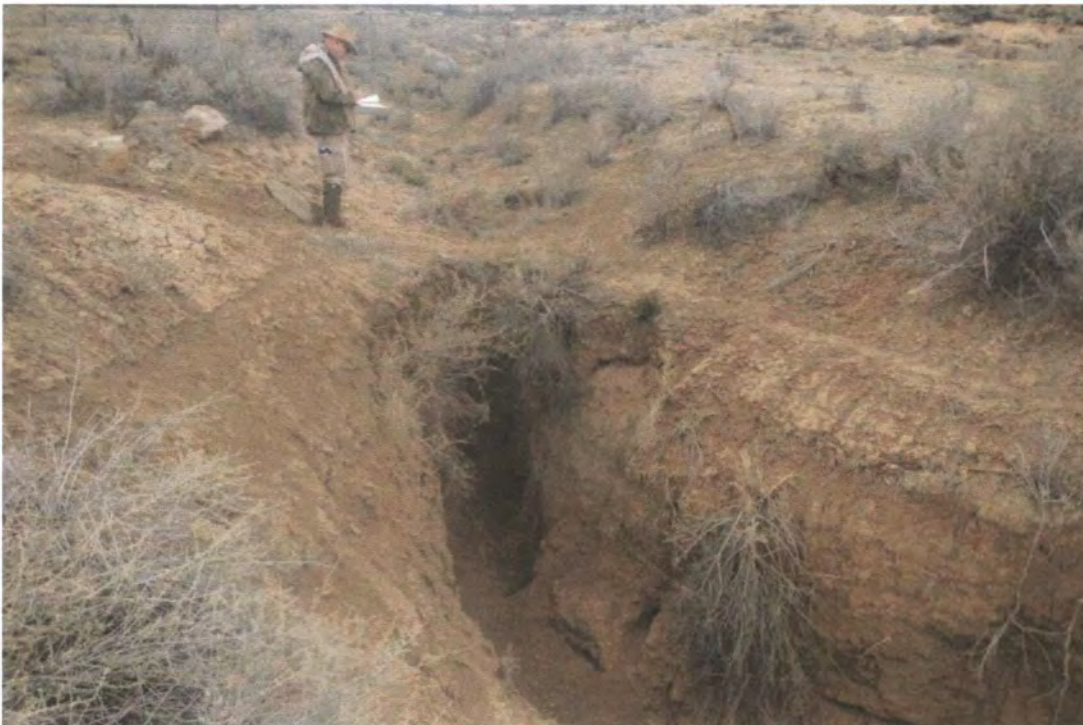
BJ1-8 Arroyo nick point (step)

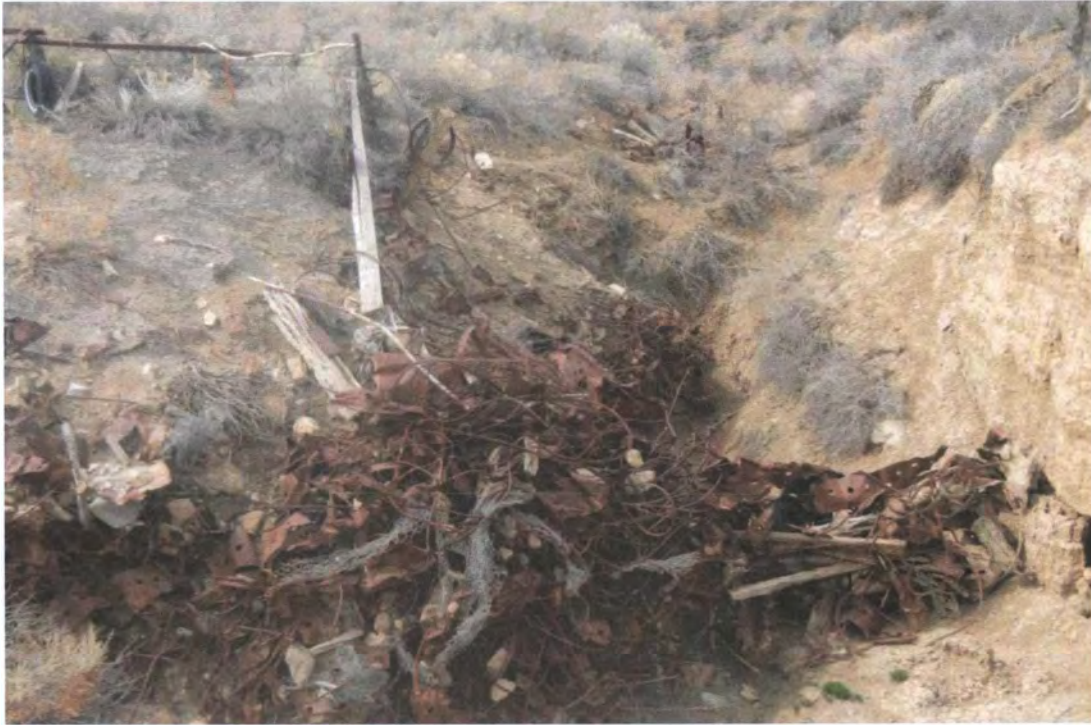
BJ1-9 Mine debris dam blocking north branch of north arroyo

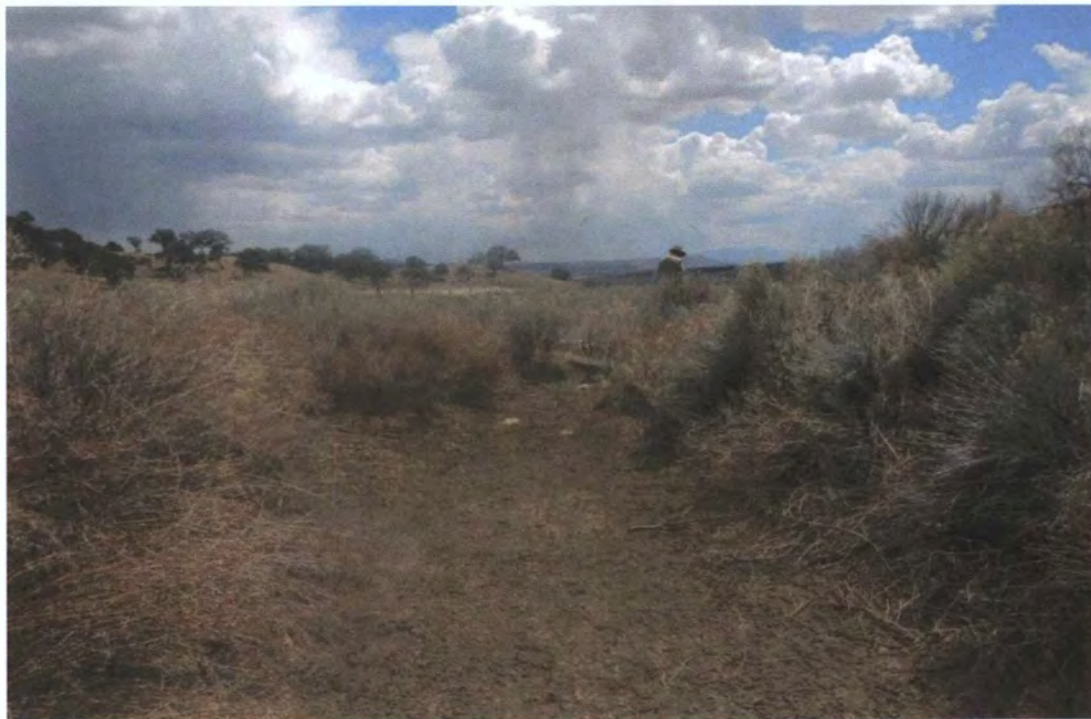
BJ1-10 Partial backfill in north branch of north arroyo

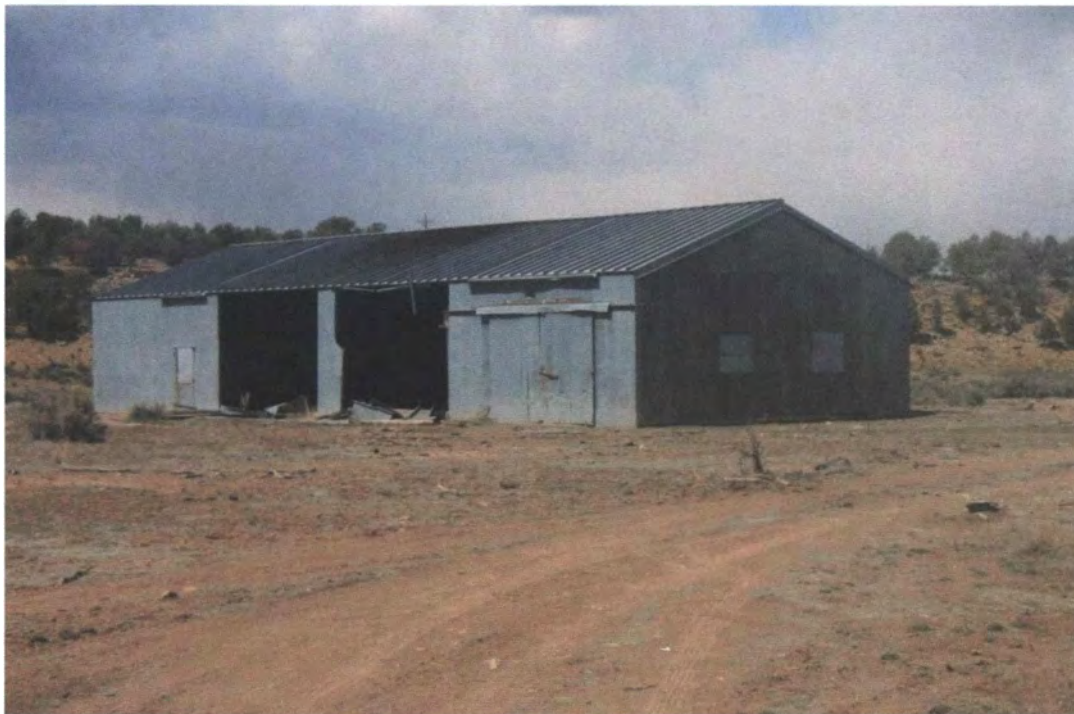
BJ2-1 Mine building

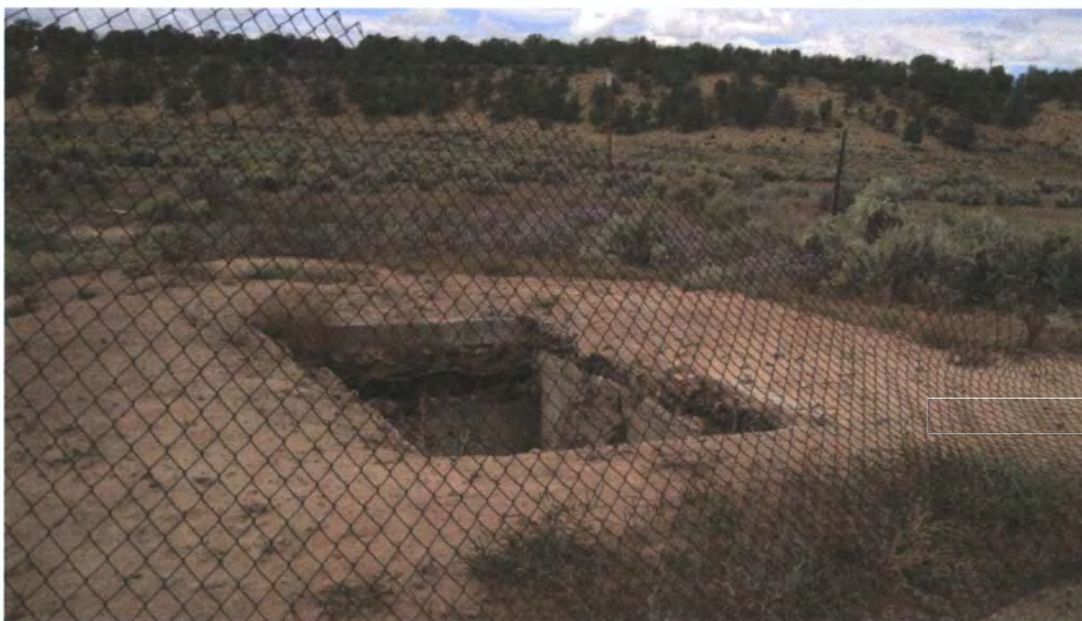
BJ2-2 Mine shaft

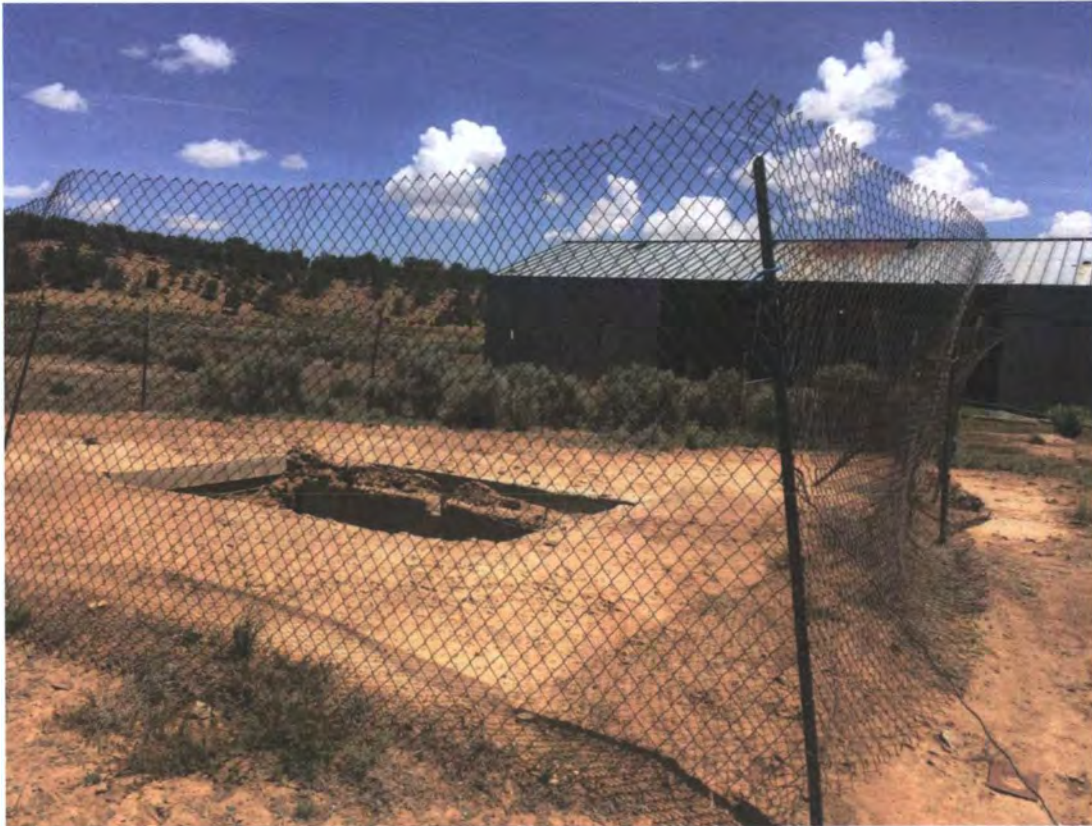
BJ2-3 Fencing around mine shaft improved in 2017, looking northwest

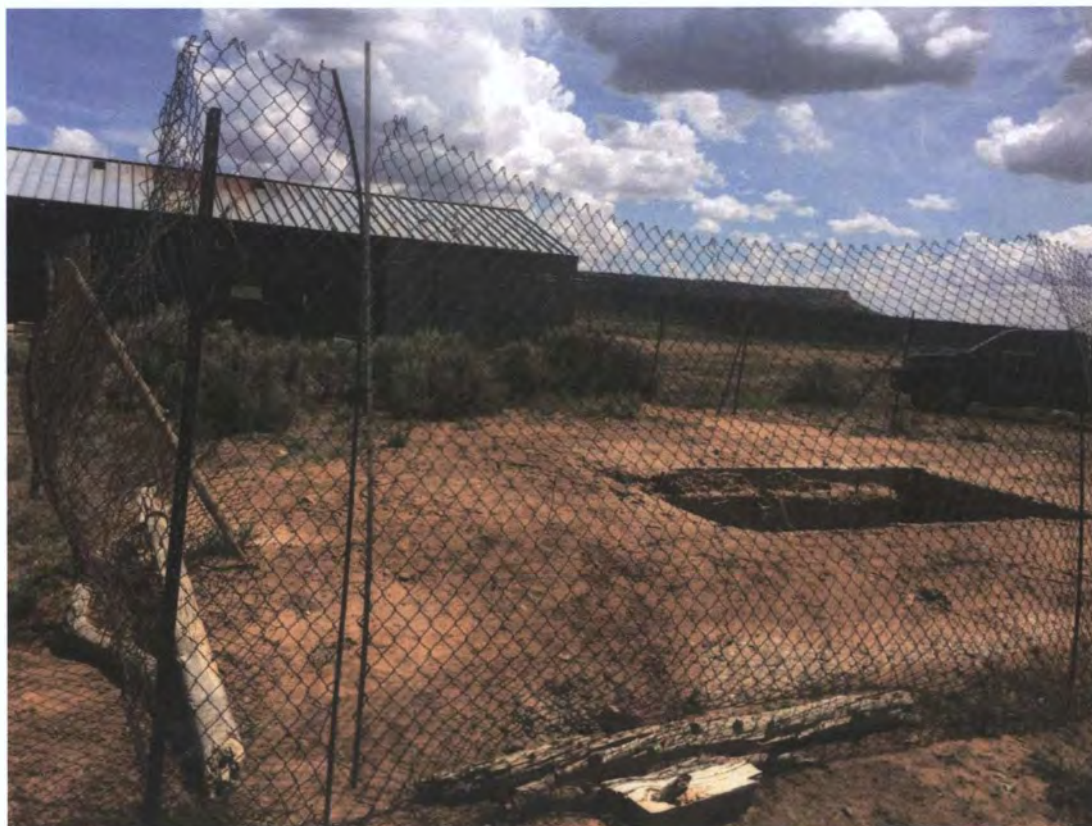
BJ2-4 Fencing around mine shaft improved in 2017, looking northeast

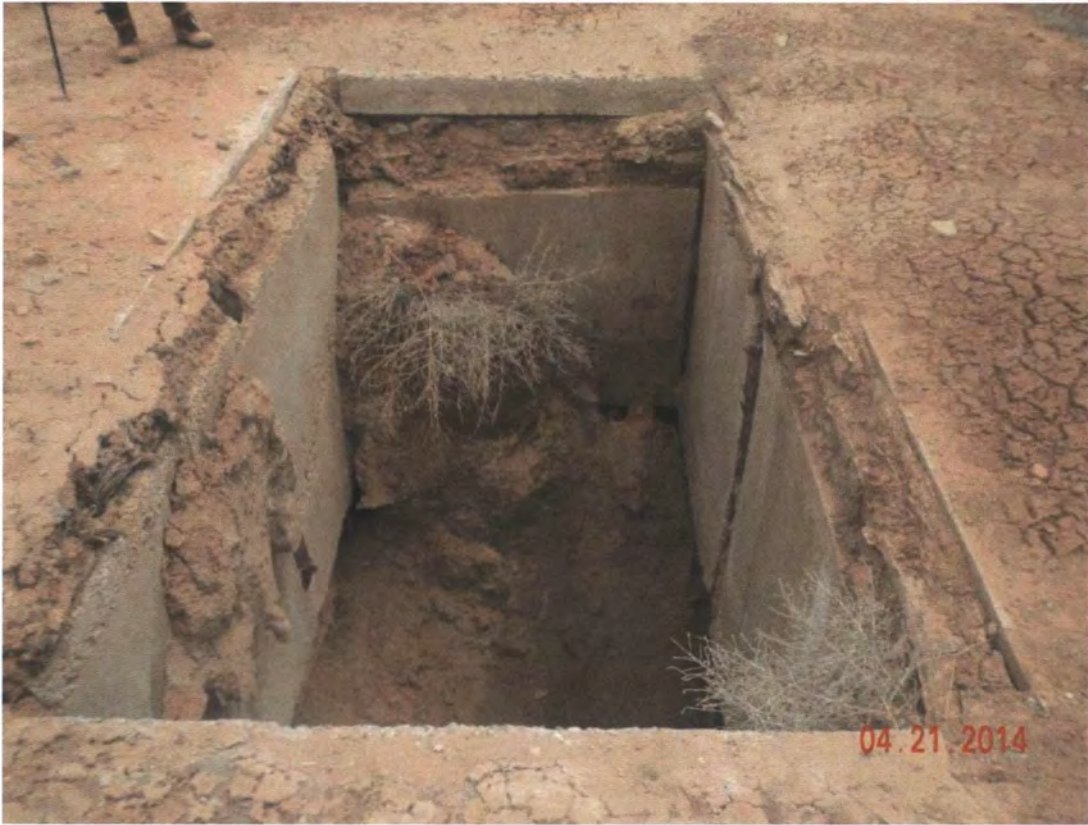
BJ2-5 Close-up of mine shaft collar

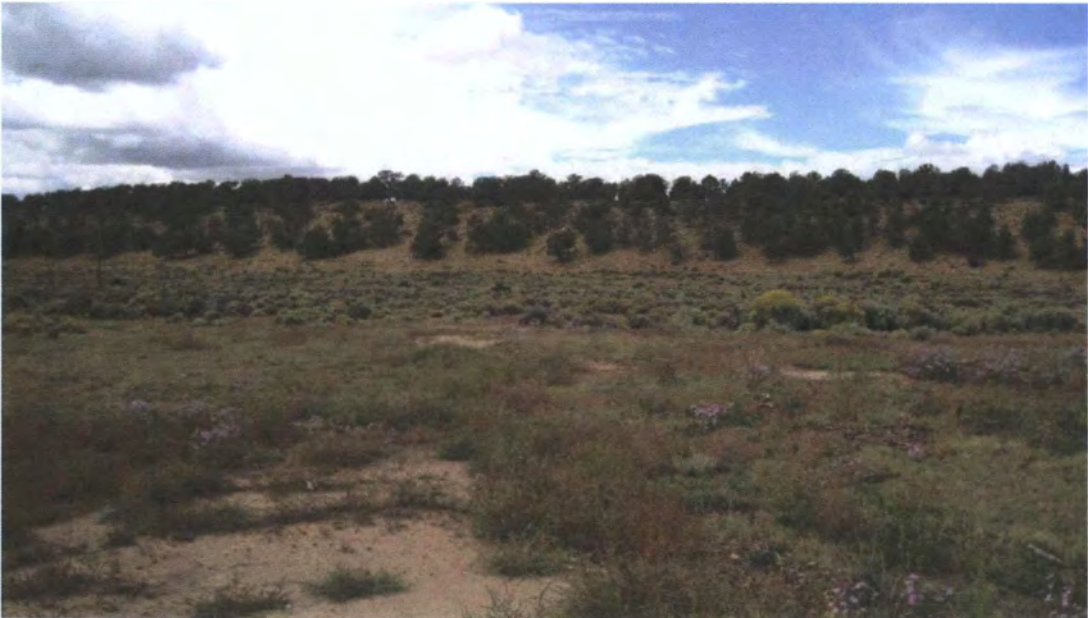
BJ2-6 Ore pad and waste pile area

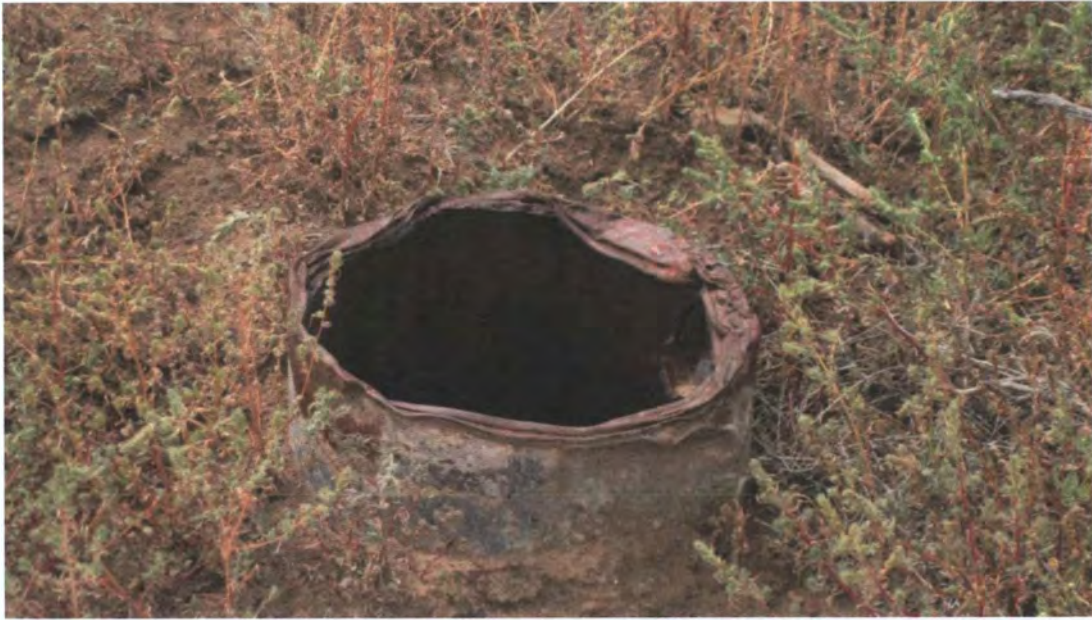
BJ2-7 Open south vent pipe west of main shaft

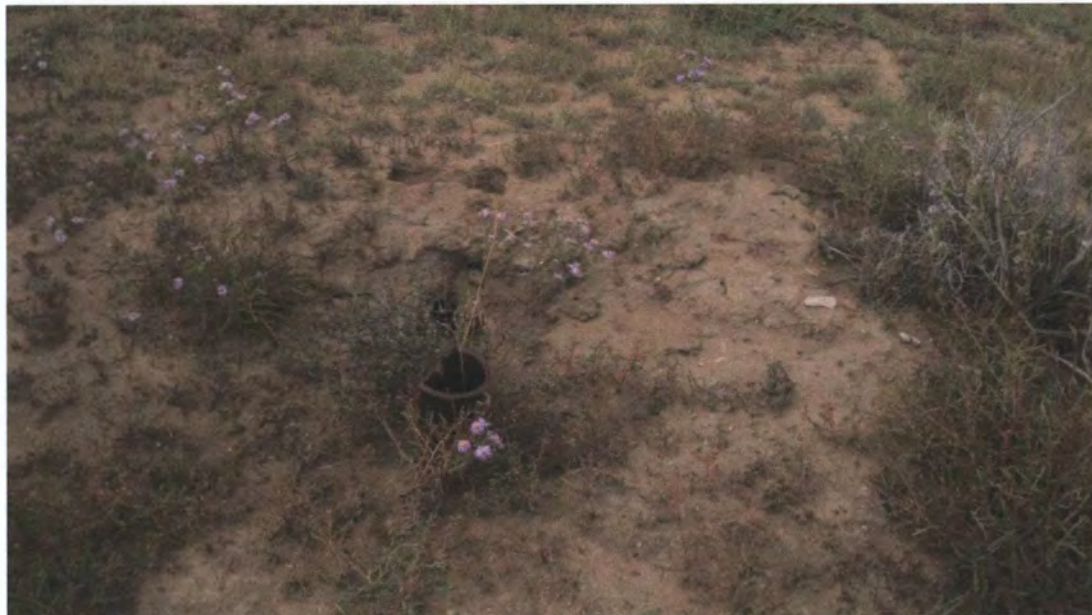
BJ2-8 Well casing or utility pipe, with backfill

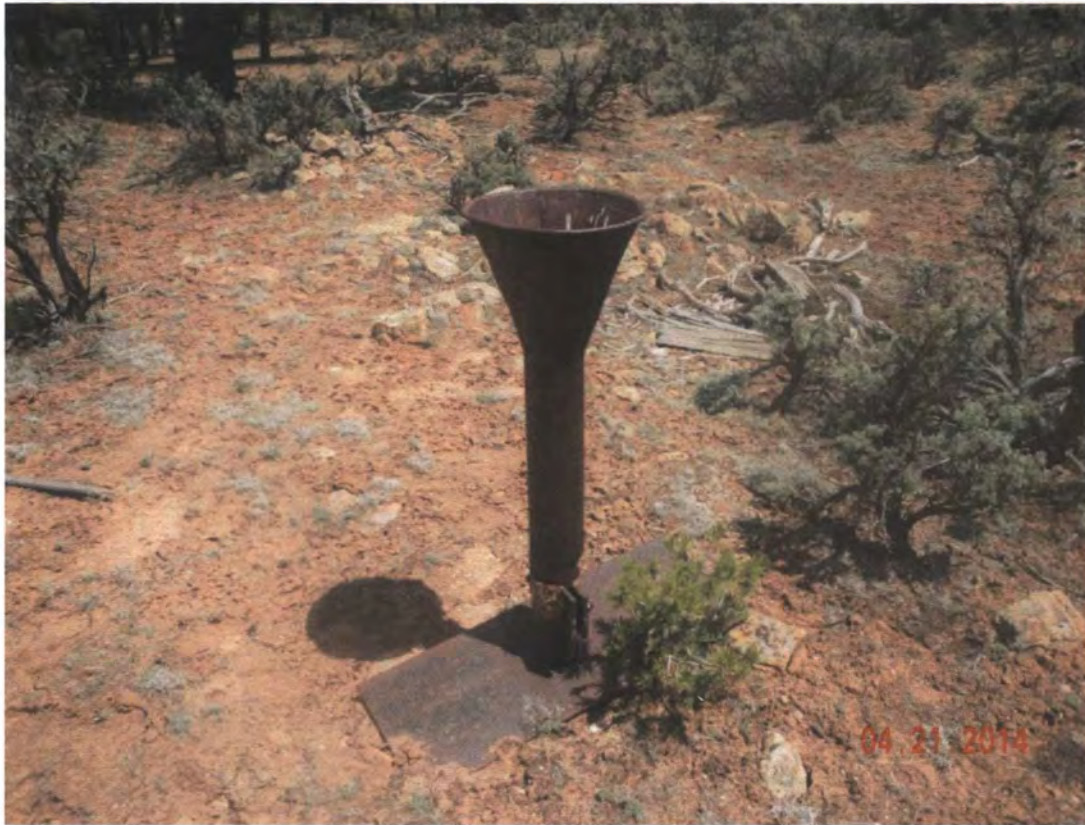
BJ2-9 Utility raise near north vent shaft

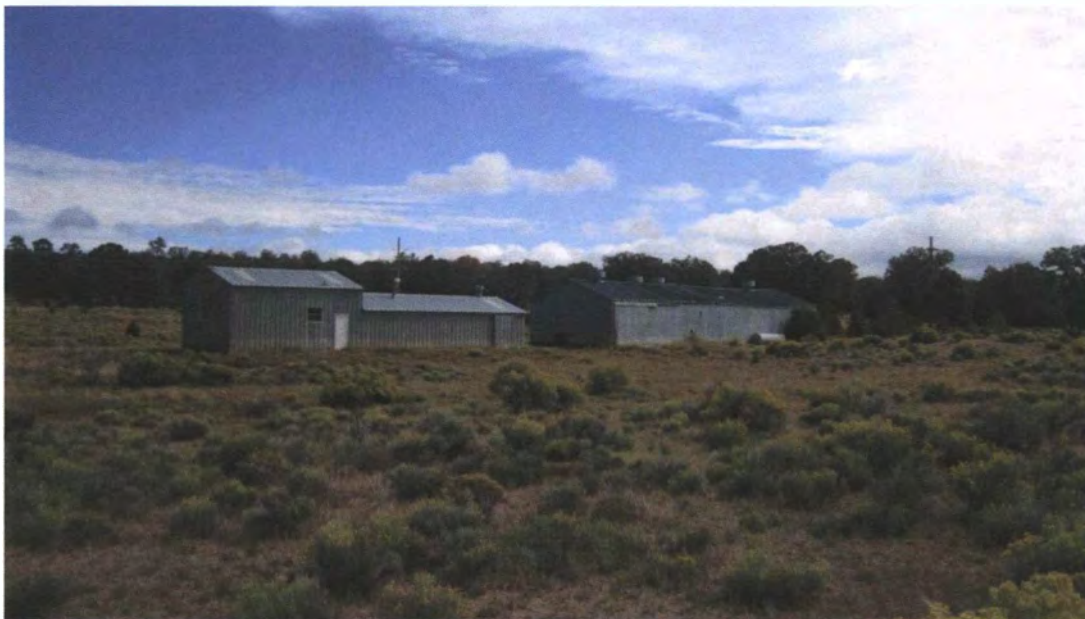
Mac1-1 Mine office building (left) and hoist/ change house (right)

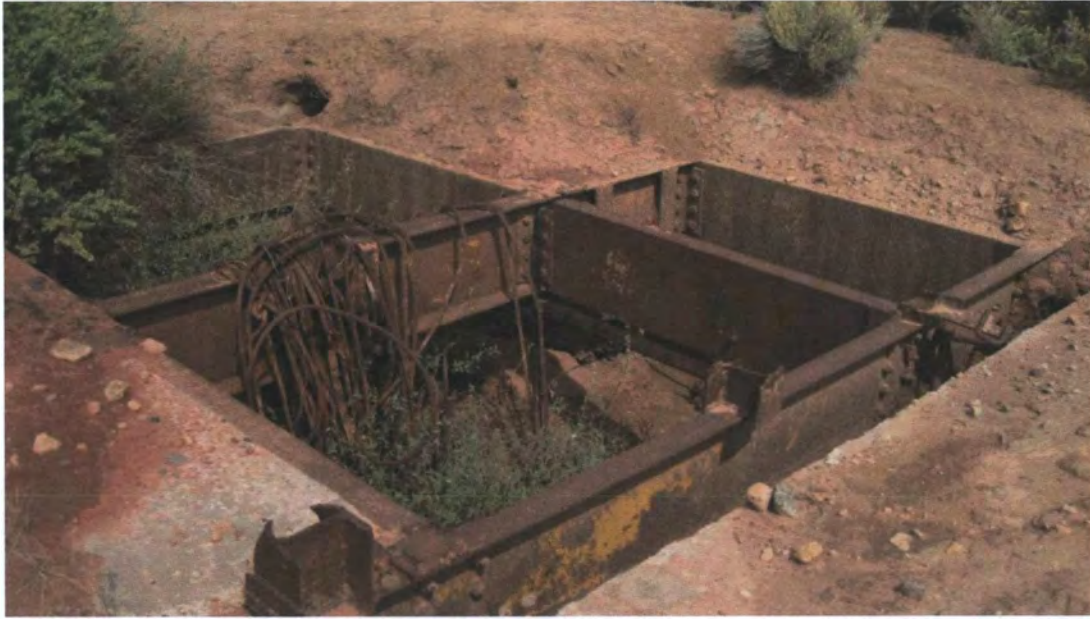
Mac1-2 Mine shaft collar
