Removal Site Evaluation and Interim Removal Action

Black Jack and Mac Mines

McKinley County, New Mexico

Phase 1 Summary Report

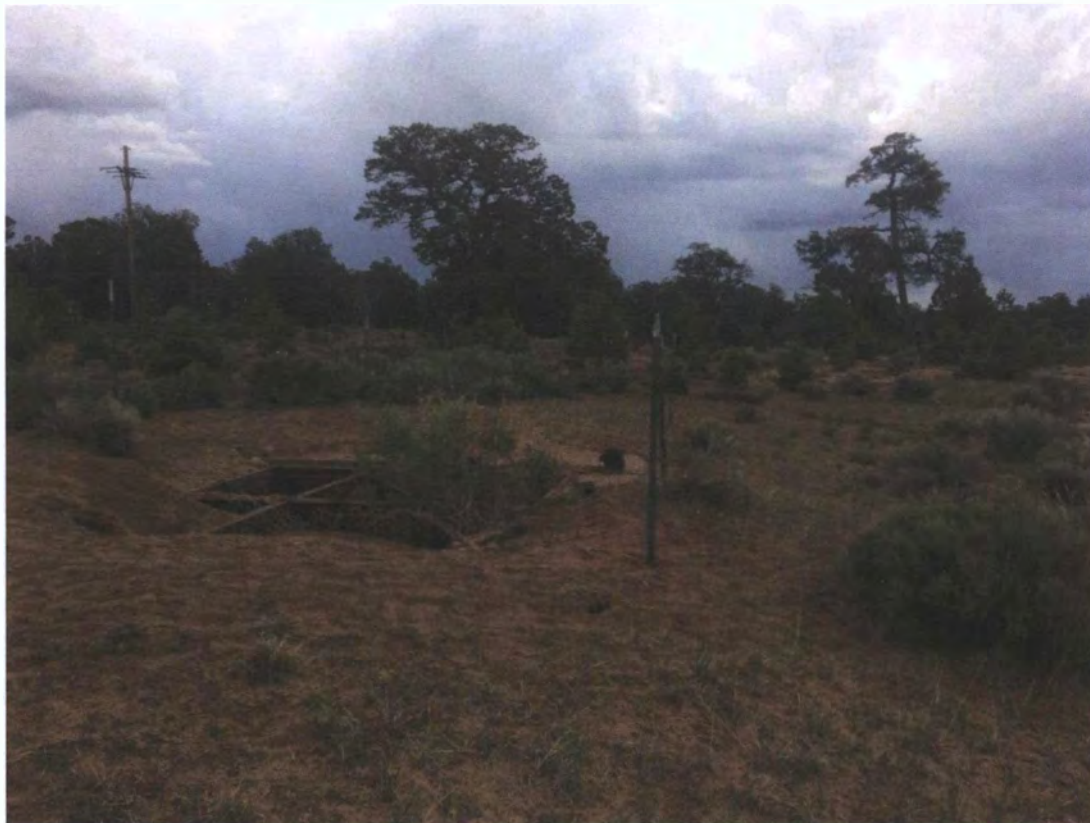
Mac1-3 Mine shaft collar with fencing installed in 2017

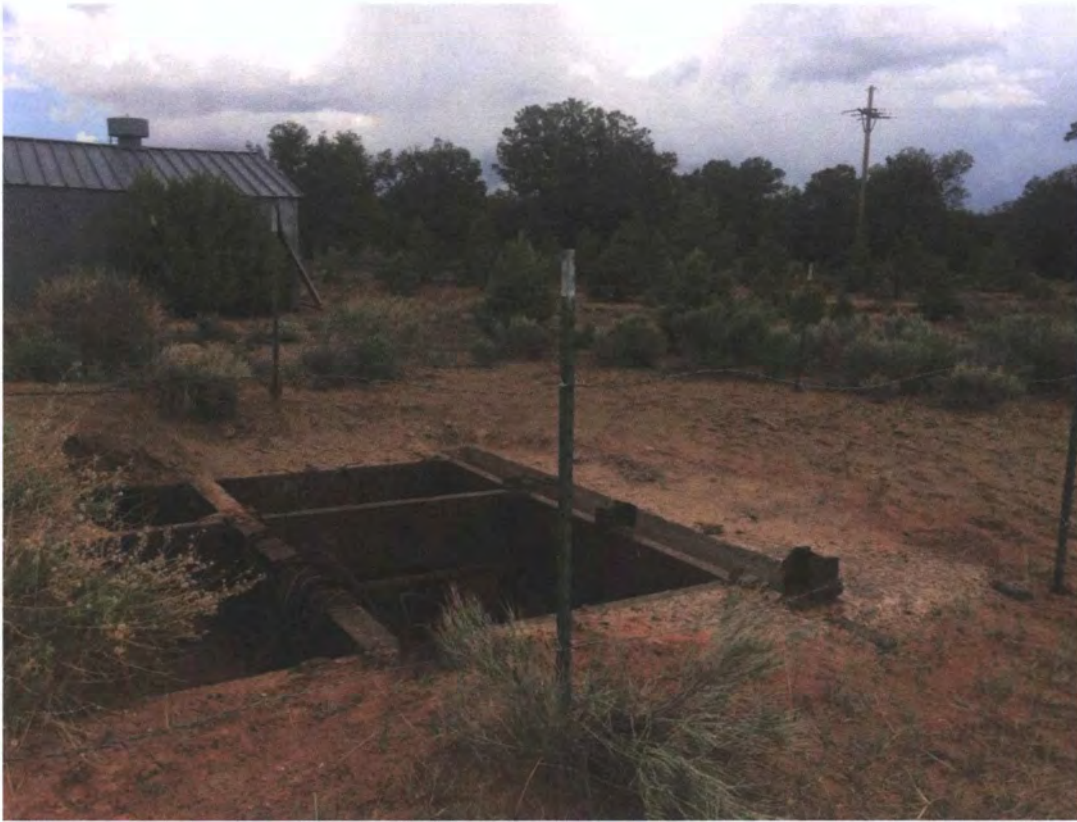
Mac1-4 Close-up of mine shaft collar with fencing installed in 2017

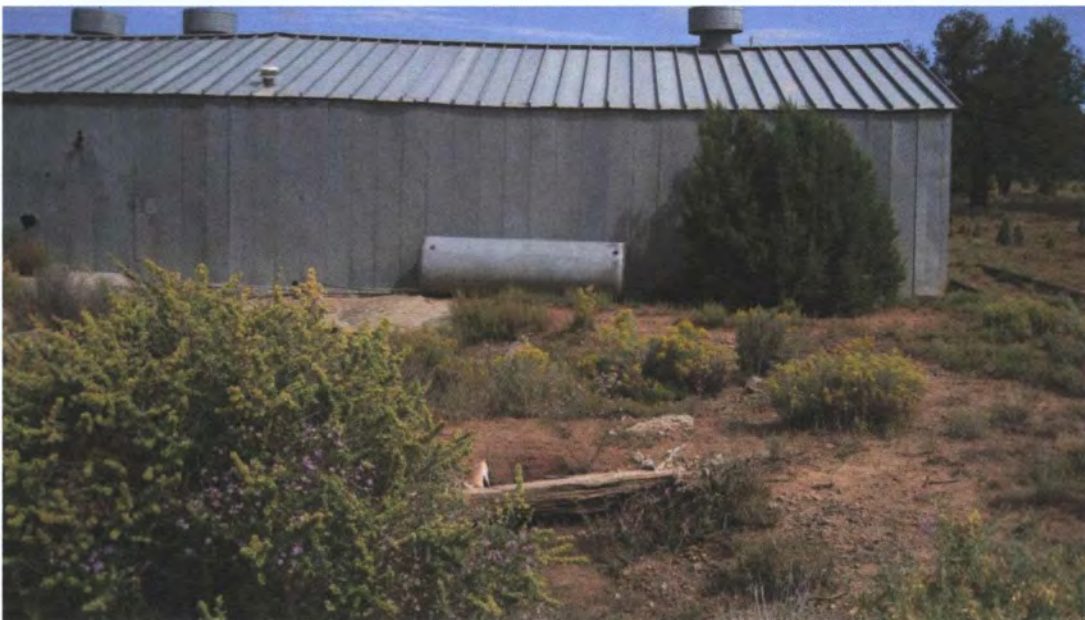
Mac1-5 Collapsed shaft tunnel (foreground, with timbers)

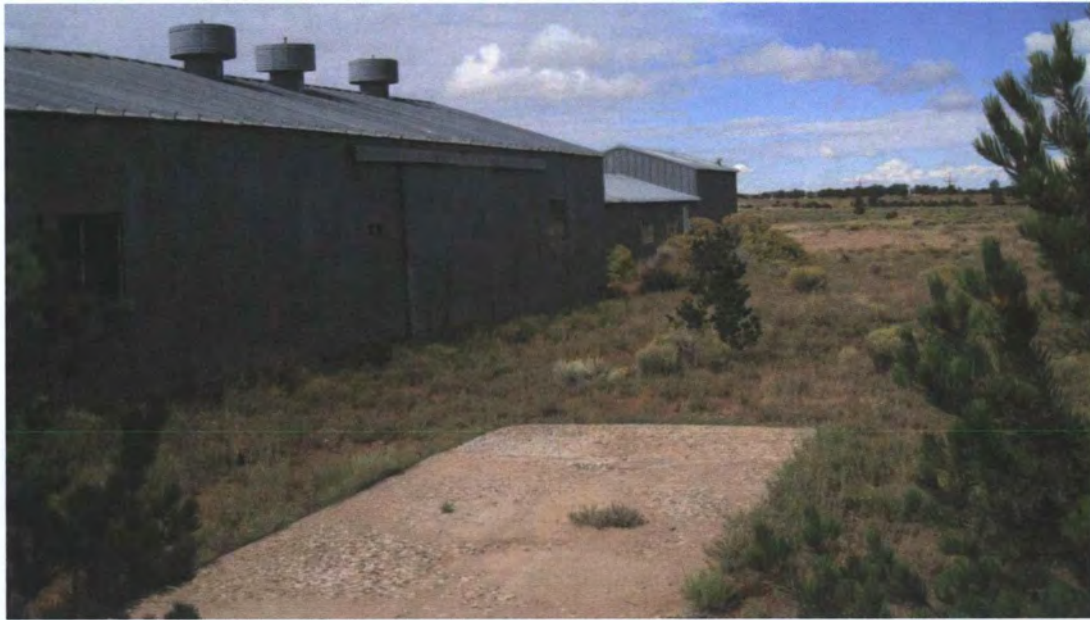
Mac1-6 Concrete slab north of hoist house

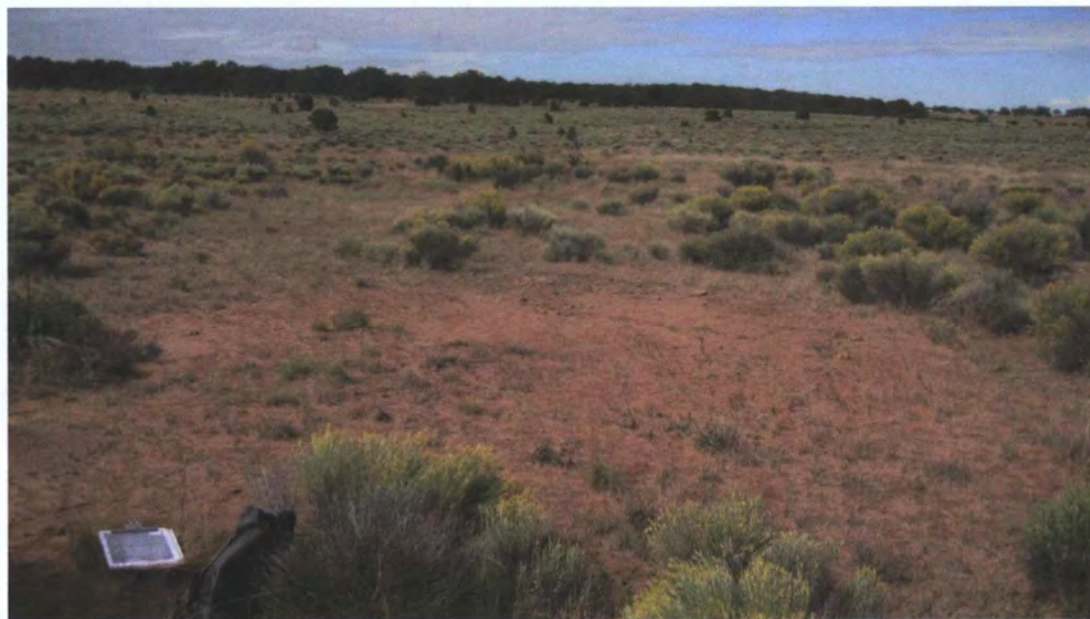
Mac1-7 Ore pad area, view to SW

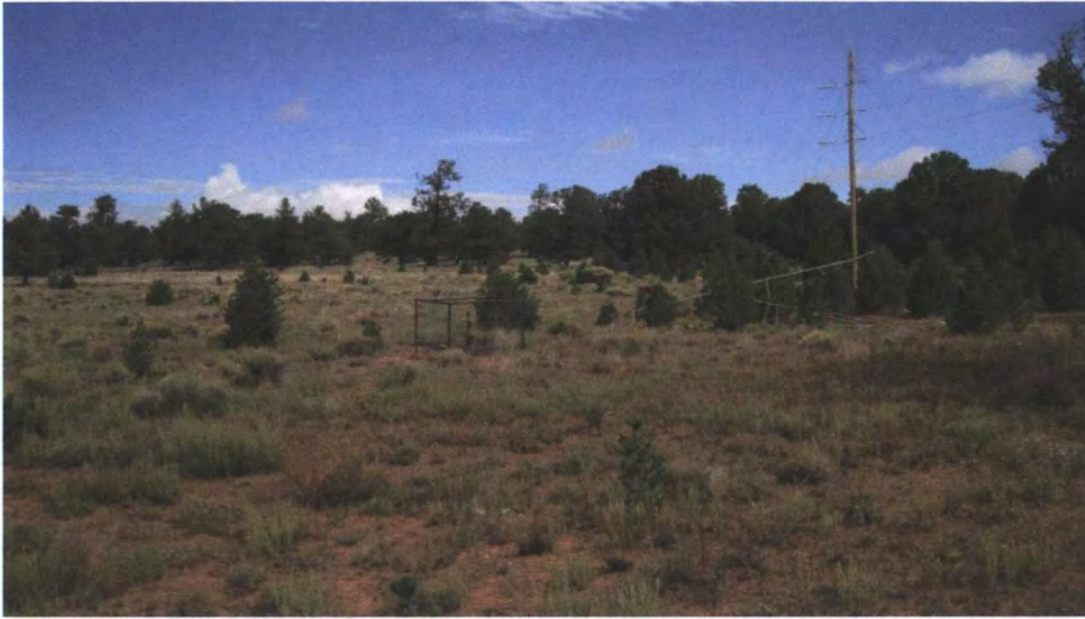
Mac1-8 Well and 10m tower (on its side), north of hoist house

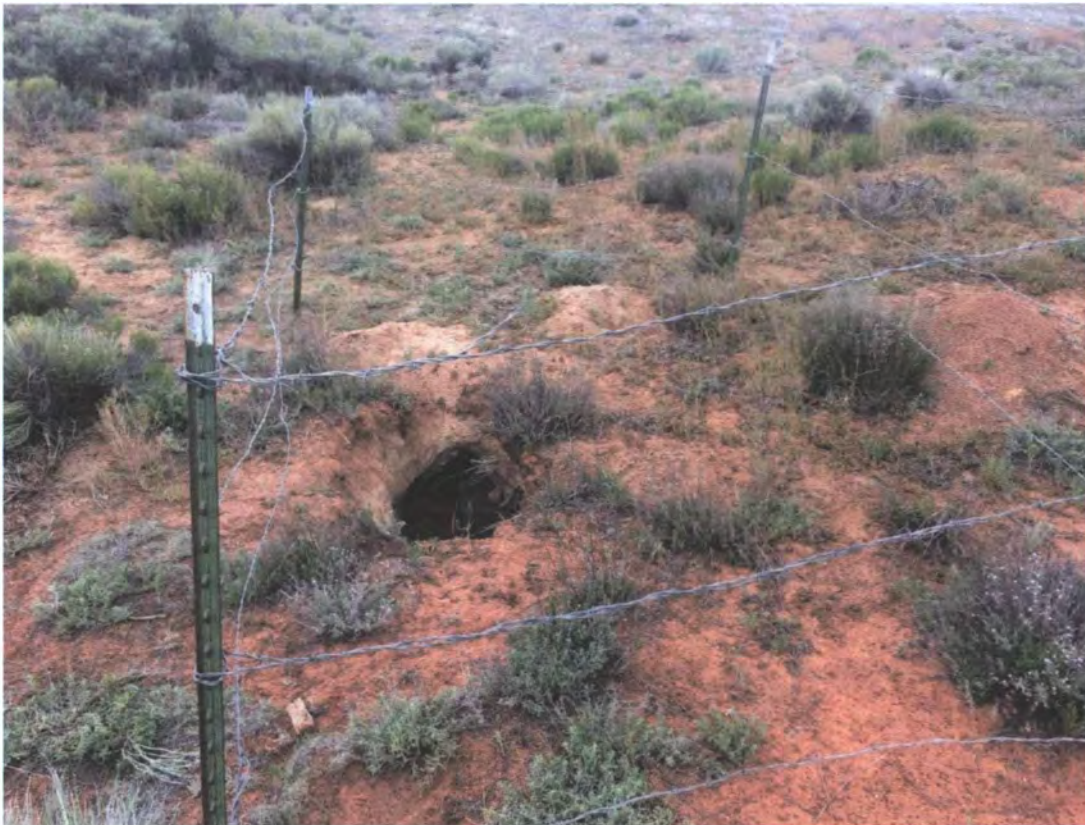
Mac 1-9 Uncovered vent raise south of office building with fencing installed in 2017

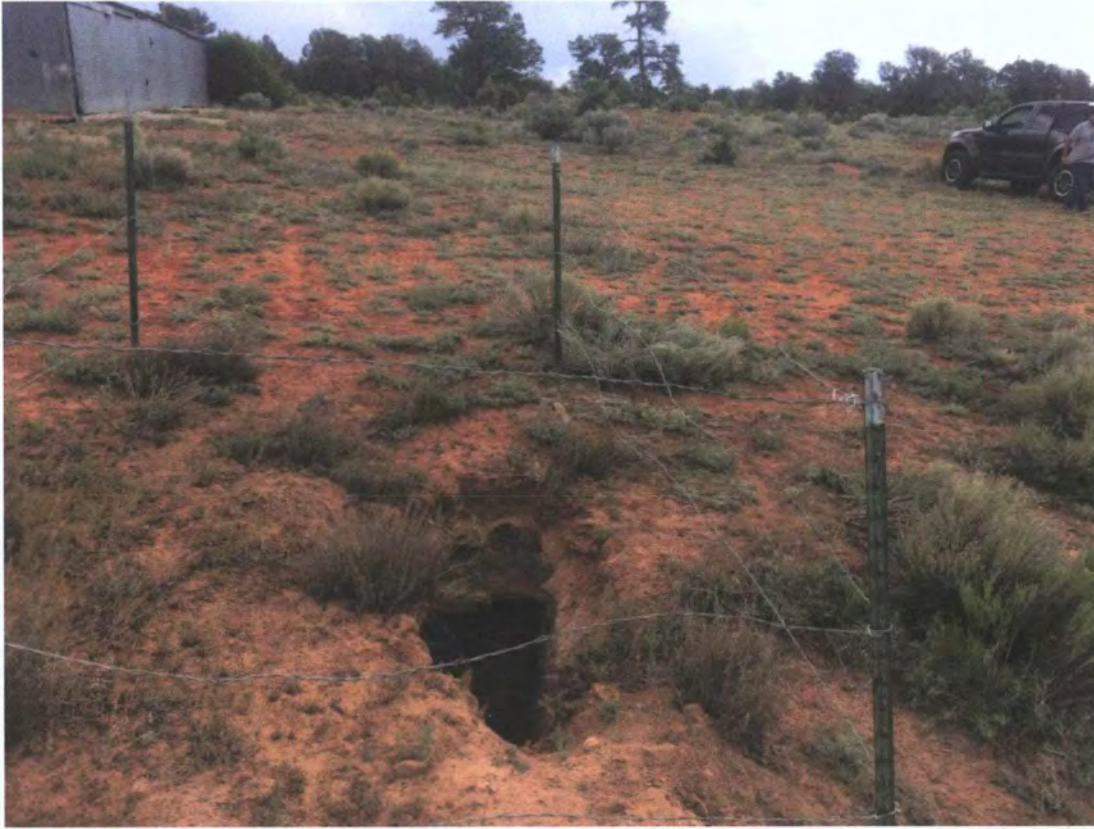
Mac 1-10 Uncovered vent raise south of office building, looking east

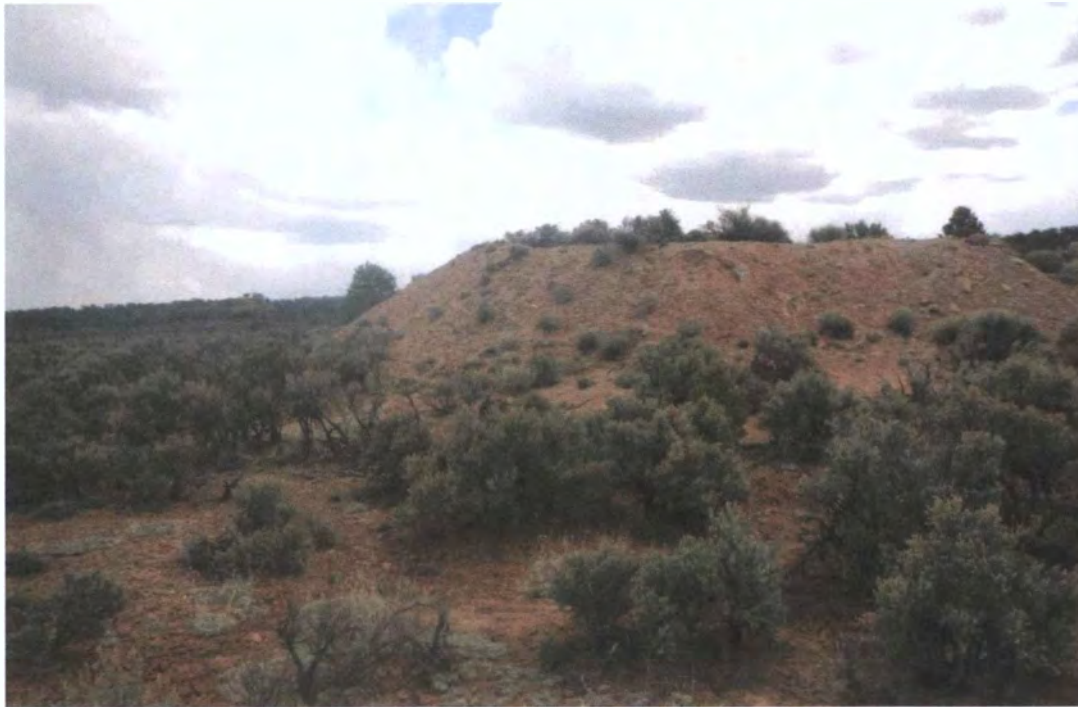
Mac2-1 Large waste rock pile south of shaft

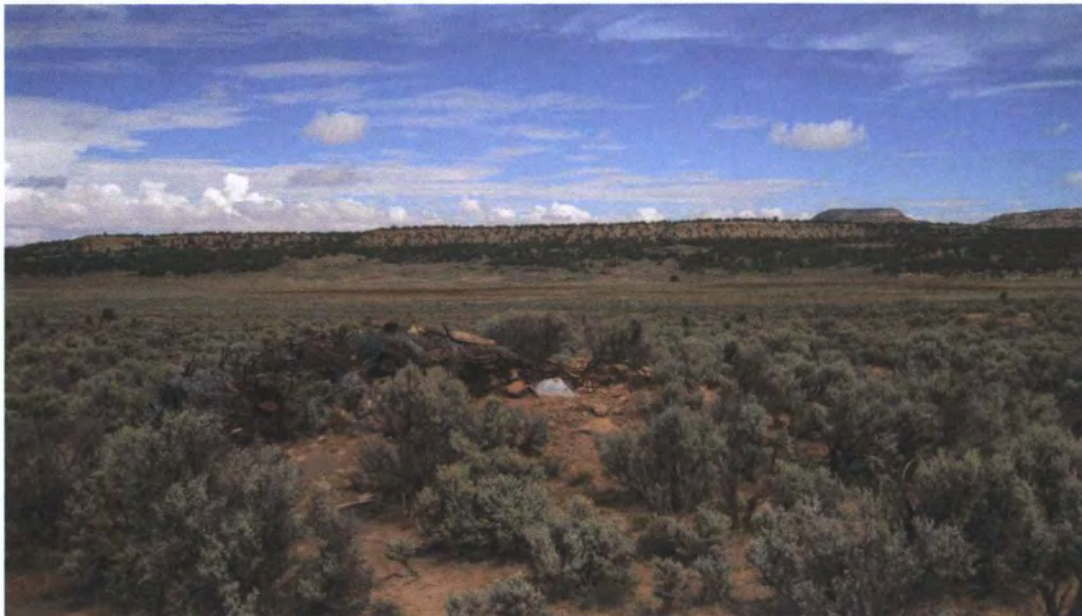
Mac2-2 Trash and waste pile west of large waste rock pile

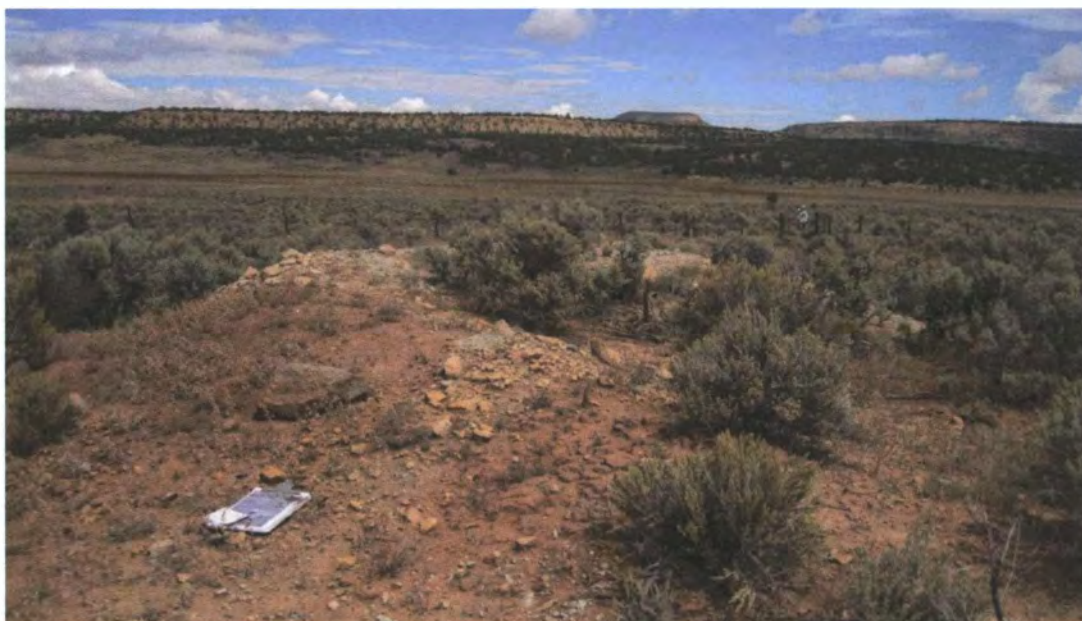
Mac2-3 Small waste pile NW of large pile

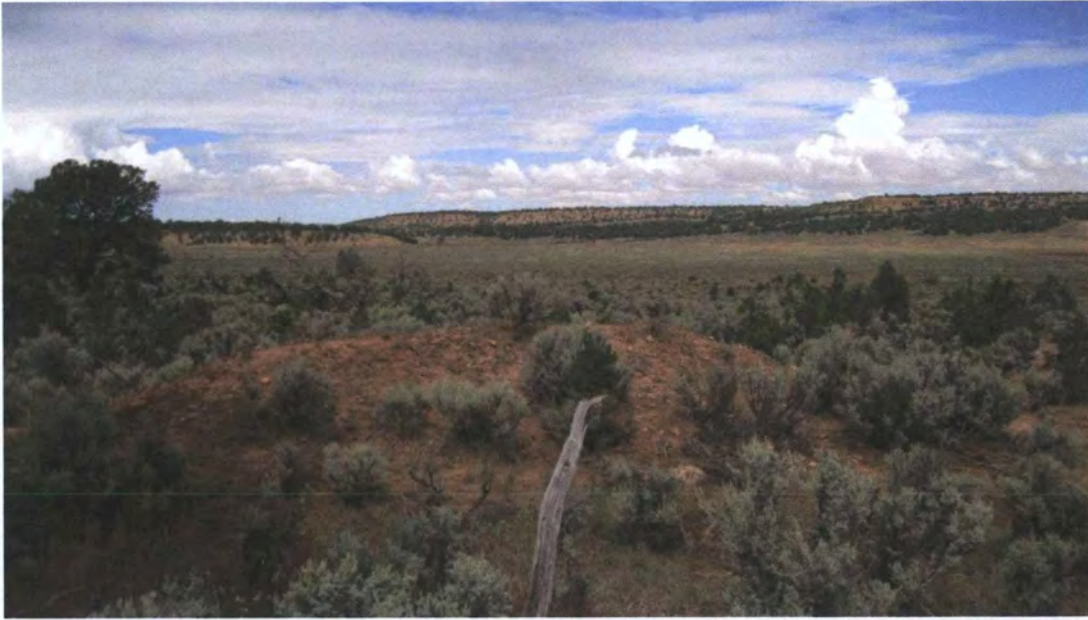
Mac2-4 Small waste pile SW of large pile

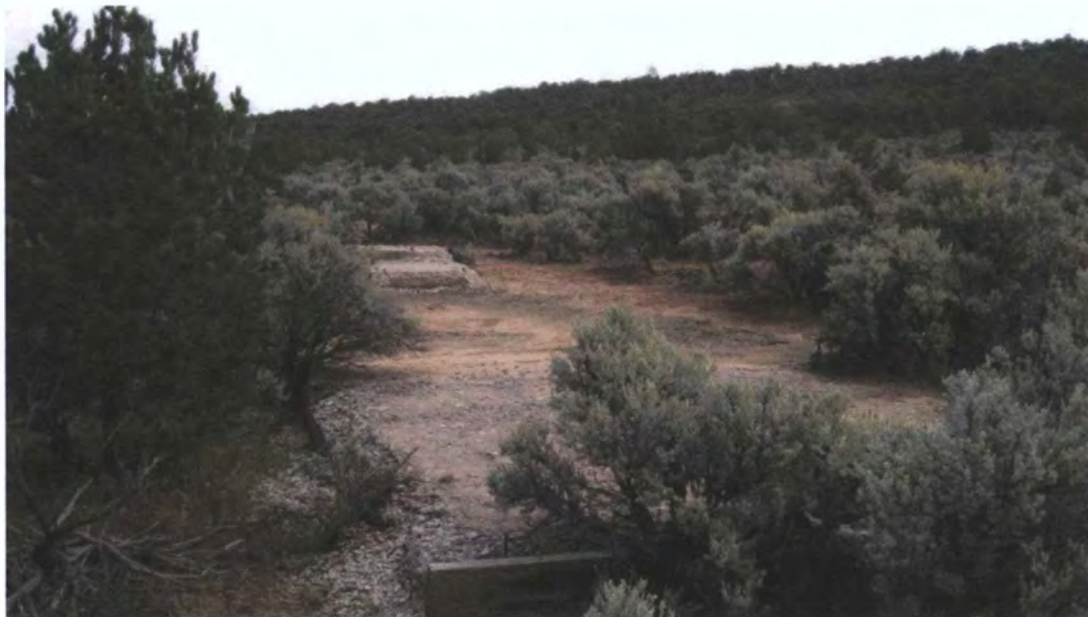
Mac2-5 Concrete slabs south of larger waste rock pile

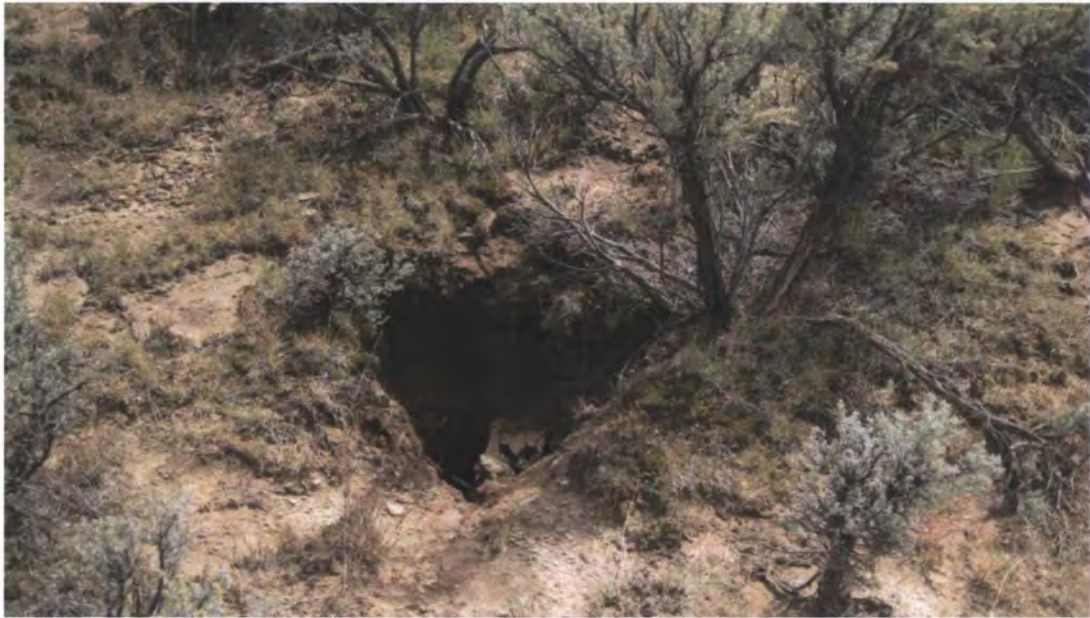
Mac2-6 Open vent raise southeast of large waste rock pile
