**PHASE 2 PHYSICAL HAZARDS MITIGATION
FORMER ABANDONED URANIUM MINE SITES
SMITH LAKE AND MARIANO LAKE CHAPTERS, MCKINLEY COUNTY, NEW
MEXICO**

JUNE 2018

***iiná bá* Project No.: 17-001-03**

PHOTOGRAPHIC DOCUMENTATION OF SITE ACTIVITIES
Phase 2 Physical Hazards Mitigation
Smith Lake and Mariano Lake Chapters, McKinley County, New Mexico

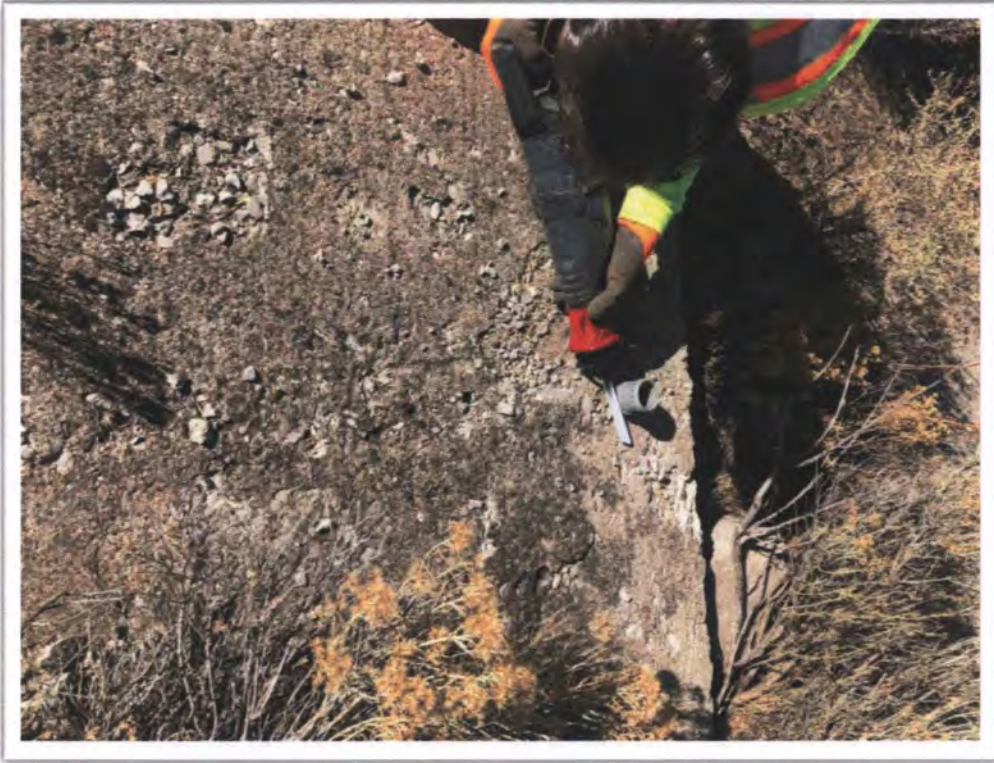
Photograph 1: View of typical cutting of metal protrusions flush with concrete slab at Ore Pad/Slab at Black Jack No. 1.

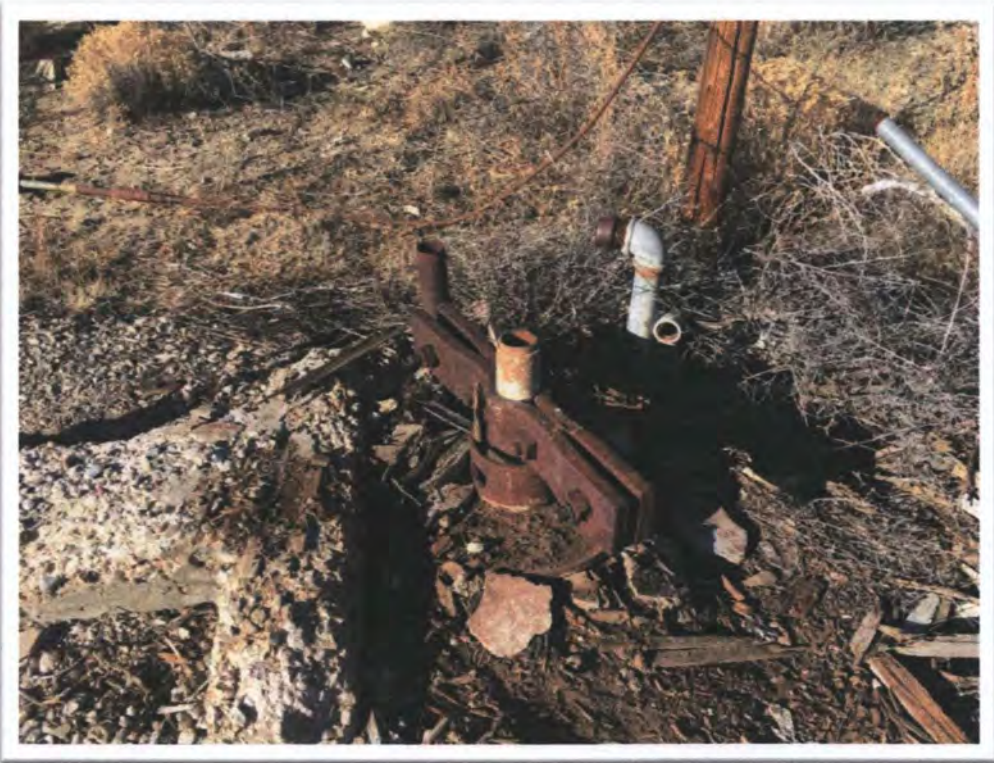
Photograph 2: View of typical cutting of anchor bolts flush with concrete slab at windmill concrete slab at Black Jack No. 1.

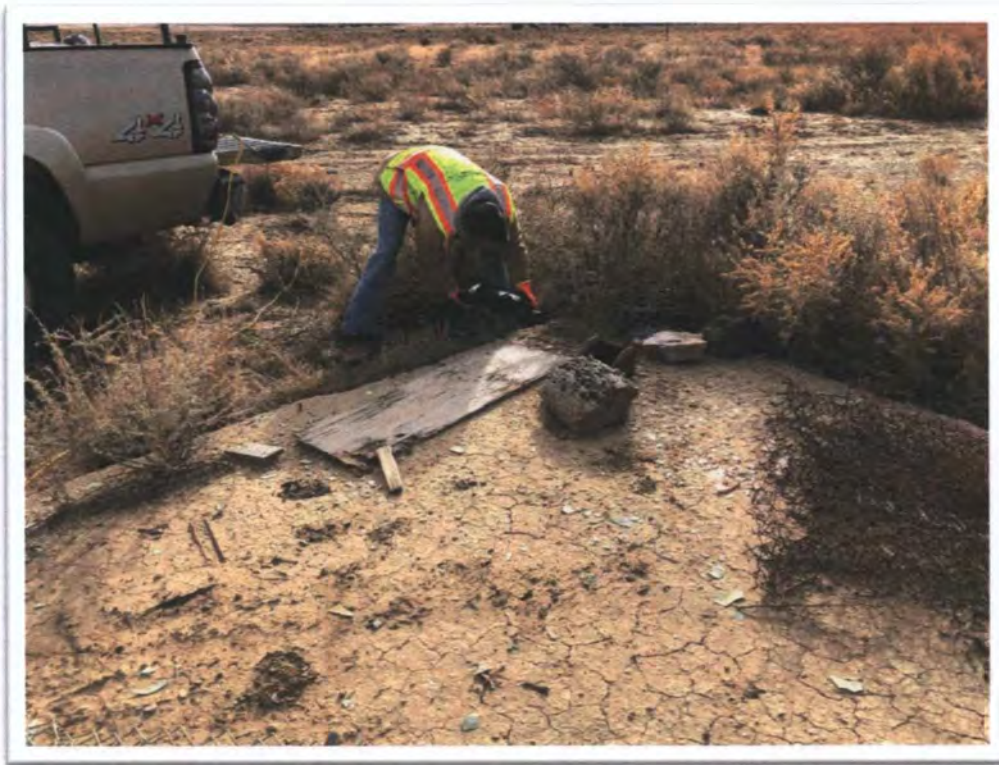
Photograph 3: View of typical cutting of wall anchor bolts flush with concrete slab at S1.

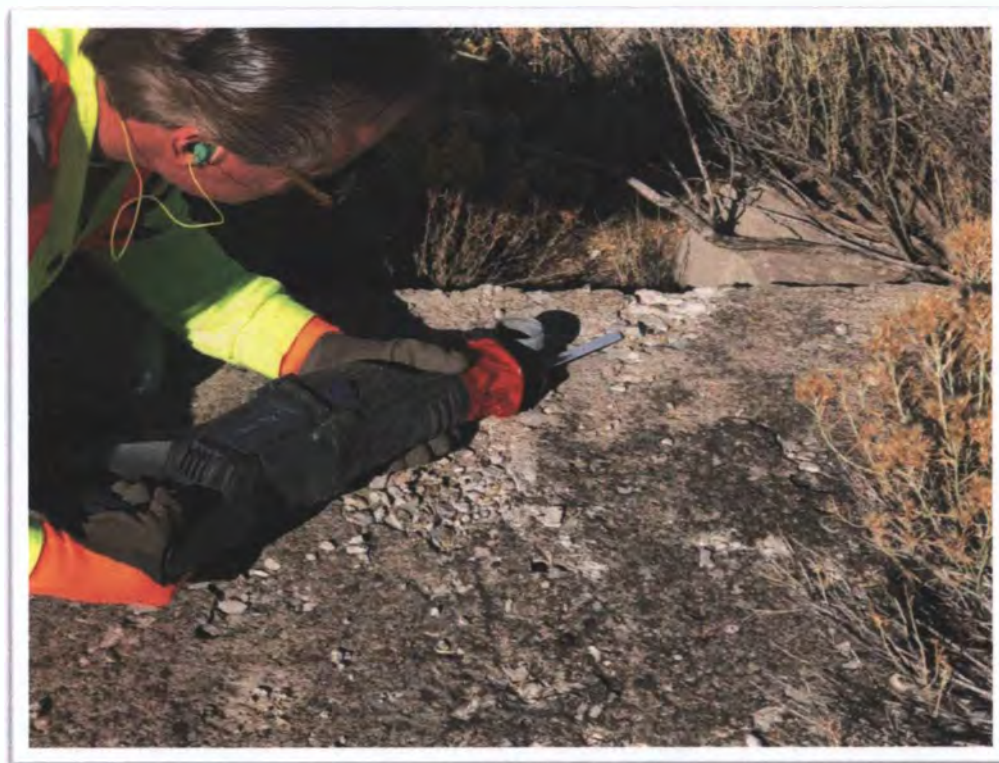
Photograph 4: View of typical cutting of wall anchor bolts flush with concrete slab at S2.

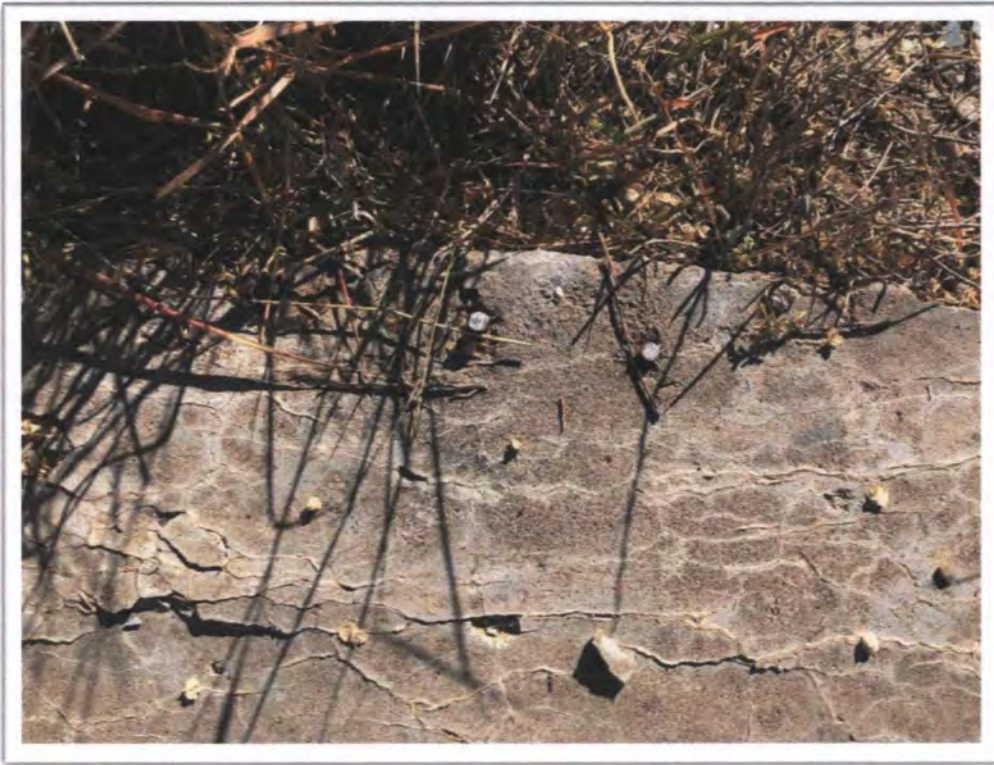
Photograph 5: View of typical wall anchor bolt cut flush with concrete slab at S3.

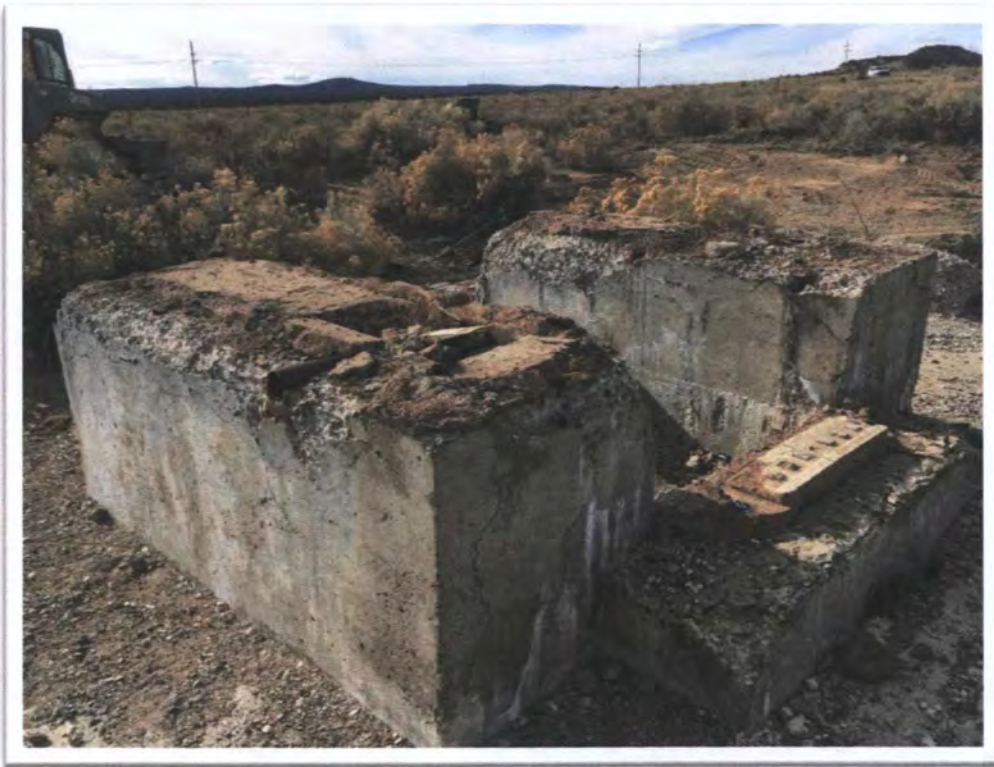
Photograph 6: View of typical Hoist House anchor bolts cut flush with concrete at Black Jack No. 1.

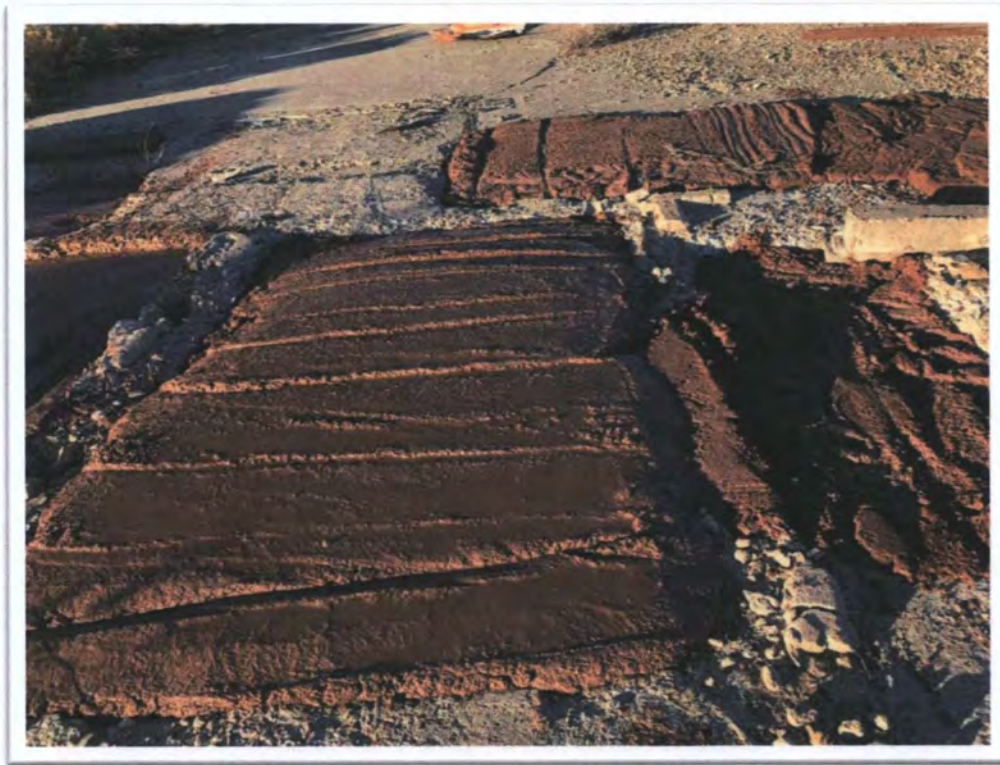
Photograph 7: View of typical placement of flowable fill into pits of Hoist House at Black Jack No. 1.

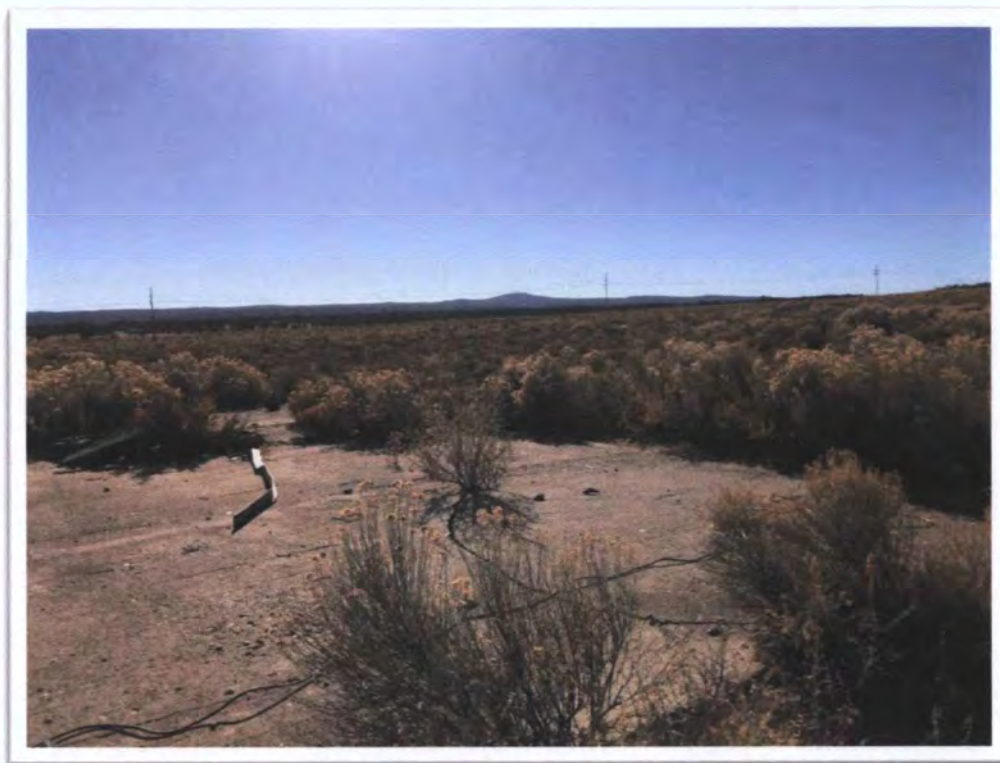
Photograph 8: View of typical wall anchor bolts cut flush with concrete slab at SL9 at Black Jack No. 1.

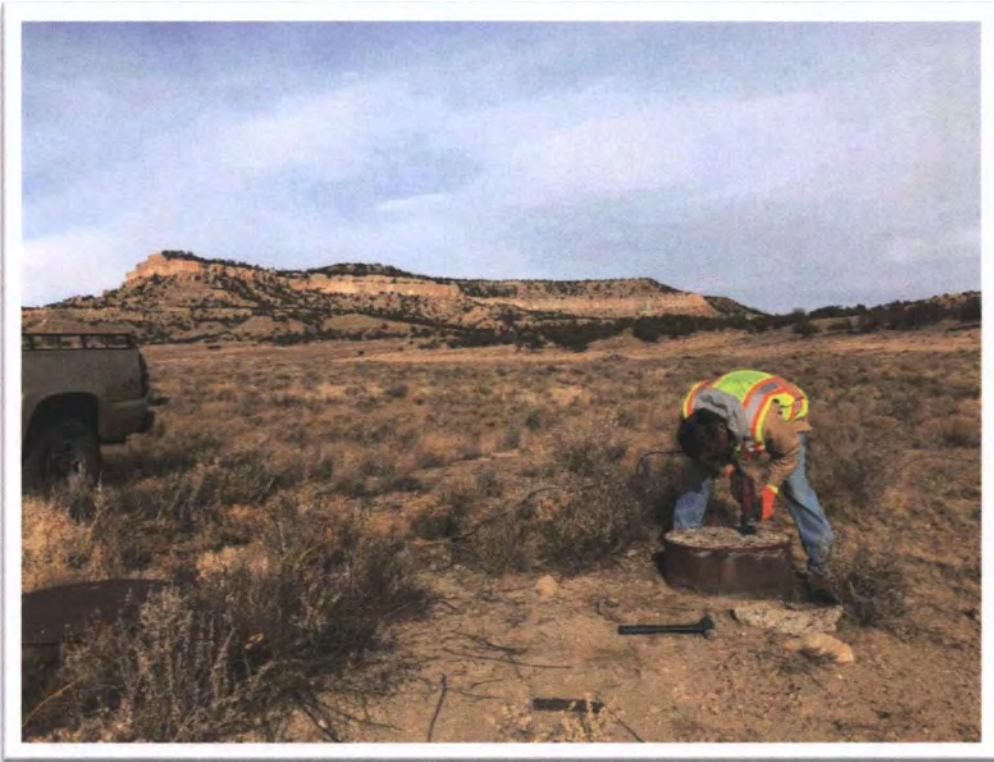
Photograph 9: View of typical cutting of hoist anchor bolts flush with concrete at central Vent Shaft at Black Jack No. 1.

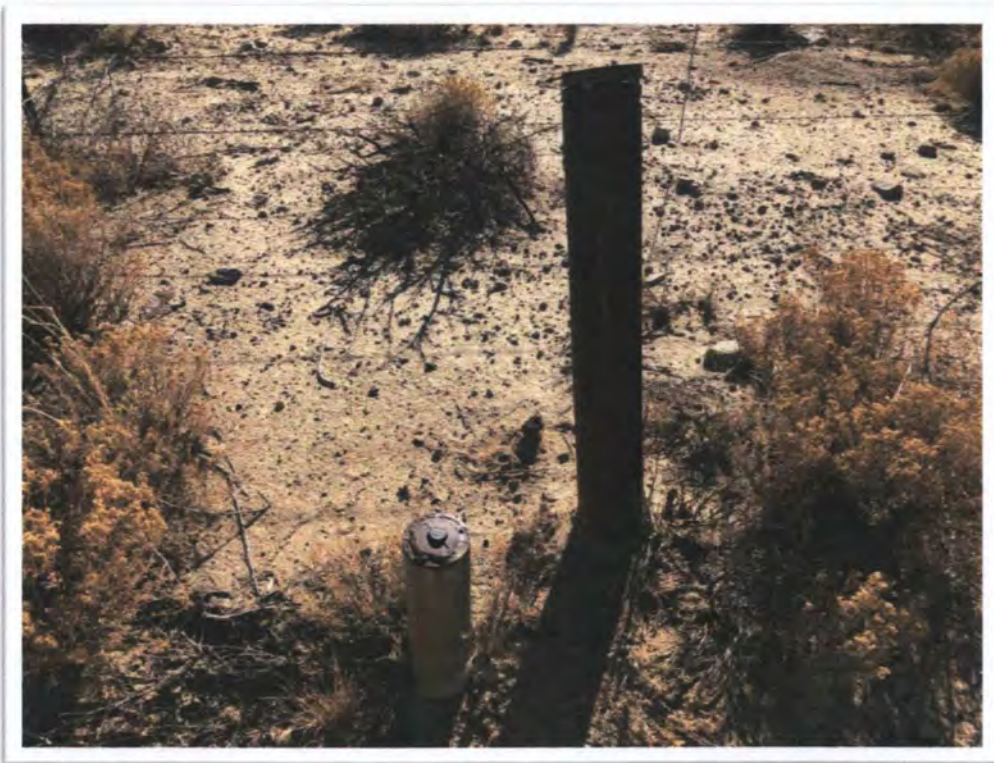
Photograph 10: View of typical cutting of "T"-handle at Utility Raise (U2) at Black Jack No. 1.

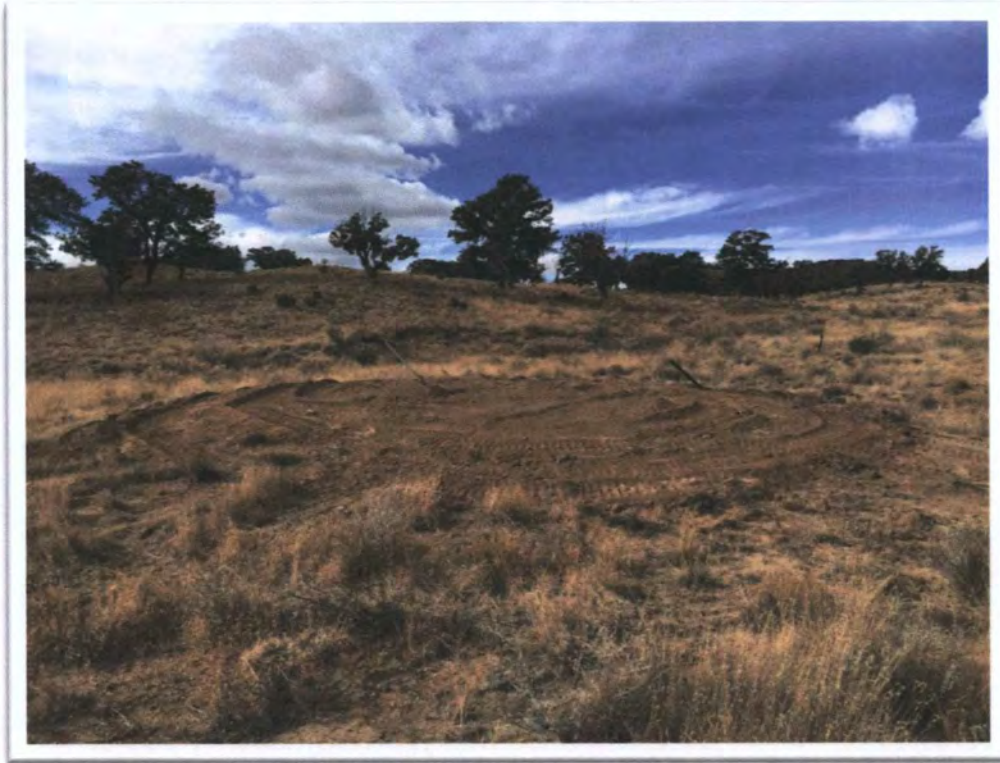
Photograph 11: View of typical backfilling, compaction, and grading at North Vent Shaft (NV) at Black Jack No. 1.

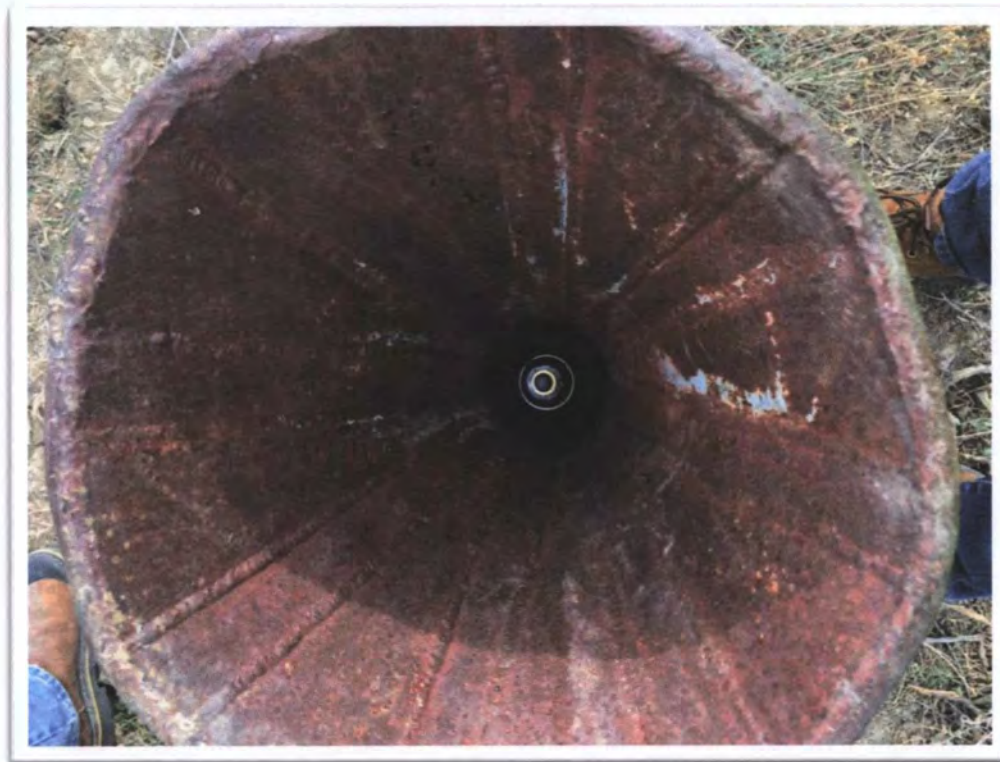
Photograph 12: View of typical inflatable hole plug installed in Open Hole (HS) and Utility Raise U4 at Black Jack No. 1.

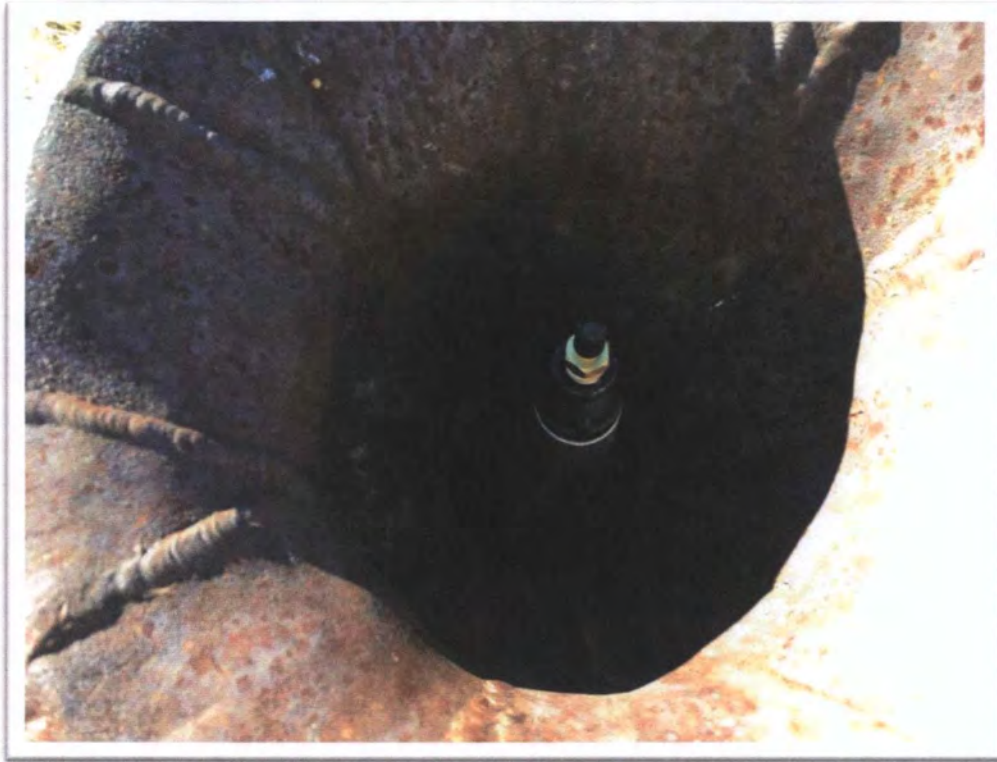
Photograph 13: View of typical inflatable packer (hole plug) installed in Utility Raise U4 at Black Jack No. 1.

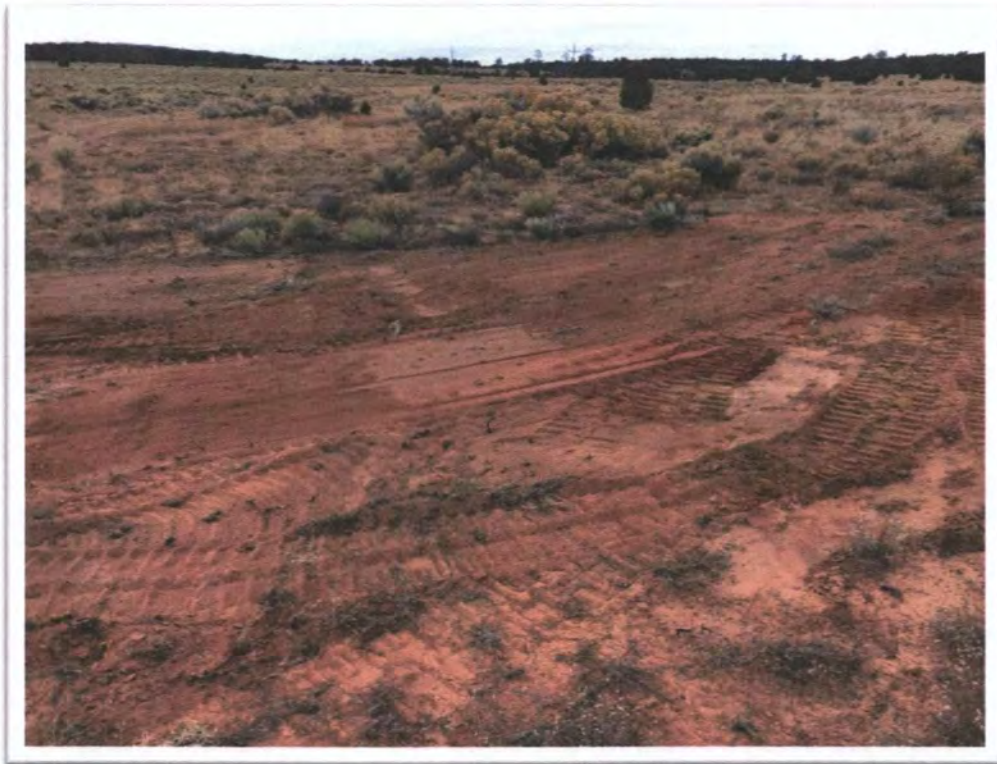
Photograph 14: View of typical removal of sharp metal feature with backfilling and compact on at Utility Raise U5 at Black Jack No. 1.

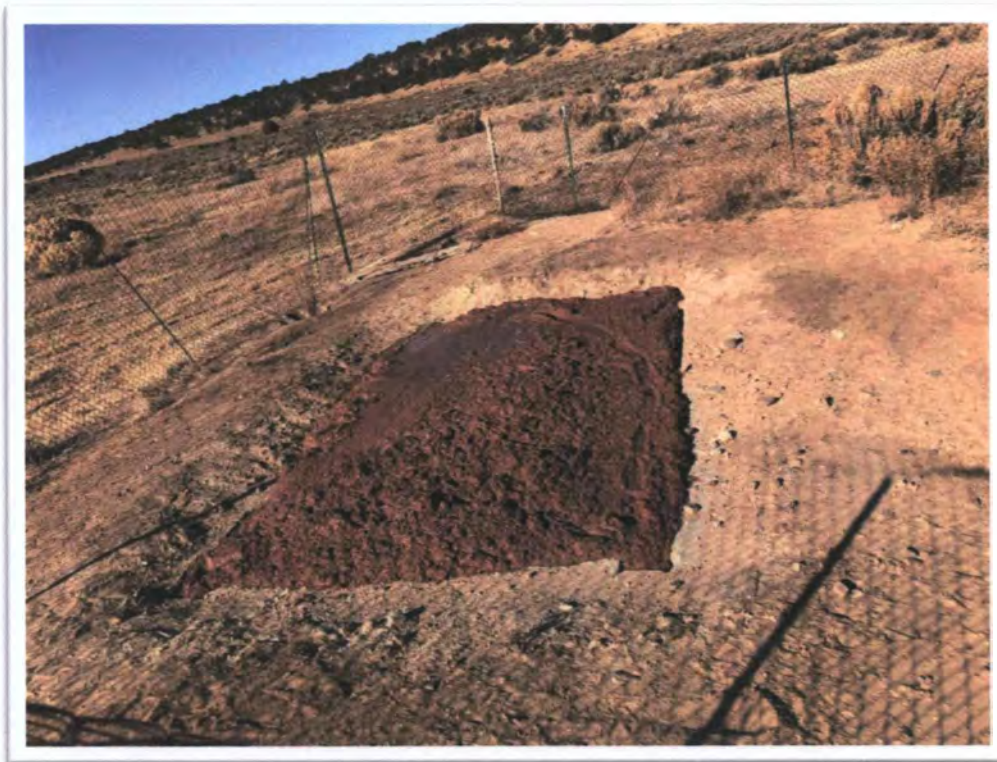
Photograph 15: View of typical flowable fill placement in Mine Shaft (MI) at Black Jack No. 2.

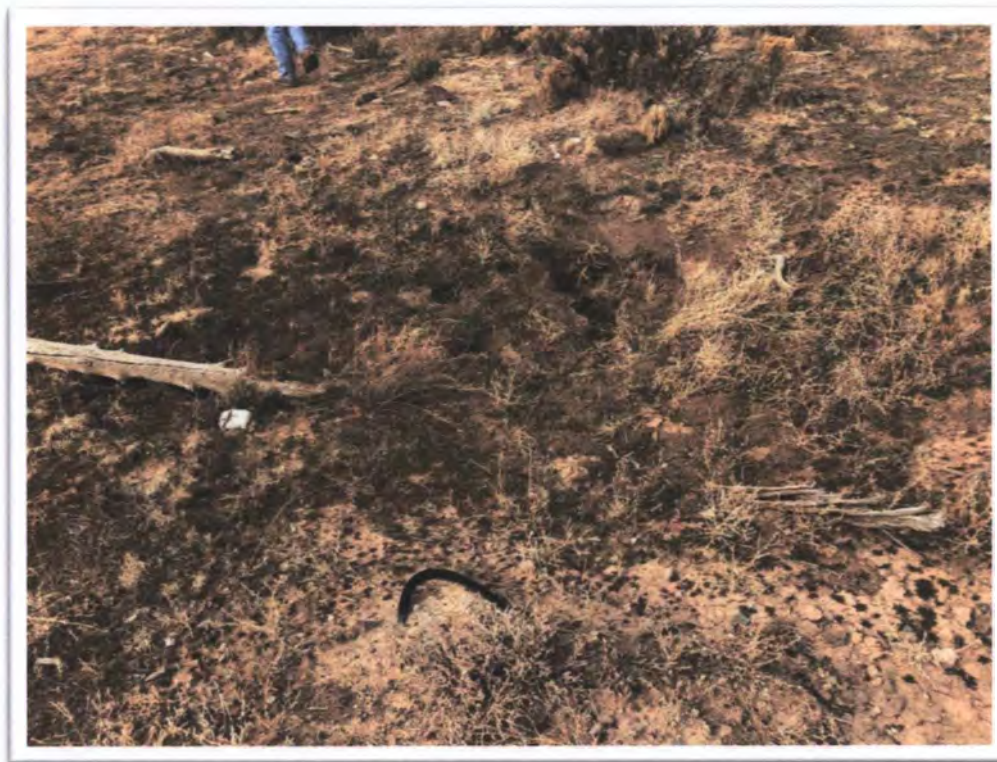
Photograph 16: View of typical backfilling and covering Utility Raise U1 at Black Jack No. 2

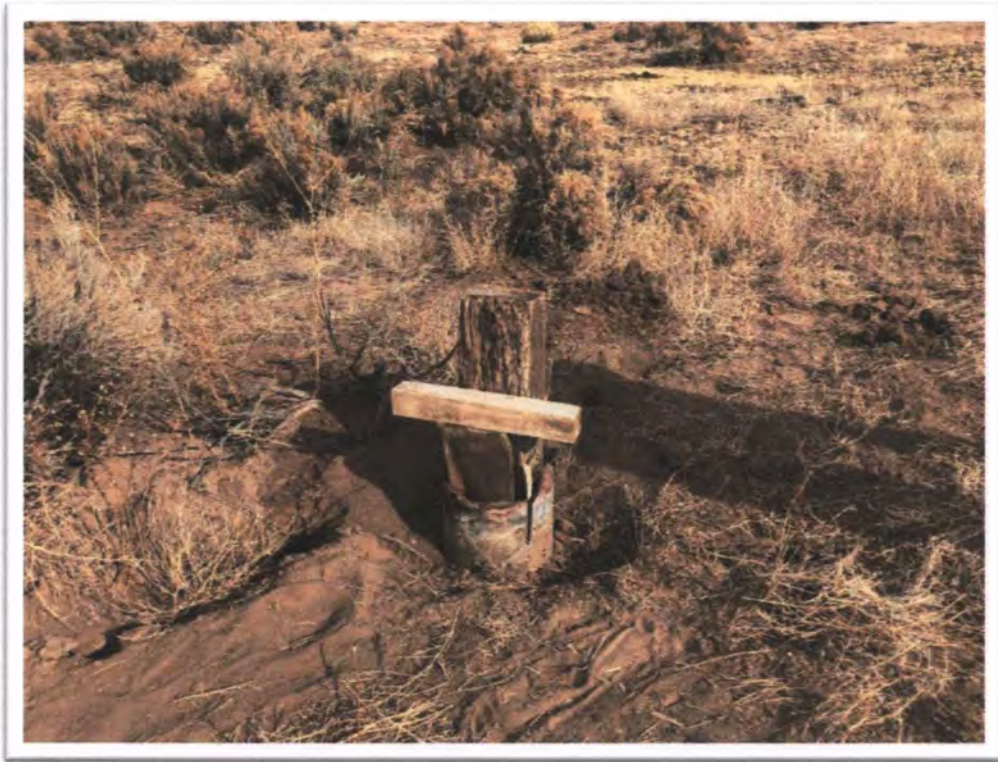
Photograph 17: View of typical plugging and sealing Utility Raise U2 at Black Jack No. 2.

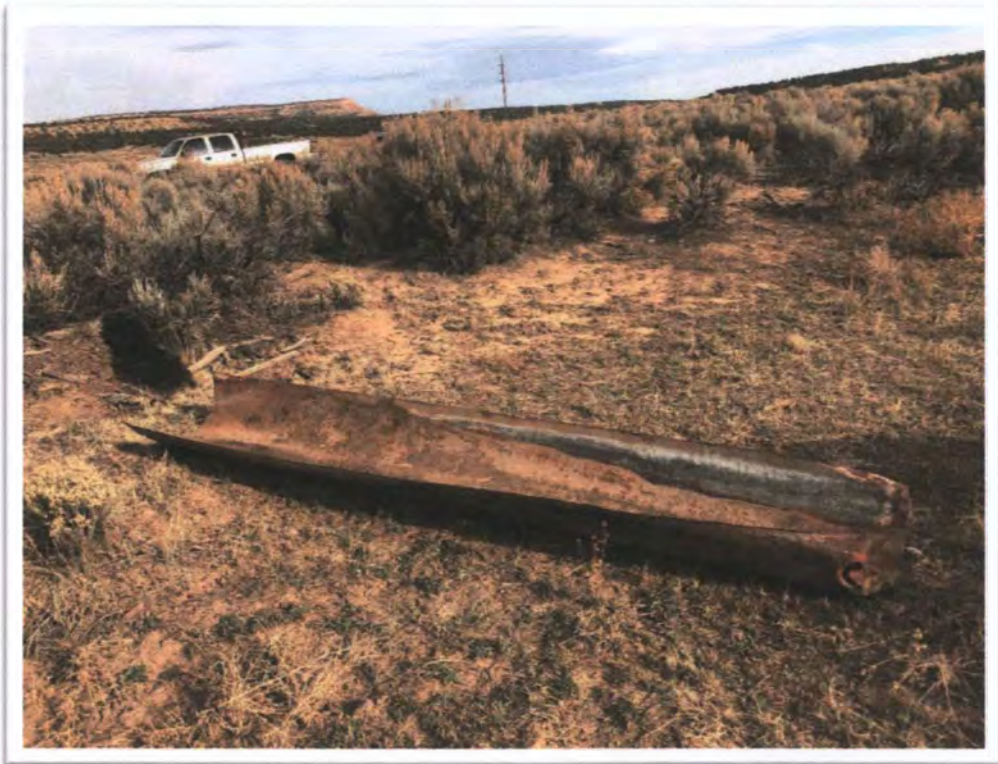
Photograph 18: View of typical diversion channel removal at Black Jack No. 2.

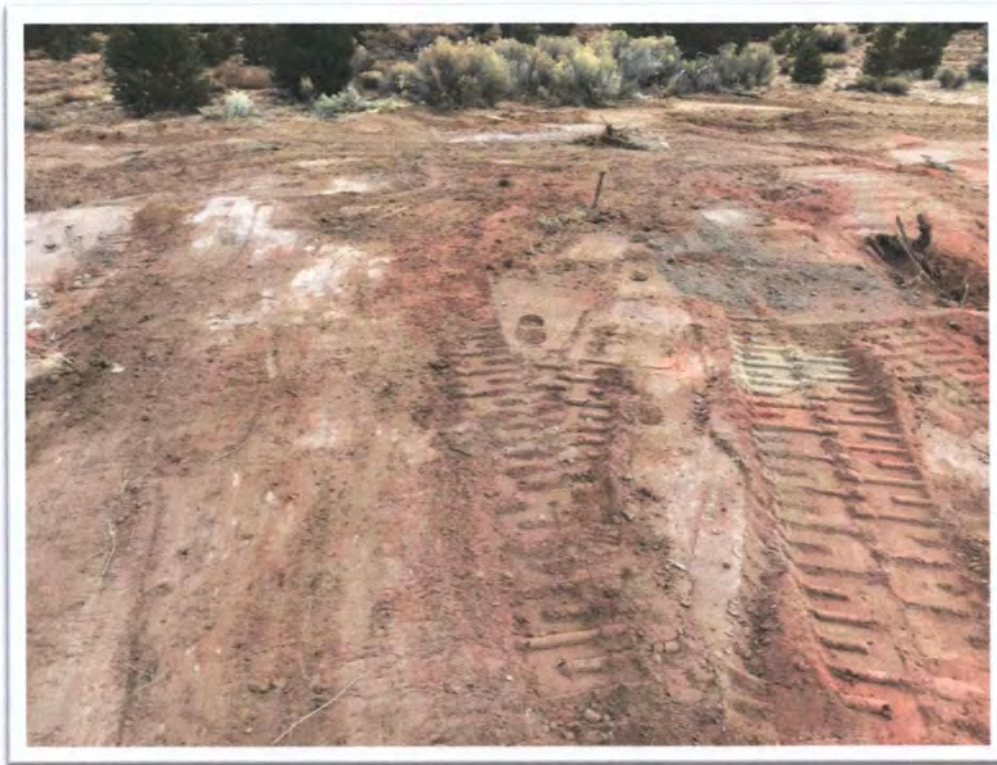
Photograph 19: View of typical backfilling, compaction, and grading of partially Buried Mine Shaft at MAC No. 1.

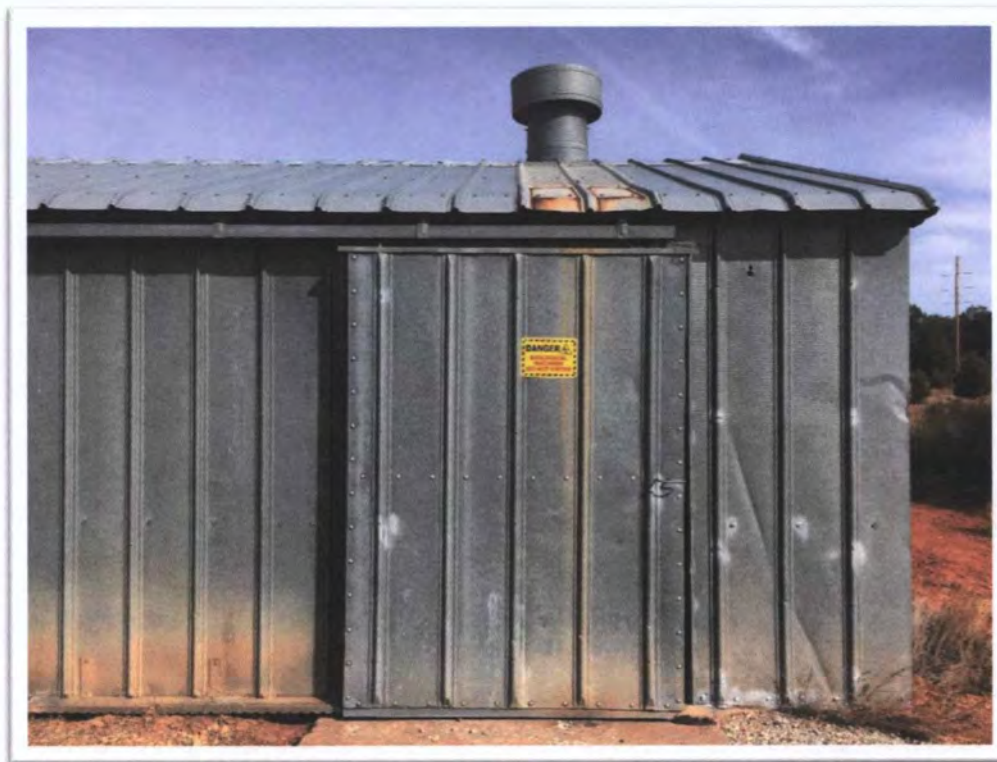
Photograph 20: View of typical Biohazard sign installation (front and rear) on Service Building (B1) at MAC No. 1

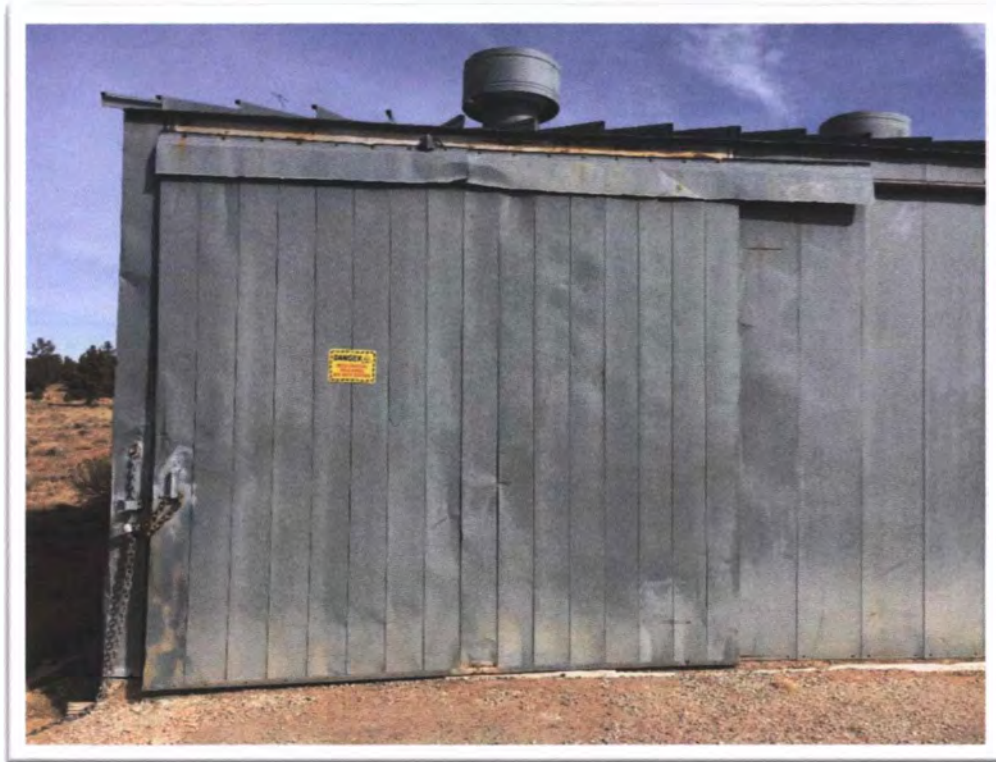
Photograph 21: View of typical Biohazard sign installation (front and rear) on Hoist House at MAC No. 1.

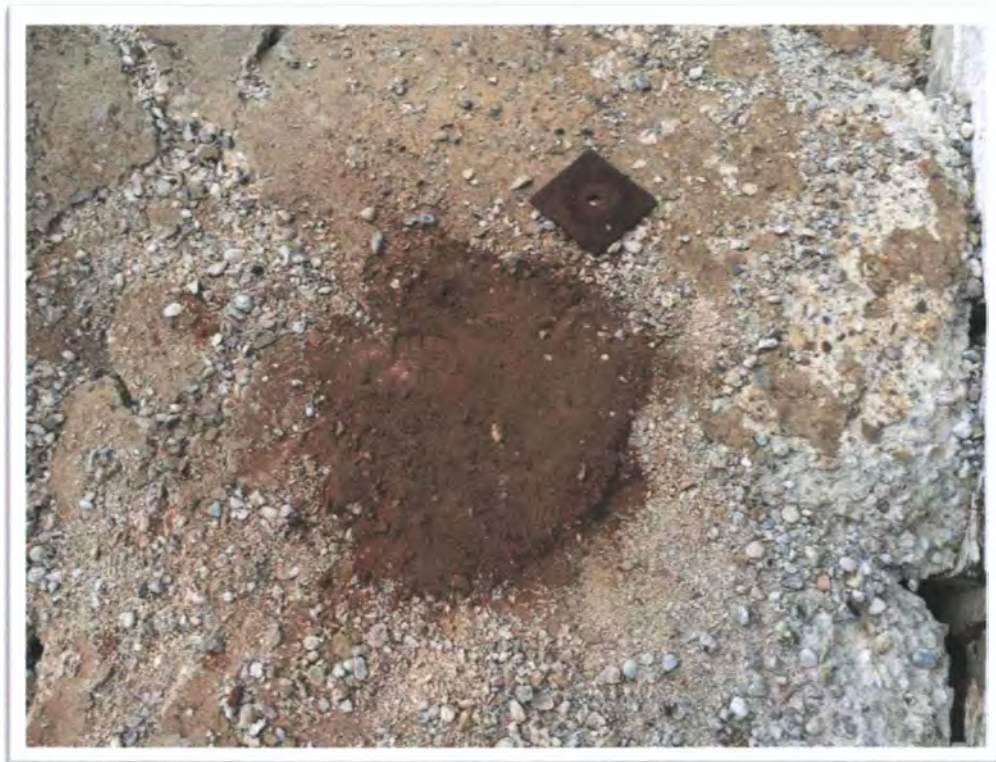
Photograph 22: View of typical cutting of sharp metal surface flush with concrete slab (S2) at MAC No. 1.

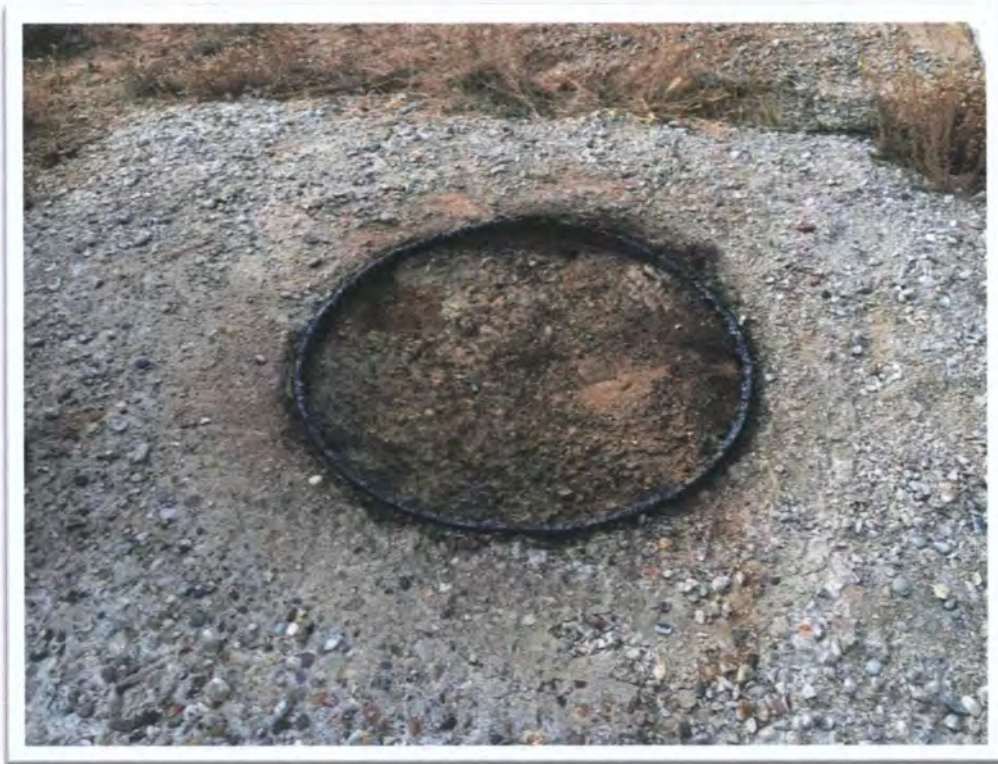
Photograph 24: View of typical cutting of sharp metal surface flush with concrete slab (S3) at MAC No. 1.

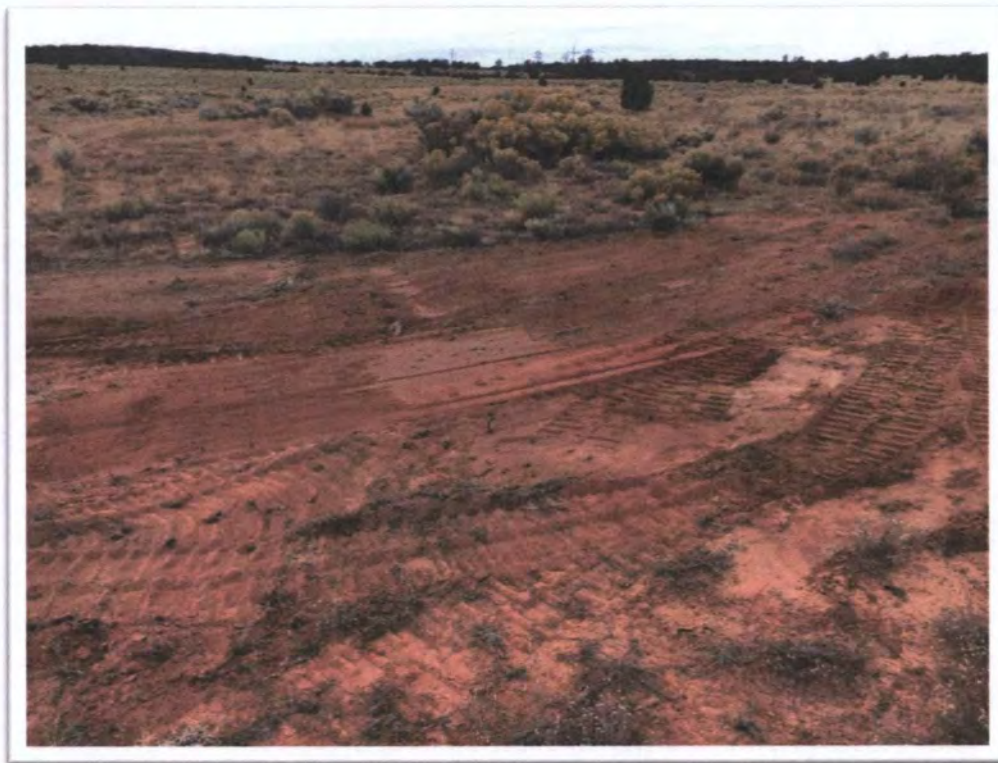
Photograph 24: View of typical backfilling, compaction, and grading of septic tank hazard at MAC No. 1.

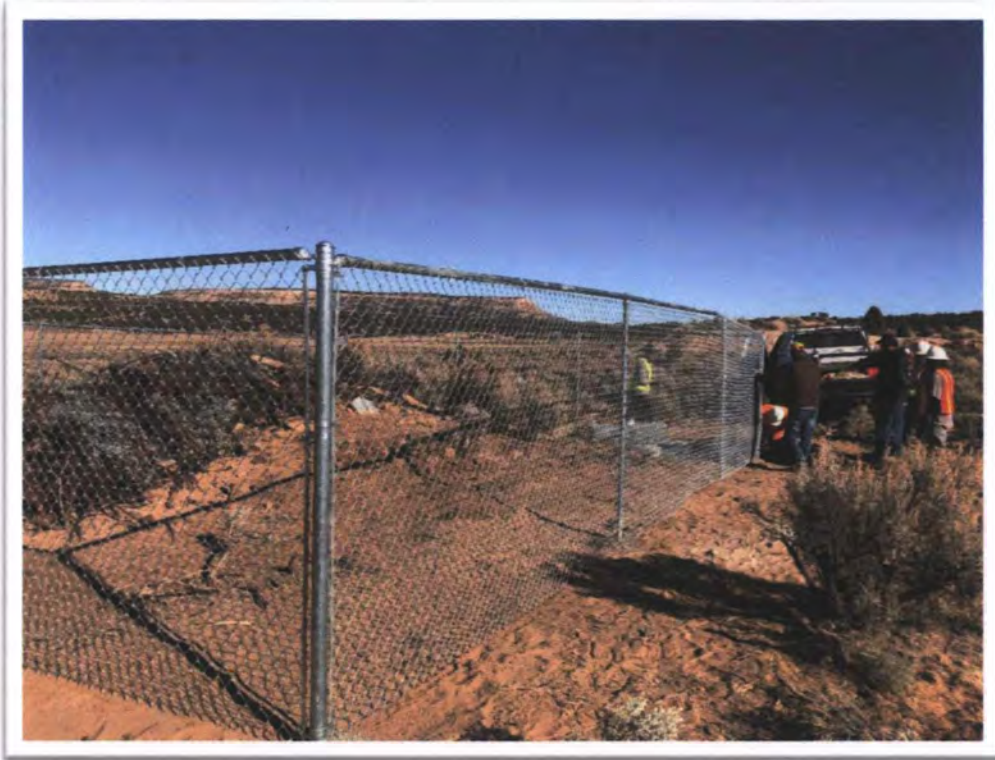
Photograph 25: View of typical fence installation around Mine Waste (debris) Pile (W3) at MAC No. 2.

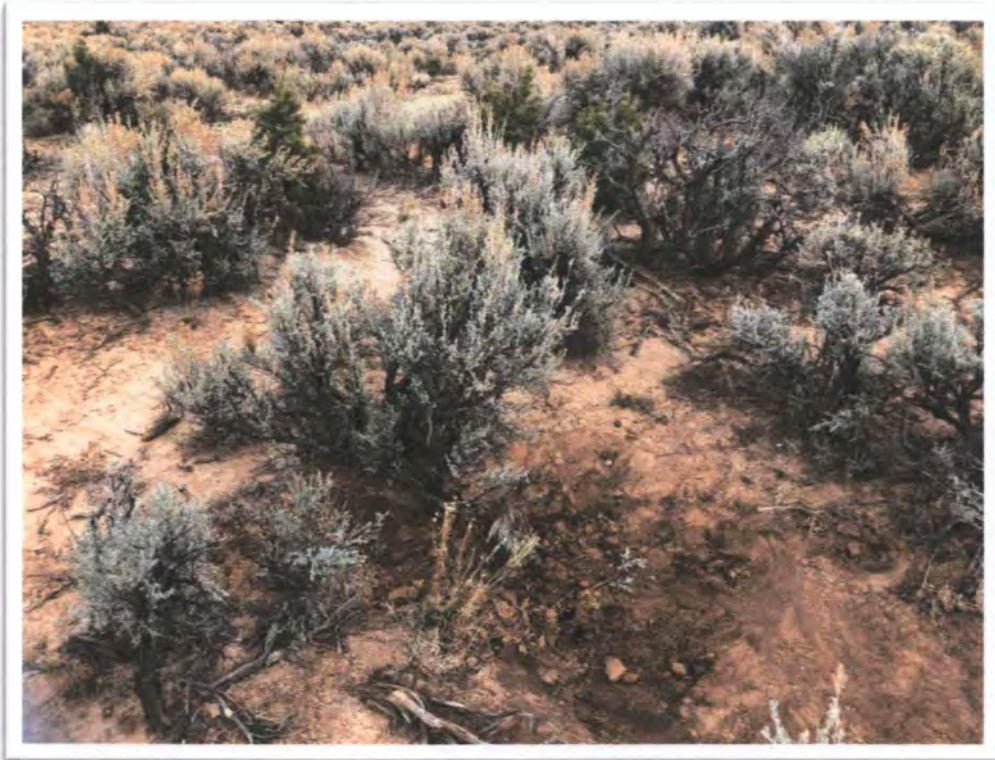
Photograph 26: View of typical backfilling, compaction, and grading of Open Hole (OH1) at MAC No. 2.

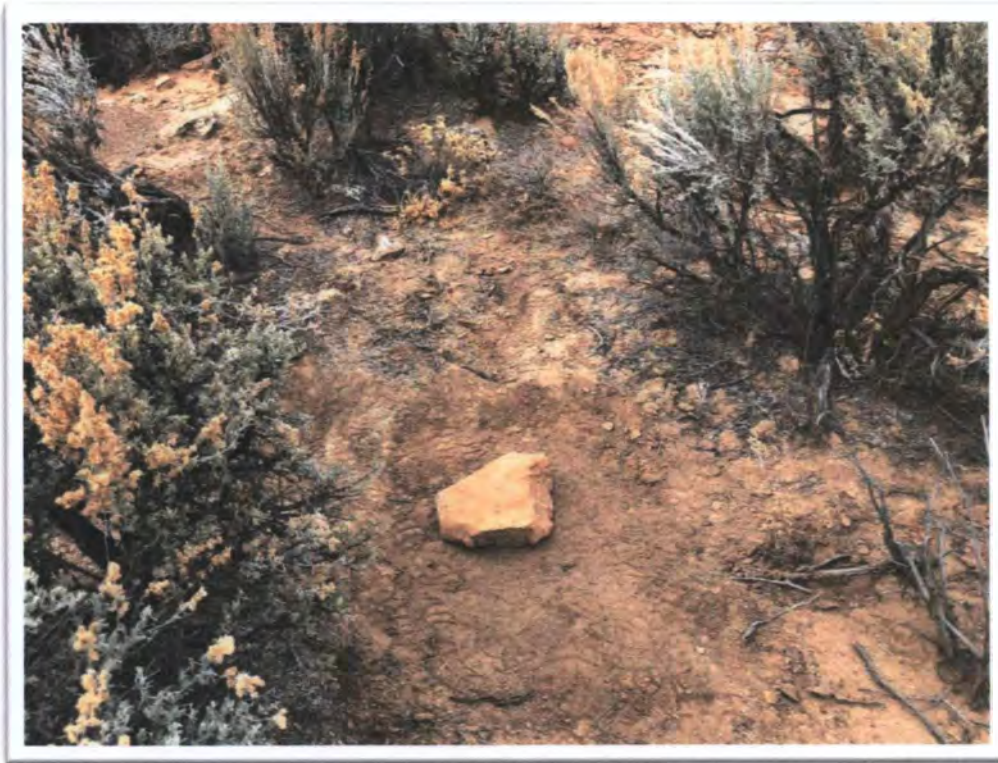
Photograph 27: View of typical backfilling, compaction, and grading at Open Hole (OH2) at MAC No. 2.

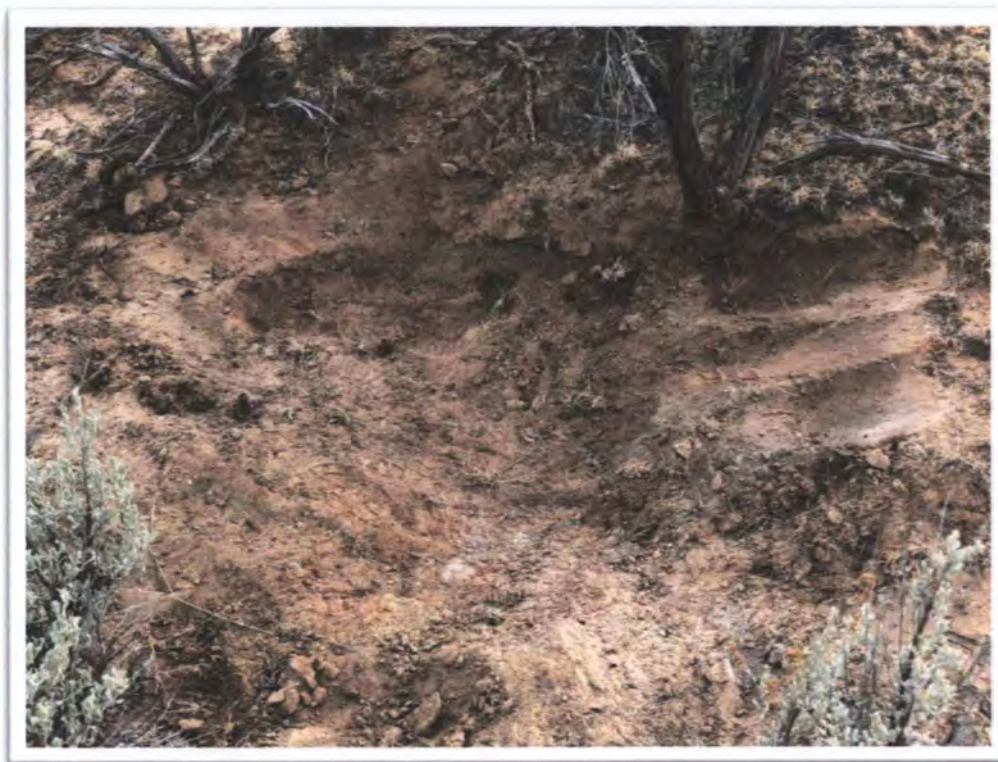
Photograph 28: View of typical backfilling, compaction, and grading at Vent Shaft-Borehole at MAC No. 2.

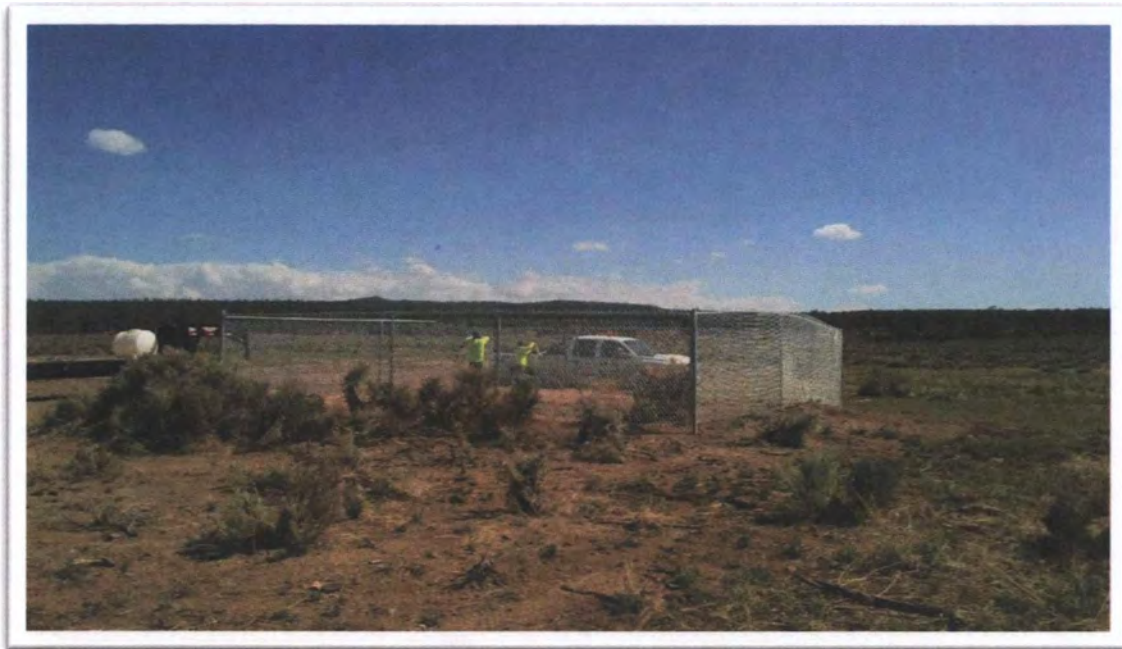
Photograph 29: View of new fencing installed around Mine Shaft (MK) at Black Jack No. 2.
