***Operation and Maintenance Report
January 2013 to December 2013
McCormick and Baxter
Superfund Site
Portland, Oregon***

***Prepared for
Oregon Department of
Environmental Quality***

***April 9, 2014
15670-10/Task 4***

Prepared by
GSI Water Solutions, Inc.

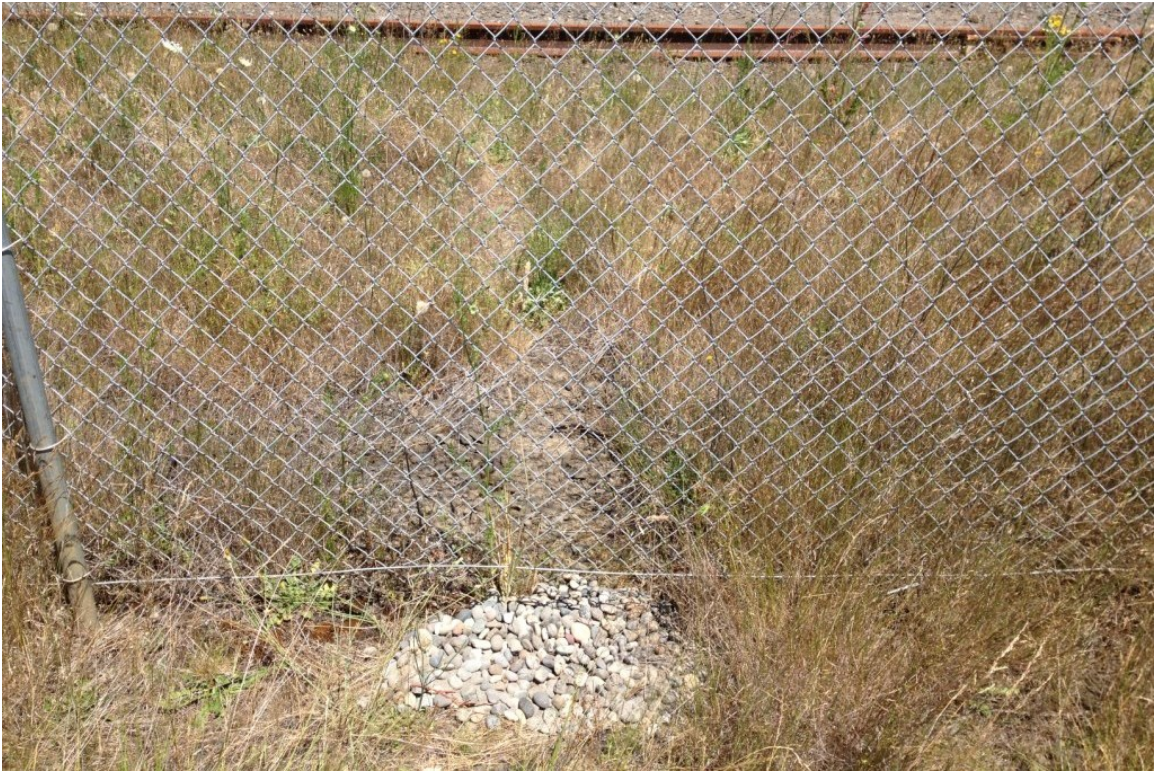
The upland soil cap provides habitat for rabbits, ground squirrels, Canada geese, several other species of birds, and coyotes. Despite placing gravel to fill gaps under the fence around the upland portion of the site, periodic burrowing continues to be observed under the fence and along the perimeter road. These burrows are filled routinely and are not of major concern (Photograph 1, Appendix A).

Photograph 1 – Typical animal burrow underneath perimeter fence. Photograph taken facing east with Union Pacific Railroad in the background.

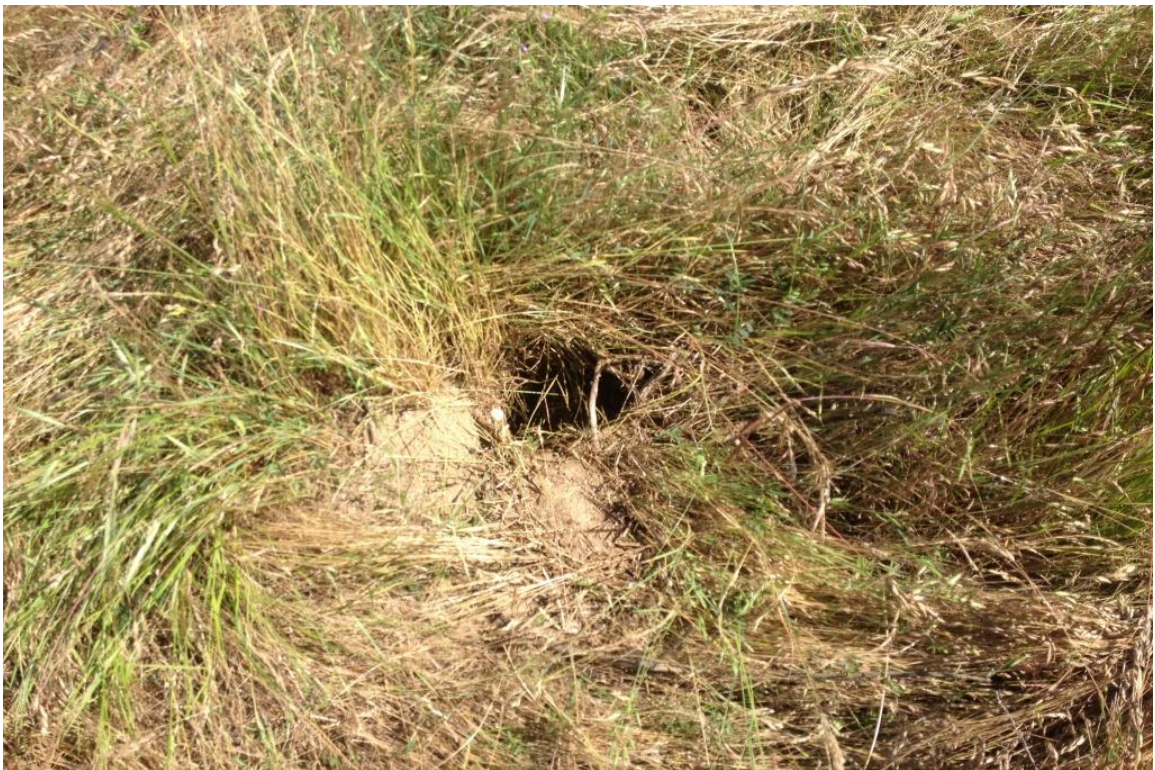
Evidence of ground squirrel activity was observed at several locations south of the site trailers and in various areas throughout the upland soil cap (Photograph 2, Appendix A). Ground squirrels are common to the area, and their burrows typically extend to approximately 1 foot below ground surface (bgs). The ground squirrels use the surplus articulated concrete block (ACB) stockpiled at the site, paved roadway, and concrete well monuments as habitat. There are no indications that any of these burrows extend below the depth of the soil cap and, therefore, the soil cap continues to isolate site contaminants from human and ecological receptors. Continued monitoring of the burrows is recommended; no action to remove burrowing animals or to fill in the burrows is planned or is necessary at this time.

Photograph 2 – Evidence of ground squirrel on upland soil cap.

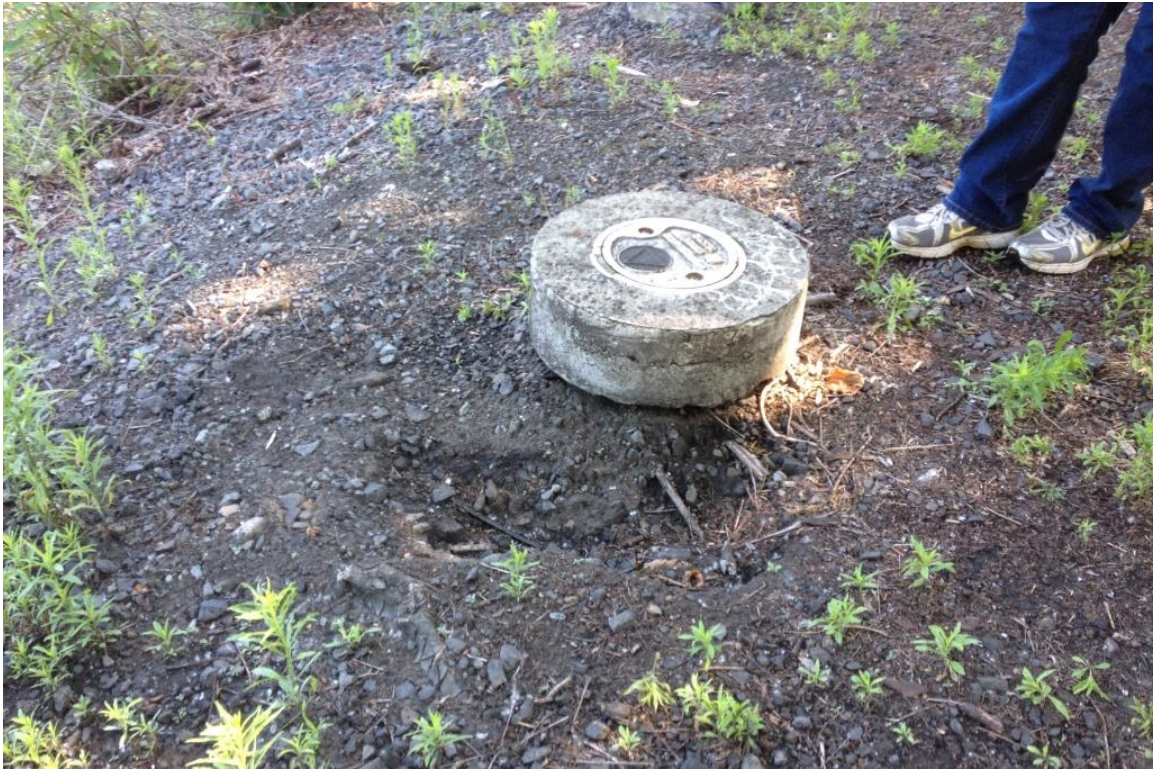
The gravel surface around monitoring wells, MW-58s, MW-58i, and MW-58d had been slowly eroding away and was beginning to undercut the concrete surface seal of each of the wells. To protect the integrity of the wells, the well monuments were replaced, and the ground surface leveled. The MW-58 well cluster is located on a gravel access path located on a steep slope adjacent to the Burlington Northern Railroad north of the site (Figure 2-1). Hart Crowser staff met with a licensed drilling crew from Pacific Soil and Water of Tigard, Oregon, on October 9, 2013, to repair the monuments. The monuments and concrete surface seal were removed without making adjustments to the monitoring well casings. New concrete surface seals were constructed to 2 feet bgs over each of the three wells, and new steel flush-mounted well monuments were installed. The ground surface surrounding each of the monuments was re-graded and additional gravel placed to slow future erosion around the monuments. Erosion in the area is unavoidable due to the steep slope and soft subsurface surrounding the wells. The integrity of the MW-58 well cluster will continue to be observed during future site inspections. Photographs of the monument replacement can be viewed in the Photograph Log provided in Appendix A.

Photograph 3 – One of the MW-58 monitoring wells showing localized erosion and concrete surface seal completely undermined prior to repairs.

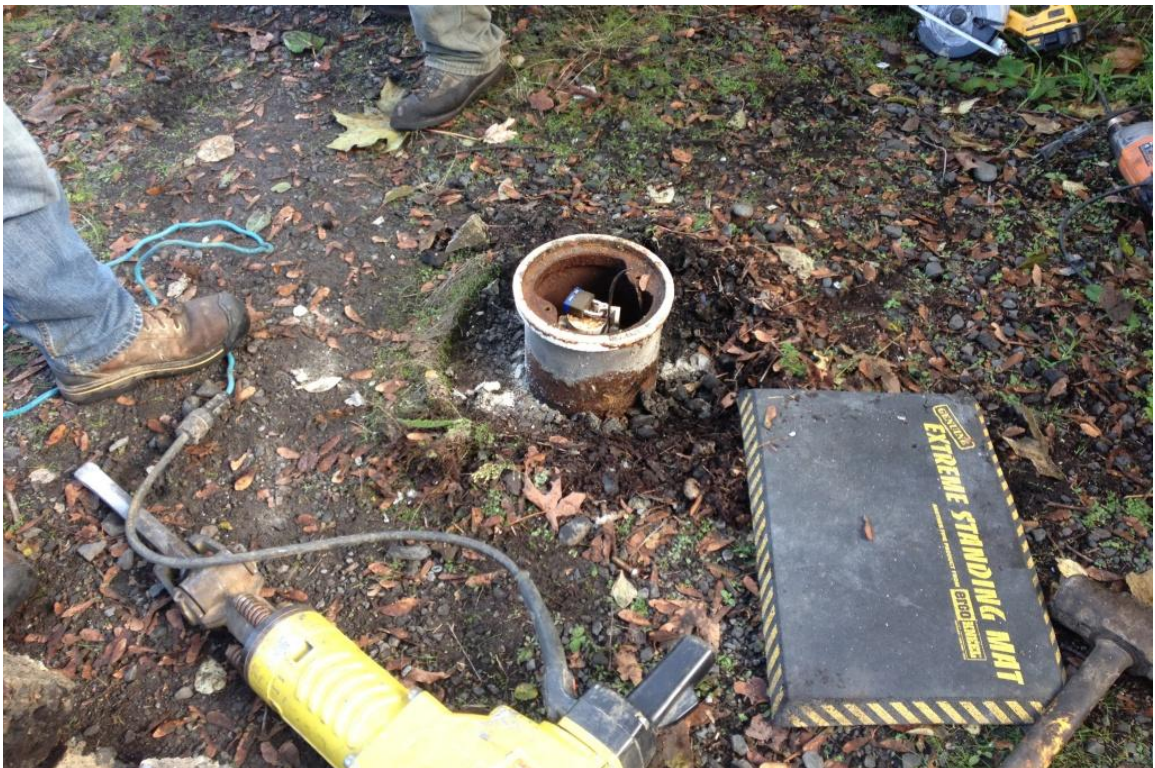
Photograph 4 – MW-58 well under repair. Old concrete surface seal and well monument removed prior to replacement.

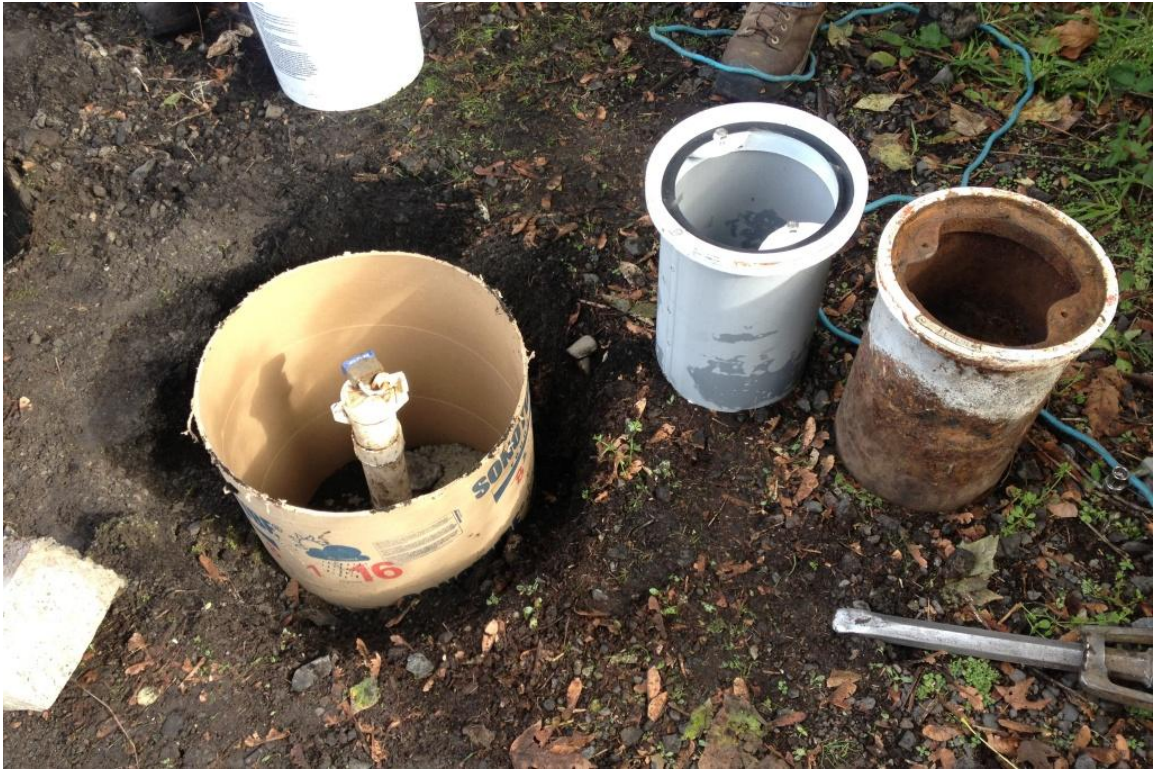
Photograph 5 – MW-58 well under repair. Old surface seal and monument removed. New concrete surface seal is approximately 2-feet deep.

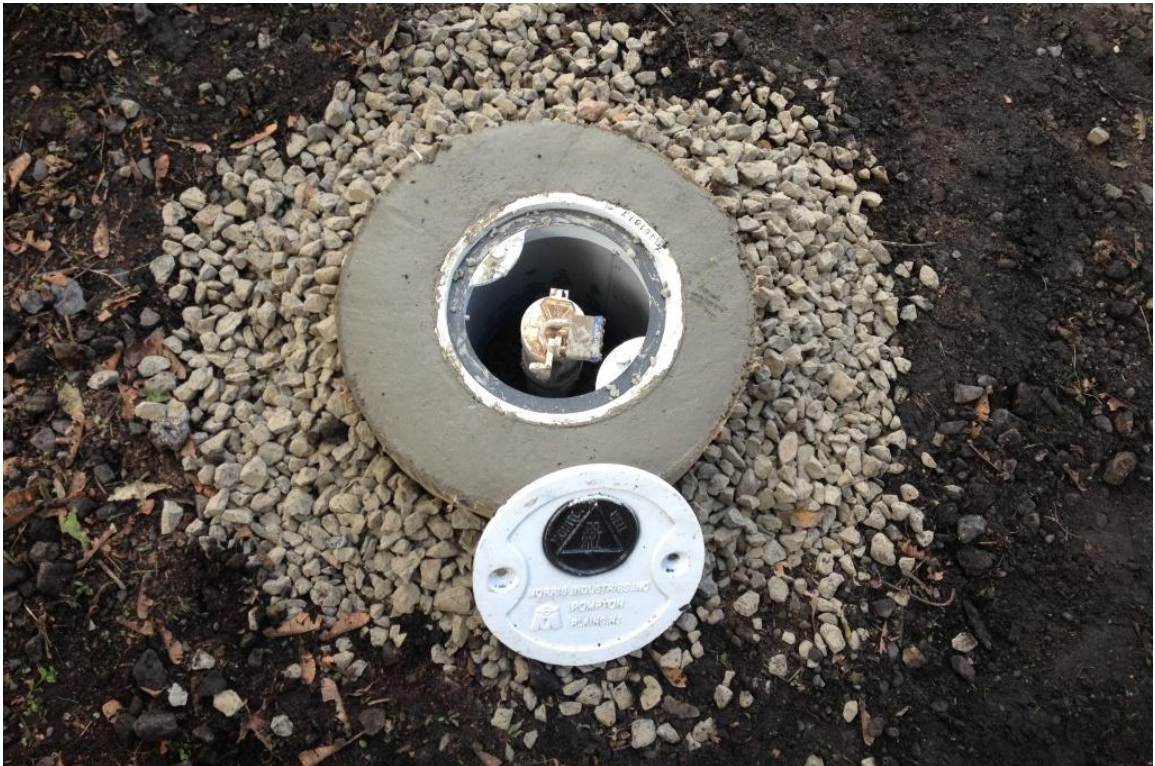
Photograph 6 – MW-58 well cluster repairs completed without making modifications to the existing well casing heights.

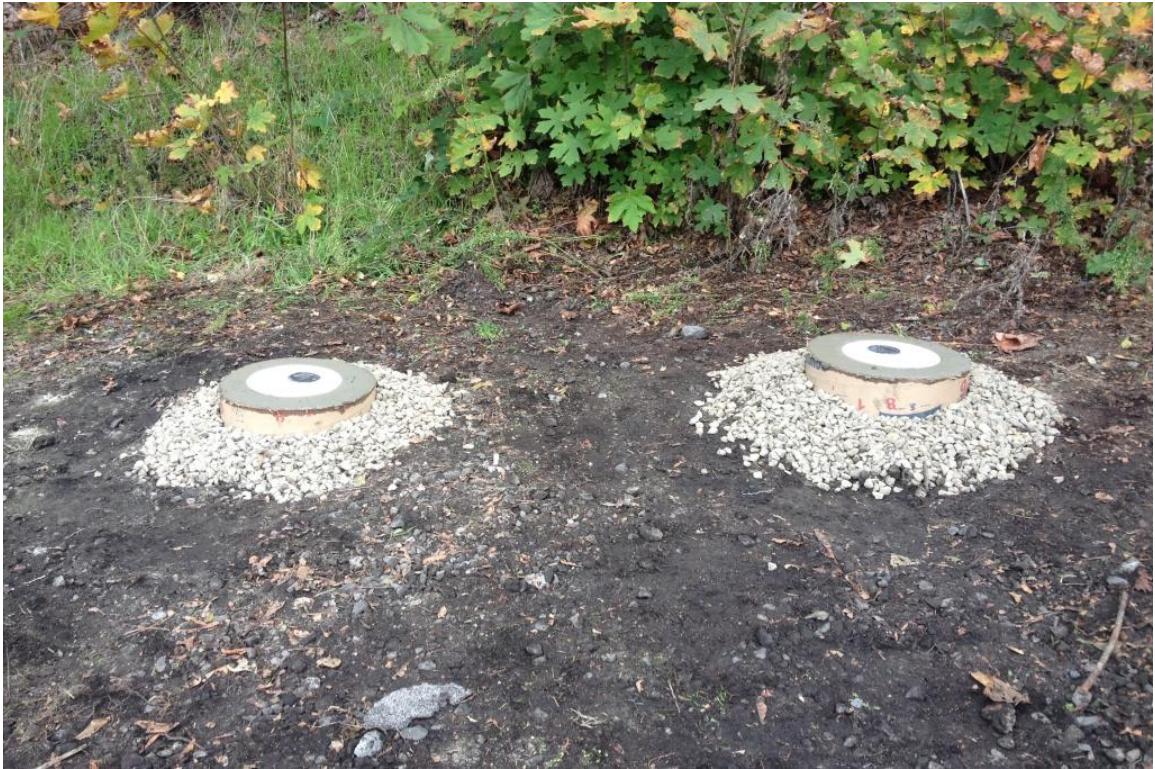
Photograph 7 – Two of the three MW-58 wells in the well cluster completed.

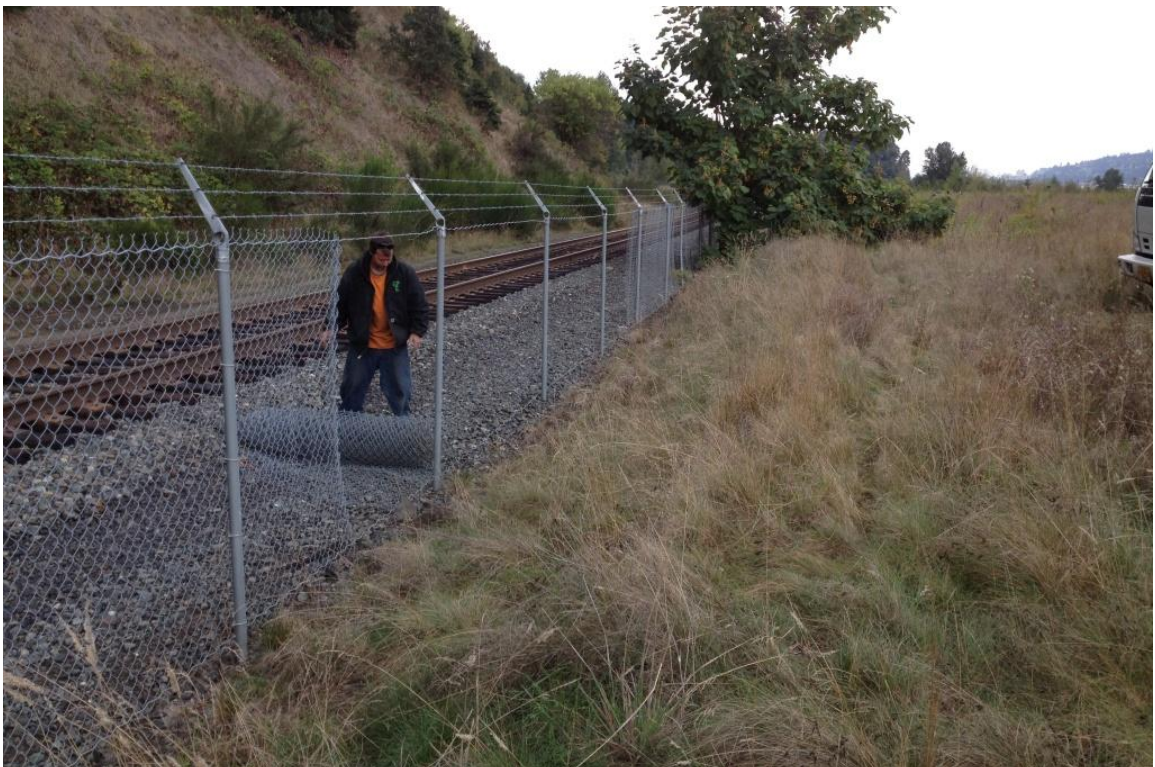
Soil cap maintenance activities were limited to a non-routine fence repair. A segment of the site perimeter fence, parallel to the Union Pacific Railroad tracks, was repaired in September 2013. A tension wire that runs along the bottom of the fence had broken and allowed the fence to stretch, creating a gap along the bottom of the fence approximately 1 foot high. No signs of foul play or entry

Photograph 8 – Perimeter fence along Union Pacific Railroad under repair. Photograph taken facing southeast.

were observed. West-Meyer Fence of Portland, Oregon, was contacted to make the fence repairs (Photograph 8, Appendix A).

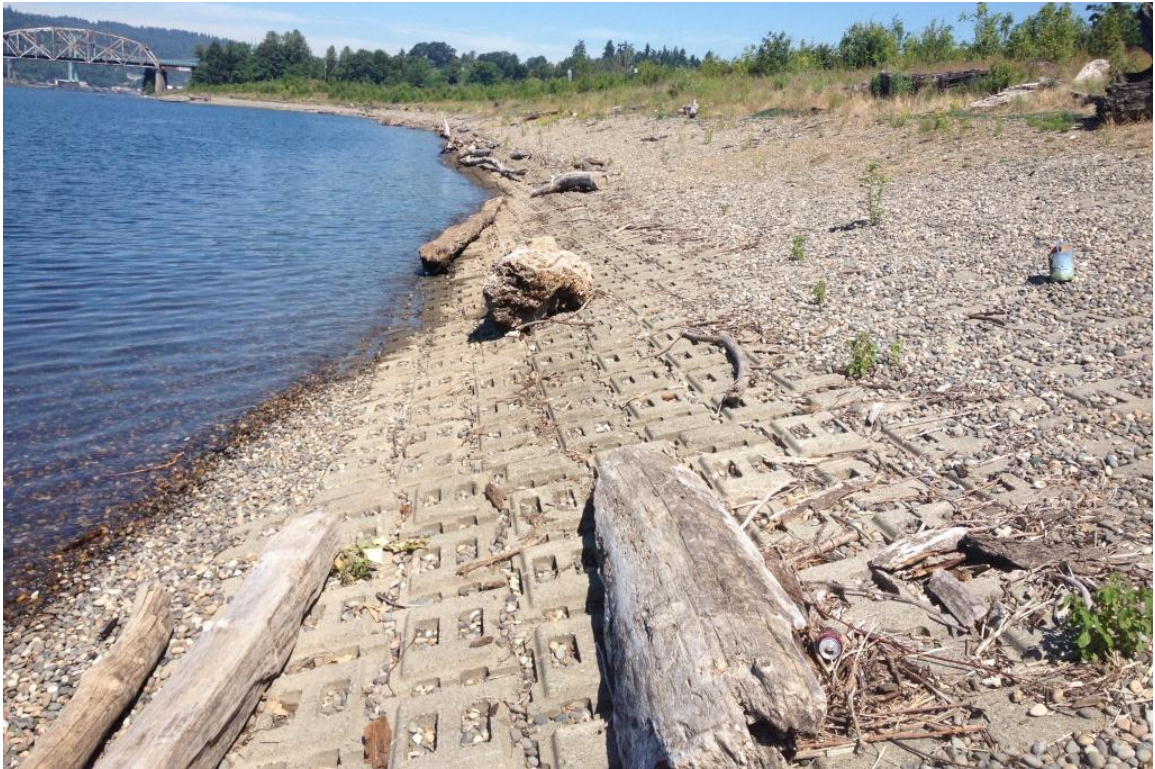
Photograph 9 – Willamette River shoreline showing distribution of woody debris and habitat gravel on ACB armoring. Photograph taken facing northwest.

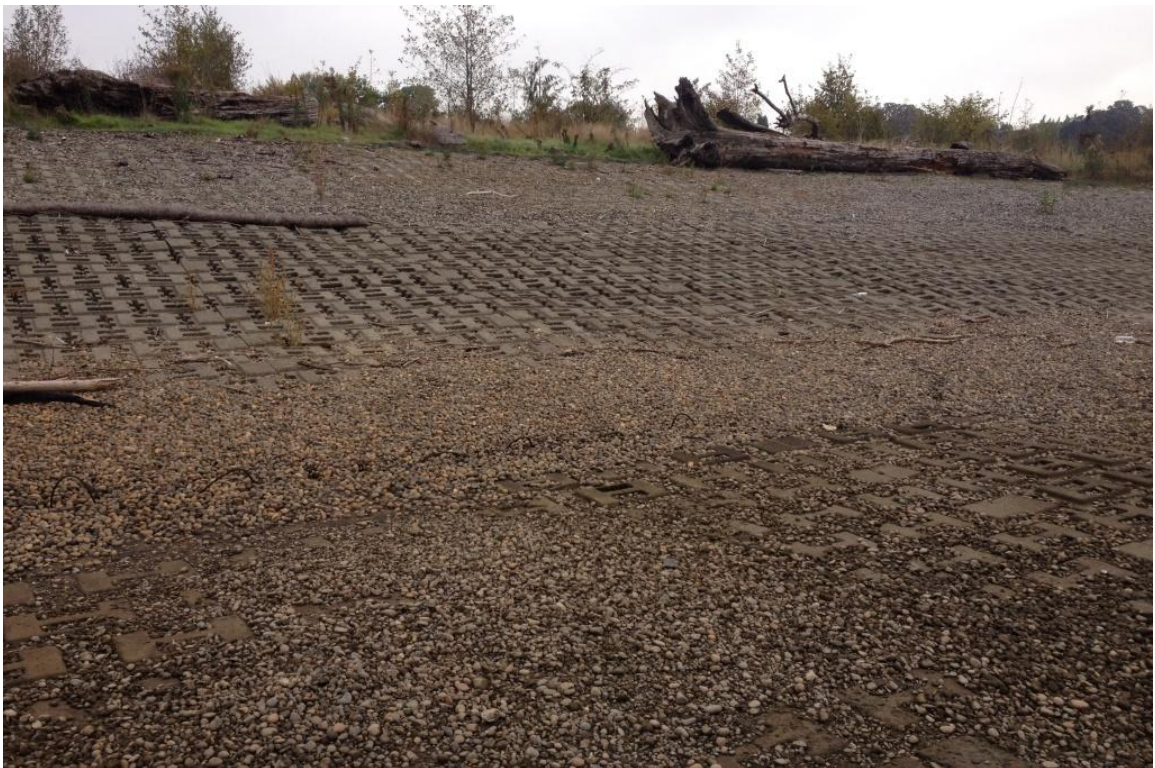
Photograph 10 – Habitat gravel distribution on ACB armoring. Photograph taken facing west.

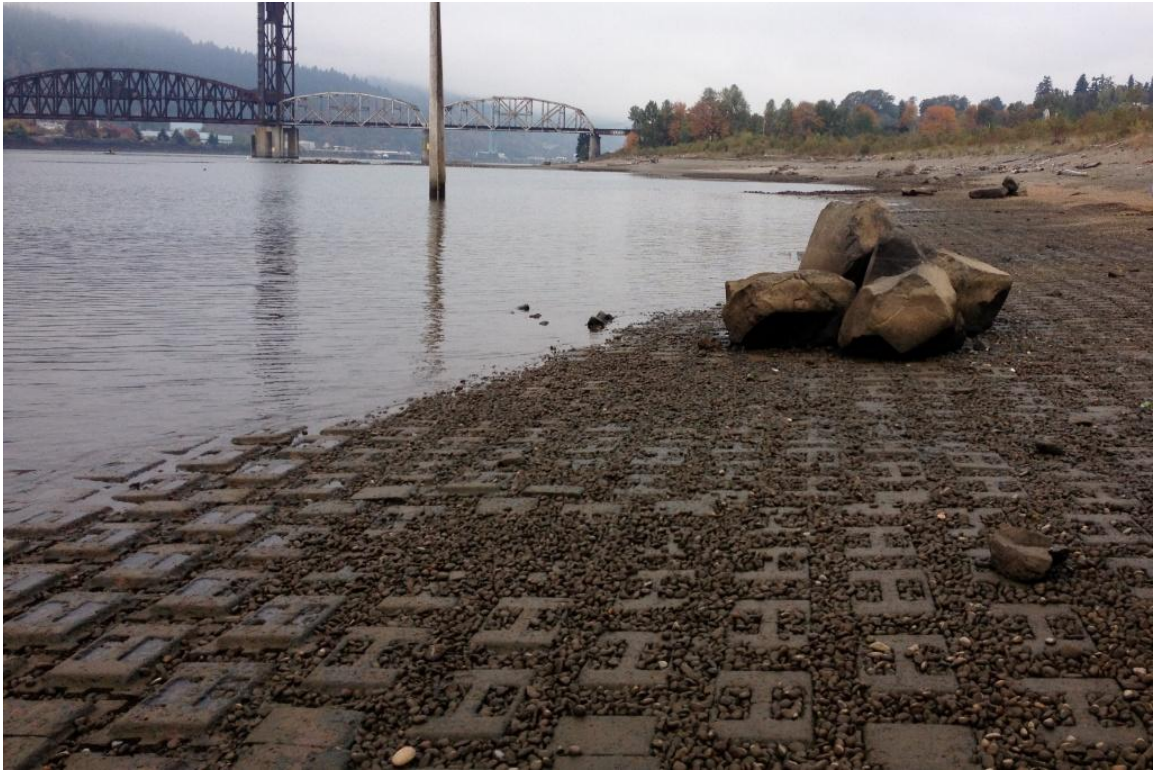
Photograph 11 – Habitat gravel settled throughout lower, flatter, shoreline. Habitat boulder cluster can also be seen in the photograph. Photograph taken facing northwest.

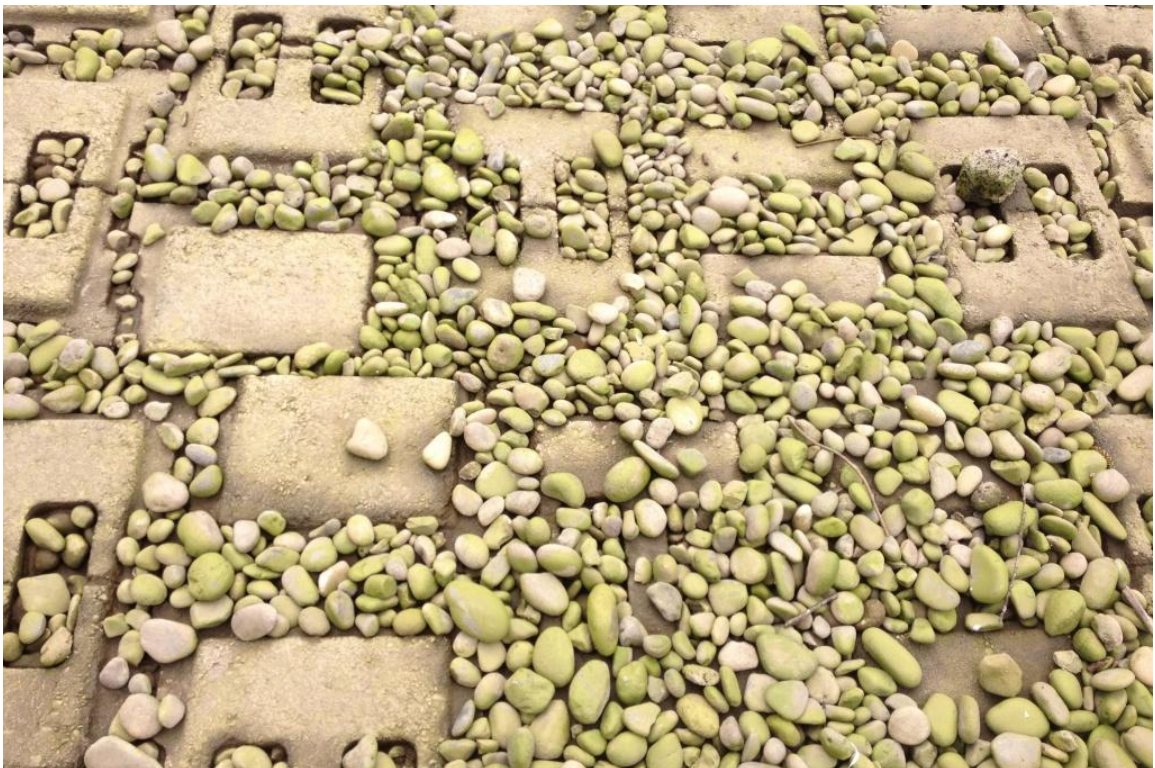
Photograph 12 – Habitat gravel settled on lower shoreline.

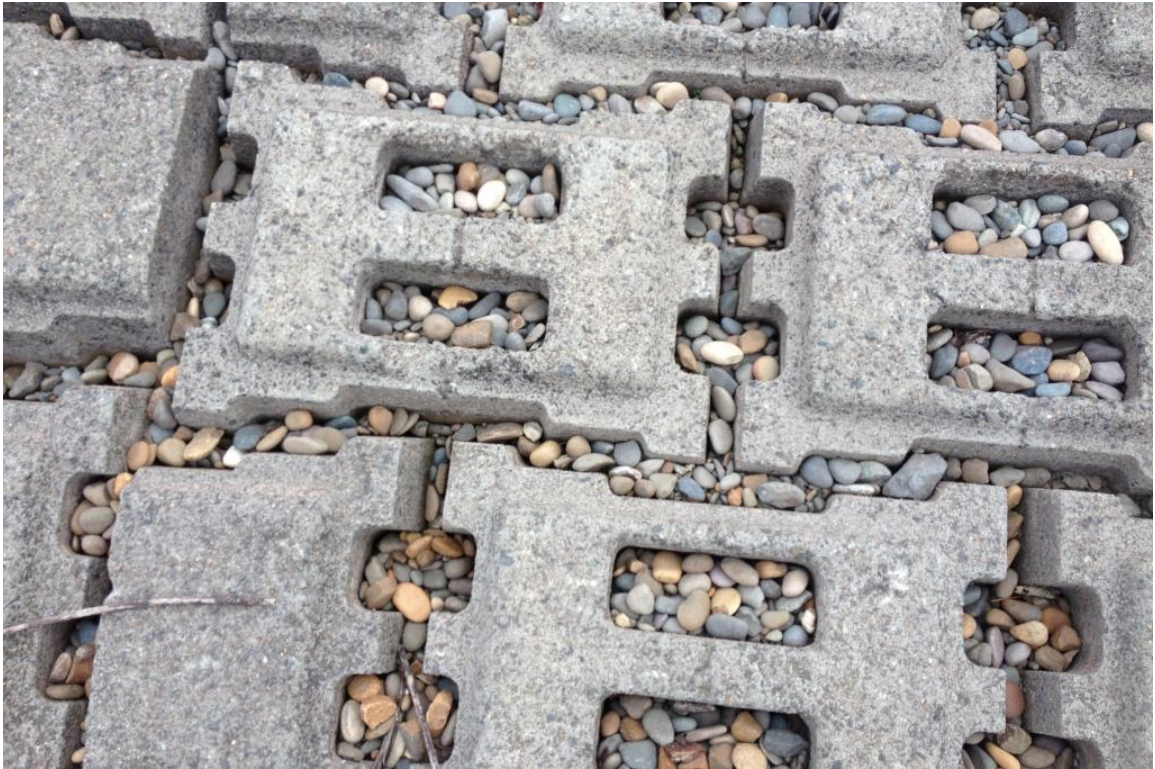
Photograph 13 – Typical habitat gravel placement throughout upper shoreline.

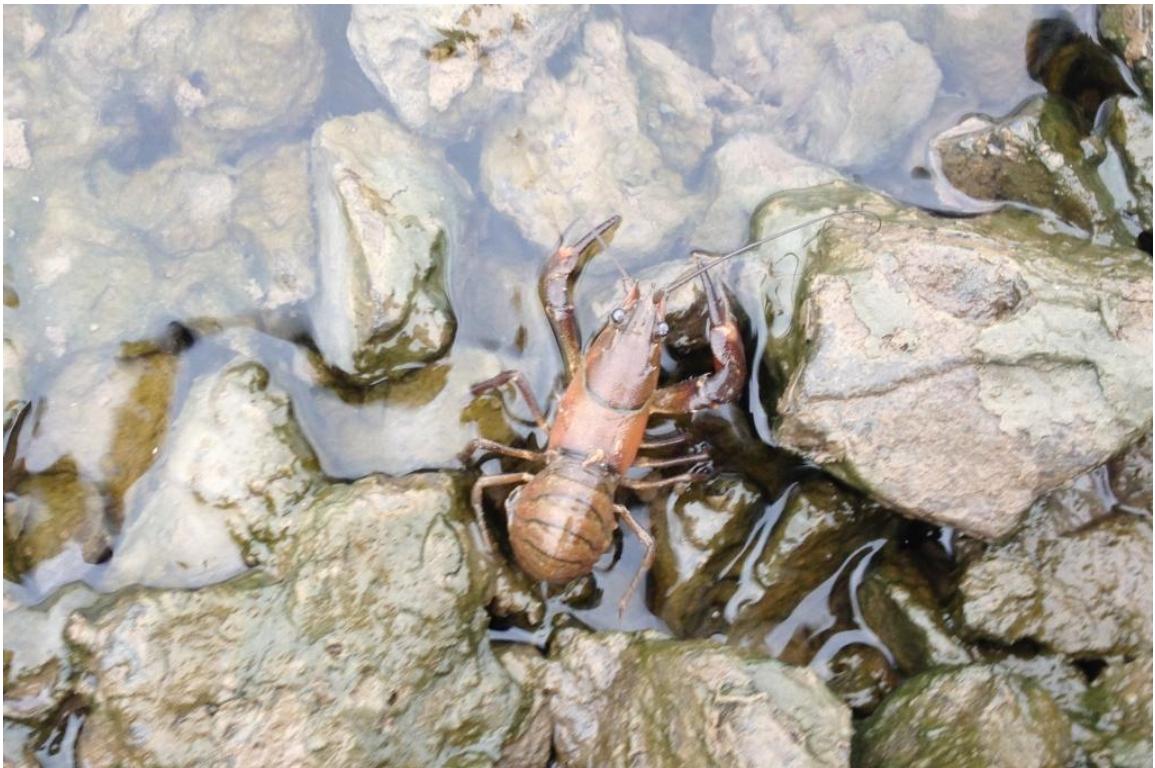
Photograph 14 – Crayfish seen on sediment cap rock armoring.

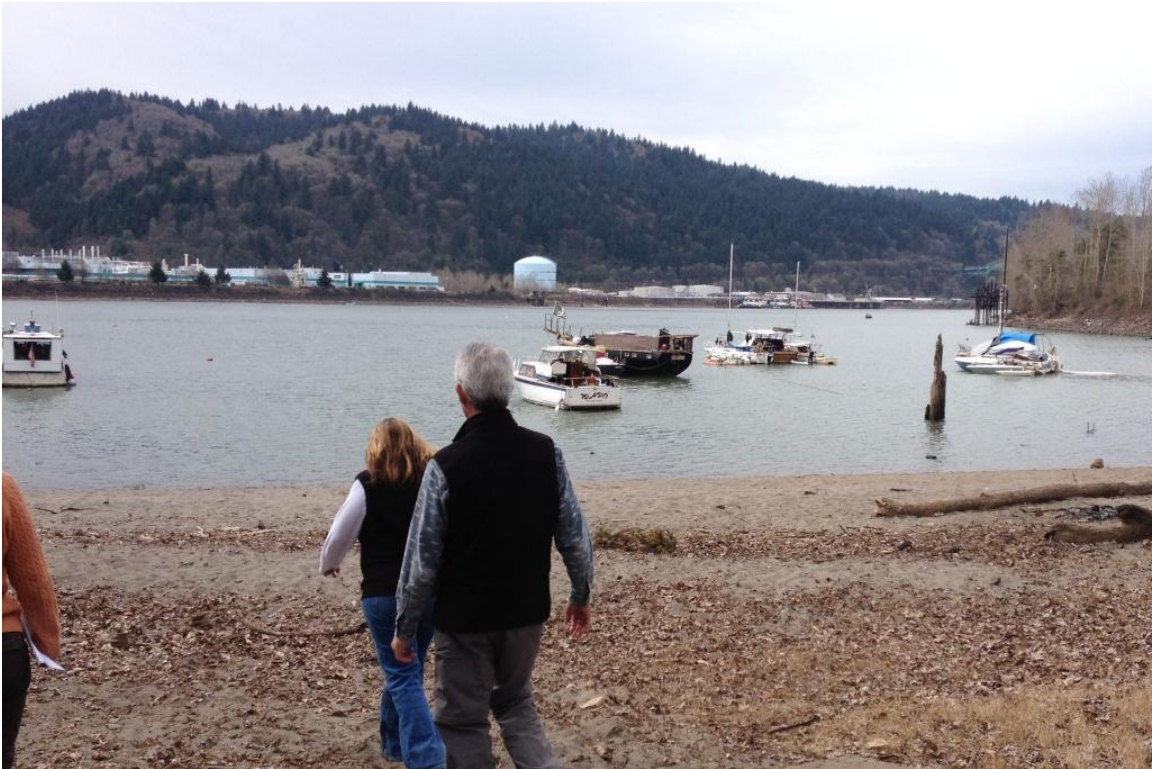
Numerous dilapidated boats (used as dwellings) were seen beached in Willamette Cove during every site visit (Photograph 15, Appendix A). No visible effects on the sediment cap were observed from mooring or from physical contact with these boats on the sediment cap. Although no damage to the ACB was observed or expected, the DEQ communicated these observations to Portland's regional metropolitan government agency, Metro, that owns the Willamette Cove property. The US Coast Guard and Oregon State Marine Board rules prohibit anchoring on the sediment cap.

Photograph 15 – Transient boats throughout Willamette Cove. Photograph taken facing west.

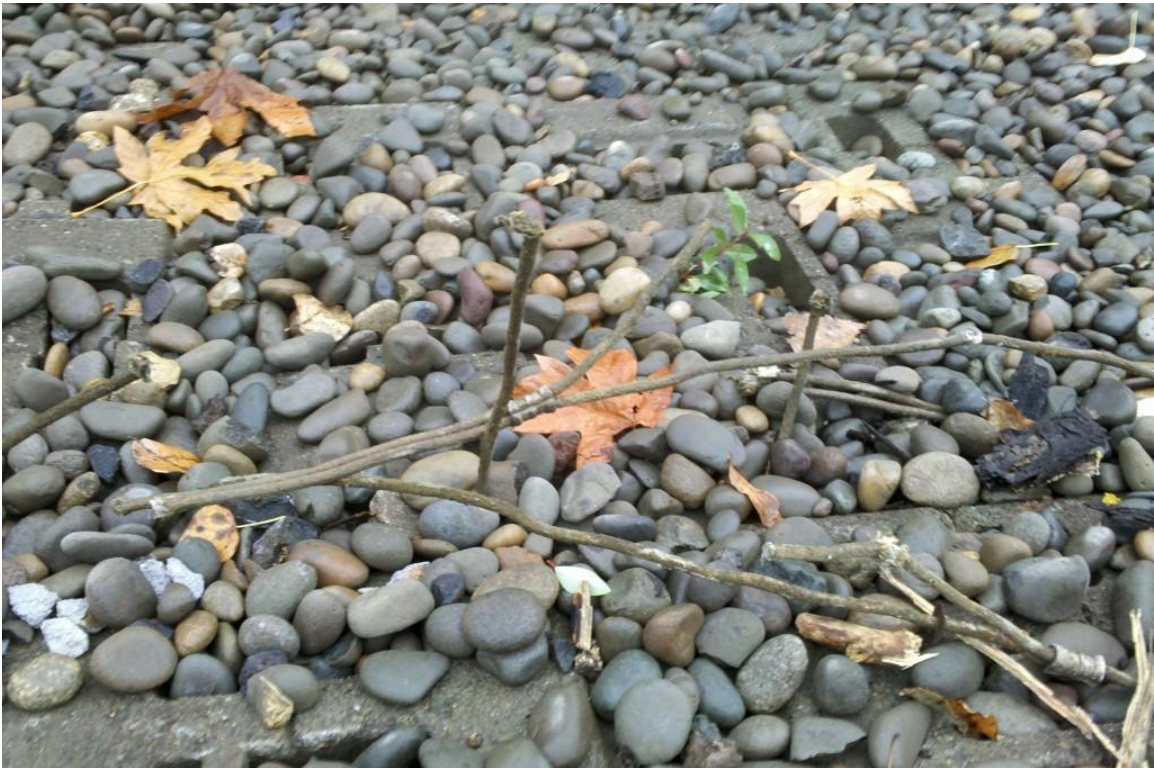
Cable loops used to install and adjoin ACB armoring sheets were observed sticking out of the armoring (Photograph 16, Appendix A). The cables used to place the ACB are no longer necessary to maintain the integrity of the ACB armoring. The cables were cut off close to the ACB armoring to remove the potential trip hazard from the shoreline.

Photograph 16 – Exposed ACB armoring cables were cut to remove the trip hazard.

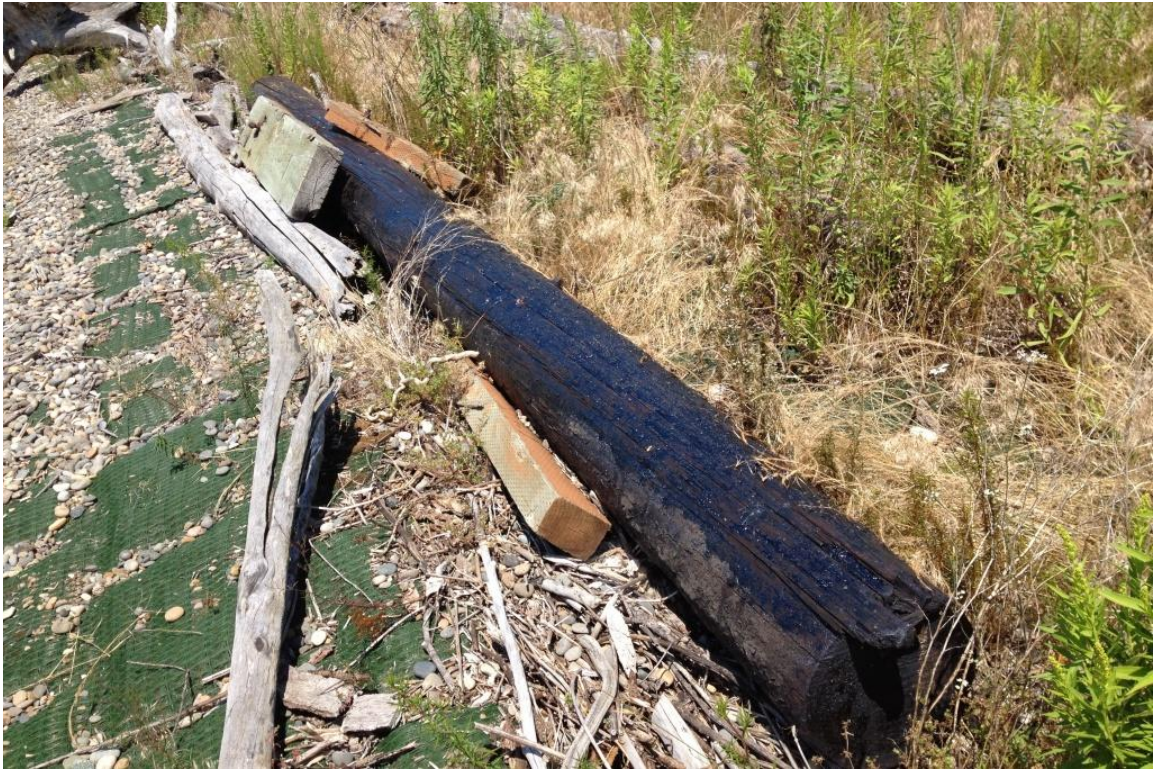
Photograph 17 – Creosote pole washed up on Willamette River shoreline. This pole was removed from the shoreline. Photograph taken facing southwest.

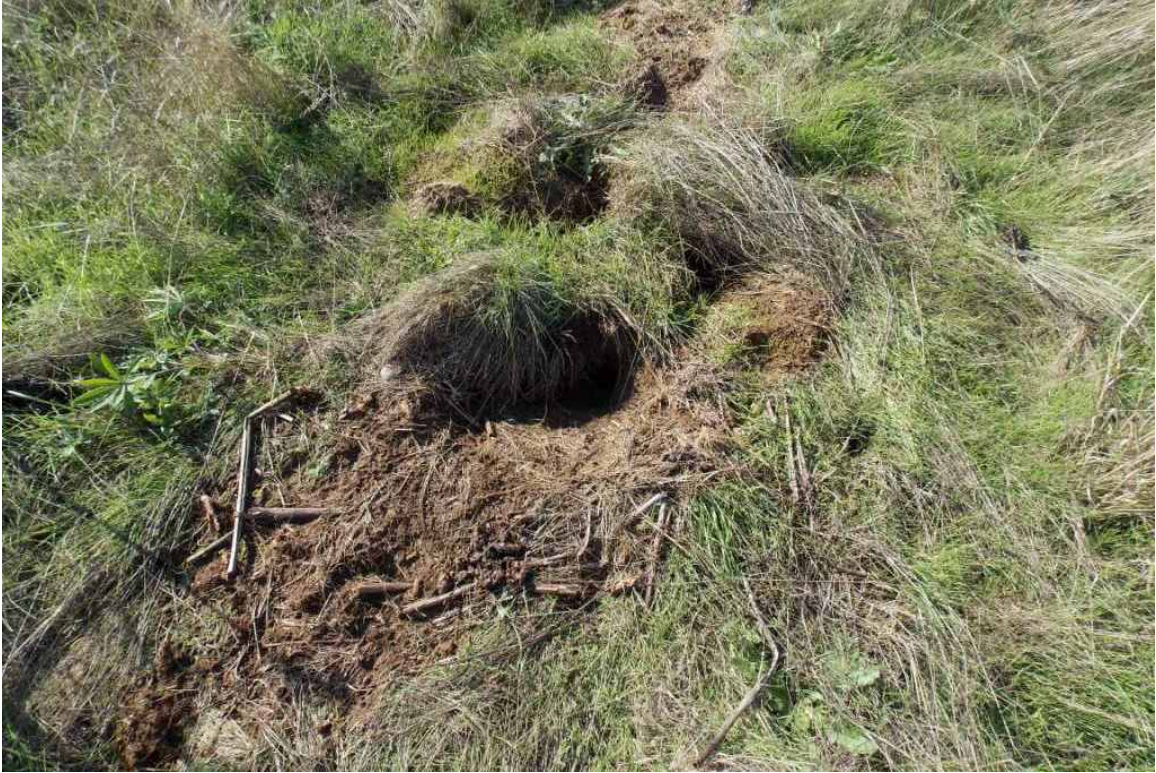
Photograph 1 – Typical rodent holes, these were observed in the stormwater swale area.
(October 2013)

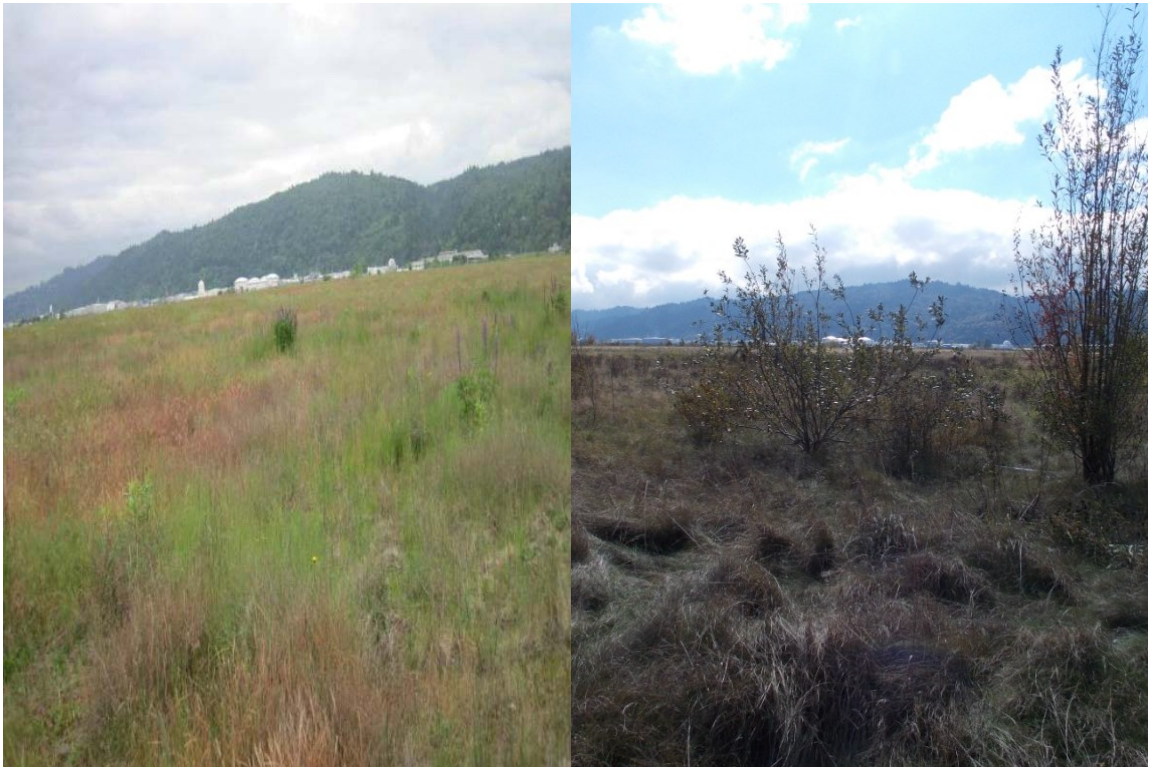
Photograph 2 – Earthen cap and drainage swale in the foreground with the impermeable cap in the background. Taken looking south from Photograph Location 1 comparing baseline and current conditions.
(Left - June 2011, Right - October 2013)

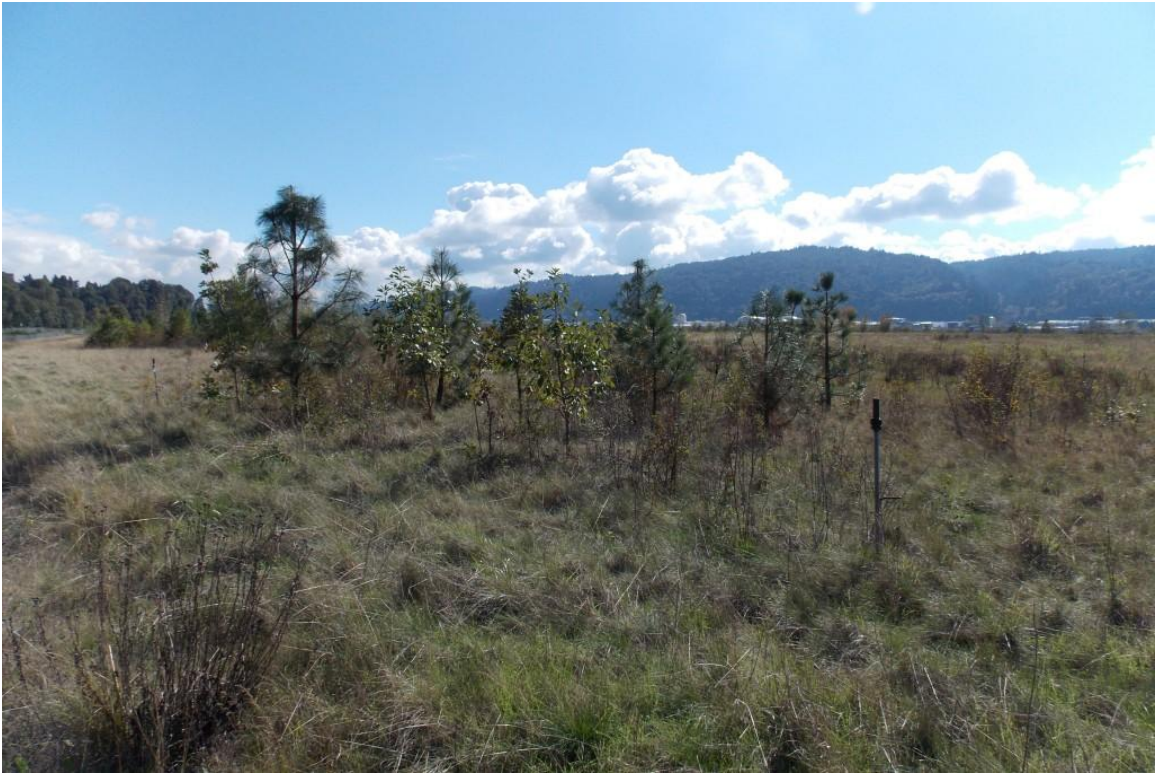
Photograph 3 - Tree and shrub plantings on the earthen cap are spreading. Taken looking southeast from Photograph Location 2. (October 2013)

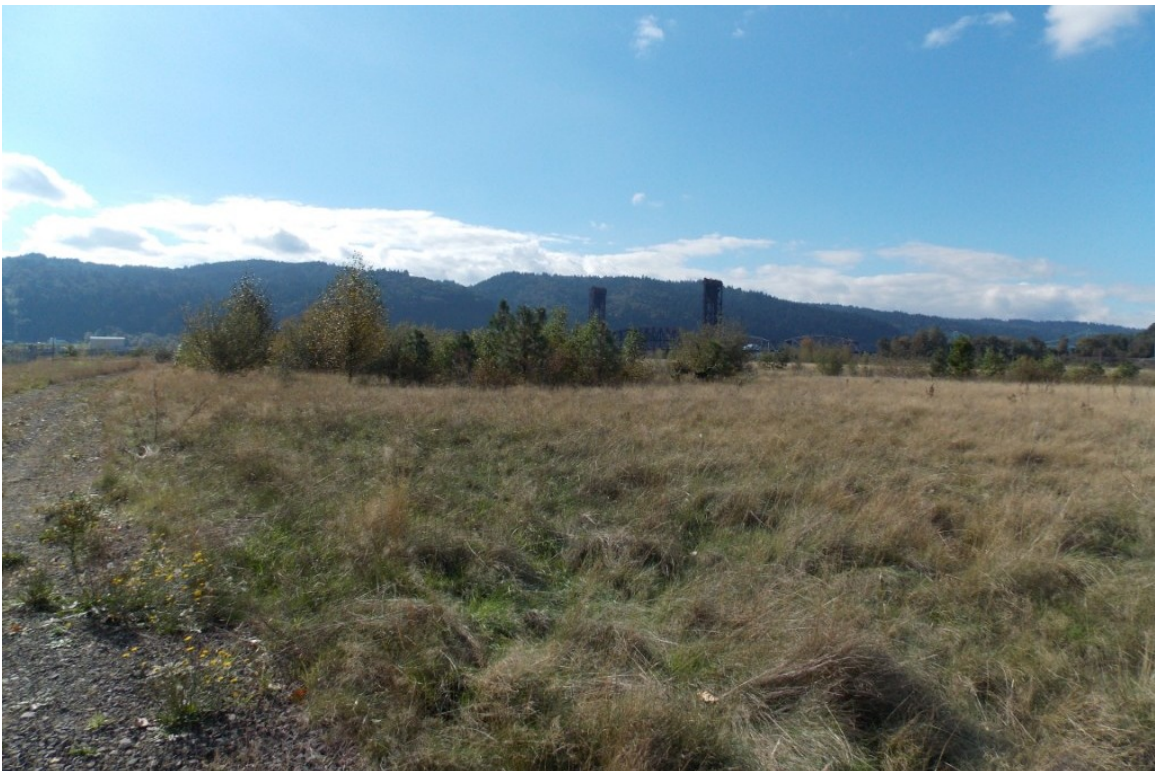
Photograph 4 – Eastern edge of the earthen cap with perimeter road in foreground. Taken looking west from Photograph Location 3. (October 2013)

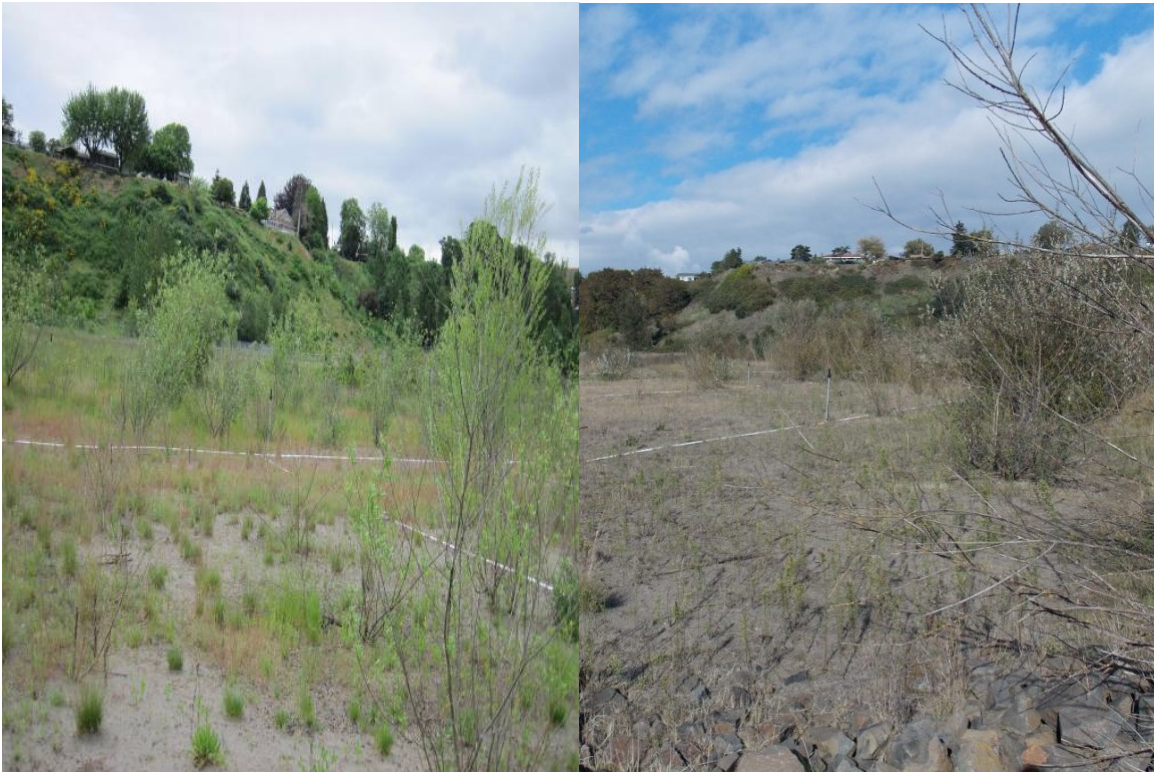
Photograph 5 – Stormwater pond scarcely vegetated although willow and alder continue to survive. Taken looking northeast from Photograph Location 4 comparing baseline and current conditions. (Left - June 2011, Right - October 2013)

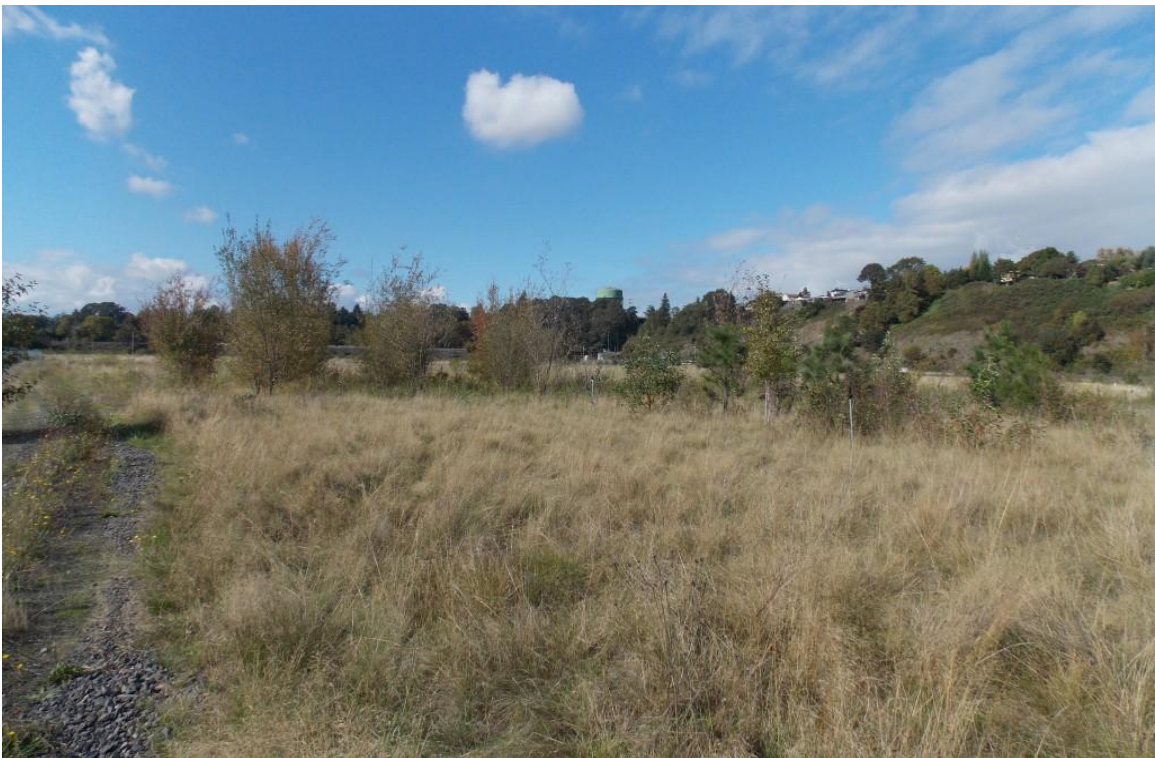
Photograph 6 – Tree plantings on the earthen cap. Taken looking northwest from Photograph Location 5. (October 2013).
