***Operation and Maintenance Report
January 2013 to December 2013
McCormick and Baxter
Superfund Site
Portland, Oregon***

***Prepared for
Oregon Department of
Environmental Quality***

***April 9, 2014
15670-10/Task 4***

Prepared by
GSI Water Solutions, Inc.

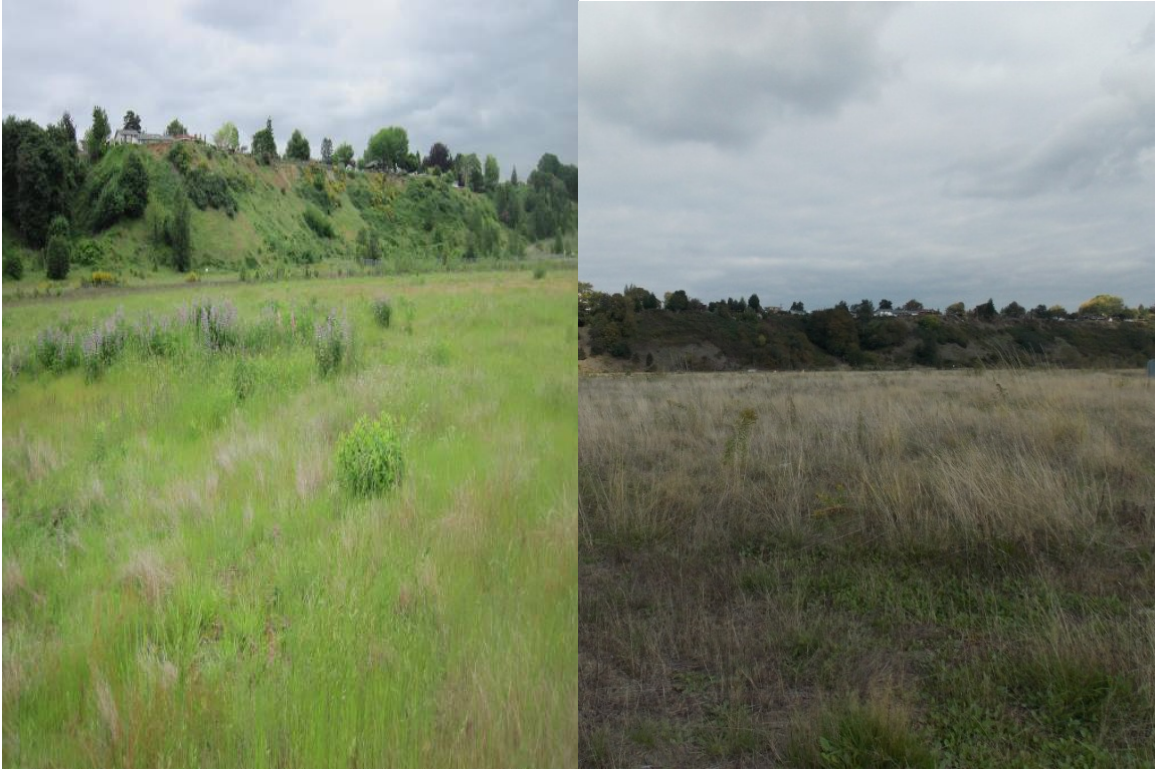
Photograph 7 – Impermeable cap dominated by grasses and herbaceous vegetation. Taken looking east from Photograph Location 6 comparing baseline and current conditions. (Left - June 2011, Right - October 2013)

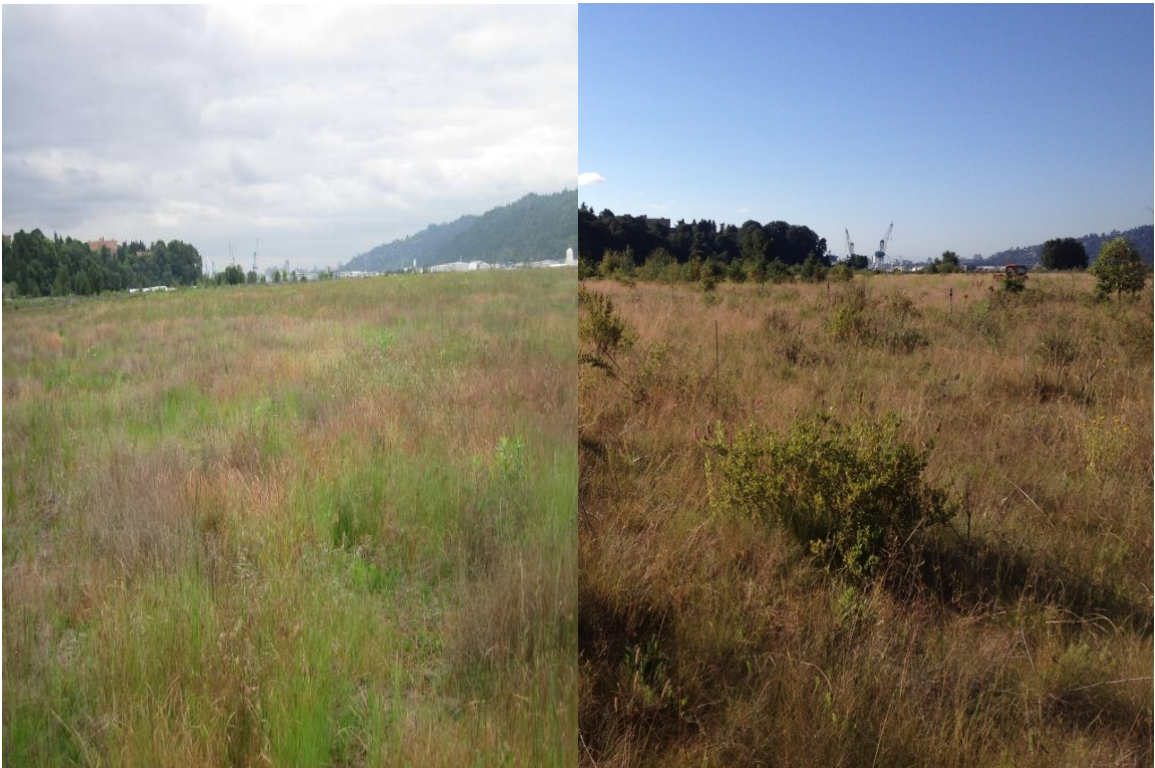
Photograph 8 – Impermeable cap dominated by grasses and herbaceous vegetation. Taken looking southeast from Photograph Location 7 comparing baseline and current conditions. (Left - June 2011, Right - October 2013)

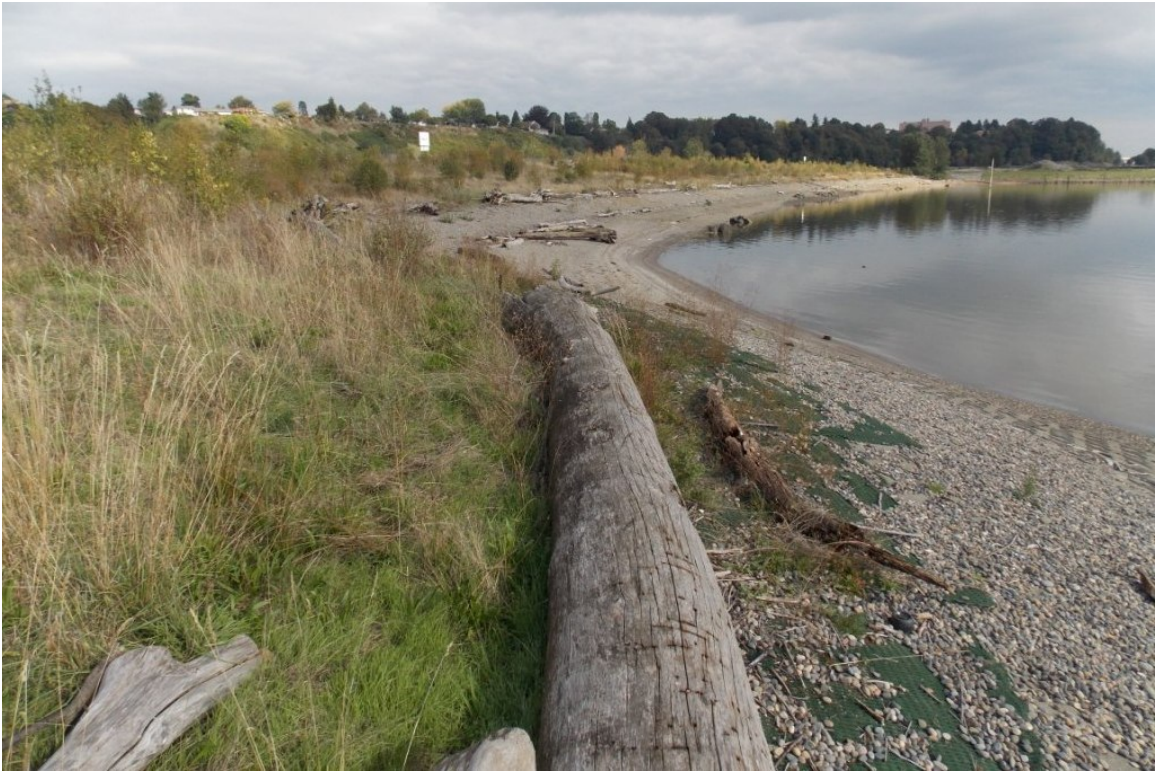
Photograph 9 – Vegetation growth and wood debris within the lower riparian component. Taken looking southeast from Photograph Location 8. (October 2013)

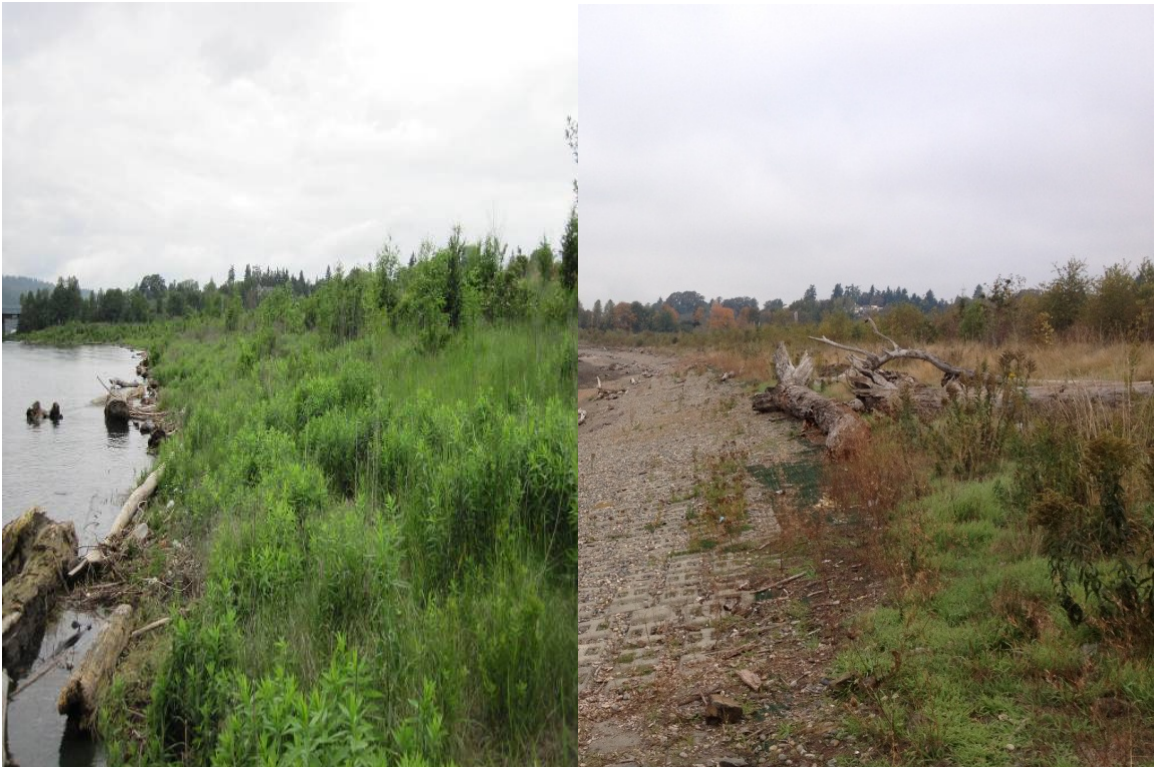
Photograph 10 – Lower riparian component with large wood debris along the edge. Taken looking northwest from Photograph Location 9 comparing baseline and current conditions. (Left - June 2011, Right - October 2013)
