Operation and Maintenance Report  
January 2014 to December 2014

## McCormick and Baxter Superfund Site

Portland, Oregon

Oregon Department of  
Environmental Quality

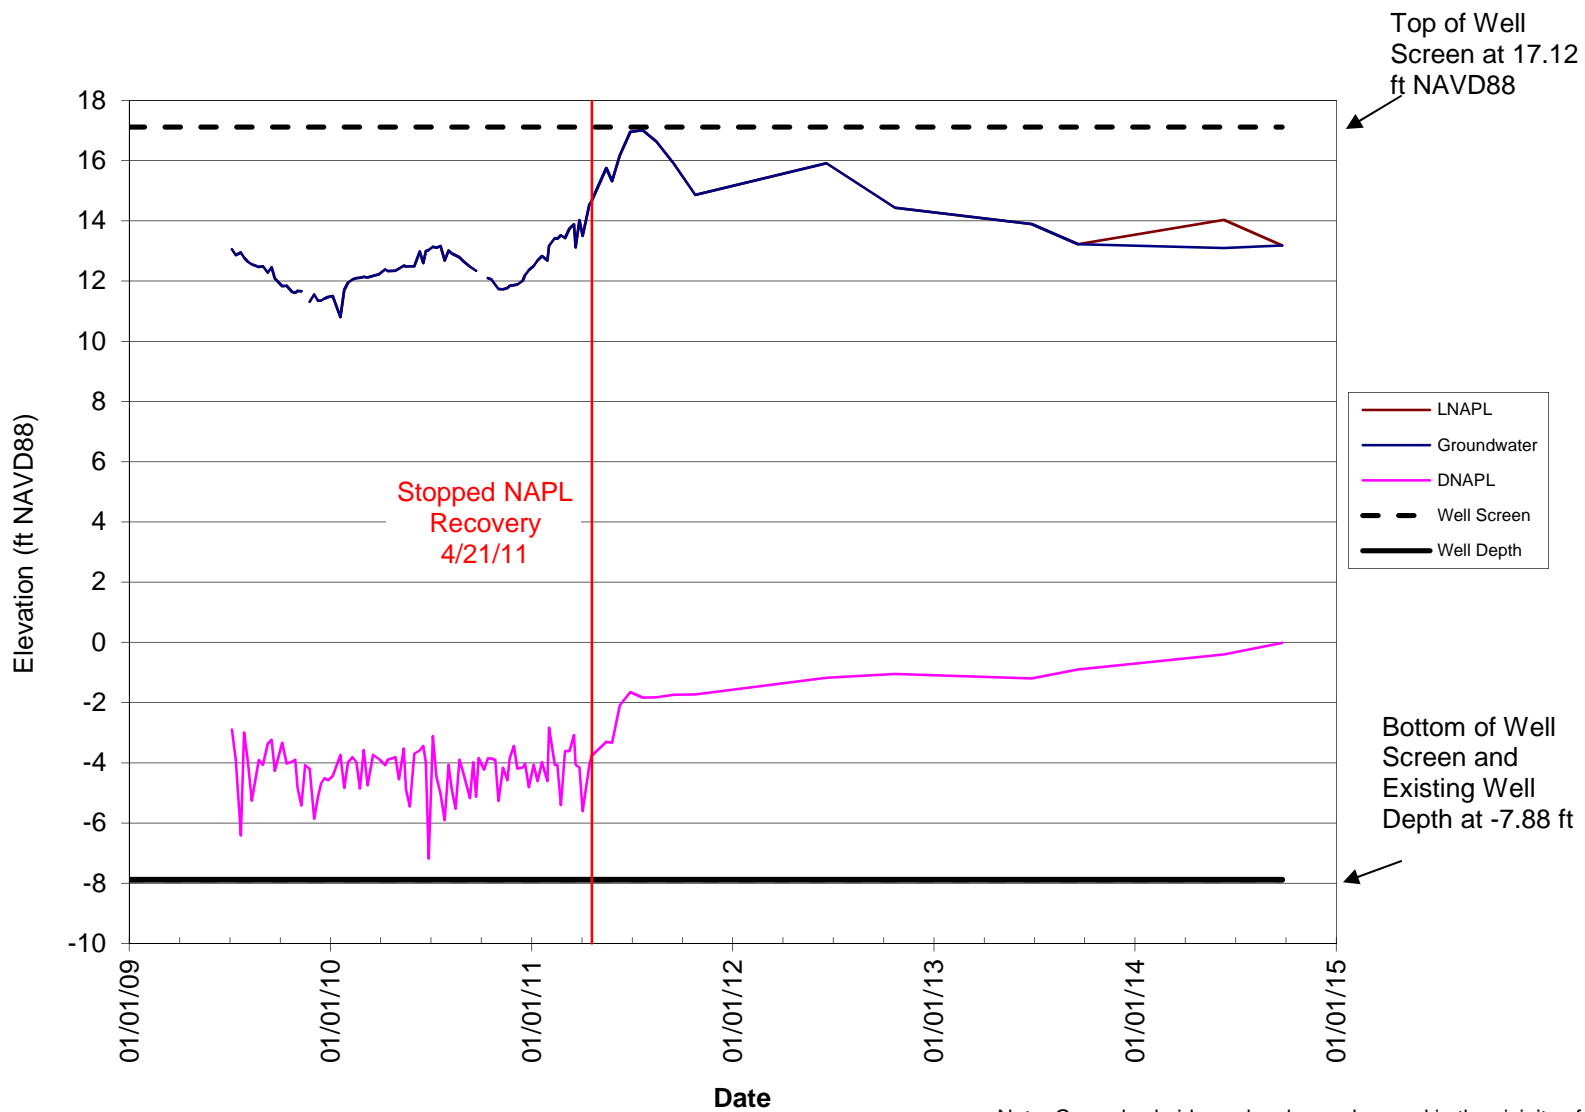
Figure  
**4-21**

Monitoring well EW-1s was recorded as having a LNAPL thickness of 0.9 foot during the June 11, 2014, semiannual monitoring event. Despite a handful of trace LNAPL readings in the past, this is the first measurable LNAPL thickness observed in this well (Figure 4-21). The DNAPL thickness in well EW-1s (Figure 4-21) has been increasing slowly to a thickness of approximately 8 feet since mid-2011, after termination of a temporary recovery period in April 2011.

Note: Ground subsidence has been observed in the vicinity of EW-1s and the well casing has sunk over time. The screened interval and total well depth have been referenced to the most recent ground survey from September 2009. Given that the elevations are changing with time, the elevations shown are approximate.

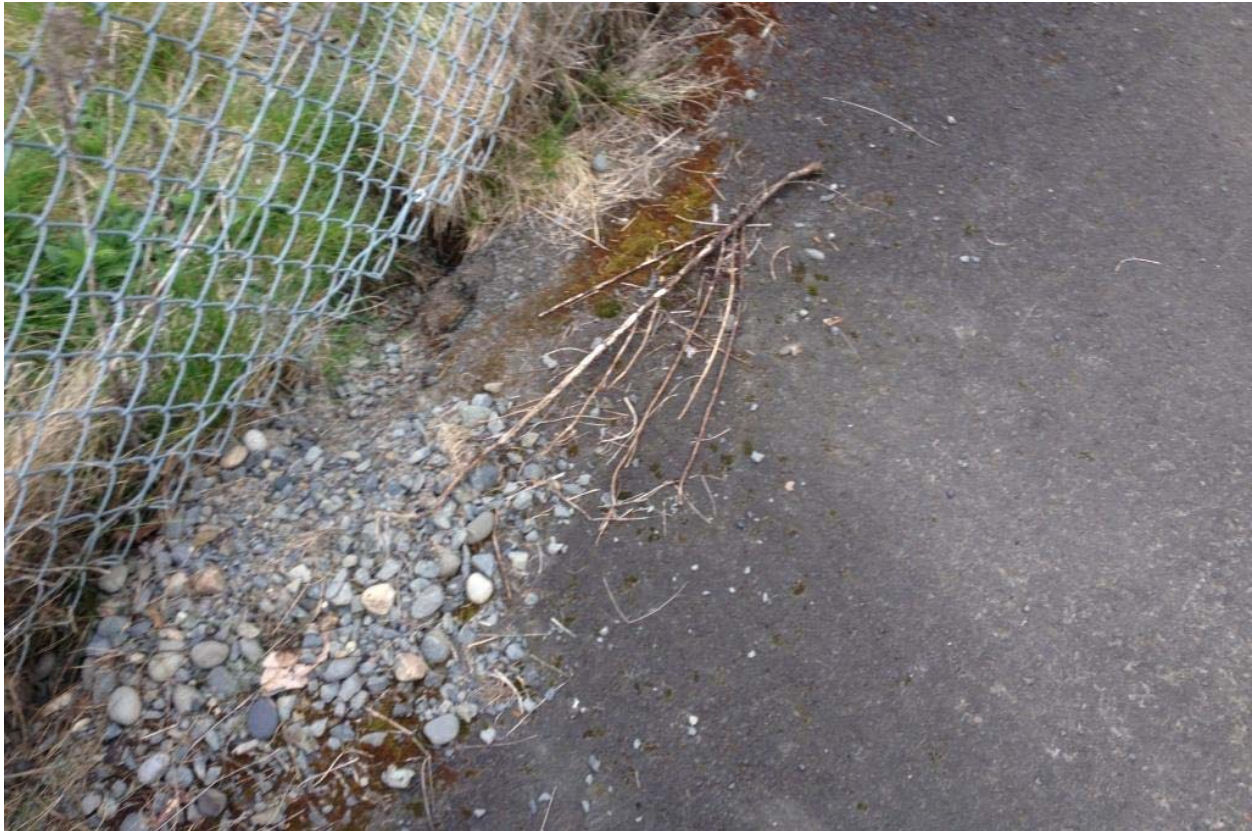
The upland soil cap provides habitat for rabbits, ground squirrels, Canada geese, several other species of birds, and coyotes. Despite placing gravel to fill gaps under the fence around the upland portion of the site, periodic burrowing continues to be observed under the fence and along the perimeter road. These burrows are filled as necessary and are not of major concern (Photograph 1, Appendix A).

Photograph 1 – Typical animal burrow underneath the site perimeter fence. Photograph taken near the entrance to the Support Facility.

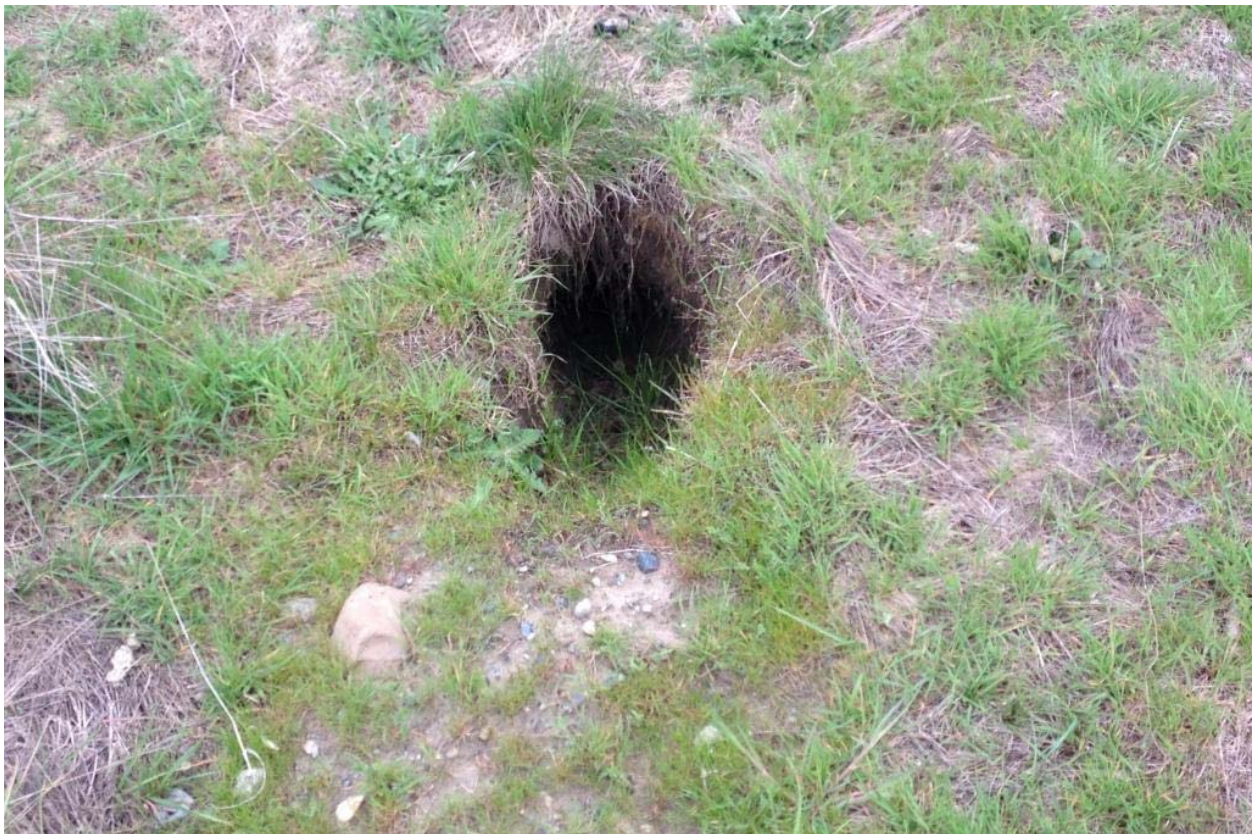
Evidence of ground squirrel activity was observed at several locations throughout the upland soil cap. Ground squirrels are common to the area, and their burrows typically extend to approximately 1 foot below ground surface (bgs). The ground squirrels use the surplus articulated concrete block (ACB) stockpiled at the site, paved roadway, and concrete well monuments as habitat. A larger than typical animal burrow was observed on the soil cap, likely from a coyote (Photograph 2, Appendix A). None of the observed burrows extend more than 1-foot into the 2-foot soil cap and, therefore, the soil cap continues to isolate site contaminants from human and ecological receptors. Continued monitoring of the burrows is recommended; no action to remove burrowing animals or to fill in the burrows is planned or is necessary at this time.

Photograph 2 – Slightly larger animal burrow observed on the earthen cap.

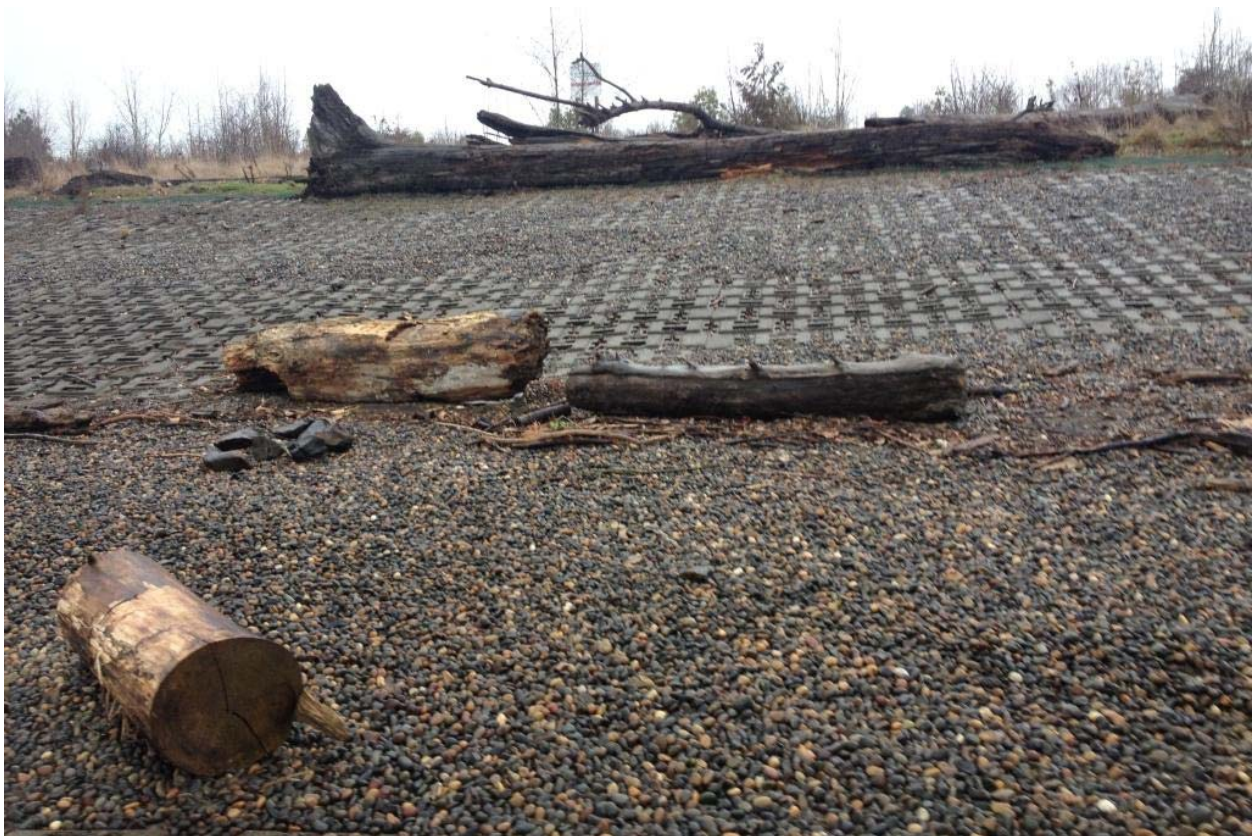
Photograph 14 – Photograph showing variation in habitat gravel cover as it settled into ACB armoring along the shoreline. Photograph taken facing northeast.

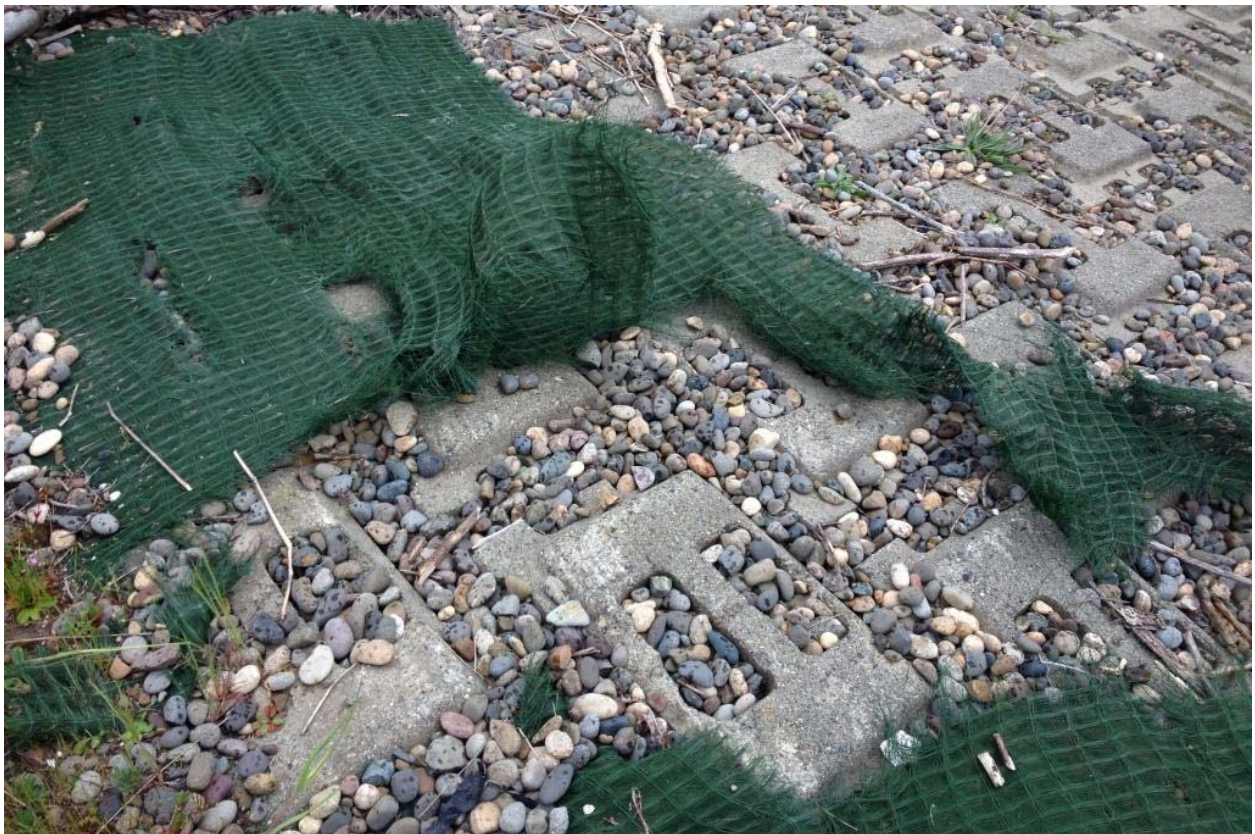
Photograph 16 – Typical damage to TRM at the lower Riparian Area where TRM meets ACB armoring. Photograph taken facing south.

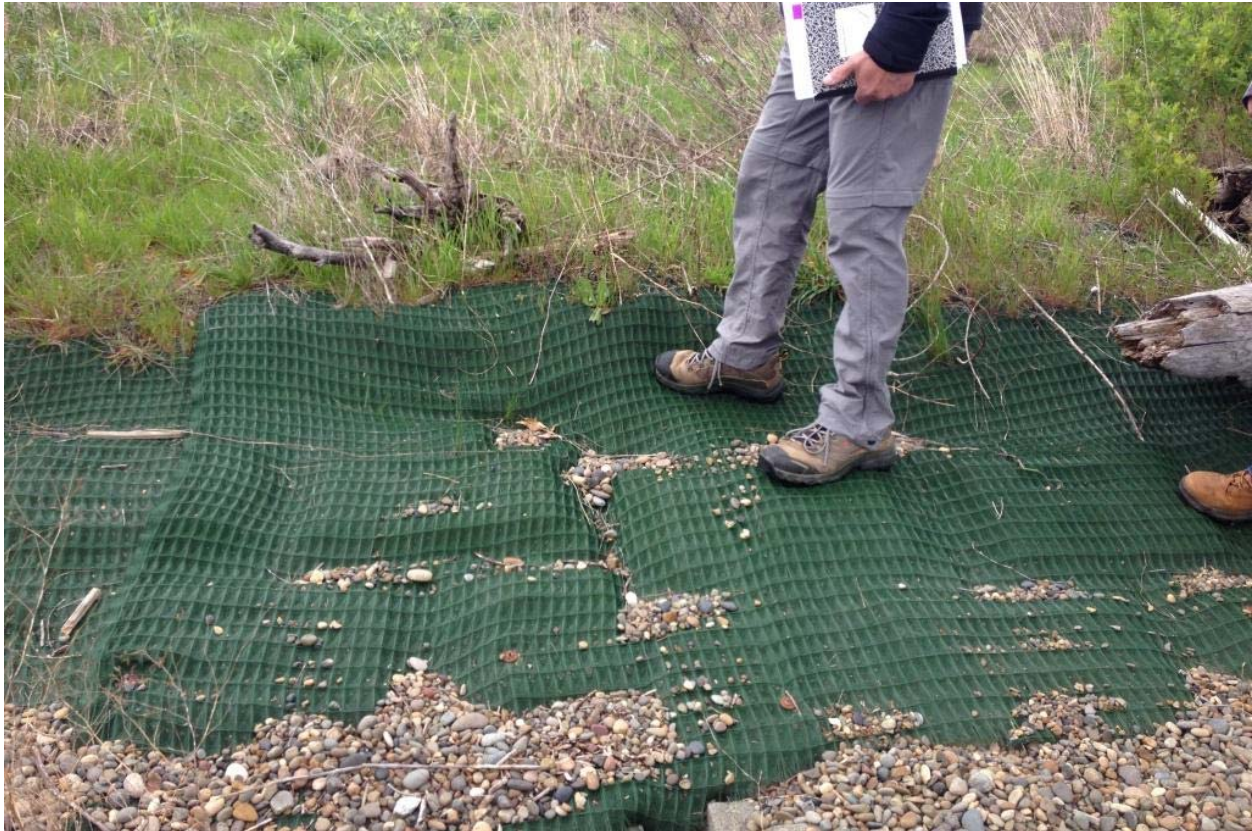
Photograph 17 – Photograph showing TRM overlapping ACB at lower Riparian Area. Void spaces have grown in some areas under the TRM. Photograph taken facing northeast.

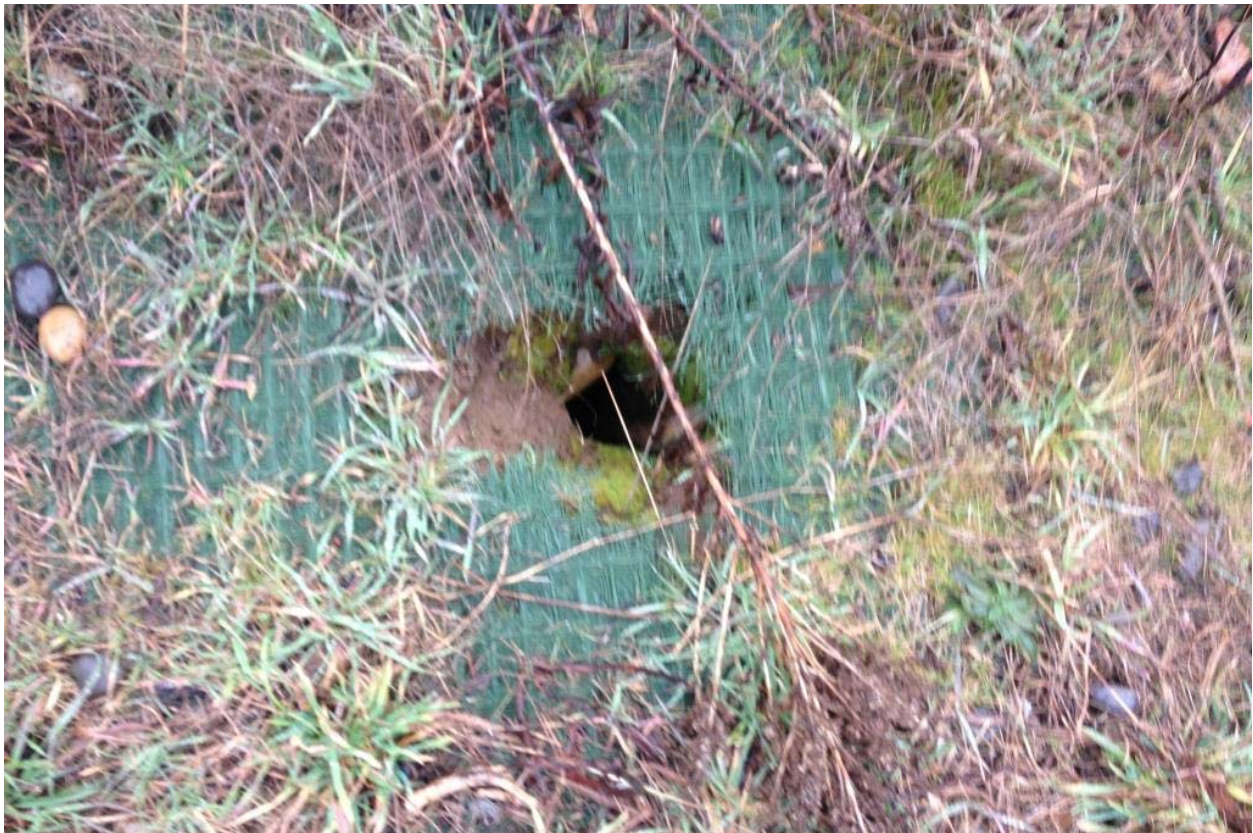
Photograph 19 – Typical burrowing observed through TRM in the Riparian Area.

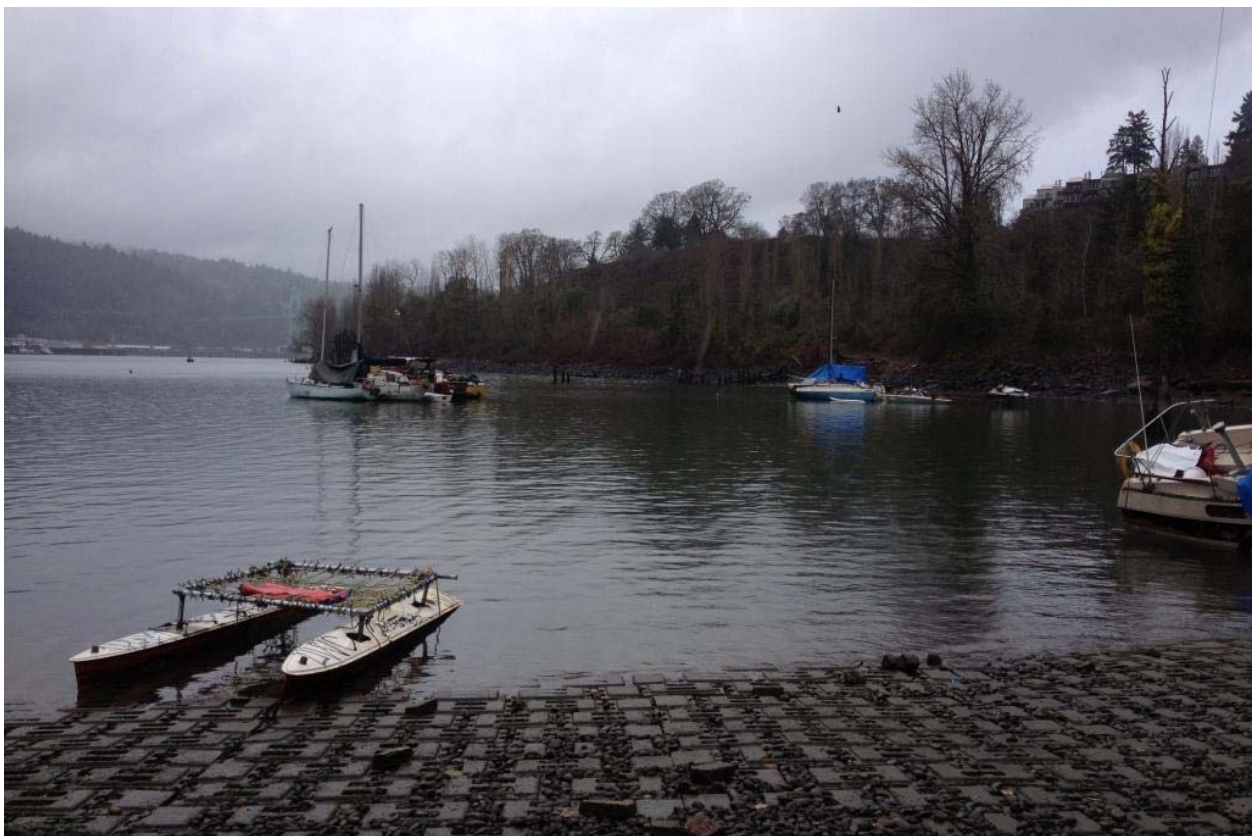
Numerous dilapidated boats (used as dwellings) were seen anchored in the Willamette Cove during every site visit (Photographs 20 and 21, Appendix A). No effects to the sediment cap were observed from mooring or from physical contact with these boats on the sediment cap. Although no damage to

Photograph 20 – Transient boats observed in Willamette Cove. Photograph taken facing west.

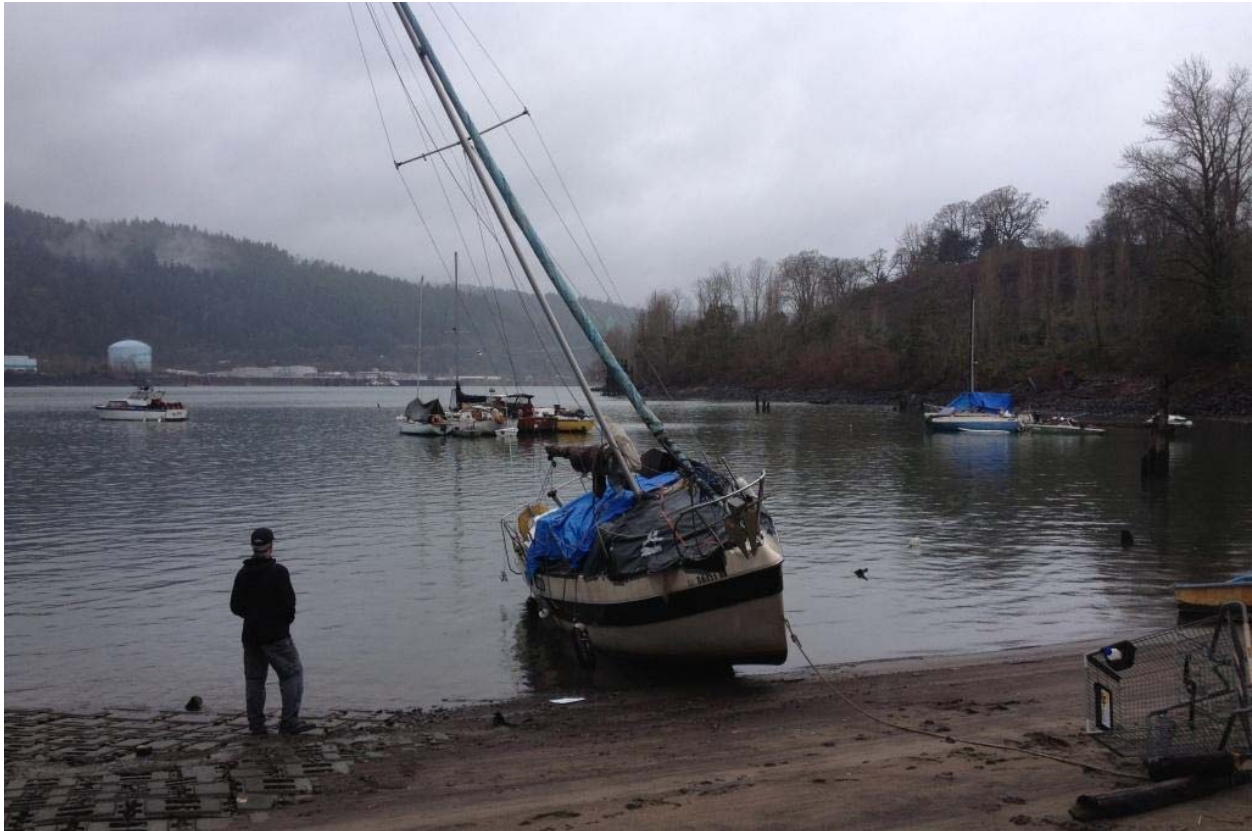
Photograph 21 – Transient boat moored and resting on the edge of the sediment cap. Photograph taken facing west.

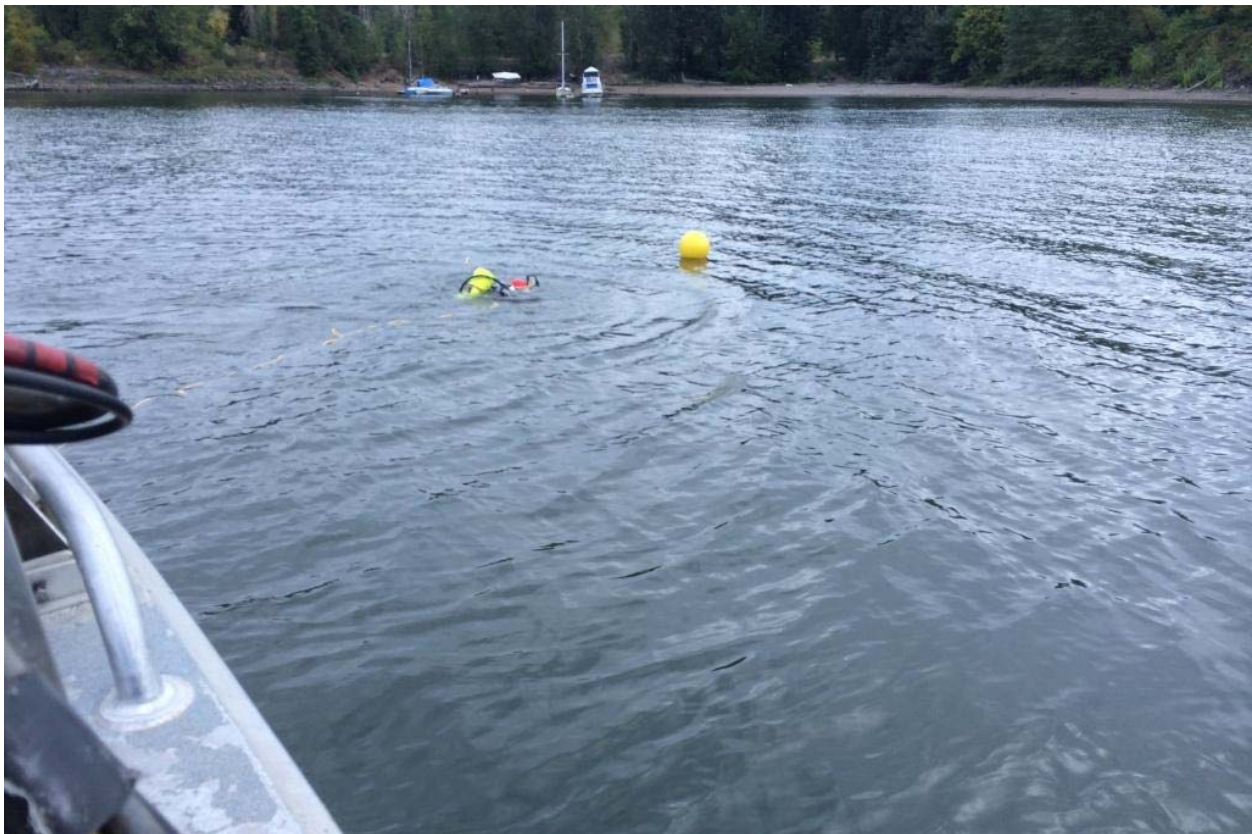
Five permanent buoys were installed in August 2011 along the perimeter of the sediment cap warning boaters of navigational hazards. During the January 2014 site inspection, it was observed that Buoy #4 was missing. This was confirmed during site inspections in April and July 2014. An underwater inspection of the buoy location was conducted in September 2014 as described below.

Photograph 22 – Diver searching for missing Buoy #4 at Willamette Cove. Photograph taken facing northeast.

On September 10, 2014, Hart Crowser and Ballard Underwater Construction (Ballard) mobilized to the site to determine the circumstances regarding the missing buoy. Prior to the inspection, it was unclear whether the buoy was submerged or completely missing. The buoy anchor (concrete ecology block) was located with no hardware attached. The buoy, the buoy chain, and securing hardware were all missing. The diver also inspected the sediment cap armoring around the anchor for damage. The 6-inch minus armoring around Buoy #4 appeared to be in good condition with no scour observed. After determining that the buoy was missing, a replacement buoy was ordered. The buoy is the same model and manufacturer as the original buoy. The buoy has been ordered and is expected to be delivered to Ballard in February 2015. Hart Crowser and Ballard will install the buoy upon its delivery.

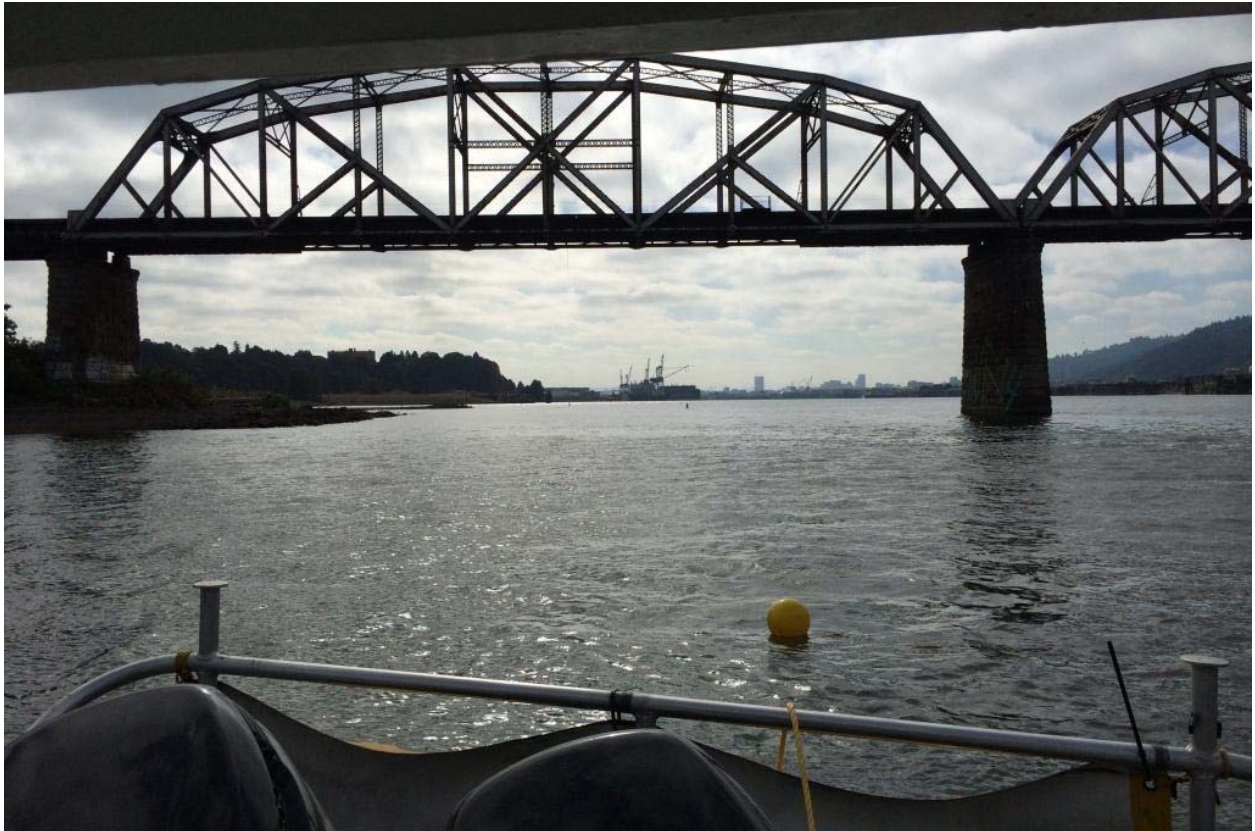
Photograph 23 – Yellow buoy is attached to the missing Buoy #4 anchor block. Photograph taken facing southeast.

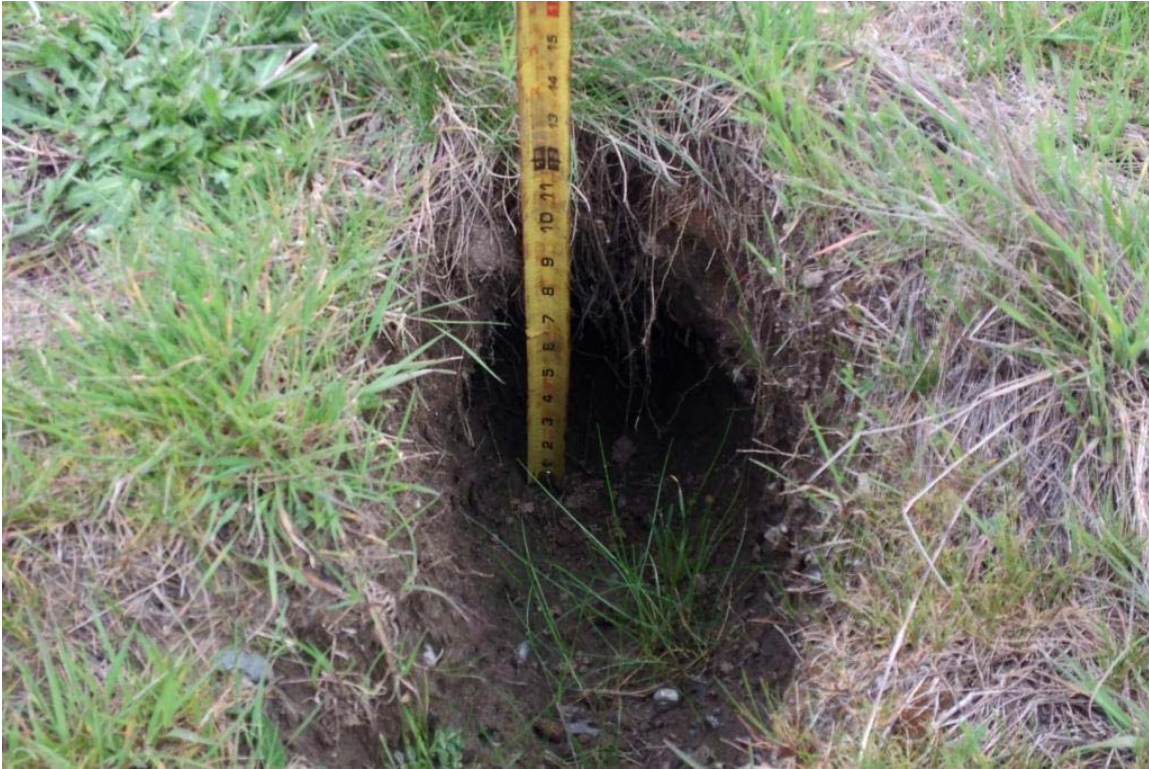
Photograph 1 – Slightly larger than typical burrow observed in the earthen cap area. (April 2014)

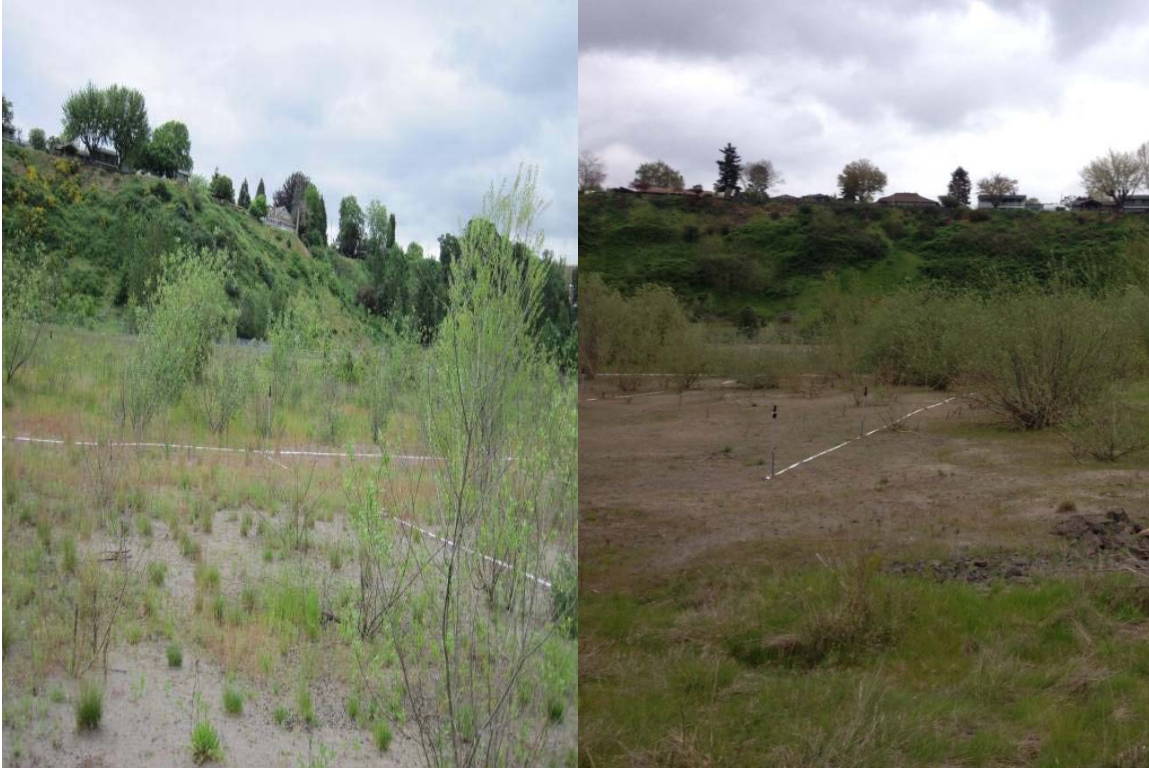
Photograph 5 – Stormwater pond scarcely vegetated although willow and alder continue to survive. Taken looking northeast from Photograph Location 4 comparing baseline and current conditions. (Left - June 2011, Right – June 2014)

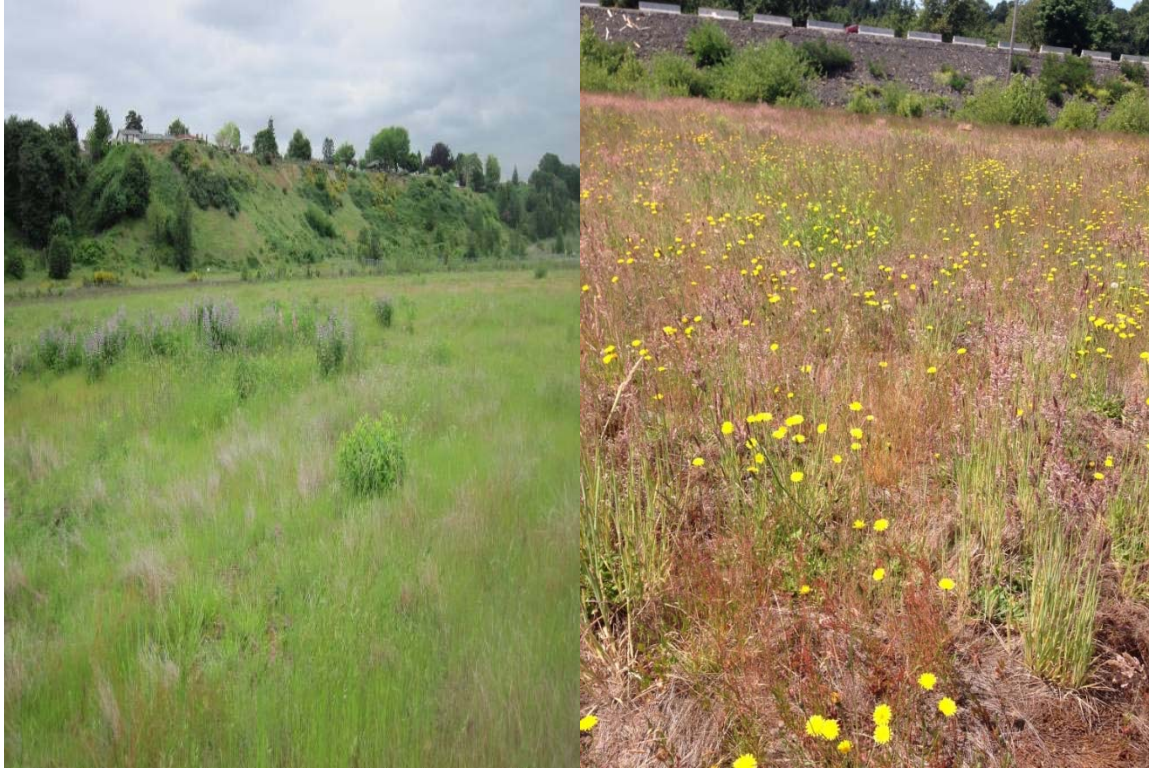
Photograph 7 – Impermeable cap dominated by grasses and herbaceous vegetation. Baseline photograph on the left taken looking east from Photograph Location 6 (June – 2011). Current conditions (Right – June 2014) show skeletonweed established on the impermeable cap.
