**THIRD FIVE-YEAR REVIEW REPORT FOR
TAYLOR LUMBER AND TREATING SUPERFUND SITE
YAMHILL COUNTY, OREGON**

MAY 2022

**U.S. Environmental Protection Agency
Region 10
Seattle, Washington**

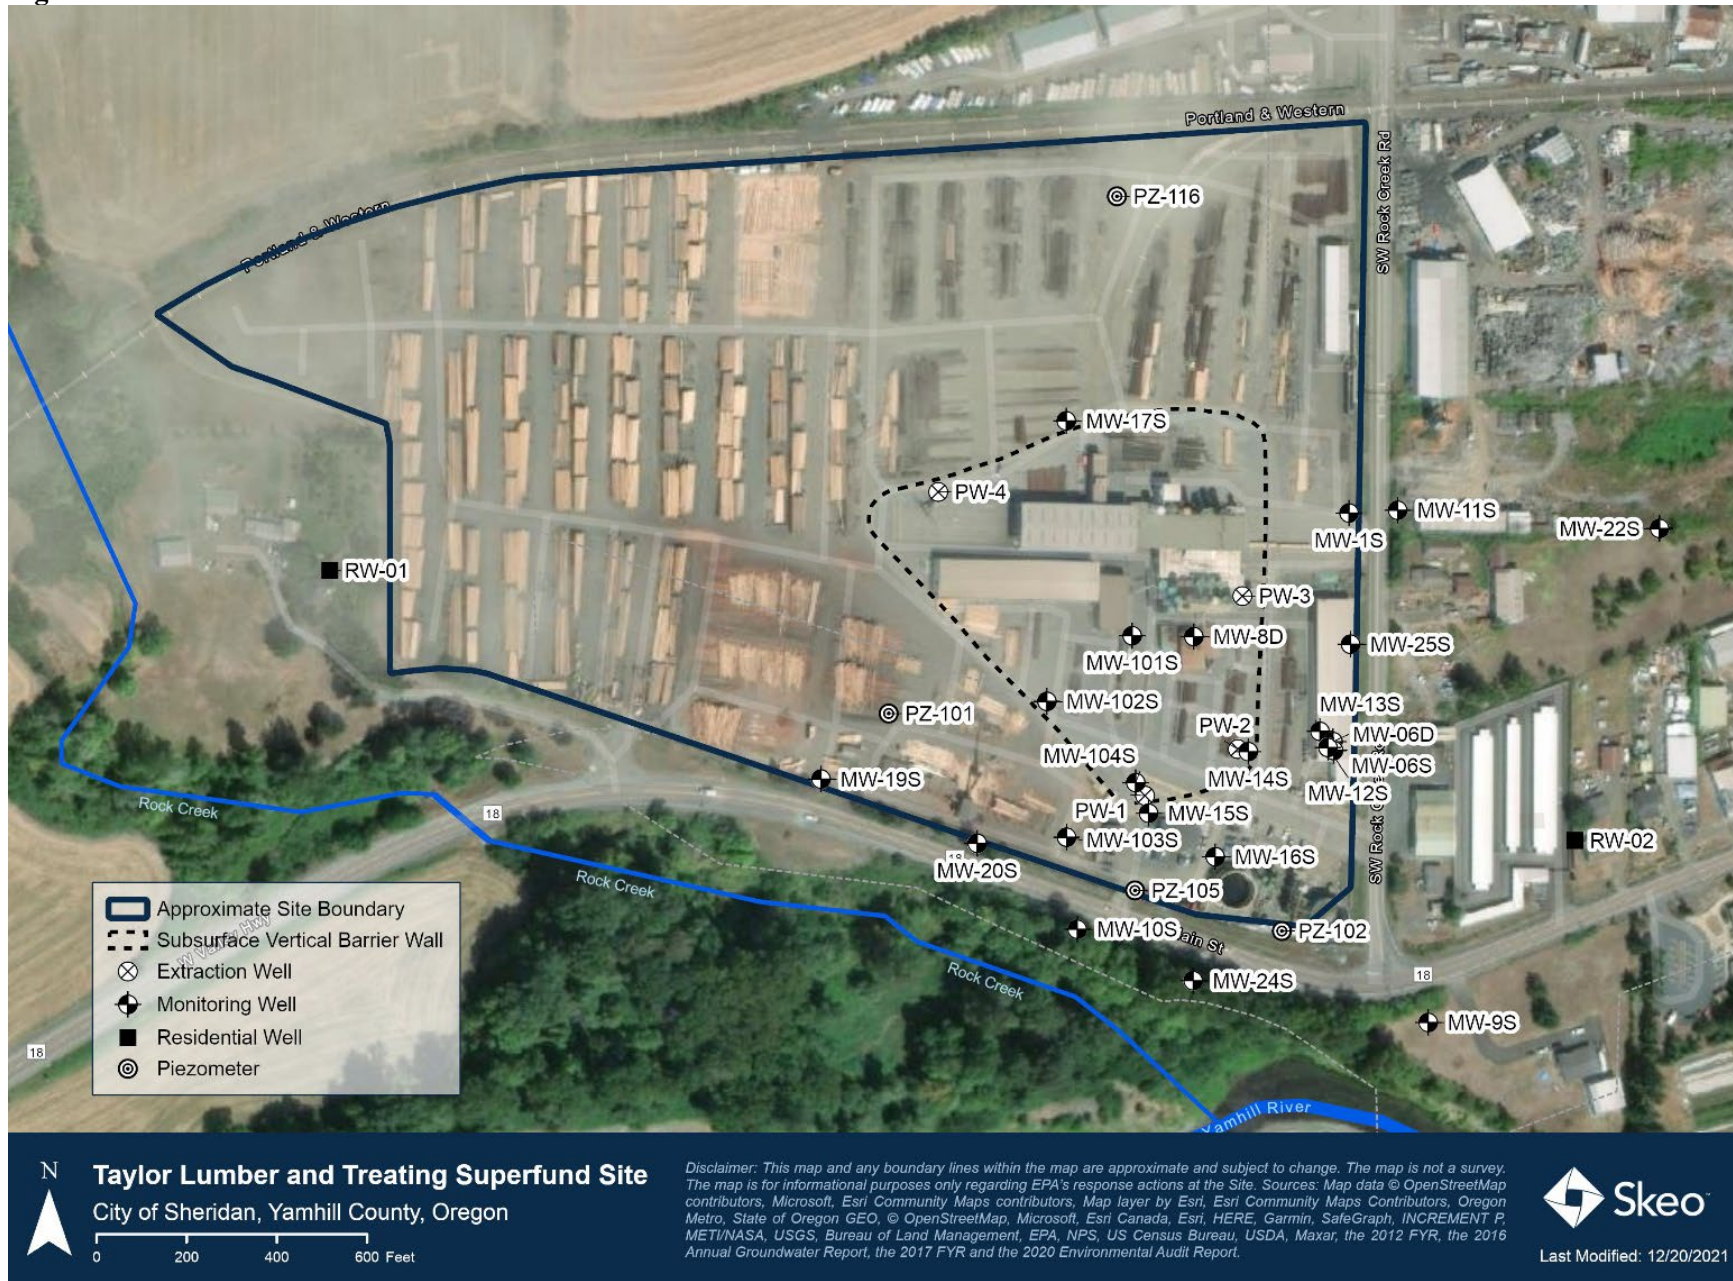
Figure 4: Locations of the Subsurface Barrier Wall and Groundwater Wells

PCP contamination persists at MW-25S, located outside the barrier wall and at the property line, and concentrations increased in 2017, with no subsequent sampling. Data suggest residual source material and principal threat waste remain uncontained on the Site and do not indicate decreasing trends towards cleanup levels in the groundwater plume. Therefore, EPA believes sources of COCs remain at Site that have not been adequately addressed. Further, the groundwater monitoring network does not adequately characterize conditions east and southeast of MW-25S and it is likely that contamination observed in MW-25S has migrated off-site. In addition, EPA hydrogeological analysis indicates that contaminated groundwater is not being isolated sufficiently within the vertical barrier wall. Overall, EPA believes migration of contaminants is uncontrolled and poses an unacceptable risk to human health and the environment. To address these concerns, EPA intends to sample the area and fully characterize the nature and extent of contamination, including identifying whether there are any drinking water wells with contaminants above MCLs. If necessary, EPA will implement additional response actions.

OU: 1	Issue Category: Remedy Performance			
	Issue: A May 2021 hydrogeological analysis of the 2017 data suggests that the subsurface barrier wall is not containing contaminated groundwater effectively.			
	Recommendation: Reevaluate groundwater conditions and determine if modifications are needed to the subsurface barrier wall system.			
Affect Current Protectiveness	Affect Future Protectiveness	Party Responsible	Oversight Party	Milestone Date
No	Yes	EPA	EPA	9/30/2023

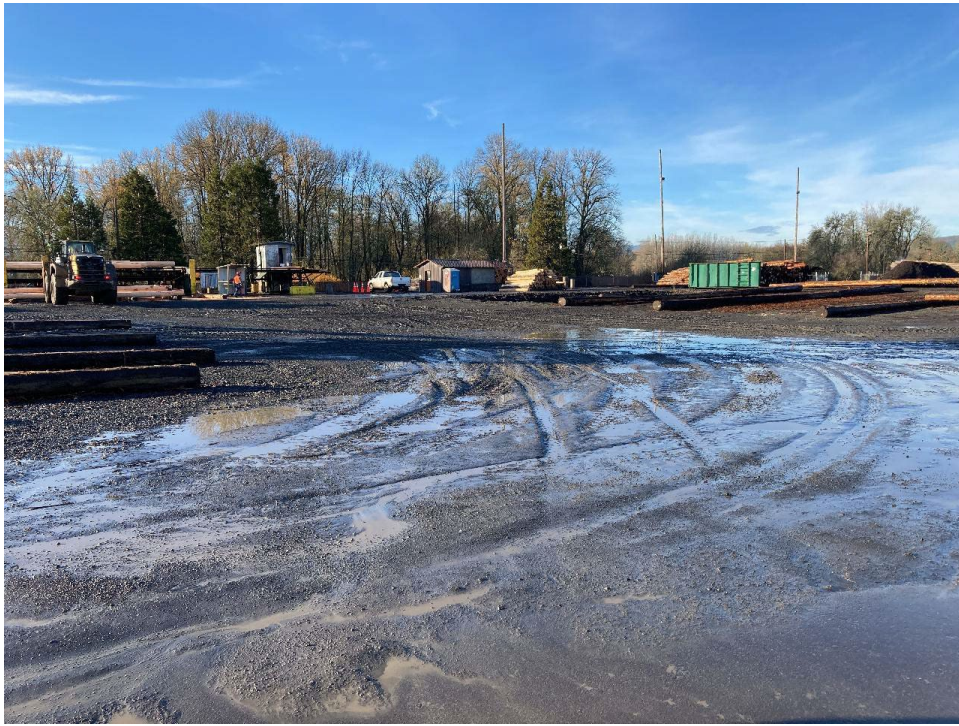
Minor ponding in the White Pole Storage Area

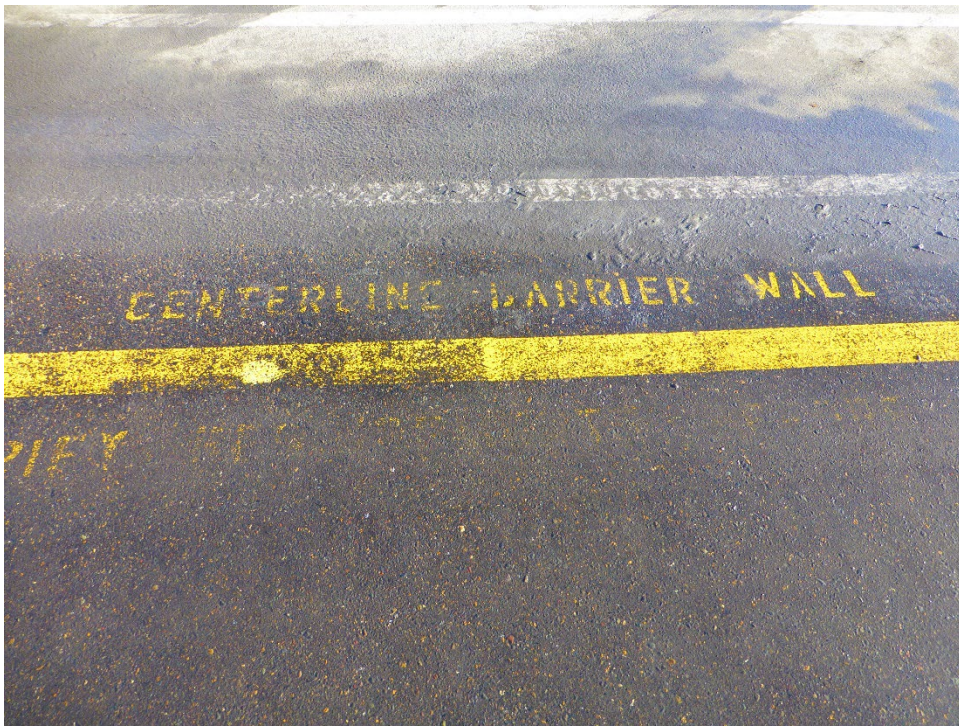
Participants met in the Stella-Jones conference room and walked around the perimeter of the MatCon asphalt cap. The Stella-Jones representatives noted a yellow line marking the subsurface vertical barrier wall had been repainted in July 2021 but was faded in high-traffic portions of the facility. Bubbles were present on the surface of the cap in some areas. Stella-Jones representatives stated that MatCon had taken samples in areas with bubbles and did not find any structural issues. Stella-Jones appears to have located MW-17S, which had not been found during the 2017 FYR, with a metal detector. The well is presumed to be about 1 foot below ground surface in a graveled area. Participants also observed the locations of other monitoring wells, the extraction wells, the drip pad and the stormwater treatment system. EPA expects to determine additional response actions by September 2024.

Painted yellow line marking subsurface barrier wall

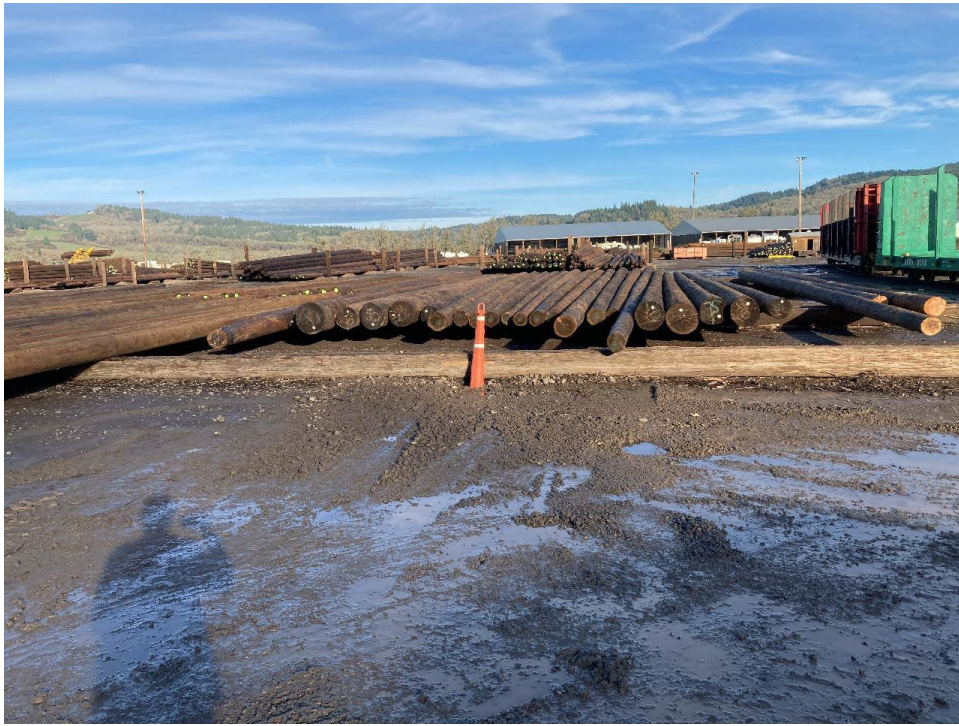
Orange cone marking the potential location of MW-17S

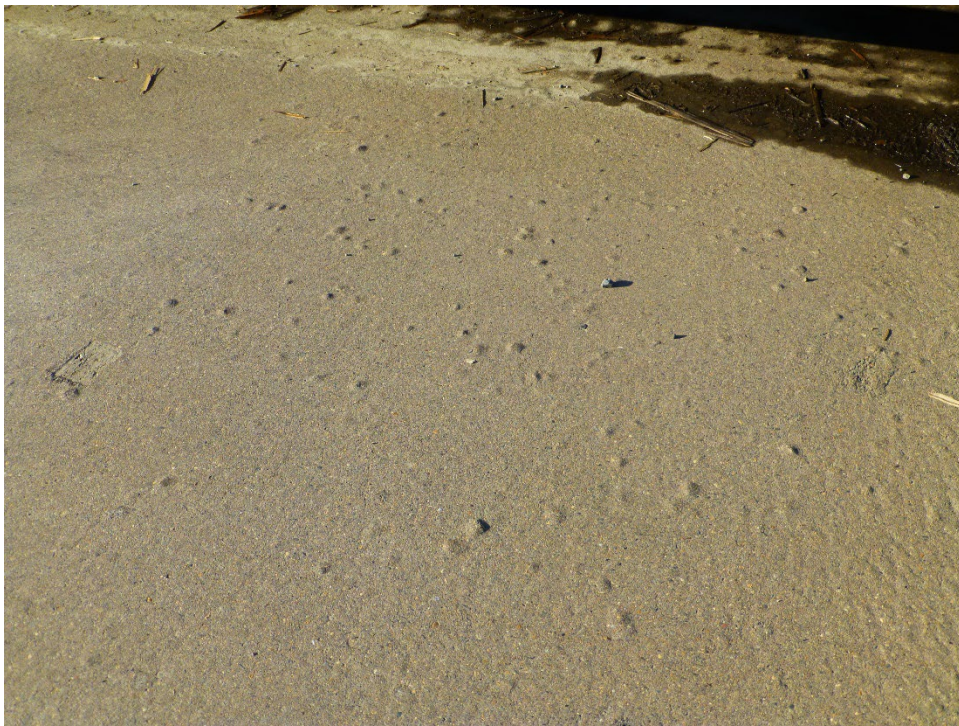
"Bubbles" on the MatCon cap
