**FIFTH FIVE-YEAR REVIEW REPORT FOR
WYCKOFF CO./EAGLE HARBOR SUPERFUND SITE
KITSAP COUNTY, WASHINGTON**

**U.S. Environmental Protection Agency
Region 10
Seattle, Washington**

July 26, 2022

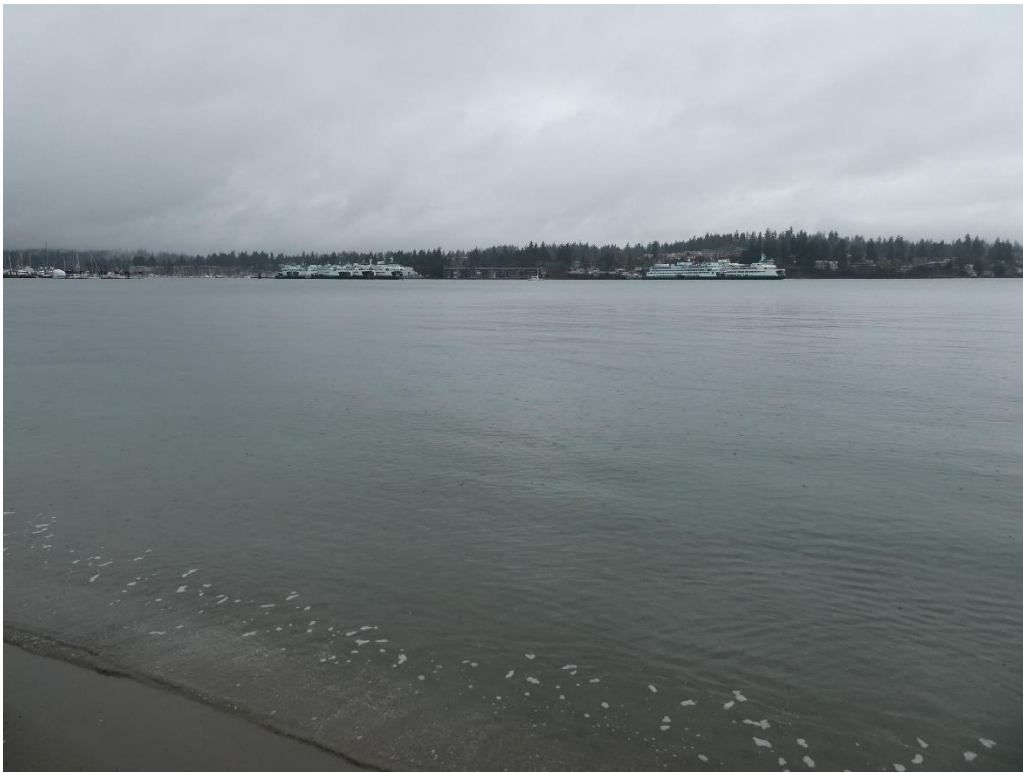
Sediment cap

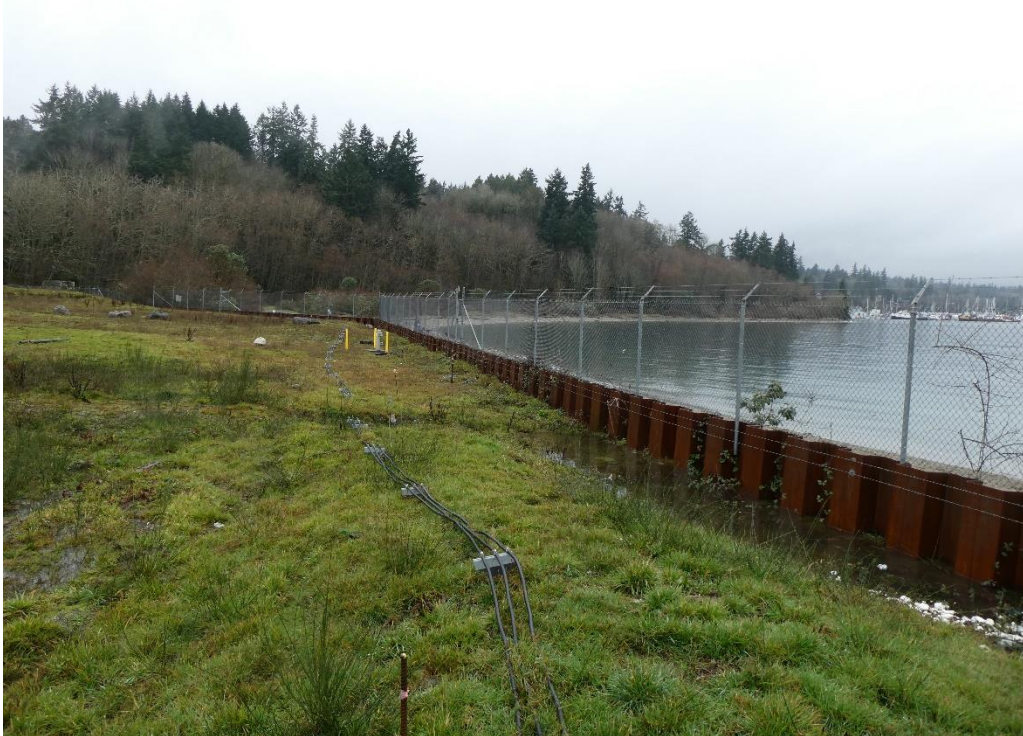
FPA, extraction and production wells visible with ponding

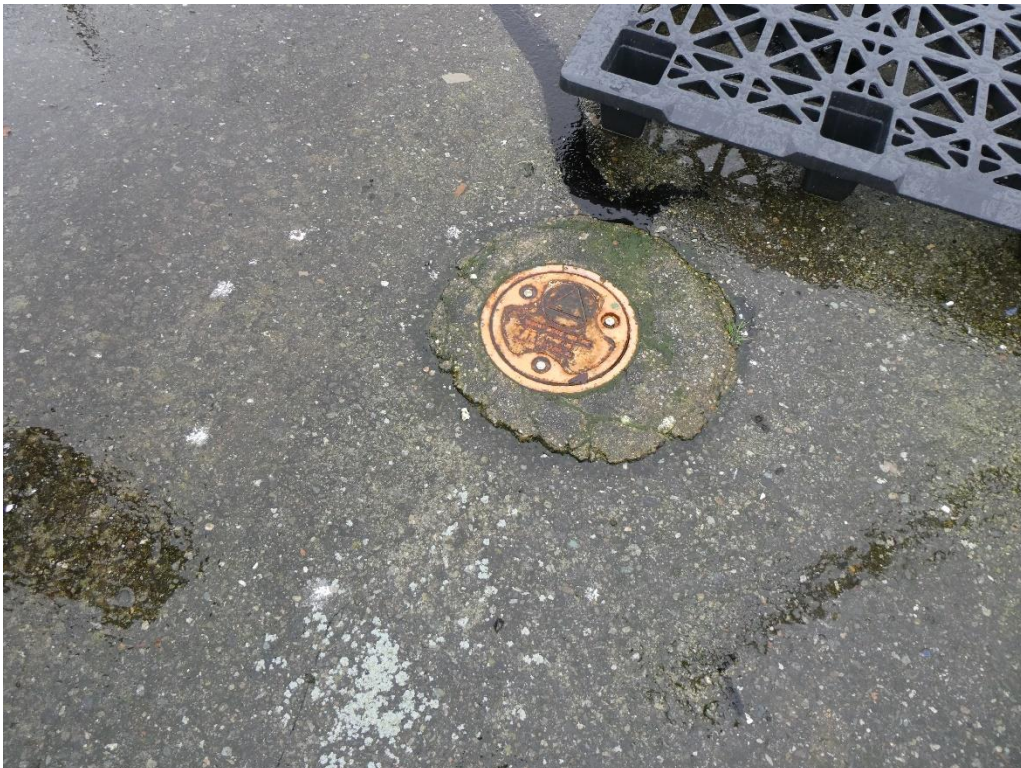
During the previous FYR period, asphalt cracking was a persistent problem at OU3. Several long cracks along the construction joints were originally discovered in 2009 and were sealed with asphalt the same year. Additional repairs were made in 2011 and 2012. In 2011, a pavement engineer evaluated the asphalt cap surface and found it in overall good structural condition, though showing signs of aging. In 2013, the cracks were resealed using a new method. Evaluations of the cap condition in 2016 and 2017 found it in sound structural condition despite the signs of aging. It was decided to continue monitoring semi-annually to determine when a full asphalt overlay is needed. During this FYR period, asphalt repairs were conducted in 2018 and 2019. In 2020, a 6-foot-long crack of medium severity (1/4 to 1/2 inch wide) was observed in the subsidence area adjacent to the southern edge of the asphalt concrete cap. In addition, a minor crack of low severity (less than 1/4 inch wide) was observed near the fence west of the CDF. The observed asphalt cracks were not repaired in 2020 due to work constraints associated with COVID-19, but WSDOT pavement repair crew completed the repairs in spring 2021.

Asphalt crack repair
