FIFTH FIVE-YEAR REVIEW REPORT FOR WYCKOFF CO./EAGLE HARBOR SUPERFUND SITE KITSAP COUNTY, WASHINGTON

U.S. Environmental Protection Agency Region 10 Seattle, Washington

July 26, 2022

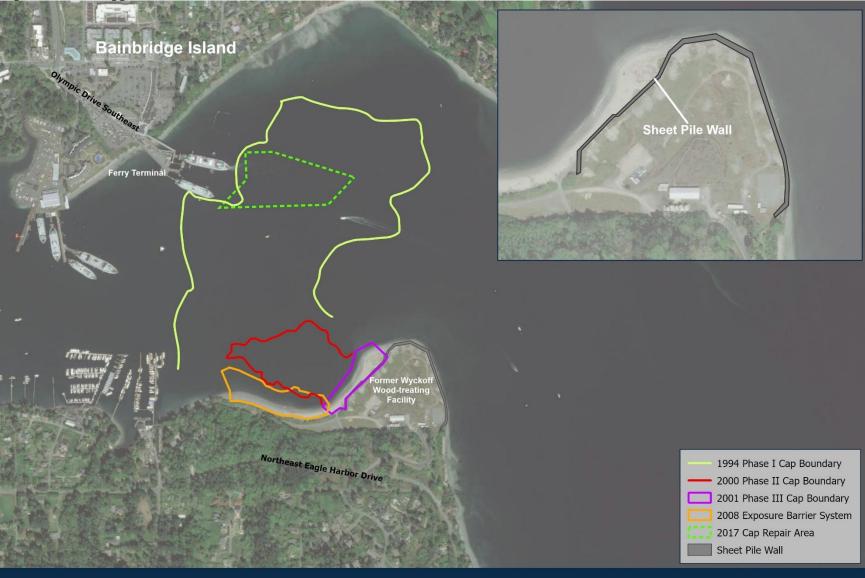
Figure 2: OU1 Capped Areas

In addition, material loss was seen on the northern portion of the subtidal Phase I cap, along the ferry lane, particularly at the approach to the Winslow terminal. In early 2017, repairs were made to the subtidal cap in this area (Figure 2). To restore necessary isolation, 1 foot of clean sand was added over the exposed area (9.3 acres). The high impact center of the ferry lane (3.5 acres) also received an additional 2-foot-thick rock/armor layer to prevent future erosion of the clean sand cap. In September 2017, a Remedial Action Report was issued detailing the subtidal sediment cap repair work completed. In April 2021, EPA and Ecology agreed that the remedy in the subtidal portion of OU1 is complete and functioning as intended. EPA transferred responsibility for O&M of subtidal sediments in OU1 to Ecology. EPA remains responsible for the intertidal areas of OU1 and areas that may be needed for construction of the remedy selected in the 2018 Interim ROD Amendment.

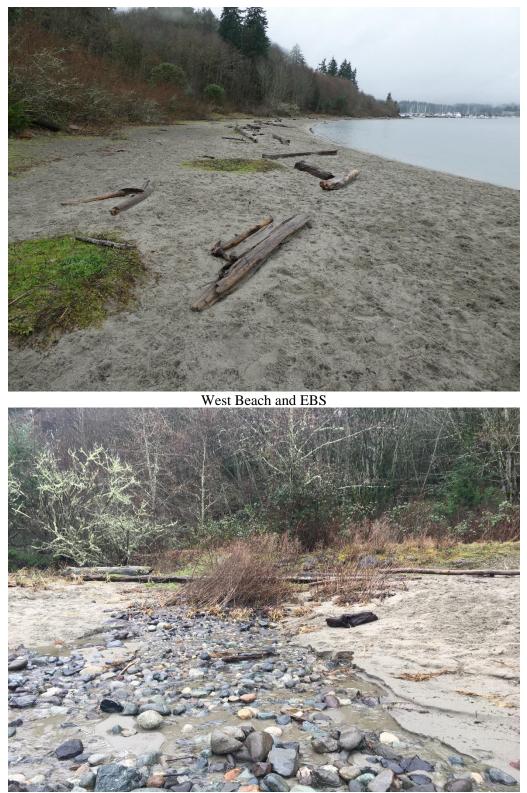
OU1, East Harbor

Cobbles downgradient from the outfall that drains onto the EBS

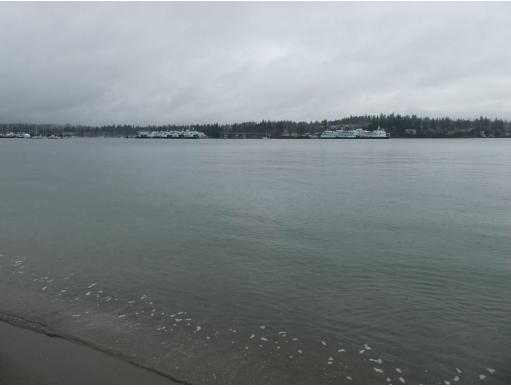
Eagle Harbor looking toward the 2017 cap repair

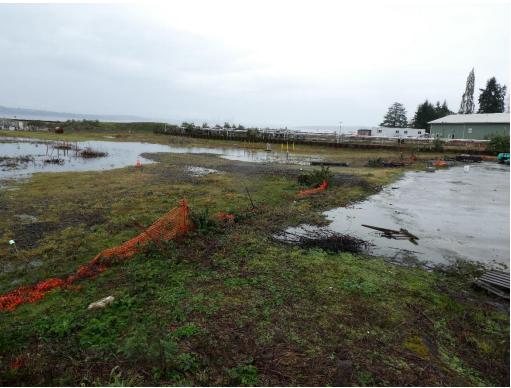
FPA, extraction and production wells visible with ponding

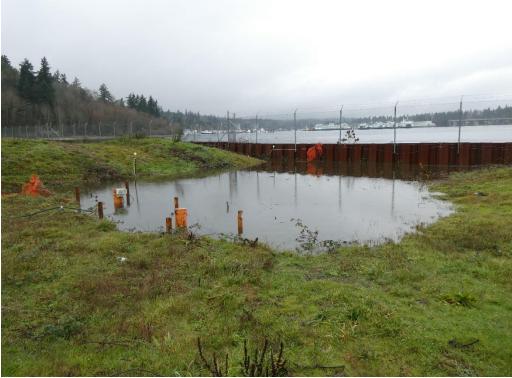
Western sheet pile wall and extraction wells with standing water

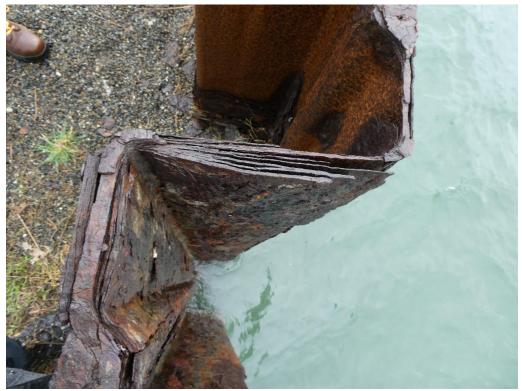
The sheet pile wall around the full FPA was installed in 2001 (Figure 3). The wall is about 1,870 feet long and extends to a depth of 20 to 90 feet below grade. In December 2013 a Technical Memorandum evaluated construction methods, exposure scenarios, tidal profiles, and life-span evaluations for the sheet pile wall. Additional investigations, conducted in 2016, indicated the sheet pile wall was corroding rapidly. In December 2019, EPA decided to build the replacement perimeter wall inside the current wall. This minor change to the 2018 Interim ROD Amendment was recorded as a memorandum. In 2020, a predesign investigation was completed, focusing on the nature and extent of subsurface debris in upland soils as well as refining the cost estimate and debris handling and disposal plan. The investigation also informs the design of the replacement perimeter wall, which uses a concrete soil mix as a primary technology. Design of the replacement perimeter wall is ongoing.

2/4	The sheet pile wall has experienced significant corrosion reducing its life span.	Perform repairs, or replace, the sheet pile wall to prevent leaks and other failures.	Ongoing	In 2018 an interim ROD amendment was signed selecting a replacement wall. In 2020, a predesign investigation was completed, focusing on the nature and extent of subsurface debris in upland soils and soil/reagent mix design tests to compare different mix designs for the new perimeter wall, which will use a concrete soil mix as a primary technology. This investigation will help inform the design of the replacement perimeter wall. It will also help refine the cost estimate and debris handling and disposal plan. Design of the replacement perimeter wall is ongoing.	Not applicable
2/4	Recent groundwater data has shown increasing PAH concentrations in the lower aquifer, which is considered a potential drinking water source.	Evaluate opportunities to limit migration of contamination to the lower aquifer.	Completed	The May 2019 Interim ROD Amendment selected a new remedy for upland soil and groundwater that will solidify NAPL in upland soil, preventing further migration to the lower aquifer. The remedy will also reinforce portions of the aquitard that are thin, further limiting contaminant transport to the lower aquifer.	5/10/2019

Degraded eastern sheet pile wall

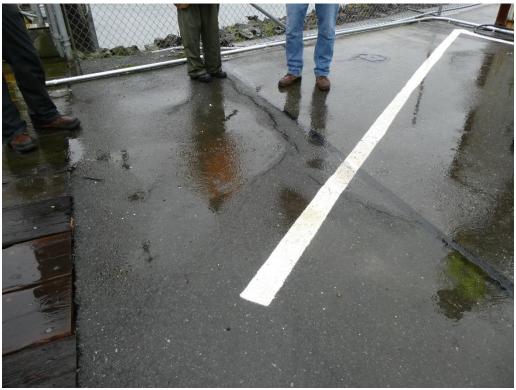
During the previous FYR period, asphalt cracking was a persistent problem at OU3. Several long cracks along the construction joints were originally discovered in 2009 and were sealed with asphalt the same year. Additional repairs were made in 2011 and 2012. In 2011, a pavement engineer evaluated the asphalt cap surface and found it in overall good structural condition, though showing signs of aging. In 2013, the cracks were resealed using a new method. Evaluations of the cap condition in 2016 and 2017 found it in sound structural condition despite the signs of aging. It was decided to continue monitoring semi-annually to determine when a full asphalt overlay is needed. During this FYR period, asphalt repairs were conducted in 2018 and 2019. In 2020, a 6-foot-long crack of medium severity (1/4 to 1/2 inch wide) was observed in the subsidence area adjacent to the southern edge of the asphalt concrete cap. In addition, a minor crack of low severity (less than 1/4 inch wide) was observed near the fence west of the CDF. The observed asphalt cracks were not repaired in 2020 due to work constraints associated with COVID-19, but WSDOT pavement repair crew completed the repairs in spring 2021.

Asphalt crack repair

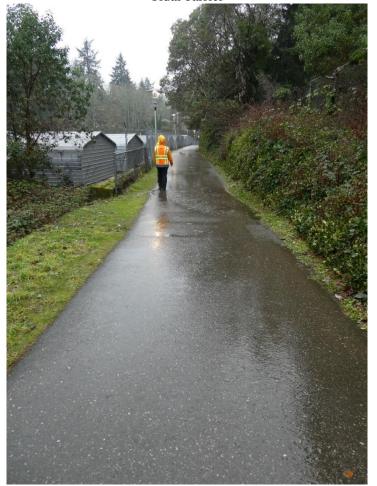
Ponded water near the northern drainage cutoff wall
