**EPA Evaluation of Subsurface Engineered  
Barriers at Waste Sites**

**Volume II  
Appendix B**

**Site Summaries**

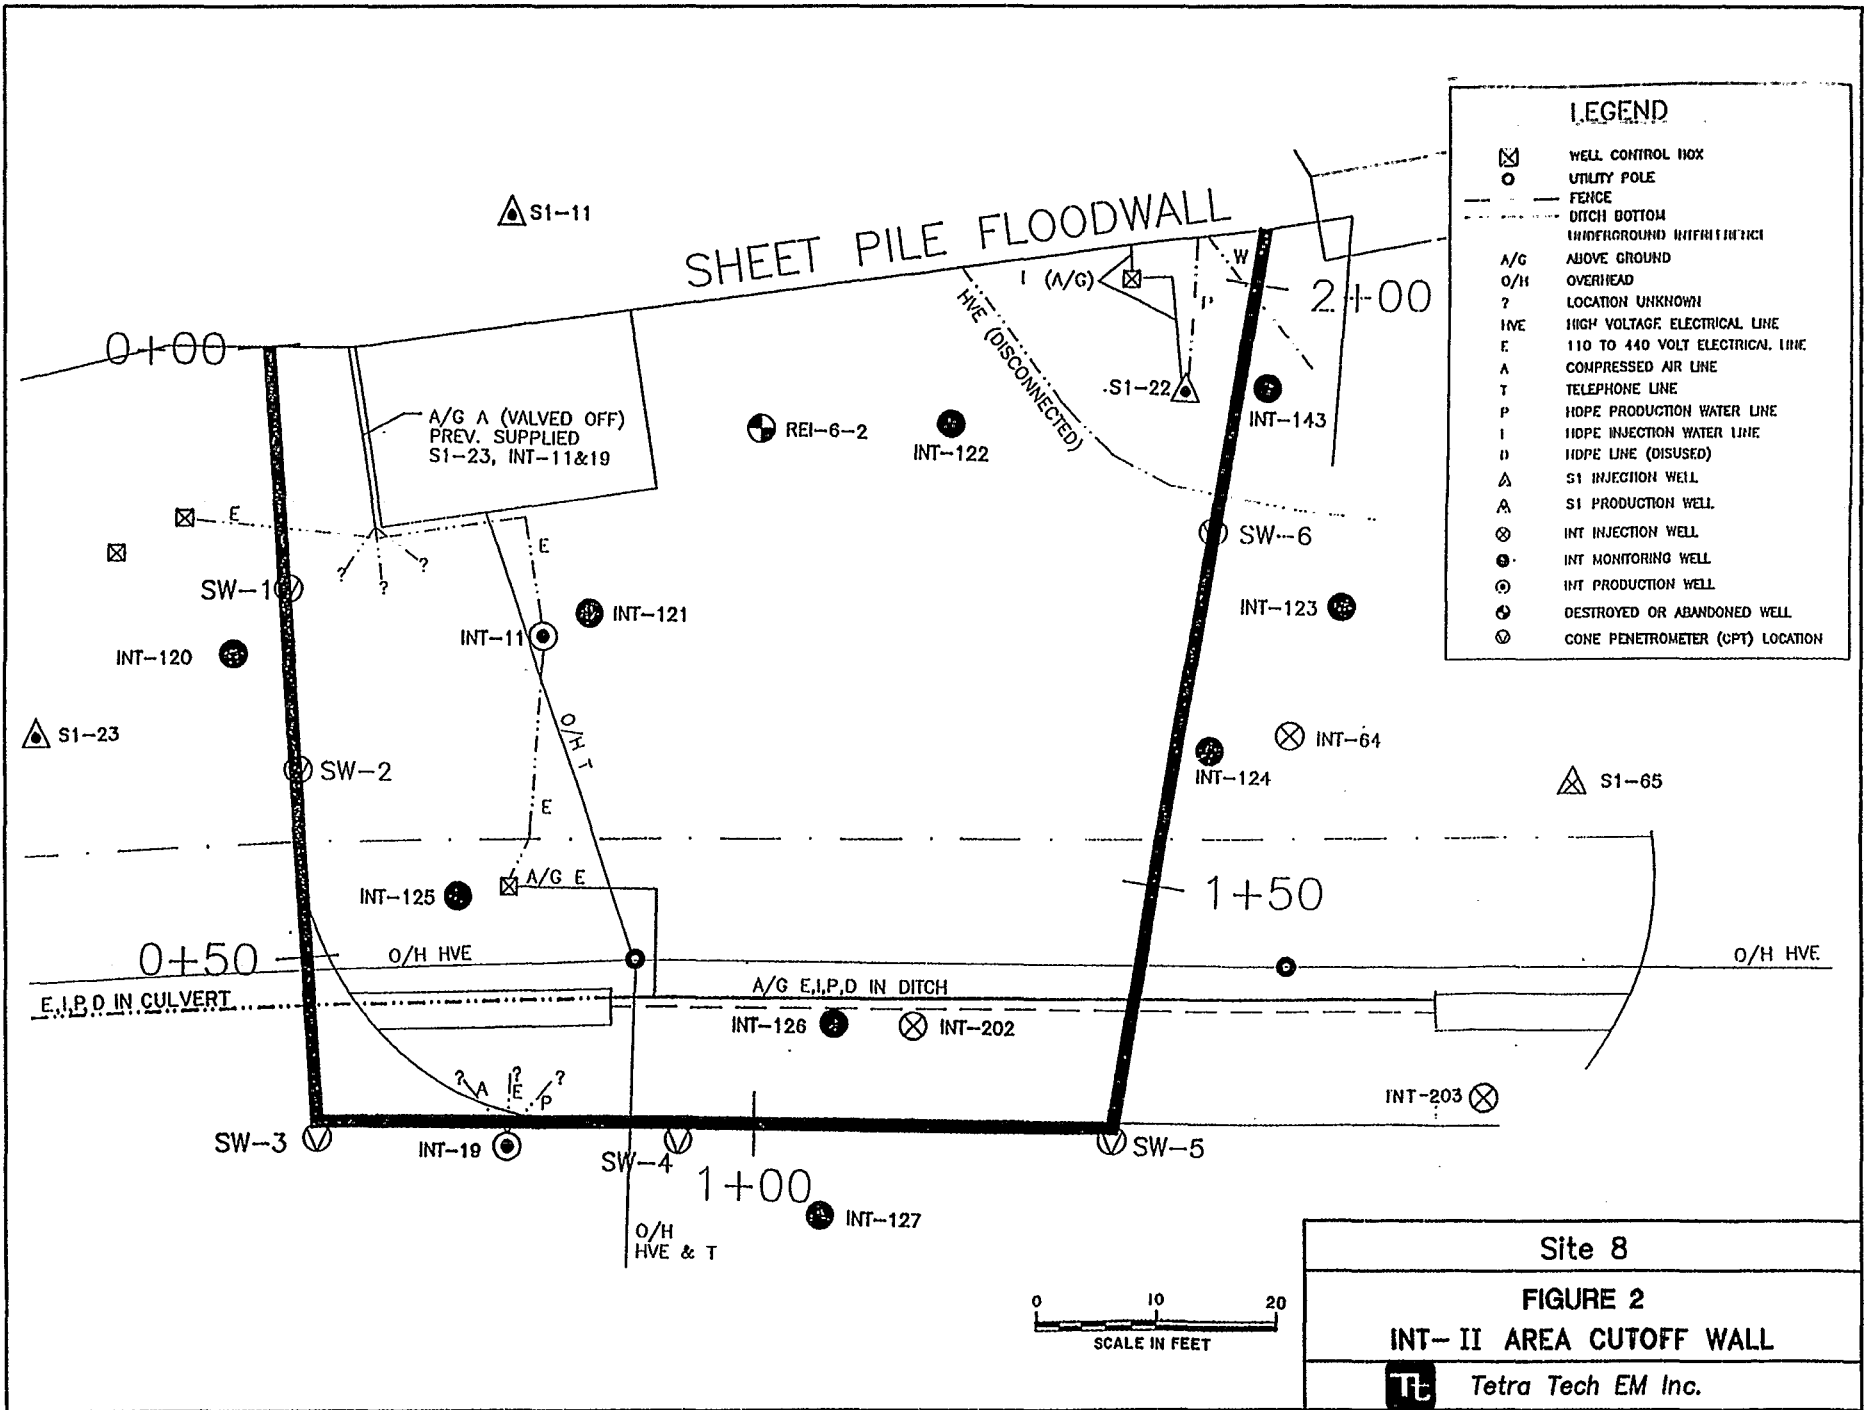
Site 8  
**FIGURE 2**  
**INT- II AREA CUTOFF WALL**  
 Tetra Tech EM Inc.

A permeability certification test was conducted on the INT-11 area cutoff wall after construction was completed. On August 22, 1994, all recovery and injection wells within a 120-foot radius of the INT-11 cutoff wall were turned off to establish baseline conditions. The test was conducted from August 31 through September 14, 1994. Tests were conducted on each of the three sides of the wall (east, south, and west). For each test, one well near the center of each side was either pumped or injected, and groundwater elevations on both sides of the wall were monitored. Each test consisted of a pumping or injection phase followed by a recovery phase. However, this test was inconclusive because cyclic pumping at wells outside the 120-foot radius affected groundwater levels in the S1 and INT zones during the test. Therefore, a modeling approach was used to evaluate the wall's permeability. The field test was simulated using Visual MODFLOW and by applying a sensitivity analysis for the wall's effective permeability to determine the best fit for the observed data. The modeled permeability certification test indicated that the effective permeability of the INT-11 area cutoff wall is  $1 \times 10^{-10}$  cm/sec. The certification test further indicated that this result is equivalent to  $1 \times 10^{-9}$  cm/sec for a conventional, 2.5-foot-thick, slurry wall. Based on this test, the INT-11 area cutoff wall meets the target permeability value of  $1 \times 10^{-7}$  cm/sec. However, an oversight contractor for the U.S. EPA reviewed the sensitivity analysis and determined that (1) the  $1 \times 10^{-10}$  cm/sec result is not necessarily conclusive and (2) a result of  $2.3 \times 10^{-7}$  cm/sec is also valid but not necessarily conclusive.

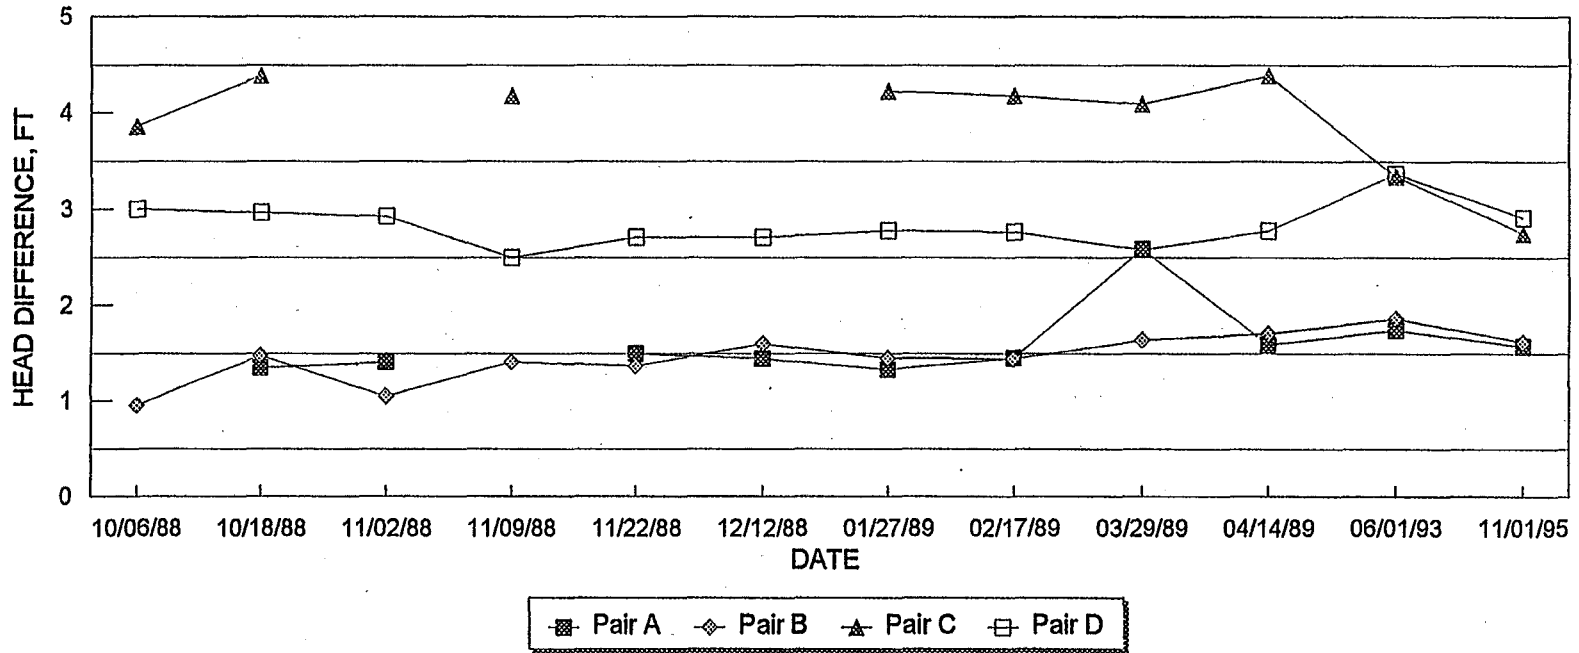
Site 16  
FIGURE 2  
HEAD DIFFERENCE vs TIME  
Tetra Tech EM Inc.

An attempt was made to measure physical integrity of the wall using self-potential geophysical methods. The streaming self-potential method was used. This method measures changes in electrical potential as a result of ions in solution passing through a porous medium. The survey was performed on 25-foot centers along the cutoff wall and was intended to measure leakage. Background noise and poor response resulted in inconclusive data. In areas believed to have some possible leakage based on geophysical findings, hydraulic head measurements revealed no unusual head loss, and presumably no leakage.
