**SECOND FIVE-YEAR REVIEW REPORT FOR
HATHEWAY AND PATTERSON SUPERFUND SITE
BRISTOL COUNTY, MASSACHUSETTS**

**U.S. Environmental Protection Agency
Region 1
Boston, Massachusetts**

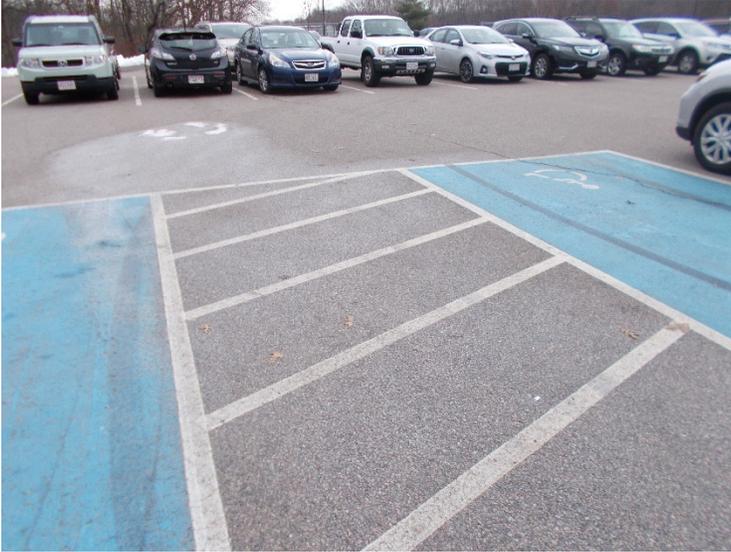
Photo #1: Capped Area in Foxborough/ Parking Lot

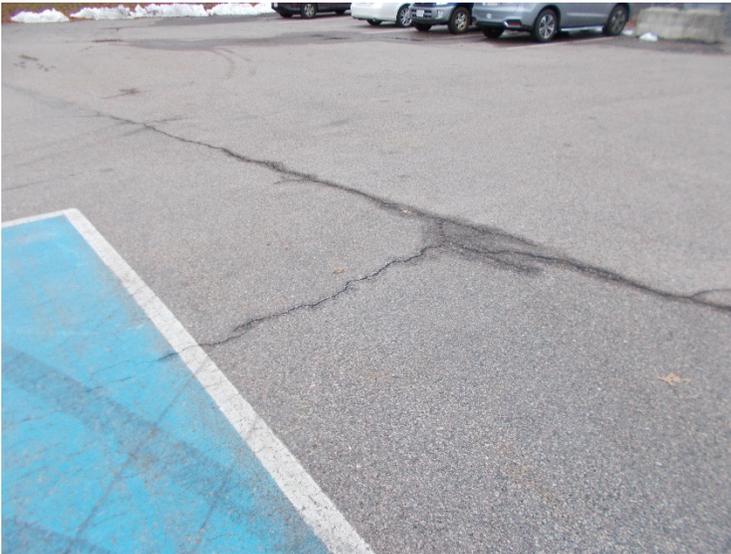
Remarks normal cracks/seams were observed in the pavement (see photos); the parking lot is well maintained.

Photo #2: Cracks in pavement in Asphalt cover, Foxborough/ Parking Lot

- *Cracks in the asphalt cover on the Foxborough property should be repaired.*
- *The cover on the NE quadrant of the Mansfield property should be maintained; rutted areas should be repaired.*

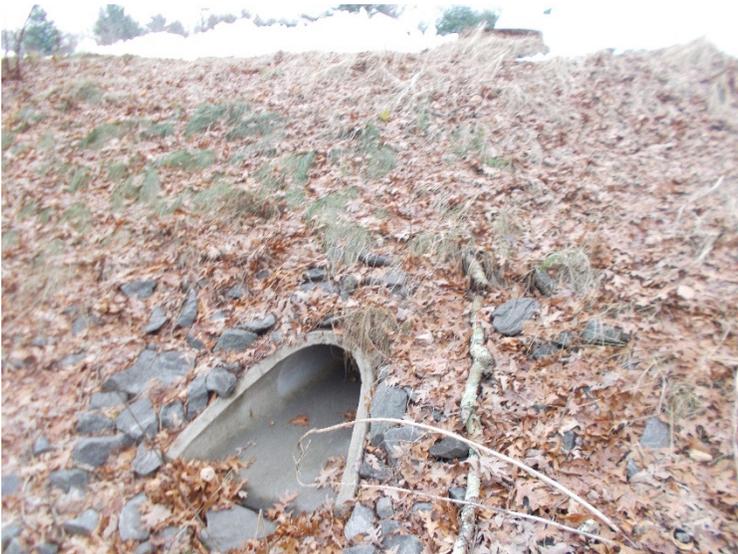
Photo #3: Stormwater control structure on Foxborough property. Drainage area clear; no obstructions noted.

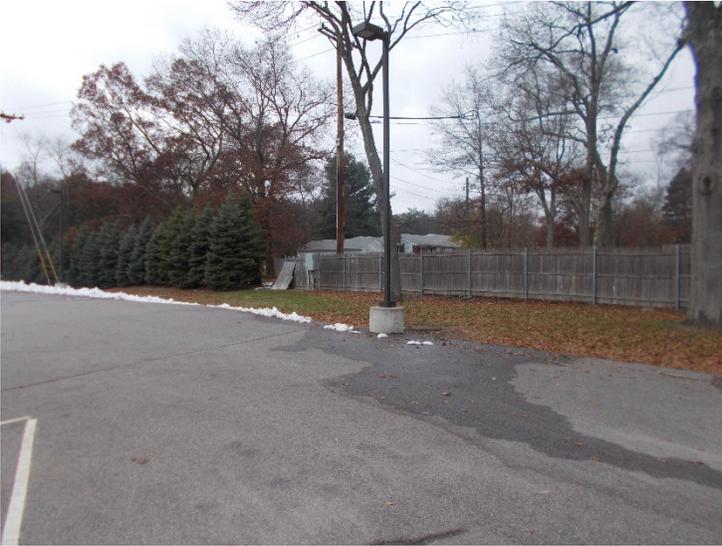
Remarks minor damage to stockade fence

Photo #4: Well-maintained vegetated buffer along the Foxborough parking area; stockade fence on the northwest side of the lot- minor damage observed.

- *Damaged fencing around the Site should be repaired, as appropriate.*
- *Due to exceedances of groundwater performance standards at the compliance boundary, EPA will continue to confirm that groundwater uses at private properties adjacent to the compliance boundary along the southeast quadrant of the Site do not change significantly during future five-year reviews.*

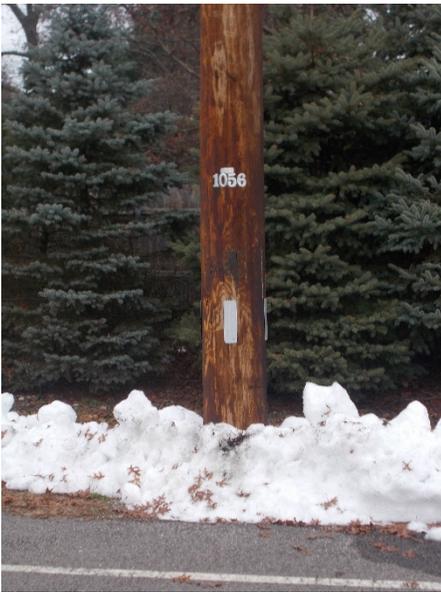
Photo #5: Utility Poles along the Foxborough Parking lot. EPA & MassDEP were notified when pole was replaced by utility company; no issues noted.

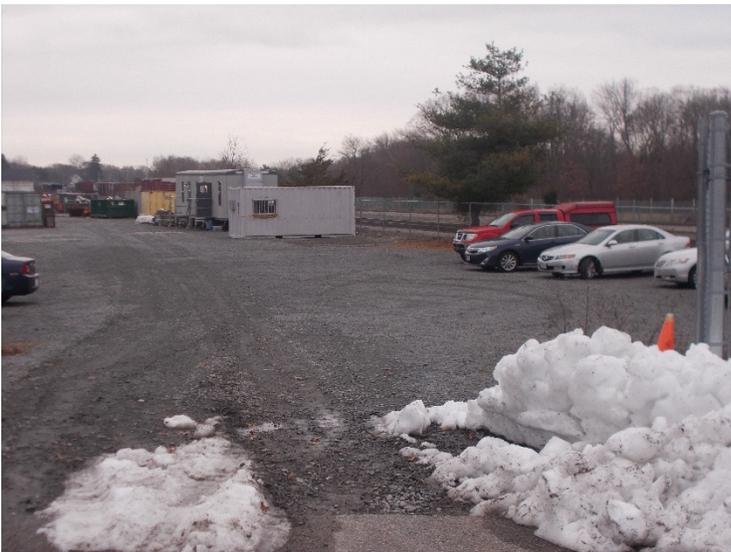
Photo #6: The NW quadrant of the Site, within the Town of Mansfield, is mostly covered with crushed rock. This area is being used for parking and as an equipment laydown area by MassDOT contractors.

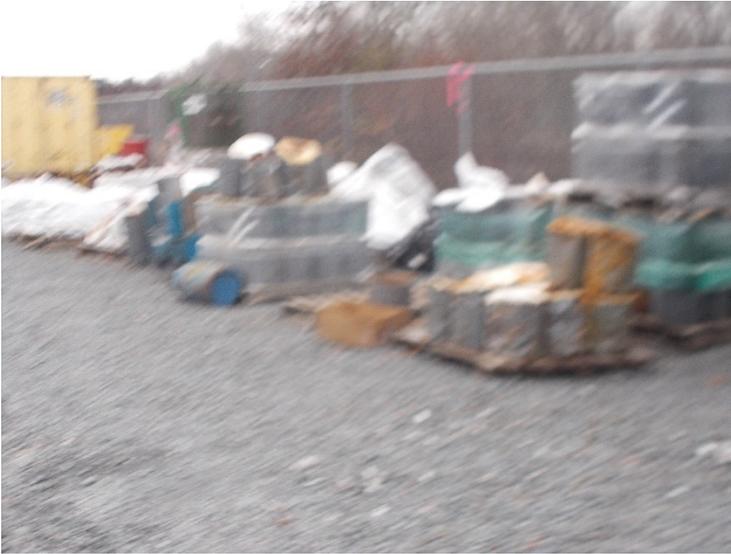
Photo #7: Material stockpiles in NW quadrant.

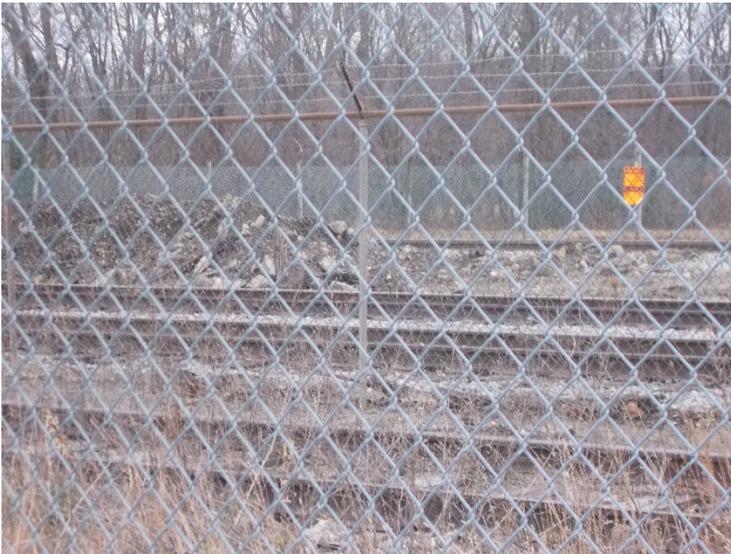
Photo #8: Crushed rock and fill material stockpile along railroad right-of way. MassDOT indicated that this material was from another part of the track.

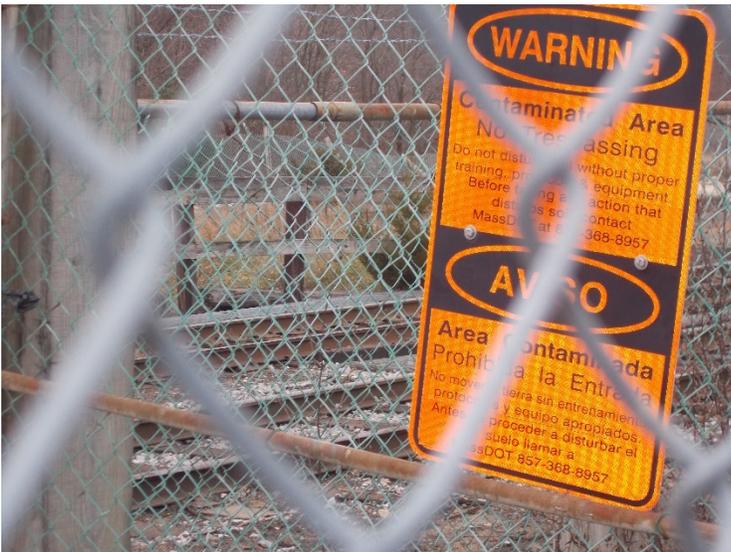
Warning signs placed on the fencing along the MassDOT railroad Right-of-Way remain visible and in good condition.

Photo #9: signage along the Railroad right-of way warning of contamination below the tracks; phone number listed works and signs in good condition.

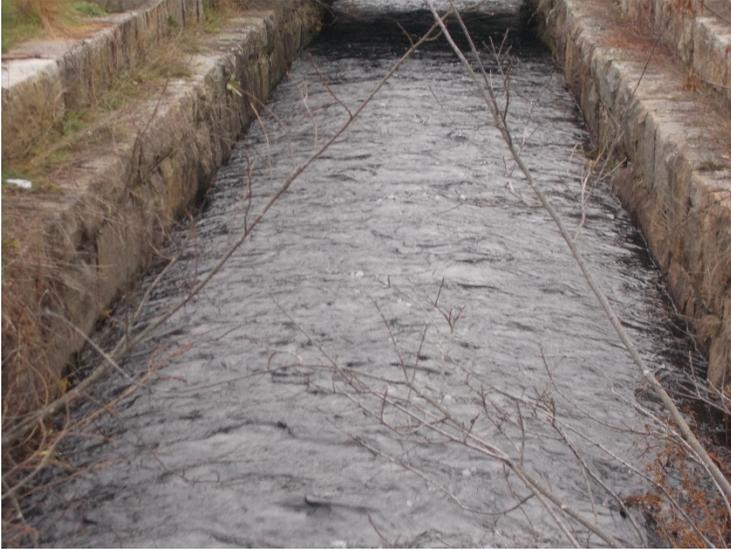
Photo #10: Rumford River, near the confluence with the backwash channel had an observable flow.

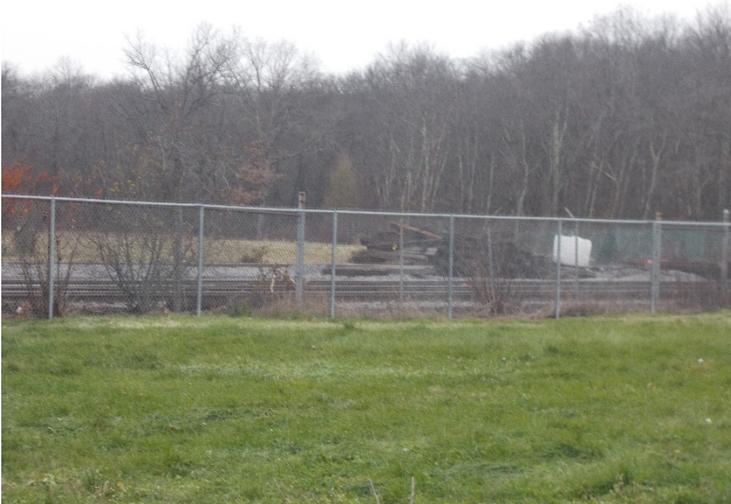
Photo #11: Vegetative cover on NE quadrant of the Site appeared well maintained; fencing along the Site in good condition.

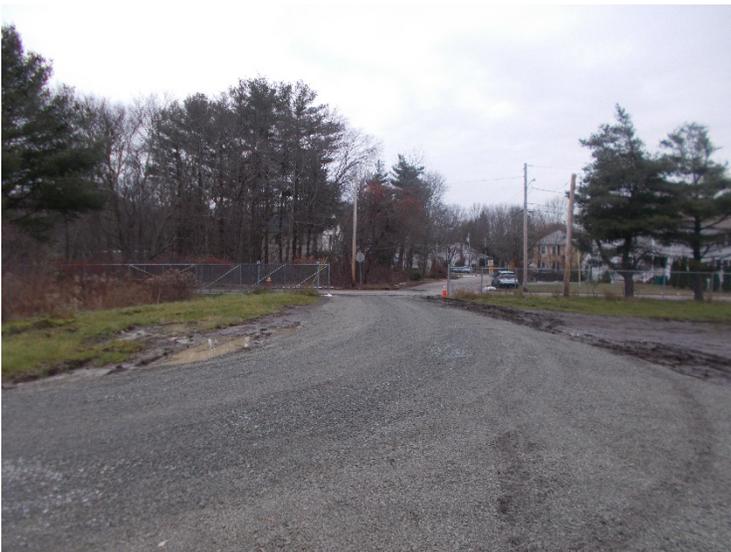
5. Have there been any unusual or unexpected activities or events at the site (e.g., flooding)? If so, what if anything was done to address these issues? Presently there has been some wear and tear on the access road across from King Street to the site, some rutting in the beginning of the field area and parking area abutting Foxboro's parking lot needs to be regraded. These areas are being addressed with the contractors that are using the site and many repairs have happened today. No excavation has occurred just rutting and wear and tear.

Photo #12: Some portions of the vegetated cover in NE quadrant rutted; interview form from town of Mansfield DPW indicates that this area will be repaired.

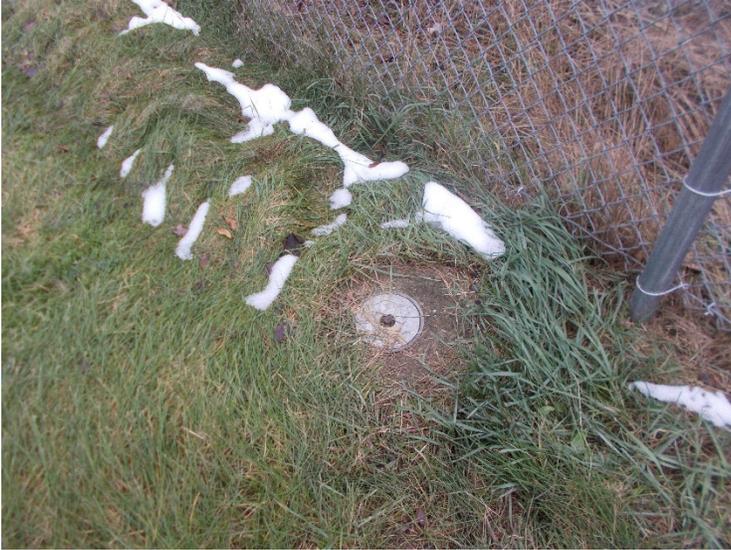
Photo #13: Monitoring Well on Northeast quadrant of Mansfield portions of the Site; well secured and in good condition.

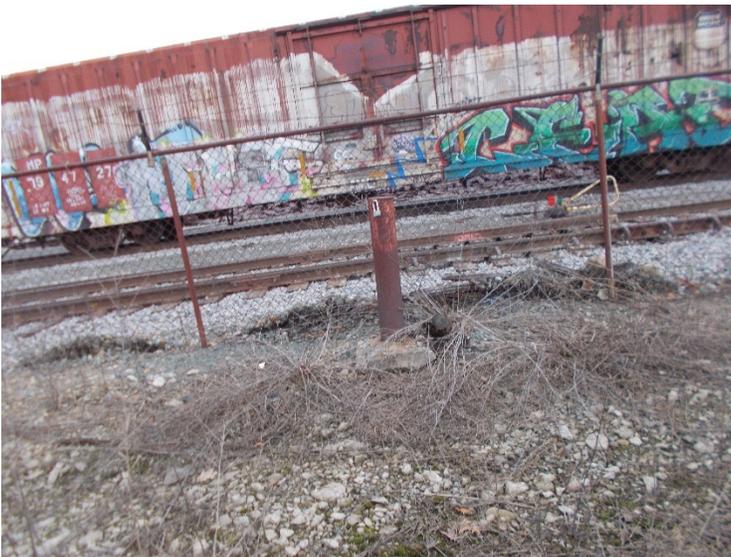
Photo #14: Monitoring Well along Railroad fencing; Well in good condition and secured.

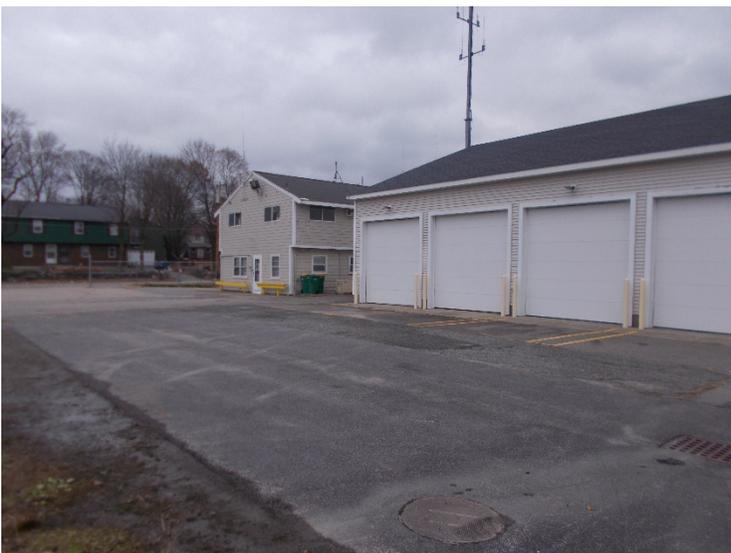
Photo #15: Mansfield Emergency Management Office and parking area on the Northeast Quadrant / Mansfield portion of the Site
