Five-Year Review Report

Second Five-Year Review Report
for
Raymark Industries, Inc. Site
Stratford, Connecticut

September 2005

The United States Environmental Protection Agency
Region 1, New England
Boston, Massachusetts

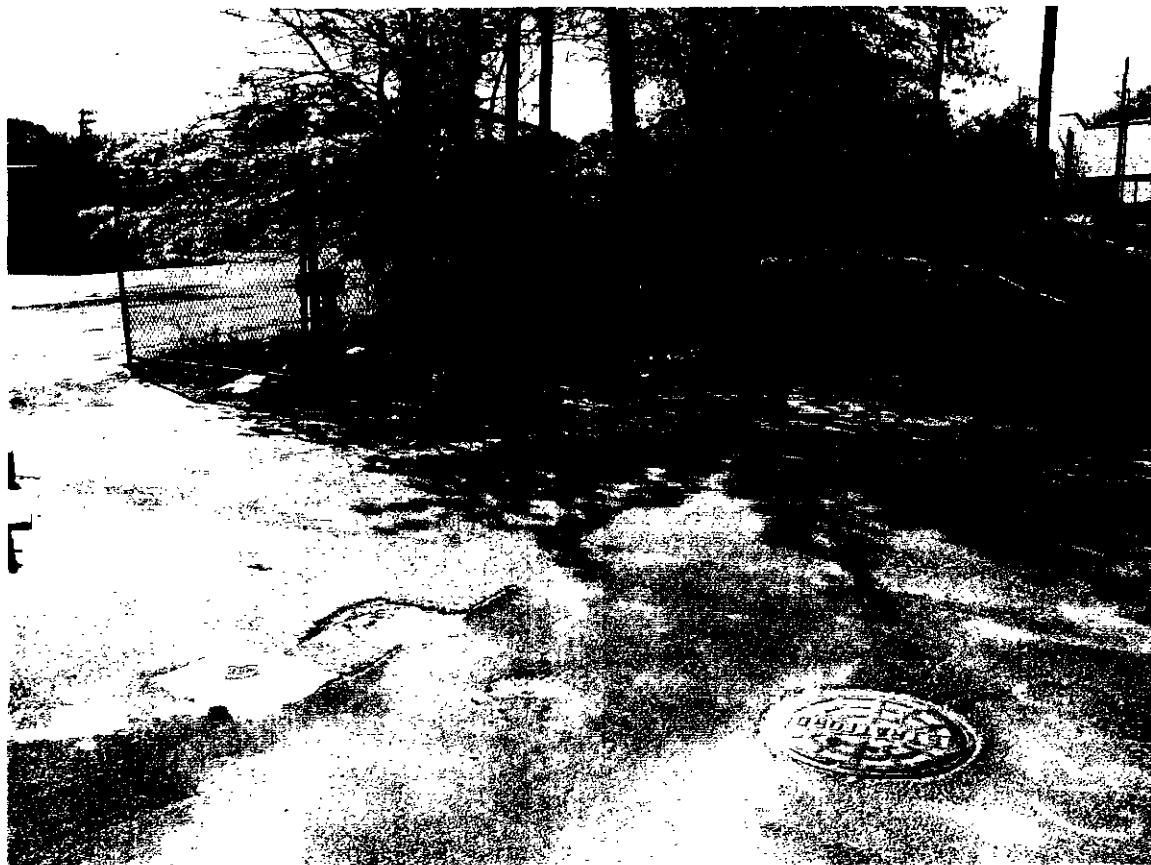
Entrance to OU4 Ballfield. Monitoring Well MW-521S shown on left side of photo; Frog Pond Lane shown on right side of photo

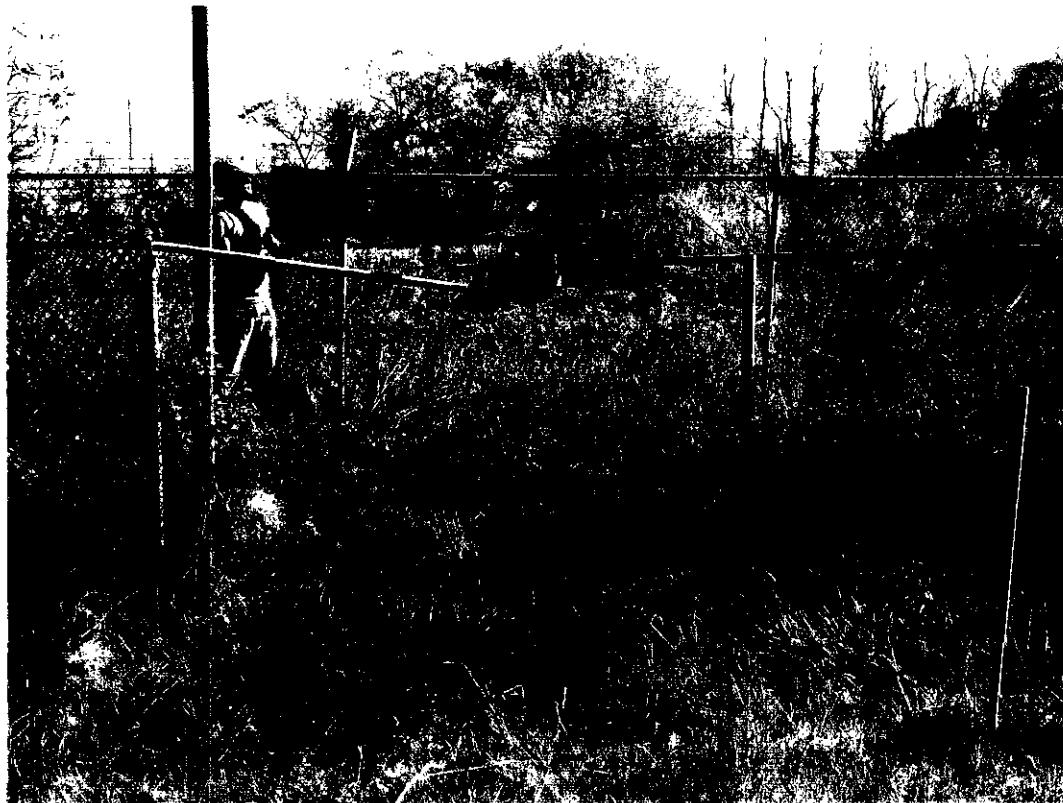
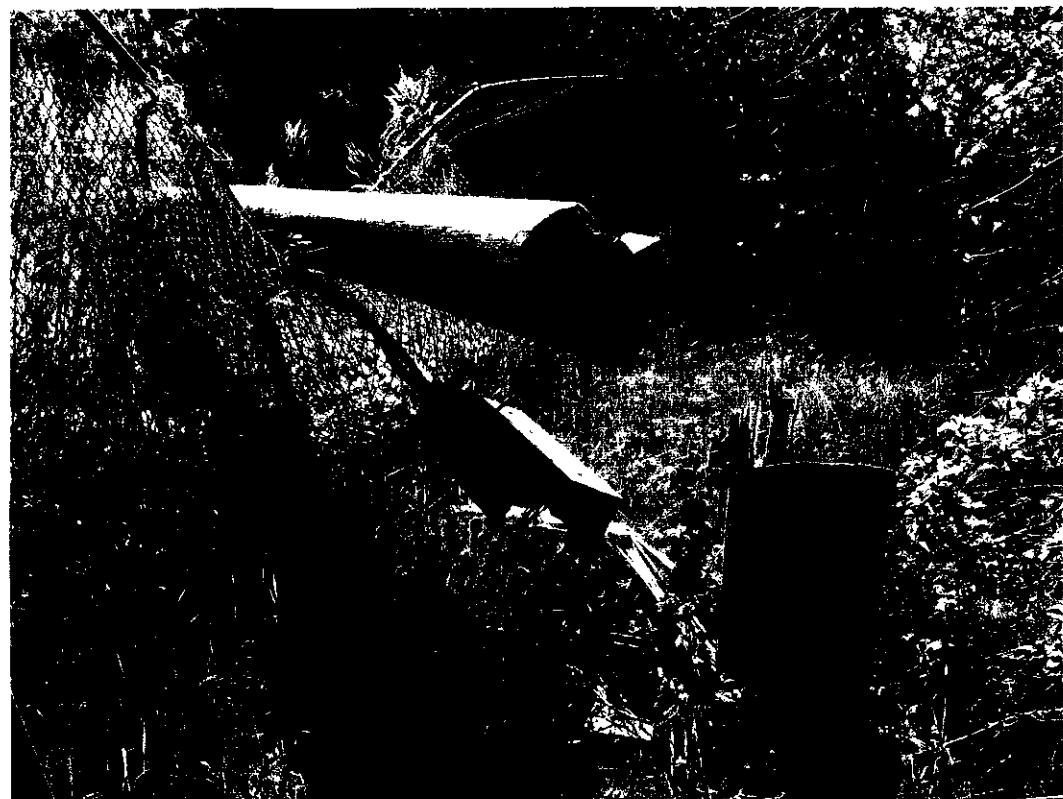
A breach in the two right outfield fences was used to leave the ball field and inspect the open field south of the ball diamond. This breach was originally made during earlier field investigations but had been repaired in the fall of 1998. For unknown reasons, a large wooden utility pole/light stand in between the two outfield fences in this area has been cut down by some one using a chainsaw, this pole fell onto one of the fence sections damaging it; however, it is unclear why the fence breach was made. Next 2 pictures.

1. The fence erected by EPA during removal actions in 1993/1994 has been deliberately cut to provide access between the ballfield and the abutting Contract Plating property. This fence should be repaired to prevent trespassing on the ballfield.

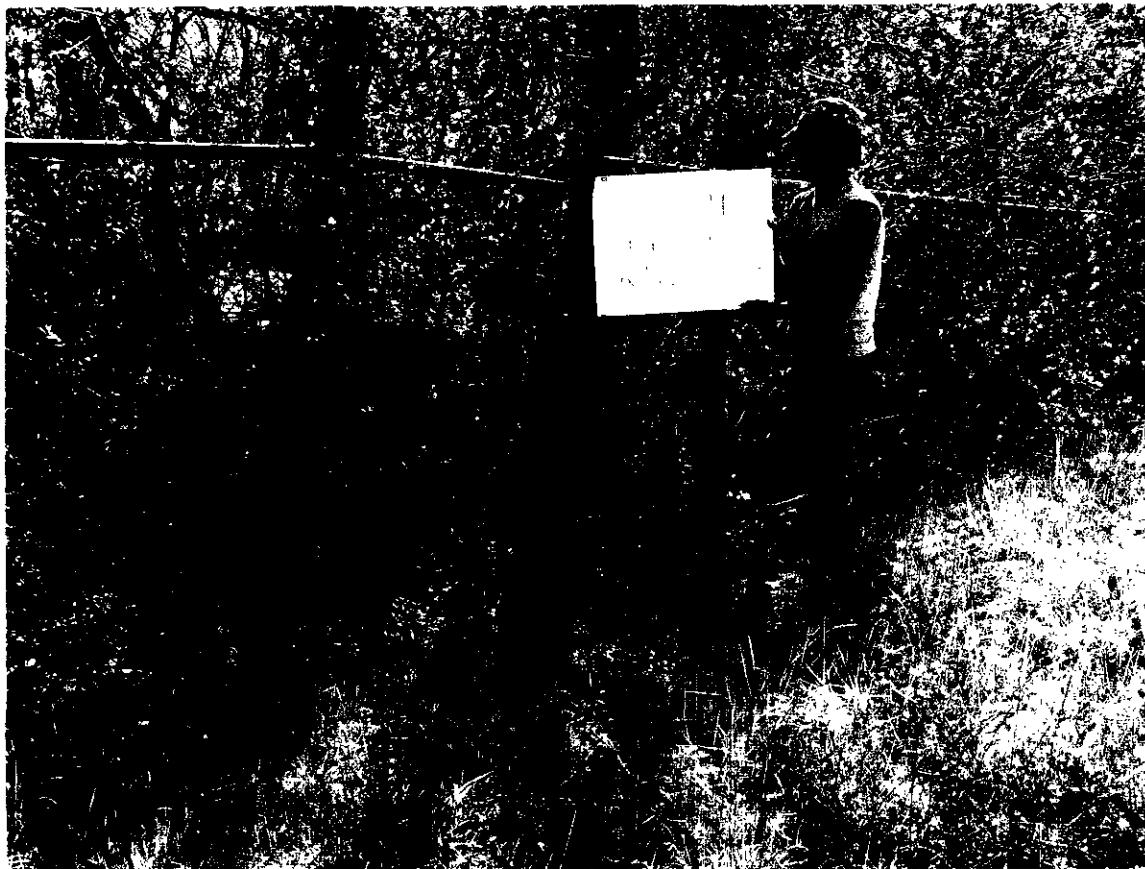
Multiple breaches in the perimeter fence between OU4 and Contract Plating were noted and numbered sequentially as found. Many of these breaches appear to coincide with locations where the fence had been cut and repaired during the RI/FS test pitting activity. Breach number 1 is located approx. 100 feet from the south corner of the fence.

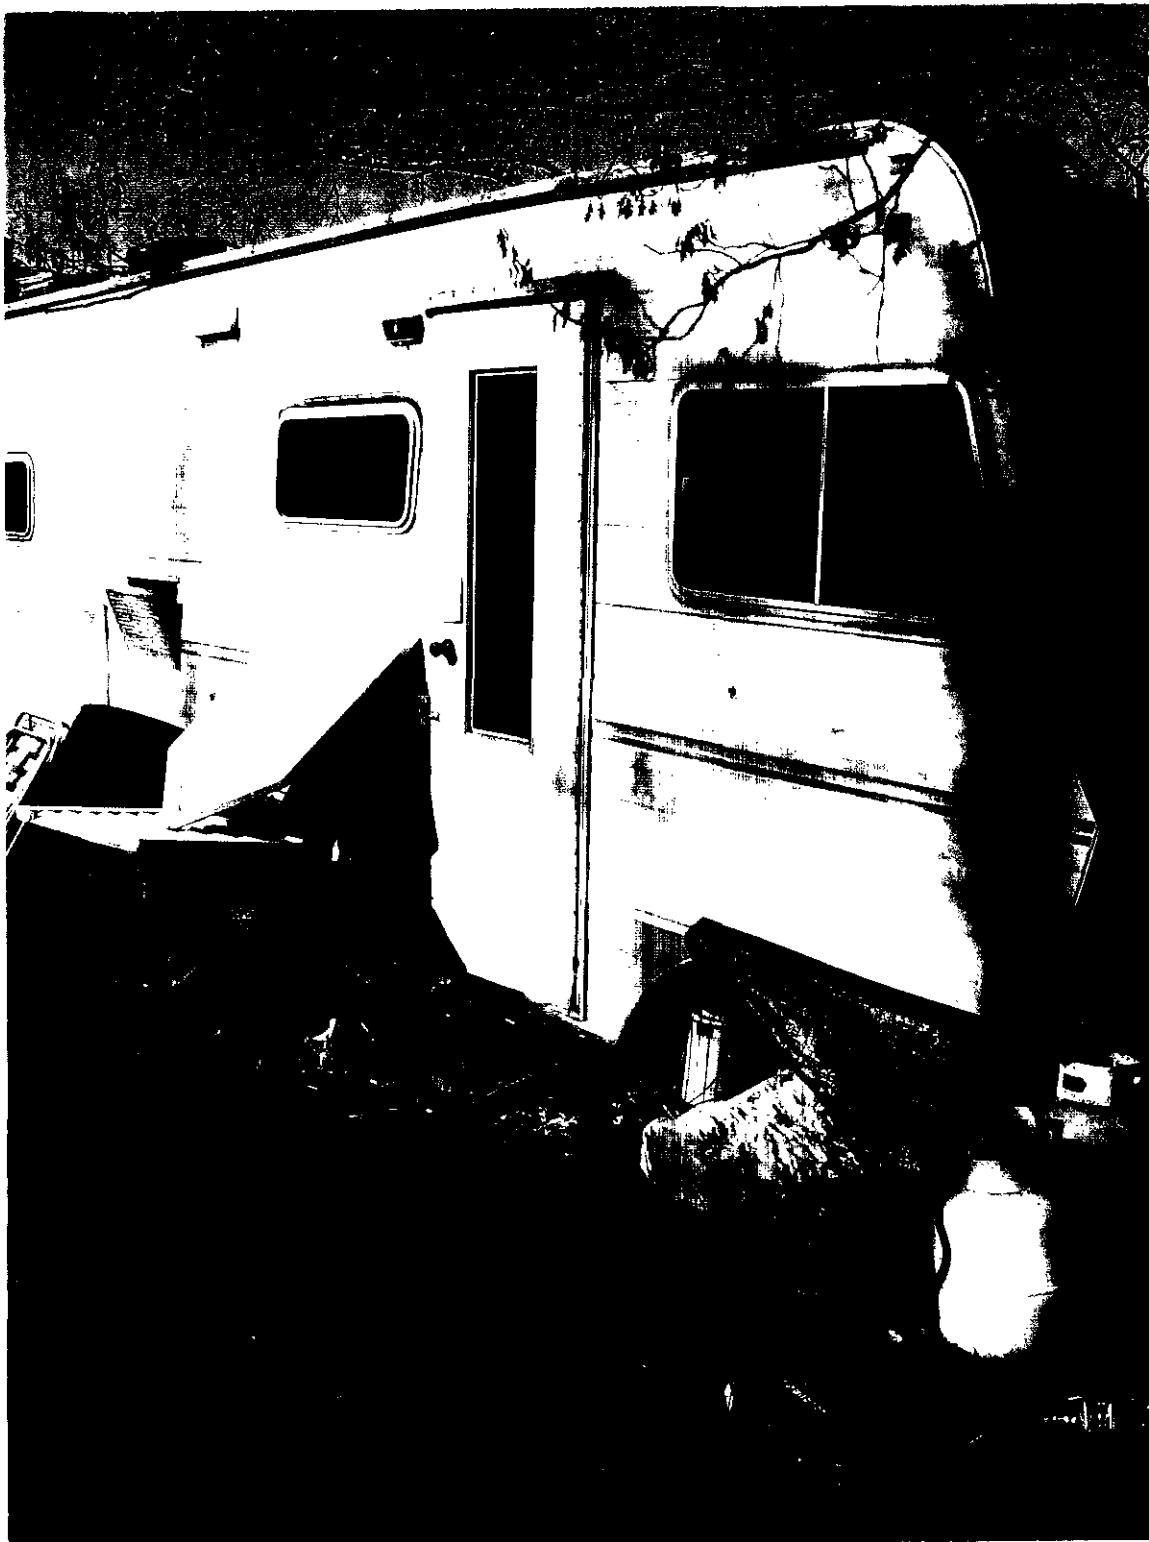
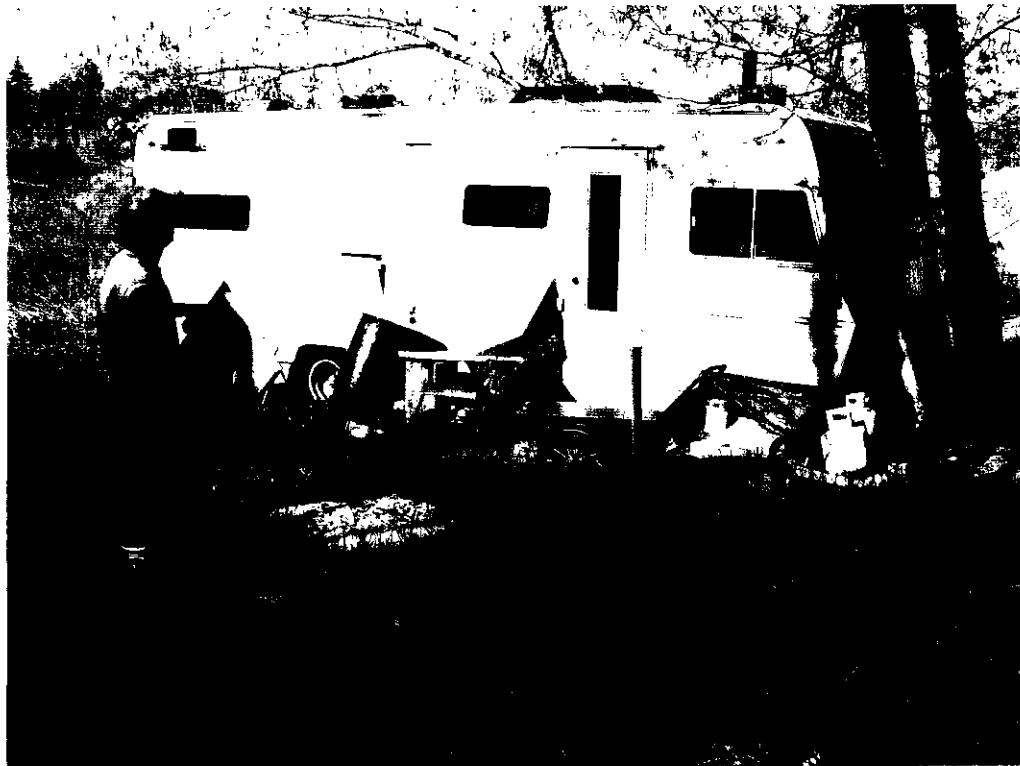
Between breach number 2 and 3, we encountered the mobile home parked in the wooded area between MW-401 and MW-2. The mobile home is surrounded by garbage and debris including plywood, empty beer cans & liquor bottles, cat-food cans, old clothes, propane bottles and a kerosene heater. There is a heavily worn footpath leading to the mobile home from the gate to the parking area as discussed earlier. See next 3 photos.

In the photo above, monitoring well MW-2 can be seen near the bottom just to the left of the wood-handled brush axe we stuck in the ground as a marker. The well was not opened, but the protective casing hasp is broken so that the well is available for access. The condition of the well was not determined, nor was the repair of protective casing made. We did return the protective casing lid back to the closed position.

4. A reconnaissance of all on-site groundwater wells should be made and repairs made as needed (at least one well near an on-site trailer was no longer locked.).

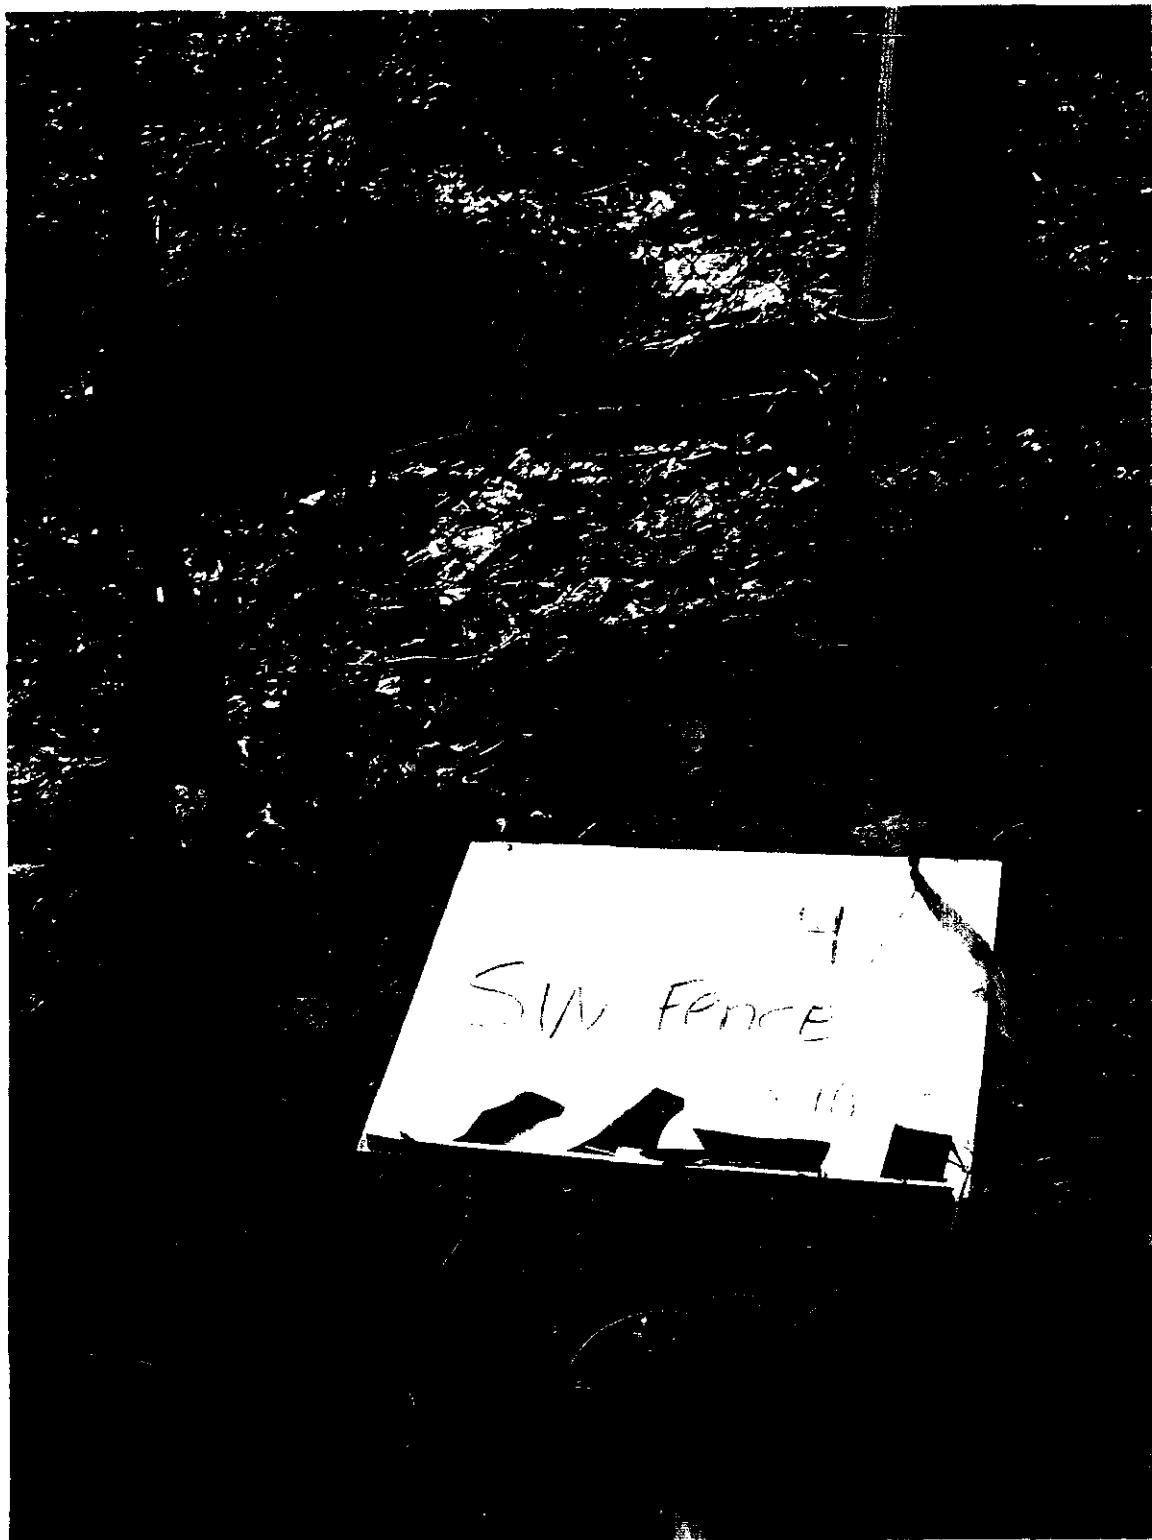
An area located between breach 5 and the corner of the fence was found to have brake pads/clutch plates at the ground surface near a fence post.

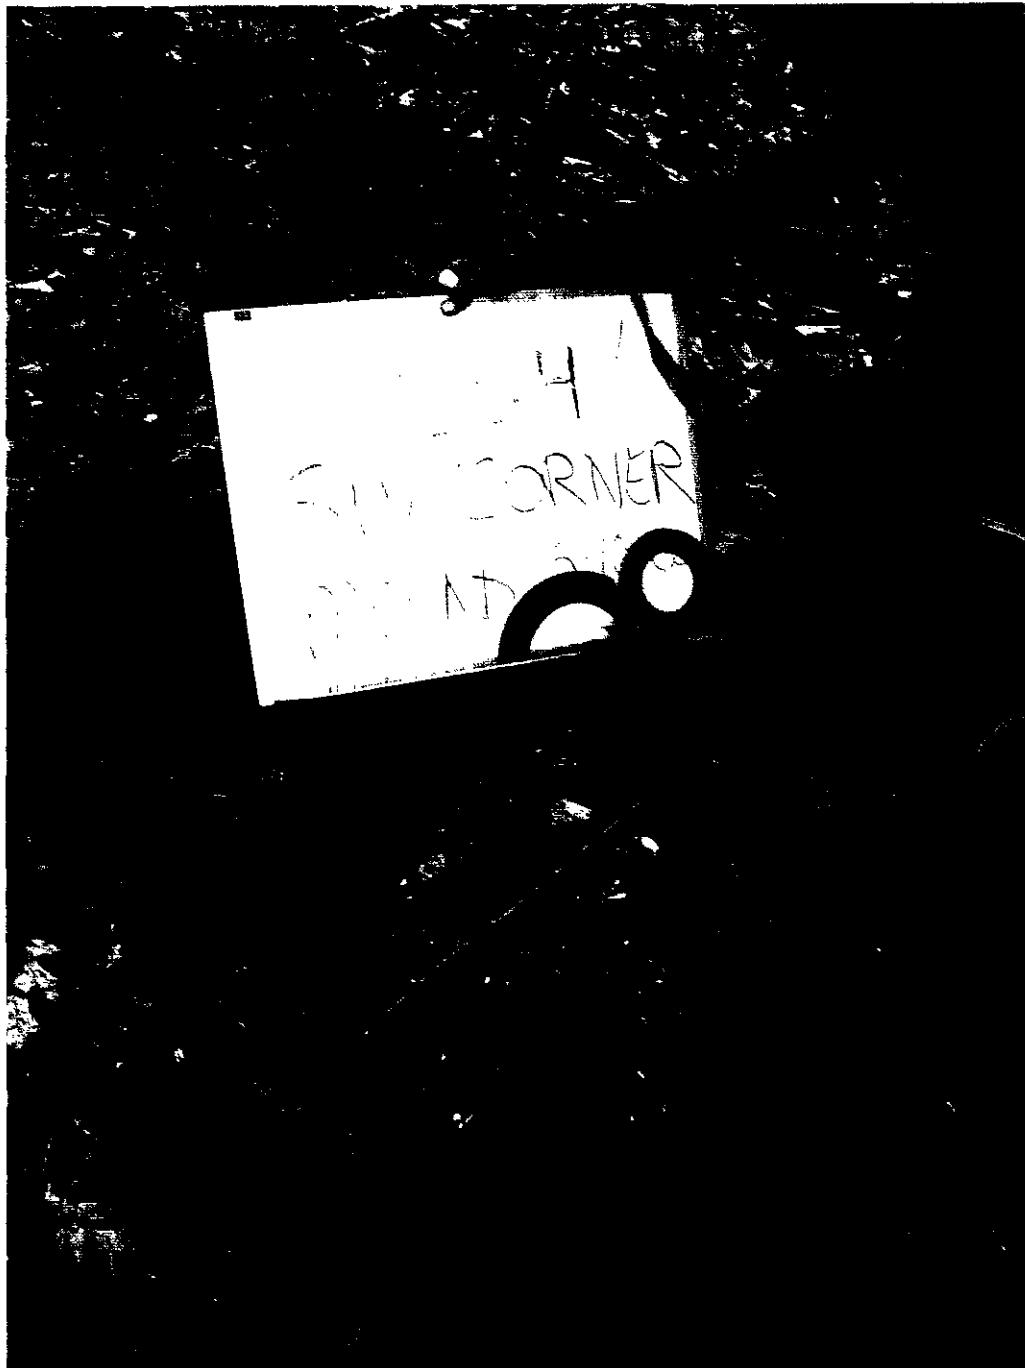
Upon further investigation, additional Raymark type waste/fill was noted exposed at the ground surface, especially along the sleep slope leading out of the woodline east of #50 & 60 Clinton Ave.

5. A break in the fence from a Clinton Avenue residence should be repaired and disposal of yard waste and other trash should be stopped. Residents should be informed that Raymark waste is visible on the surface.

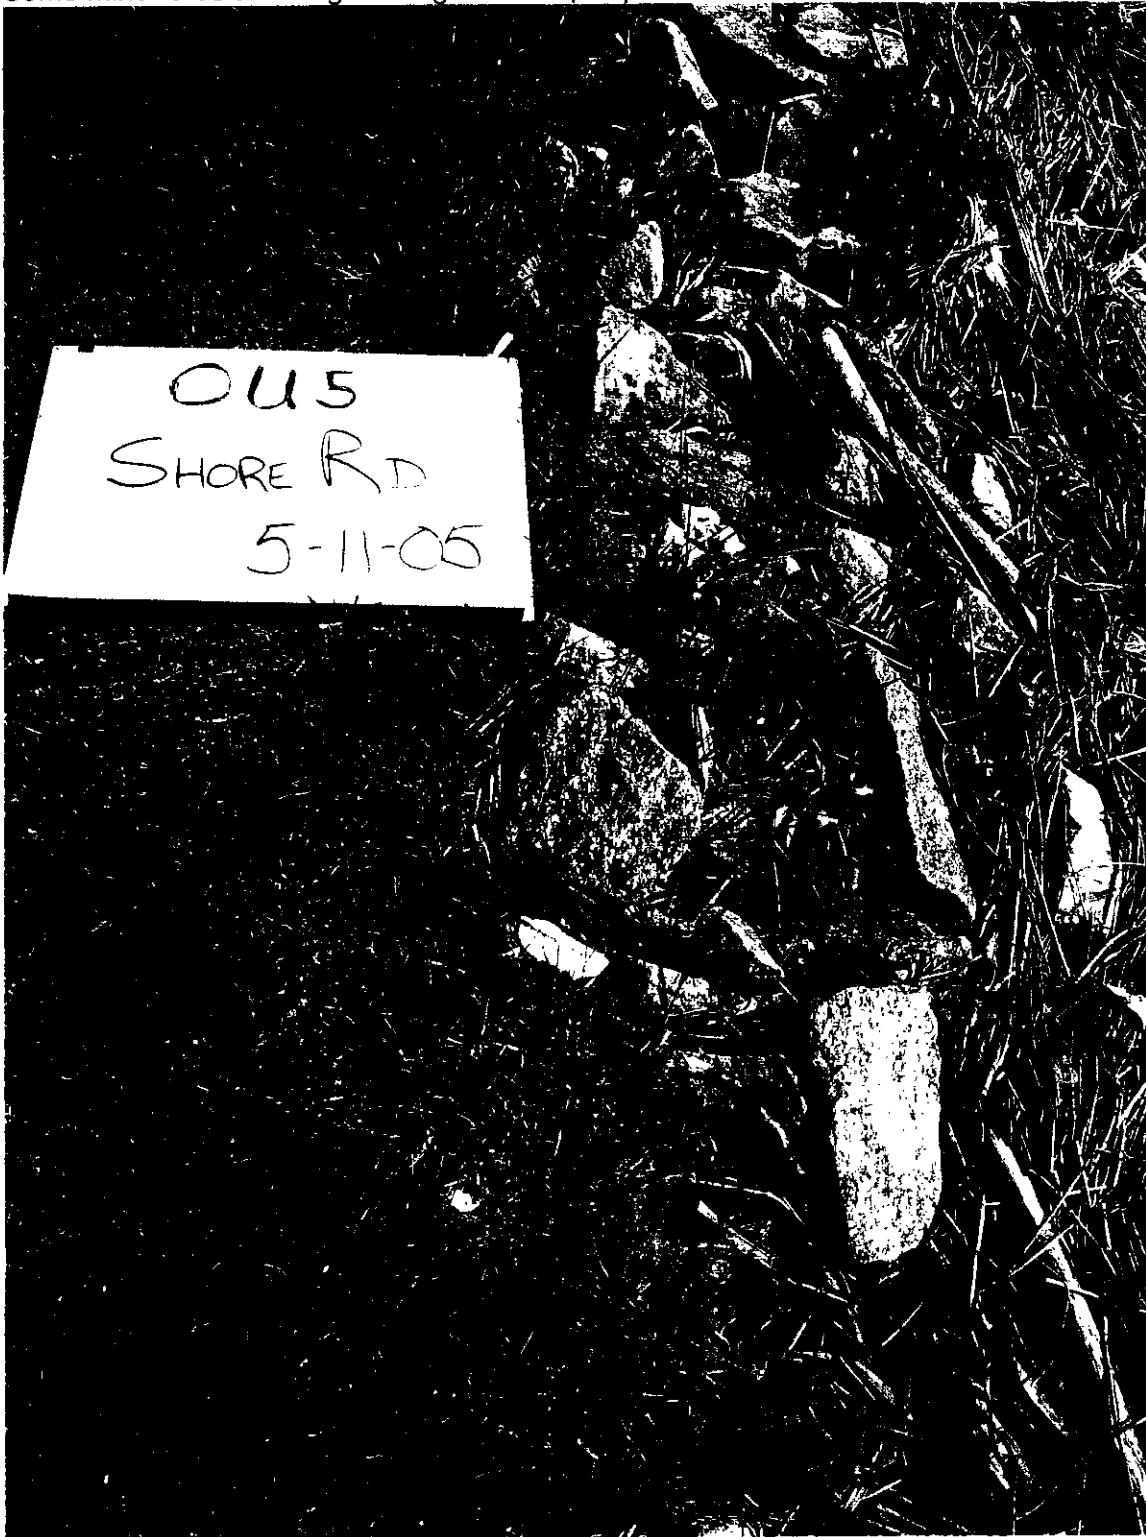
Some minor erosion along the edge of the rip-rap was noted as seen below

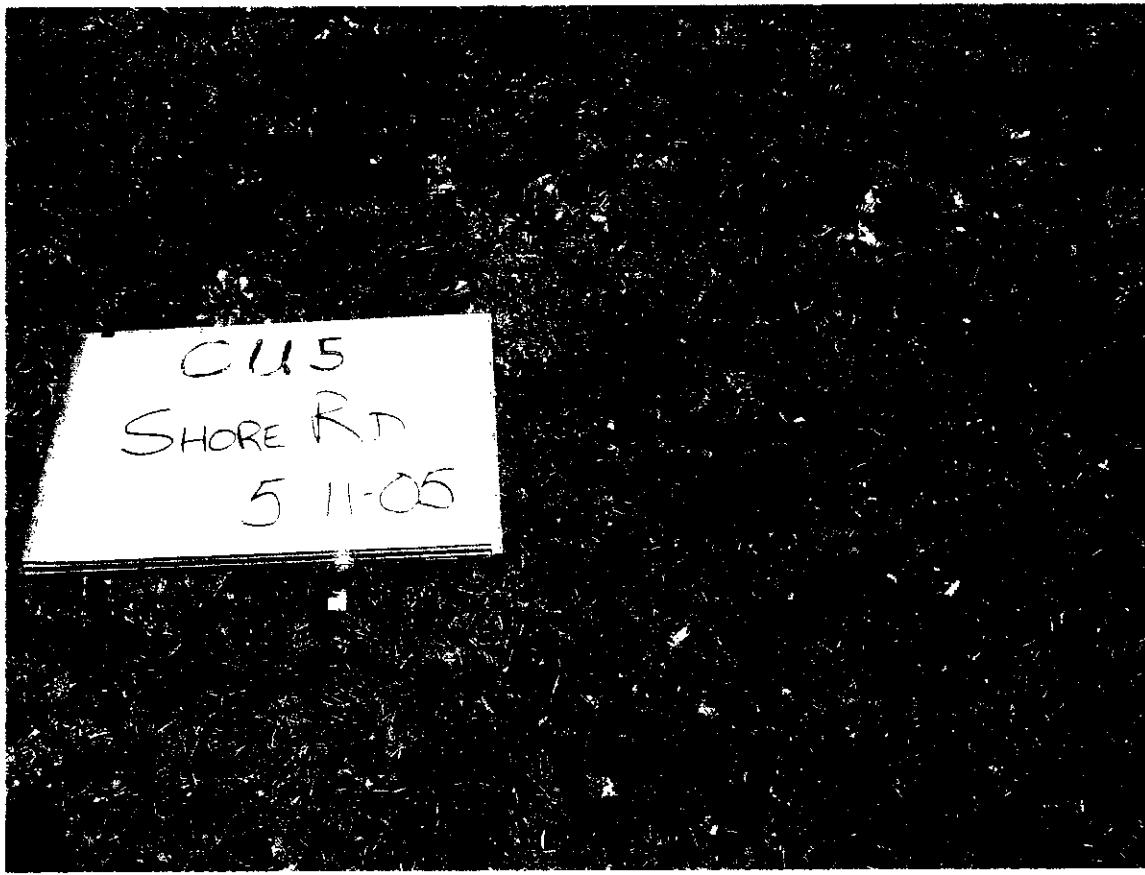
A small area of exposed and cut geotextile was noted on the lawn south of the boat club entrance drive.

1. Cracks in pavement should be sealed, especially along Shore Road.
2. Repair of monitoring well MW-532S and roadbox and monitoring well MW-530 should be made.
3. Geotextile repairs to the cover (south of the entrance to the boat club and along the concrete block retaining wall) and riprap repair (downstream of boat ramp structure) should be made.
4. Additional soil cover is needed for exposed areas south of the boat club entrance.
5. Settlement along the retaining wall and pavement should be regularly monitored for changes.

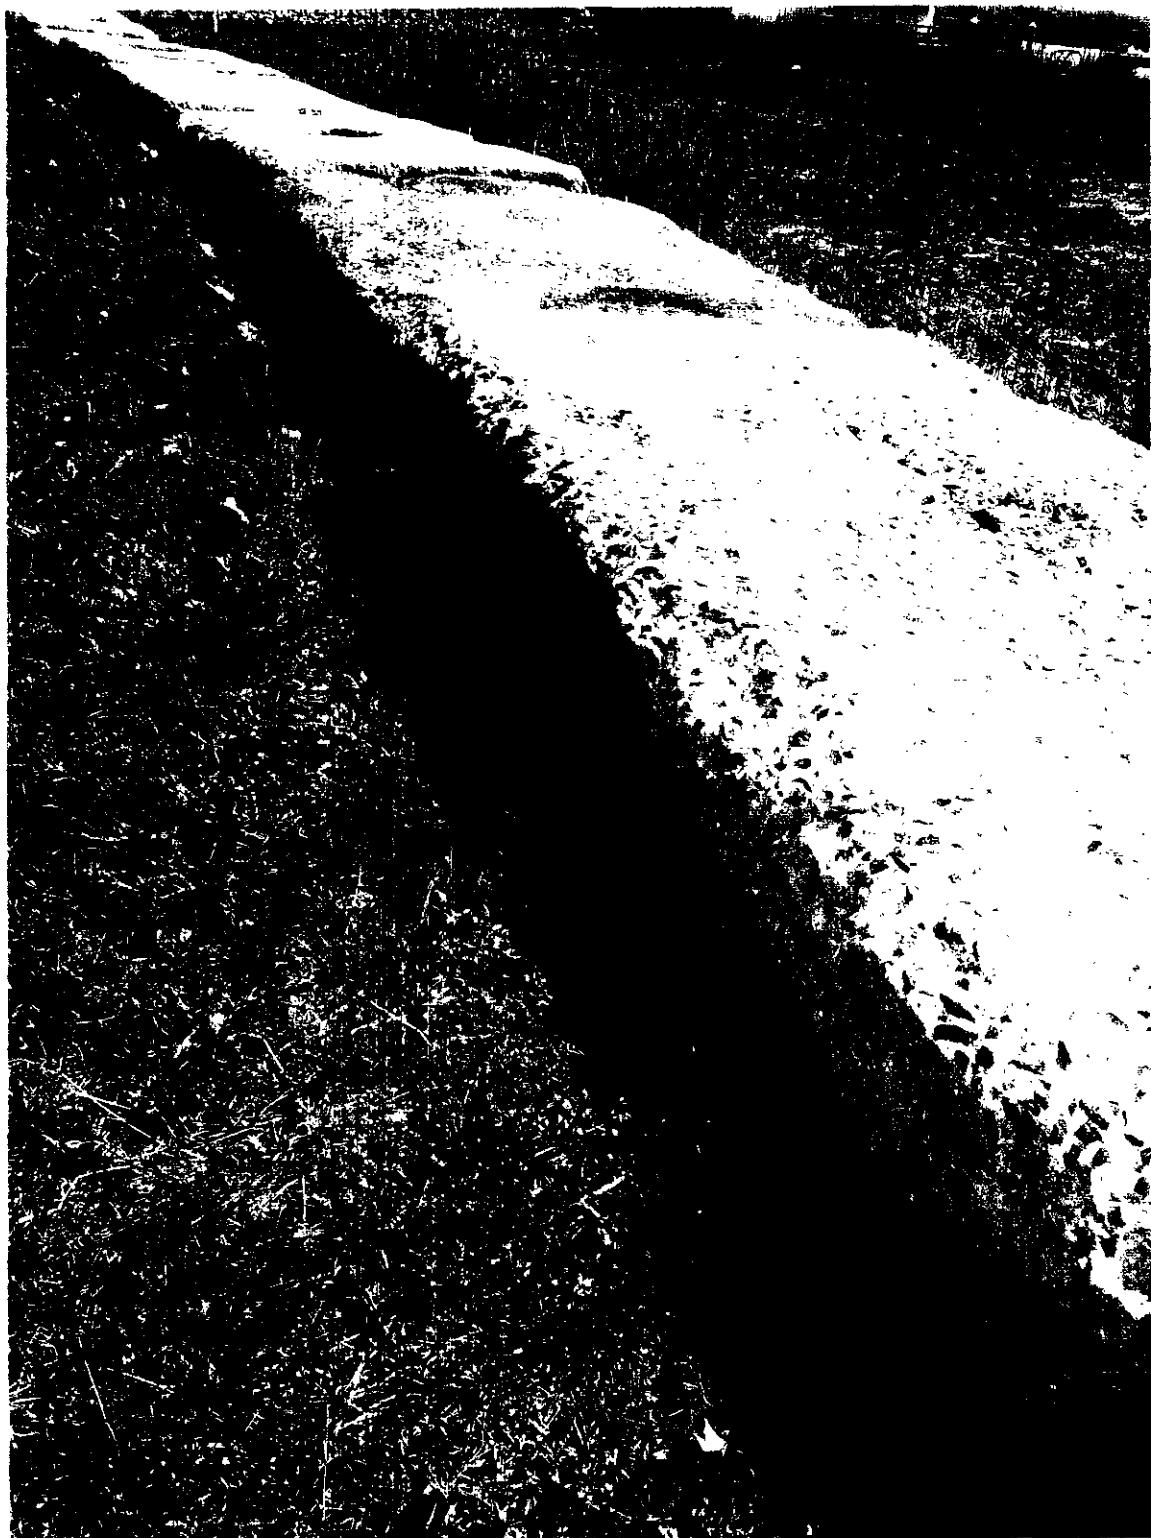
The geotextile was exposed in numerous areas where it meets the concrete block retaining wall.

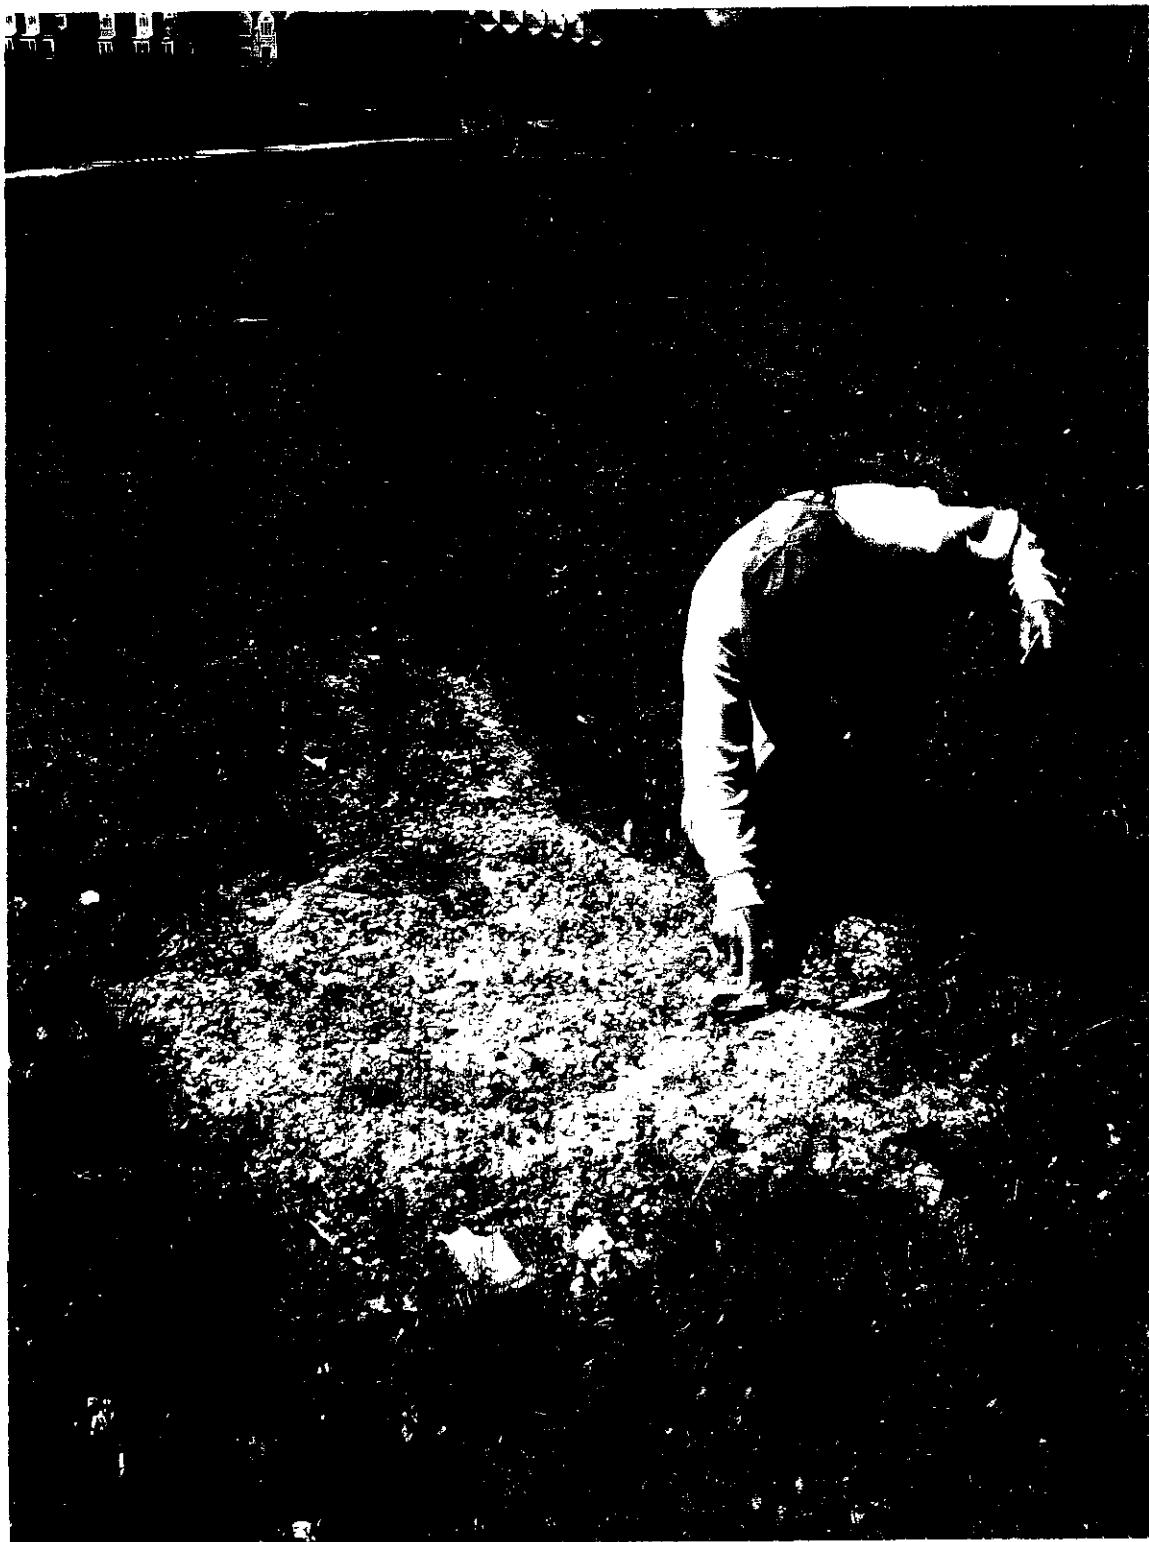
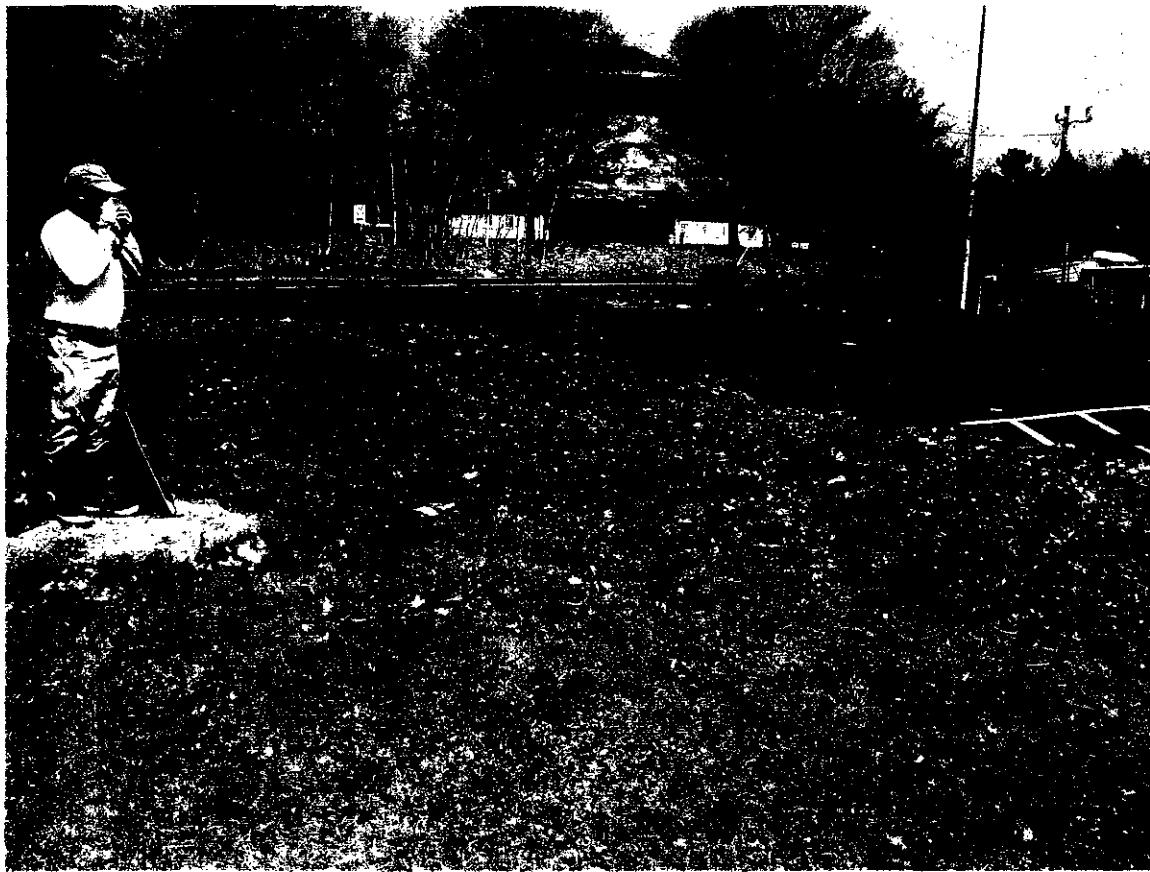
An area lacking topsoil appears to expose concrete or other fill in the same lawn immediately south of the boat club entrance. Next 2 photos.

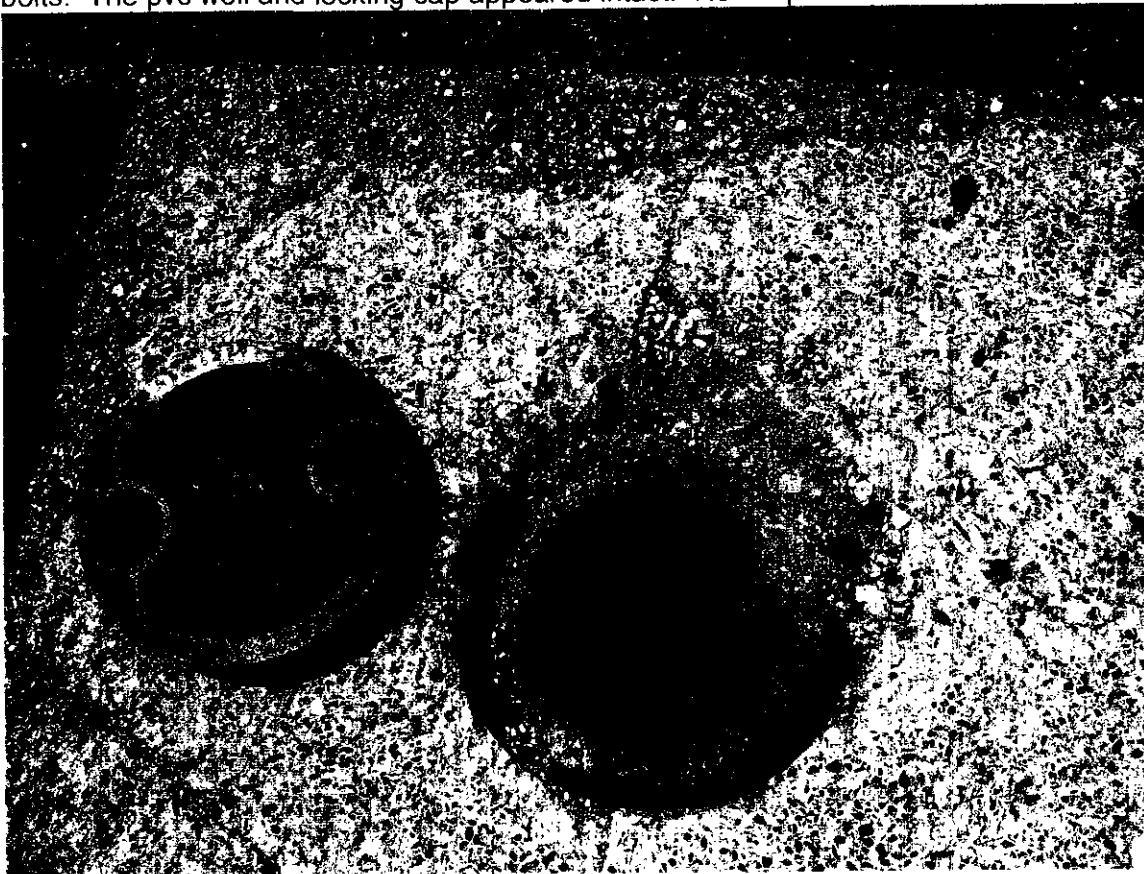
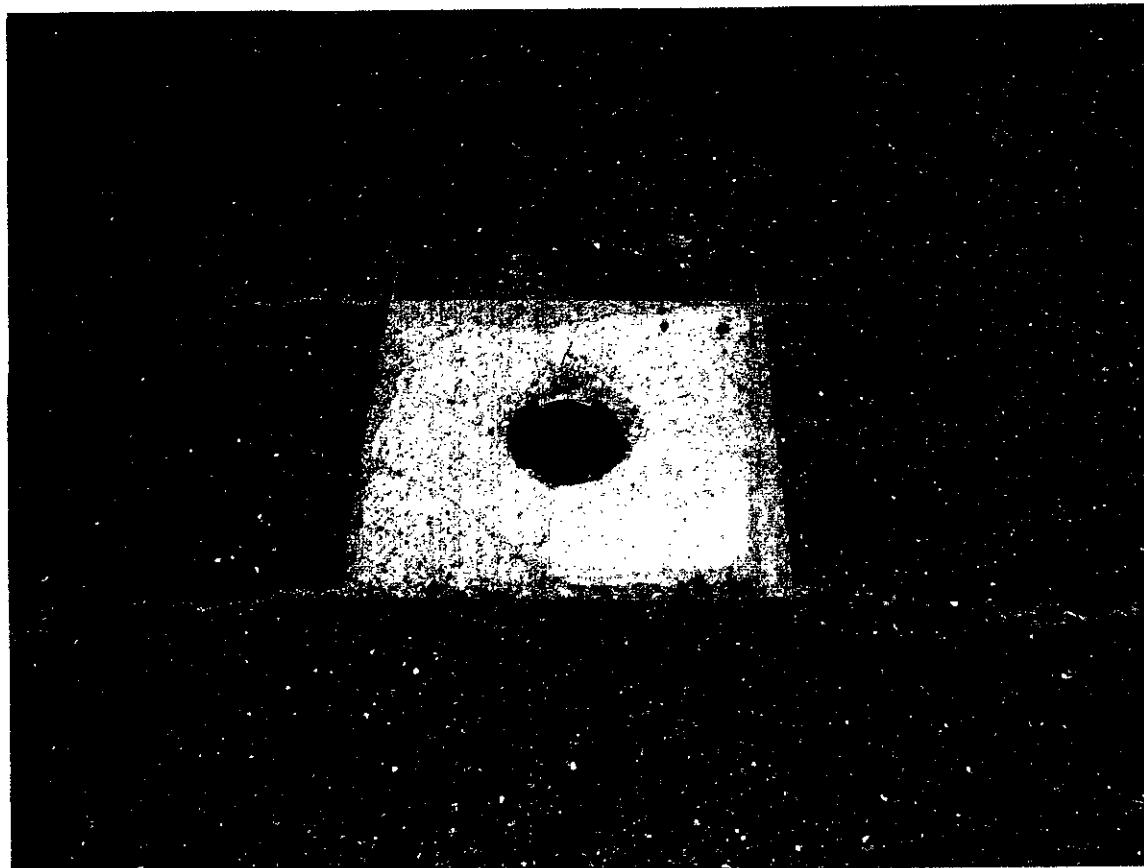
Monitoring well MW-532S in Shore Rd. was found with a broken road box id and missing lid bolts. The pvc well and locking cap appeared intact. Next 2 photos.

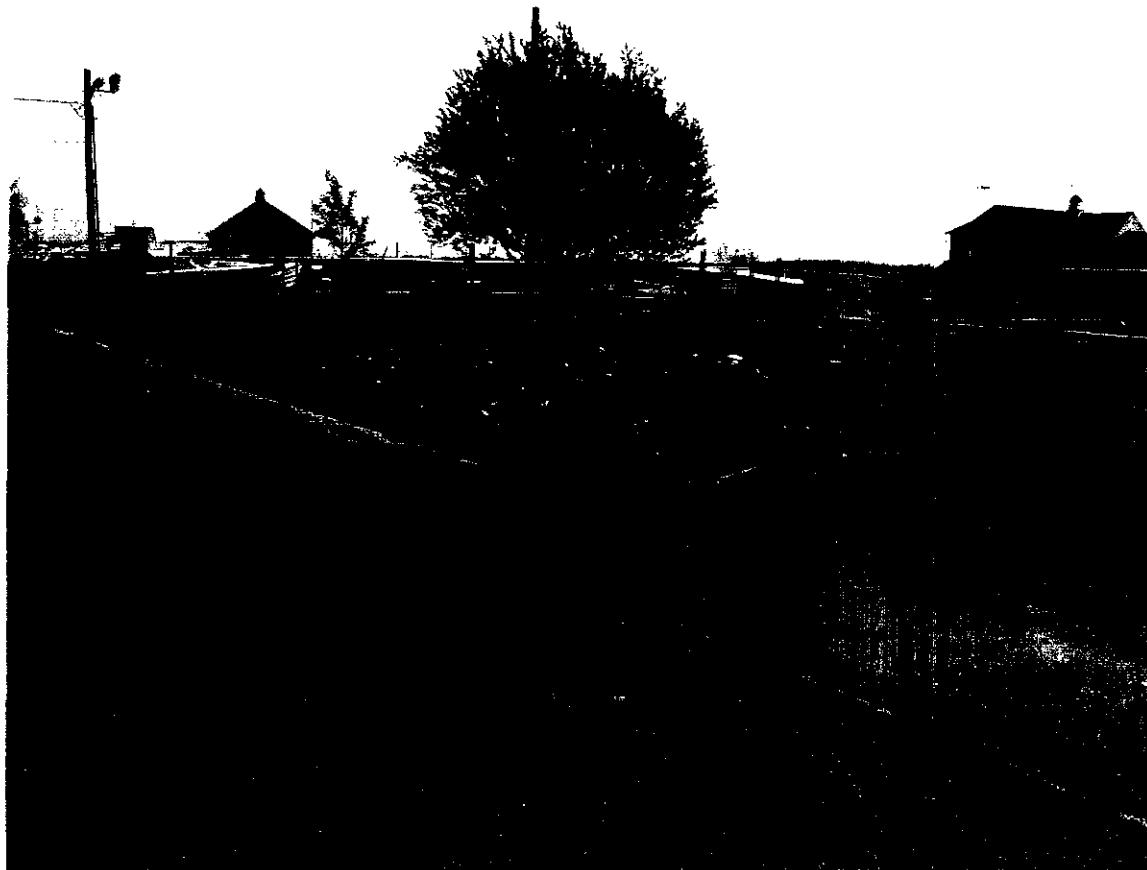
While some maintenance of the pavement has taken place inside the boat club property, the pavement on Shore Rd. itself is heavily cracked along seams with no sealer or patching evident.

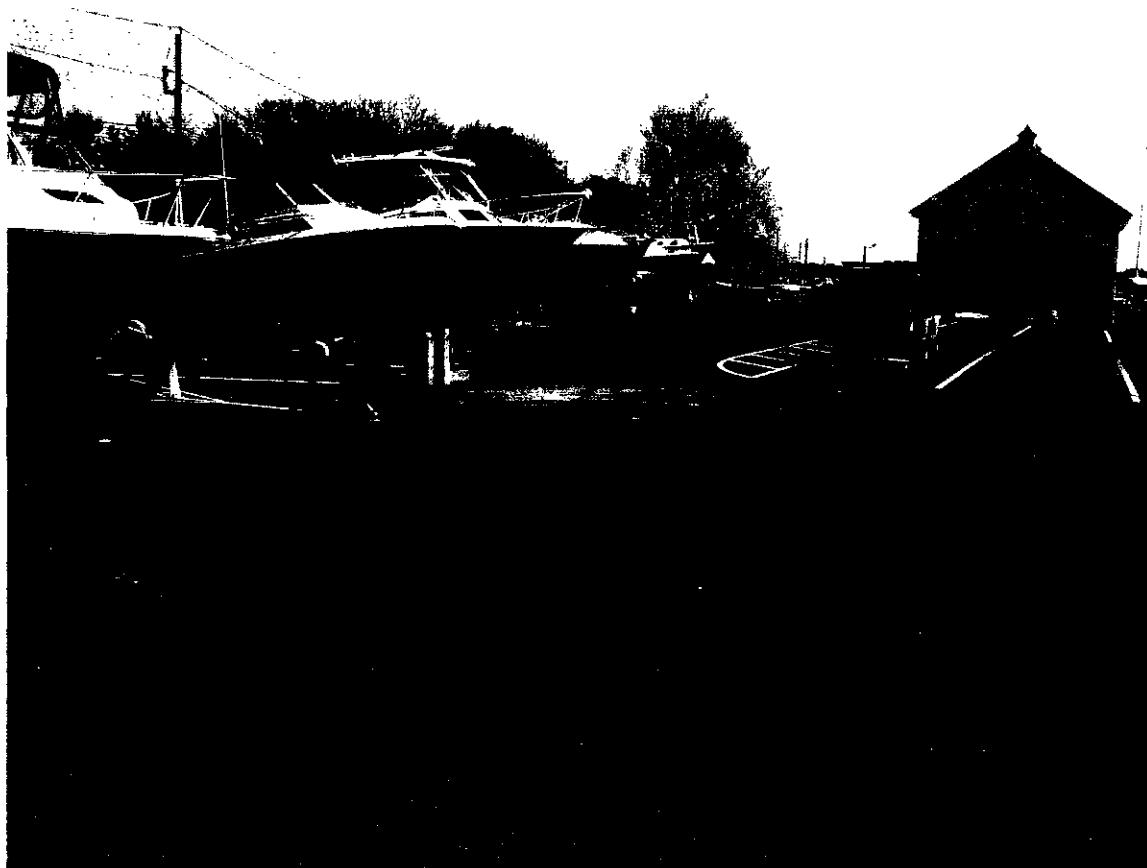
Photo of interior of Housatonic Boat Club property with previously cracked, sealed, and re-cracked pavement. The boat maintenance shed is on the right side of the photo.
