Five-Year Review Report

Second Five-Year Review Report
for
Raymark Industries, Inc. Site
Stratford, Connecticut

September 2005

The United States Environmental Protection Agency
Region 1, New England
Boston, Massachusetts

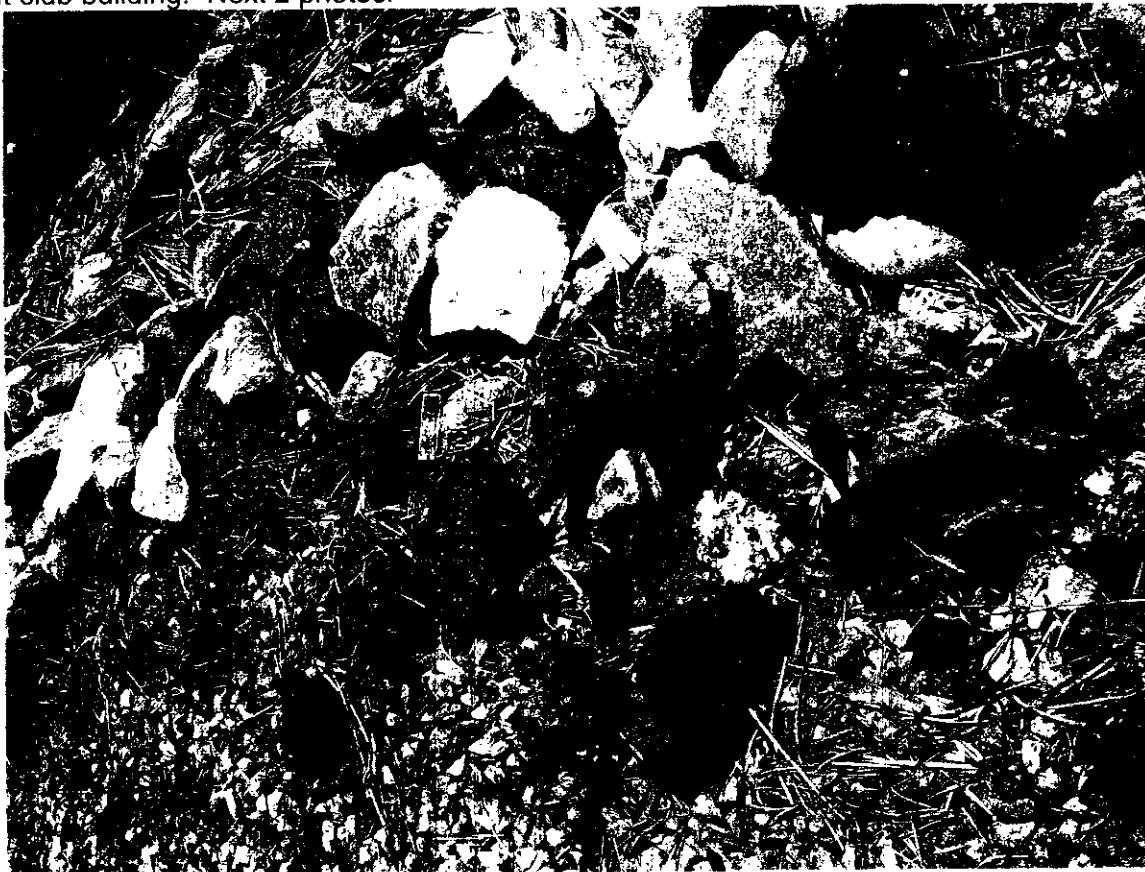
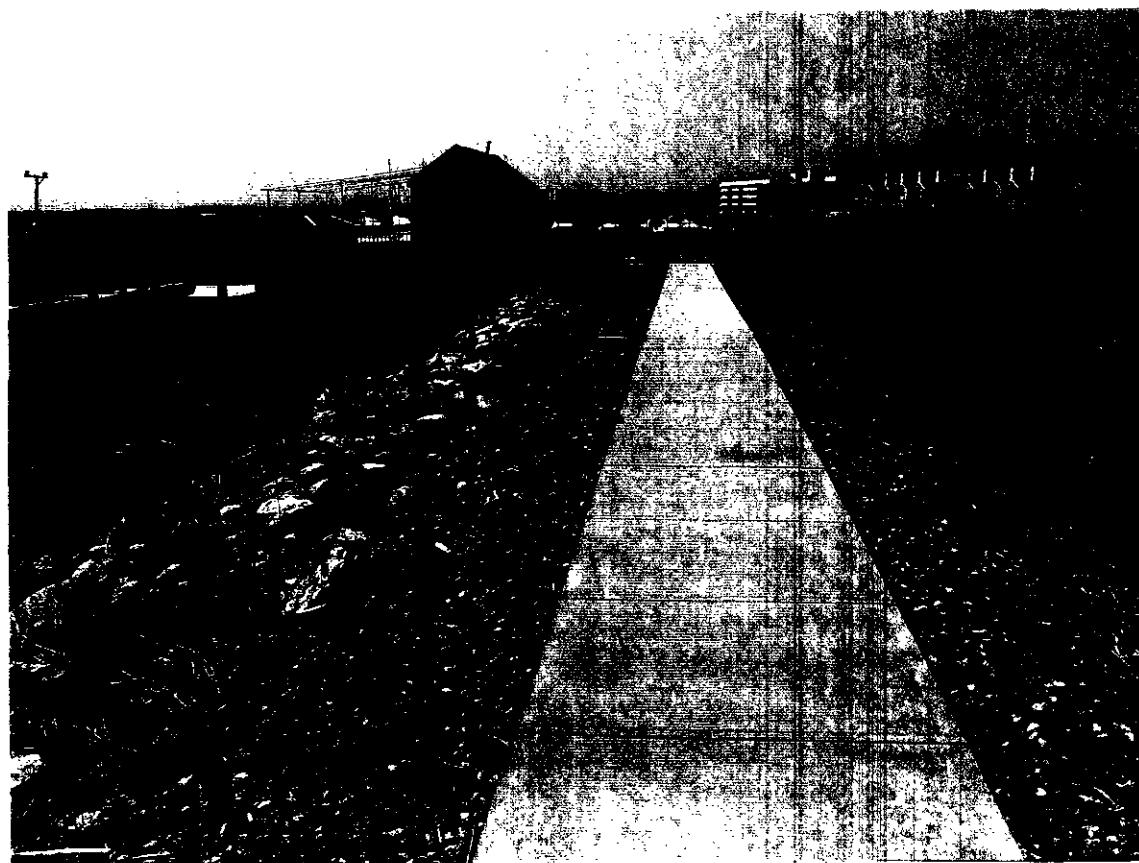
Steel slag and debris is easily noted within the rip-rap along the causeway south of the main boat club building. Next 2 photos.

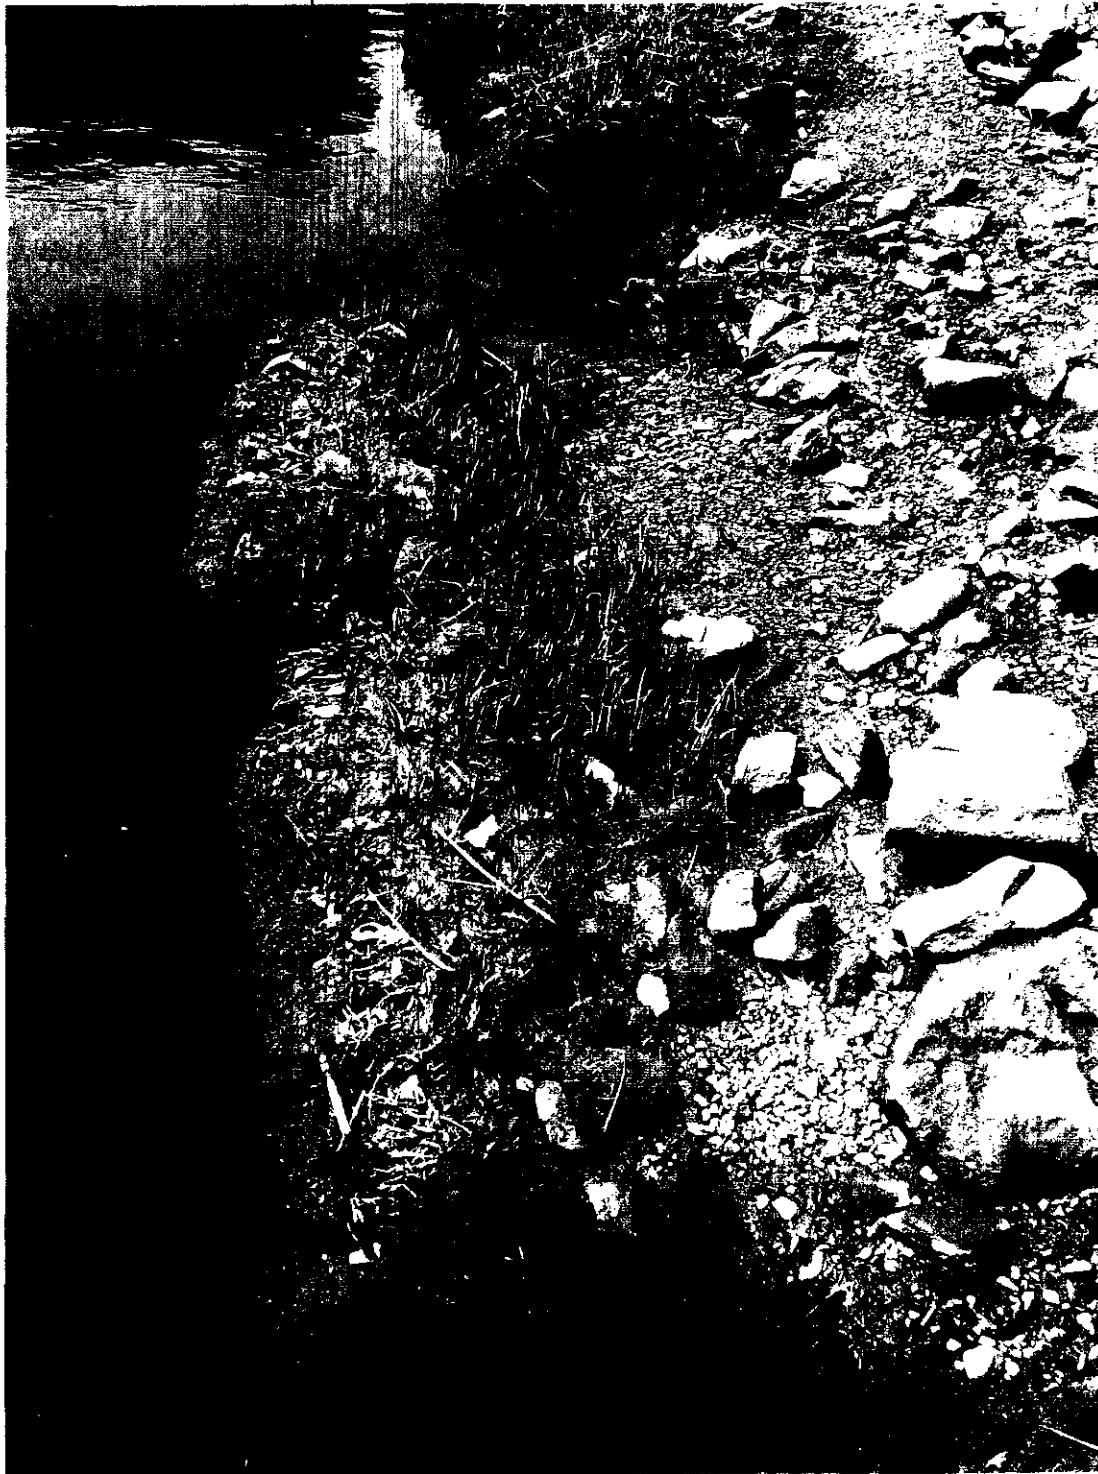
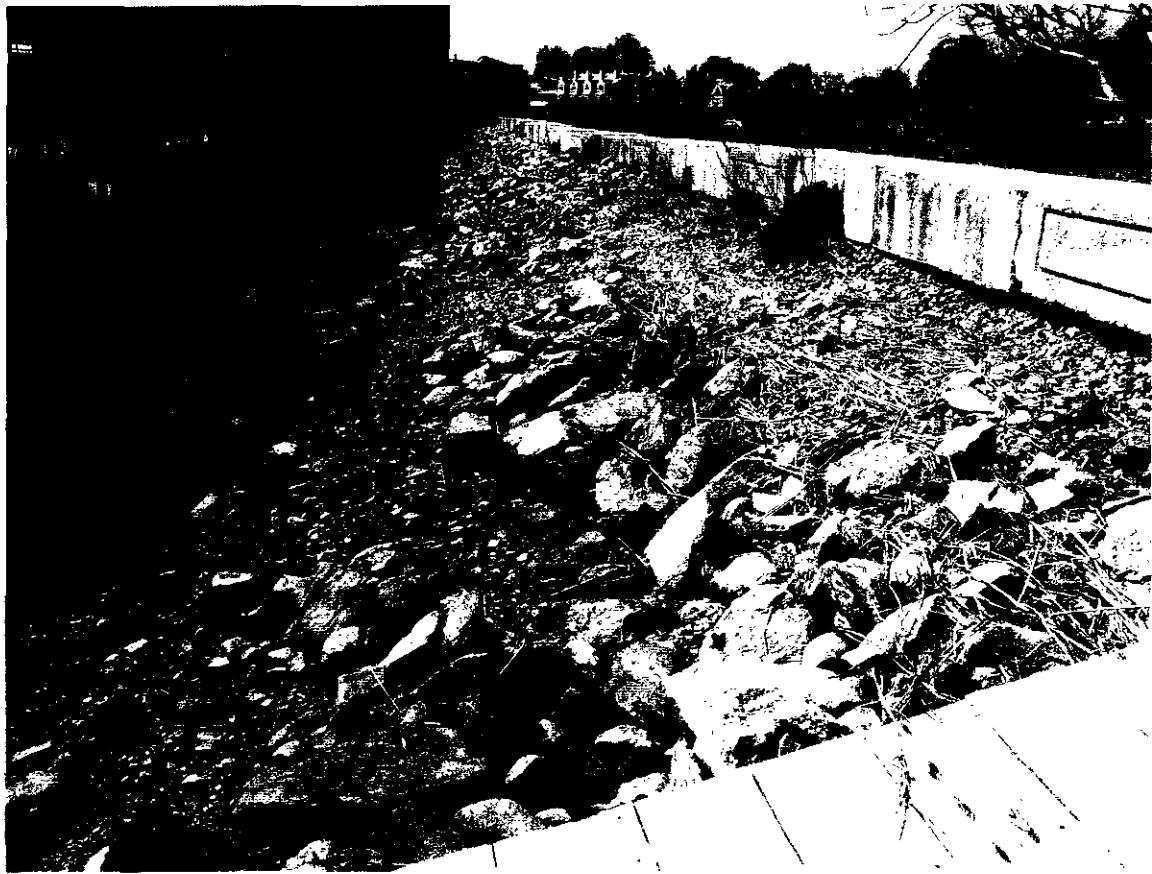
An area approx. 20 feet in length immediately south (downstream of the boat ramp structure) appears to have slumped/eroded into the river and may have allowed rip rap from above to fall into the river as well. Next 2 photos.

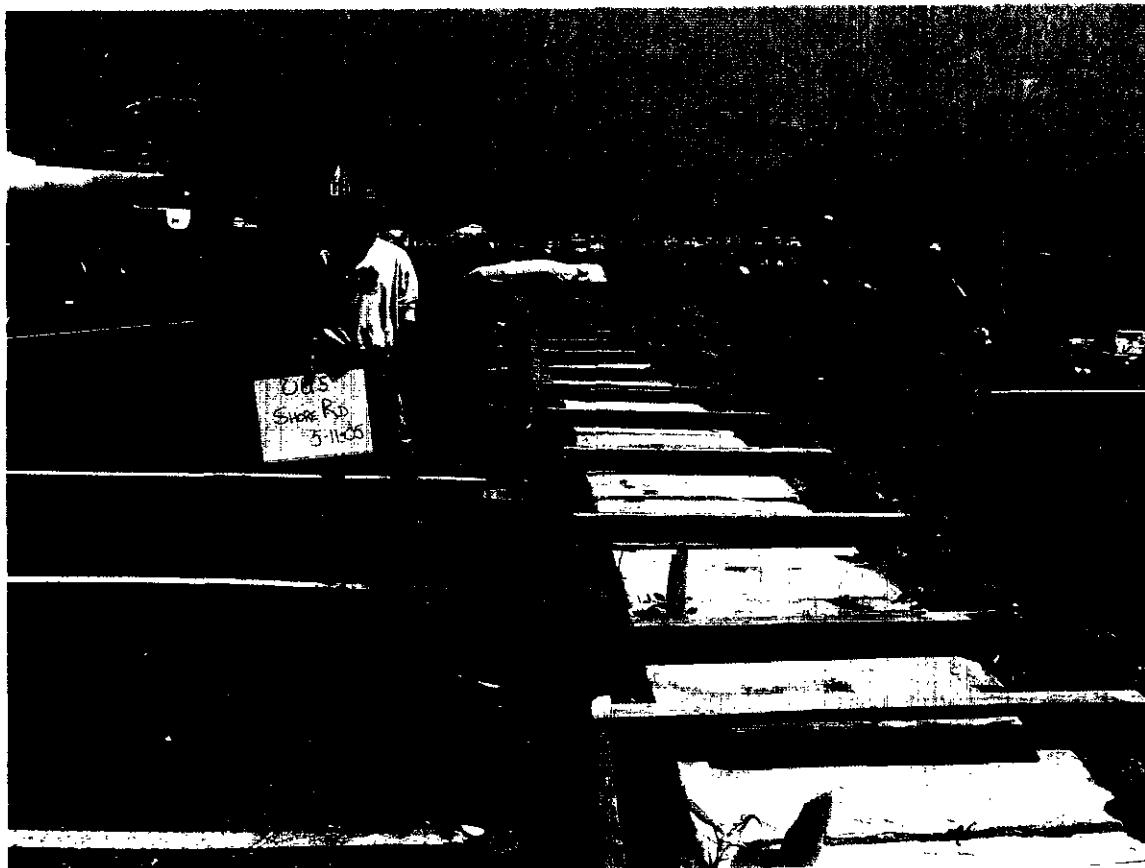
Areas along the edge of the pavement nearing the river show slight differential settling. Next 3 photos.

1. Cracks in pavement should be sealed, especially along Shore Road.
2. Repair of monitoring well MW-532S and roadbox and monitoring well MW-530 should be made.
3. Geotextile repairs to the cover (south of the entrance to the boat club and along the concrete block retaining wall) and riprap repair (downstream of boat ramp structure) should be made.
4. Additional soil cover is needed for exposed areas south of the boat club entrance.
5. Settlement along the retaining wall and pavement should be regularly monitored for changes.

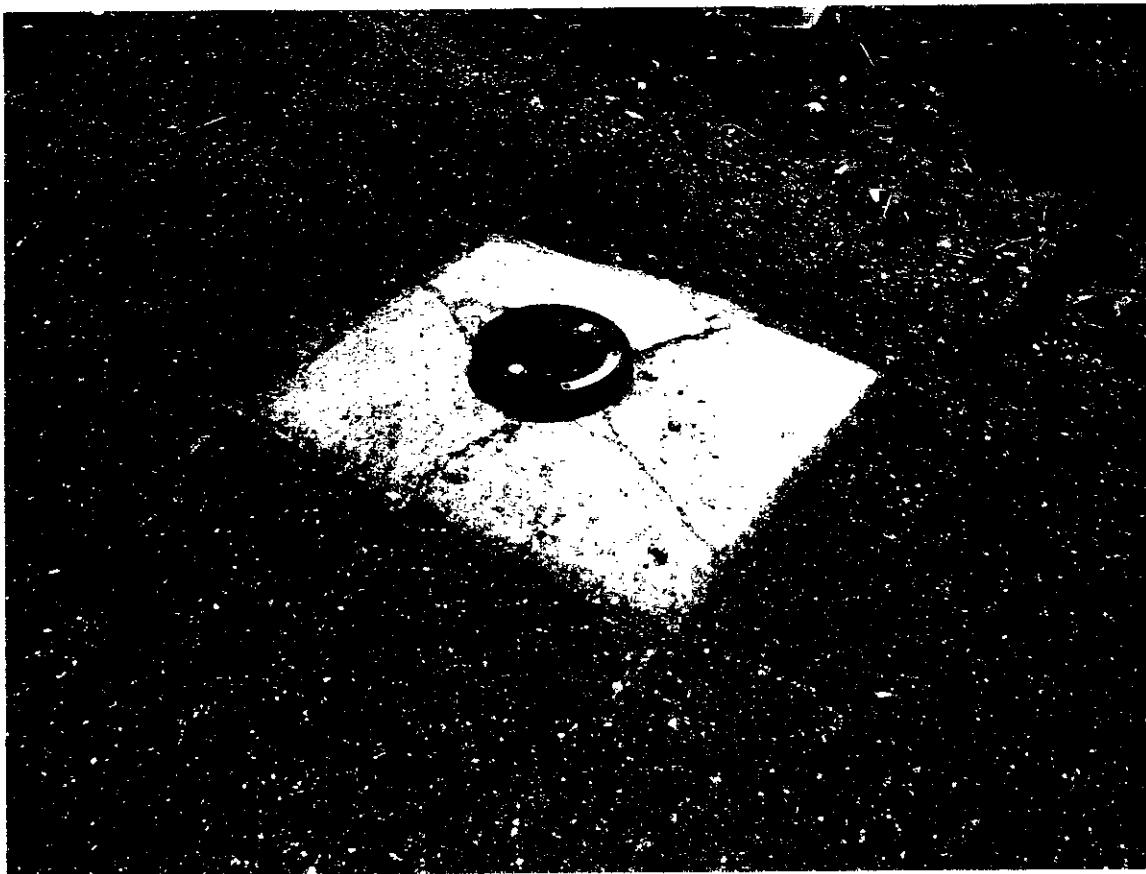
Monitoring well MW-530 near the sheet pile wall was found to have frost heave damage causing the road box to be heaved slightly above grade and cracking the surface seal.

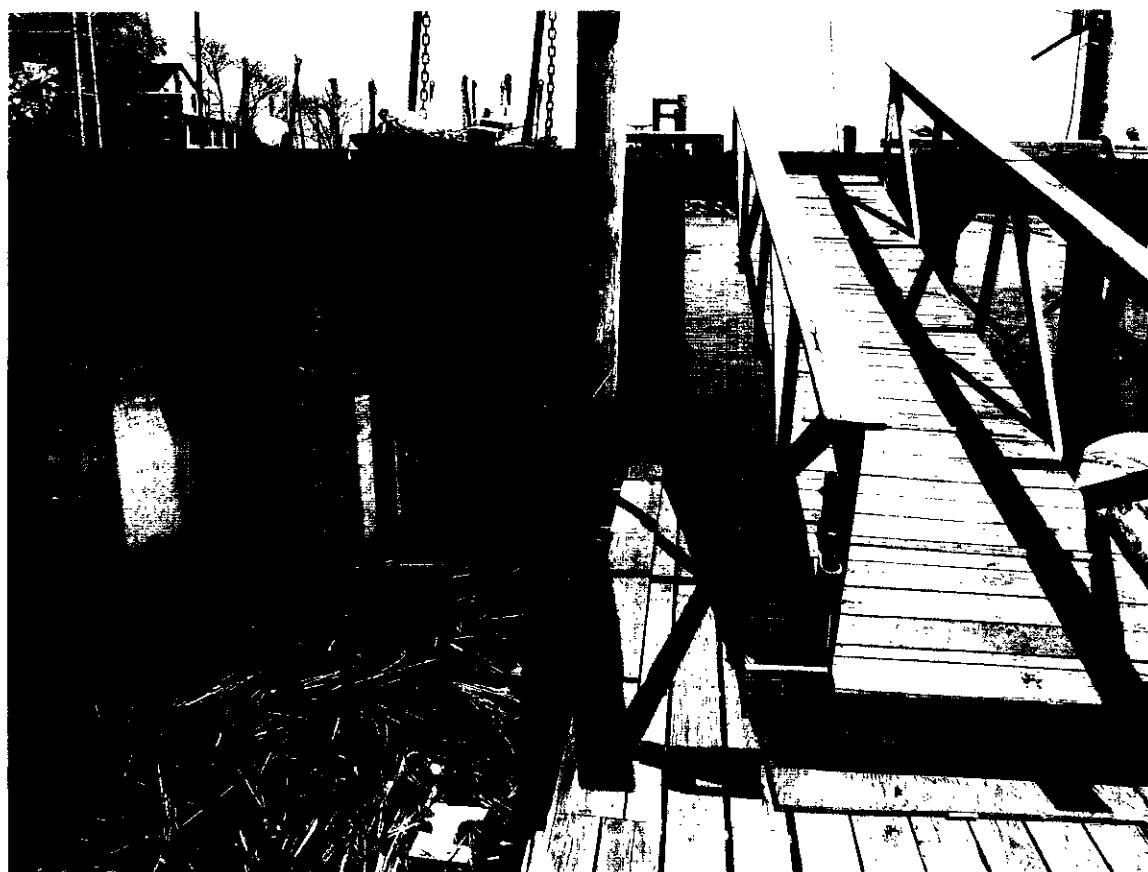
No issues were noted with the sheet pile walls other than typical wear and rust. Next 2 photos.

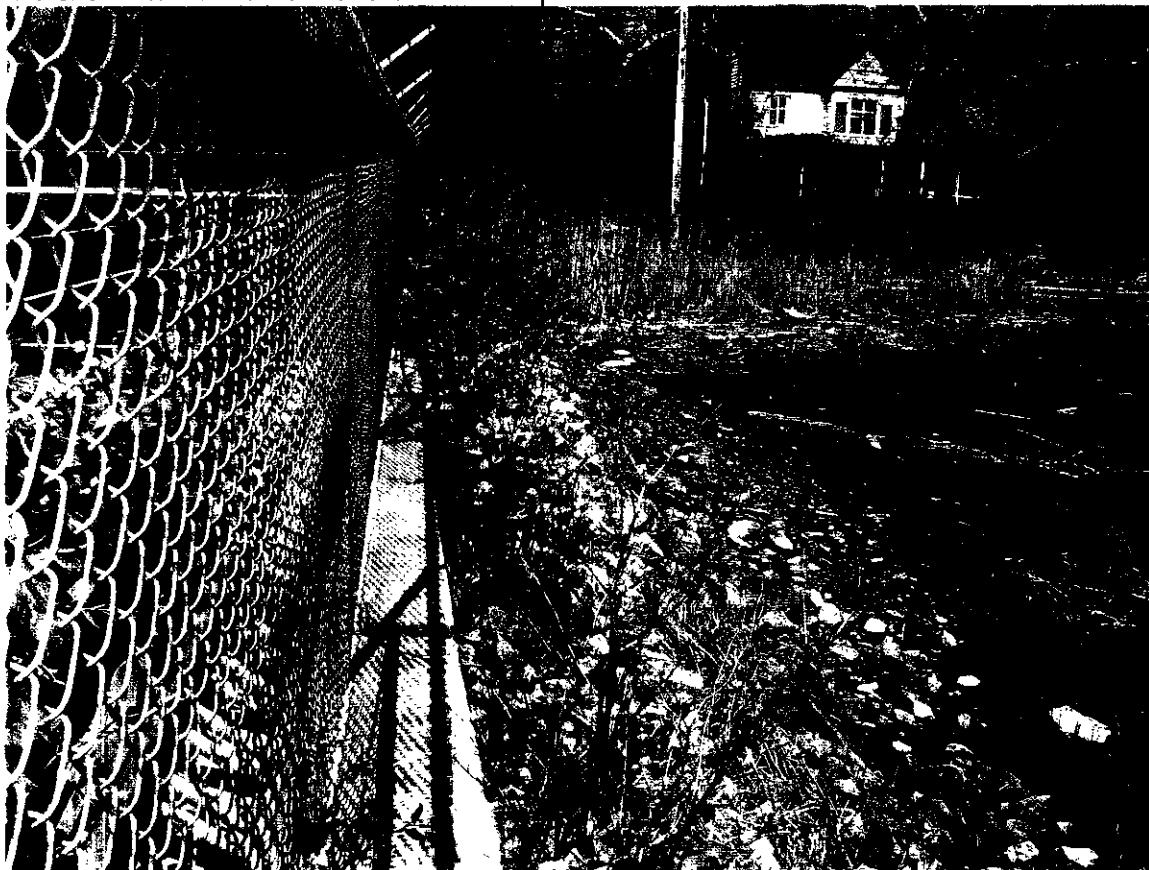
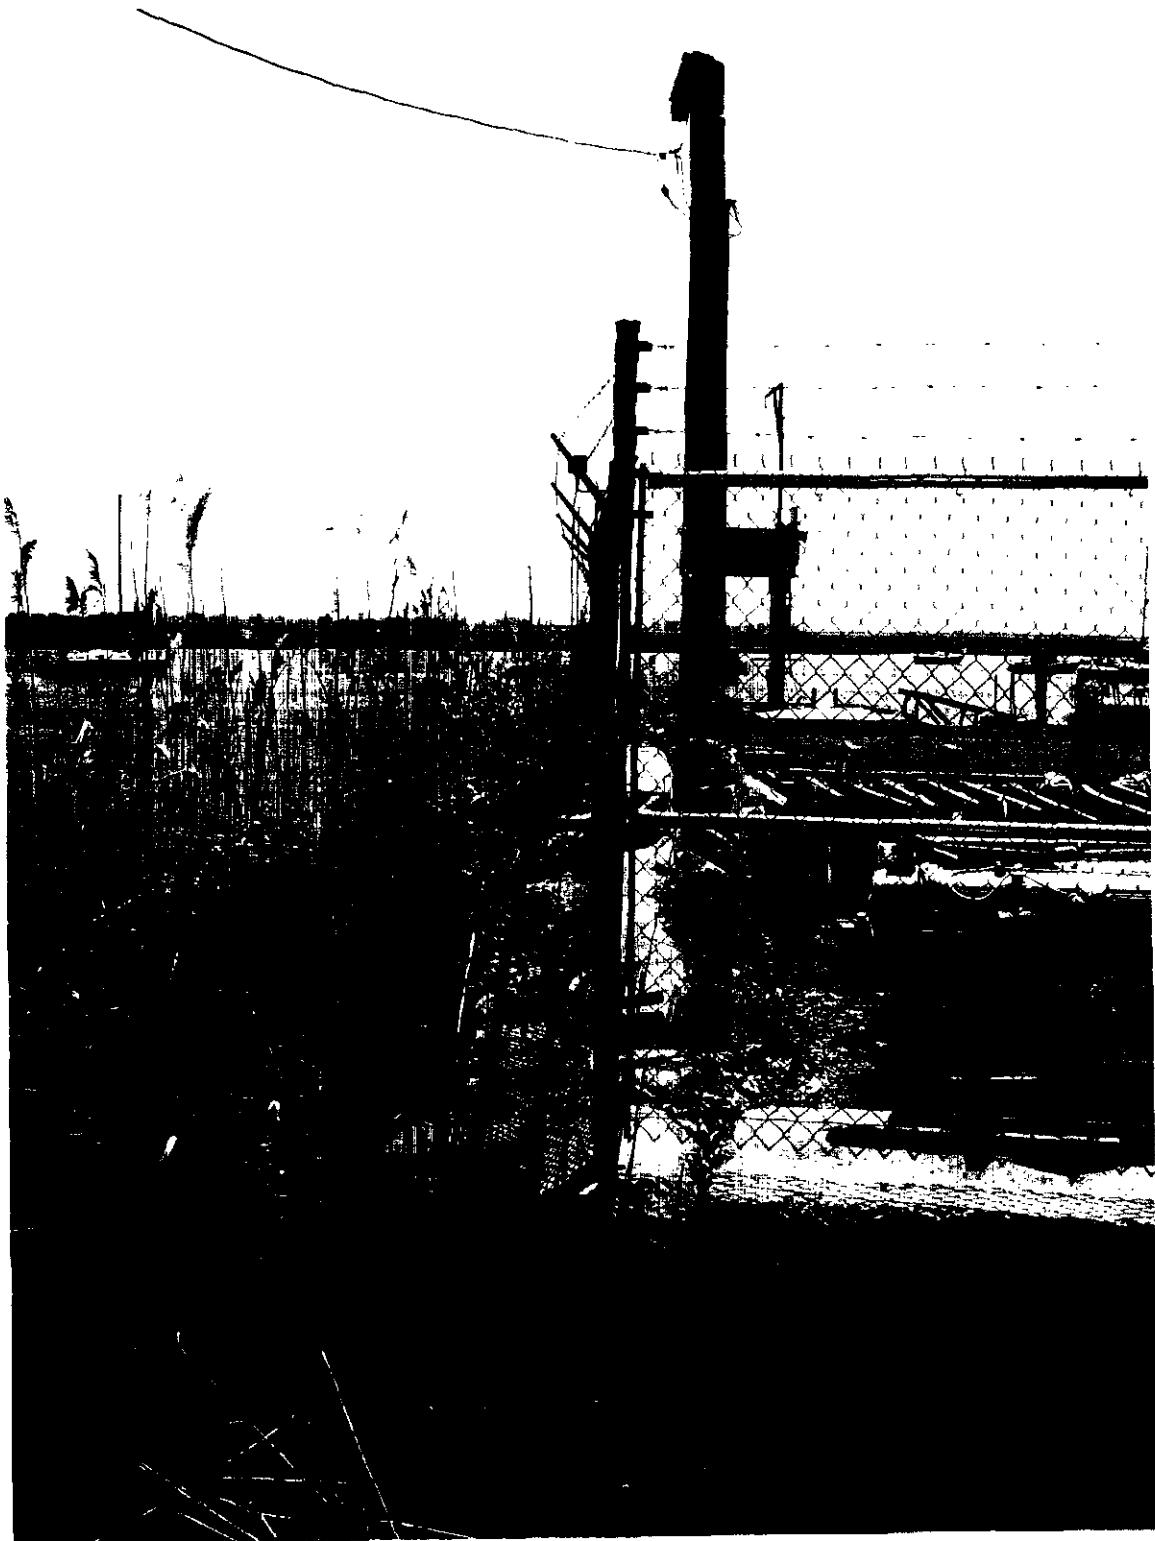
The northernmost retaining wall was difficult to observe due to heavy vegetation covering the fence and other physical obstructions. A possible slight bowing outward was visible by viewing the chain-link fence from end on. Next 2 photos.
