**Second Five -Year Review Report
for
Old Springfield Landfill Superfund Site
Springfield, Vermont**

September 2003

**United States Environmental Protection Agency
Region 1
Boston, Massachusetts**

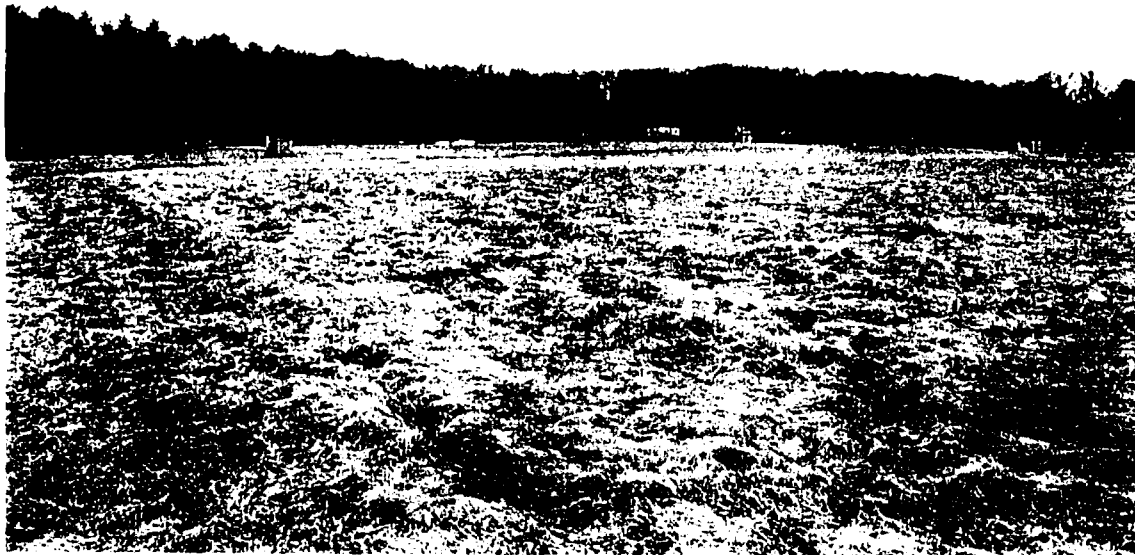
Photo 1: Landfill cover over waste area No. 4, facing south.

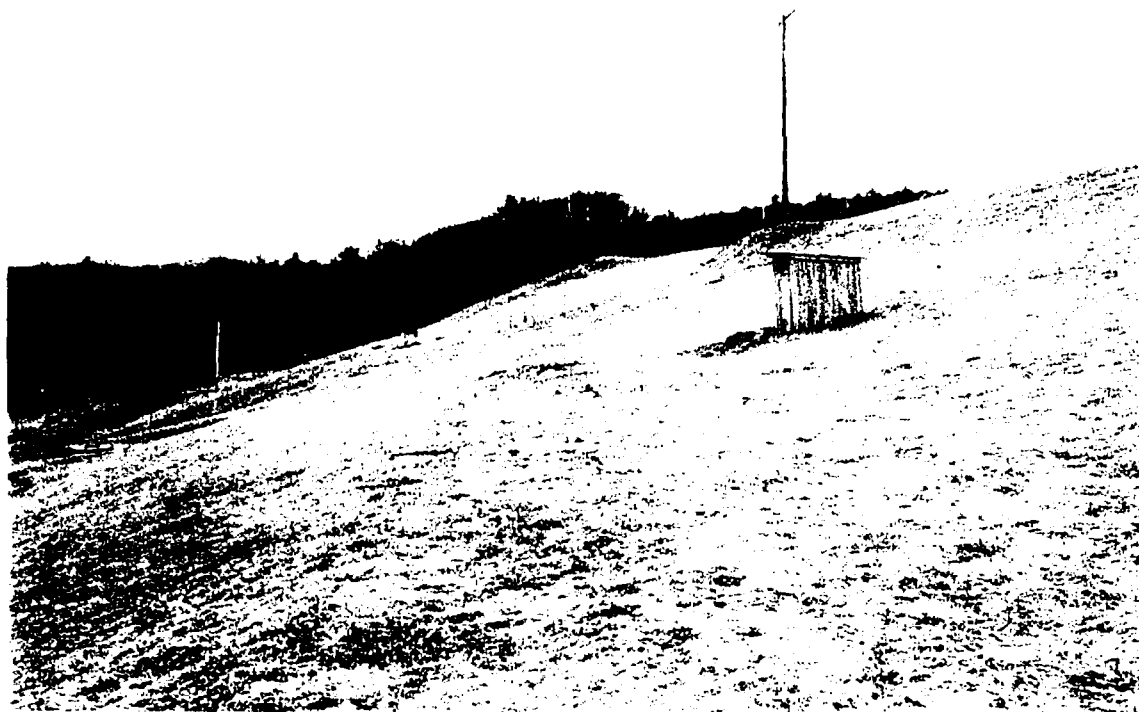
Photo 2: Landfill slope on east side of waste area No. 2, facing southeast.

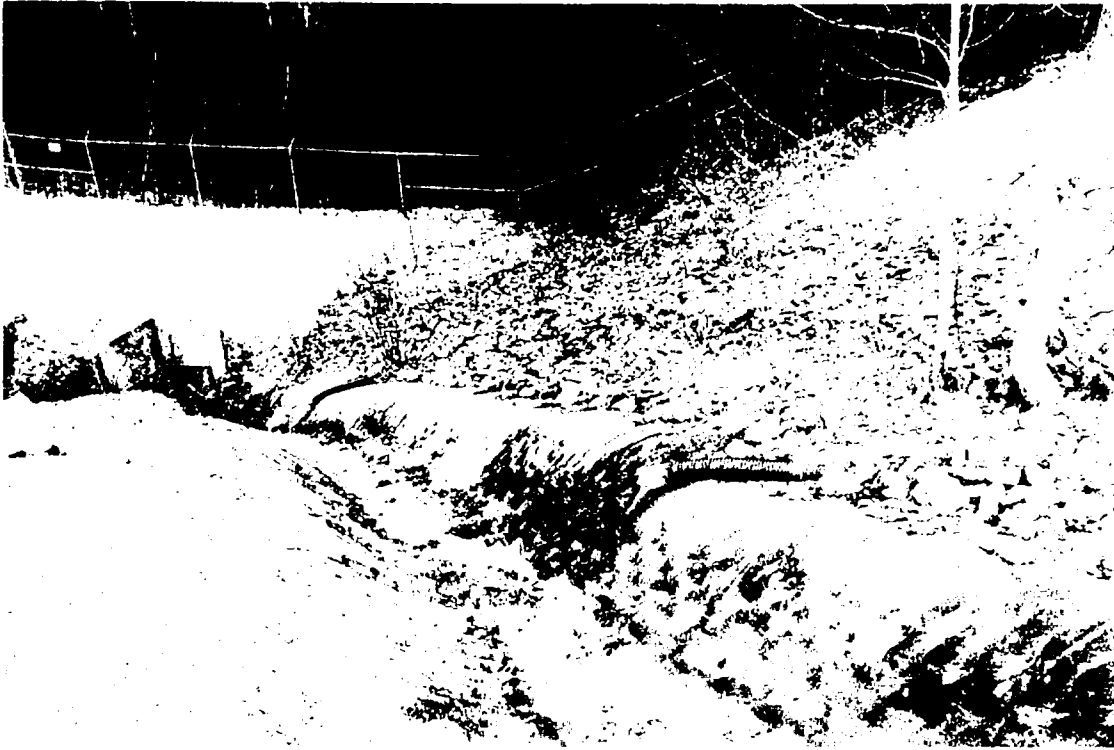
Photo 3: South Fabri-Form ditch at slope repair area.

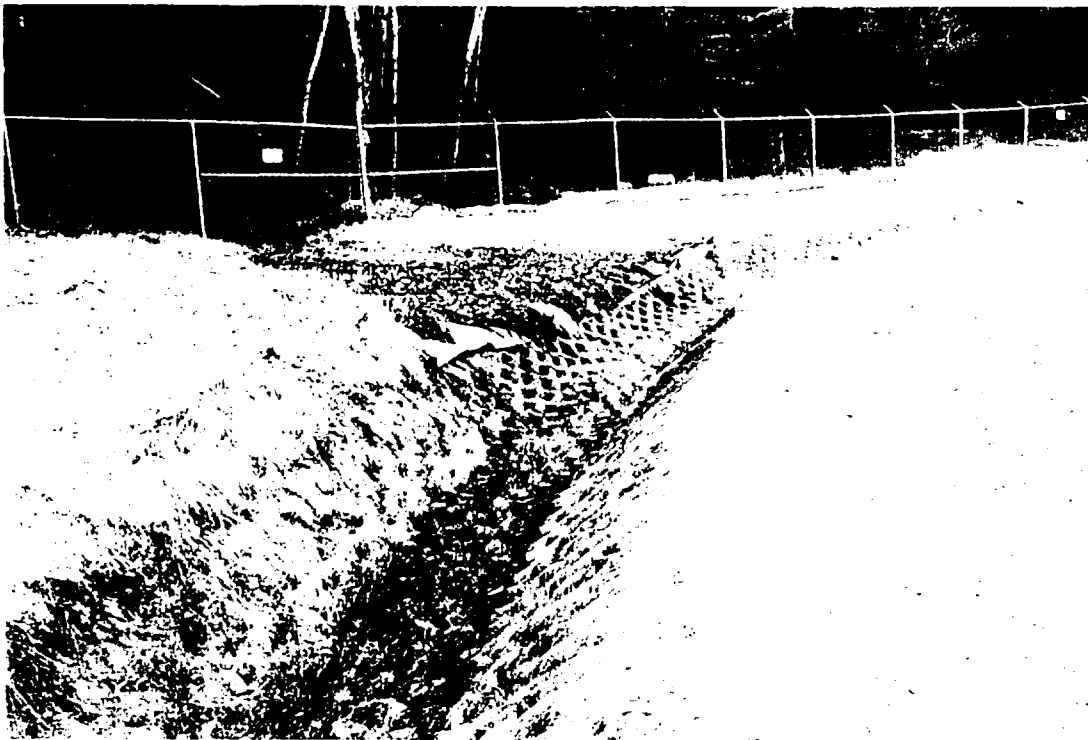
Photo 4: South Fabri-Form ditch at top of landfill/south end of waste area No. 4.

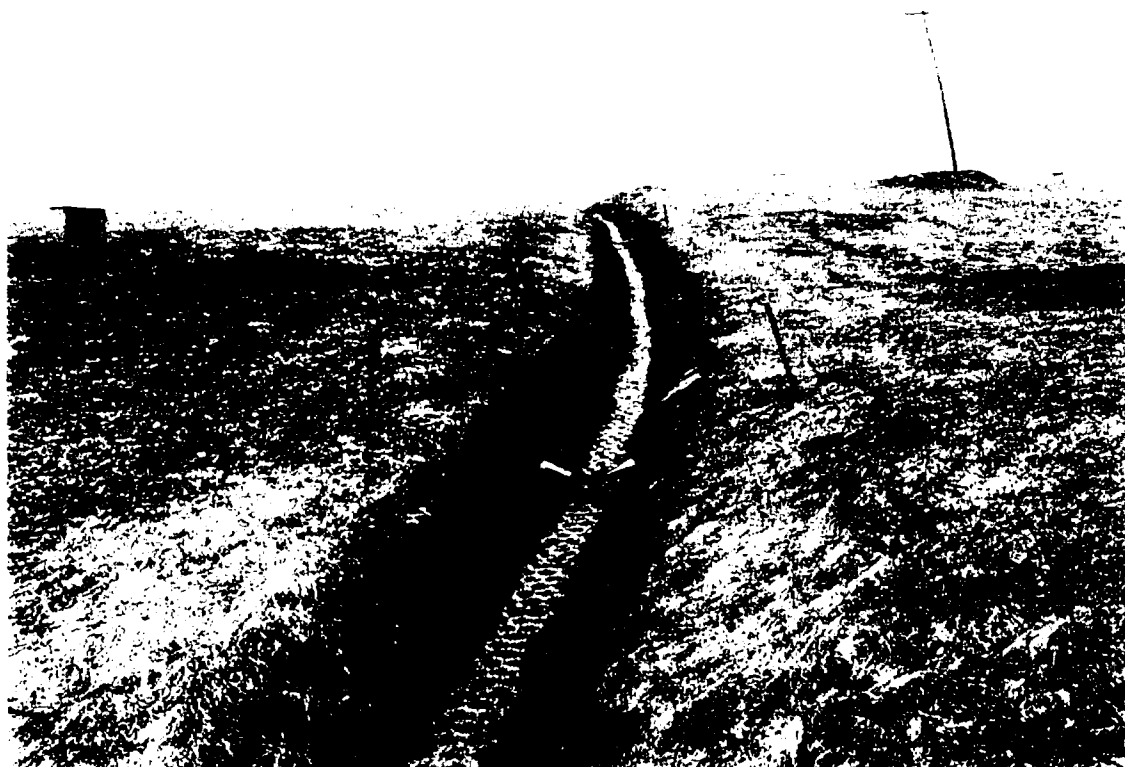
Photo 5: Middle Fabri-Form ditch, facing west.

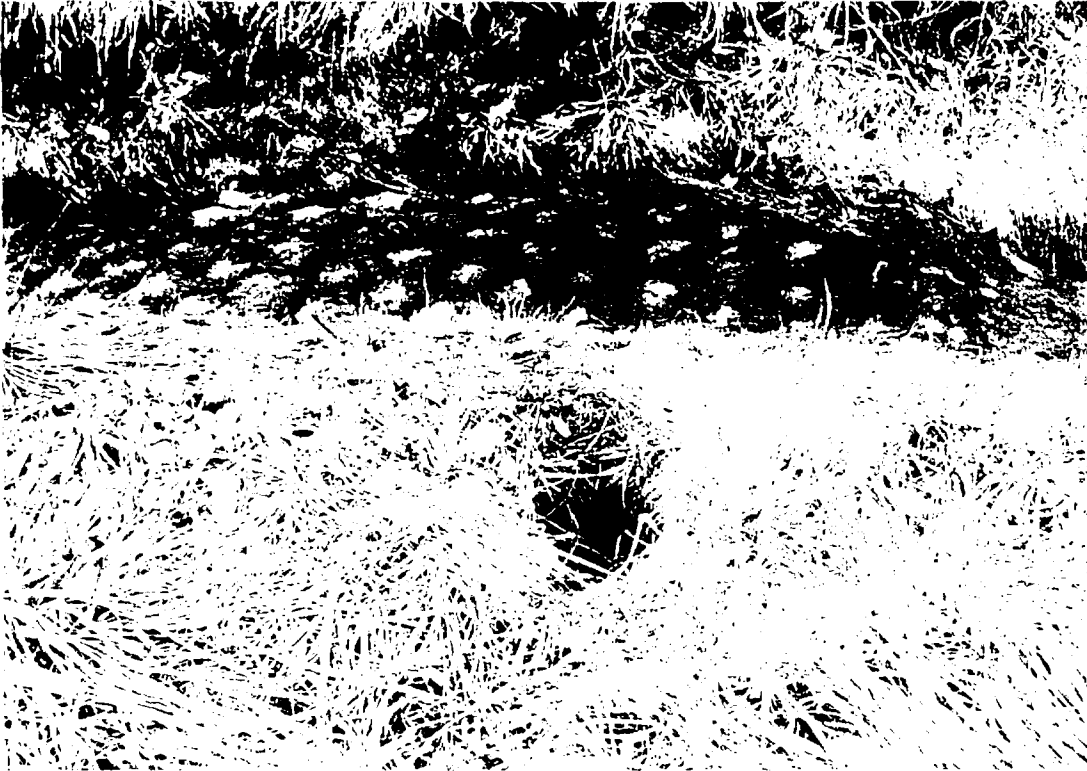
Photo 7: Cavity next to south Fabri-Form ditch near crack in ditch.

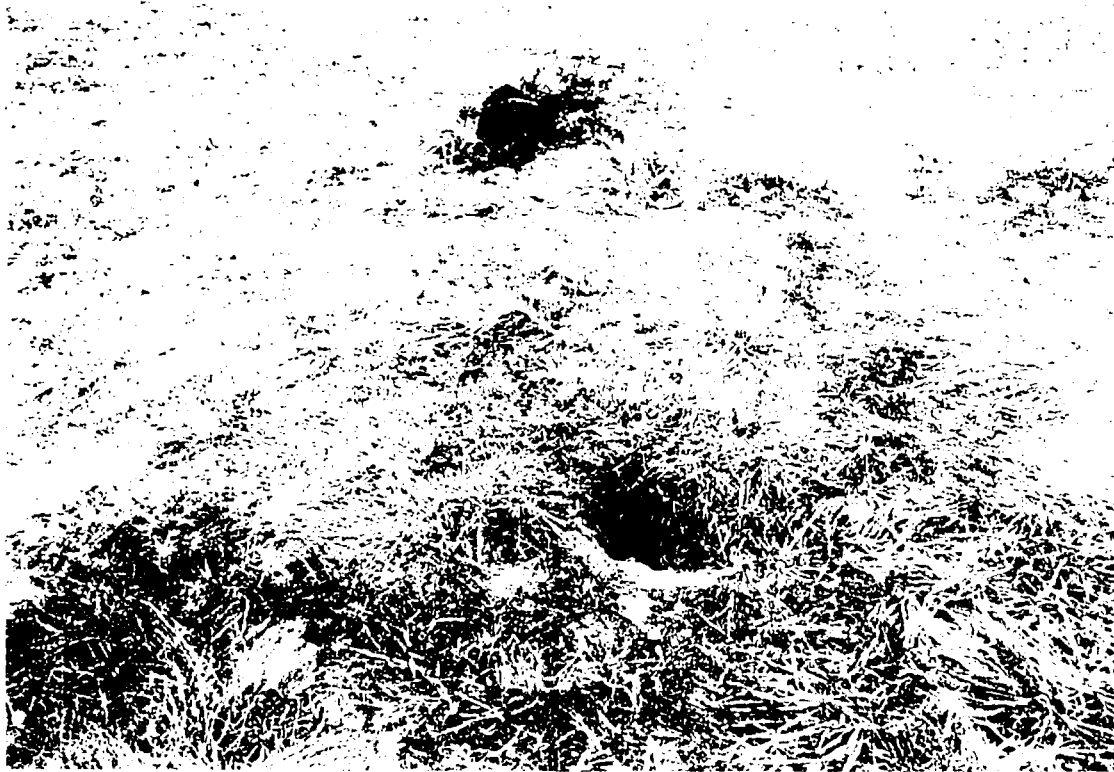
- **Landfill surface** -- The landfill surface was generally in good condition with some rodent holes on Waste Areas 3 and 4.
- **Fabri-Form Channels**-- Overall, the three Fabri-Form channels were observed to be in good condition. A slight separation was observed at a seam in the Fabri-Form material in the southern channel. A cavity was present in the soils next to the seam, where runoff was entering the cavity from off the cap. Repair of the channel was recommended to prevent further degradation of the Fabri-Form channel.
- **Cover penetrations** -- In general the gas vents and gas vent sheds were in good condition with no signs of operational issues. However, rodent damage, including mounded soil and displaced insulation, was observed in many of the sheds. TRC

Photo 9: Animal burrow in northwest portion of waste area No. 4.

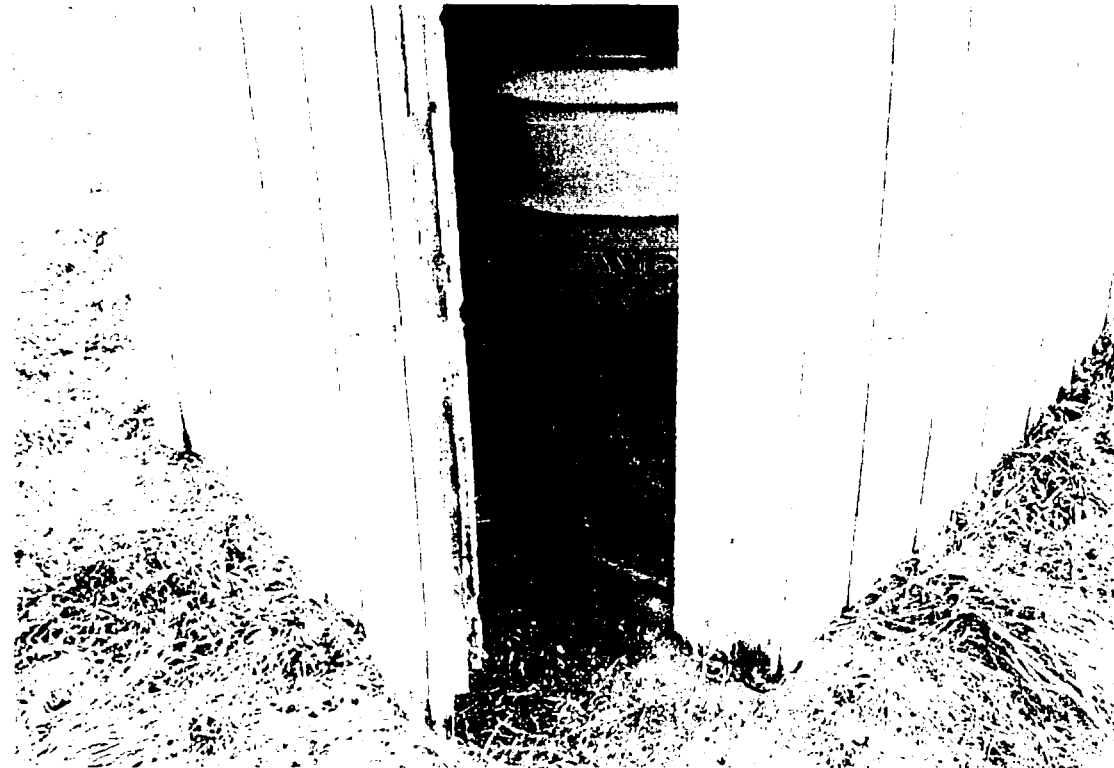
Photo 10: Gas vent shed with 1-foot deep soil inside (from gopher) on waste area No. 2.

recommended removal of the mounded soils and continued rodent control measures. The O&M staff indicated that they planned to install concrete floors in the gas vent sheds in the next year. This should not affect the performance of the gas vents.

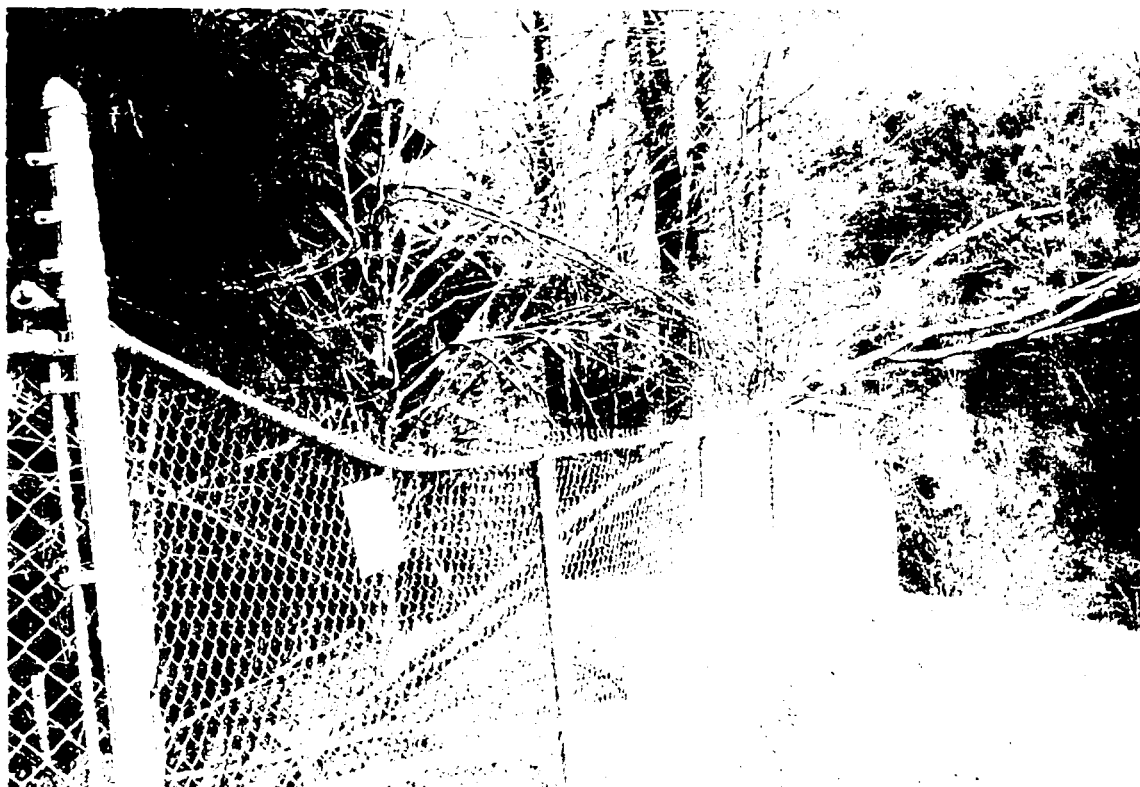
Photo 13: Damaged barbed wire fence near north Fabri-Form ditch, east of Gate C.
