**Re: Biennial Structural Integrity Assessment (April 2006)
Quarterly Inspection Report (April 2006)
Woods Pond Dam, Housatonic River, Lee/Lenox, MA**

Woods Pond Dam Quarterly Inspection – April 27, 2006
Crest of Spillway Looking West to East

2005 STRUCTURAL INTEGRITY ASSESSMENT

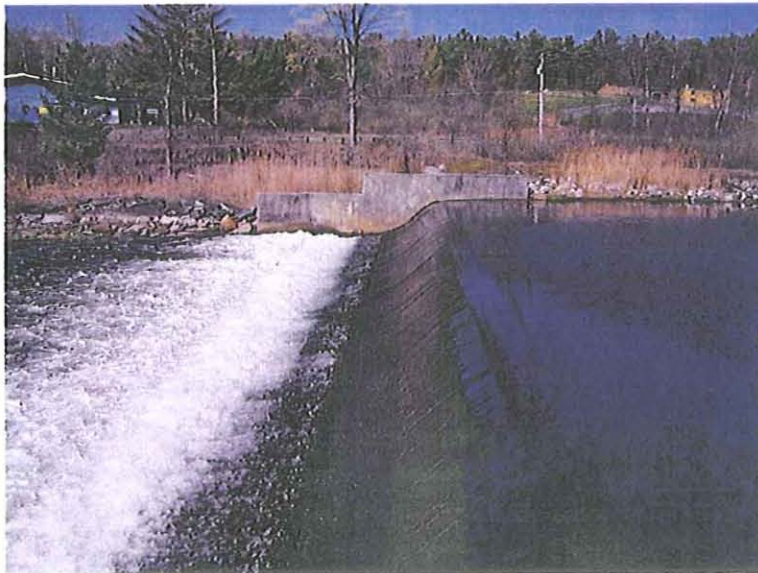
Woods Pond Dam Quarterly Inspection – April 27, 2006
Crest of Spillway Looking East to West

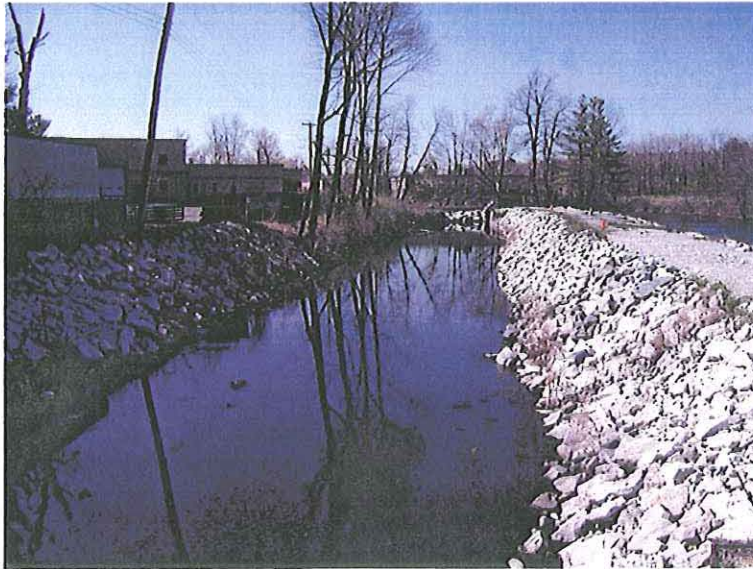
Woods Pond Dam Quarterly Inspection – April 27, 2006
Raceway Channel Looking Downstream

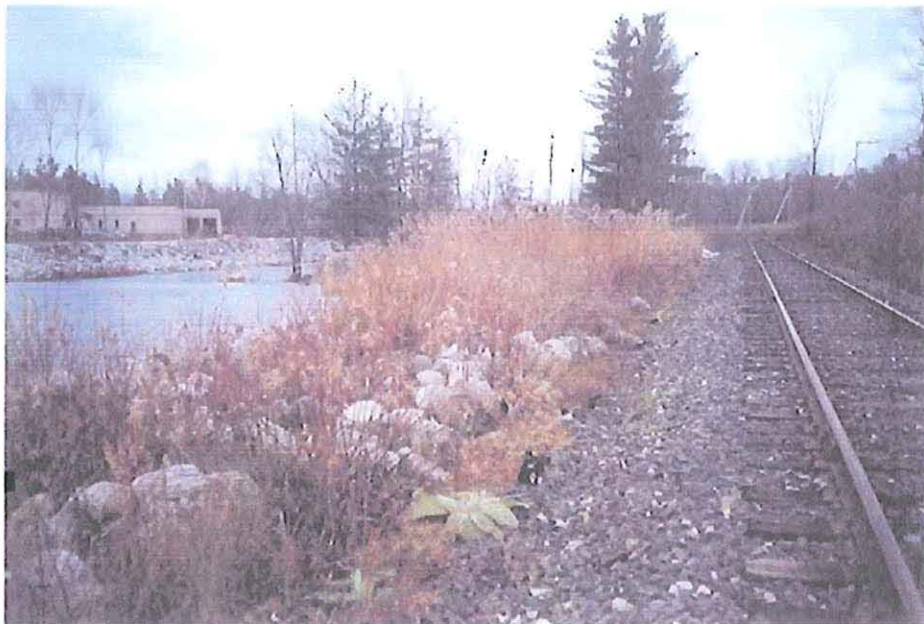
The west (right) abutment consists of a training wall adjacent to the spillway, which extends upstream and downstream of the spillway crest, and a mass concrete gravity section that ends at the railroad tracks at a sheetpile wall. The abutment was observed to be in good condition. No signs of differential movement of the concrete gravity monoliths, areas of visible spalling, significant cracking, erosion, exposed reinforcement, or other signs of deterioration on the visible portions of the upstream face, crest, downstream face, or riverside face were observed. The joints above ground were observed to be in good condition. A few small cracks that have been observed in the past three inspections in the top of the right training wall at the right abutment do not appear to have changed. The riprap along the west embankment, both upstream and downstream of the spillway, appeared to be in good condition with no scour or undermining of the riprap observed (Photo 3).

Photo 3 Riprap protection along right bank upstream of overflow spillway; railroad at right abutment. Viewed from the right bank upstream of the overflow spillway.

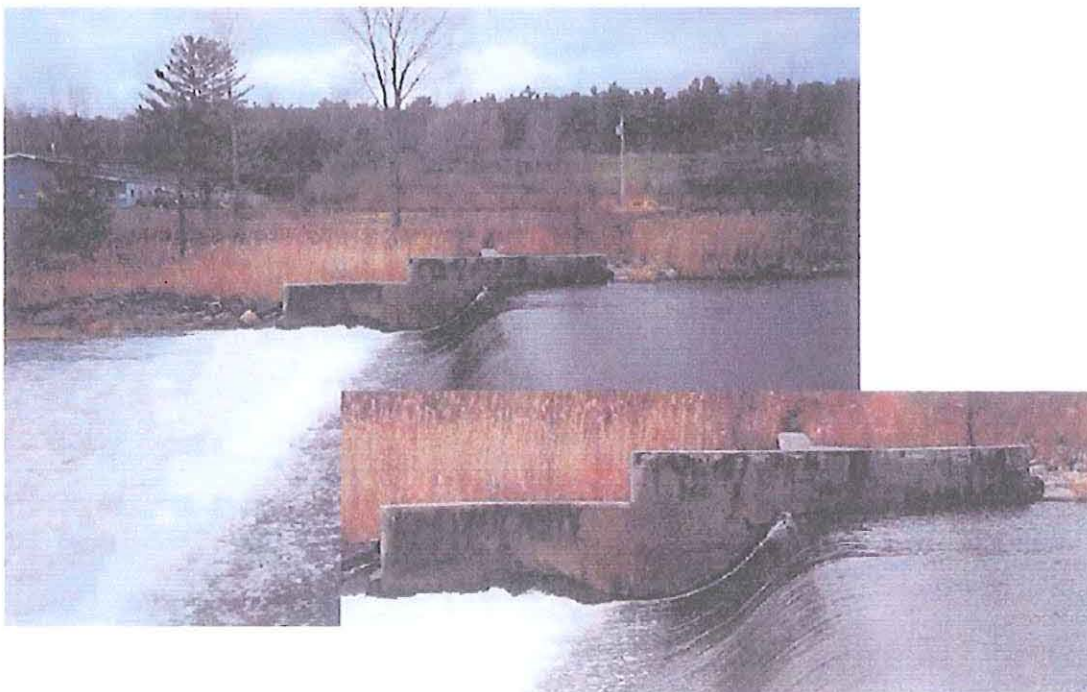
The training wall at the end of the overflow spillway is in good condition with no large cracks or significant deterioration or signs of movement or undermining observed (Photo 4). Some deterioration and rust-colored stains have been noted near the base of the training wall downstream of the spillway crest. The concrete in this area should continue to be monitored for signs of deterioration or rusting reinforcing steel.

Photo 4 View of right training wall from raceway closure structure

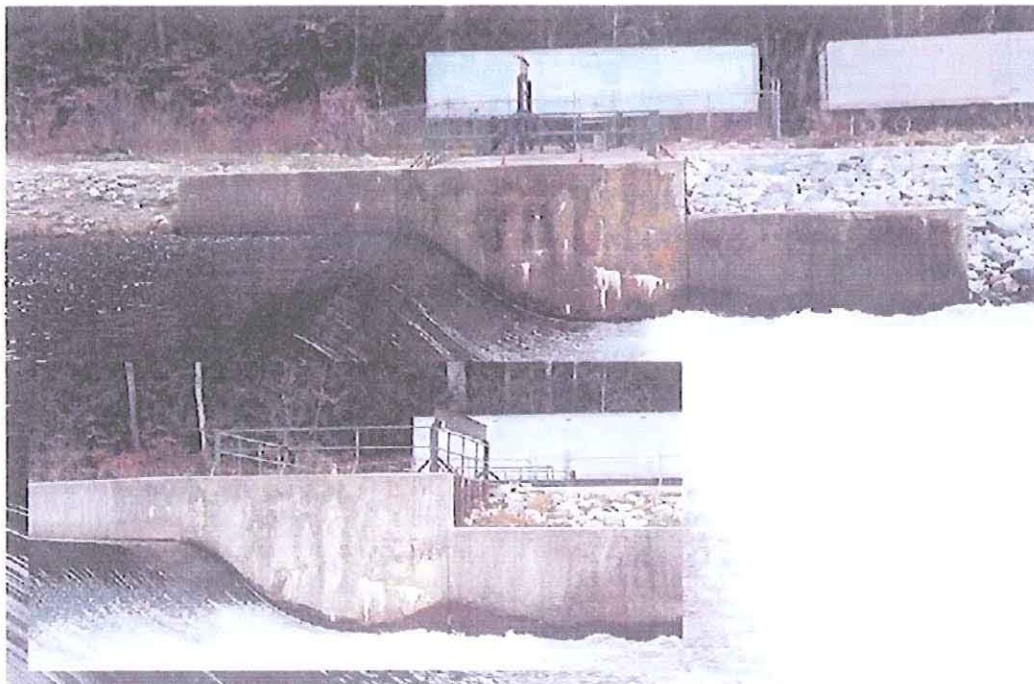
The minor cracking in the concrete facing on the left spillway training wall, just downstream of the crest of the spillway, has not changed or worsened from previous inspections (Photo 6). This concrete is a facing on the steel sheet pile and is not critical to the integrity of the water retaining structures, but helps with the approach hydraulics and smooths flow over the spillway at the abutment interface. The cracks have no structural integrity significance. The concrete cap between the sheetpiles is in good condition (Photo 7). The joints have been cleaned and refilled, and are holding up well. The steel sheetpile is in good condition with no indication of bowing or interlock distress in any of the piles or of loss of fill from within the sheetpile.

Photo 6 View of overflow spillway and left concrete training wall from right training wall. Inset is photo taken in 2004 for comparison.

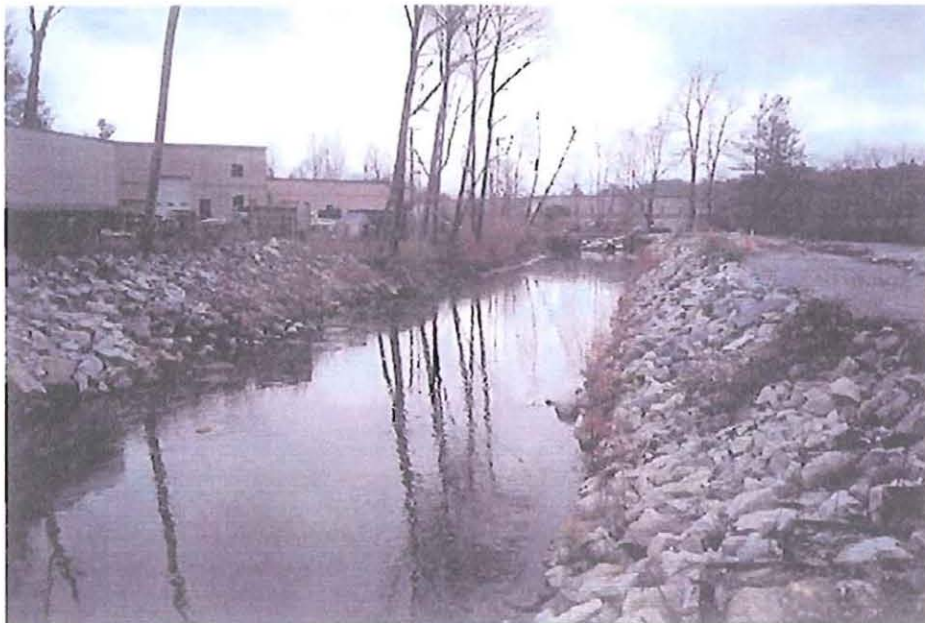
Photo 8 View of raceway channel from raceway closure structure looking downstream; thin layer of ice on water.

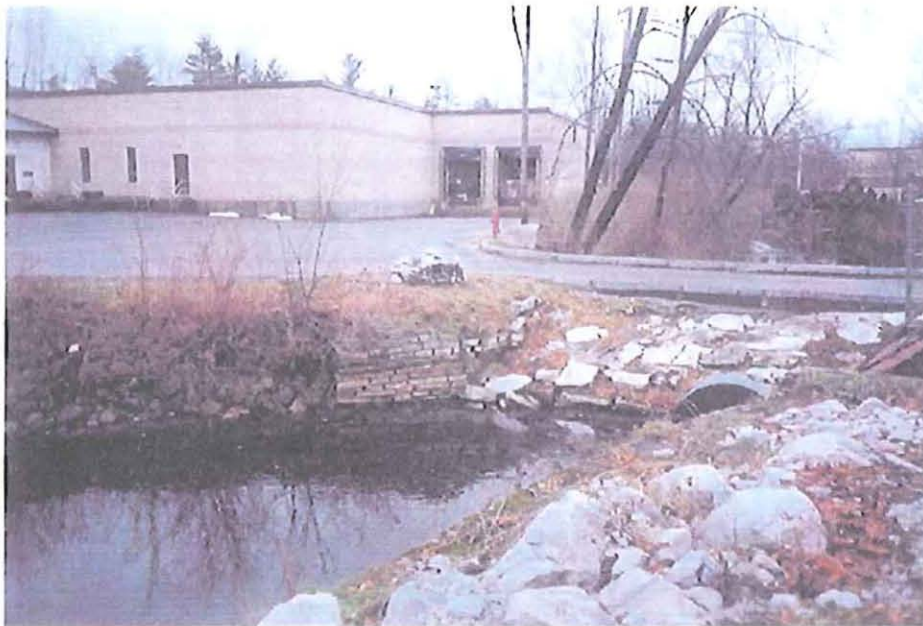
then back up water in the channel so that it might overtop the embankment. The masonry wall on the left side of the culvert at the end of the raceway channel was observed to be leaning outward (Photo 9) more than during the last inspection. This masonry wall does not serve any dam safety or water retaining function, so its condition is not relevant to the structural integrity of the dam.

Photo 9 View of downstream end of raceway channel from crest of raceway embankment.

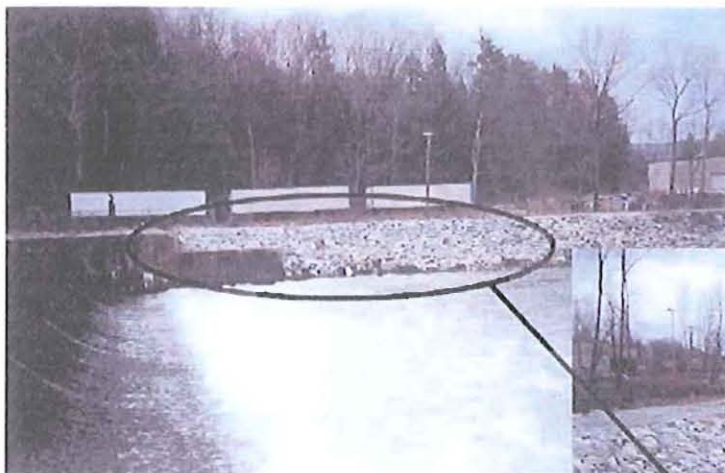
Photo 10a View of riverside of raceway embankment from downstream toe of right (west) training wall. Note newly riprapped area.

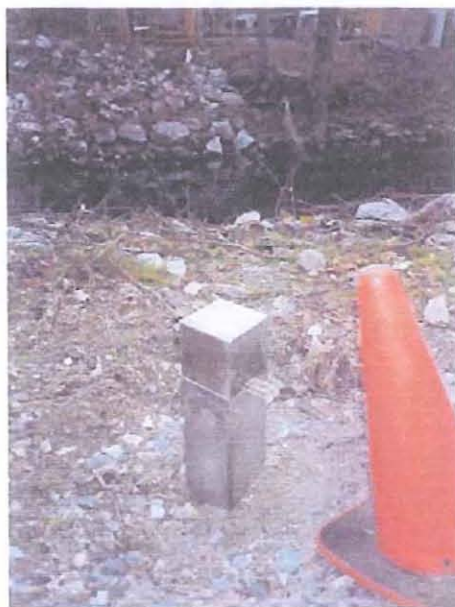
The three piezometers installed along the crest are marked with orange traffic cones. The locking caps for the piezometers were damaged during the recent riprap placement activity and therefore new locking caps were placed with additional visible identification (Photo 12). The newly repaired piezometers have been resurveyed to provide for accurate piezometer readings. Readings from these instruments are currently taken quarterly and are discussed further in Section 4.0. Based on discussions between GE and MWH, the frequency of the readings will be increased to a monthly basis.

Photo 12 Orange cone identifying piezometer locations on crest.

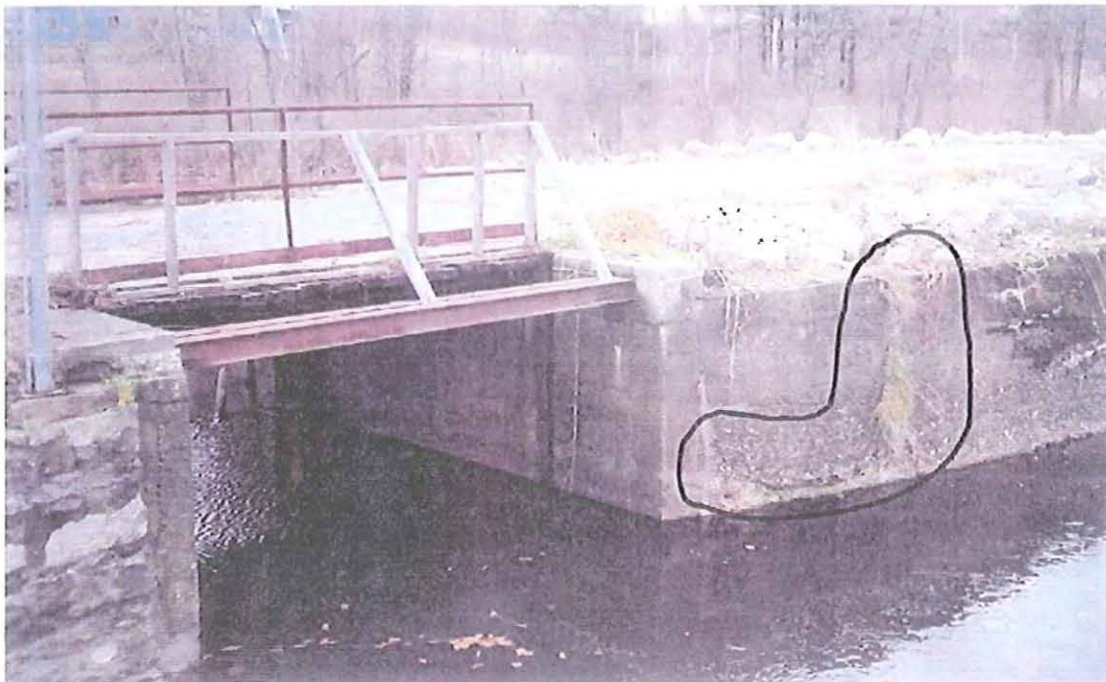
Photo 14 Upstream face of raceway stoplog sluice structure. Note damage at waterline and vertical crack (with vegetation) on right wall.

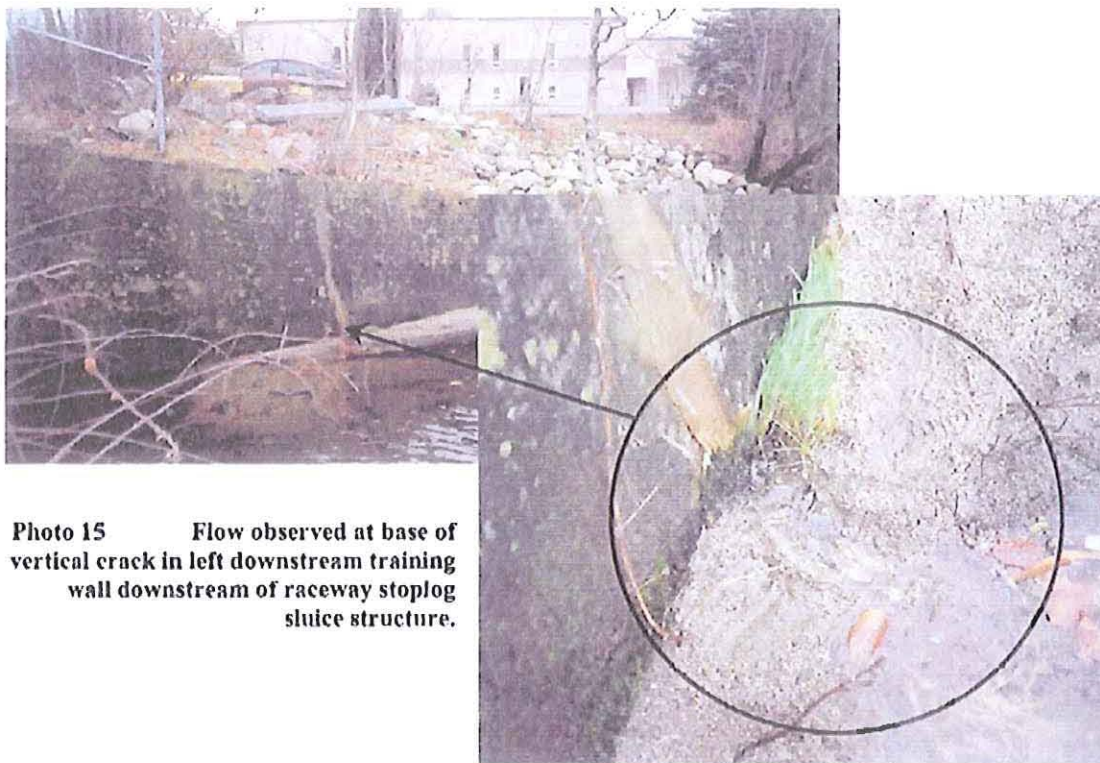
Photo 15 Flow observed at base of vertical crack in left downstream training wall downstream of raceway stoplog sluice structure.
