CHARLES GEORGE LAND RECLAMATION TRUST LANDFILL ADMINISTRATIVE RECORD

EBASCO SERVICES INCORPORATED

INTERIM TECHNICAL MEMORANDUM  
EVALUATION OF  
CHARLES GEORGE LANDFILL SETTLEMENT  
CHARLES GEORGE LAND RECLAMATION  
TRUST LANDFILL SITE  
TYNGBOROUGH, MASSACHUSETTS  
NOVEMBER 1988

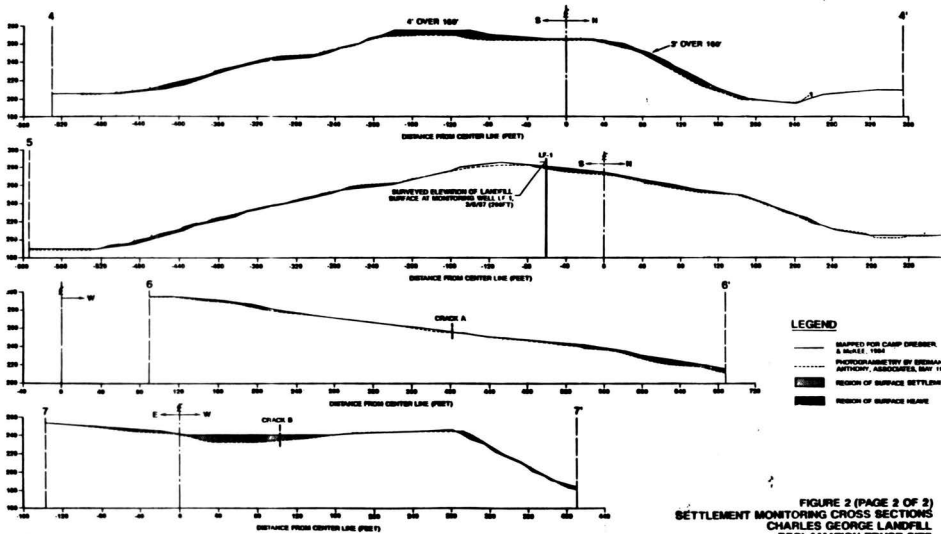
FIGURE 2 (PAGE 2 OF 2)  
 SETTLEMENT MONITORING CROSS SECTIONS  
 CHARLES GEORGE LANDFILL  
 RECLAMATION TRUST SITE  
 TYNGSBOROUGH, MASSACHUSETTS  
 E.C. JORDAN CO.

Indications of landfill settlement were evident at each of the selected cross sections. The upper, flat portion of Section 1-1' shows that the landfill may have experienced up to 6 feet of settlement between 1984 and 1987 (see Figure 2). Cracks, which may be the result of landfill settlement, were observed in this area in April 1988. The sloped section indicates approximately 2 to 4 feet of heave, which suggests that the eastern slope may be bulging due to settlement of the top of the landfill surface.

The upper, northeastern slope of Section 2-2' displays settlement on the order of 6 to 8 feet. The middle and lower slope areas also show some settlement. The top and southern slopes of the landfill in this section appear to be stable. The surface around Monitoring Well LF-2 also appears to have been relatively stable; however, the 18 inches of exposed concrete seal observed at this well in December 1987 suggests that landfill settlement is occurring in this area as well.

The upper northern slope of Section 3-3' shows approximately 2 to 4 feet of settlement. The lower northern slope and the southern slope show some settlement and heave, respectively.

Section 4-4' indicates that between 6 and 8 feet of settlement occurred at the top of the landfill. The northern slope shows settlement; the southern slope indicates heave similar to Section 3-3'.

Between 2 and 4 feet of settlement is indicated at the top and upper northern slope of Section 5-5'; the southern slope appears to have heaved approximately 2 feet. Settlement in the vicinity of monitoring well LF-1 is approximately 2 to 3 feet, suggesting that the 15 inches of exposed concrete seal observed during the site visits were caused by settlement of the landfill around the well.

Section 6-6' is generally stable with some indication of settlement in the upper and lower slopes, on the order of 2 feet. Settlement may have also occurred in the vicinity of the large crack (denoted as A-A') in the western slope. This crack was not observed until after the May 1987 survey; therefore, considerable surface deformation could have occurred since the 1987 photogrammetry.

Finally, Section 7-7' indicates approximately 6 to 8 feet of settlement in the vicinity of a landfill crack along the western slope (denoted as B-B'). The section also shows 2 to 4 feet of heave on the western slope.

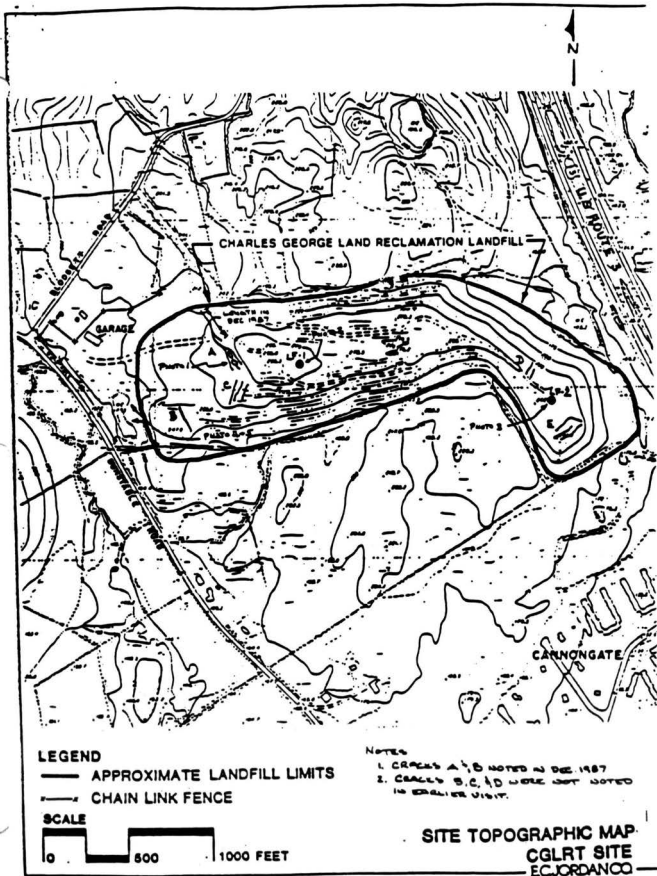
3. Additional cracks were noted at the locations shown on Figure 1. The cracks in general were only 2 to 3 inches in depth and perhaps 0.5 to 1 inch wide. Their orientation on the landfill surface appeared to be largely random, and it could not be determined whether or not they were related to a sliding stability problem. For instance, there were a number of cracks oriented at right angles to the center axis of the landfill. The cracking observed seemed to be limited to the relatively level portions of the landfill surface. Inspection of the steeper side slopes on the north side did not reveal the presence of cracking or any other obvious signs of instability.

1. CRACKS A, B NOTED IN DEC 1987
2. CRACKS C, D WERE NOT NOTED IN ORIGINAL VISIT.

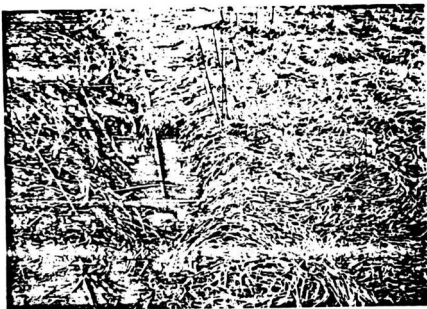
1. The crack denoted A-A (Figure 1) at the west end of the landfill has lengthened and appears to have branched off into more than one crack. The width and depth of the original portion of the crack are generally the same. Two large holes were observed at the southern end of the enlarged crack (see Photograph 1). The holes were about 2 feet wide, 3 feet long, and 3 feet and greater in depth. At least one of the holes appeared to extend laterally below the surface and away from the entry point. Considerable gas venting was noted at the cracks and holes. Smoke was also seen. The odor at this end of the landfill seemed to be much worse than elsewhere.
2. Crack B-B, which was noted during the December 1987 site visit, did not appear to be any larger.

PHOTOGRAPH 1: HOLE OBSERVED AT THE SOUTHERN END OF CRACK A-A  
APRIL 7, 1988

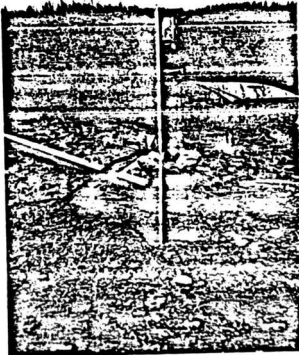
4. The conditions at monitoring wells LF-1 and LF-2 do not appear to have worsened (Photographs 2 and 3).
5. Gas venting was noted at other locations on the landfill. It is our perception that the gas venting/odor was strongest in the areas where cracks were observed. Gas was observed bubbling through puddles of water on top of the landfill.

PHOTOGRAPH 2:  
EXPOSED CONCRETE SEAL AT MONITORING WELL LF-1

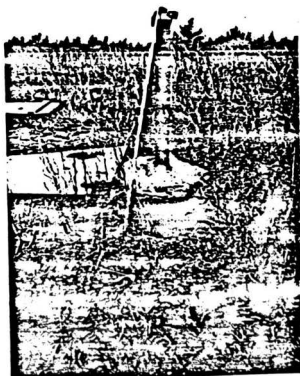
PHOTOGRAPH 3:  
EXPOSED CONCRETE SEAL AT MONITORING WELL LF
