**Failure Mode and Effect Analysis at
Ely Copper Mine Superfund Site**

SLR Ref: 117.00975.00002

June 2016

Nobis Engineering, Inc.

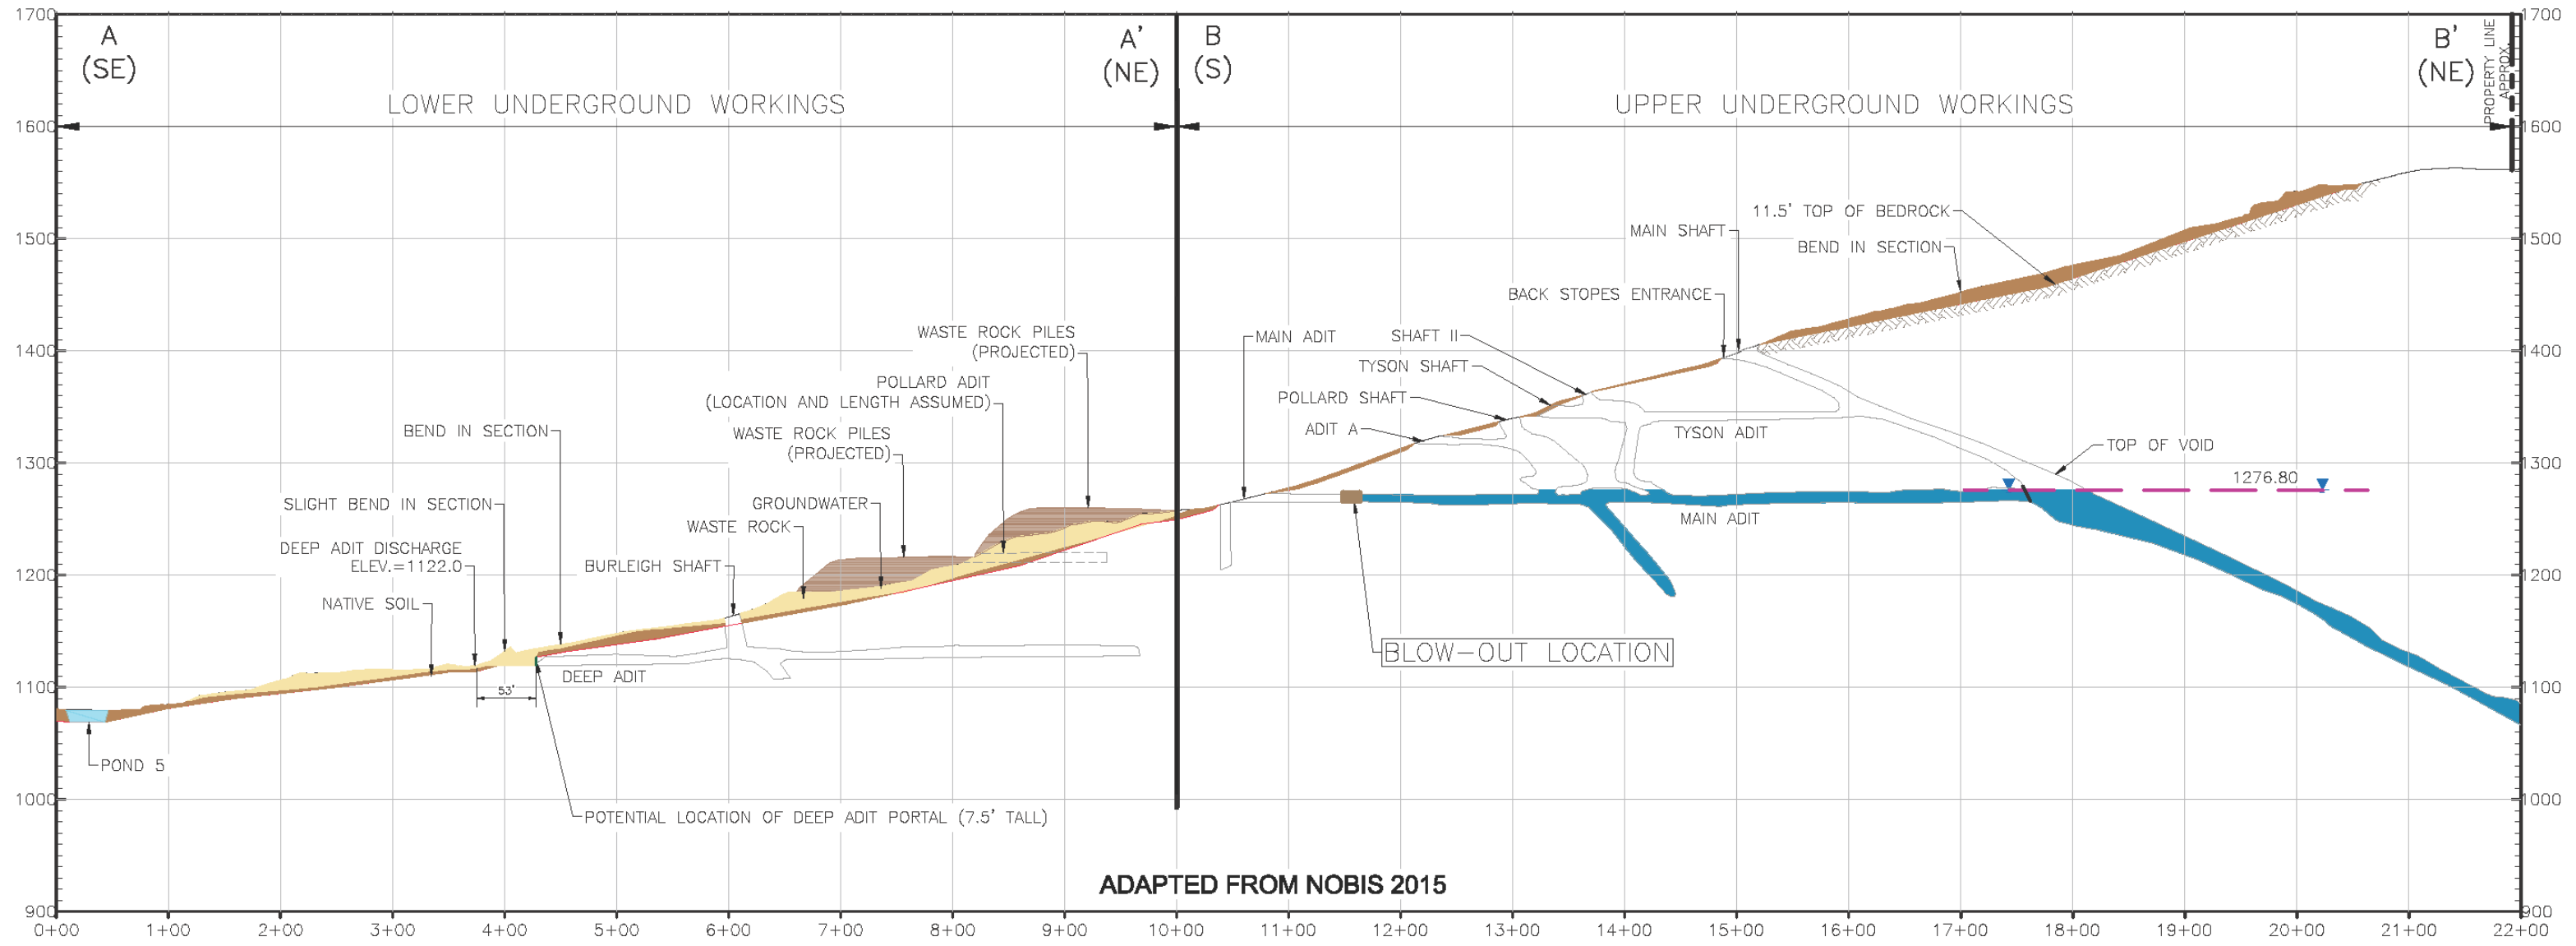
Figure 6-1: Failure Mode 1 Diagram

1. Main Adit is blocked (regardless of cause)
2. Water accumulates behind blockage (Figure 6-1), and the following can happen:
 - a. Blockage fails as soon as the Main Adit is full. The amount of water released is at most the volume stored in the Main Adit or approximately 225,000 gallons (Table 4-4). However, the pressure head applied to the blockage is only 7 ft (height of adit). Such a low pressure head is not likely to displace the amount of material needed to block the adit (which needs to be at least 6 ft wide by 7 ft tall (dimensions of the adit) by say 2 to 3 ft thick) or a volume of 84 to 126 ft³, or approximately 5 to 8 tons of material.

This is Failure Mode 1 on Table 6-1 and is depicted on Figure 6-1.

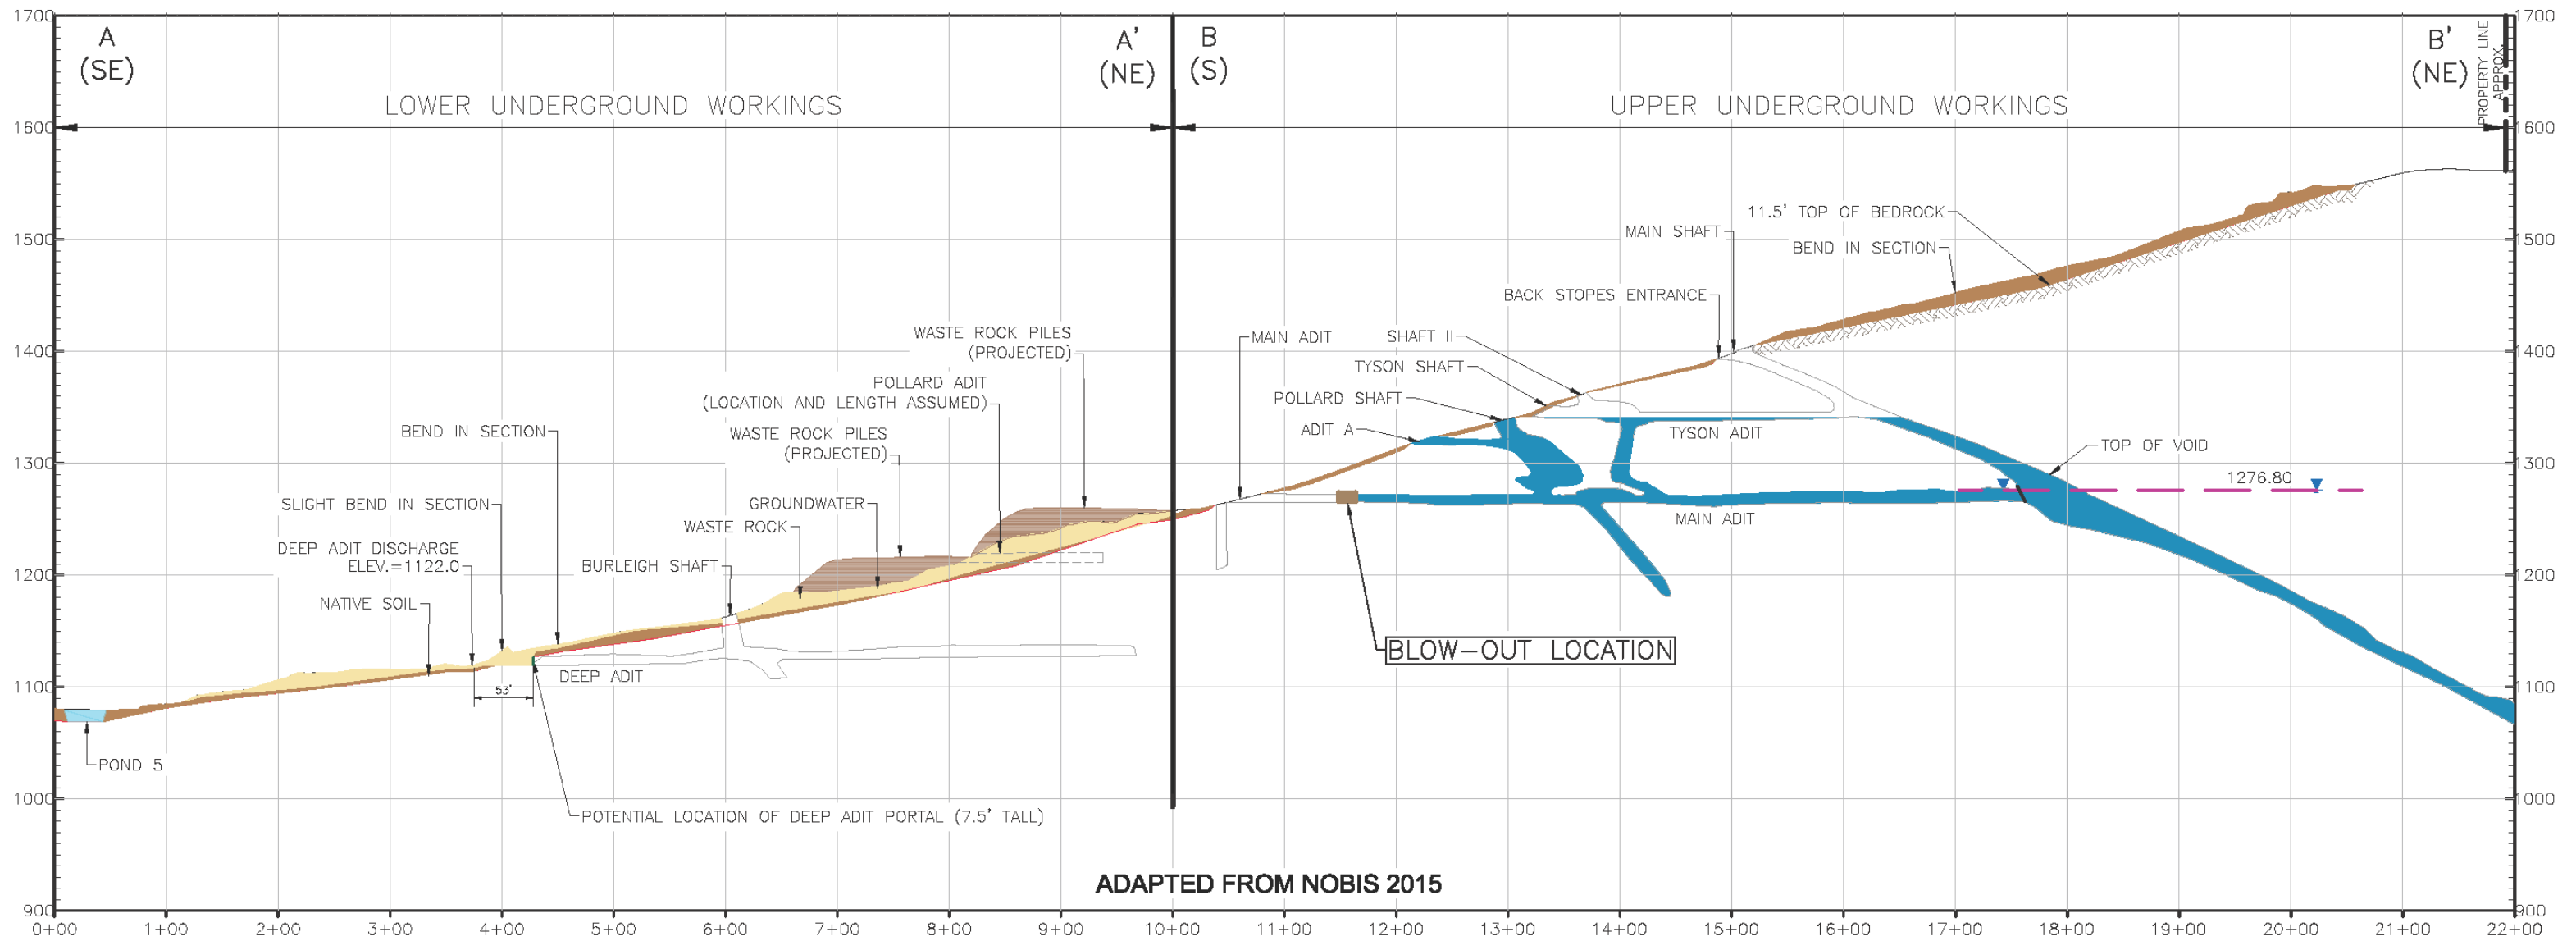
Figure 6-2: Failure Mode 1a Diagram

- b. Blockage fails when water has filled up the Main Adit and because Adit A is blocked, the water rises in the Pollard Shaft, Shaft II, and the Main Shaft to the elevation of either the Pollard Shaft or Shaft II. This is the maximum elevation since these two shafts are open, and water reaching that elevation will seep out. This elevation is on the order of 70 ft.

This is Failure Mode 1a on Table 6-1 and is depicted on Figure 6-2.

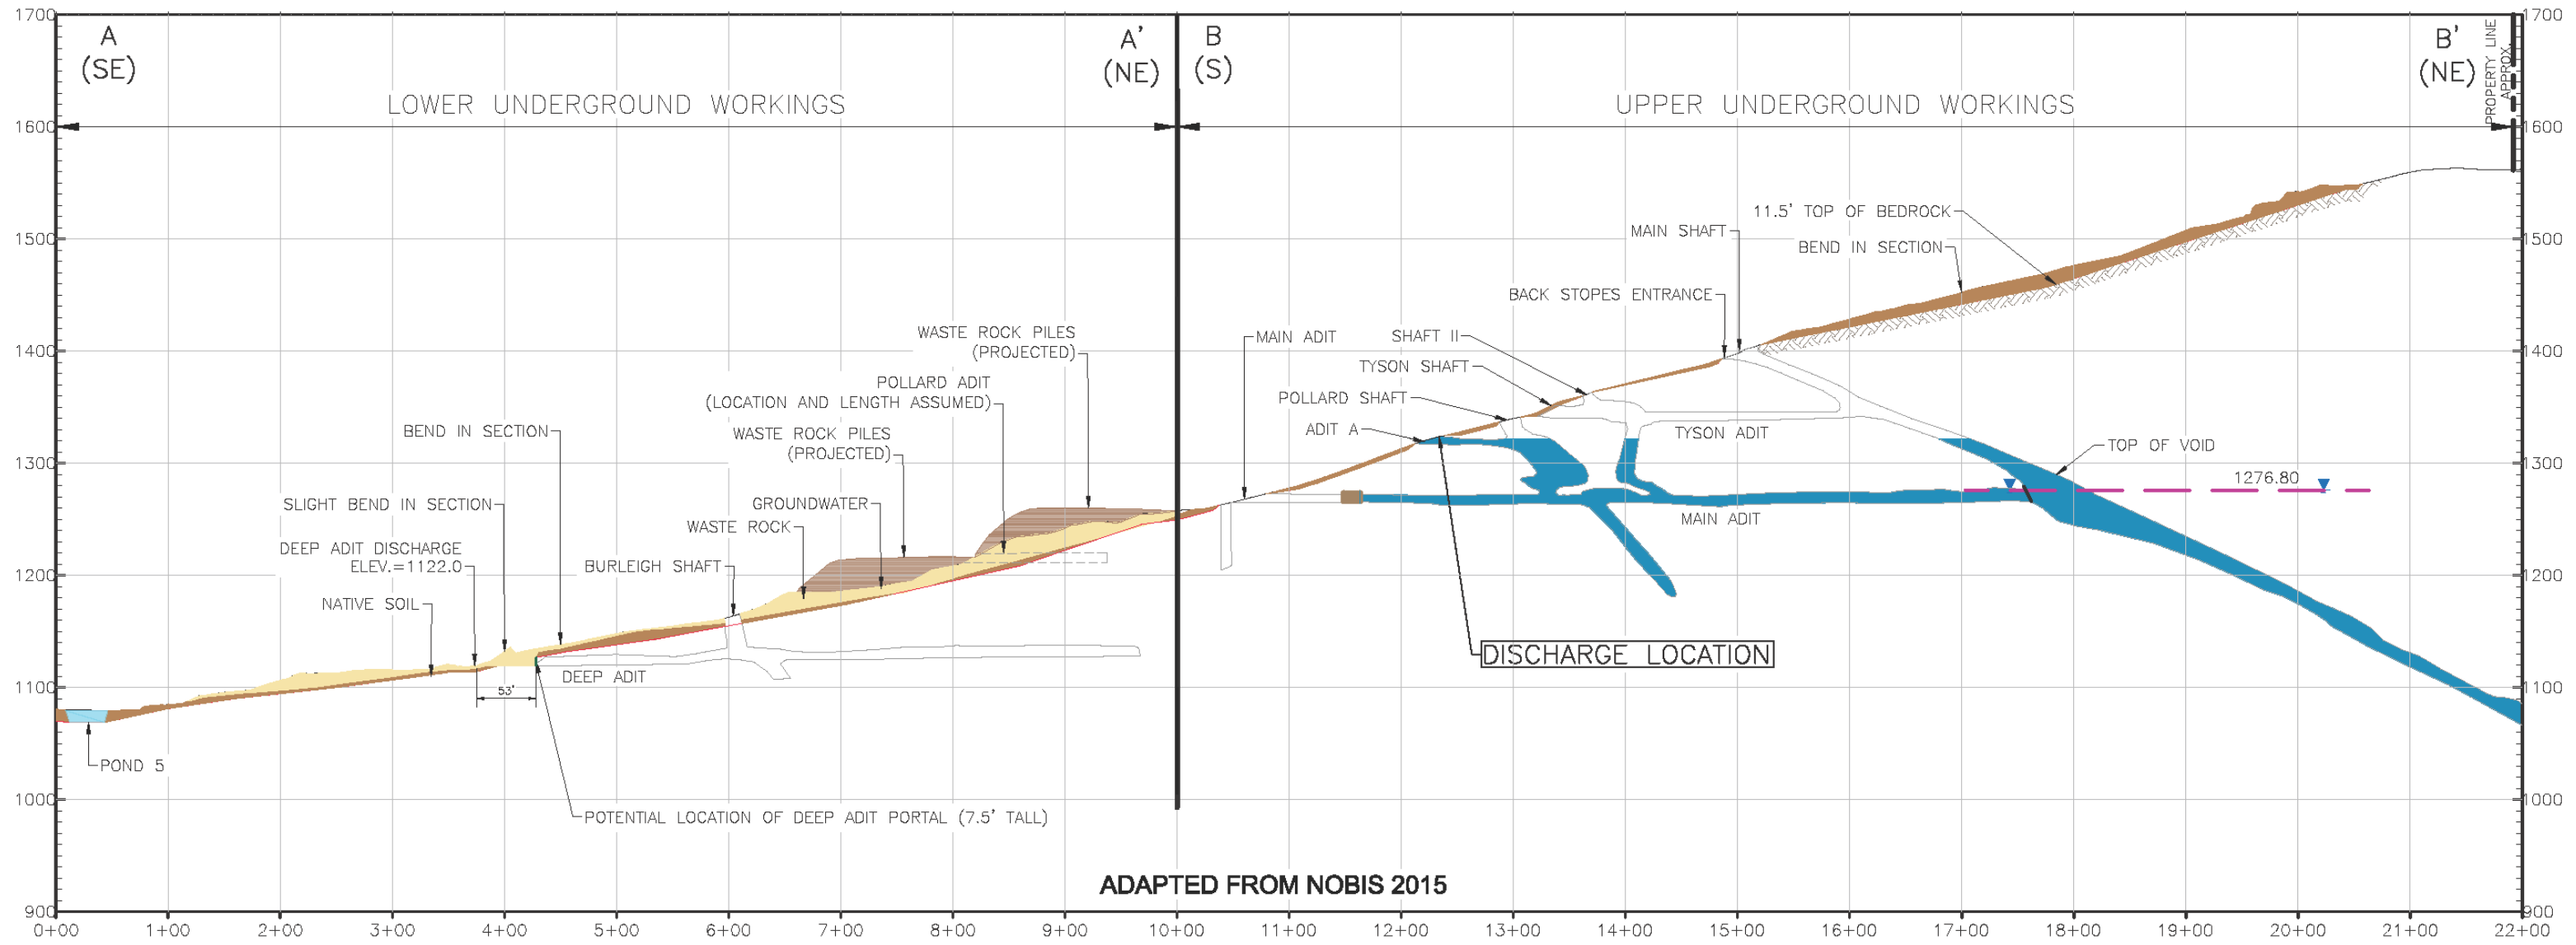
Figure 6-3: Failure Mode 2 Diagram

This is Failure Mode 2 on Table 6-1 and is depicted on Figure 6-3.

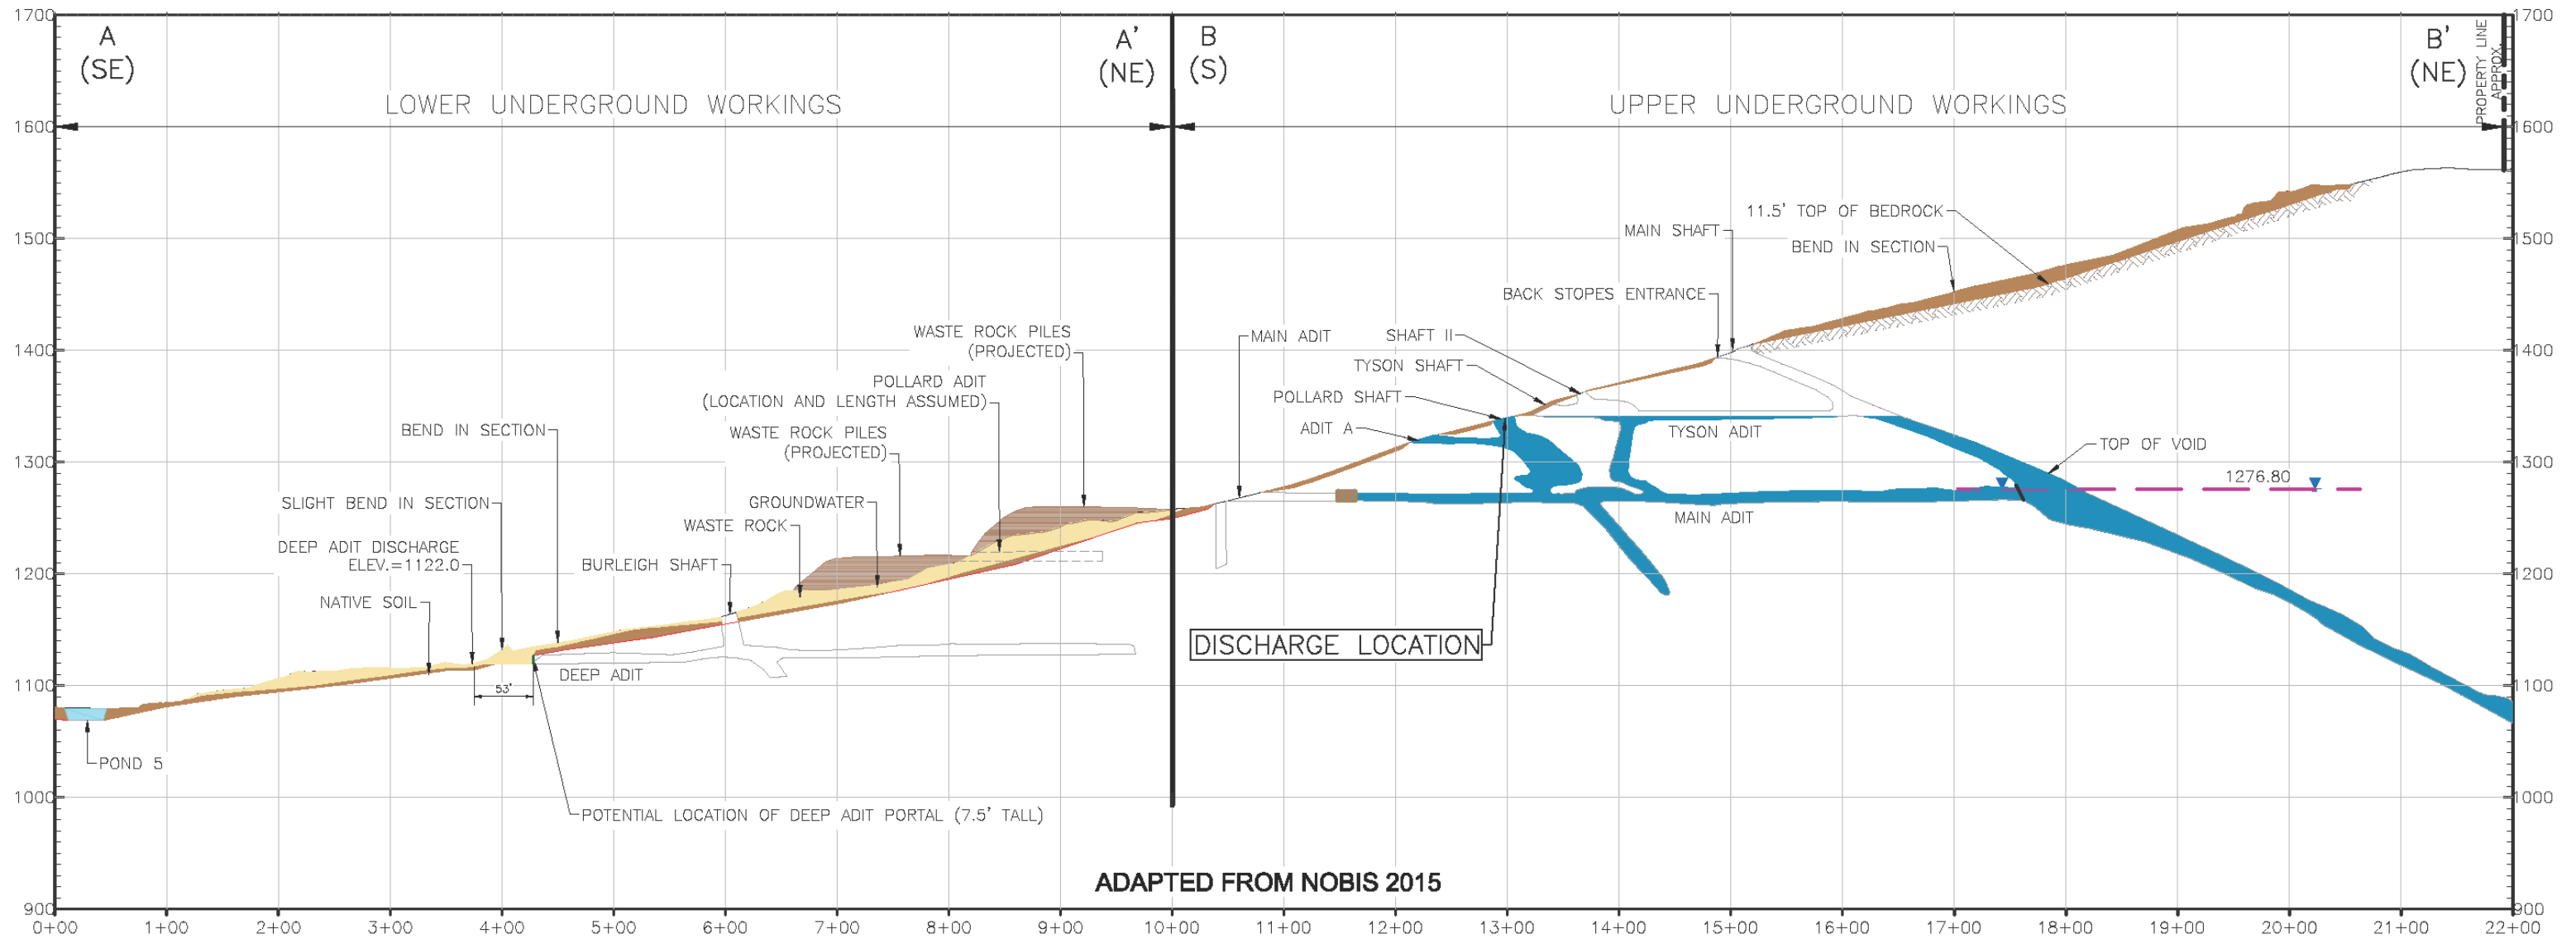
Figure 6-4: Failure Mode 4 Diagram

This is Failure Mode 4 on Table 6-1 and is depicted on Figure 6-4.

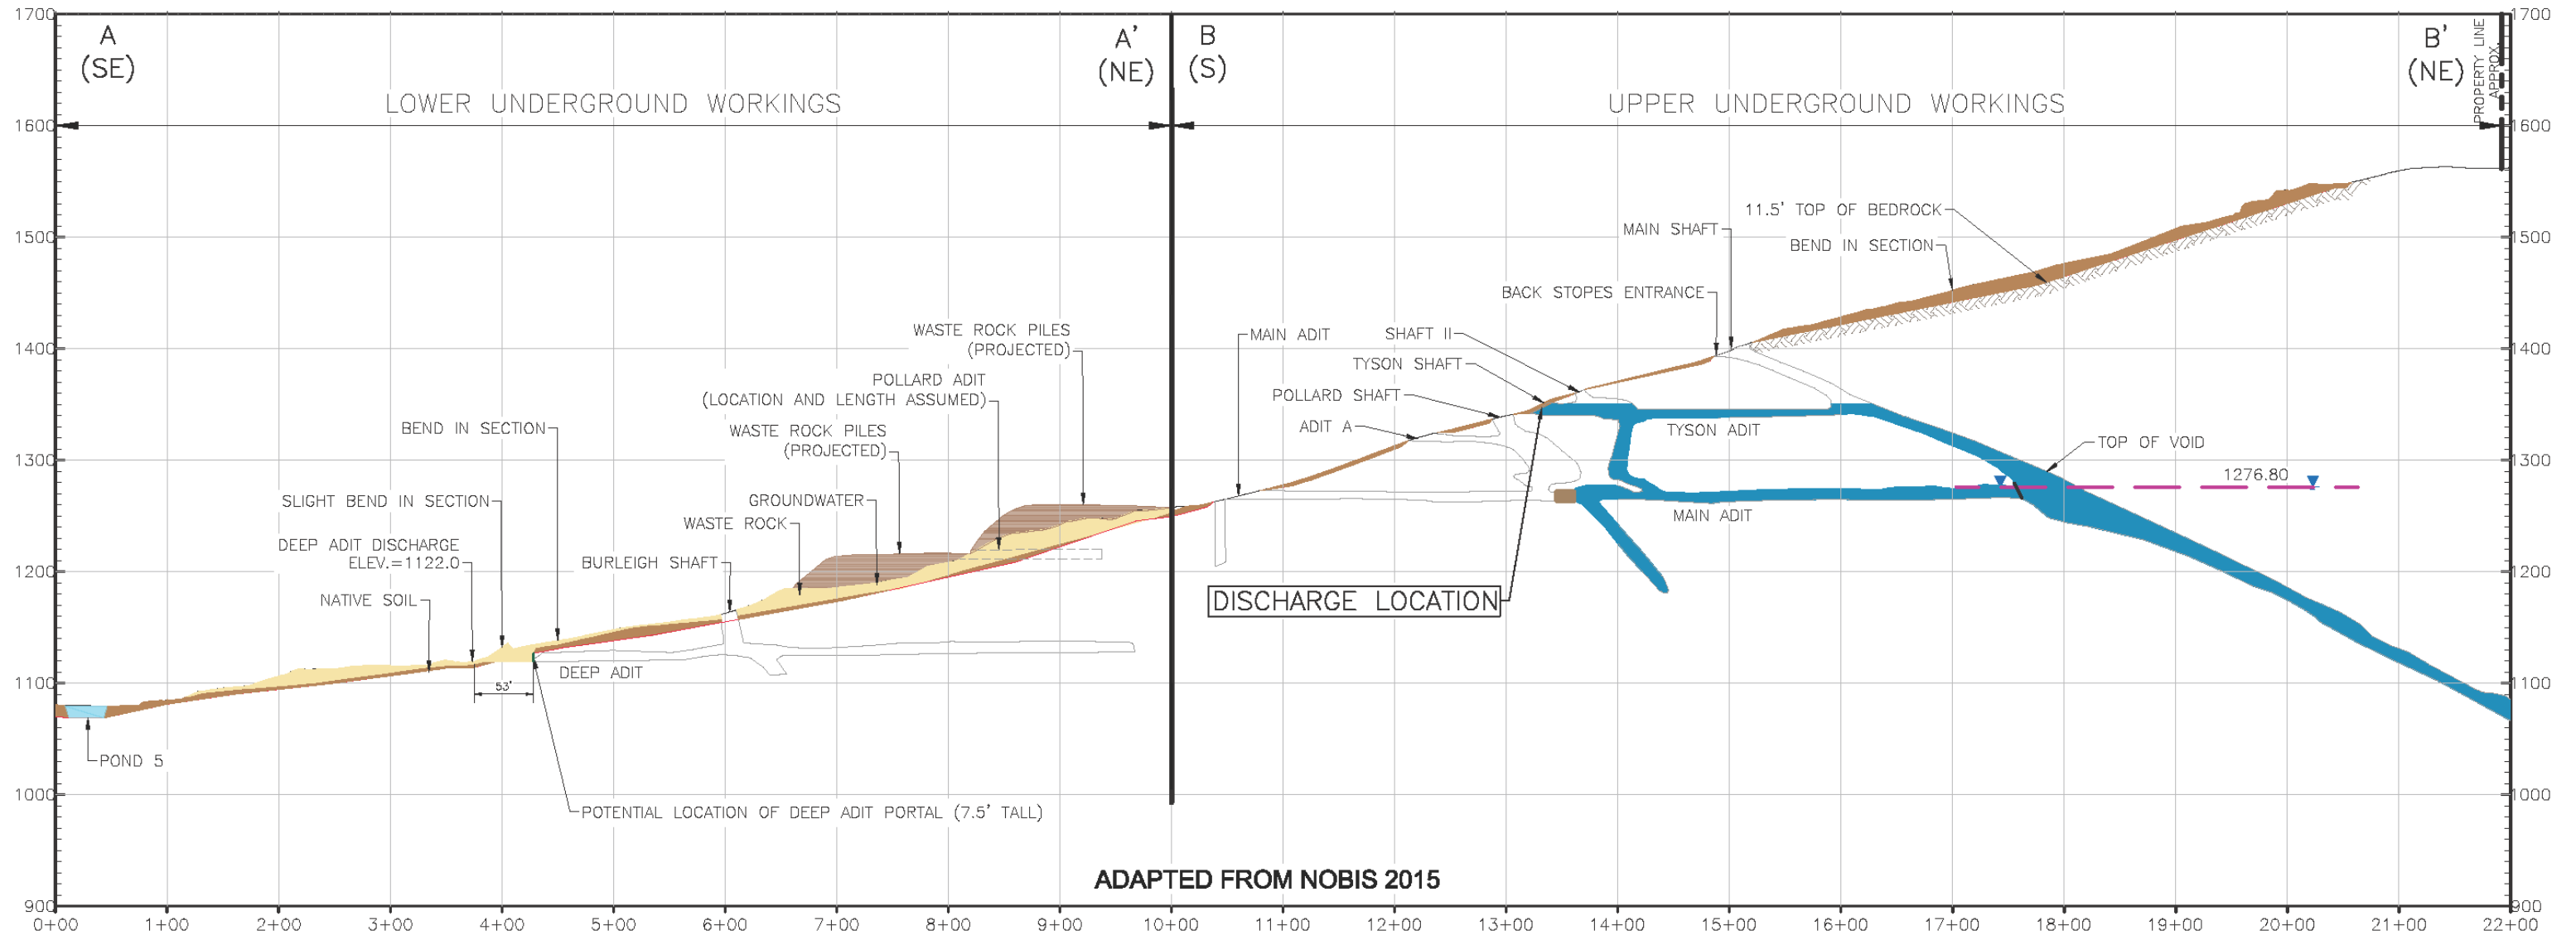
Figure 6-5: Failure Mode 3 Diagram

The location of the blockage within the adit can also affect the failure type, resulting in the development of numerous failure scenarios. Figures 6-5 through 6-9 show the schematics of the other failure modes identified at the UUGW and listed in Table 6-1.

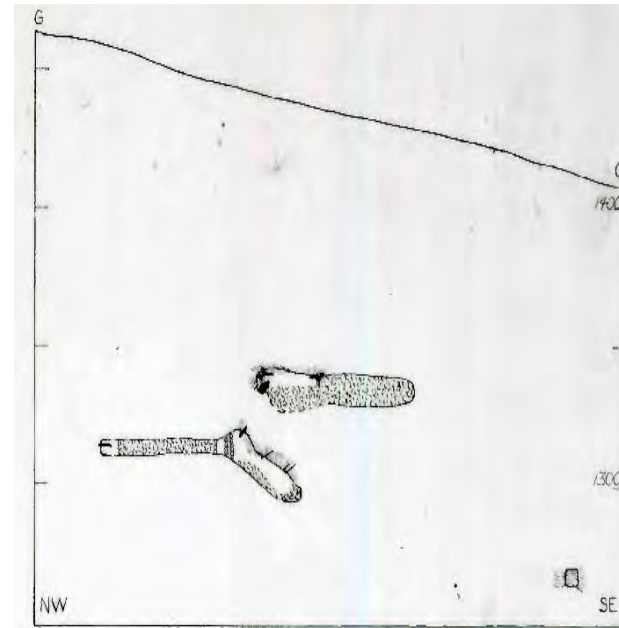
Section G-G

Figure 2: Selection of Cross-sections prepared by White, 1944 showing extend of collapsed ground in the north eastern part of the upper workings.
