# First Five-Year Review Report

Callahan Mine Superfund Site

Brooksville, Maine

April 2016

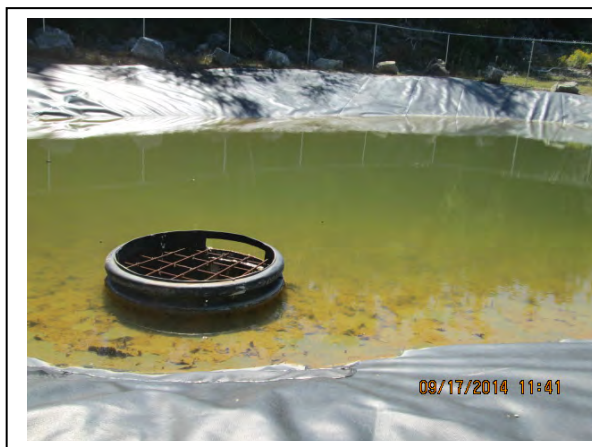
Stormwater pond outlet structure at Mine Ops Area

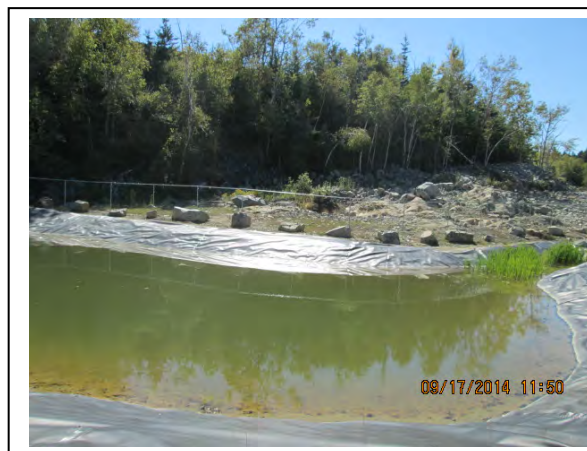
Stormwater pond inlet at Mine Ops Area

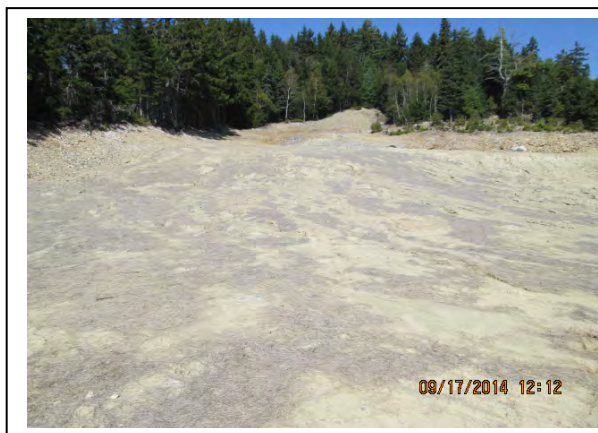
Ore pad surface, view looking north

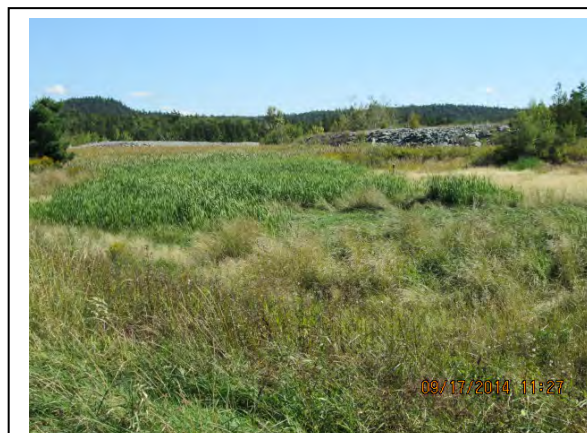
Vegetation re-establishing at Stink Cove borrow area

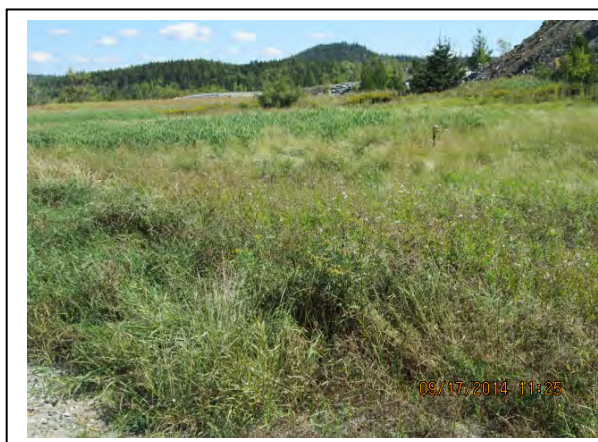
Vegetation re-establishing at Stink Cove borrow area

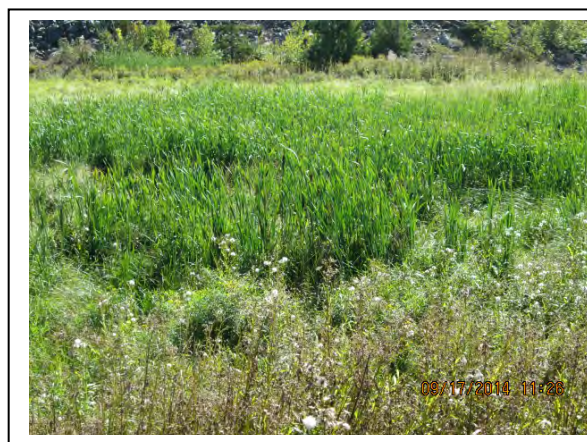
Vegetation re-establishing at Stink Cove borrow area

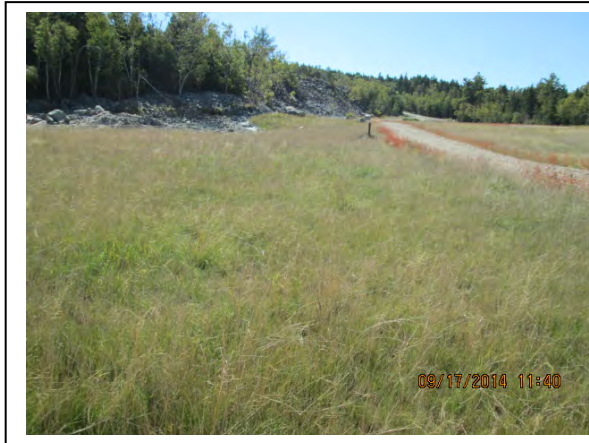
Grass growth in former Zone 3 work area

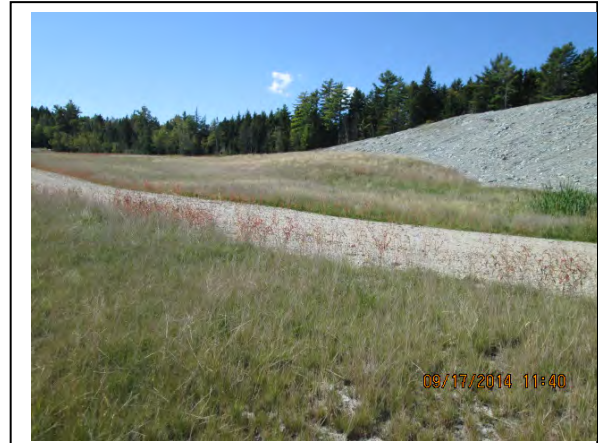
Grass growth in former Zone 4 work area

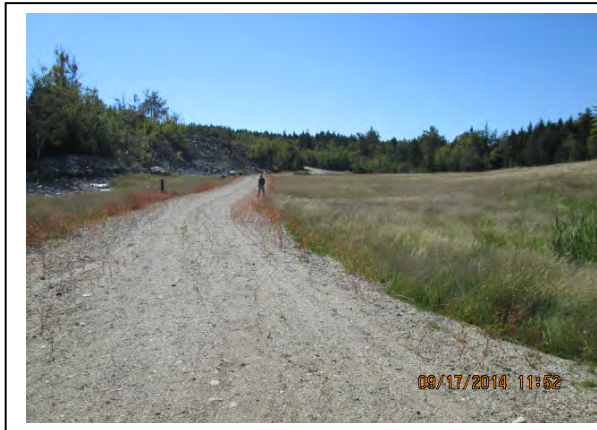
Access road surface dividing Zones 3 & 4

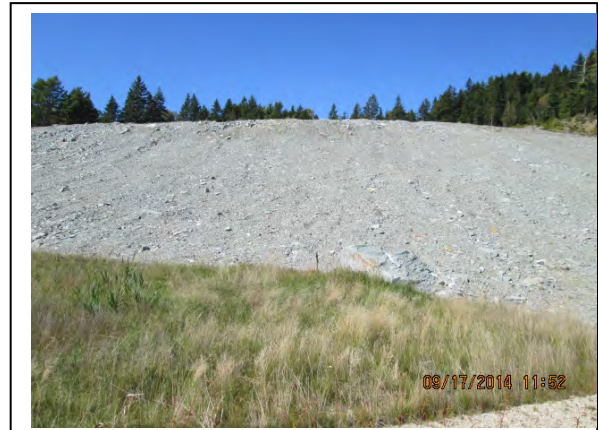
Sideslope of Waste Rock Pile #2

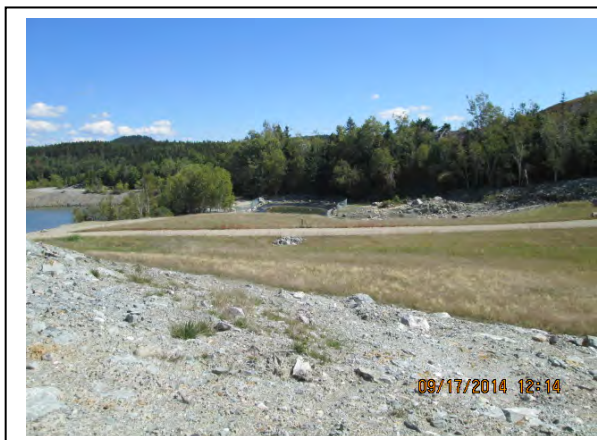
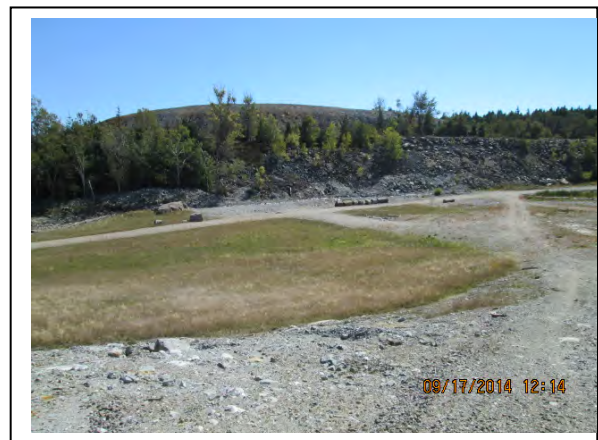
Panoramic view of former Mine Operations Area – view from the ore pad area  
**MINE OPERATIONS AREA**

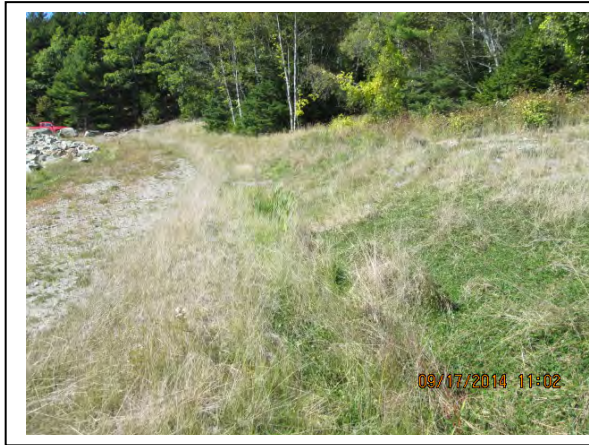
Drainage swale along tailings access road

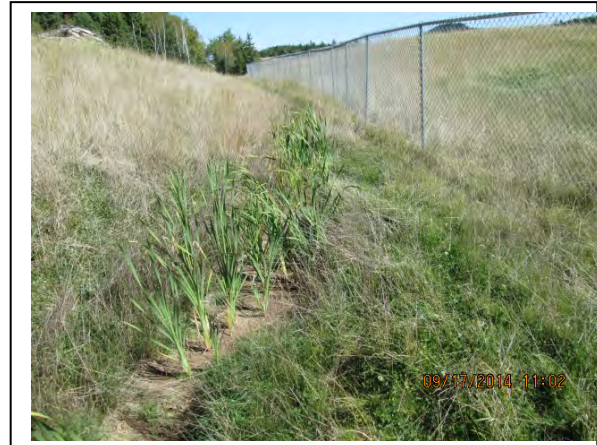
Western drainage swale by PCB storage area

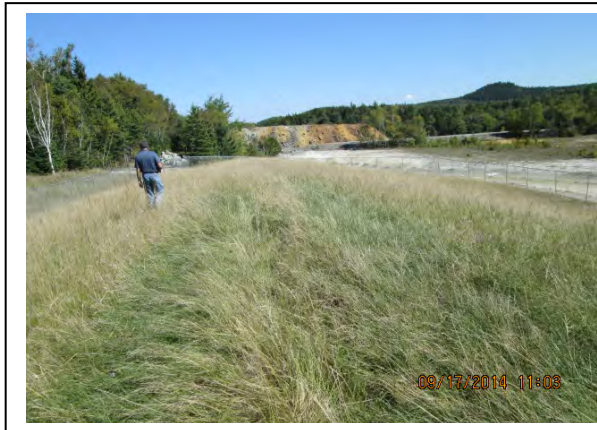
Grass growth on top of PCB storage area

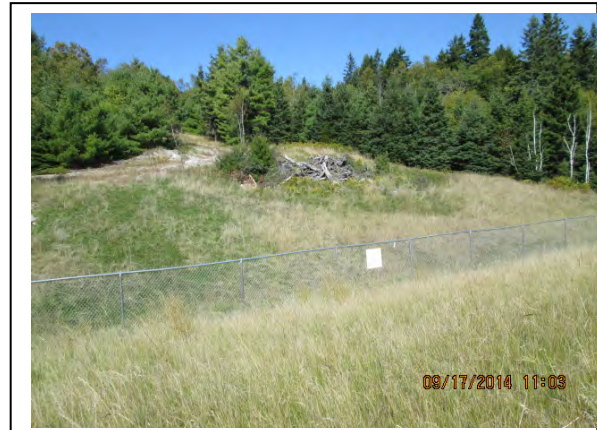
Western backslope adjacent to PCB storage area

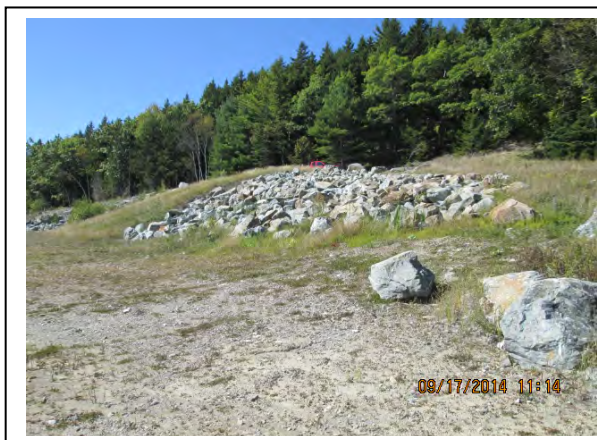
Concrete and rock storage areas at tailings

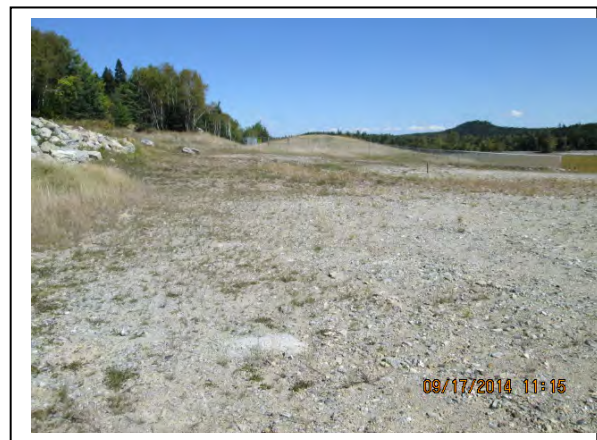
Surface of ore pad material at tailings impoundment

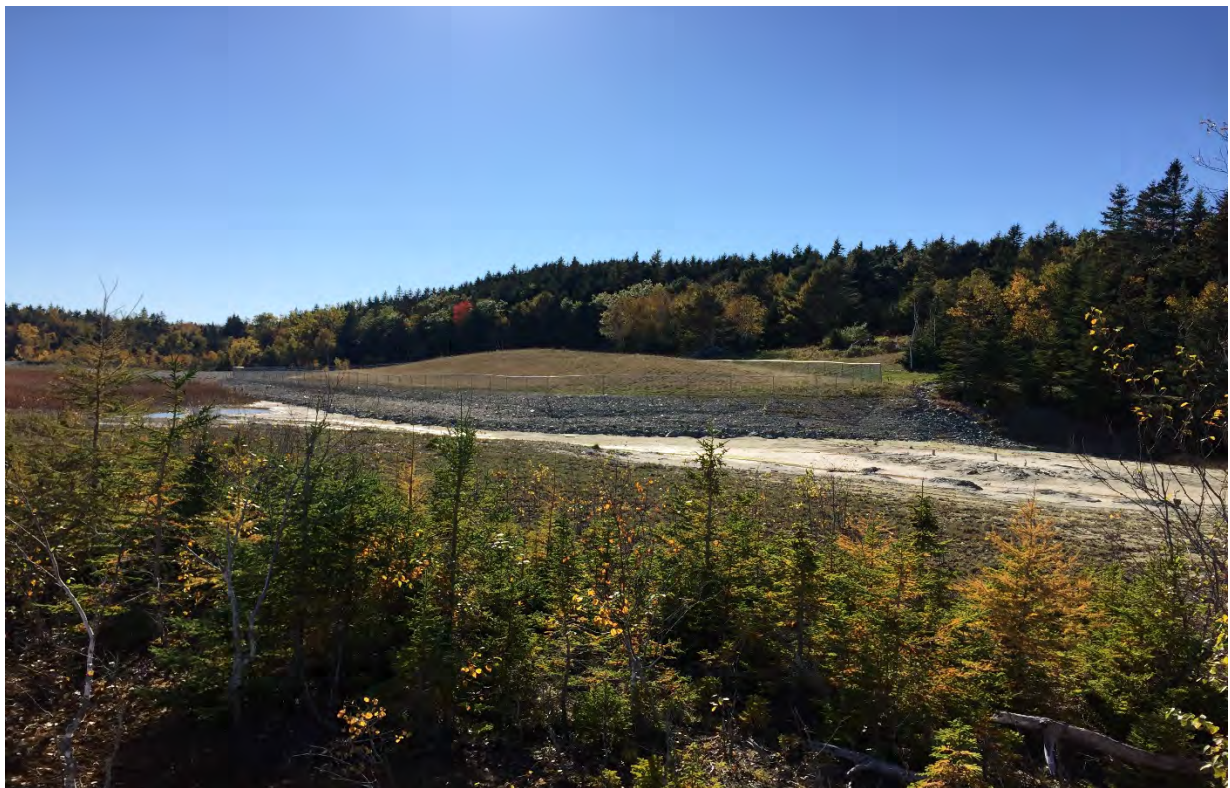
**Photo 6 - PCB Cap Looking SW**

- Cap is in good condition. Cap remains vegetated with appropriate grasses. No large vegetation (trees, shrubs, etc.) were observed growing on the Cap.
- No rutting or erosional features observed during the Site inspection.
- Cap toe drainage area(s) appeared in good condition during the Site inspection.
- Cap fence and signage appeared in good condition during the Site inspection.

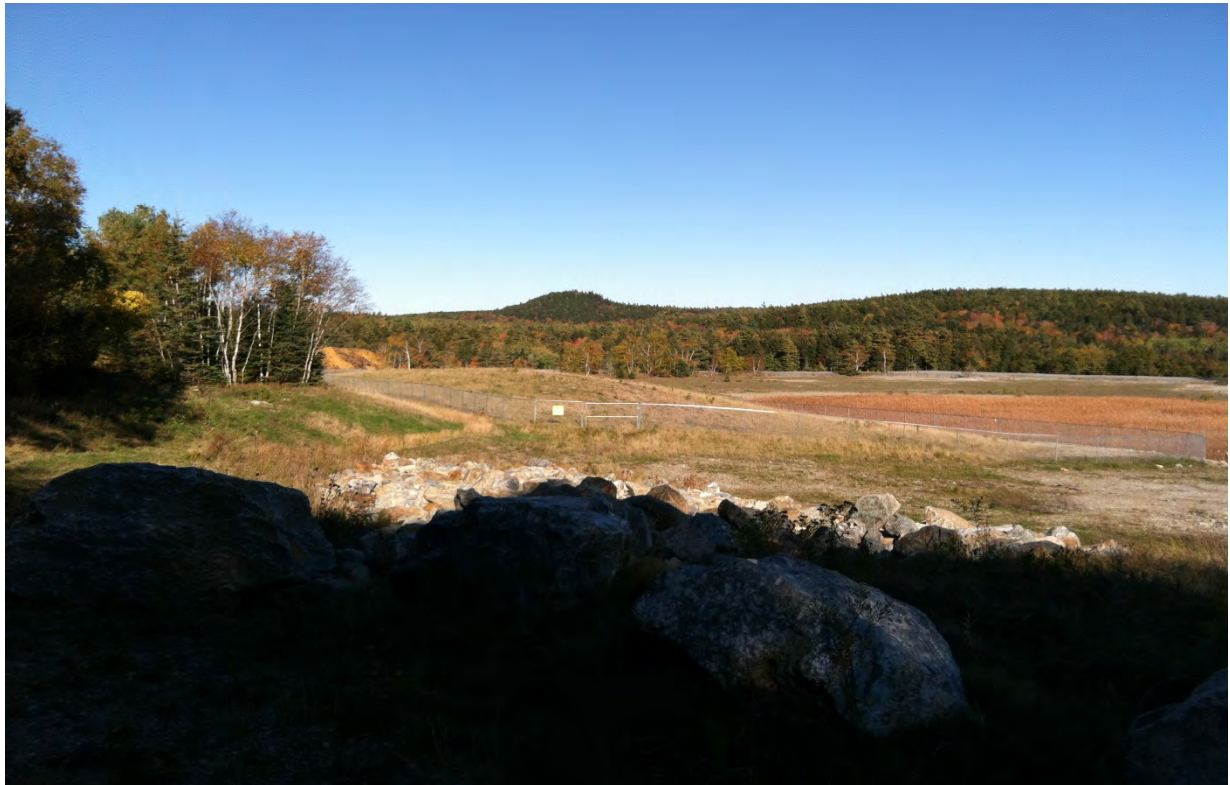
**Photo 7 - PCB Cap Looking NW**

| IV. O&M COSTS | |
|---|---|
| 1. | <b>Fencing</b> <input checked="" type="checkbox"/> Location shown on site map <input checked="" type="checkbox"/> Gates secured <input type="checkbox"/> N/A<br>Remarks <u>Fence surrounding PCB cap area is in good condition, 8' tall.</u> |

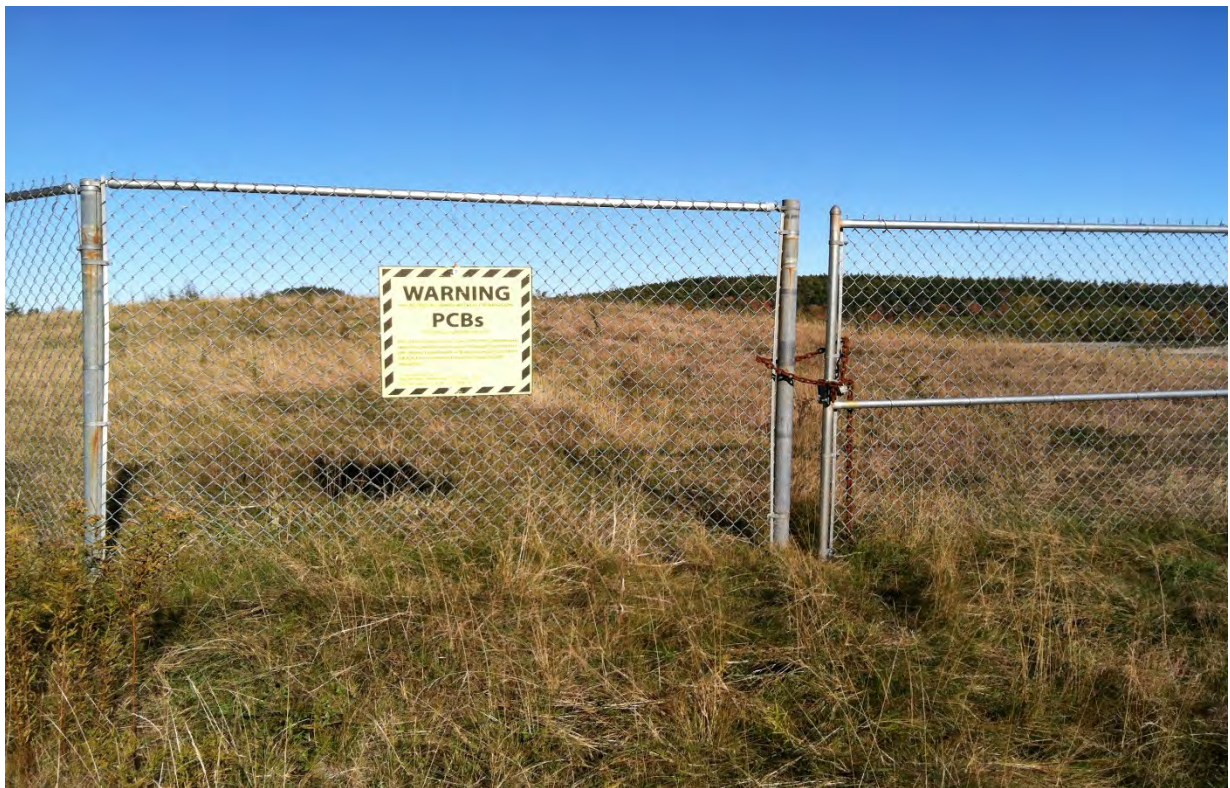
**Photo 8 - PCB Cap Sign**

| IV. O&M COSTS | |
|---|---|
| 1. | <b>Signs and other security measures</b> <input checked="" type="checkbox"/> Location shown on site map <input type="checkbox"/> N/A<br>Remarks. <u>Signs surrounding PCB cap area is in good condition</u> |
