**SUPPLEMENTAL  
ENVIRONMENTAL SITE ASSESSMENT**

**Old Village Mill, LLC  
57-59 & 65 Brunswick Avenue Ext.  
Plainfield, CT  
file 2672**

**October 18, 2001**

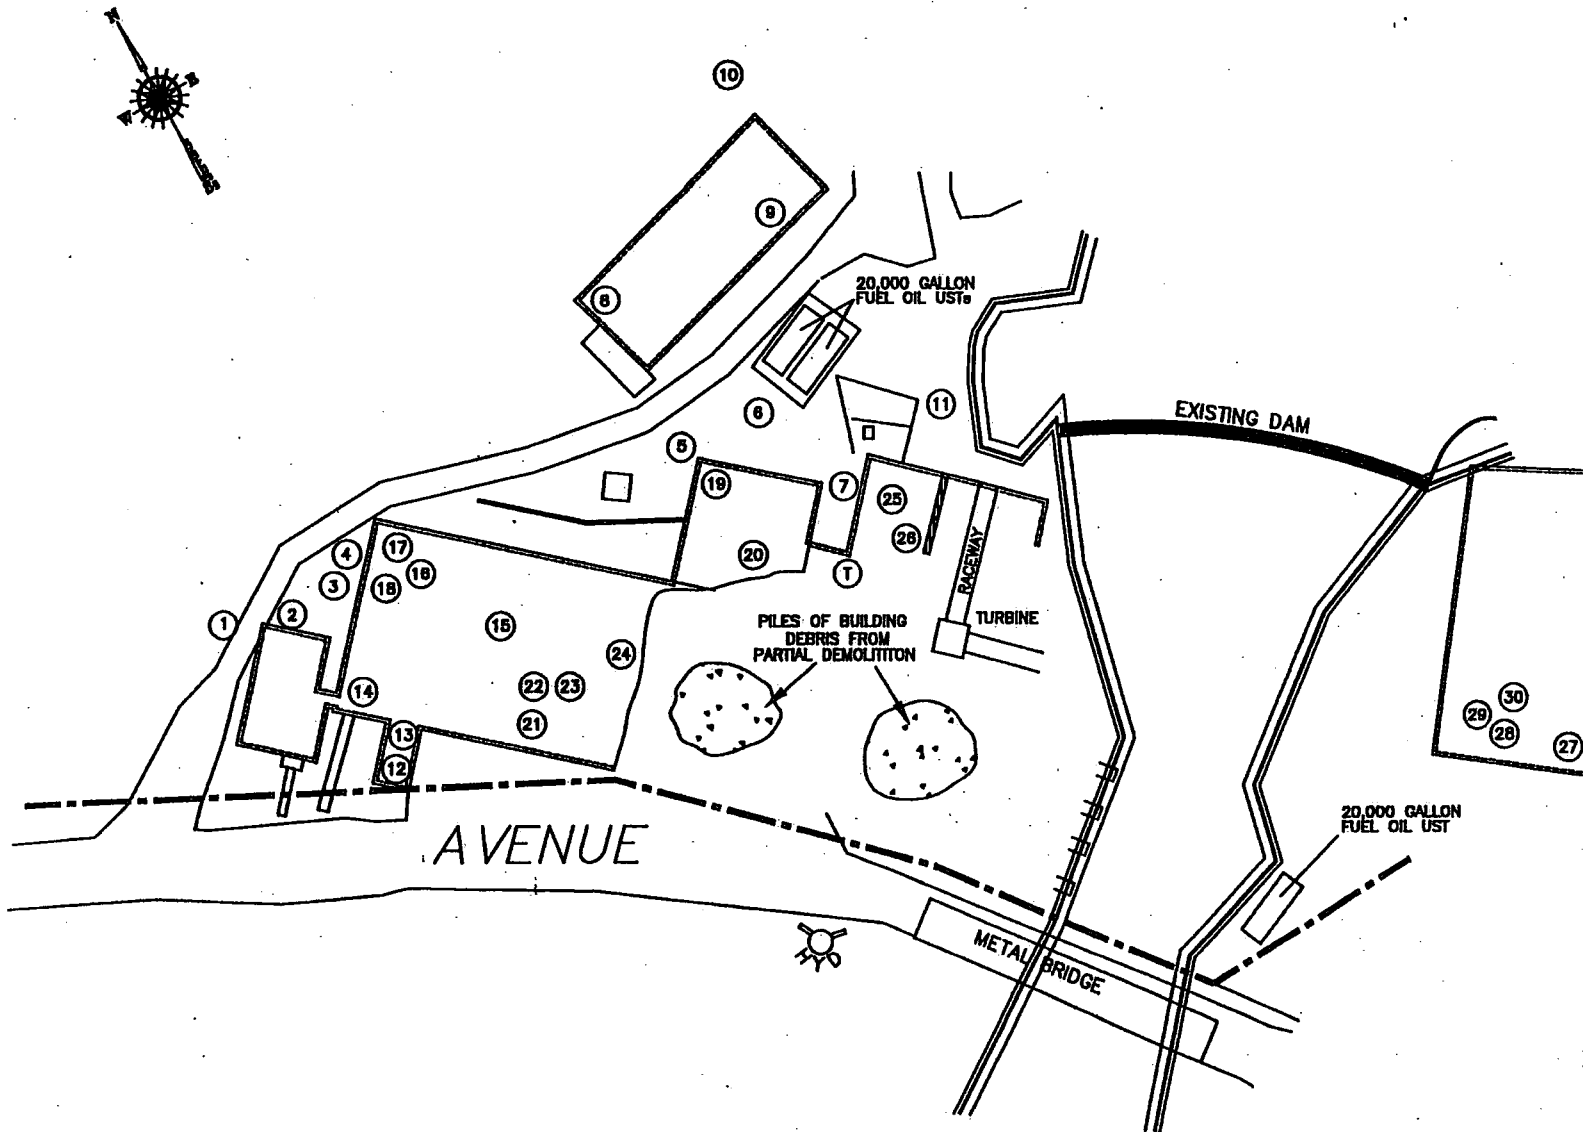
**2-Story House and Adjacent Property** - No drums or containers were identified within the 2-story house structure itself. Two 55 gallon size drums were identified in the area immediately surrounding the building. These containers were identified at locations 1 and 2 which are located along the access road that runs to the westside of the 2-story house. The containers appear to be filled with household trash and fiberglass fabric. The containers are in fair condition and neither container appears to pose a significant hazard in its current state.

**Main Mill Building - West of River** - Several locations were identified within this building that contained miscellaneous drums or containers. Two, one gallon size, containers, in fair condition, were identified at locations 13 and 23 that appear to contain waste oil. Several 55 gallon size drums were noted at locations 12, 14, and 22 that appear to contain polyester/fiberglass resin and/or fiberglass fabric. Approximately thirty other 55 gallon size drums were identified within the remainder of the structure. Most of these drums are in fair to poor condition and either appear to be empty or containing small amounts of unidentified liquids (the liquid may be water that has leaked into the drums through open tops or bungs). Several drums were inaccessible (location 25) due to safety concerns and their contents could not be ascertained. One plastic 55 gallon size drum (location 19), in good condition, contained a label indicating the contents to be Acetic Acid. This drum appeared to contain approximately 5 gallons of a liquid. Acetic Acid is considered to be hazardous, therefore, this container is a potential concern. Four, 55 gallon size, drums were identified in the area immediately outside this structure at locations 3, 4, 5, and 6. Two of these drums are filled with fiberglass fabric and trash, one is empty, and one (with an open top) appears to be full of rain water. These four drums are in fair condition and do not appear to pose a significant hazard. In addition, approximately ten 5-gallon buckets labeled as asphalt sealer and roofing tar are

**Corrugated Steel Storage Building** - Approximately six, 55 gallon size drums are located in and around this structure (locations 8, 9, and 10). These drums are in fair condition and appear to be full of household trash and foam rubber. They do not appear to pose a significant hazard in their current state.

**Remote Mill Building - East of River** - Several drums and containers were identified within this building. Approximately eight, 5 gallon size, containers believed to contain paint, oil, or cleaning solvents are located in the maintenance shop in the basement. Two other 55 gallon size drums contain liquids which may be waste oils. These 5 gallon and 55 gallon containers are in fair condition. One 55 gallon size drum is present which contains a solid white material. This drum is in poor condition, as the solid white material is visible through the sides near to the bottom.

NOTE: LOCATIONS 27, 28, 29, AND 30  
ARE IN THE MILL BUILDING EAST  
OF THE RIVER.

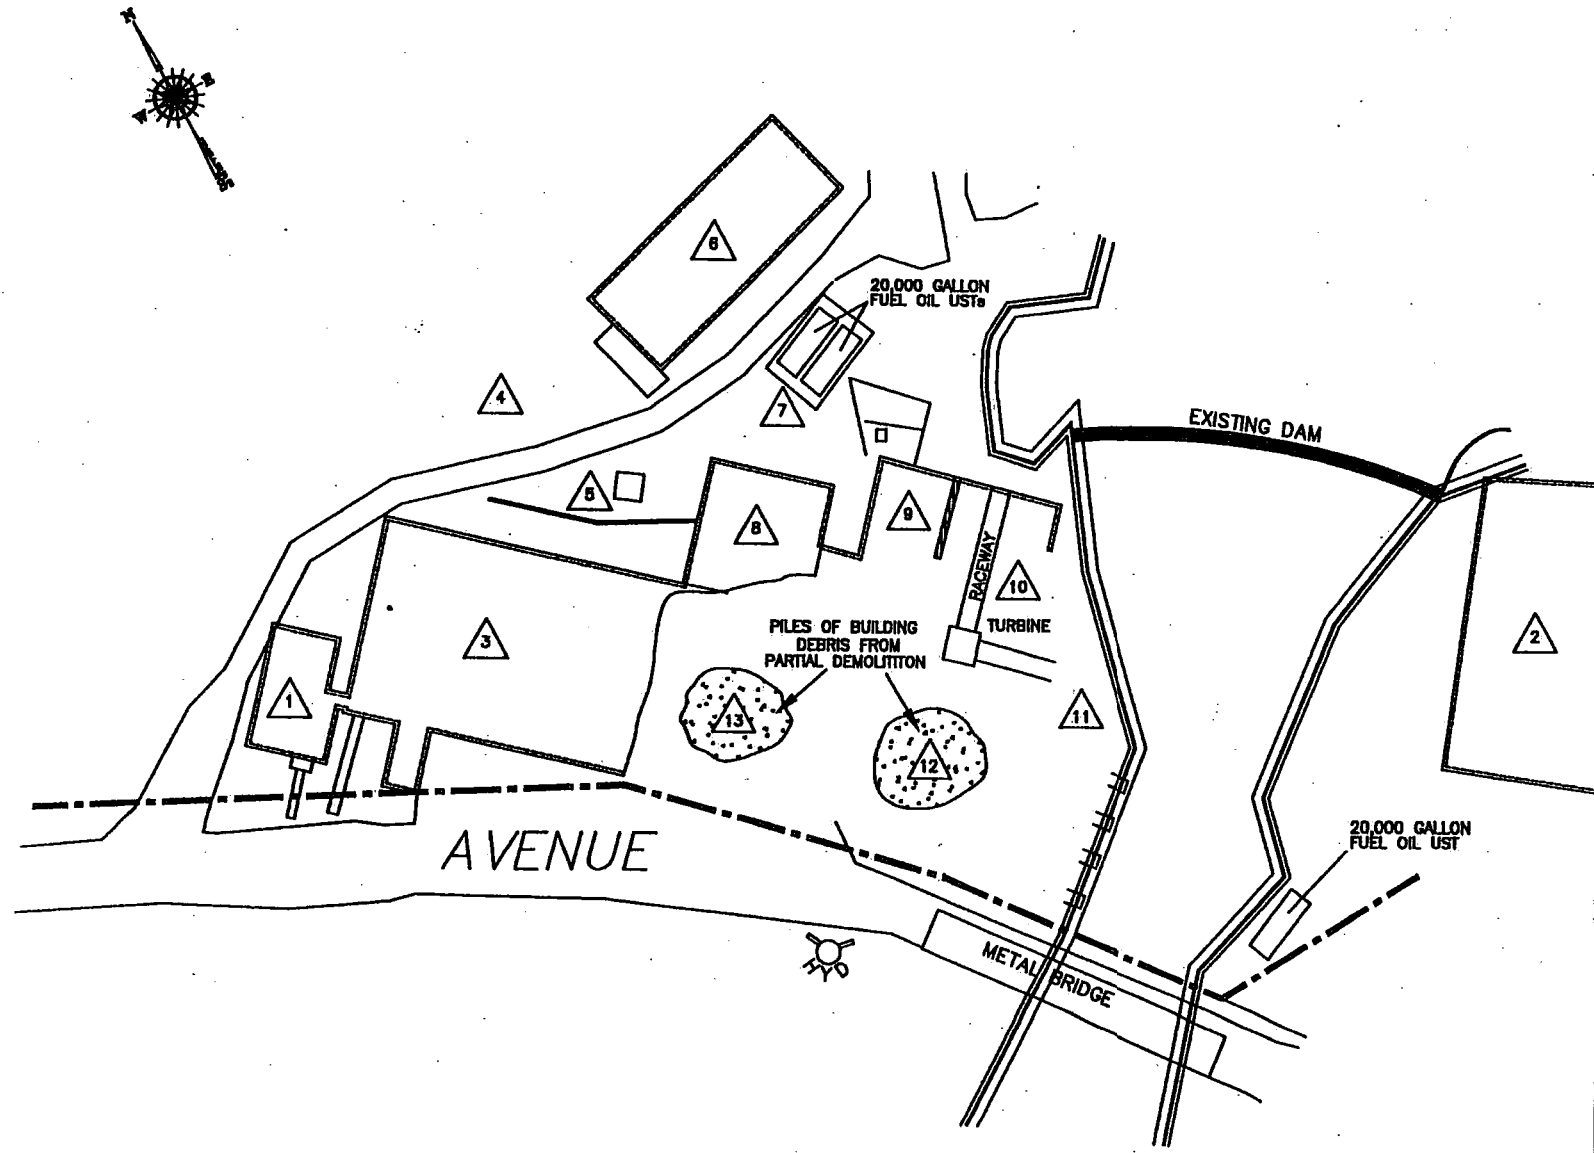
NOTE: BUILDING NUMBER 2 IS THE MILL  
 BUILDING LOCATED EAST OF THE RIVER
