Department of Environmental Management

EMERGENCY RESPONSE REPORT

Superfund Records Center  
SITE: Centerville Rd  
EPA ID: 2.1  
OTHER: 605708

INVESTIGATION OF ABANDONNED PAINT IN STORAGE BUILDING.

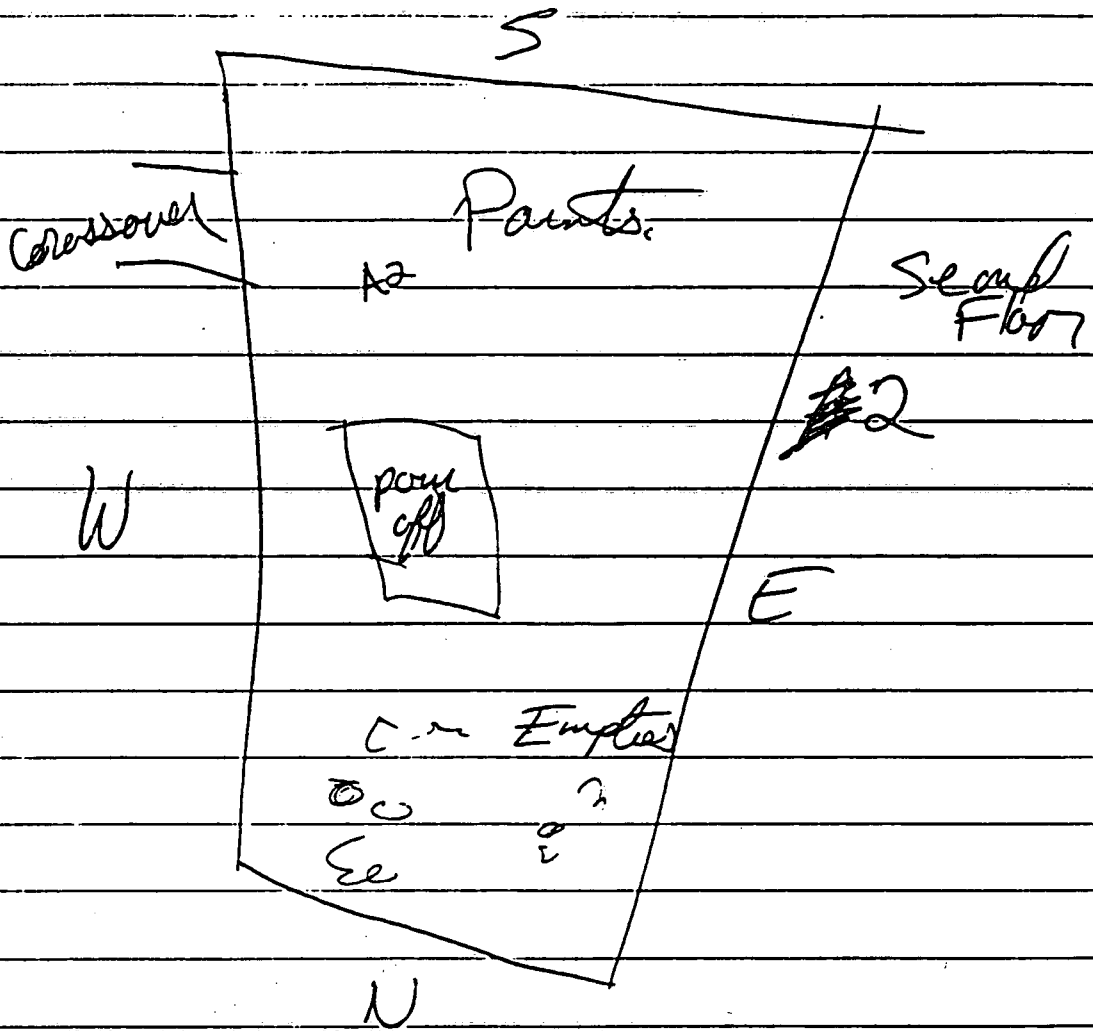
# FLOOR 2 -

A-2 ± 57 1 gal Can Floor Paint E-side  
 Crossover  
 B-2 ± 11 " Latex S wall  
 C-2 ± 199 " Floor S wall  
 West  
 D-2 ± 199 " " N of C2  
 E-2 ± 156 " " Latex paint N of D2  
 F-2 ± 52 " " W of B-2  
 G-2 ± 166 " " refer N of F2  
 H-2 ± 152 " " N of G-2

J-2	± 152	1 gal	Flam	N of H-2
J-2	± 199	1 gal	Flam	W of F-2
K-2	± 109	"	"	S wall
L-2	± 153	"	"	S wall w of K-2
M-2	± 153	"	"	N of L-2
N-2	± 154	"	"	W of M-2
O-2	± 154	"	"	N of N-2
P-2	± 154	"	"	N of O-2
Q-2	± 199	"	"	W of P-2
R-2	± 136	"	"	S of Q-2
S-2	± 143	"	"	S of R-2
T-2	± 173	"	"	S of S-2
U-2	± 145	"	"	S of T-2 S wall
V-2	± 155	"	"	S wall W of U-2

X-2	± 156	1 gal	Floor	N of V-2
Y-2	± 194	1 gal	"	N of X-2
Z-2	± 194	"	"	S wall W wall
AA-2	± 162	"	"	N of Z-2
BB-2	± 197	"	"	N of AA west wall
CC-2	± 77	"	"	N of BB W wall
D-2	± 95	"	"	N of CC W wall
EE-2	± 150	"	"	N of DD W wall
FF-2	± 155	"	"	N of EE W wall
GG-2	± 133	"	"	N of FF W wall
HH-2	± 155	"	"	N of GG W wall
II-2	± 134	"	"	N of HH W wall
IJ-2	± 46	"	"	Loading Dock N Side
