# GE-Housatonic River Superfund Site

## Silver Lake 2025 Sediment Cap Maintenance

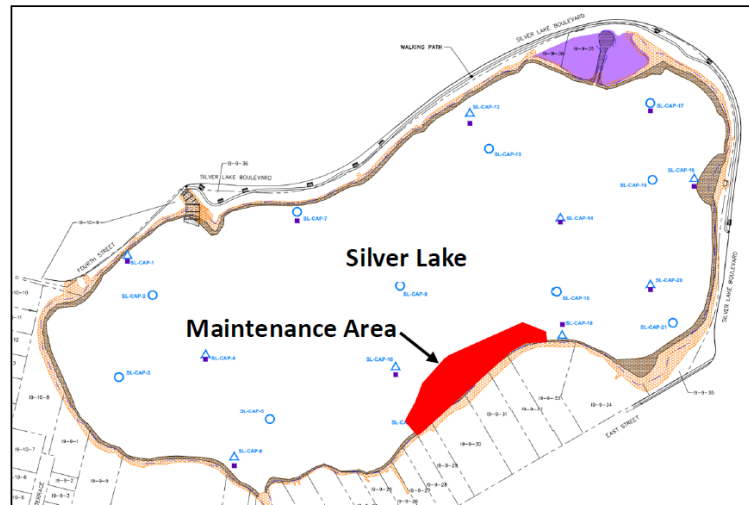
Figure 4: Approximate Area of the 2025 Cap Maintenance

However, at one location in the southern area of the Lake along East Street, it appeared that the cap thickness was less than the required 14 inches. Three additional cores were collected in the surrounding area and the average measured thickness was 9.4 inches. In 2024, GE collected an additional 12 cores in the southern area for a total of 16 cores to further define the area requiring maintenance. As noted above, the measured cap thickness can vary over time due to several factors. The exact factors causing the variability in cap thickness are uncertain, which underscores the importance of monitoring and maintenance. The maintenance of the cap does not indicate cap failure. Monitoring and maintenance is a routine requirement of any cap installation.

Based on the results, GE identified an area of approximately 33,000 square feet over which they propose to add an additional 6 to 9 inches of cap material (approximately 810 cubic yards of material in total). The material will be placed both from the shore and from a floating platform on the Lake. Turbidity curtains will be placed to minimize the movement of material away from the Lake. Upon completion, any disturbed areas along the shore will be restored. The approximate area over which this cap maintenance will occur is shaded red in Figure 4.
