## CITY OF PITTSFIELD

Re: Housatonic Rest of River (GECD850) Road Assessment Work Plan

STRUCTURES INSPECTION FIELD REPORT

BR. DEPT. NO.  
P-10-023

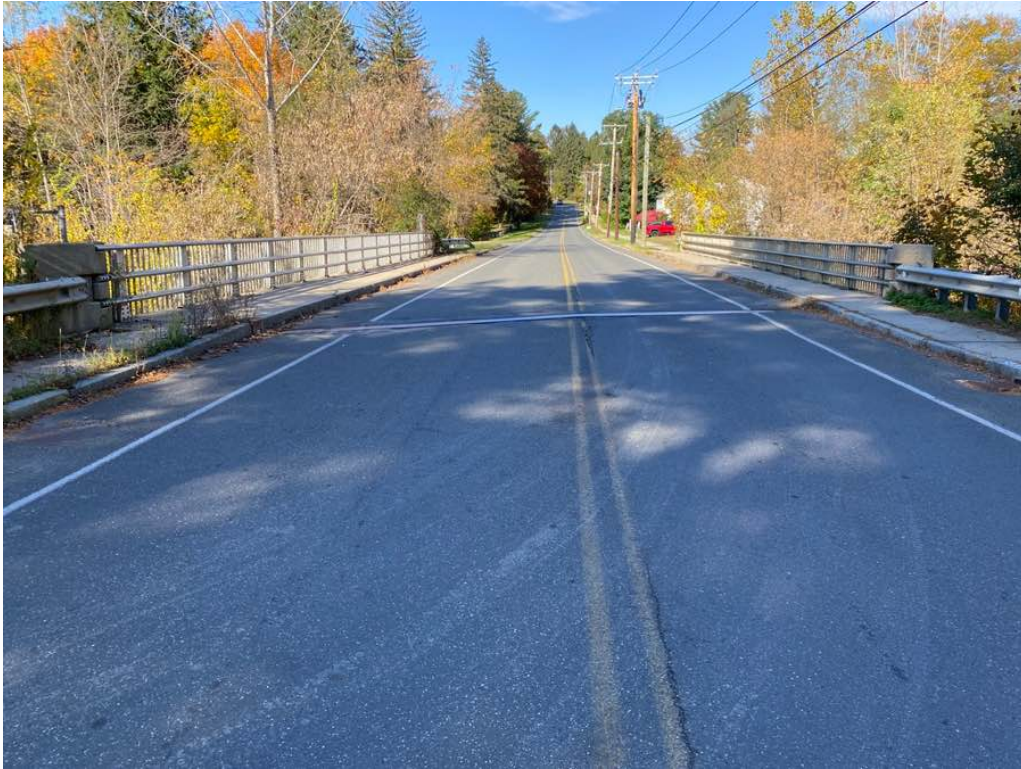
**Photo 1: General topside, looking west.**

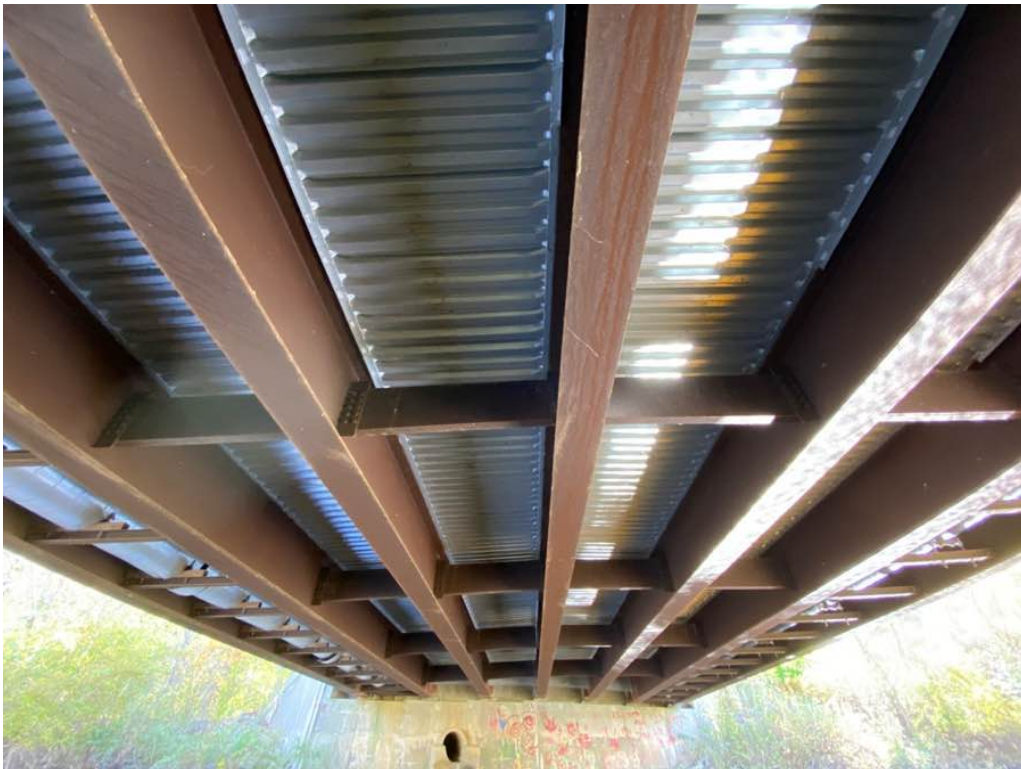
**Photo 2: Typical underside, looking east.**

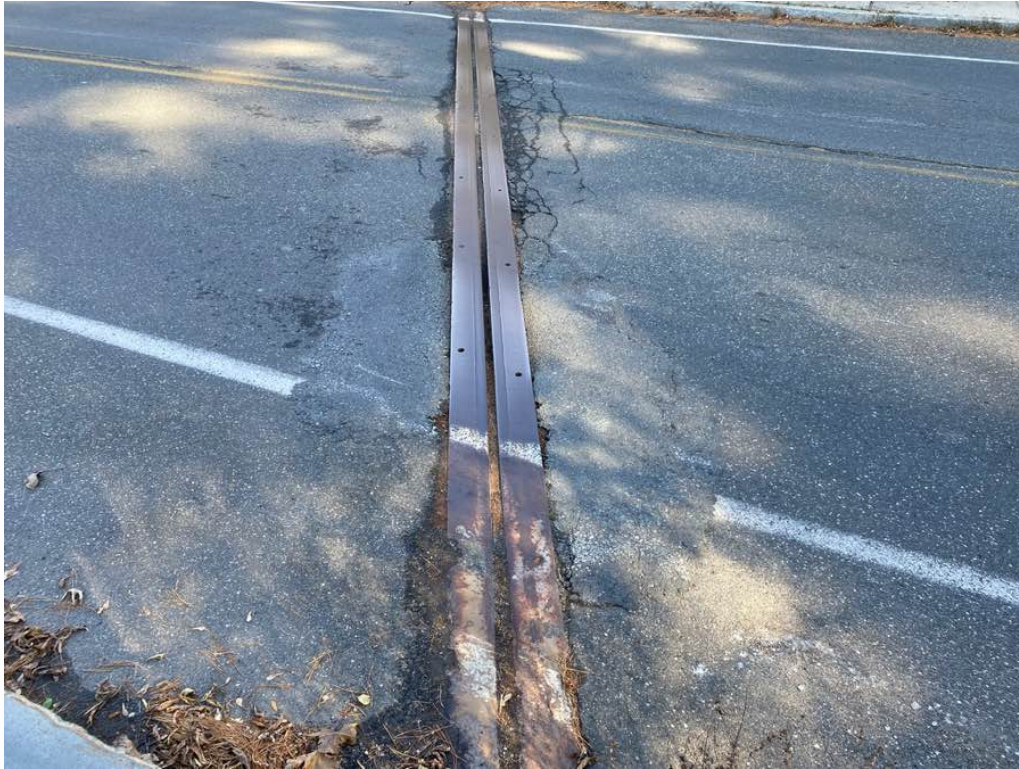
At the east deck joint, the wearing surface is pulling away from the armor, with cracking and patches. See photo 3.

At the east deck joint, the approach pavement is pulling away from the armor, with cracking and patches. See photo 3.

**Photo 3:** East deck joint filled with sand and debris. Note the approach pavement pulling away from the armor and patches.

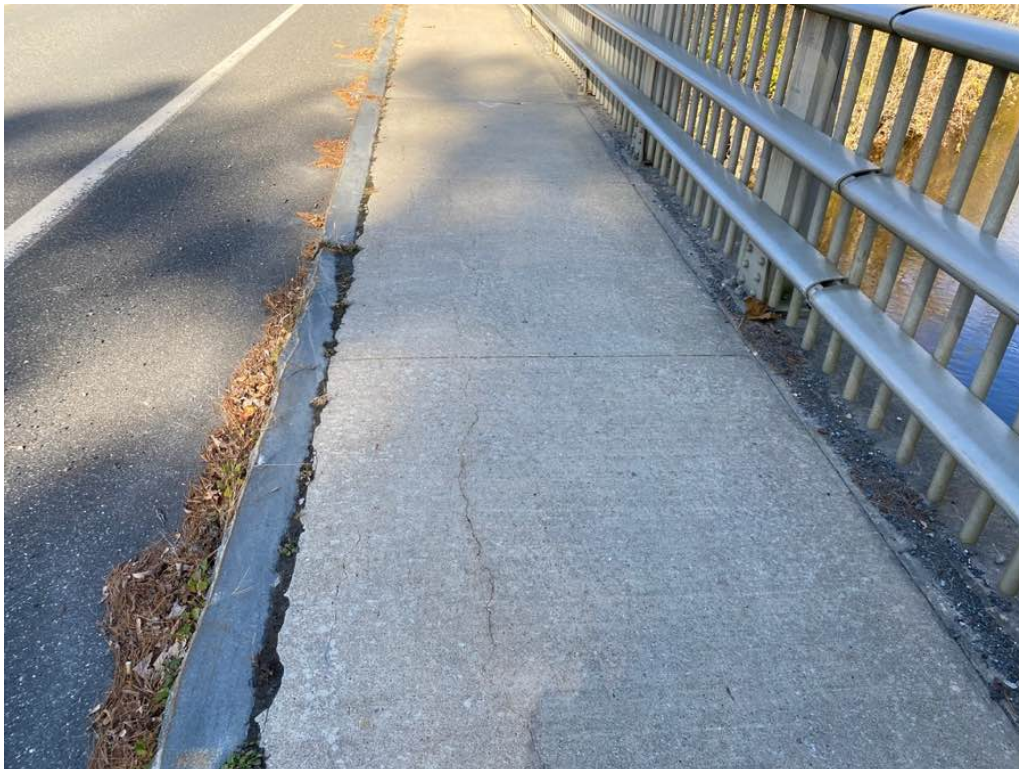
**Photo 4:** Vegetation growing between the north sidewalk and curb.

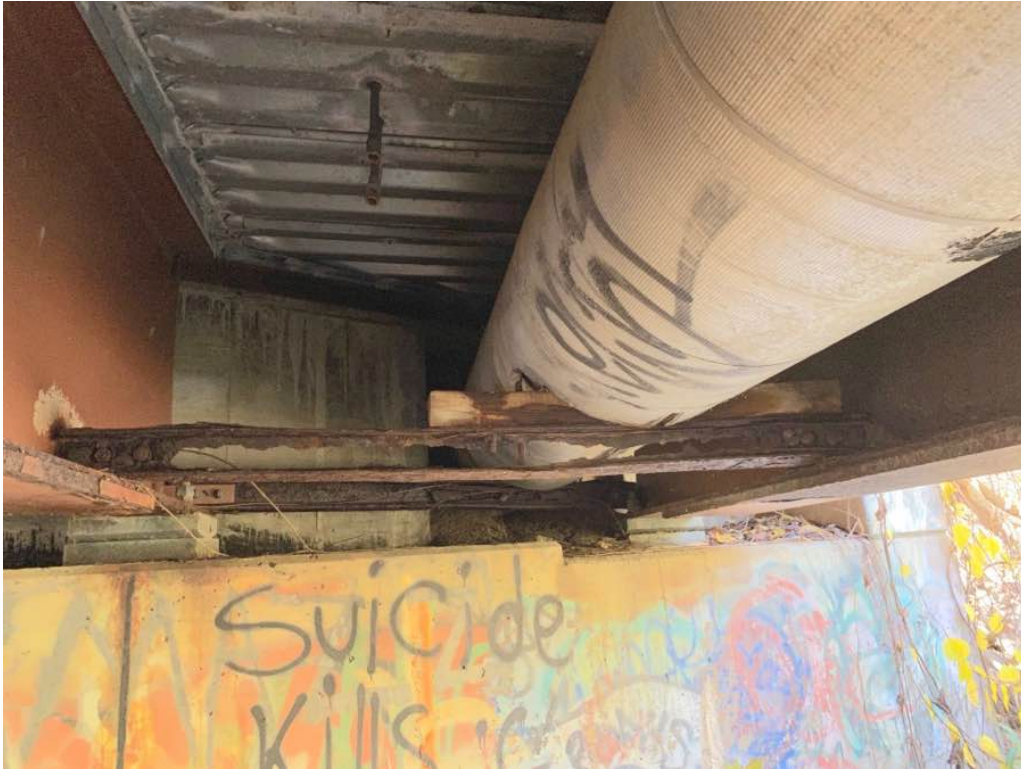
In bay 1, the second bracket from the west is severely rusted with holes throughout the web. The utility is located directly under a set of deck weeps. See photo 5.

At both backwalls, in bay 1 around the utility pipe, the bricks and mortar are deteriorated. Fill from below the approach sidewalks is spilling through in these areas. See photo 5.

**Photo 5:** Rusted utility support at the west end of bay 1. Also, note the fill spilling through the utility bay in the backwall.

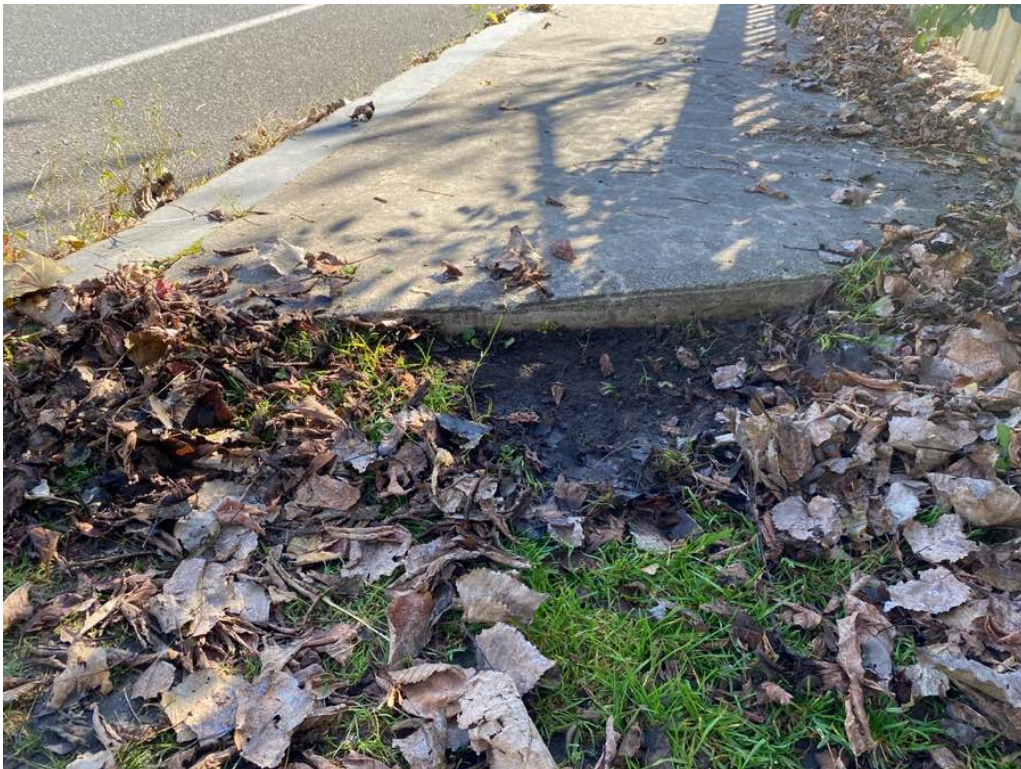
**Photo 6:** Approach sidewalk settlement at the west end of the south sidewalk.

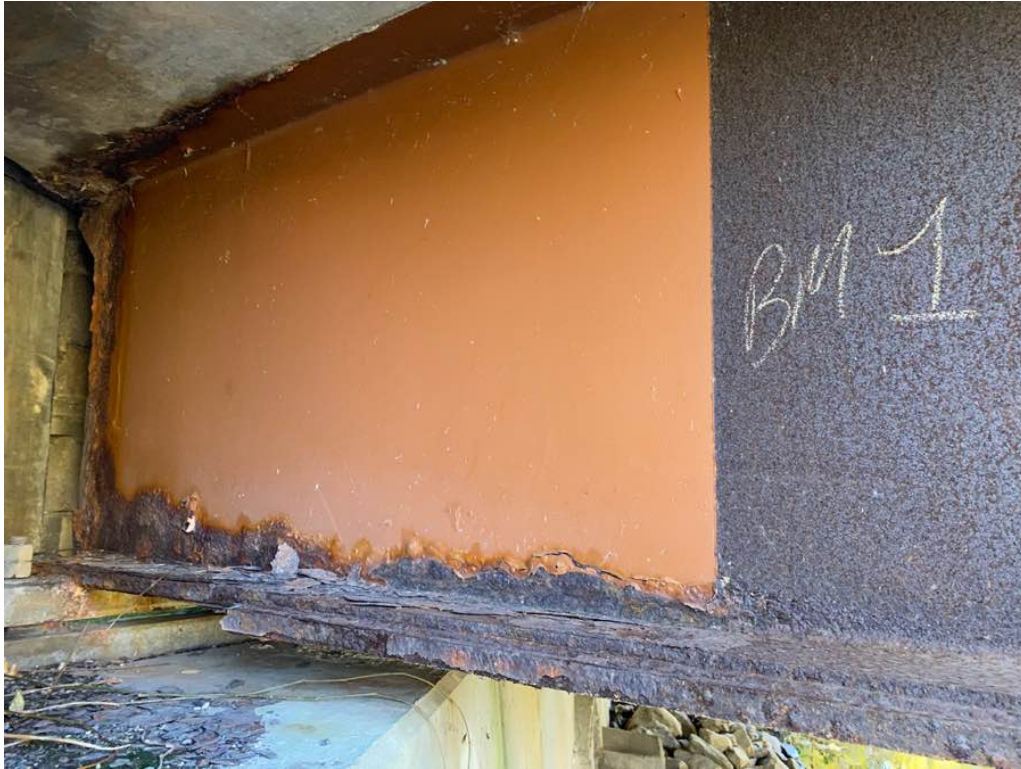
Beam 1, at the east end, has minor laminating rust in the painted section near the bottom flange, 6' long. See photo 7.

At the east end of beam 1, the cover plate welds have rust with delamination. See photo 7.

Beam 1, at the east end, mostly along the bottom of the web, has peeling in the paint and patina failure, 6' long. See photo 7.

**Photo 7:** Rusting with delamination at the east end of beam 1. Also, note the delamination in the cover plate and the associated welds.

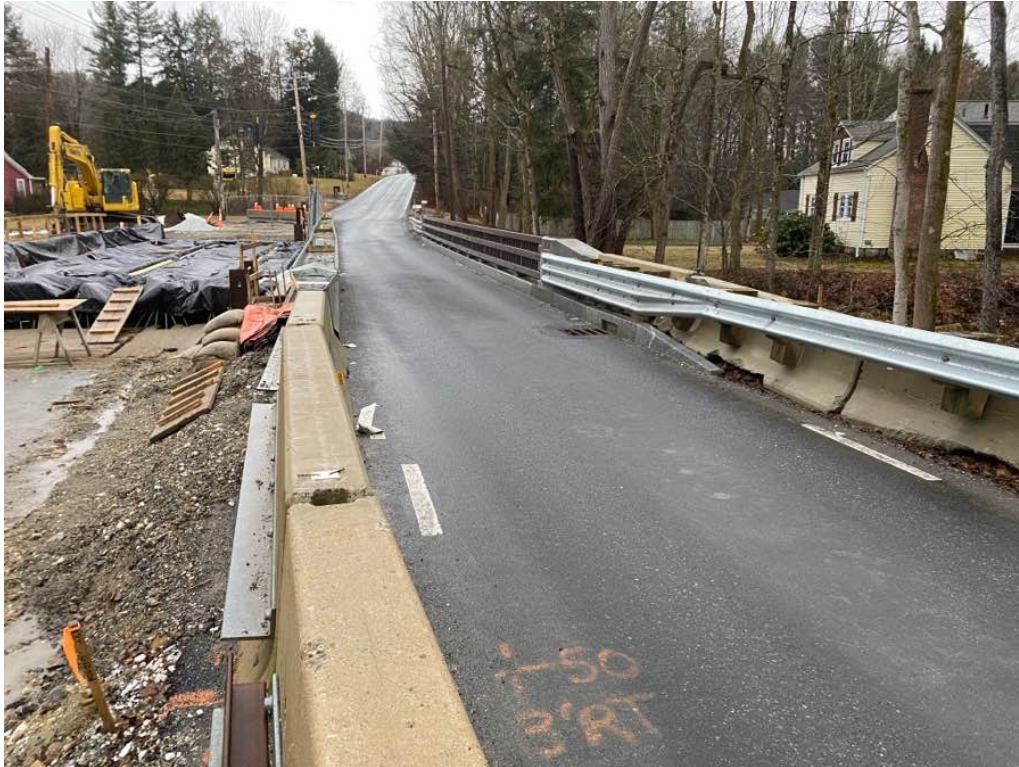
Photo 1: General topside, looking south.

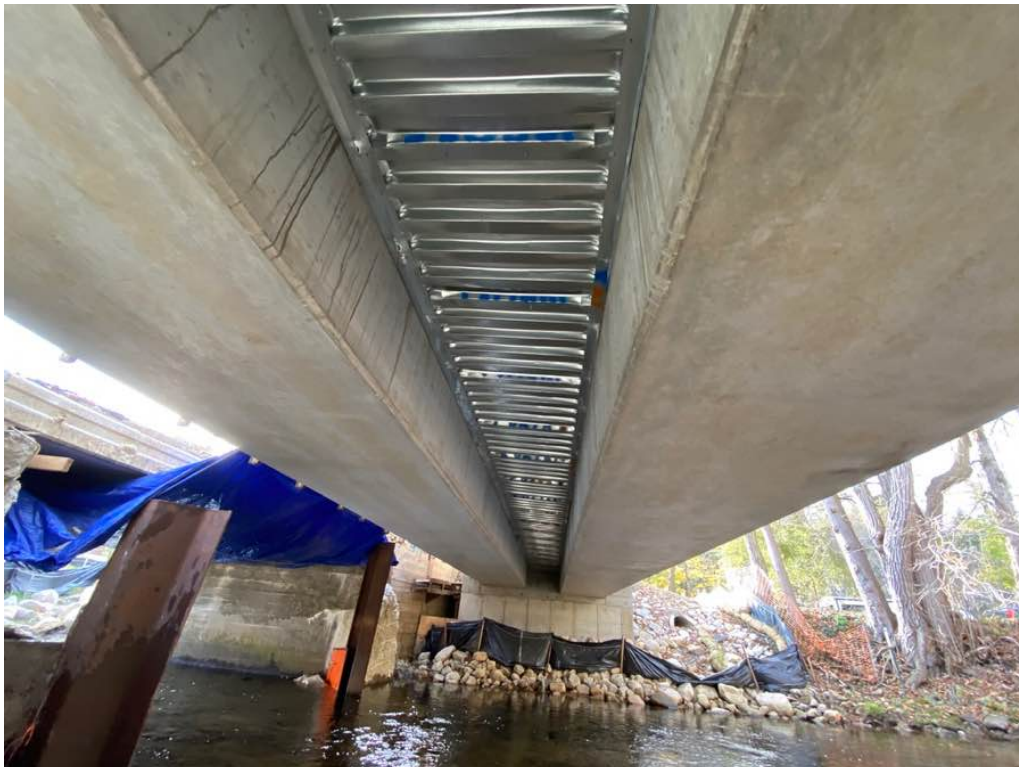
Photo 2: General underside, looking south.
