**Slope Area Mitigation Project
Completion Report**

Curtis Specialty Papers Site
Milford, New Jersey

August 2013

Prepared for:
United States Environmental Protection
Agency

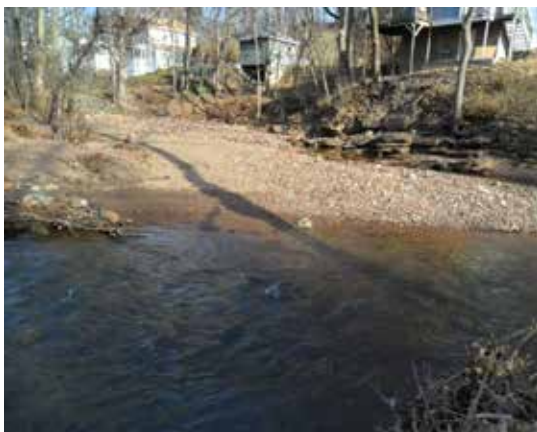
During the summer and fall of 2011, heavy rains and flooding occurred within the Delaware River basin and its tributaries, including Q Creek in the vicinity of the site. Following subsidence of floodwaters, an inspection of Q Creek identified that the bed of the emergency storm flow channel had been scoured to a depth several feet below that of the main channel around the meander. As a result, during typical seasonal flow conditions, Q Creek flows through the emergency flow channel and the former channel of the meander is a dry creek bed consisting of gravel, cobble and bedrock outcrops (as seen in the photographs below).

Former Channel/Dry Creek Bed

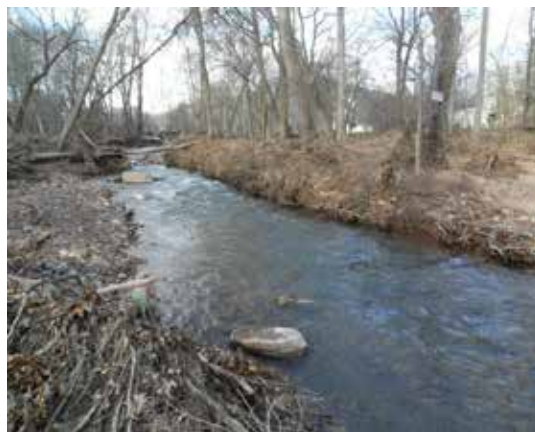
Water routed through the shorter and steeper emergency flow channel results in the normal creek flow reaching downstream sections of Q Creek with greater velocity and potential energy. Further, regional flood events in the Delaware River result in backflow conditions, where river water levels rise quicker than those in Q Creek. These conditions inhibit drainage from Q Creek and result in higher water levels with less water velocity. Under this hydraulic regime, the soils along the lower portion of the Q Creek bank became saturated, increasing instability and the potential for erosion. In combination, these altered flow conditions resulted in erosion, undercutting and destabilization of the steep banks along the former CFA.

Emergency Storm Flow Channel

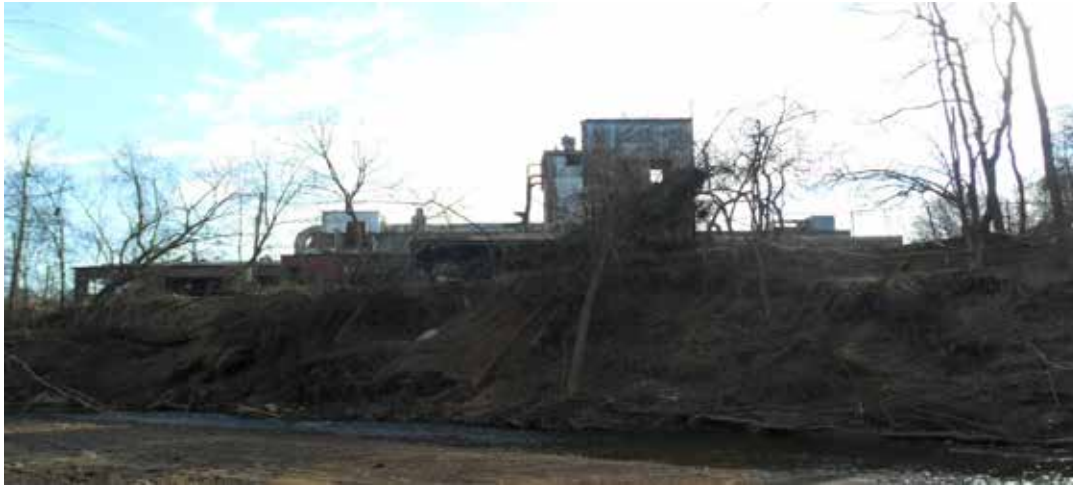
In the months immediately after the flooding, portions of the earthen bank adjacent to the former CFA and directly beneath the former location of Building 54 eroded along the toe of the bank (as seen in the photograph below). This erosion changed the slope, resulting in instability in areas of the upper portion of the bank. A portion of a block retaining wall

adjacent to the northeast corner of former Building 54 and the outer security fence had collapsed as a result of the slope instability, as depicted in the photo below.

The bank continued to remain unstable until SAM activities were implemented. IP, GP, USEPA and NJDEP agreed that the presence of USTs (reportedly abandoned) near the top of the slope, and the continued degradation of the slope, required immediate attention. As described in Section 1, IP and GP conducted SAM activities in two phases. The following sections provide SAM implementation details.
