**VIDEO INSPECTION REPORT AND DVD**

**STORM SEWER VIDEO INSPECTION  
 LOCATION IDENTIFIERS  
 KENTUCKY AVE. WELLFIELD SITE - OU4  
 HORSEHEADS, NEW YORK**

Prepared For:  
 KOPPERS POND RI/FS GROUP

# INSPECTION REPORT

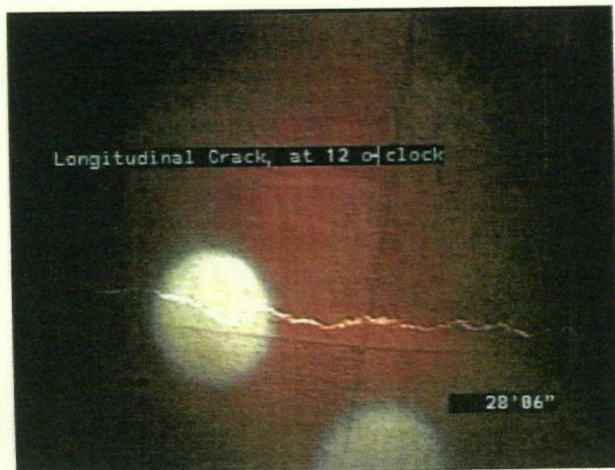
IMAGE: 3a, TAPE #: 01, 00:00:00  
28.5FT, Longitudinal Crack, at 12 o'clock

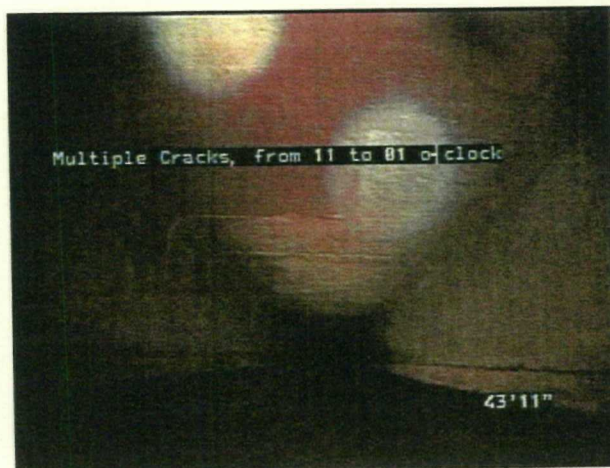
IMAGE: 4a, TAPE #: 01, 00:00:00  
43.95FT, Multiple Cracks, from 11 to 01 o'clock

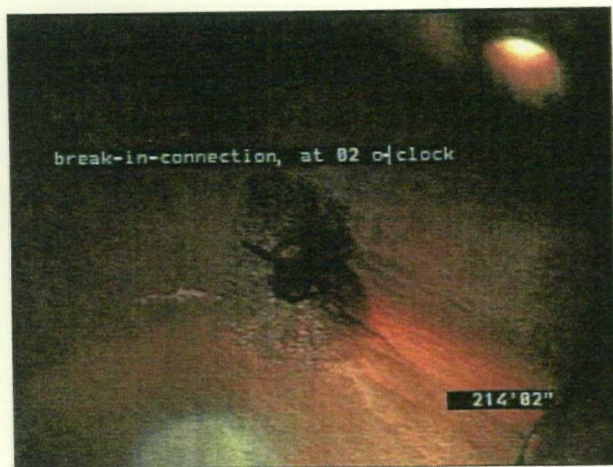
IMAGE: 6a, TAPE #: 01, 00:00:00  
214.2FT, break-in-connection, at 02 o'clock

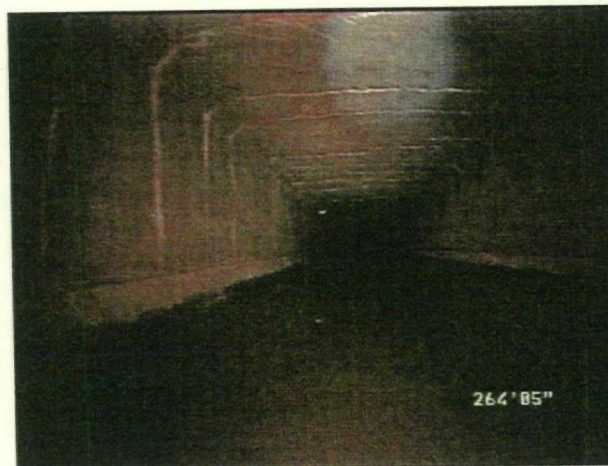
IMAGE: 7a, TAPE #: 01, 00:00:00  
264.4FT, Multiple Cracks, from 08 to 04 o'clock

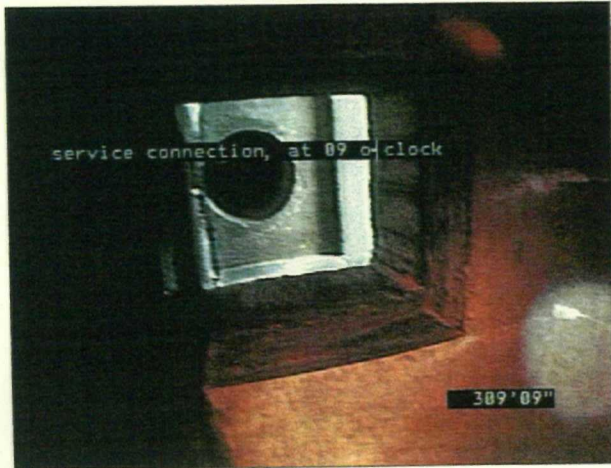
IMAGE: 8a, TAPE #: 01, 00:00:00  
309.75FT, service connection, at 09 o'clock

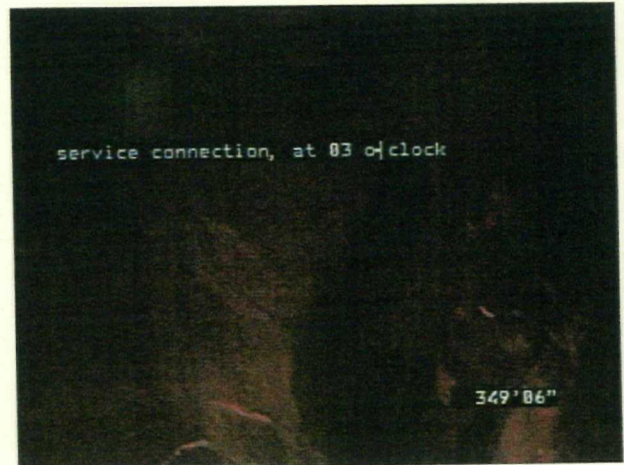
IMAGE: 9a, TAPE #: 01, 00:00:00  
349.5FT, service connection, at 03 o'clock

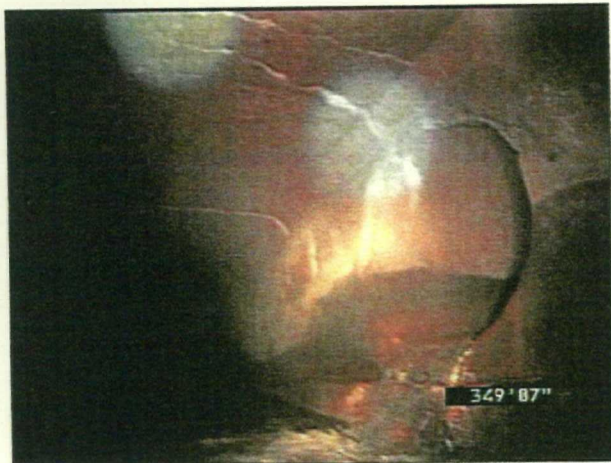
IMAGE: 9b, TAPE #: 01, 00:00:00  
349.5FT, service connection, at 03 o'clock

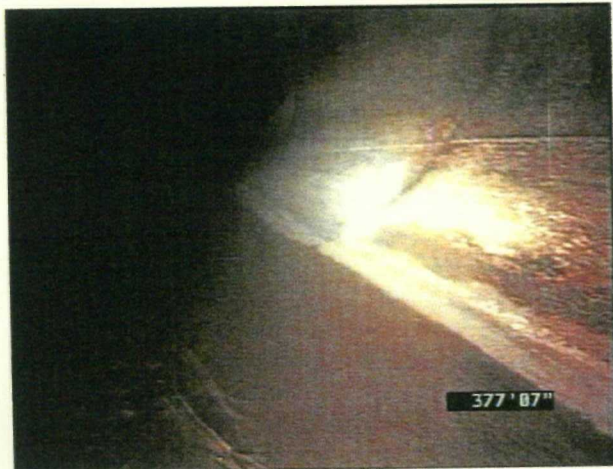
IMAGE: 14a, TAPE #: 01, 00:00:00  
377.55FT, pipe

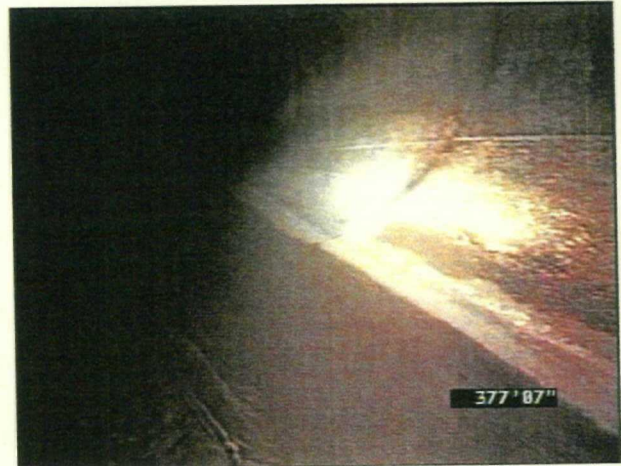
IMAGE: 14b, TAPE #: 01, 00:00:00  
377.55FT, pipe

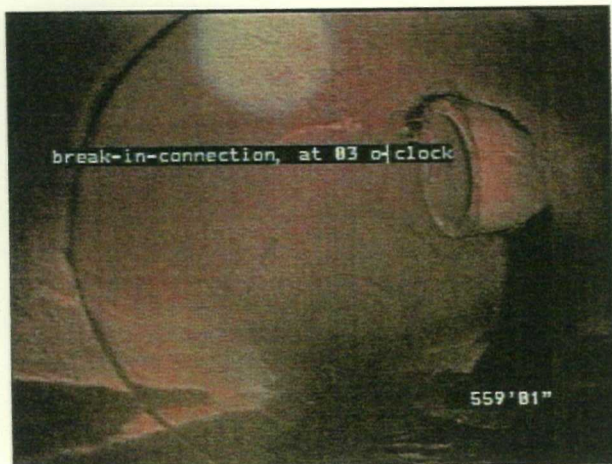
IMAGE: 15a, TAPE #: 01, 00:00:00  
559.1FT, break-in-connection, at 03 o'clock

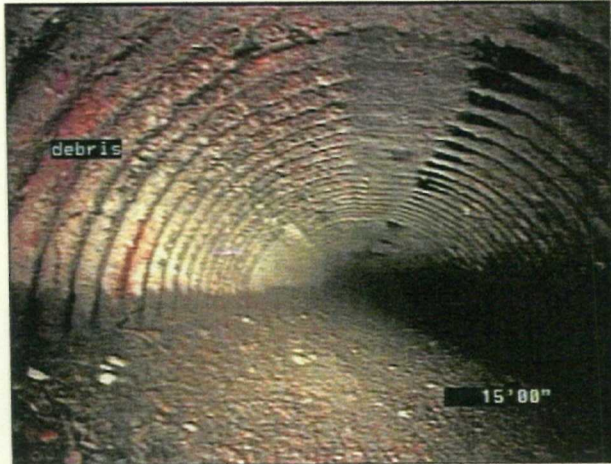
IMAGE: 27a, TAPE #: 01, 00:00:00  
15FT, debris

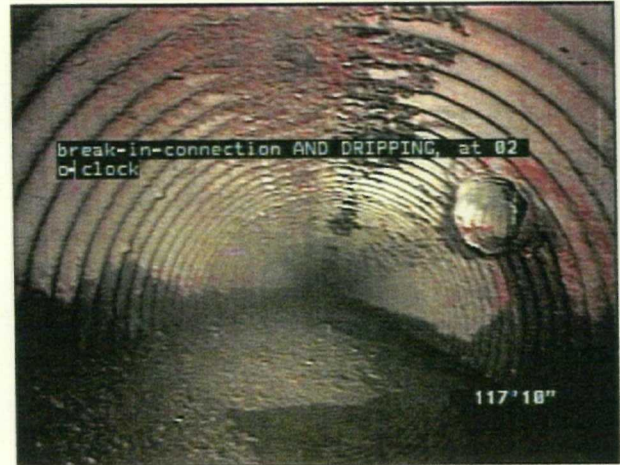
IMAGE: 28a, TAPE #: 01, 00:00:00  
117.8FT, break-in-connection AND DRIPPING, at 02 o'clock

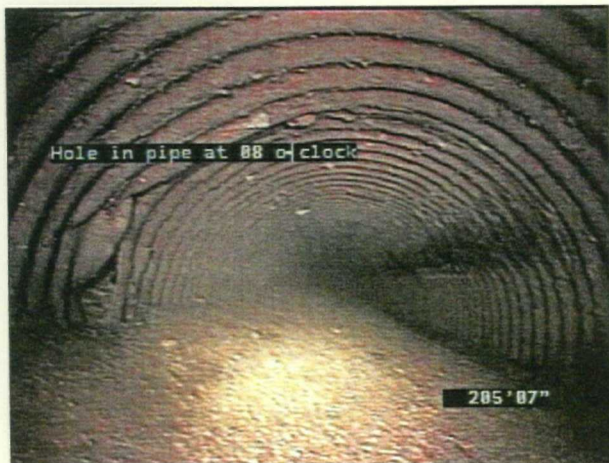
IMAGE: 29a, TAPE #: 01, 00:00:00  
205.55FT, Hole in pipe at 08 o'clock

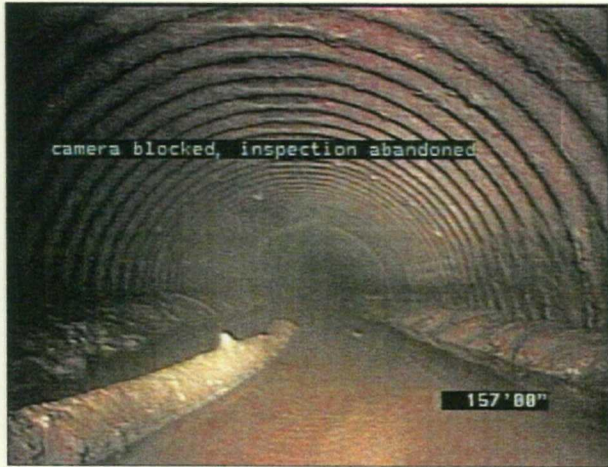
IMAGE: 32a, TAPE #: 01, 00:00:00  
157FT, camera blocked, inspection abandoned
