**SUPERFUND TECHNICAL ASSESSMENT AND RESPONSE TEAM
EPA CONTRACT 68-W5-0019**

Re: Grand Street Site
DCN # 00108
PCS #1139

On December 27, 1995, a mercury vapor monitoring survey was conducted by Region II START at 722 Grand Street, Hoboken, NJ. The survey was performed by START members Dennis Foerter, Paul Potvin and Tom O'Neill, using the Jerome 431-X Mercury Vapor Analyzer (S/N: 01418). The survey results are included in Attachment A. Outside weather at the time of the survey was sunny, 20-30°F, with a northwest wind at 10-15 mph. The temperatures inside the building ranged from approximately 60-70°F.

**Photographs from December 27, 1995
Mercury Vapor Survey**

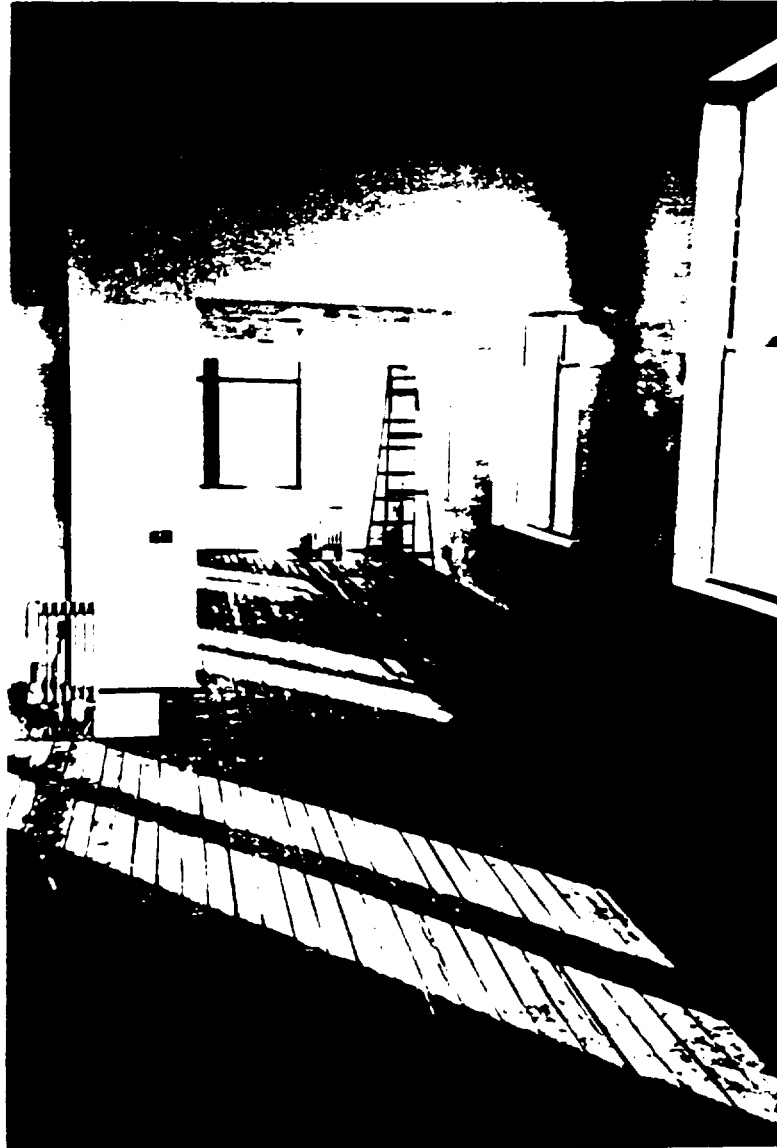
Photo 1: Apartment 5D, View of Living Room, East Side of Building

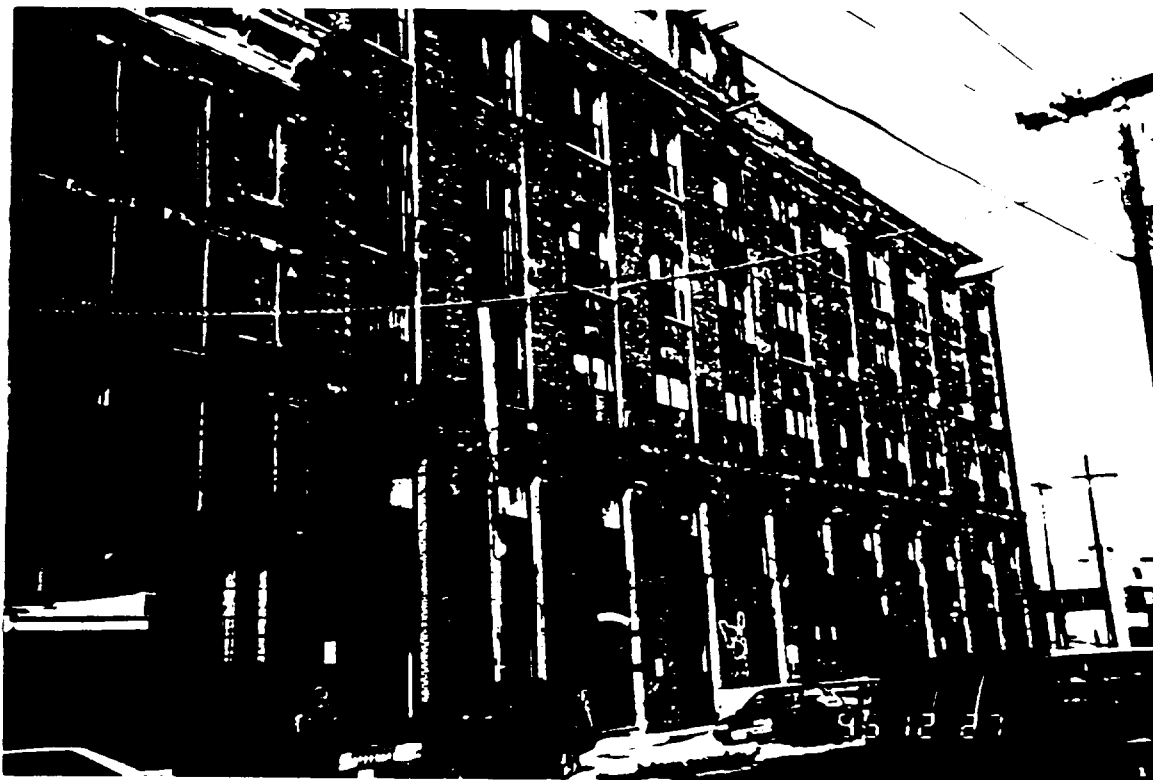
Photo 5: Exterior of 722 Grand St., Hoboken , NJ.
Unoccupied Townhouse is to the left.
