EPA CONTRACT No: EP-S2-14-01
TDD No: TO-0370-0064
DC No: RST3-05-D-0014
SUBJECT: REMOVAL ASSESSMENT REPORT
PIONEER METAL FINISHING SITE
FRANKLINVILLE, GLOUCESTER COUNTY, NEW JERSEY

REMOVAL ASSESSMENT REPORT

PIONEER METAL FINISHING SITE Franklinville, Jefferson County, New York

August 2018

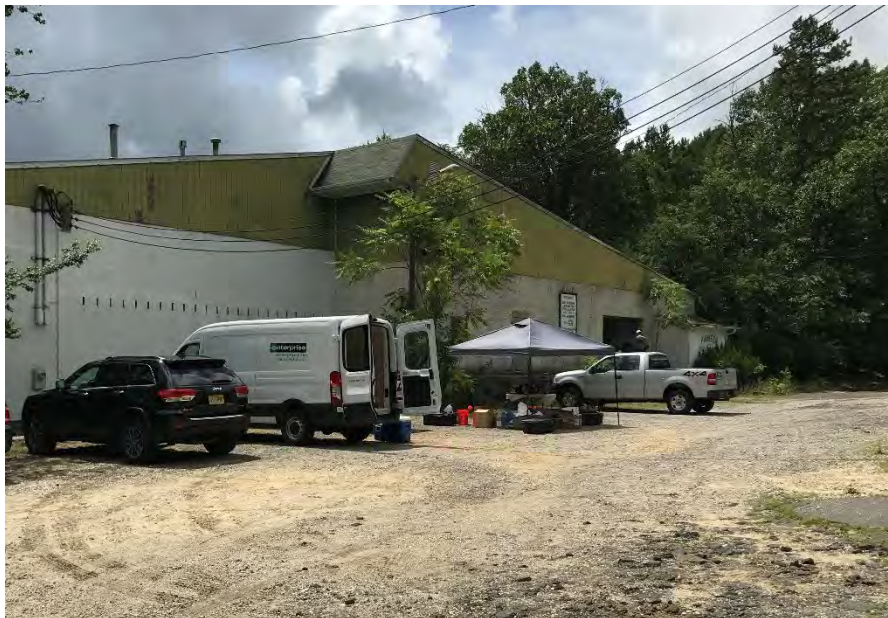
Photograph 1: The U.S. Environmental Protection Agency (EPA) and its Removal Support Team 3 (RST 3) contractor, Weston Solutions, Inc., conducted a Removal Assessment at the Pioneer Metal Finishing Site (the Site). The photograph above is a view of the parking area at the Pioneer Metal Finishing Facility (the Facility).

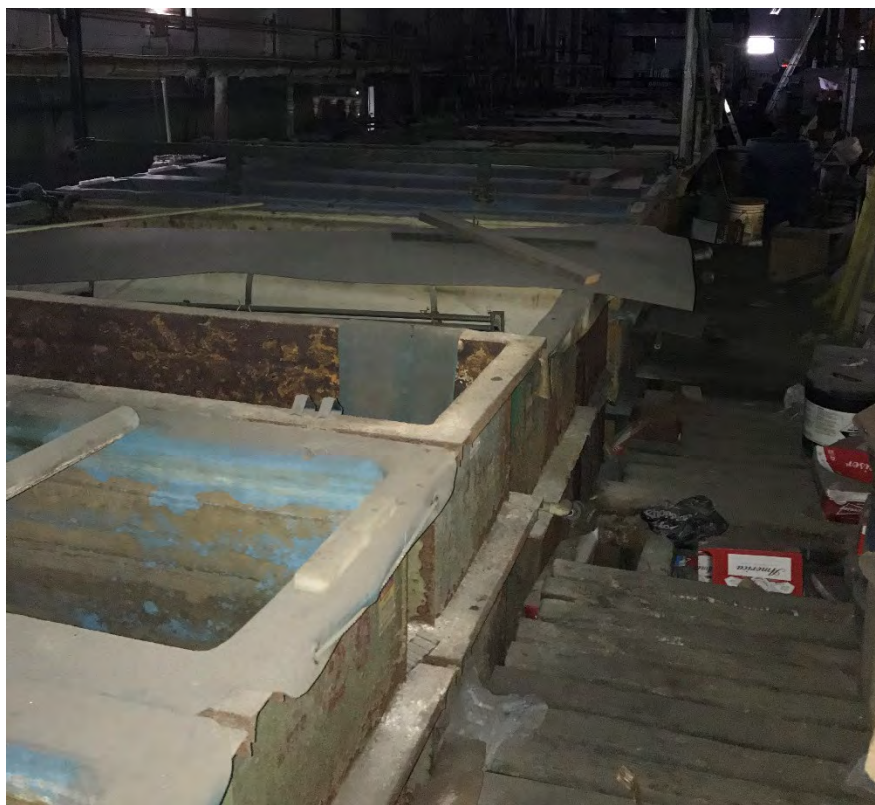
Photograph 2: A view of the plating vats in the former plating area, facing southeast.

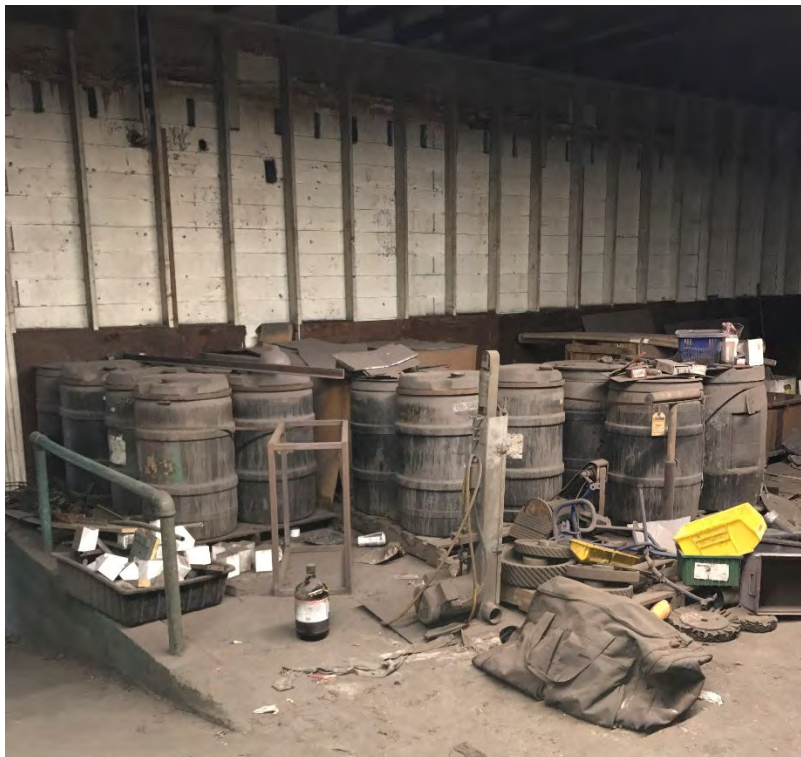
Container No. 0003 is a 55-gallon poly drum located in the storage room near the entrance to the powder coating operation area, with an ammonium hydroxide and corrosive hazard label. The sample collected from Container No. 0003 was a clear, dark-yellow liquid, with a pH of 12.

Photograph 3: A view of several 55-gallon polyethylene (poly) drums with ammonium hydroxide and corrosive hazard labels staged in the storage area near the entrance to the powder coating operation area, facing east.

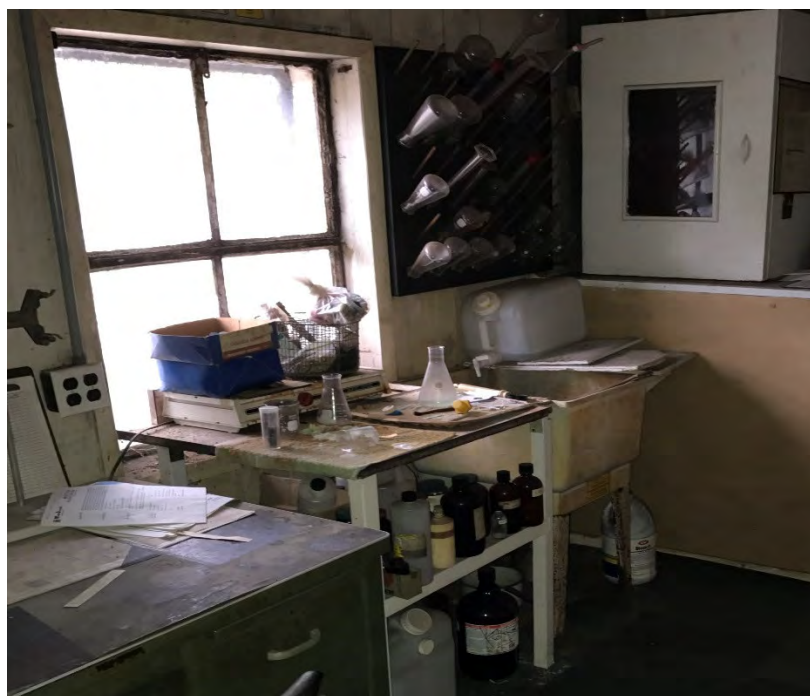
Photograph 4: A view of the former laboratory.

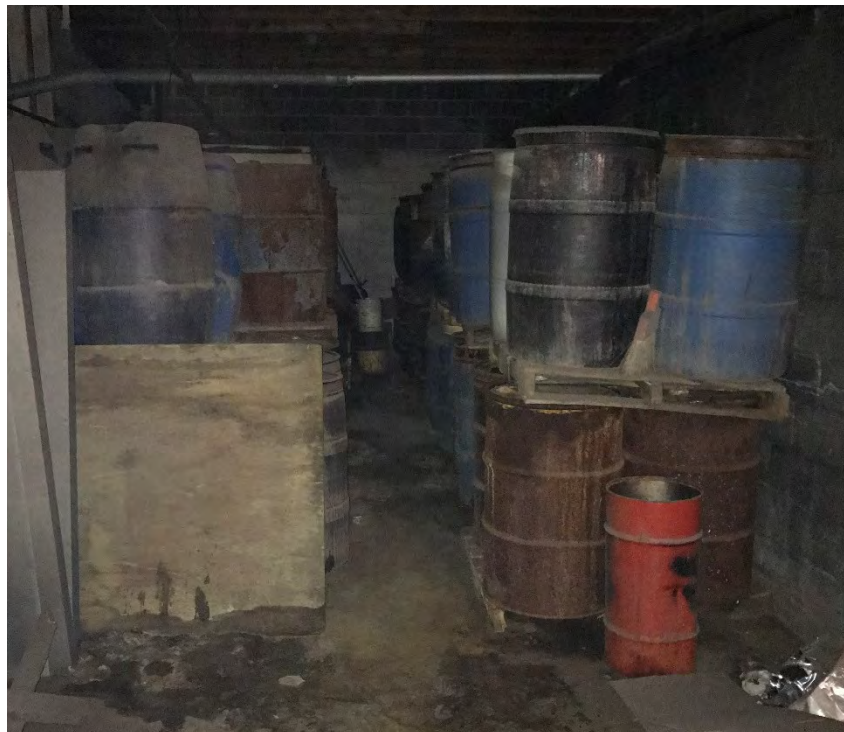
Photograph 5: A view of numerous double stacked 55-gallon drums in the southeastern portion of the storage area, facing southeast.

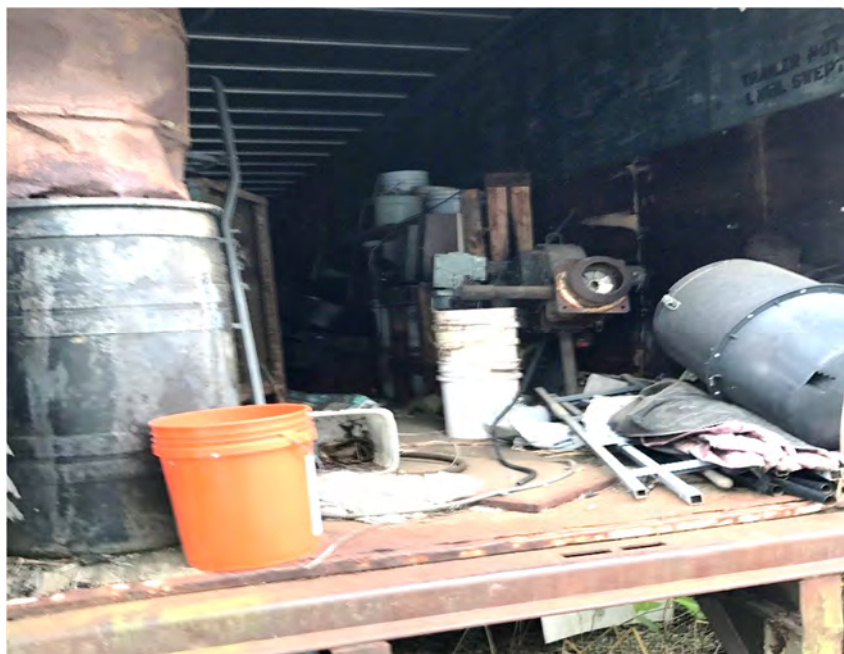
Photograph 6: A view inside one of the two storage trailers which are located immediately northeast of the Facility.

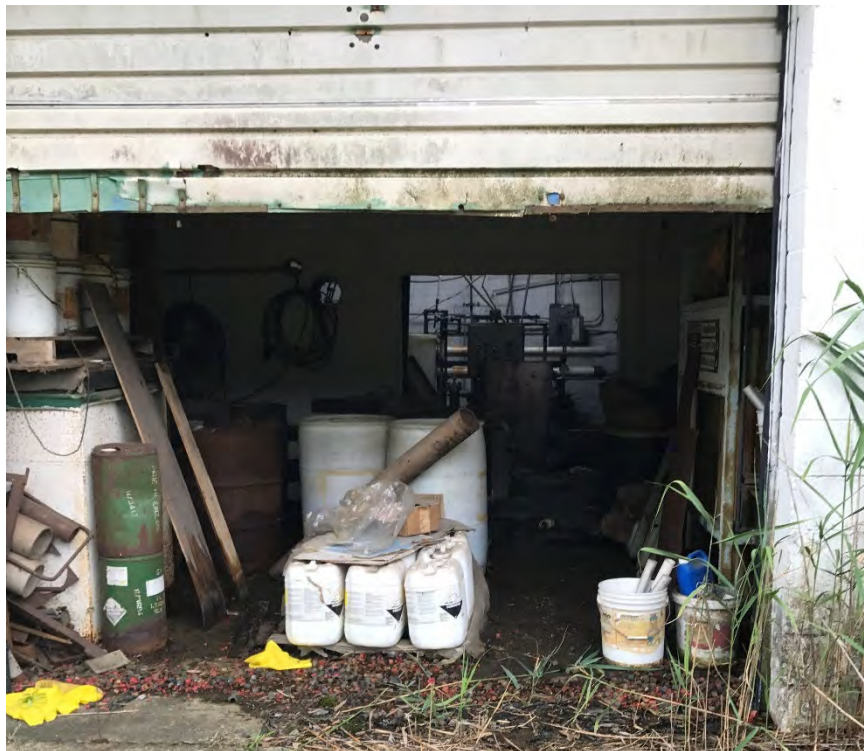
Container No. 0008 is a 5-gallon poly container located in the boiler room near the garage bay door, with a sodium hydroxide and corrosive hazard label. The sample collected from Container No. 0008 was a clear, colorless liquid, with a pH of 13.

Photograph 7: A view of several 5-gallon poly containers with sodium hydroxide and corrosive hazard labels staged in the boiler room near the garage bay door, facing west.

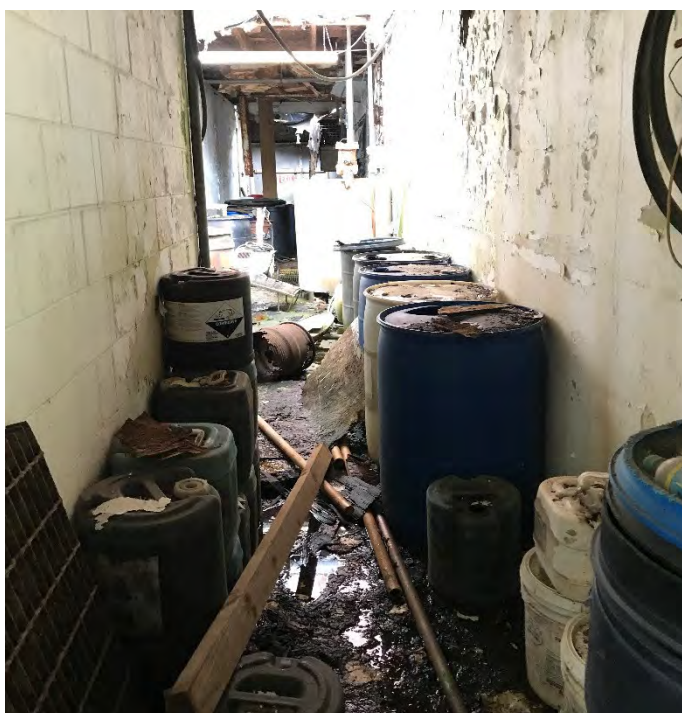
Photograph 8: A view inside of the boiler room, facing north northwest.

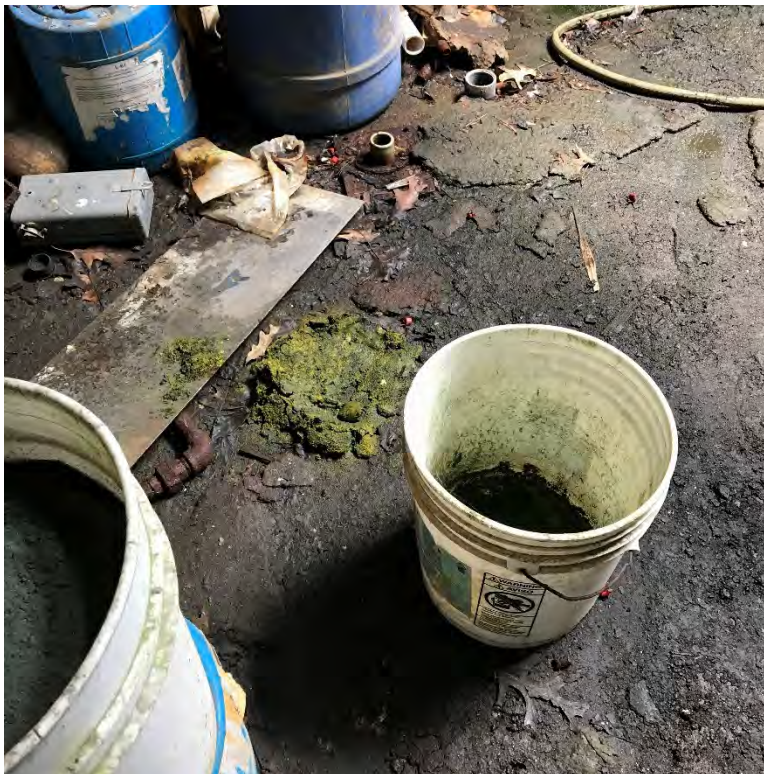
garage bay door. Additional observations in the boiler room and the former wastewater treatment room included yellowish-green sediment-like material on the floor of the boiler room, and several storage and treatment tanks in the former wastewater treatment room, which were used as part of the former wastewater treatment system.

Photograph 9: A view inside of the boiler room where a yellowish-green sediment-like material was observed on the floor.

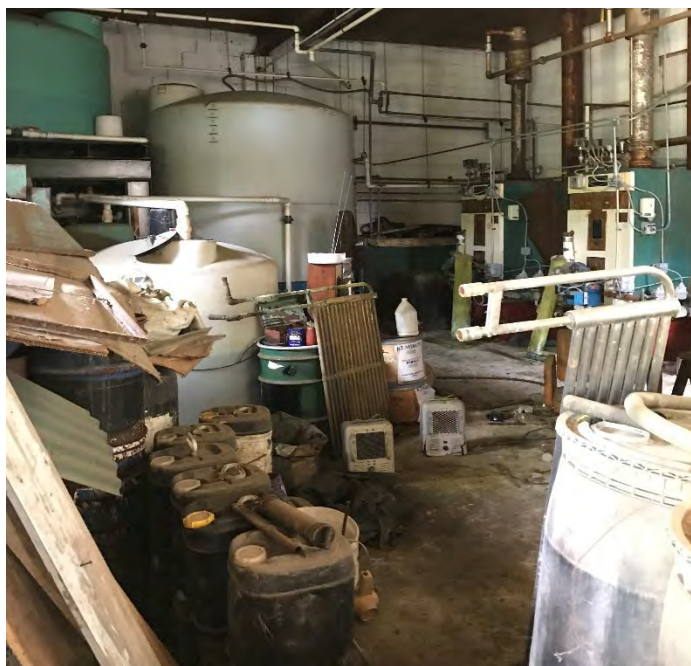
Photograph 10: A view inside of the former wastewater treatment room, facing south.

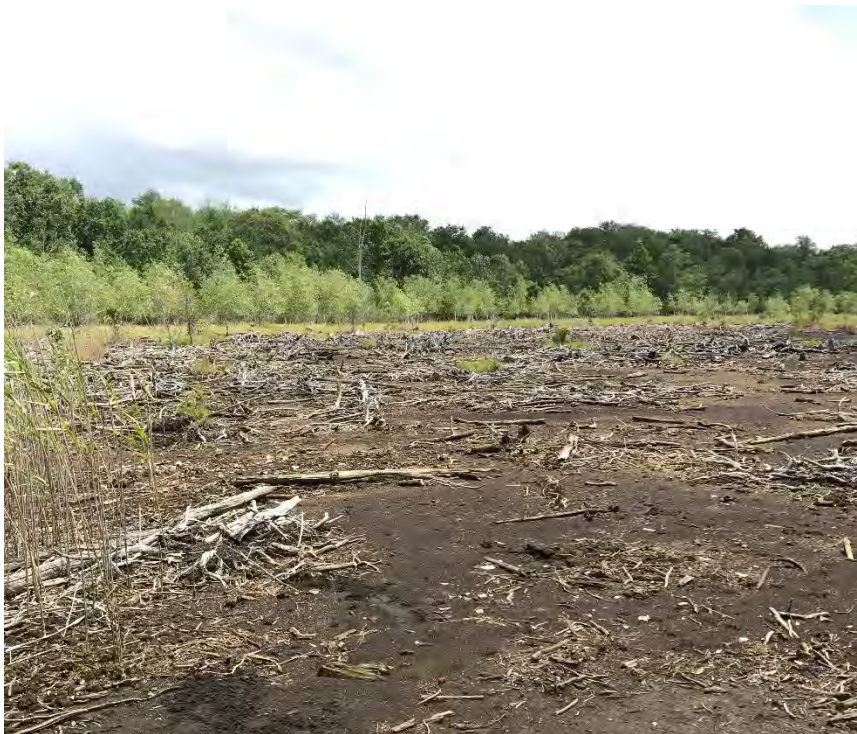
Photograph 11: A view of an area with sparse and dead vegetation located to the east and southeast of the facility, facing southeast.

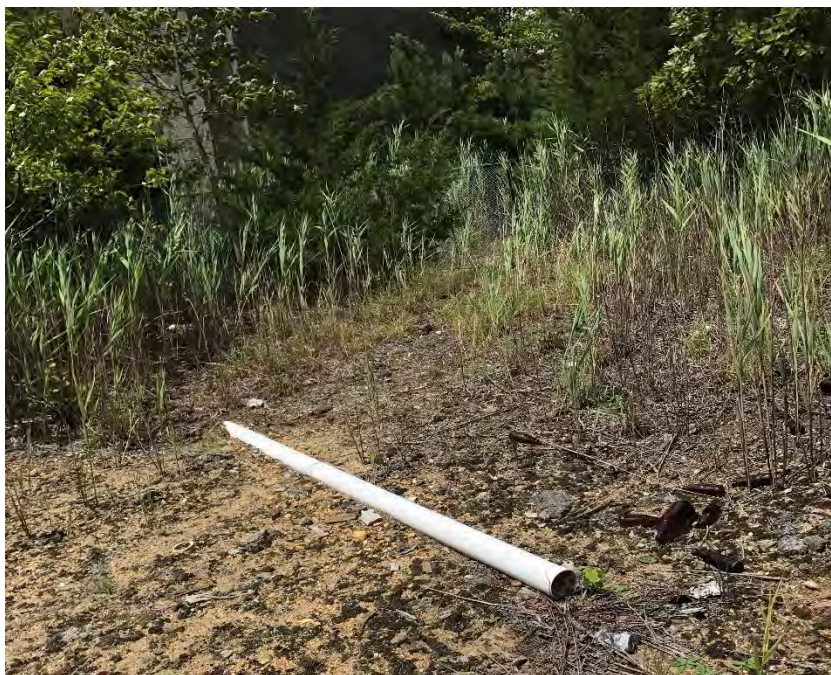
Observations in exterior areas of the Site include two trailers and a drainage pipe located immediately northeast of the Facility. One of the trailers was open, and appeared to be filled with debris and numerous containers, including 55 gallon drums and smaller containers. A drainage pipe was observed, and it extended approximately 60 feet from the former wastewater treatment room to an area of sand and gravel with sparse vegetation.

Photograph 12: A view of the drainage pipe extending approximately 60 feet from the former wastewater treatment room to an area of sand and gravel with sparse vegetation, facing northwest.
